## NPDES Compliance Inspection Report

### Tacoma Yard – DTG Recycle

Tacoma, WA

Inspection Date: February 26, 2021

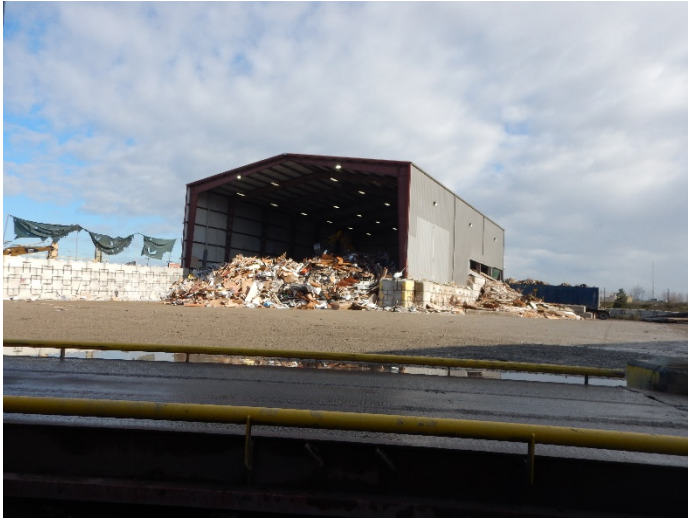
Photo #:01 (DSCN0750)

Description: Facing north, photo of the miscellaneous materials tipping pile near the main operations building.

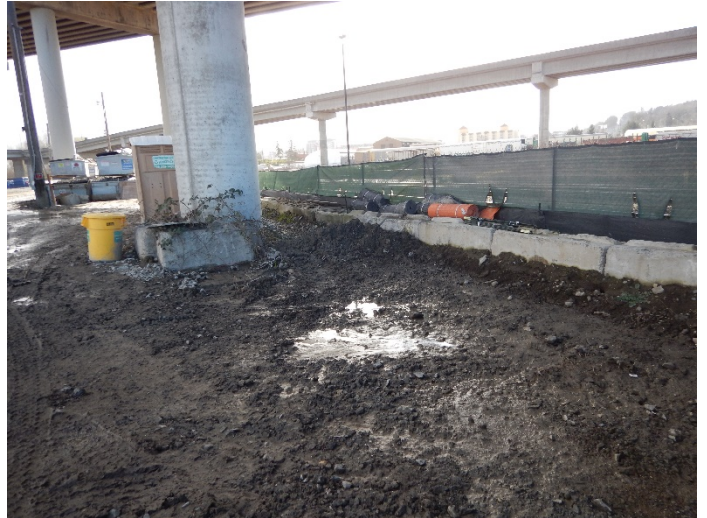
Photo #:02 (DSCN0751)

Description: Facing south, photo of concrete blocks along the property line.

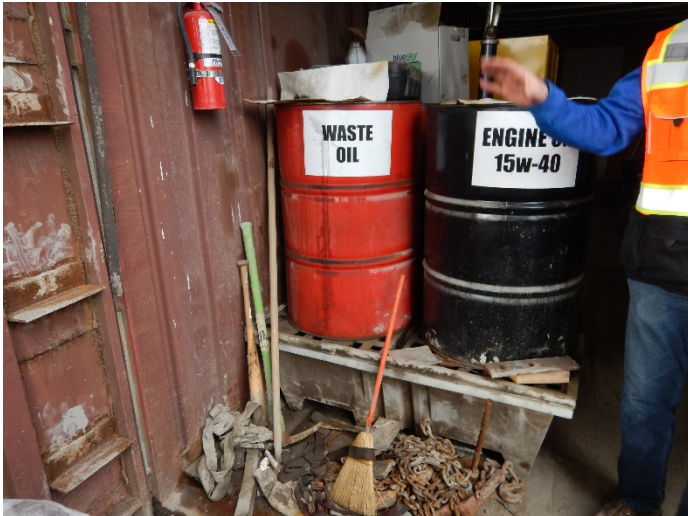
Photo #:03 (DSCN0752)

Description: Photo of materials stored in a freight container.

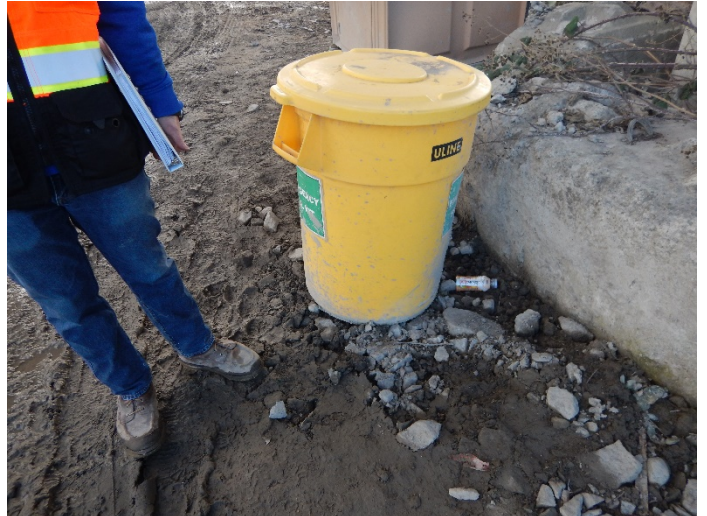
Photo #:04 (DSCN0753)

Description: Facing south, photo of one of the spill kits. Mr. Jerome informed me that there are 5 spill kits on-site.

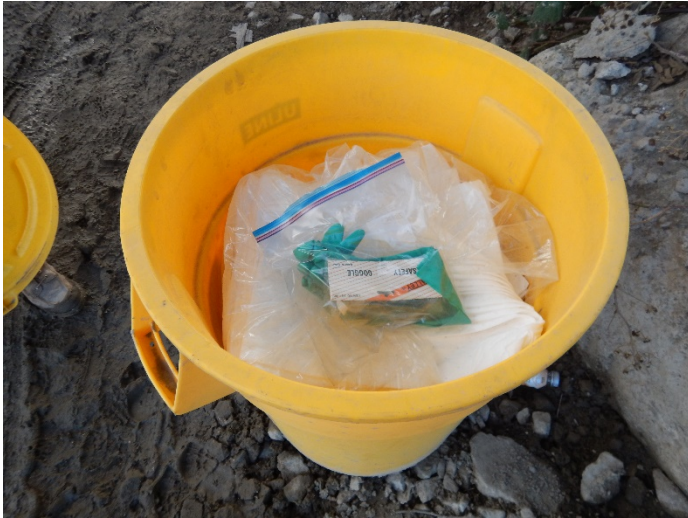
Photo #:05 (DSCN0754)  
Description: Photo of one of the spill kits.

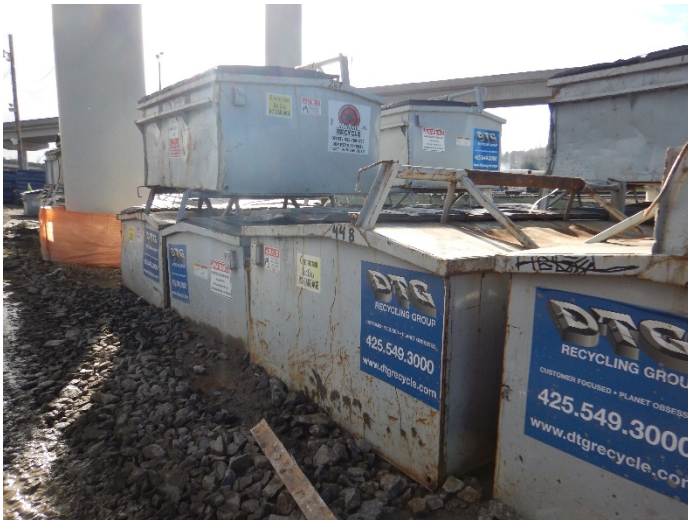
Photo #:07 (DSCN0756)  
Description: Facing southeast, photo of empty product storage containers.

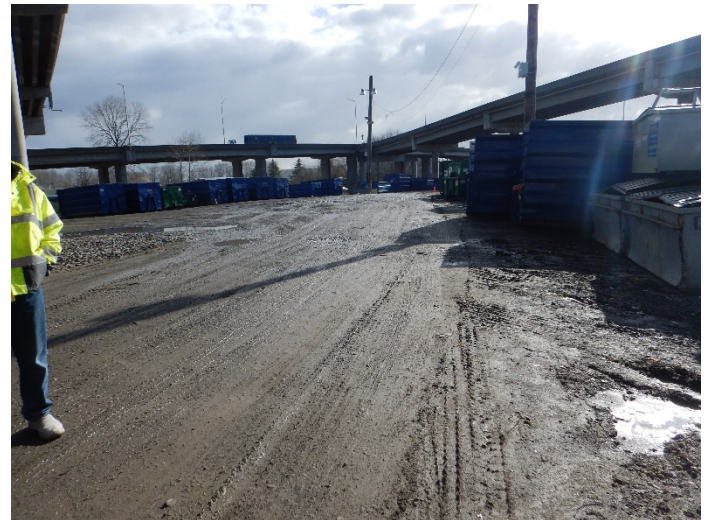
Photo #:08 (DSCN0757)  
Description: Facing southeast, photo of the storage yard area.

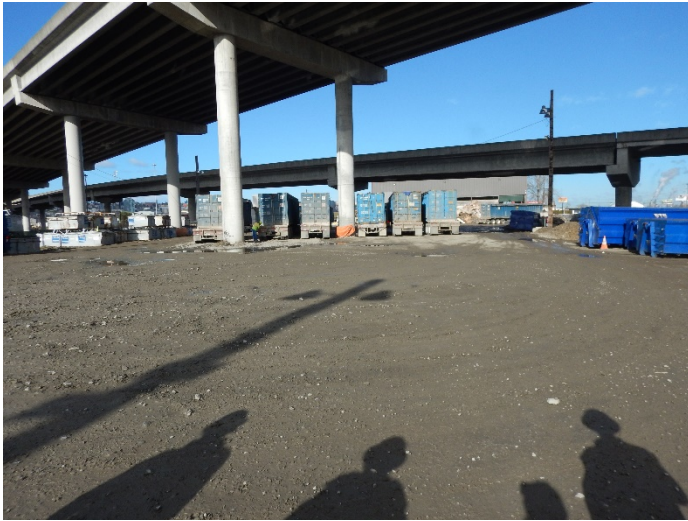
Photo #:15 (DSCN0764)

Description: Facing northwest, photo of freight containers in the storage yard area.

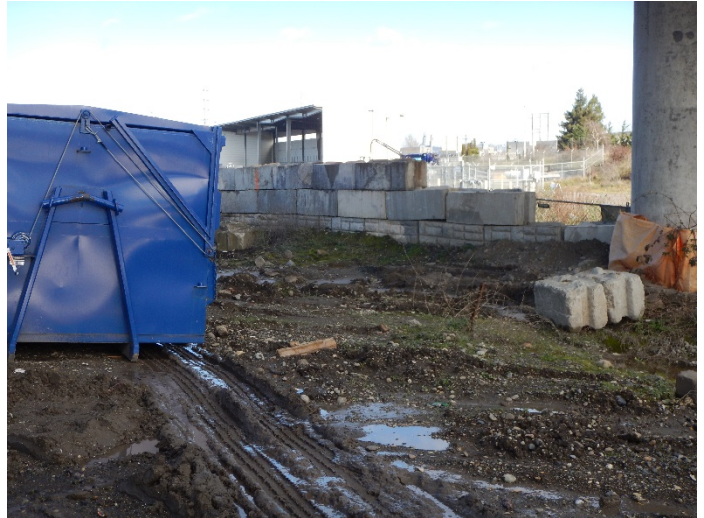
Photo #:18 (DSCN0767)

Description: Facing north, photo of concrete blocks that were installed to act as a barrier around the materials tipping and sorting area.

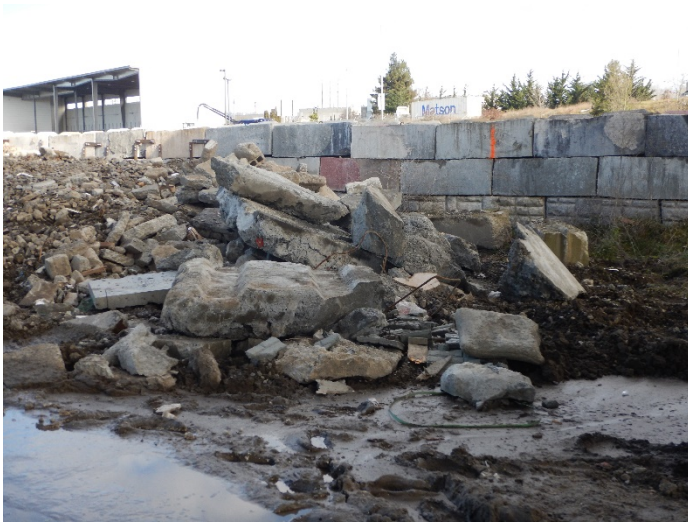
Photo #:19 (DSCN0768)

Description: Facing north, photo of concrete blocks that were installed to act as a barrier around the materials tipping and sorting area.

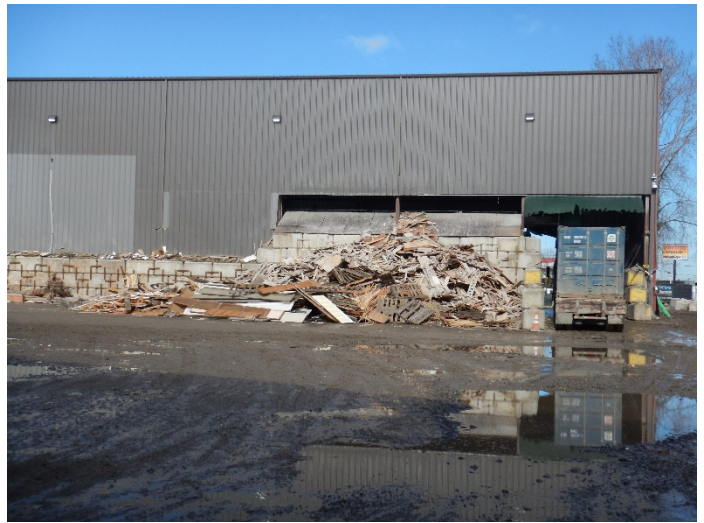
Photo #:20 (DSCN0769)

Description: Facing northwest, photo of the wood tipping pile outside of the main operations building.

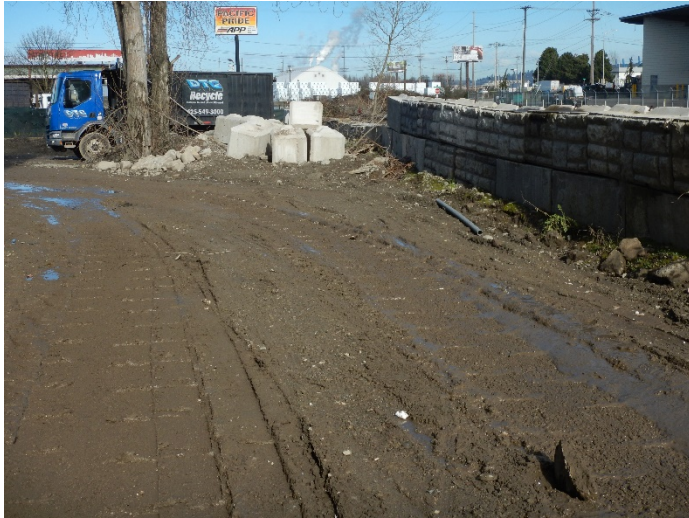
Photo #:21 (DSCN0770)

Description: Facing north, photo of the concrete blocks that were installed to act as a barrier around the materials tipping and sorting area.

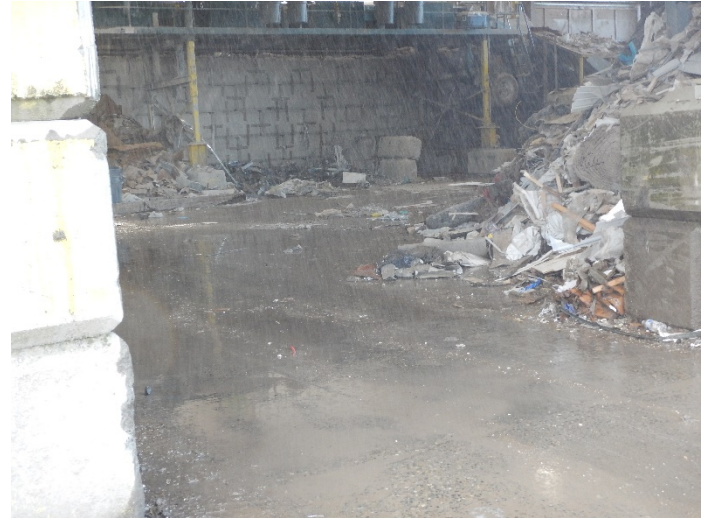
Photo #:22 (DSCN0771)

Description: Facing southeast, photo of the interior of the main operations building. The recently installed drain is located in the middle of the building floor.

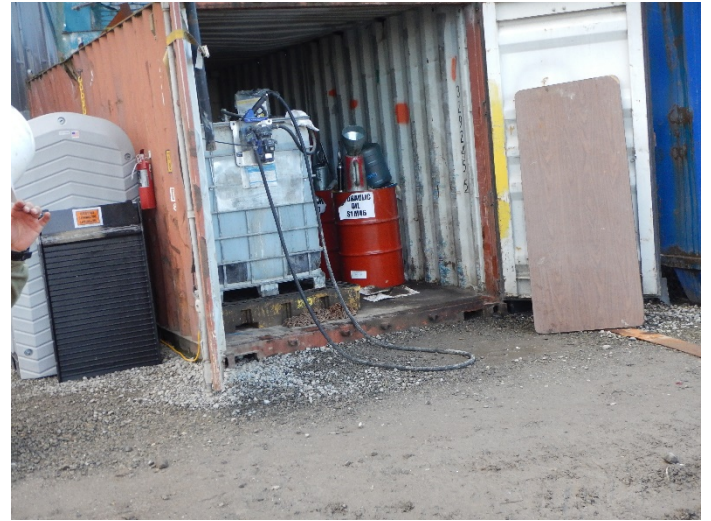
Photo #:24 (DSCN0773)

Description: Facing southeast, photo of materials stored within a freight container.

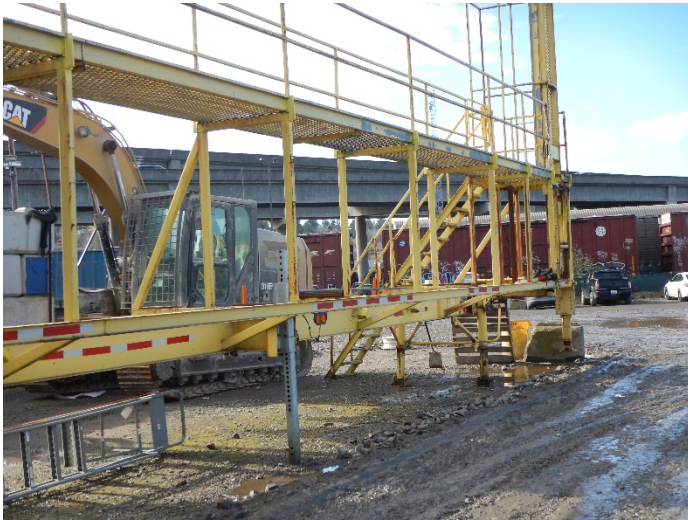
Photo #:25 (DSCN0774)

Description: Facing south, photo of a catwalk and product processing equipment near the main operations building.

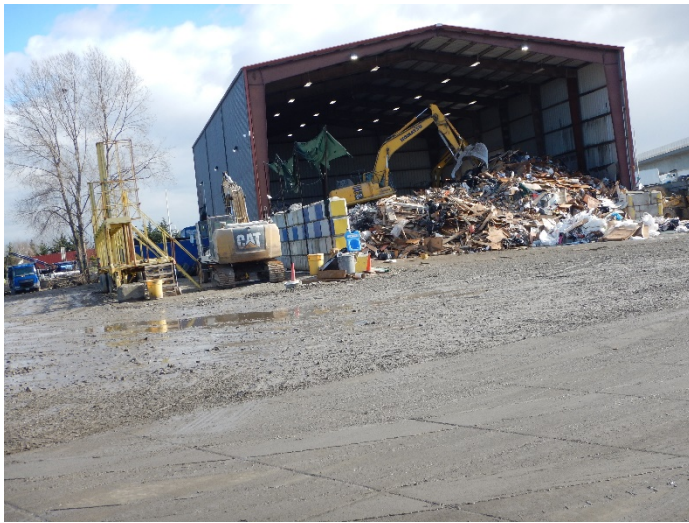
Photo #:31 (DSCN0780)

Description: Facing east, photo of the main operations building, miscellaneous materials tipping pile, and equipment.
