INSPECTION REPORT

| <b>Type of inspection:</b> | CEI - Compliance Evaluation Inspection | | | | |
| <b>Facility or Site Name:</b> | Mt. Orab WWTP | | | | |
| <b>Permit Number:</b> | OH0026646 | | | | |

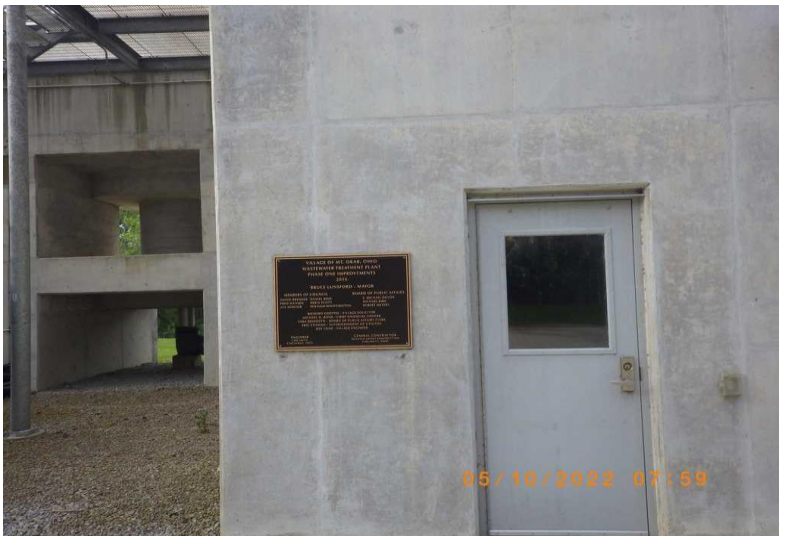
| <p>Pretreatment building</p> <p>RIMG2659.JPG</p> <p>05/10/2022 08:59 AM (ET)</p> <p>Andi Hodaj</p> <p>Pretreatment</p> <p>No CBI</p> <p>No PII</p> <p>Pretreatment building was built in 2016.</p> | |

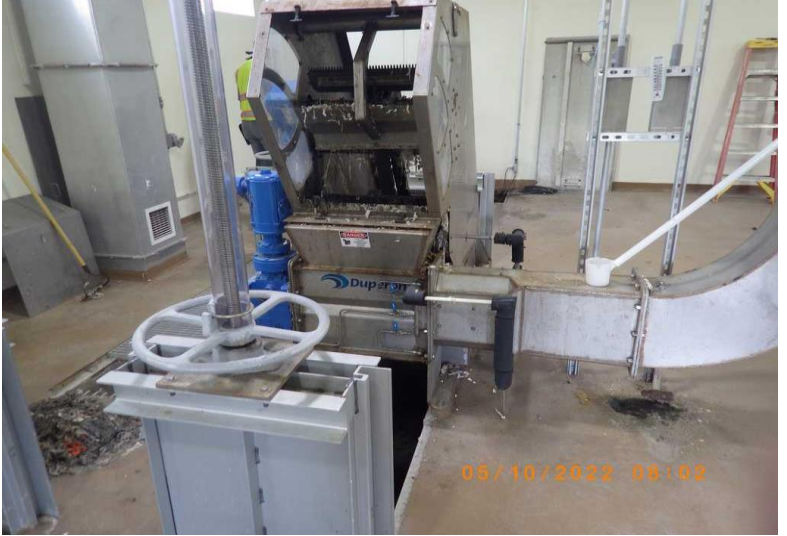
| <p>EPA observed the influent channel, the vortex grit separator, the grit dumpster and the influent autosampler inside the pretreatment building. The grit from the dumpster is taken by Rumpke of Ohio, Inc. (Rumpke) as needed, according to Mr. Standring. The pretreatment building was built in 2016 and also houses the control room. The Facility has a supervisory control and data acquisition (SCADA) system that monitors flows and one of the clarifiers. During the inspection, EPA observed two influent 10" pipes that convey flows from the Villages of Mt. Orab and Hamersville. According to the Facility, it uses geothermal heating to keep pipes from freezing in the pretreatment building. During the inspection, EPA observed a thermometer reading of 5°C at the influent autosampler. From the top of the pretreatment building, EPA observed the EQ tank that was about a quarter full of rain water. Mr. Standring stated that monthly copper samples are taken from both the influent and effluent in order to understand what has caused recent copper limit exceedances in the effluent. Mr. Standring stated that based on the data so far, increased copper concentrations were due to the copper sulfate that was added at the drinking water treatment plant for algae control. Since the drinking water plant substituted the copper sulfate with ultrasonic radiation to treat for algae, no high copper readings have occurred at the Facility since November 2021.</p> | |

| <p>Influent channel</p> <p>RIMG2660.JPG</p> <p>05/10/2022 09:02 AM (ET)</p> <p>Andi Hodaj</p> <p>Pretreatment</p> <p>No CBI</p> <p>No PII</p> <p>Influent channel and bar screen inside the pretreatment building.</p> | |

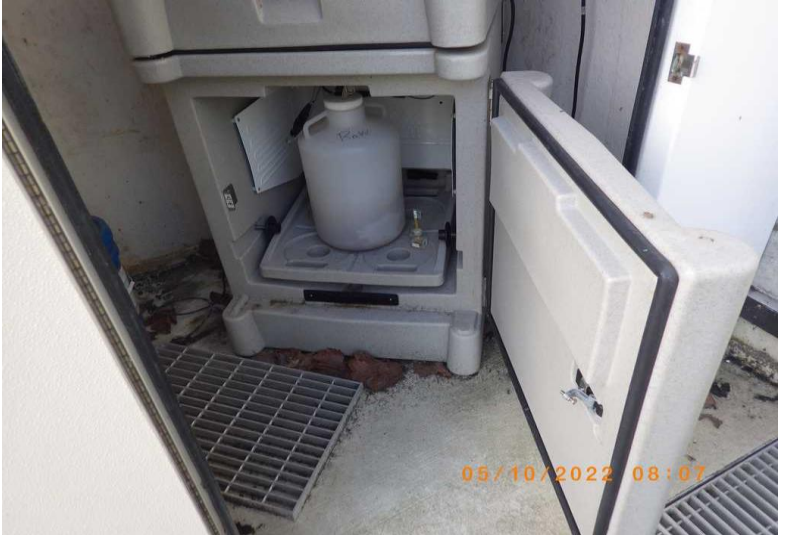
| <p>Influent autosampler</p> <p>RIMG2661.JPG</p> <p>05/10/2022 09:07 AM (ET)</p> <p>Andi Hodaj</p> <p>Pretreatment</p> <p>No CBI</p> <p>No PII</p> <p>Influent autosampler and the thermometer inside it in the pretreatment building.</p> | |

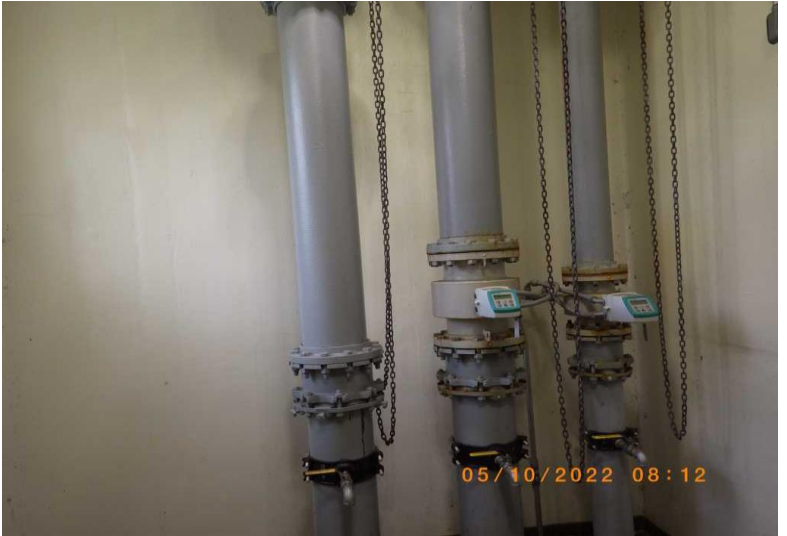
| <p>Inflow pipes</p> <p>RIMG2662.JPG</p> <p>05/10/2022 09:12 AM (ET)</p> <p>Andi Hodaj</p> <p>Pretreatment</p> <p>No CBI</p> <p>No PII</p> <p>Inflow pipes, from left to right: for future expansion, from Mt. Orab and from Hamersville.</p> | |

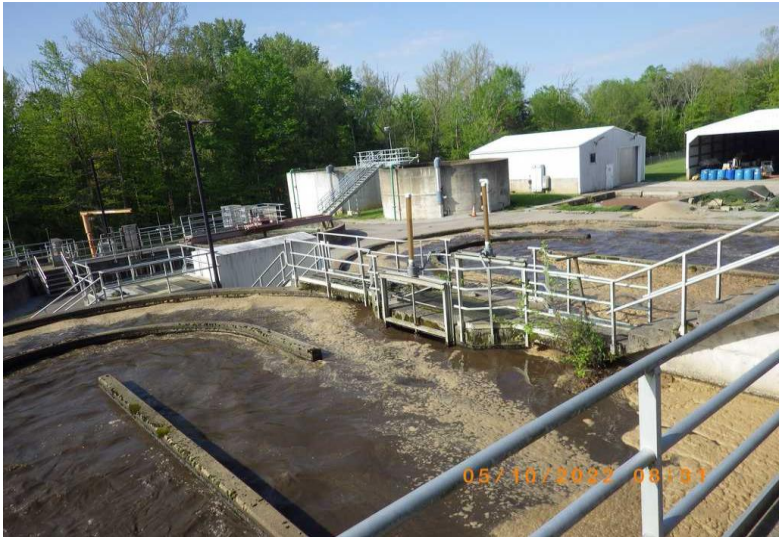
| Oxidation ditches | |

From pretreatment, wastewater is routed to the oxidation ditches. The oxidation ditches are a modified activated sludge biological treatment that provide longer retention time to remove organics. Wastewater from the oxidation ditches flows into a splitter box that splits the flow equally among three clarifiers. Mr. Standing stated that one of the clarifiers was constructed in 2008, and the other two were constructed earlier. EPA observed floating foam and solids on the two older clarifiers. Return flow from the clarifiers goes back to the oxidation ditches, and effluent from the clarifiers flows into the UV channel for disinfection. Effluent flow is measured at the UV channel. EPA observed a discharge of 546 gallons per minute from the flowmeter at the time of the inspection. According to Mr. Standing, the flowmeter is calibrated annually. Flow from the UV channel is directed to the post aeration tank and the cascade aerator and from there to outfall 001. At the bottom of cascading stairs there is a bypass pipe on the south side of the channel that is used when bypass of the post aeration tank is needed for maintenance.

| Oxidation ditches. Camera looking southwest. | |

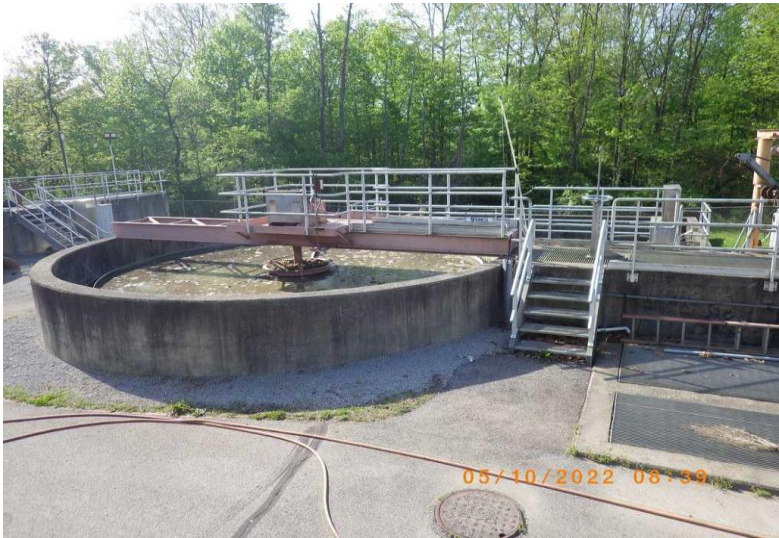
| Clarifier | |

| EPA observed floating foam and solids on the two older clarifiers. |

| One of the three clarifiers. Camera looking Southeast. | |

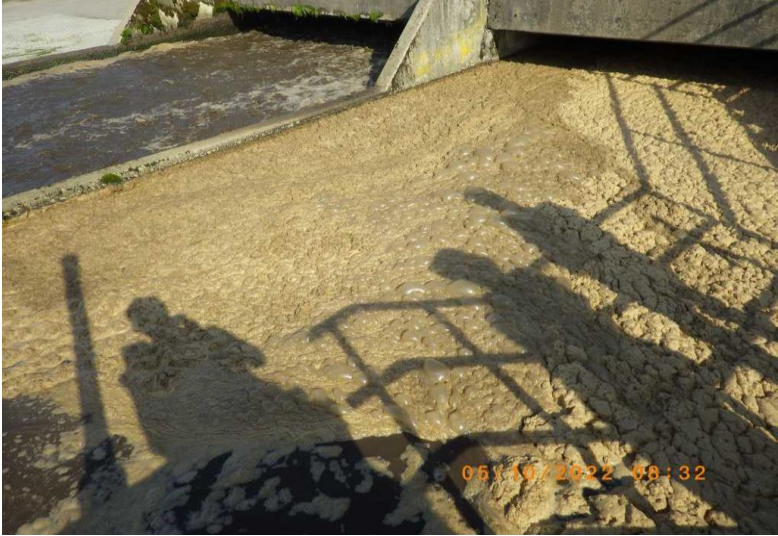
| Oxidation ditch | |

| The west oxidation ditch. Camera looking northwest. | |

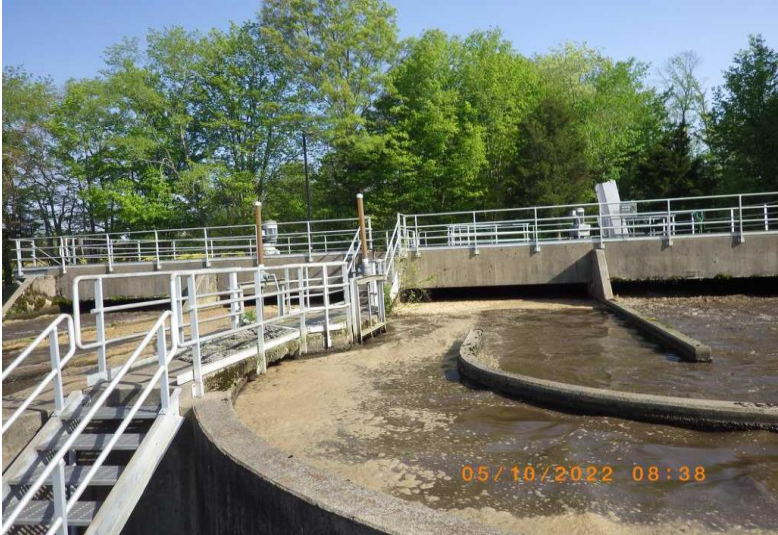
| Oxidation ditches | |

| Oxidation ditches. Camera looking north. | |

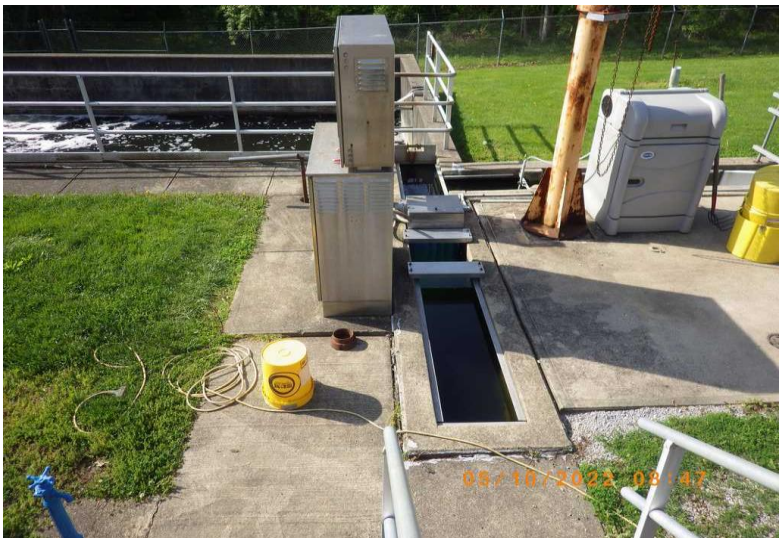
| UV disinfection | |

| UV disinfection channel. Camera looking south. | |

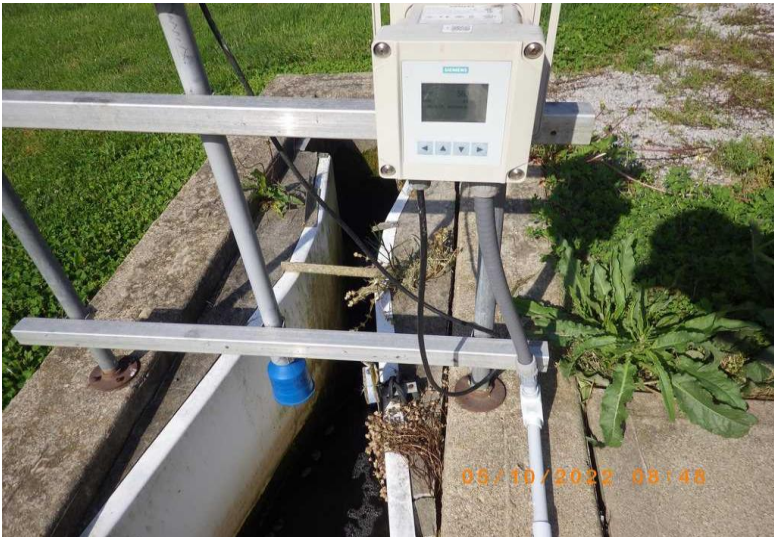
| Flow meter | |

| Effluent flow meter. Camera looking south. | |

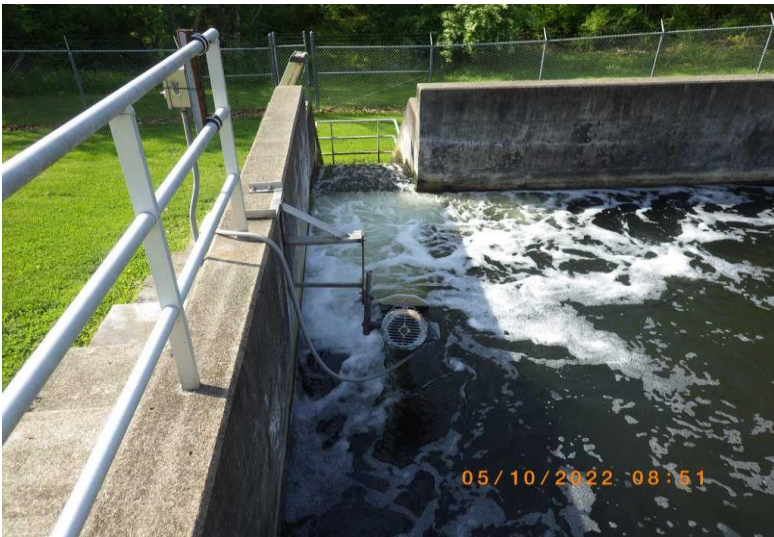
| Post aeration tank | |

| Post aeration tank and the top of the cascade aerator. Camera looking southwest. | |

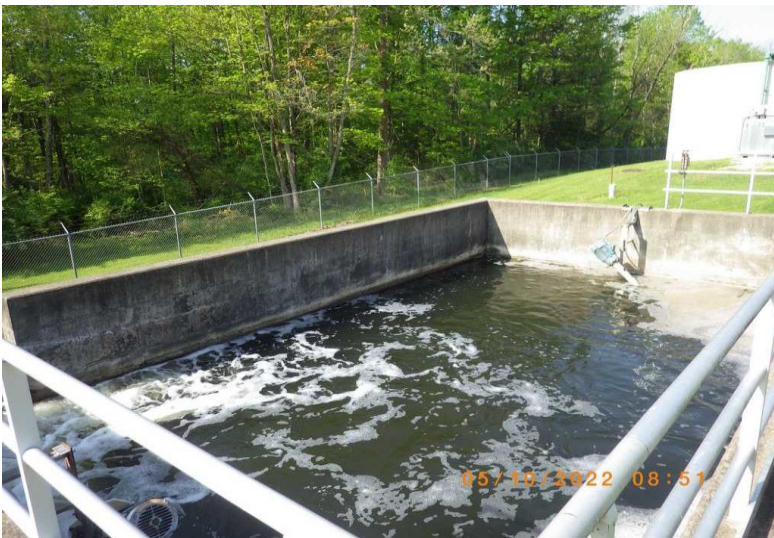
| Post aeration tank | |

| Post aeration tank. Camera looking southwest. | |

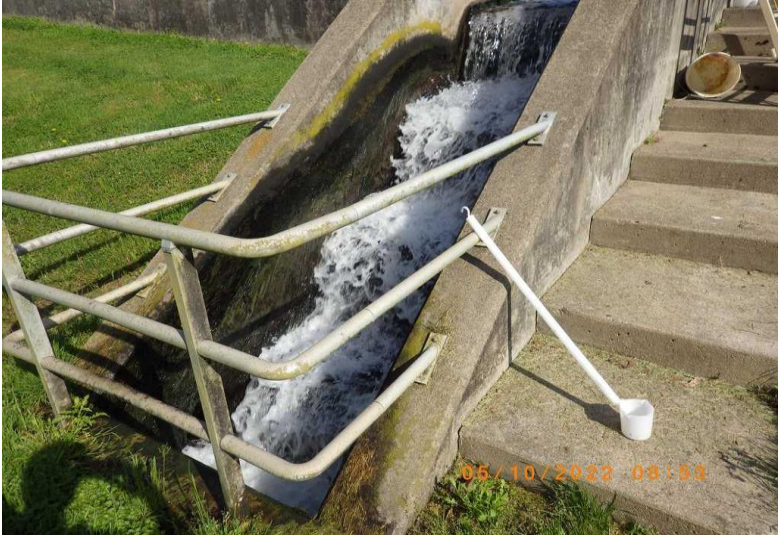
| Cascade aerator | |

| Cascade aerator. Camera looking northwest. | |
