**UNITED STATES ENVIRONMENTAL PROTECTION AGENCY  
REGION III**

**Report Title:** Clean Water Act, Section 404 Inspection Report for Rosedale Development Site  
**Inspection Date(s):** 06/29/2023  
**Start Time:** 8:00AM **End Time:** 10:45AM  
**Regulatory Program(s):** Inspections authorized pursuant to Clean Water Act, Sections 308 and 404 (33 U.S.C. §§ 1318 and 1344)  
**Site Name:** Rosedale Development Site  
**Site Location:** 1600 Graves Mill Road  
Lynchburg, Virginia 24502  
**Latitude:** 37.3762 **Longitude:** -79.2315  
**County/Parish:** City of Lynchburg  
**Site Owner(s):** Rosedale Investments, LLC  
T.B.P. Properties, LLC  
**Mailing Address:** P.O. Box 148  
Forest, Virginia 24551  
**Unique Project #:** 3E23WW039A

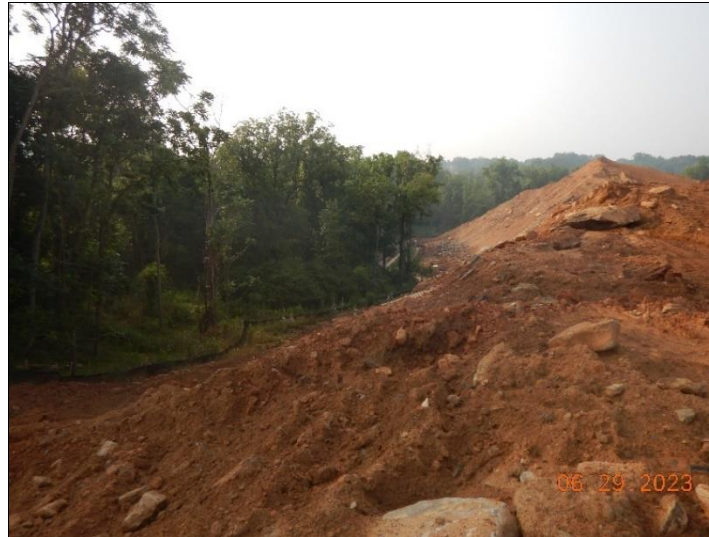
Rosedale Development Site  
Date: 29 June 2023  
Photo ID: DSCN4698.JPG  
Photo taken by: Katelyn Almeter

Notes: Eastward facing view of stockpiled soil along the eastern side of the Site with a silt fence located at the foot of the pile.

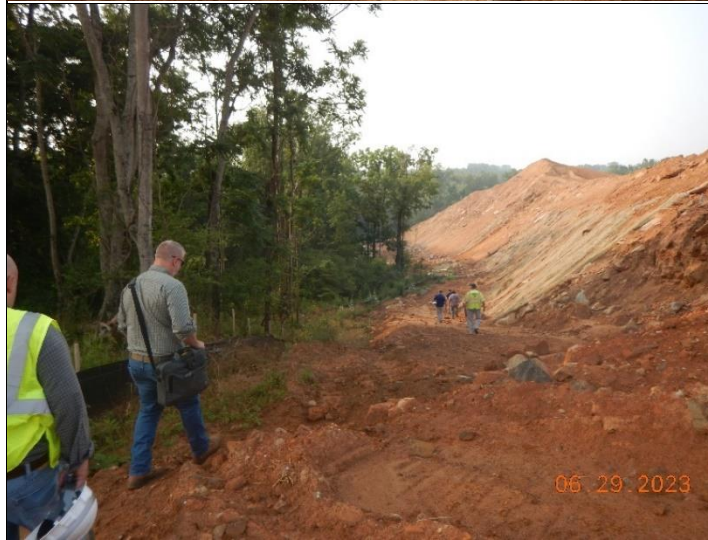
Rosedale Development Site  
Date: 29 June 2023  
Photo ID: DSCN4699.JPG  
Photo taken by: Katelyn Almeter

Notes: Eastward facing view of stockpiled soil along the eastern side of the Site.

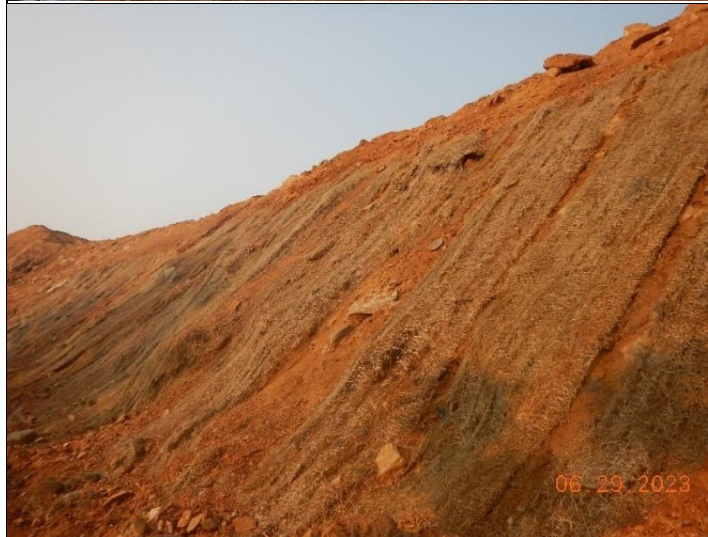
Rosedale Development Site  
Date: 29 June 2023  
Photo ID: DSCN4700.JPG  
Photo taken by: Katelyn Almeter

Notes: View from the foot of the stockpiled soil looking up.

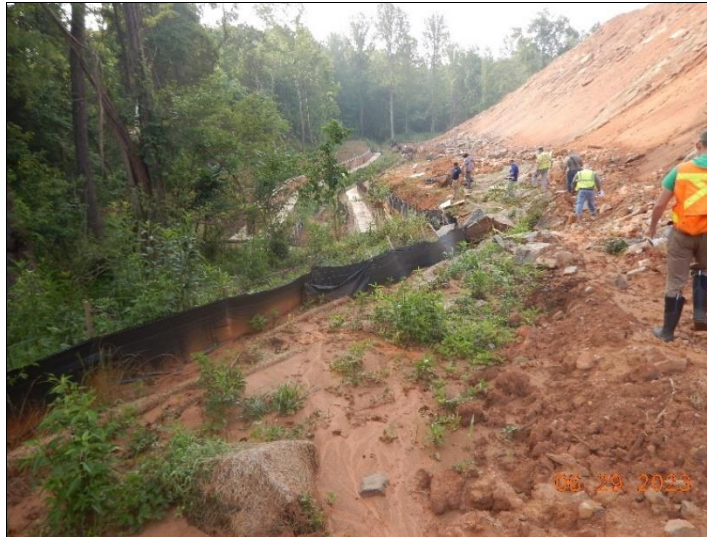
Rosedale Development Site  
Date: 29 June 2023  
Photo ID: DSCN4701.JPG  
Photo taken by: Katelyn Almeter

Near the northeastern limits of disturbance, the inspection walkthrough approached the upstream end of a stream, Unnamed Tributary 1 (UNT1) (DSCN4701). Earthmoving activity occurred in the area of UNT1 and a steeply sloped, unvegetated fill pile ran along the right descending bank (DSCN4700 and DSCN4701). Concrete abutments were observed to have been constructed at the base of the fill slope and along the limits of disturbance (DSCN4702; DSCN4704; DSCN4705). Silt fence was also present along the concrete abutments. UNT1 was observed between the two concrete abutments in a channel that contained significant sediment. Mr. Cyrus stated that the silt fence was installed prior to construction activity. UNT1 was observed to have flow originating from a groundwater seep with the presence of iron oxidizing bacteria (DSCN4702; DSCN4719). Saturated, fine sediment was observed in the stream channel (DSCN4705; DSCN4710; DSCN4713; DSCN4714; DSCN4723; DSCN4732).

Notes: Eastward facing view of silt fence along the foot of the stockpile of soil.  
Note the concrete abutments.

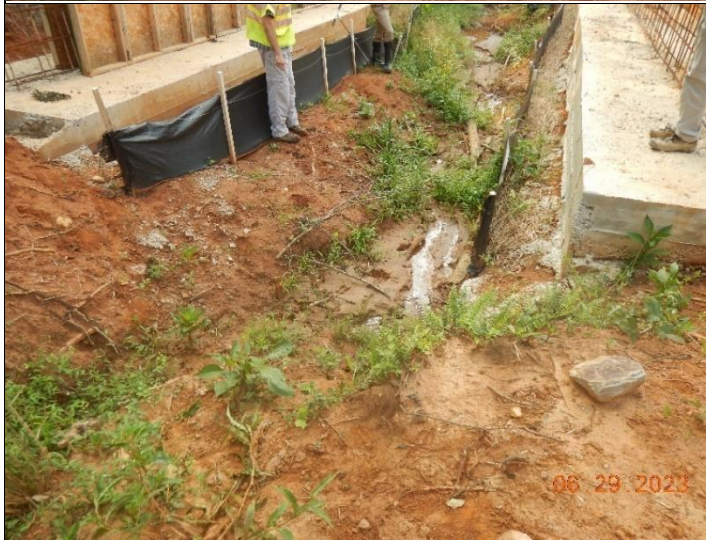
Rosedale Development Site  
Date: 29 June 2023  
Photo ID: DSCN4702.JPG  
Photo taken by: Katelyn Almeter

Notes: View of UNT1 and concrete abutments.

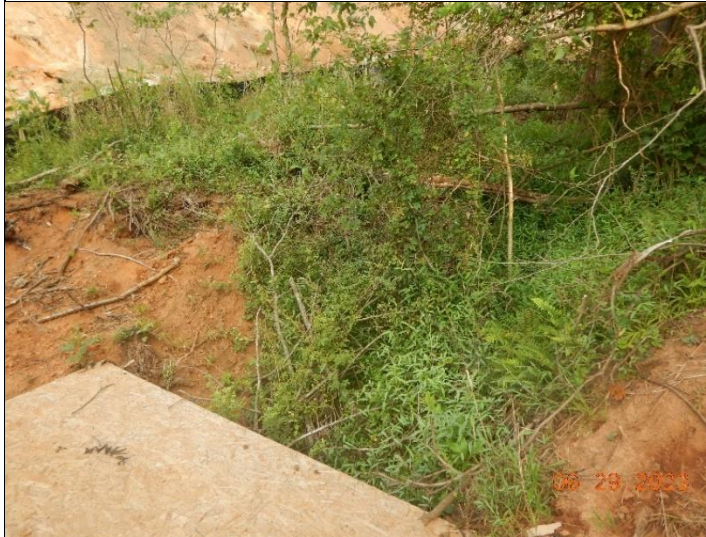
Rosedale Development Site  
Date: 29 June 2023  
Photo ID: DSCN4703.JPG  
Photo taken by: Katelyn Almeter

Notes: Looking west upslope of UNT1.

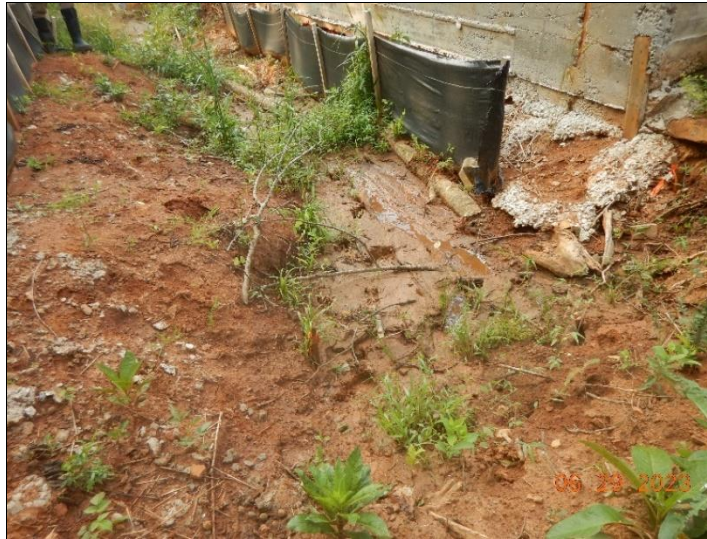
Rosedale Development Site  
Date: 29 June 2023  
Photo ID: DSCN4704.JPG  
Photo taken by: Katelyn Almeter

Notes: View of the head of UNT1 with the discharged material along the bank and the bed of the tributary.

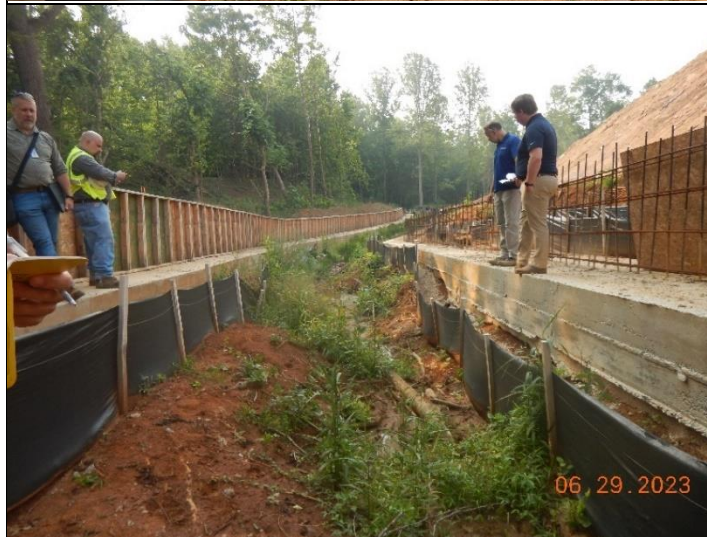
Rosedale Development Site  
Date: 29 June 2023  
Photo ID: DSCN4706.JPG  
Photo taken by: Katelyn Almeter

Notes: View looking downstream of UNT1 bordered by silt fence on either side. Note discharged material present on the tributary side of the silt fence.

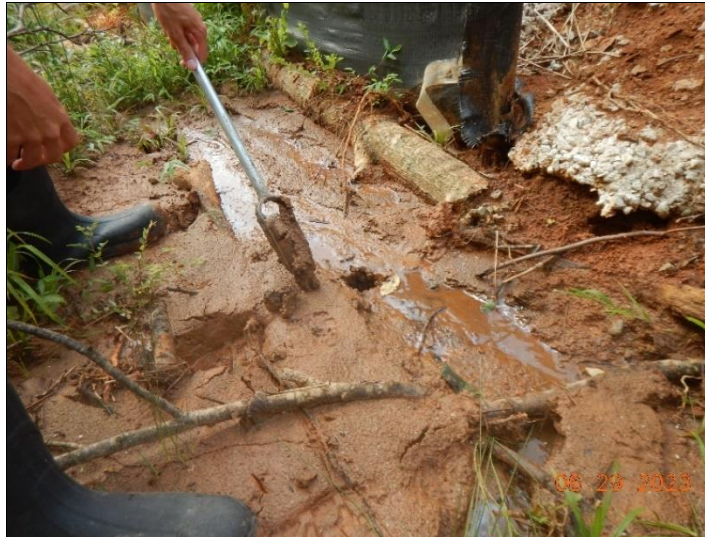
Rosedale Development Site  
Date: 29 June 2023  
Photo ID: DSCN4707.JPG  
Photo taken by: Katelyn Almeter

A soil boring was taken in the bed of the channel of UNT1 near the western end of the concrete abutments (DSCN4707). Approximately 11 inches of sediment were observed in the profile above natural surface (DSCN4709). The soil profile was described as a mixed matrix with a silty sand texture consisting of 80% 7.5YR3/3 and 20% 2.5YR4/6 with small rocks present in the profile approximately 0.5 inches to 1.75 inches in size. In the soil profile below 11 inches the soil was described as 75% 7.5YR6/1 with 10% 7.5YR6/6, 10% 5YR5/6 redoximorphic concentrations and 5% 5YR2.5/2 redoximorphic concentrations. Soils displayed a depleted matrix. The water table was present above the surface of the boring with a depth of water in above the surface approximately 1.5 inches. A VADEQ representative took a measurement in a different section of the channel and measured 6 inches of sediment near the thalweg.

Notes: View of a soil boring from the bed of UNT1.

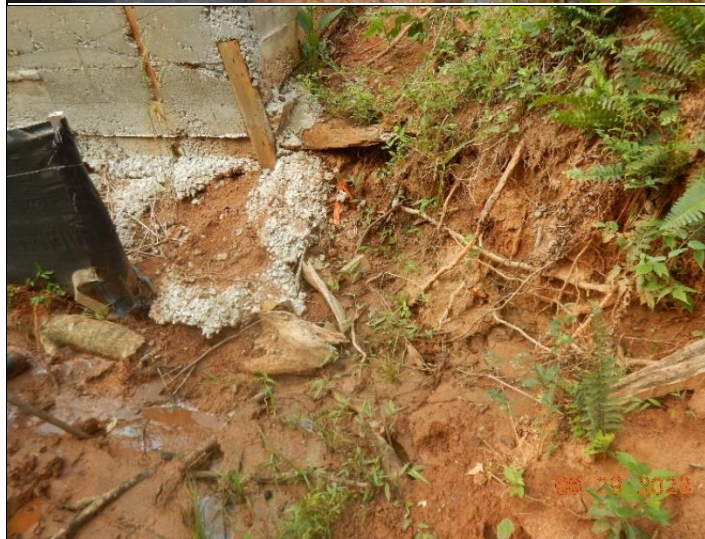
Rosedale Development Site  
Date: 29 June 2023  
Photo ID: DSCN4708.JPG  
Photo taken by: Katelyn Almeter

Notes: View showing the exposed roots of woody vegetation next to the concrete abutment along the bank of UNT1.

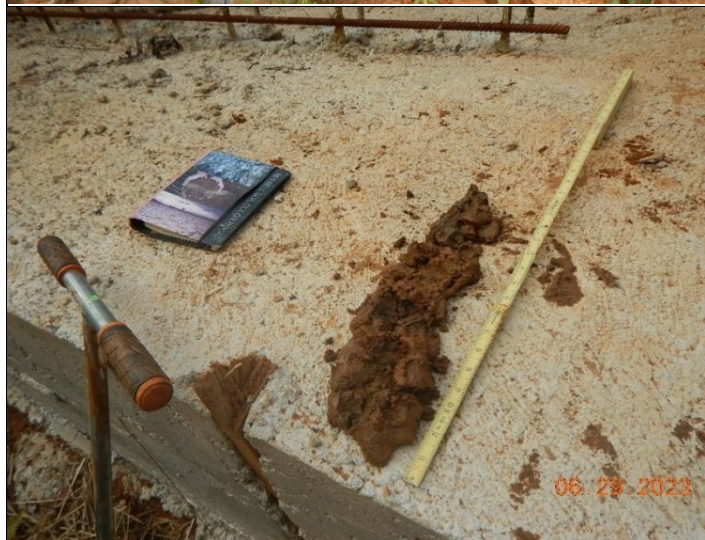
Rosedale Development Site  
Date: 29 June 2023  
Photo ID: DSCN4709.JPG  
Photo taken by: Katelyn Almeter

Notes: View of soil boring.

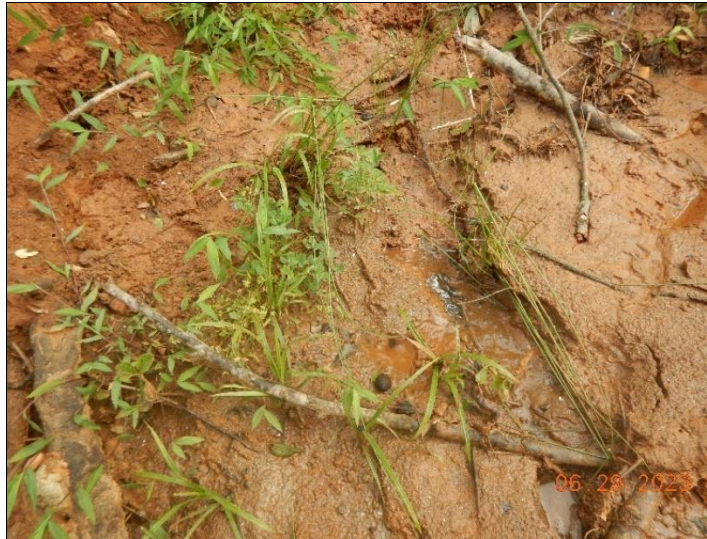
Rosedale Development Site  
Date: 29 June 2023  
Photo ID: DSCN4710.JPG  
Photo taken by: Katelyn Almeter

Notes: View of discharged material on the bank of and in the stream bed UNT1.

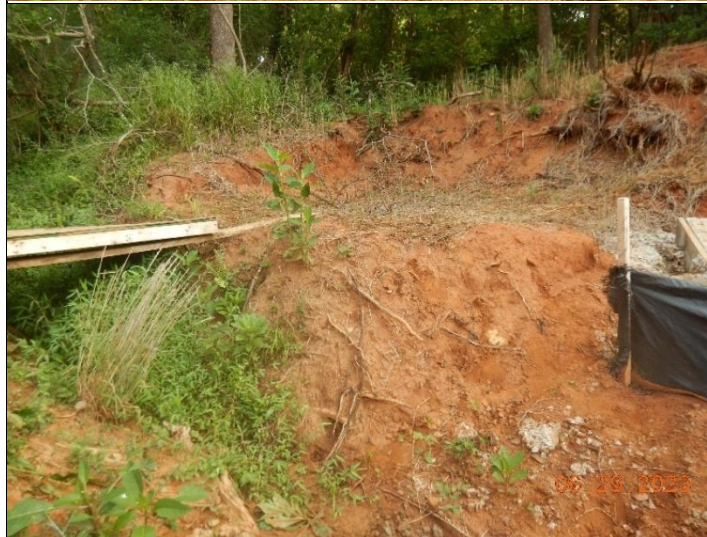
Rosedale Development Site  
Date: 29 June 2023  
Photo ID: DSCN4711.JPG  
Photo taken by: Katelyn Almeter

Notes: View of eroded area adjacent to UNT1 with exposed roots of woody vegetation.

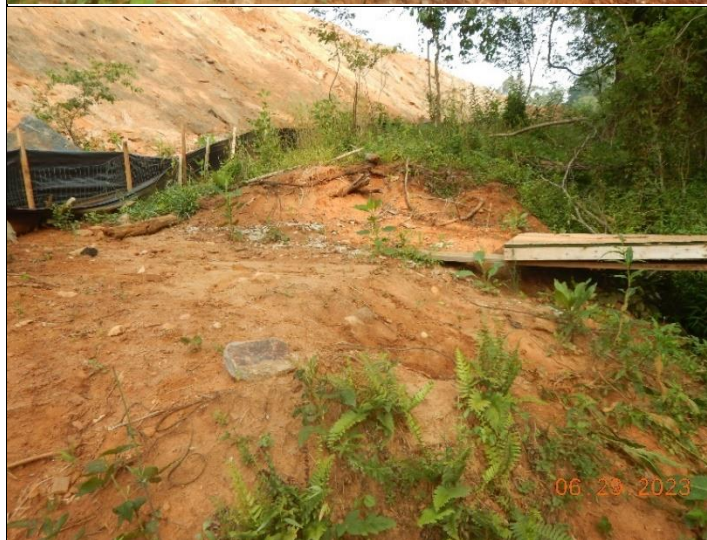
Rosedale Development Site  
Date: 29 June 2023  
Photo ID: DSCN4712.JPG  
Photo taken by: Katelyn Almeter

Notes: Northwest view of the foot of the stockpile of soil. Note the presence of fill material downgradient of the silt fence.

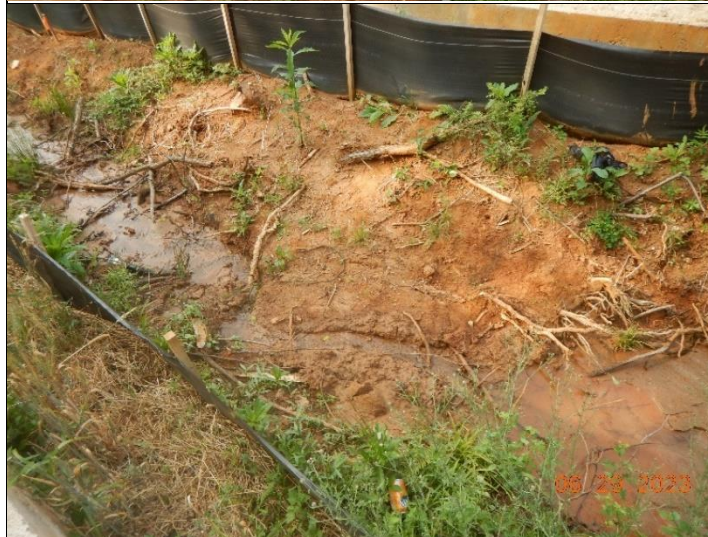
Rosedale Development Site  
Date: 29 June 2023  
Photo ID: DSCN4715.JPG  
Photo taken by: Katelyn Almeter

Notes: view of exposed roots of woody vegetation along the bank of UNT1. Note the absence of the woody vegetation.

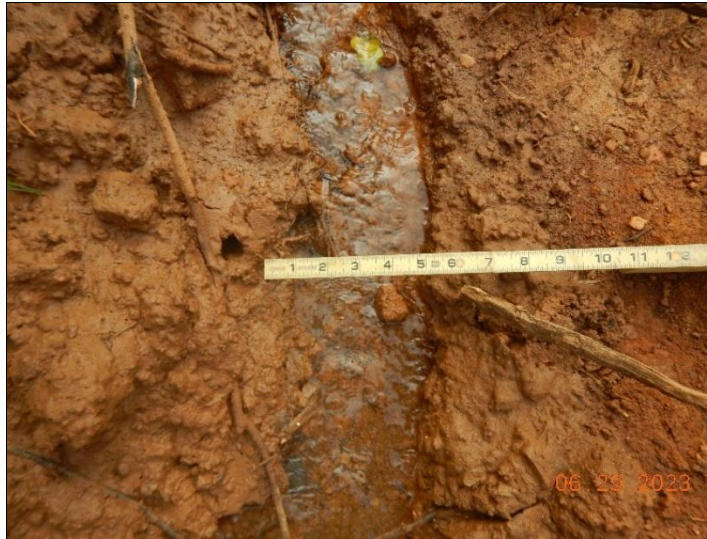
Rosedale Development Site  
Date: 29 June 2023  
Photo ID: DSCN4716.JPG  
Photo taken by: Katelyn Almeter

Notes: Measurement of UNT1 as it flows between the concrete abutments.

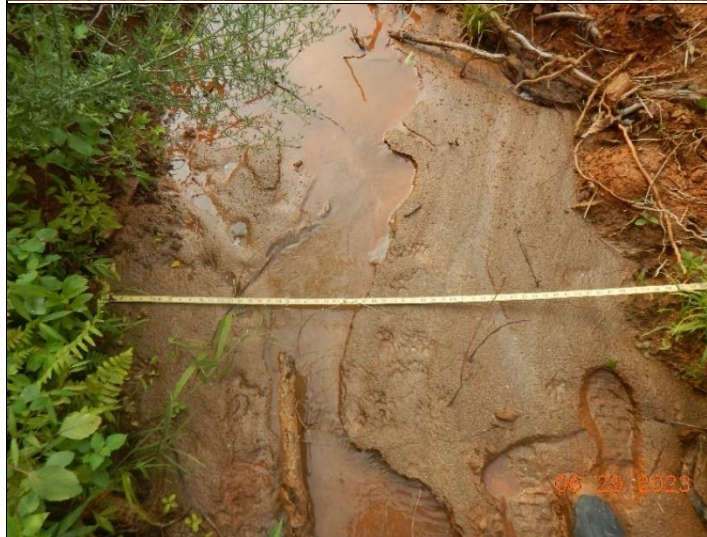
Rosedale Development Site  
Date: 29 June 2023  
Photo ID: DSCN4717.JPG  
Photo taken by: Katelyn Almeter

The bed and banks of the active channel were exposed (i.e., primarily unvegetated) and consisting of dirt with exposed roots, including roots from woody vegetation. Seeping of water with iron was observed from the current active banks of the channel was observed (DSCN4710). Volunteer herbaceous vegetation was present in patches. Patches of concrete were also observed (DSCN4713). In places the channel was clogged with the sediment and flow appeared restricted relative to the active channel width (DSCN4716 and DSCN4717). Flow appeared to be braided flow pathways or diffuse throughout the accumulated sediment within the channel. In part of the channel flow measured approximately 5 inches wide (DSCN4716), whereas, the active channel, including the accumulated saturated, fine sediment was approximately 53 inches wide (DSCN4717).

Notes: Measurement of UNT1 as it flows between the concrete abutments.

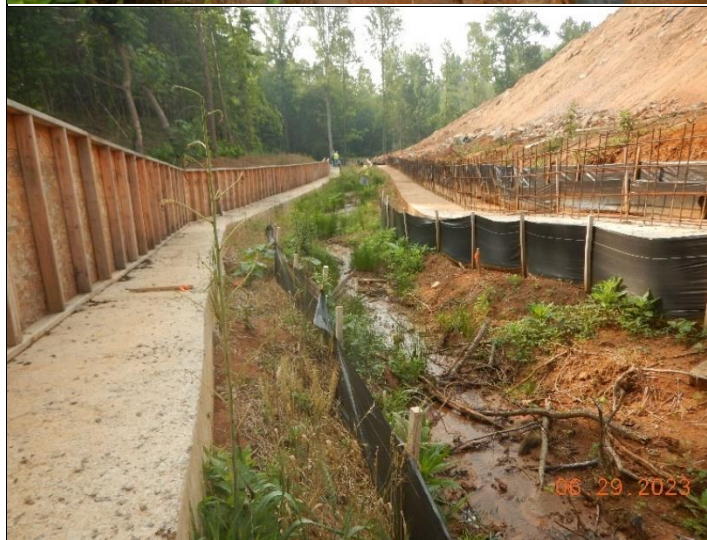
Rosedale Development Site  
Date: 29 June 2023  
Photo ID: DSCN4718.JPG  
Photo taken by: Katelyn Almeter

Notes: Southeast facing view of UNT1 flowing between concrete abutments and silt fences adjacent to the stockpiles of soils.

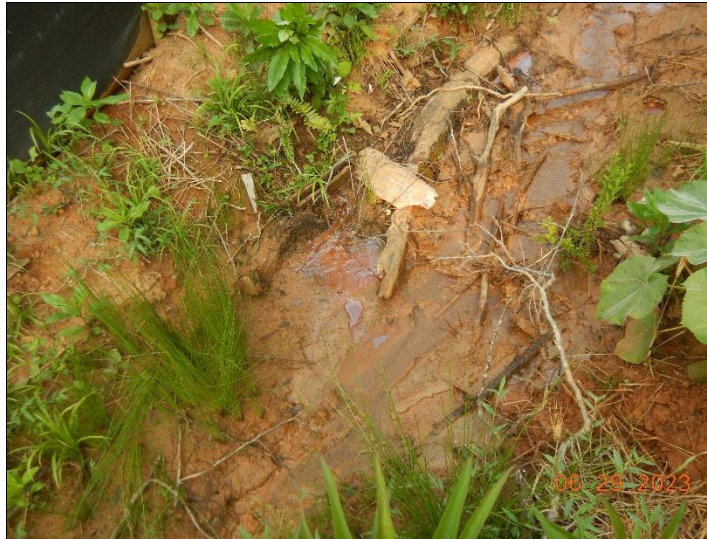
Rosedale Development Site  
Date: 29 June 2023  
Photo ID: DSCN4719.JPG  
Photo taken by: Katelyn Almeter

Approximately 75 feet downstream from the start of the concrete abutments, flow and seeping of water with iron-oxidizing bacteria was observed undercutting the abutment on the left descending bank (DSCN4719; DSCN4722; DSCN4723). On the other side between the concrete abutment and the northern limits of disturbance, a seep and pooling water, algae were observed (DSCN4726). Excess concrete and boulders were also observed (DSCN4720; DSCN4721; DSCN4725; DSCN4728). Soil boring 2 was conducted where there was the presence of 0.5 inches of standing water. In the soil profile, rocks were present through the profile measuring approximately 0.5 to 1.5 inches and the profile was described as 0-9 inches of 7.5YR4/4 saturated sandy fill with refusal at 9 inches (DSCN4727).

Notes: View of UNT1 with iron-oxidizing microbes present in the water.

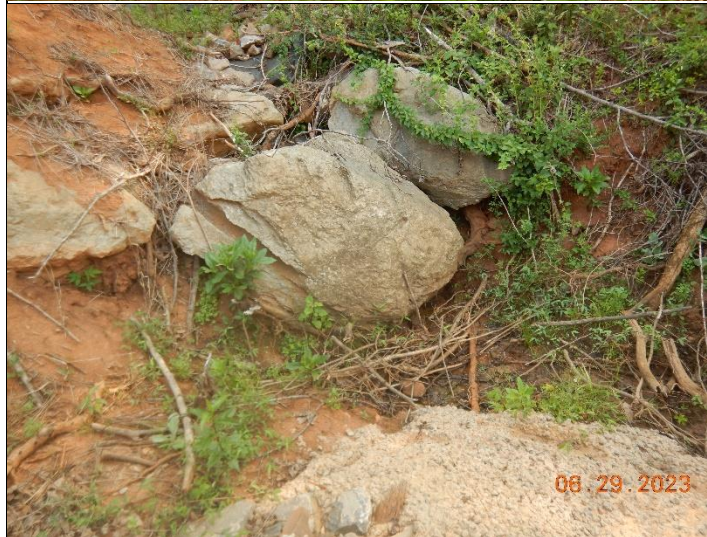
Rosedale Development Site  
Date: 29 June 2023  
Photo ID: DSCN4720.JPG  
Photo taken by: Katelyn Almeter

Notes: View of large rocks within the streambed of UNT1.

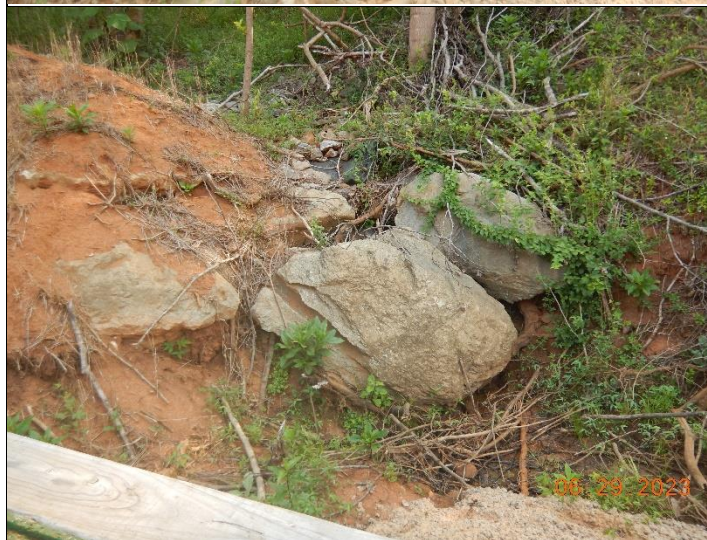
Rosedale Development Site  
Date: 29 June 2023  
Photo ID: DSCN4721.JPG  
Photo taken by: Katelyn Almeter

Notes: View of large rocks within the streambed of UNT1.

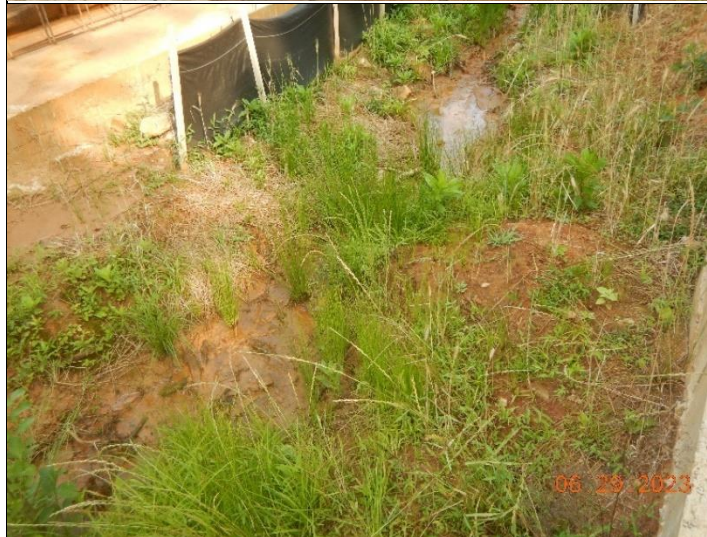
Rosedale Development Site  
Date: 29 June 2023  
Photo ID: DSCN4724.JPG  
Photo taken by: Katelyn Almeter

Notes: Herbaceous vegetation present after disturbance along bank of UNT1.

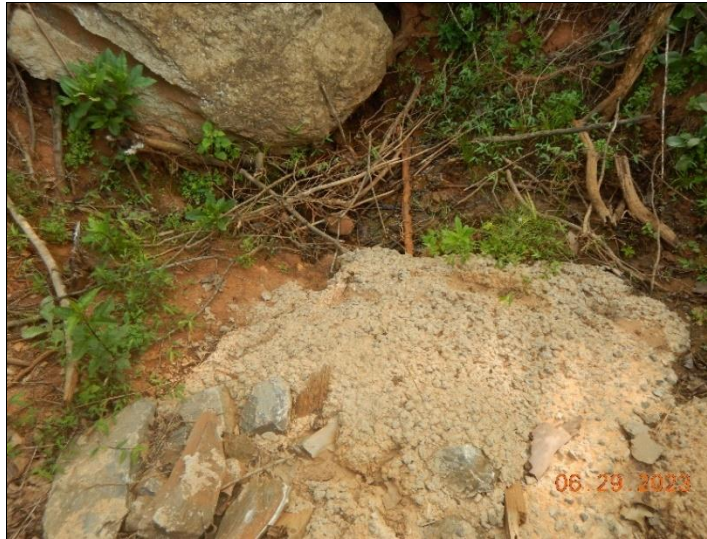
Rosedale Development Site  
Date: 29 June 2023  
Photo ID: DSCN4725.JPG  
Photo taken by: Katelyn Almeter

Notes: Large rocks and concrete in the streambed.

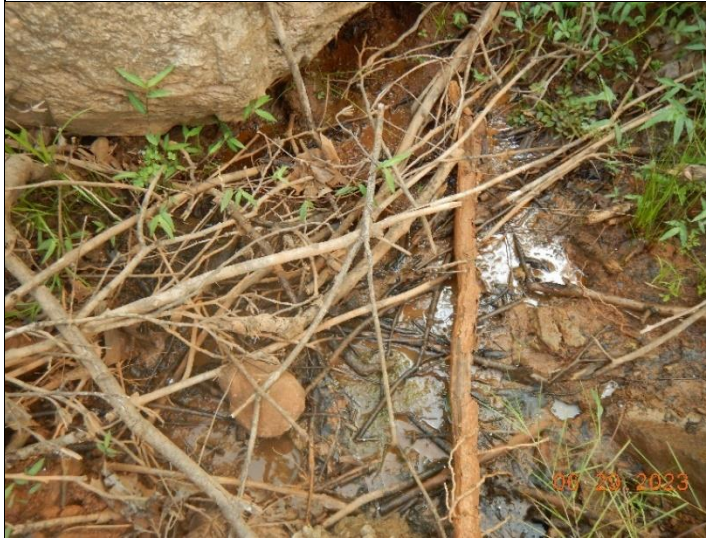
Rosedale Development Site  
Date: 29 June 2023  
Photo ID: DSCN4726.JPG  
Photo taken by: Katelyn Almeter

Notes: View of algae present on the surface of the water.

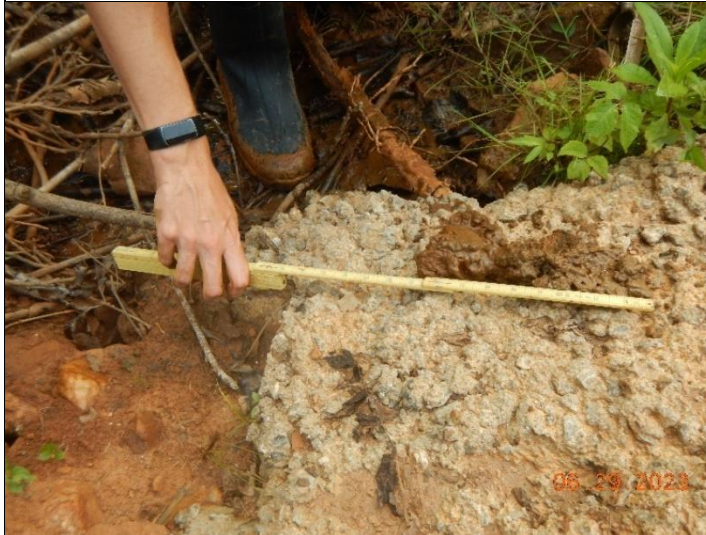
Rosedale Development Site  
Date: 29 June 2023  
Photo ID: DSCN4727.JPG  
Photo taken by: Katelyn Almeter

Notes: Soil boring collected from the streambed showing discharged material.

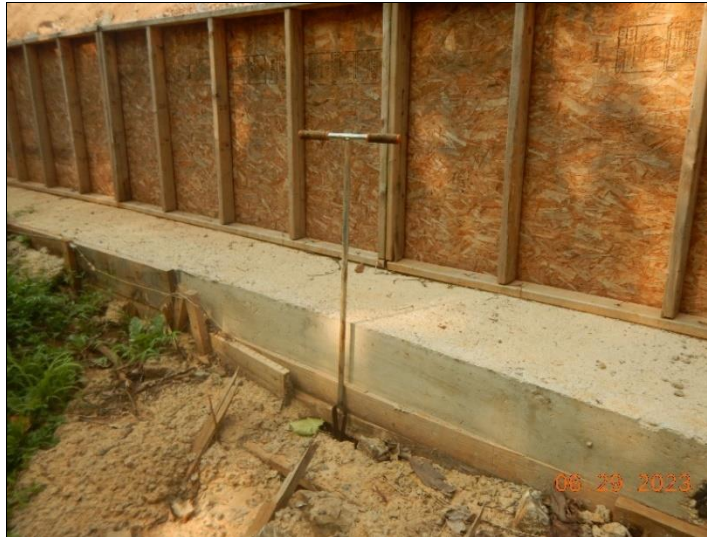
Rosedale Development Site  
Date: 29 June 2023  
Photo ID: DSCN4728.JPG  
Photo taken by: Katelyn Almeter

Notes: View of concrete abutment;  
looking south towards UNT1.

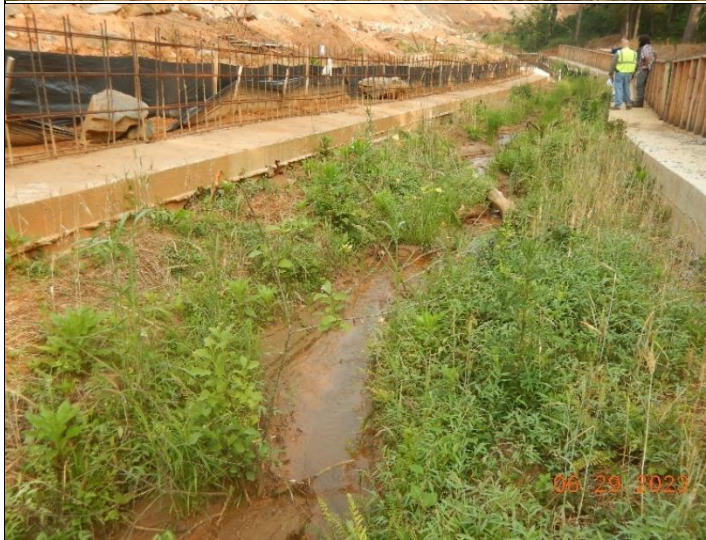
Rosedale Development Site  
Date: 29 June 2023  
Photo ID: DSCN4729.JPG  
Photo taken by: Katelyn Almeter

Notes: Northwest view of UNT1. Note  
the presence of herbaceous vegetation  
in the discharged material along the  
stream bank.

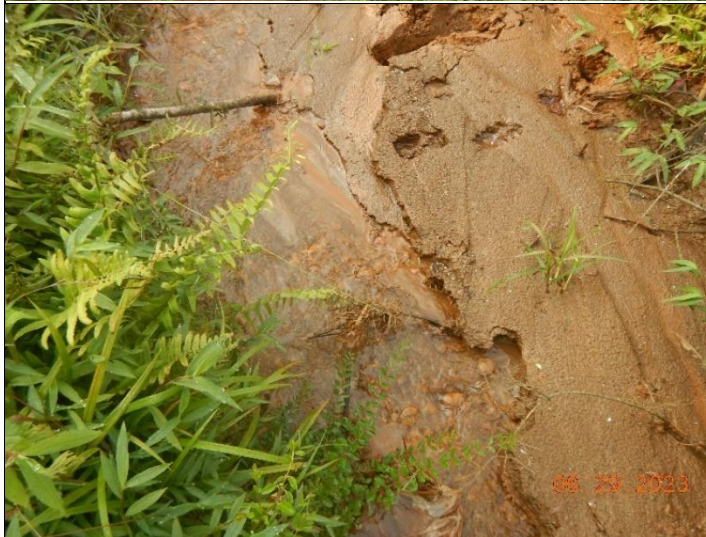
Rosedale Development Site  
Date: 29 June 2023  
Photo ID: DSCN4730.JPG  
Photo taken by: Katelyn Almeter

Notes: View of UNT1 streambed with  
discharged material present throughout.

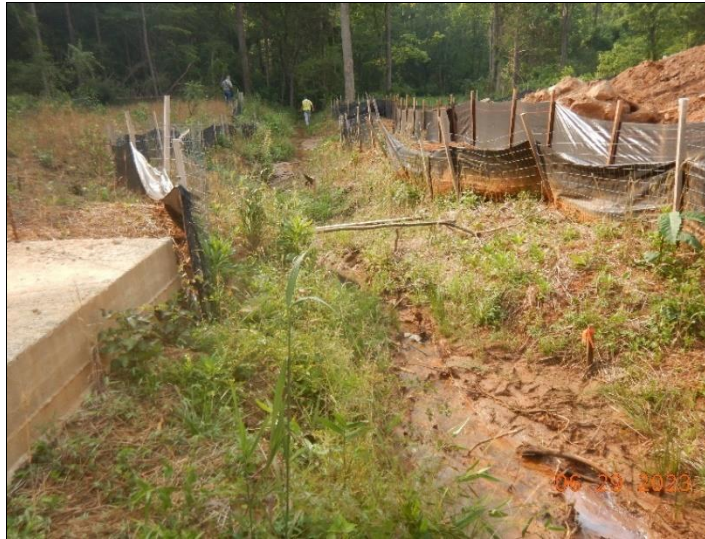
Rosedale Development Site  
Date: 29 June 2023  
Photo ID: DSCN4731.JPG  
Photo taken by: Katelyn Almeter

Notes: View facing downstream of UNT1 as it flows past the stockpiles of soil.

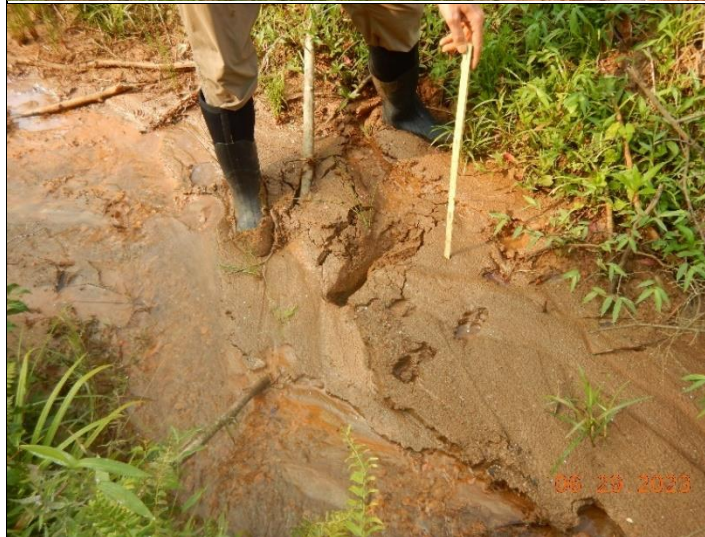
Rosedale Development Site  
Date: 29 June 2023  
Photo ID: DSCN4732.JPG  
Photo taken by: Katelyn Almeter

The inspection walkthrough continued east, downstream along UNT1 toward its confluence with Tomahawk Creek. Approximately 10 inches of sediment were measured in the stream channel (DSCN4732). A headcut, approximately 25 inches in depth, was observed (DSCN4733). As the Inspectors continued to walk downstream, UNT1 became wider and flow was present, but the active channel primarily contained saturated, fine- sediment (DSCN4738 and DSCN4739). PVC pipe perpendicular to UNT1 was observed (DSCN4735). Mr. Cyrus stated that it was preexisting pipe. A constructed stormwater control was documented near UNT1 (DSCN4737 and DSCN4753).

Notes: View of UNT1 streambed with discharged material present throughout.

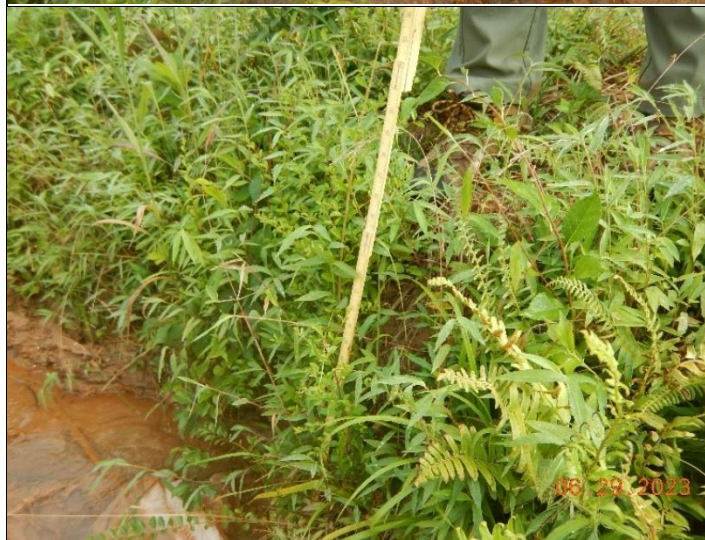
Rosedale Development Site  
Date: 29 June 2023  
Photo ID: DSCN4733.JPG  
Photo taken by: Katelyn Almeter

Notes: View of herbaceous vegetation present in discharged material along the bank of UNT1.

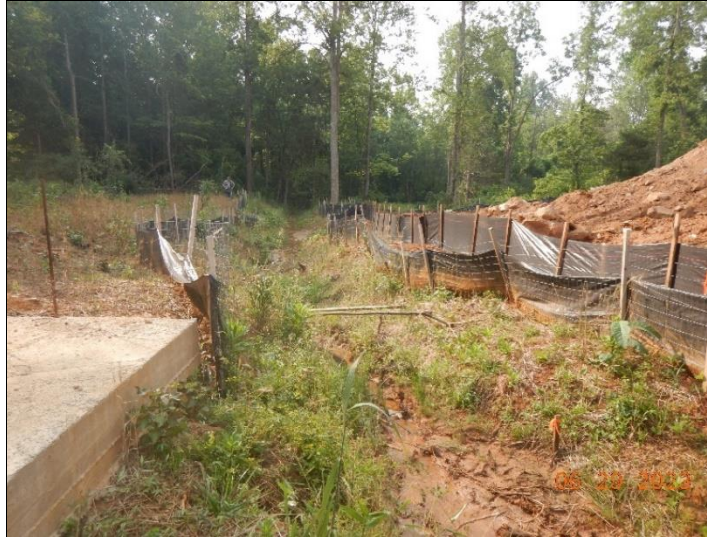
Rosedale Development Site  
Date: 29 June 2023  
Photo ID: DSCN4734.JPG  
Photo taken by: Katelyn Almeter

Notes: View facing downstream of UNT1 as it flows past the stockpiles of soil.

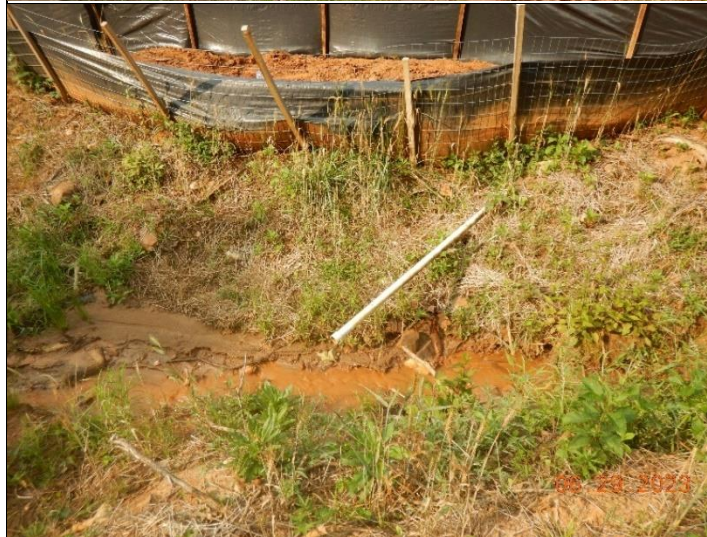
Rosedale Development Site  
Date: 29 June 2023  
Photo ID: DSCN4735.JPG  
Photo taken by: Katelyn Almeter

Notes: View of UNT1 adjacent to silt fence located at the foot of the stockpile of soils.

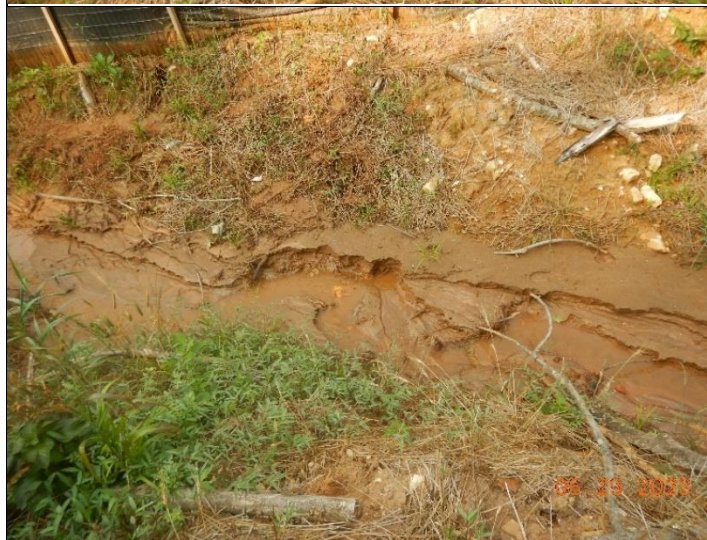
Rosedale Development Site  
Date: 29 June 2023  
Photo ID: DSCN4736.JPG  
Photo taken by: Katelyn Almeter

Notes: View of UNT1 with discharged material present throughout the bank and stream bed.

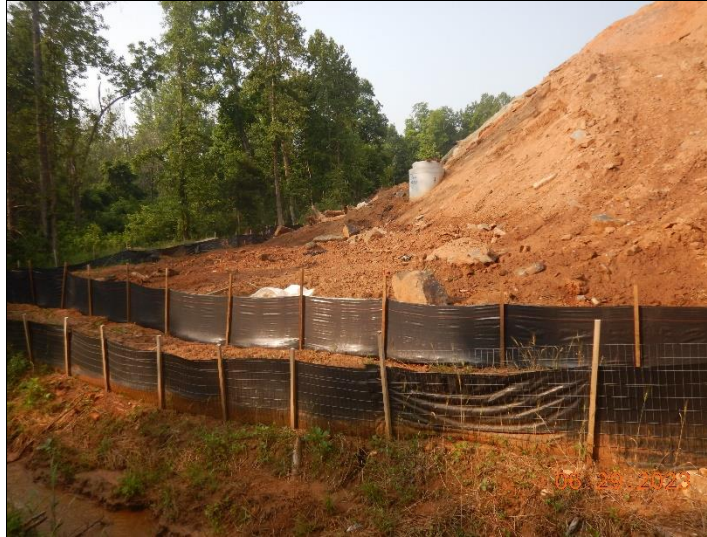
Rosedale Development Site  
Date: 29 June 2023  
Photo ID: DSCN4737.JPG  
Photo taken by: Katelyn Almeter

Notes: Northeast corner of the stockpile along a forested area.

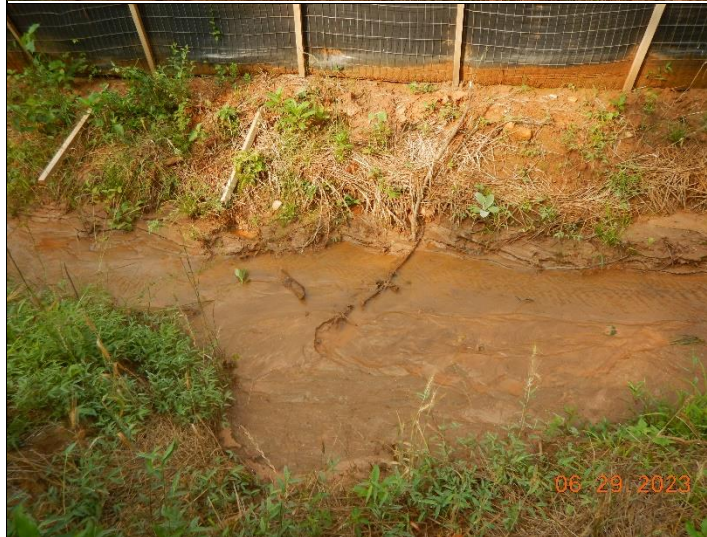
Rosedale Development Site  
Date: 29 June 2023  
Photo ID: DSCN4738.JPG  
Photo taken by: Katelyn Almeter

Notes: Looking across UNT1; facing south.

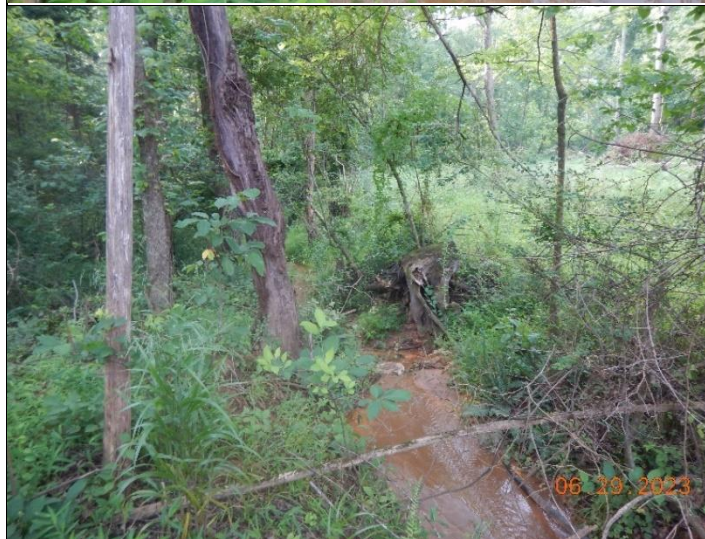
Rosedale Development Site  
Date: 29 June 2023  
Photo ID: DSCN4743.JPG  
Photo taken by: Katelyn Almeter

Notes: View of UNT1 with discharged fill on the bank and in the stream bed downstream of Site activity.

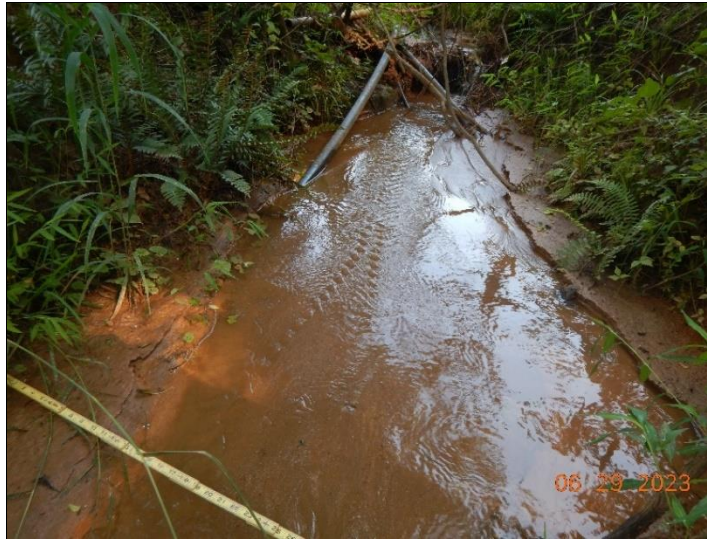
Rosedale Development Site  
Date: 29 June 2023  
Photo ID: DSCN4745.JPG  
Photo taken by: Katelyn Almeter

Further downstream and outside of the limits of disturbance, UNT1 was observed. The undisturbed width of the stream was 39 inches (DSCN4745). Active flow was present, but bars of saturated fine sediment were present along both banks (DSCN4746). The confluence of UNT1 with Tomahawk Creek was observed (DSCN4748 and DSCN4749). A sediment bar was observed in Tomahawk Creek at the confluence.

Notes: Bankfull measurement of stream downgradient of activity on the Site.

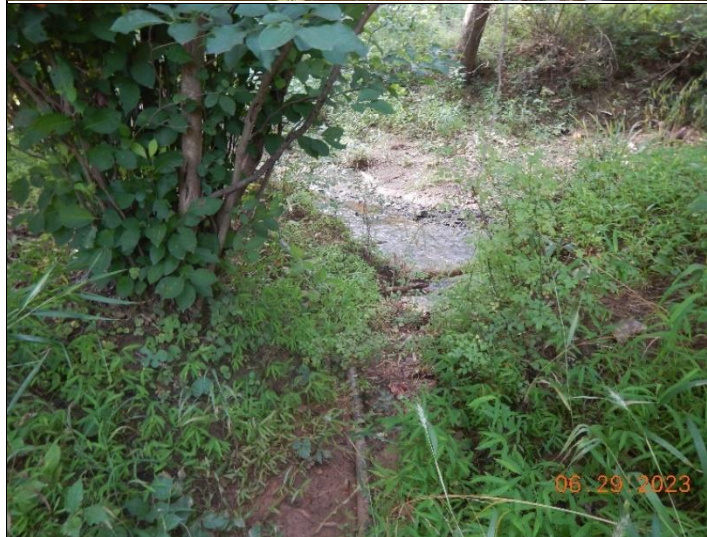
Rosedale Development Site  
Date: 29 June 2023  
Photo ID: DSCN4746.JPG  
Photo taken by: Katelyn Almeter

Notes: View of UNT1 with water muddied by discharged material.

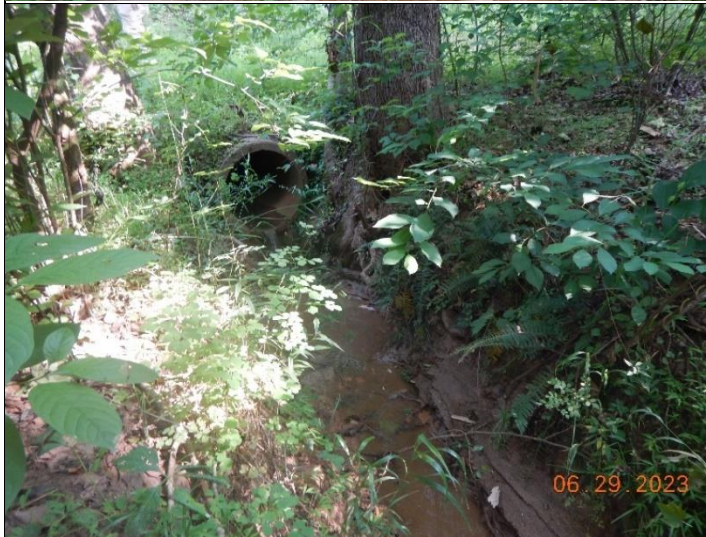
Rosedale Development Site  
Date: 29 June 2023  
Photo ID: DSCN4750.JPG  
Photo taken by: Katelyn Almeter

Notes: View of discharged material in UNT1 as it flows towards Tomahawk Creek.

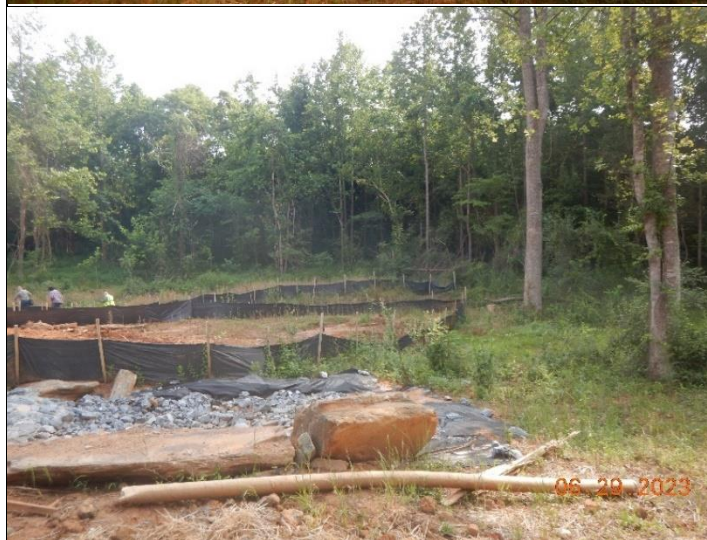
Rosedale Development Site  
Date: 29 June 2023  
Photo ID: DSCN4753.JPG  
Photo taken by: Katelyn Almeter

Notes: Storm water outfall located on one of the stockpiles of soil.

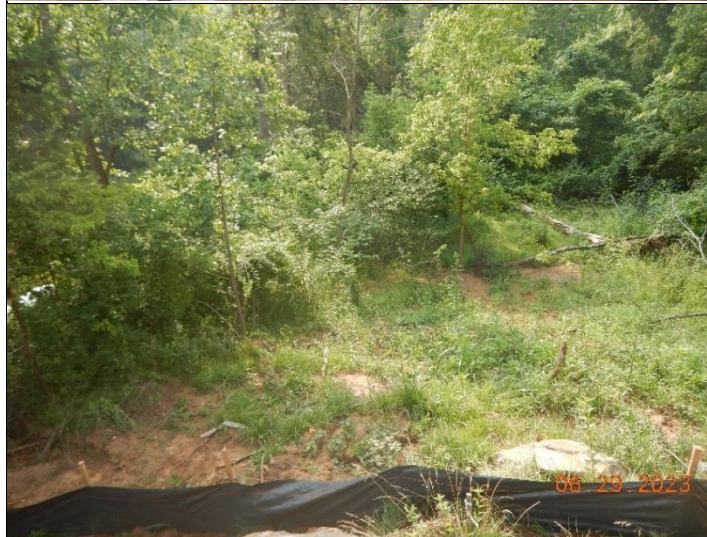
Rosedale Development Site  
Date: 29 June 2023  
Photo ID: DSCN4756.JPG  
Photo taken by: Katelyn Almeter

The inspection walkthrough continued south along a flatter bench of material in the fill pile along the eastern side of the Site (DSCN4755). On the downslope end, where the wetland and stream were mapped on the plan set, the silt fence was visible (DSCN4756). The EPA Inspectors observed a number of areas where the fence was lying on the ground, covered with dirt or sediment and/or rocks, including boulders (DSCN4758 to DSCN4763). Sediment was also observed beyond the silt fence (DSCN4756 and DSCN4757).

Notes: Eastward facing view of fill material pushing against the silt fence.

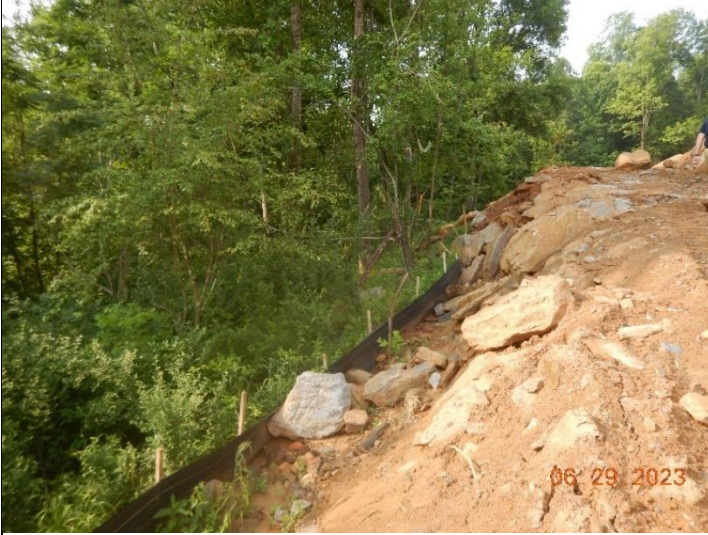
| | <p>Rosedale Development Site<br/>Date: 29 June 2023<br/>Photo ID: DSCN4758.JPG<br/>Photo taken by: Katelyn Almeter</p> <p>Notes: View of the stockpile pushing up against, and spilling over, the silt fence.</p> |

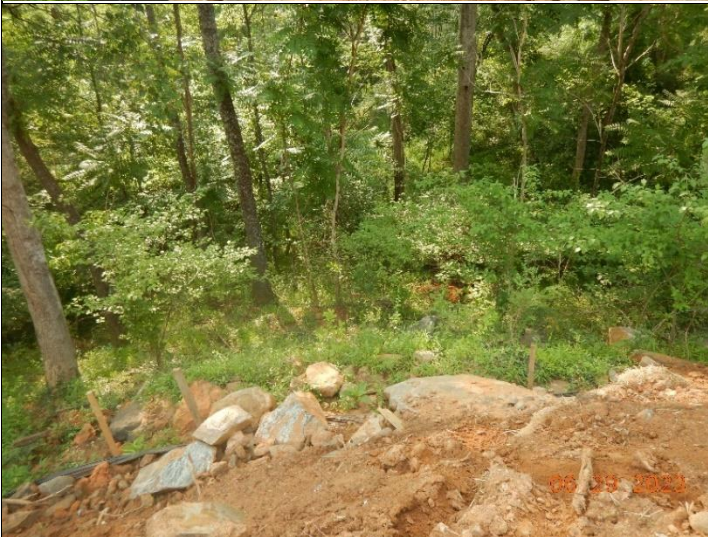
| | <p>Rosedale Development Site<br/>Date: 29 June 2023<br/>Photo ID: DSCN4760.JPG<br/>Photo taken by: Katelyn Almeter</p> <p>Notes: Another view of an area of the material covering the silt fence; looking east.</p> |

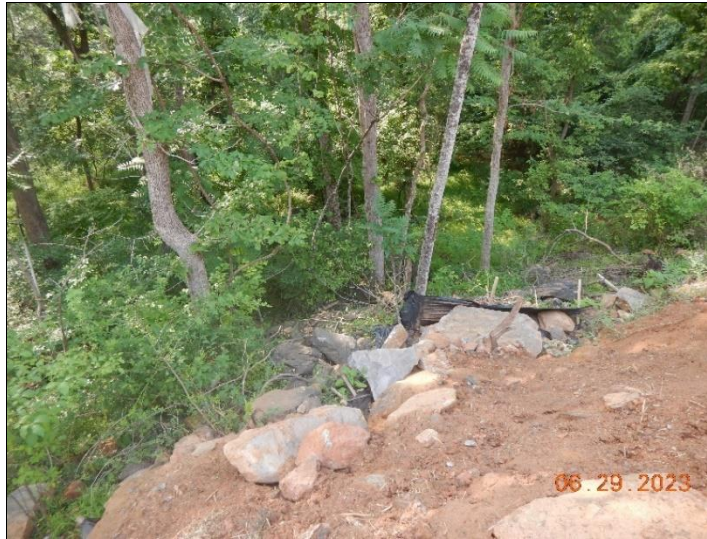
Rosedale Development Site  
Date: 29 June 2023  
Photo ID: DSCN4761.JPG  
Photo taken by: Katelyn Almeter

Notes: Large rocks and material covering the silt fence on the downgradient side of the stockpile.

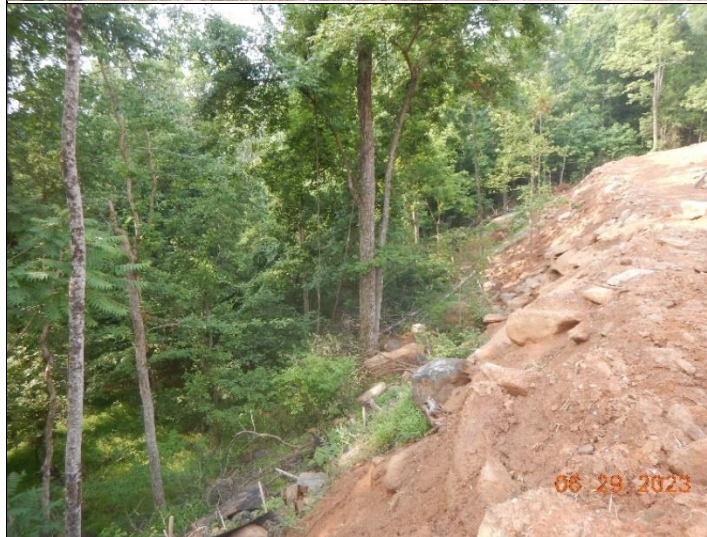
Rosedale Development Site  
Date: 29 June 2023  
Photo ID: DSCN4762.JPG  
Photo taken by: Katelyn Almeter

Notes: Large rocks and material covering the silt fence on the downgradient side of the stockpile.

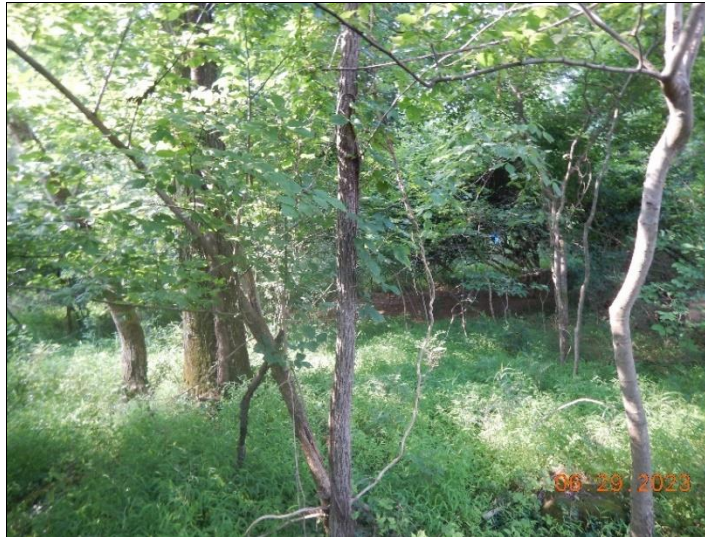
Rosedale Development Site  
Date: 29 June 2023  
Photo ID: DSCN4764.JPG  
Photo taken by: Katelyn Almeter

Notes: The forested area adjacent to the east of the stockpiles showing the limits of disturbance line in the background (blue flagging).

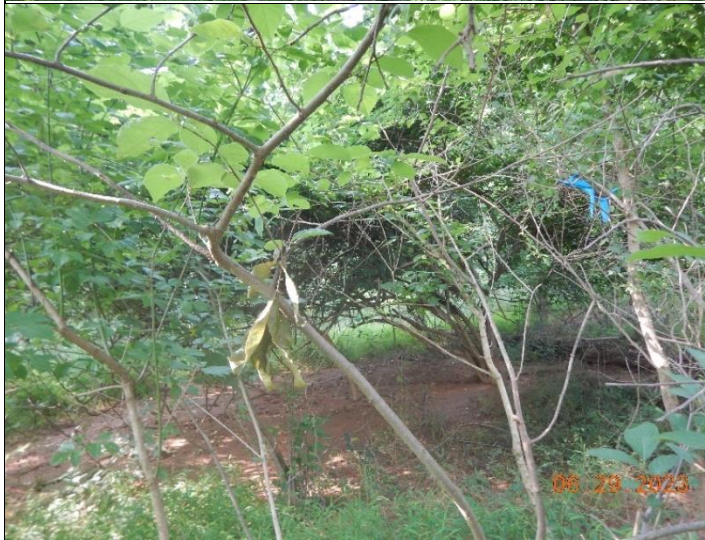
Rosedale Development Site  
Date: 29 June 2023  
Photo ID: DSCN4765.JPG  
Photo taken by: Katelyn Almeter

Notes: The blue flagging denotes the limit of disturbance area. Note the presence of material beyond the limit of disturbance.

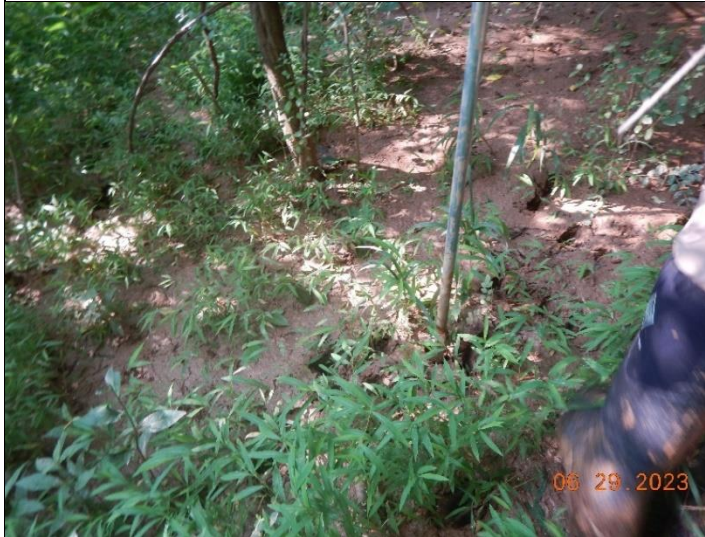
Rosedale Development Site  
Date: 29 June 2023  
Photo ID: DSCN4766.JPG  
Photo taken by: Katelyn Almeter

Notes: Another view of material beyond the limit of disturbance.
