**UNITED STATES ENVIRONMENTAL PROTECTION AGENCY  
REGION III**

**Report Title:** Clean Water Act, Section 404 Inspection Report for Rosedale Development Site  
**Inspection Date(s):** 06/29/2023  
**Start Time:** 8:00AM **End Time:** 10:45AM  
**Regulatory Program(s):** Inspections authorized pursuant to Clean Water Act, Sections 308 and 404 (33 U.S.C. §§ 1318 and 1344)  
**Site Name:** Rosedale Development Site  
**Site Location:** 1600 Graves Mill Road  
Lynchburg, Virginia 24502  
**Latitude:** 37.3762 **Longitude:** -79.2315  
**County/Parish:** City of Lynchburg  
**Site Owner(s):** Rosedale Investments, LLC  
T.B.P. Properties, LLC  
**Mailing Address:** P.O. Box 148  
Forest, Virginia 24551  
**Unique Project #:** 3E23WW039A

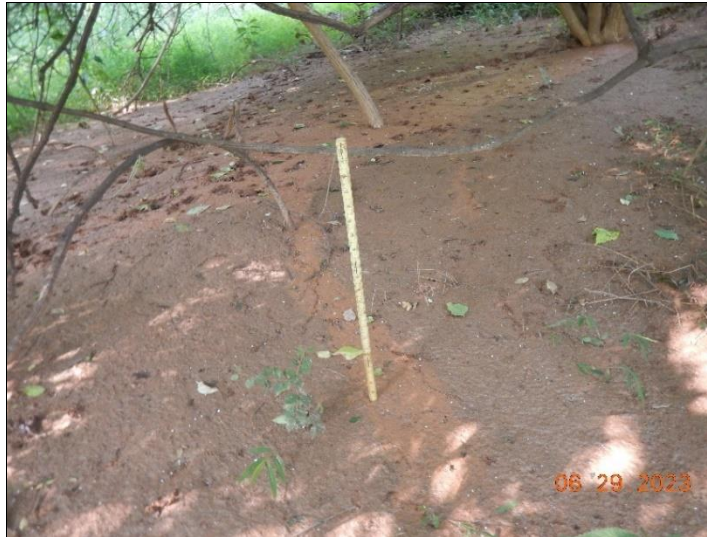
Rosedale Development Site  
Date: 29 June 2023  
Photo ID: DSCN4767.JPG  
Photo taken by: Katelyn Almeter

Notes: Material present in the mapped wetland area.

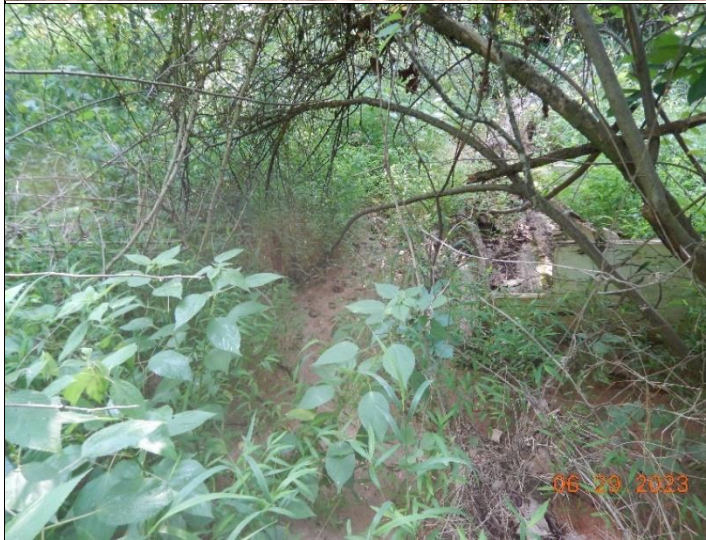
Rosedale Development Site  
Date: 29 June 2023  
Photo ID: DSCN4768.JPG  
Photo taken by: Katelyn Almeter

Notes: View of material further into the wetland area.

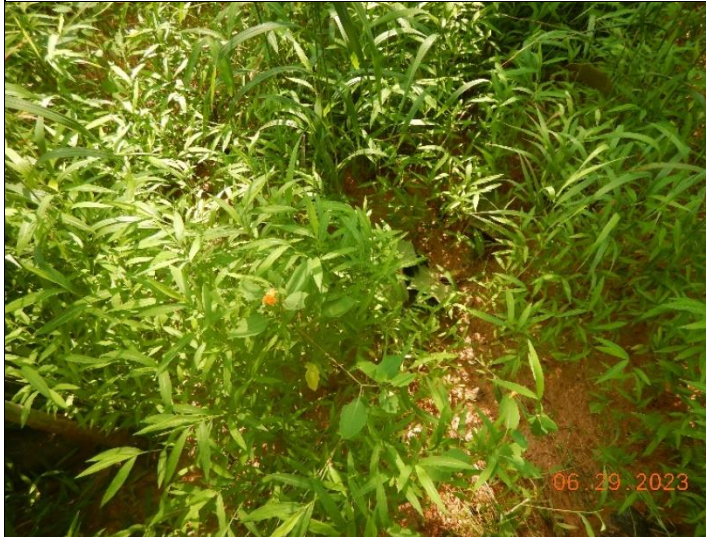
Rosedale Development Site  
Date: 29 June 2023  
Photo ID: DSCN4769.JPG  
Photo taken by: Katelyn Almeter

Notes: Additional view of material in the wetland area. Note the presence of herbaceous vegetation in the discharged material.

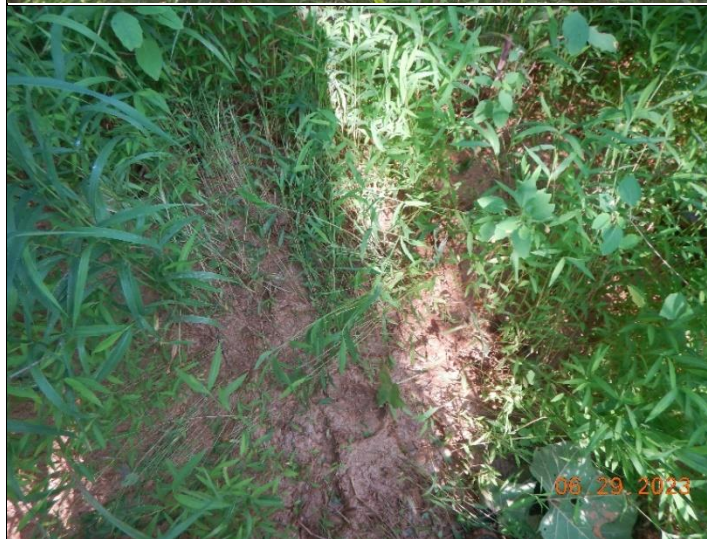
Rosedale Development Site  
Date: 29 June 2023  
Photo ID: DSCN4771.JPG  
Photo taken by: Katelyn Almeter

Notes: View of material in the wetland area.

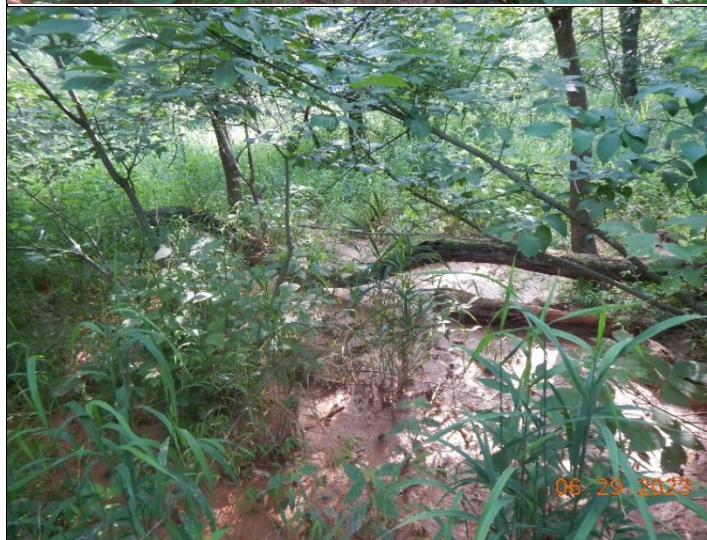
Rosedale Development Site  
Date: 29 June 2023  
Photo ID: DSCN4772.JPG  
Photo taken by: Katelyn Almeter

Notes: View of material in the wetland area.

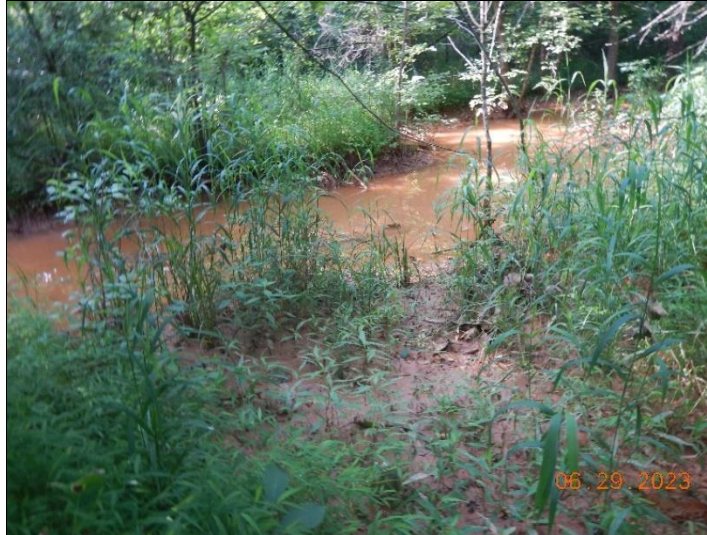
Rosedale Development Site  
Date: 29 June 2023  
Photo ID: DSCN4773.JPG  
Photo taken by: Katelyn Almeter

Notes: View of material entering Tomahawk Creek.

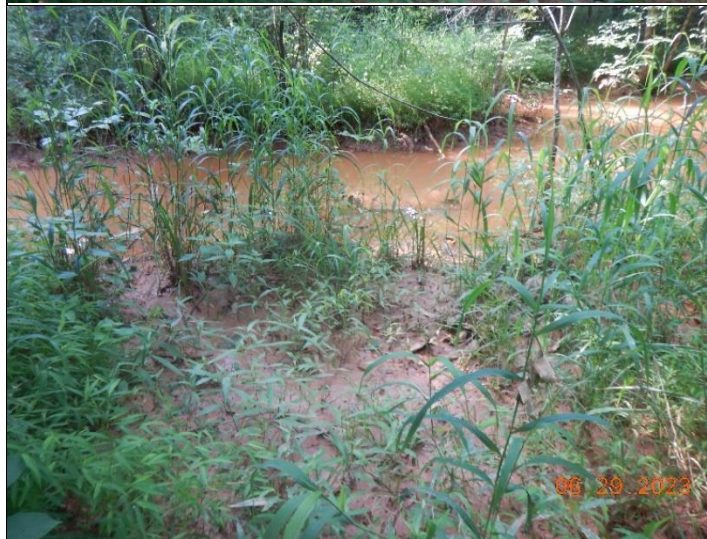
Rosedale Development Site  
Date: 29 June 2023  
Photo ID: DSCN4774.JPG  
Photo taken by: Katelyn Almeter

Notes: View of material entering Tomahawk Creek.

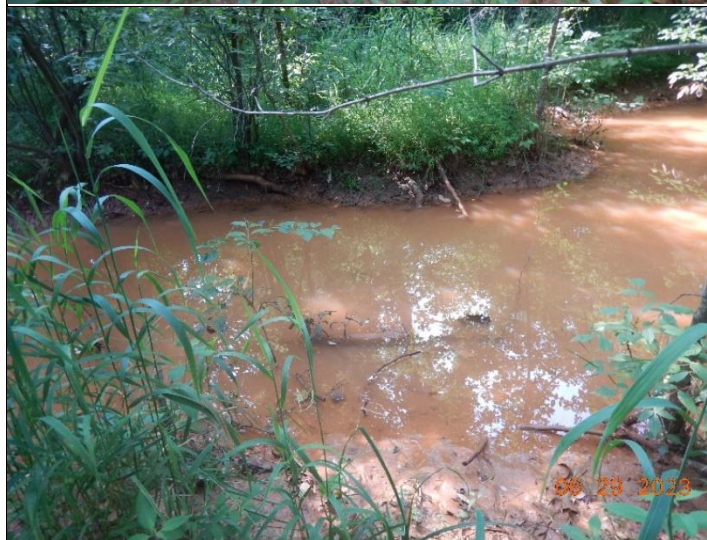
Rosedale Development Site  
Date: 29 June 2023  
Photo ID: DSCN4775.JPG  
Photo taken by: Katelyn Almeter

Notes: View of muddied water in Tomahawk Creek.

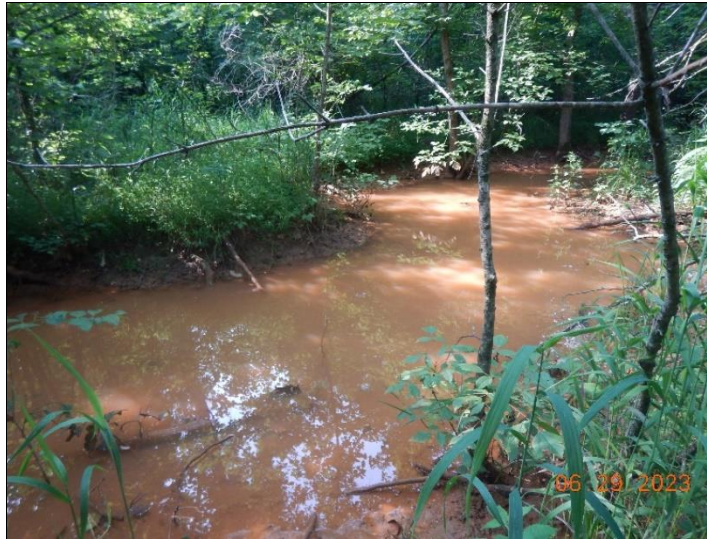
Rosedale Development Site  
Date: 29 June 2023  
Photo ID: DSCN4776.JPG  
Photo taken by: Katelyn Almeter

Notes: View of muddied water in Tomahawk Creek.

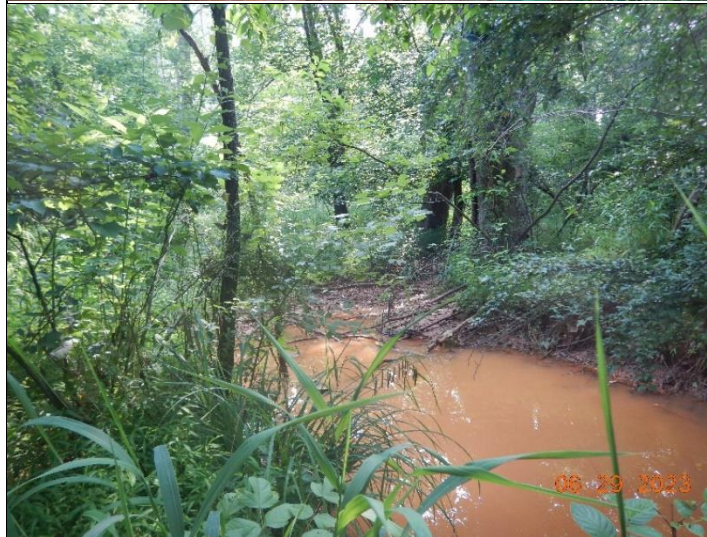
Rosedale Development Site  
Date: 29 June 2023  
Photo ID: DSCN4777.JPG  
Photo taken by: Katelyn Almeter

Notes: View of muddied water in Tomahawk Creek.

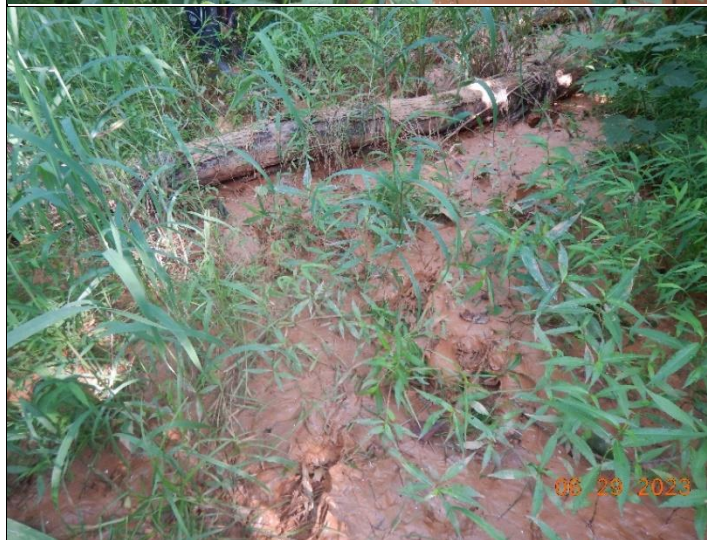
Rosedale Development Site  
Date: 29 June 2023  
Photo ID: DSCN4778.JPG  
Photo taken by: Katelyn Almeter

Notes: View of material near Tomahawk Creek.

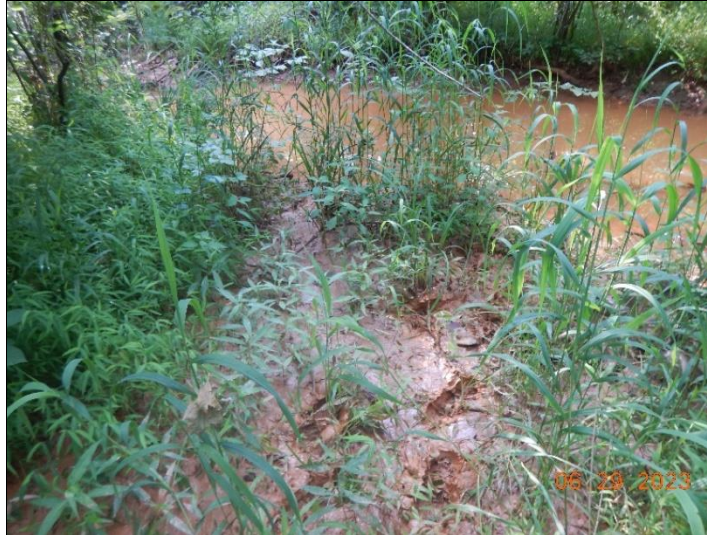
Rosedale Development Site  
Date: 29 June 2023  
Photo ID: DSCN4779.JPG  
Photo taken by: Katelyn Almeter

Notes: View of material next to Tomahawk Creek.

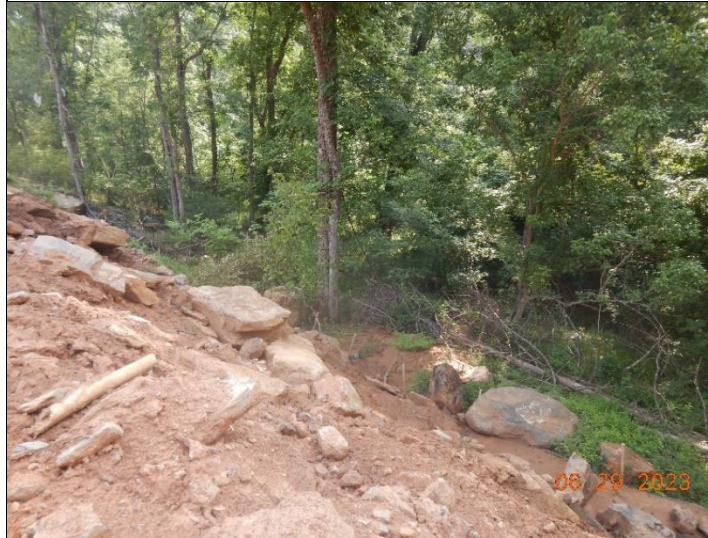
Rosedale Development Site  
Date: 29 June 2023  
Photo ID: DSCN4782.JPG  
Photo taken by: Katelyn Almeter

Notes: View of fill material covering the silt fence line into the adjacent forested area.

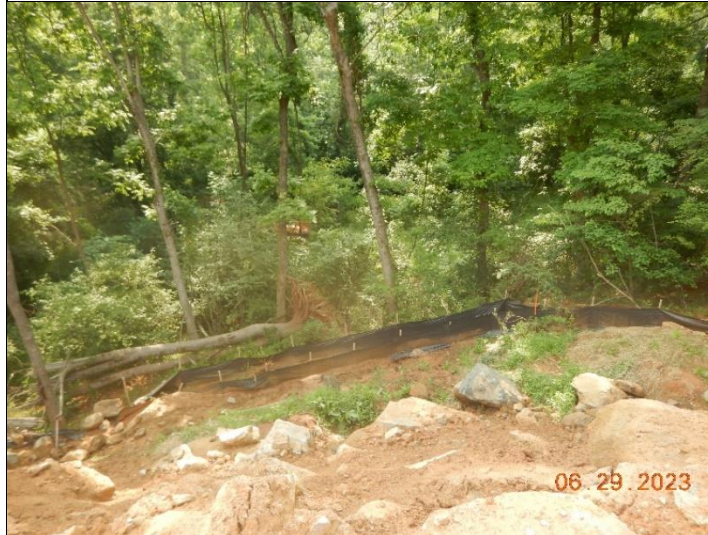
Rosedale Development Site  
Date: 29 June 2023  
Photo ID: DSCN4783.JPG  
Photo taken by: Katelyn Almeter

Notes: View of fill material covering the silt fence line into the adjacent forested area.

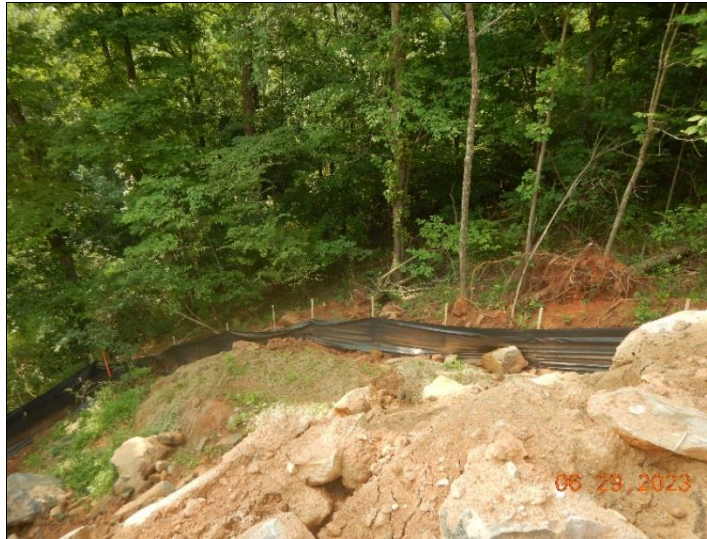
Rosedale Development Site  
Date: 29 June 2023  
Photo ID: DSCN4784.JPG  
Photo taken by: Katelyn Almeter

Notes: View of fill material up against the silt fence.

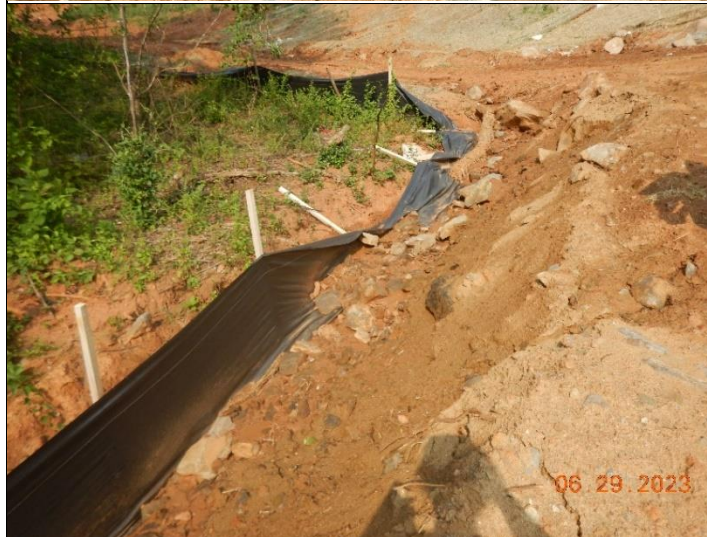
Rosedale Development Site  
Date: 29 June 2023  
Photo ID: DSCN4785.JPG  
Photo taken by: Katelyn Almeter

Notes: View of fill material up against the silt fence.

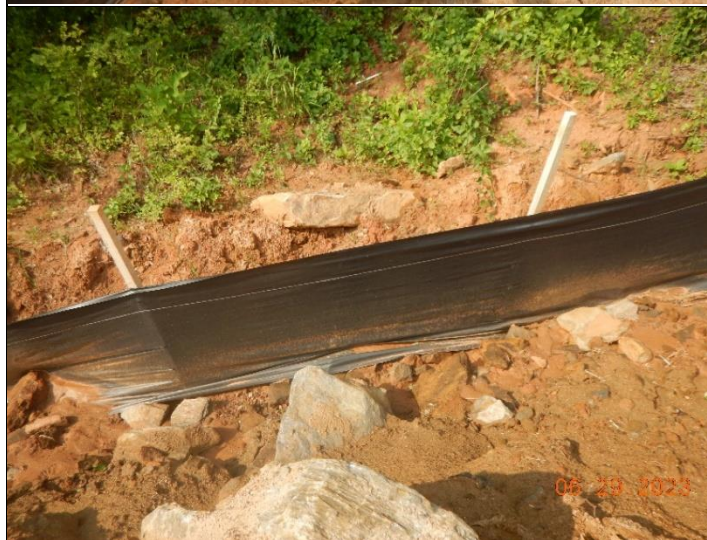
Rosedale Development Site  
Date: 29 June 2023  
Photo ID: DSCN4786.JPG  
Photo taken by: Katelyn Almeter

Notes: View of fill material covering the silt fence line and into the adjacent forested area.

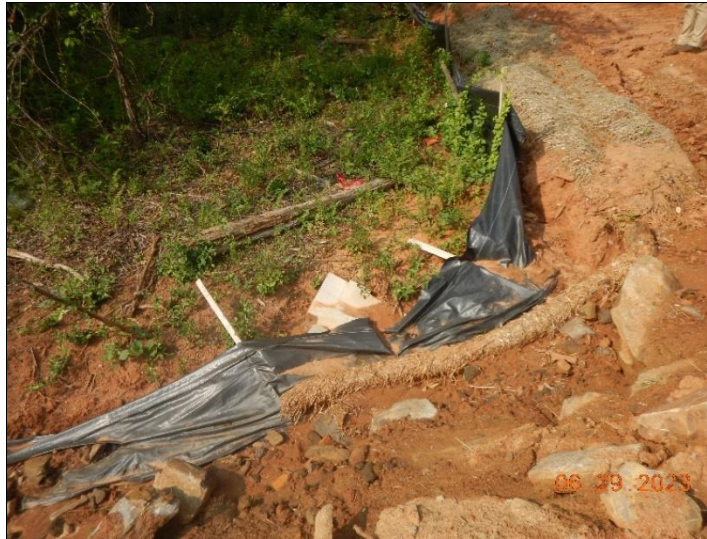
Rosedale Development Site  
Date: 29 June 2023  
Photo ID: DSCN4787.JPG  
Photo taken by: Katelyn Almeter

Notes: view of fill material on the downslope side of the silt fence.

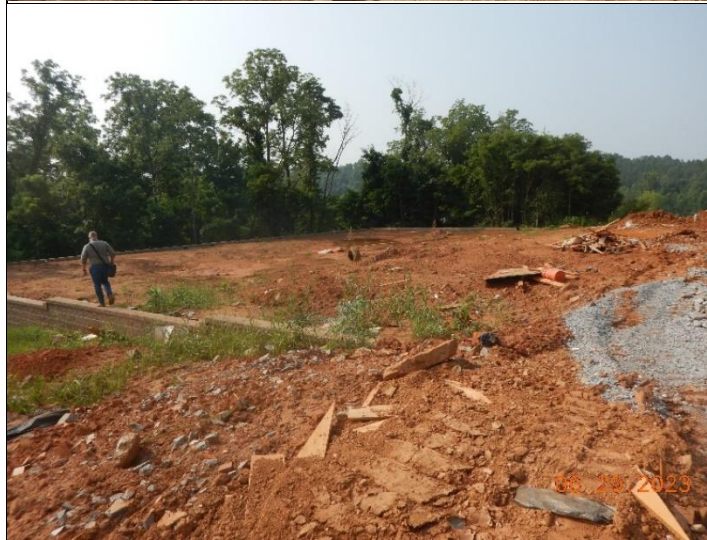
Rosedale Development Site  
Date: 29 June 2023  
Photo ID: DSCN4788.JPG  
Photo taken by: Katelyn Almeter

Notes: View of fill material and the silt fence line.

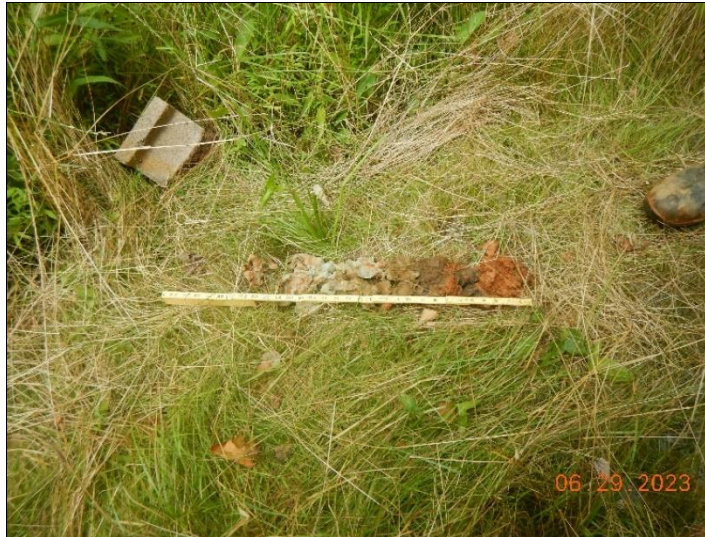
Rosedale Development Site  
Date: 29 June 2023  
Photo ID: DSCN4805.JPG  
Photo taken by: Katelyn Almeter

A soil boring was taken in the area between the stream channel and the retaining wall (outside of the orange fencing) (DSCN4805 and DSCN4806). Soil boring 3 is described. From 0-4 inches soils were 2.5YR 4/6 sandy fill. At 4 inches the natural surface was observed, and vegetation remains were present. From 4-7 inches soils were 100% 10YR4/2. From 7-9.5 inches soils were 85% 10YR4/2, 10% 2.5YR4/4 redoximorphic concentrations and 5% 10YR6/3 depletions. From 9.5-12 inches soils were 70% 10YR4/2, 15% 10YR6/3, and 15% 2.5YR4/4 redoximorphic concentrations. From 12-21<sup>+</sup> inches soils were 90% Gley 1 6/10y and 10% 10YR6/8. Vegetation around the soil boring included deertongue (*Dichanthelium clandestinum*), arrowhead (*Sagittaria latifolia*), jewelweed (*Impatiens capensis*), and woolgrass (*Scirpus cyperinus*).

Notes: Location of a soil boring collected near the culvert.

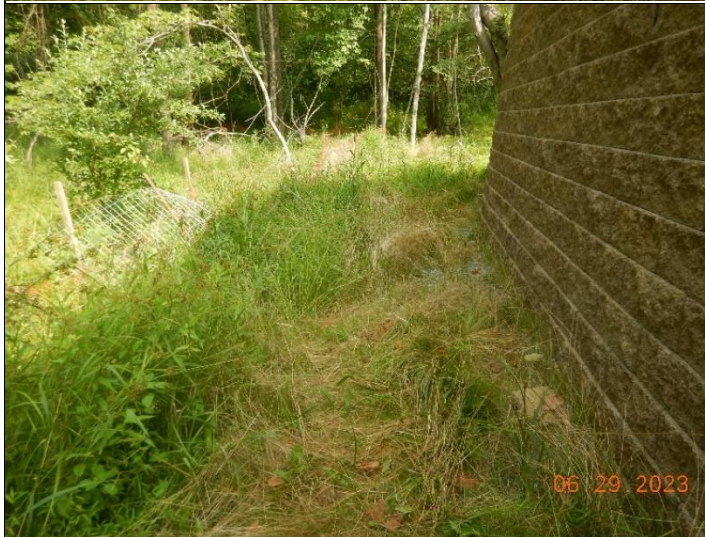
Rosedale Development Site  
Date: 29 June 2023  
Photo ID: DSCN4806.JPG  
Photo taken by: Katelyn Almeter

Notes: View of the soil boring collected near the culvert.

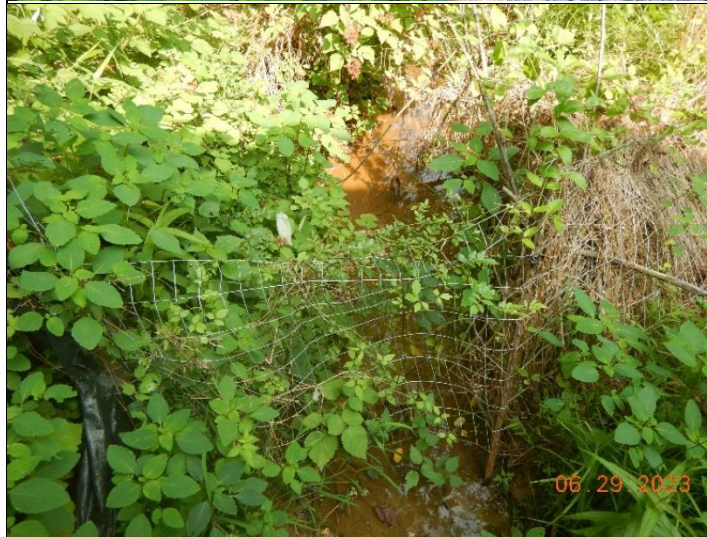
Rosedale Development Site  
Date: 29 June 2023  
Photo ID: DSCN4813.JPG  
Photo taken by: Katelyn Almeter

The EPA Inspectors observed the upstream end of the arch culvert. The arch culvert sits on two concrete abutments. As UNT2 flows towards the culvert the flow bends around the southern concrete abutment (i.e., the side closest to Graves Mill Road) (DSCN4811 to DSCN4813). Seeps and surface saturation was observed along the northern concrete abutment (DSCN4808). At the upstream end of the culvert concrete, gravel and black plastic were observed in the stream bed (DSCN4816). Within the culvert the banks and edges of the active channel of UNT2 were exposed with very little vegetation present. Woody roots were observed

Notes: UNT2 flowing around the concrete footer into the culvert.

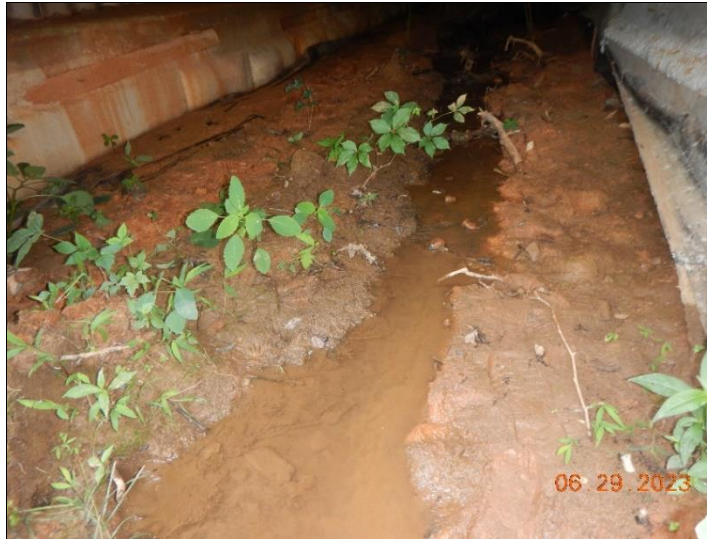
Rosedale Development Site  
Date: 29 June 2023  
Photo ID: DSCN4817.JPG  
Photo taken by: Katelyn Almeter

Notes: Active channel measurement of UNT2 after entering the culvert. Note the presence of discharged material along the bank and in the stream bed.

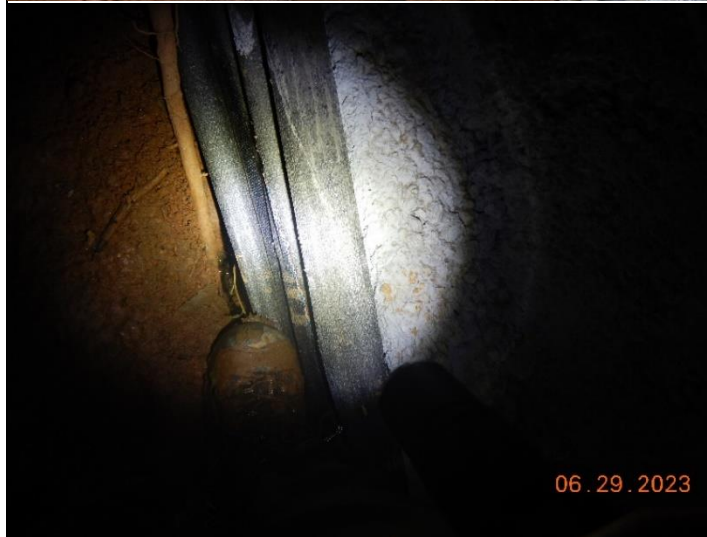
Rosedale Development Site  
Date: 29 June 2023  
Photo ID: DSCN4821.JPG  
Photo taken by: Katelyn Almeter

The Inspectors observed UNT2 within the arch culvert (DSCN4819 to DSCN4851). For the upstream portion within the culvert an actively flowing channel was present. The edges of the channel were flat, generally saturated, and mainly exposed dirt (DSCN4819 and DSCN4827). Woody roots were present and a couple of individual standing dead woody stems were observed (DSCN4821, DSCN4824, and DSCN4837). The water table was observed in gaps along the concrete abutments (DSCN4822, DSCN4823, and DSCN4826). Within the culvert, the banks and sides of the channel consisted of uneven piles of dirt with many exposed woody roots (DSCN4830 and DSCN4834). Within the culvert the channel of UNT2 measured 13 inches wide (DSCN4831). Approximately mid-way within the culvert, the active channel flowed toward and under a concrete abutment (DSCN4839 to DSCN4851). For the remainder of the culverted area there was no observable surface stream channel (DSCN4843 and DSCN4844).

Notes: View looking downstream of UNT2 flowing through the culvert. Note the presence of discharged material along the bank and in the streambed.

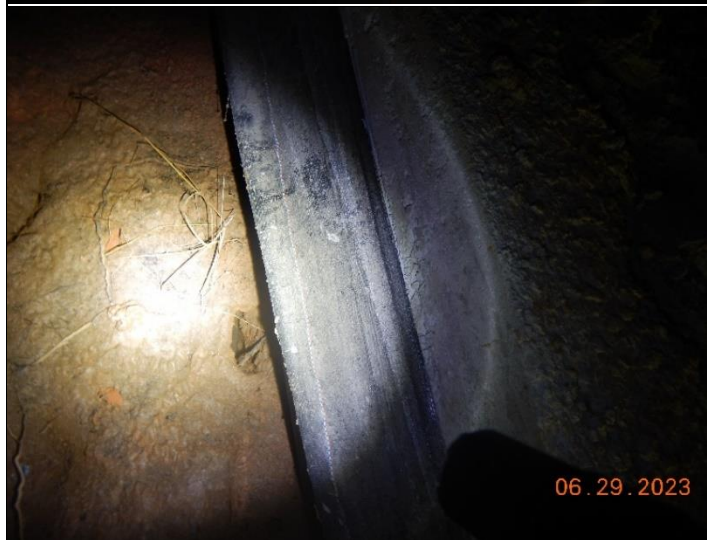
Rosedale Development Site  
Date: 29 June 2023  
Photo ID: DSCN4822.JPG  
Photo taken by: Katelyn Almeter

Notes: View of water present in gaps under the concrete footer abutting UNT2.

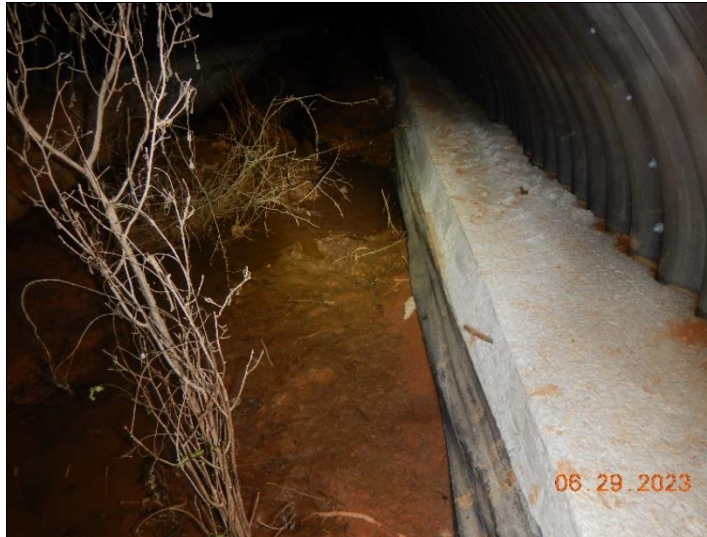
Rosedale Development Site  
Date: 29 June 2023  
Photo ID: DSCN4823.JPG  
Photo taken by: Katelyn Almeter

Notes: View of water present in gaps under the concrete footer abutting UNT2.

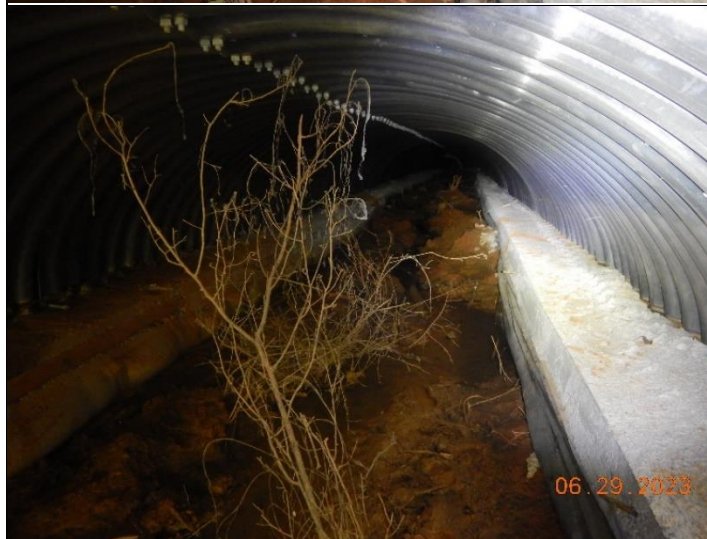
Rosedale Development Site  
Date: 29 June 2023  
Photo ID: DSCN4824.JPG  
Photo taken by: Katelyn Almeter

Notes: View of flow of UNT2 flowing against the concrete footer as it flows through the culvert.

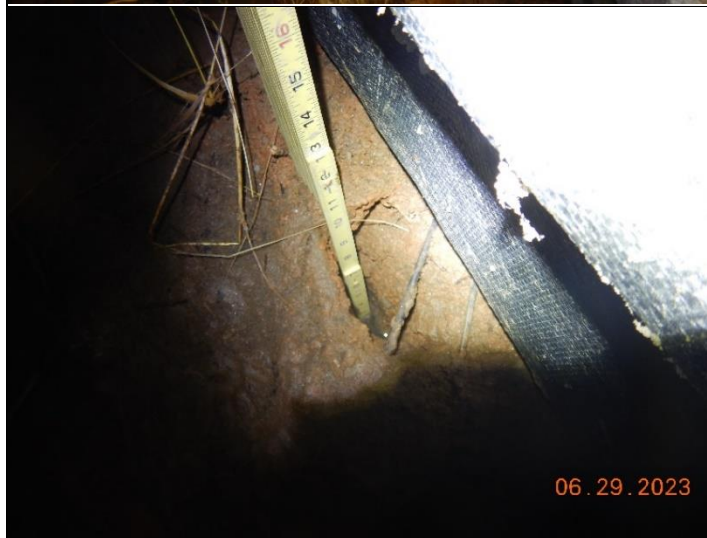
Rosedale Development Site  
Date: 29 June 2023  
Photo ID: DSCN4825.JPG  
Photo taken by: Katelyn Almeter

Notes: View of flow of UNT2 flowing against the concrete footer as it flows through the culvert.

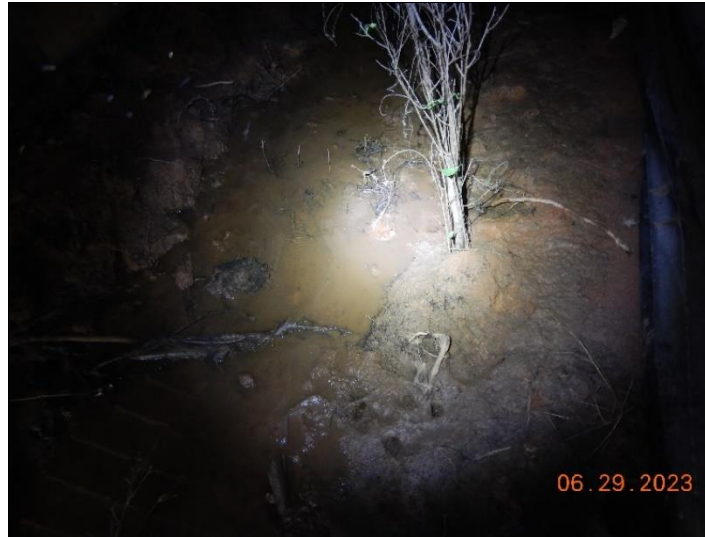
Rosedale Development Site  
Date: 29 June 2023  
Photo ID: DSCN4826.JPG  
Photo taken by: Katelyn Almeter

Notes: View of water present in gaps at the base of the concrete footer abutting UNT2.

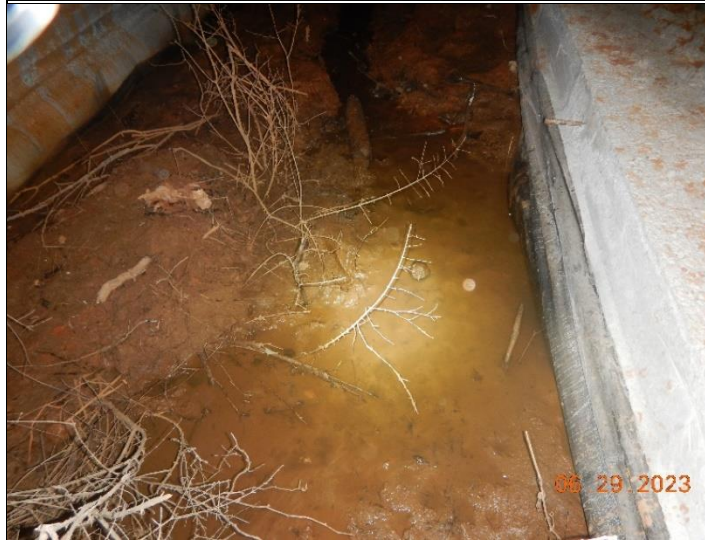
Rosedale Development Site  
Date: 29 June 2023  
Photo ID: DSCN4827.JPG  
Photo taken by: Katelyn Almeter

Notes: View looking downstream of UNT2 flowing through the culvert.

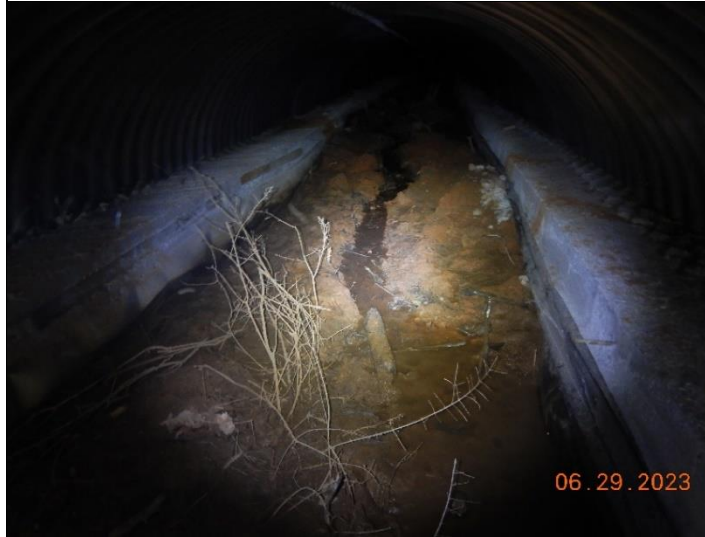
Rosedale Development Site  
Date: 29 June 2023  
Photo ID: DSCN4828.JPG  
Photo taken by: Katelyn Almeter

Notes: View of UNT2 flowing against the concrete footer as it flows through the culvert.

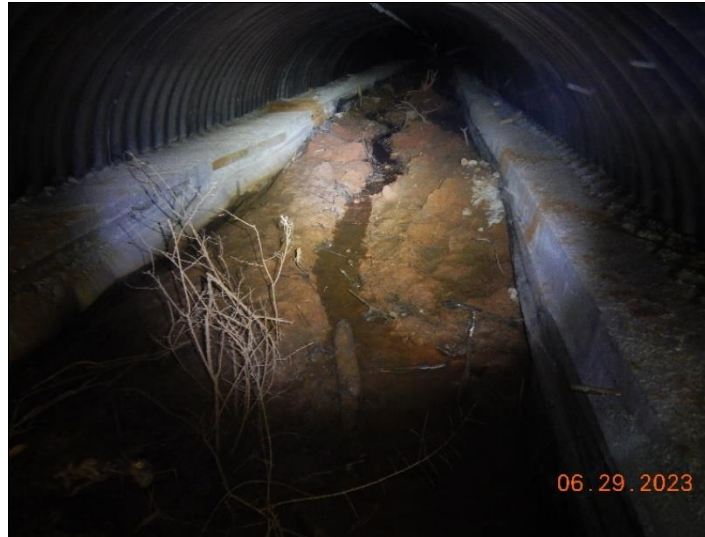
Rosedale Development Site  
Date: 29 June 2023  
Photo ID: DSCN4829.JPG  
Photo taken by: Katelyn Almeter

Notes: View of UNT2 as it flows through the culvert.

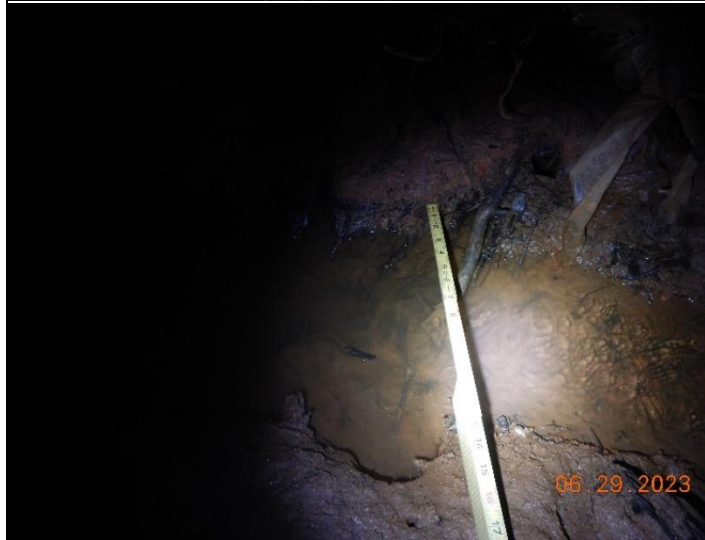
Rosedale Development Site  
Date: 29 June 2023  
Photo ID: DSCN4830.JPG  
Photo taken by: Katelyn Almeter

Notes: View looking downstream of UNT2 flowing through the culvert.

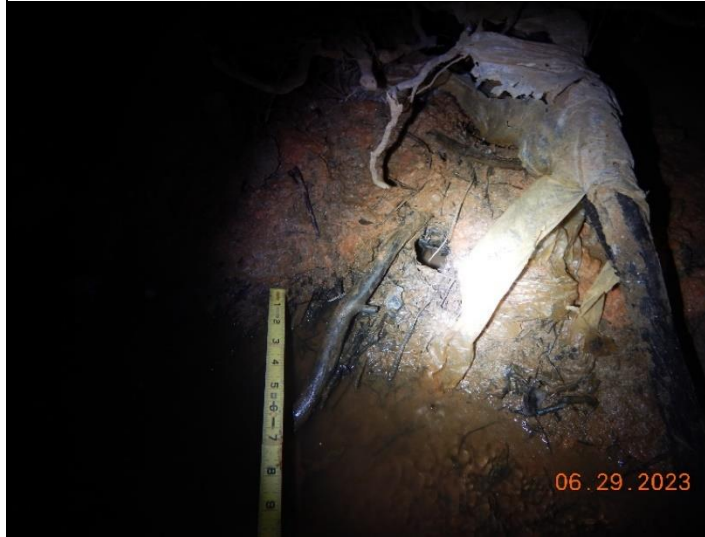
Rosedale Development Site  
Date: 29 June 2023  
Photo ID: DSCN4831.JPG  
Photo taken by: Katelyn Almeter

Notes: Active channel measurement of UNT2 approximately halfway through the culvert.

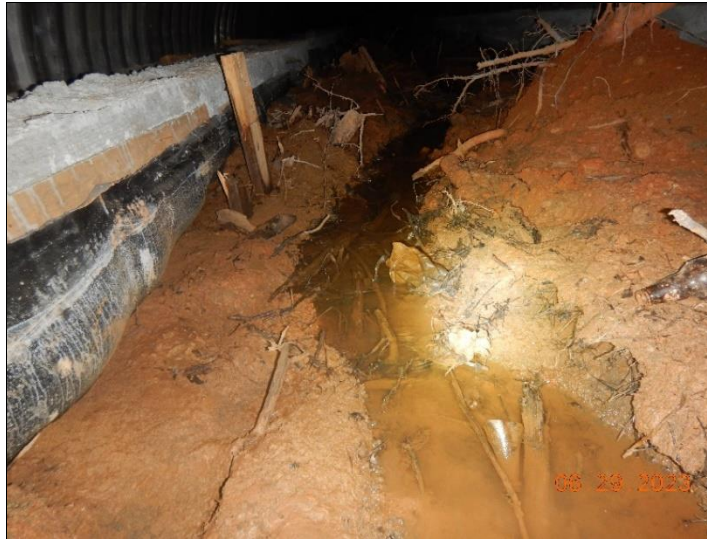
Rosedale Development Site  
Date: 29 June 2023  
Photo ID: DSCN4832.JPG  
Photo taken by: Katelyn Almeter

Notes: Active channel measurement of UNT2 approximately halfway through the culvert.

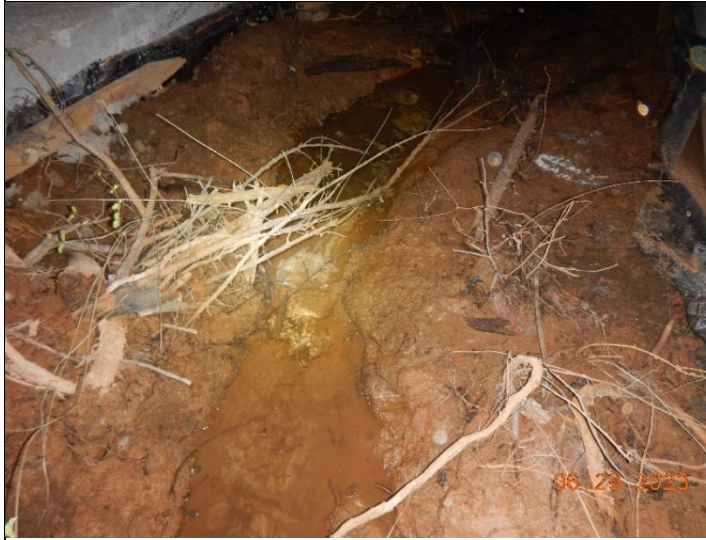
Rosedale Development Site  
Date: 29 June 2023  
Photo ID: DSCN4833.JPG  
Photo taken by: Katelyn Almeter

Notes: Downstream view of UNT2 flowing through the culvert with discharged material present throughout. Note the exposed roots of woody vegetation on the bank.

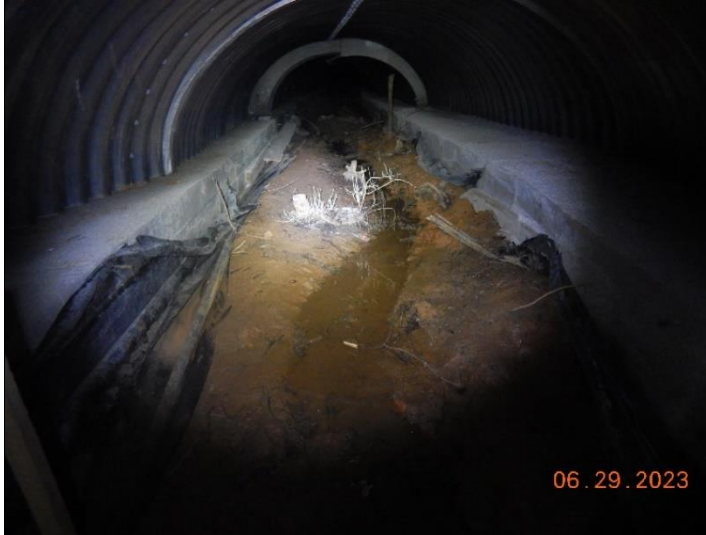
Rosedale Development Site  
Date: 29 June 2023  
Photo ID: DSCN4834.JPG  
Photo taken by: Katelyn Almeter

Notes: Downstream view of UNT2 flowing through the culvert with discharged material present throughout.

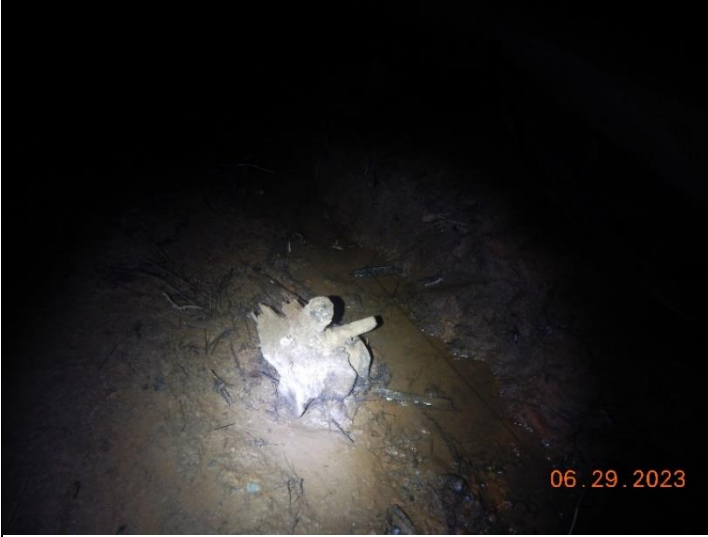
Rosedale Development Site  
Date: 29 June 2023  
Photo ID: DSCN4835.JPG  
Photo taken by: Katelyn Almeter

Notes: Downstream view of UNT2 flowing through the culvert with discharged material present throughout.

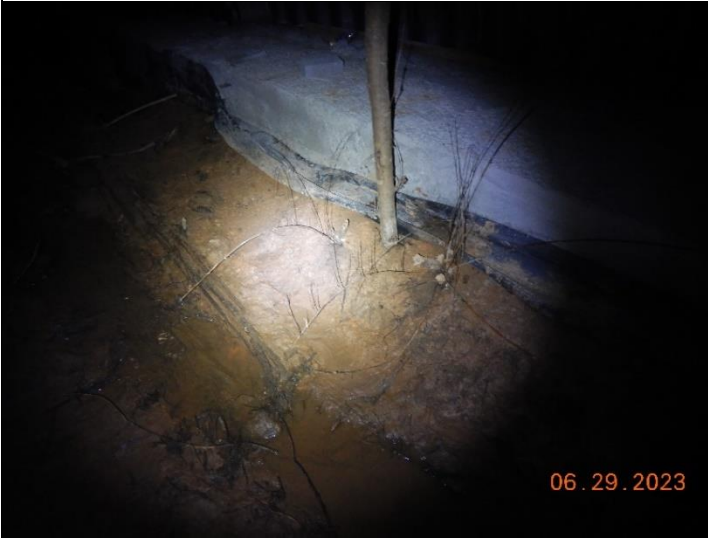
| | <p>Rosedale Development Site<br/>Date: 29 June 2023<br/>Photo ID: DSCN4836.JPG<br/>Photo taken by: Katelyn Almeter</p> <p>Notes: View of a stump of a shrub/tree.</p> |

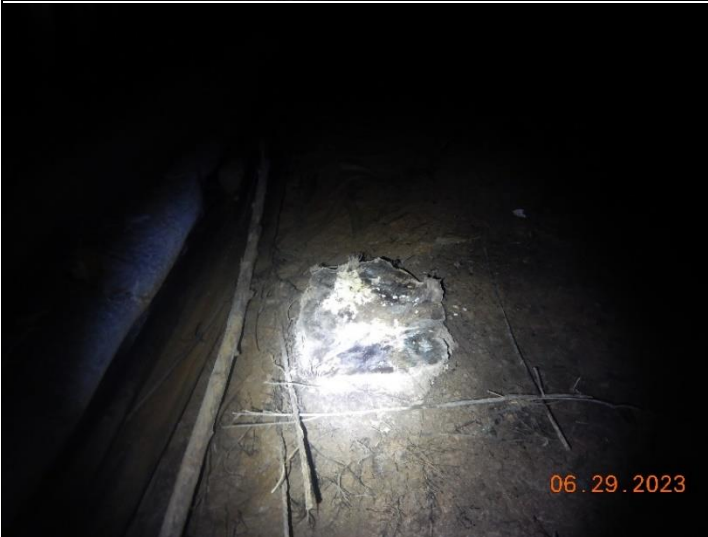
| | <p>Rosedale Development Site<br/>Date: 29 June 2023<br/>Photo ID: DSCN4837.JPG<br/>Photo taken by: Katelyn Almeter</p> <p>Notes: Facing downstream along UNT2 within the culvert.</p> |

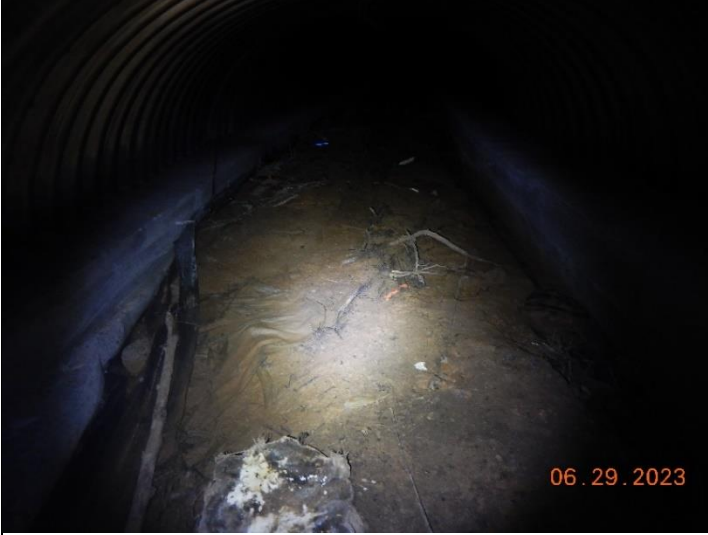
| | <p>Rosedale Development Site<br/>Date: 29 June 2023<br/>Photo ID: DSCN4838.JPG<br/>Photo taken by: Katelyn Almeter</p> <p>Notes: Facing downstream along UNT2 within the culvert.</p> |

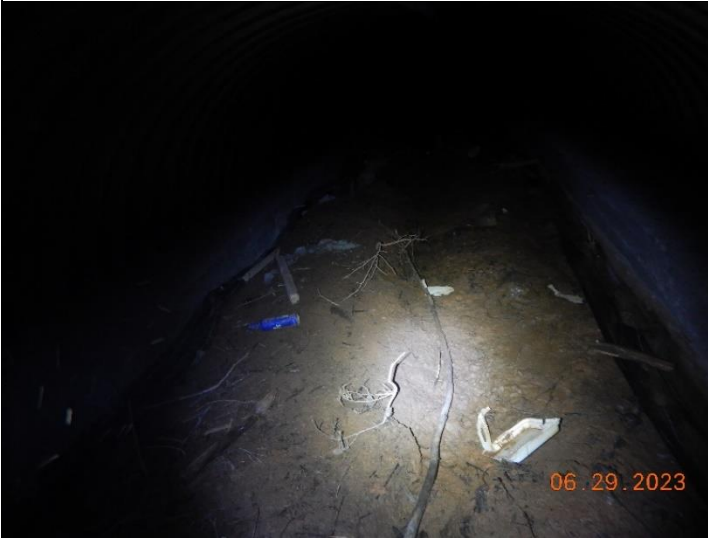
| | <p>Rosedale Development Site<br/>Date: 29 June 2023<br/>Photo ID: DSCN4839.JPG<br/>Photo taken by: Katelyn Almeter</p> <p>Notes: Facing downstream along UNT2 within the culvert. Note flow is not visible within the culvert.</p> |

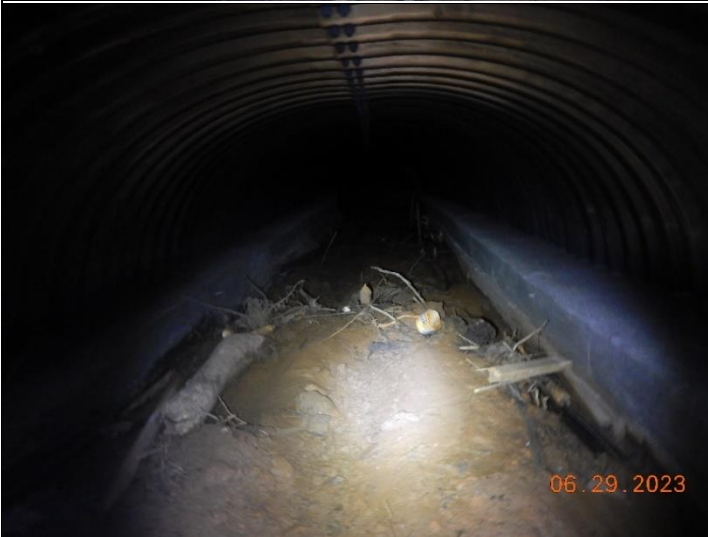
| | <p>Rosedale Development Site<br/>Date: 29 June 2023<br/>Photo ID: DSCN4840.JPG<br/>Photo taken by: Katelyn Almeter</p> <p>Notes: Facing downstream along UNT2 within the culvert. Note flow is not visible within the culvert.</p> |

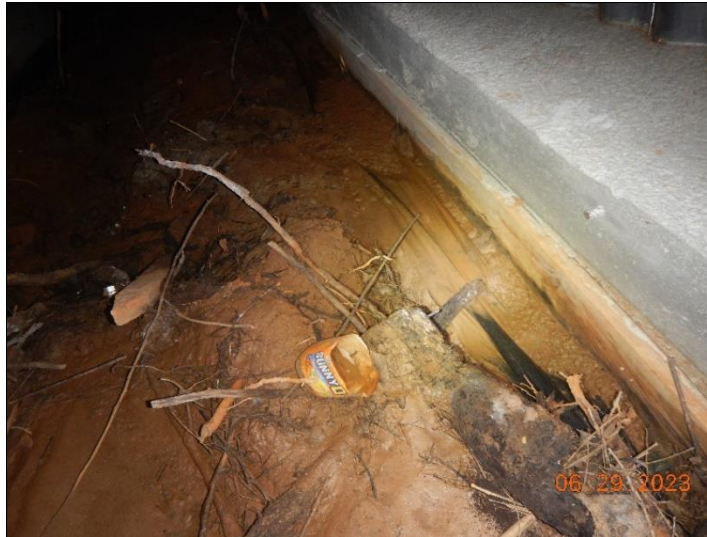
| | <p>Rosedale Development Site<br/>Date: 29 June 2023<br/>Photo ID: DSCN4841.JPG<br/>Photo taken by: Katelyn Almeter</p> <p>Notes: Facing downstream along UNT2 within the culvert. Note flow is not visible within the culvert.</p> |

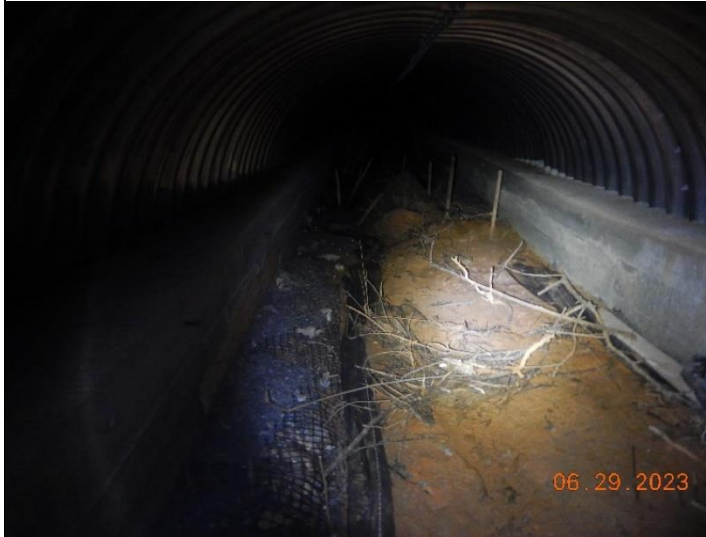
Rosedale Development Site  
Date: 29 June 2023  
Photo ID: DSCN4843.JPG  
Photo taken by: Katelyn Almeter

Notes: Facing downstream along UNT2 within the culvert. Note flow is not visible within the culvert.

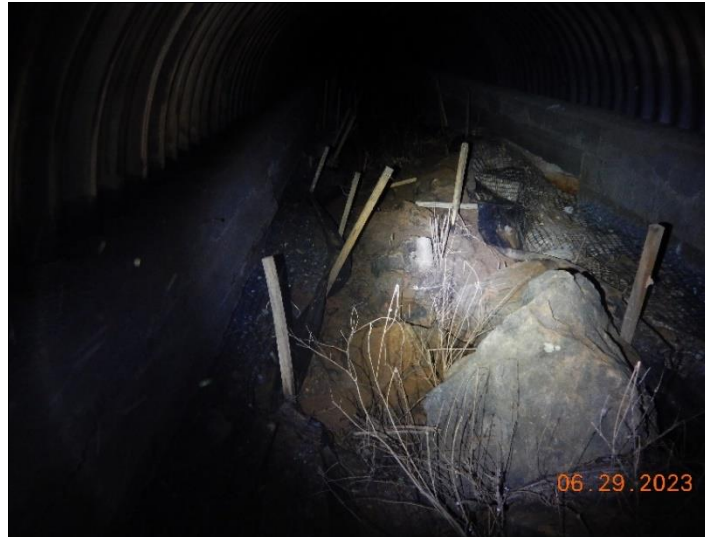
Rosedale Development Site  
Date: 29 June 2023  
Photo ID: DSCN4844.JPG  
Photo taken by: Katelyn Almeter

Notes: Facing downstream along UNT2 within the culvert. Note flow is not visible within the culvert.

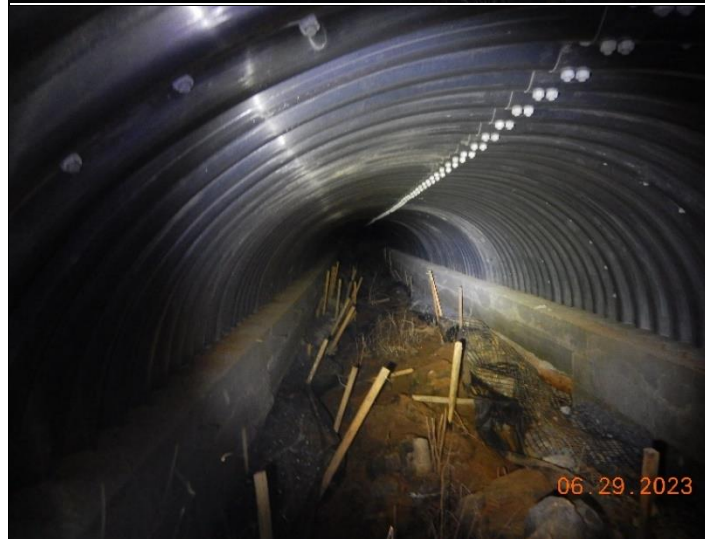
Rosedale Development Site  
Date: 29 June 2023  
Photo ID: DSCN4845.JPG  
Photo taken by: Katelyn Almeter

Notes: View of large rocks and silt fence present along UNT2 in the culvert.

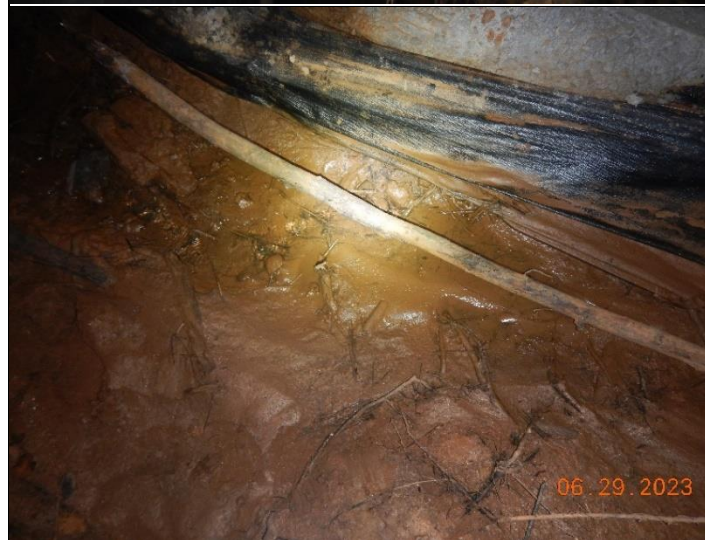
Rosedale Development Site  
Date: 29 June 2023  
Photo ID: DSCN4846.JPG  
Photo taken by: Katelyn Almeter

Notes: Facing downstream along UNT2 within the culvert. Note flow is not visible within the culvert.

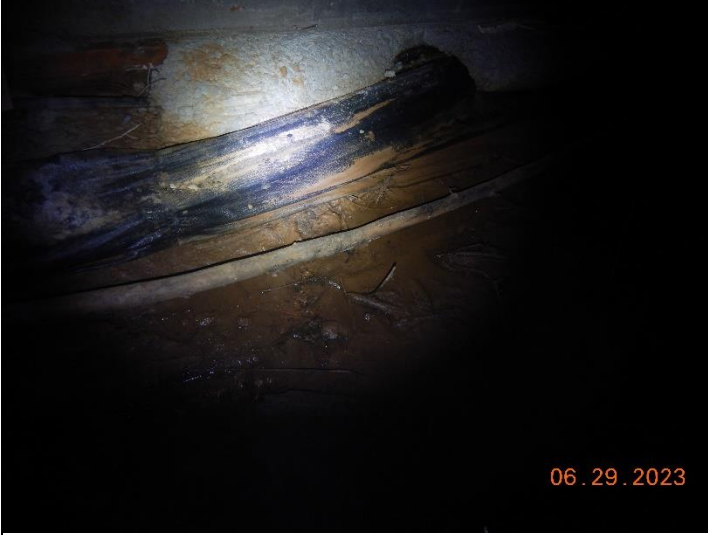
Rosedale Development Site  
Date: 29 June 2023  
Photo ID: DSCN4847.JPG  
Photo taken by: Katelyn Almeter

Notes: View of UNT2 as it appears to flow under the concrete footer.

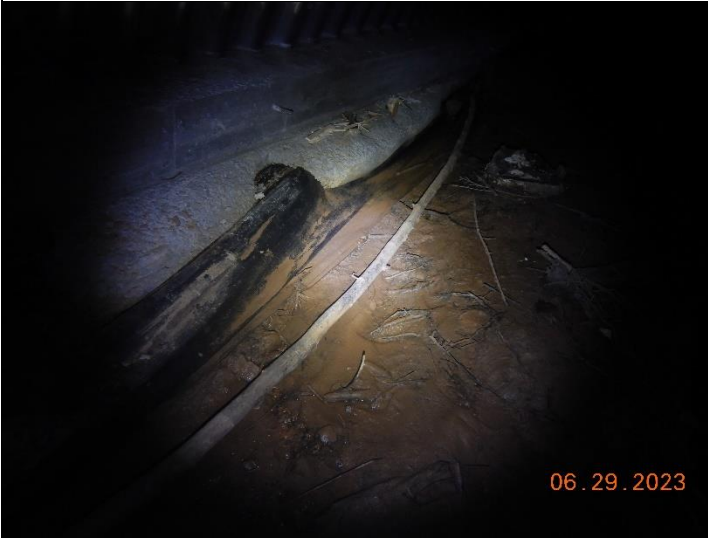
| <p>06.29.2023</p> | <p>Rosedale Development Site<br/>Date: 29 June 2023<br/>Photo ID: DSCN4848.JPG<br/>Photo taken by: Katelyn Almeter</p> <p>Notes: View of UNT2 as it appears to flow under the concrete footer.</p> |

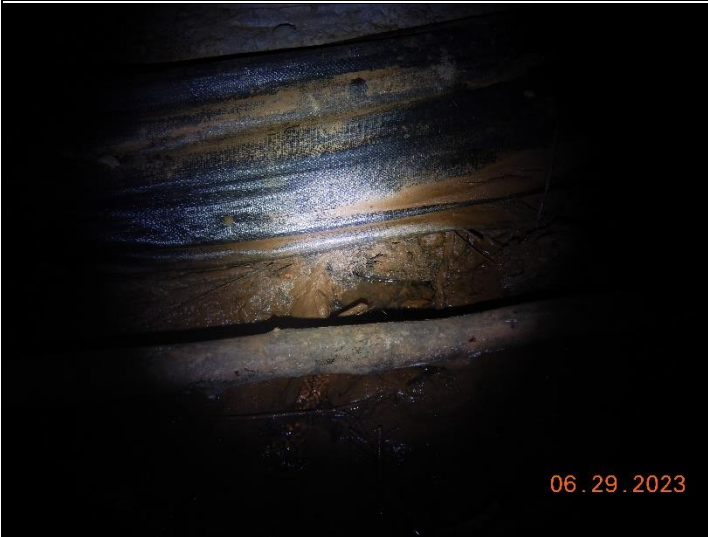
| <p>06.29.2023</p> | <p>Rosedale Development Site<br/>Date: 29 June 2023<br/>Photo ID: DSCN4849.JPG<br/>Photo taken by: Katelyn Almeter</p> <p>Notes: View of UNT2 as it appears to flow under the concrete footer.</p> |
