**UNITED STATES ENVIRONMENTAL PROTECTION AGENCY  
REGION III**

**Report Title:** Clean Water Act, Section 404 Inspection Report for Rosedale Development Site  
**Inspection Date(s):** 06/29/2023  
**Start Time:** 8:00AM **End Time:** 10:45AM  
**Regulatory Program(s):** Inspections authorized pursuant to Clean Water Act, Sections 308 and 404 (33 U.S.C. §§ 1318 and 1344)  
**Site Name:** Rosedale Development Site  
**Site Location:** 1600 Graves Mill Road  
Lynchburg, Virginia 24502  
**Latitude:** 37.3762 **Longitude:** -79.2315  
**County/Parish:** City of Lynchburg  
**Site Owner(s):** Rosedale Investments, LLC  
T.B.P. Properties, LLC  
**Mailing Address:** P.O. Box 148  
Forest, Virginia 24551  
**Unique Project #:** 3E23WW039A

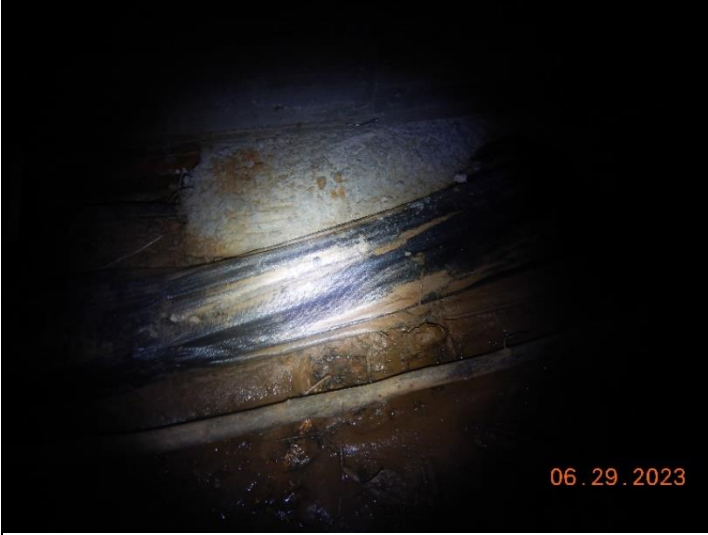
| <p>06.29.2023</p> | <p>Rosedale Development Site<br/>Date: 29 June 2023<br/>Photo ID: DSCN4850.JPG<br/>Photo taken by: Katelyn Almeter</p> <p>Notes: View of the presence of water that appears to flow under the concrete footer.</p> |
