INSPECTION REPORT

| <b>Facility or Site Name:</b> | ALASKA DOT & PF 6860 GLACIER HWY | | |

Type of inspection: CEI - Compliance Evaluation Inspection

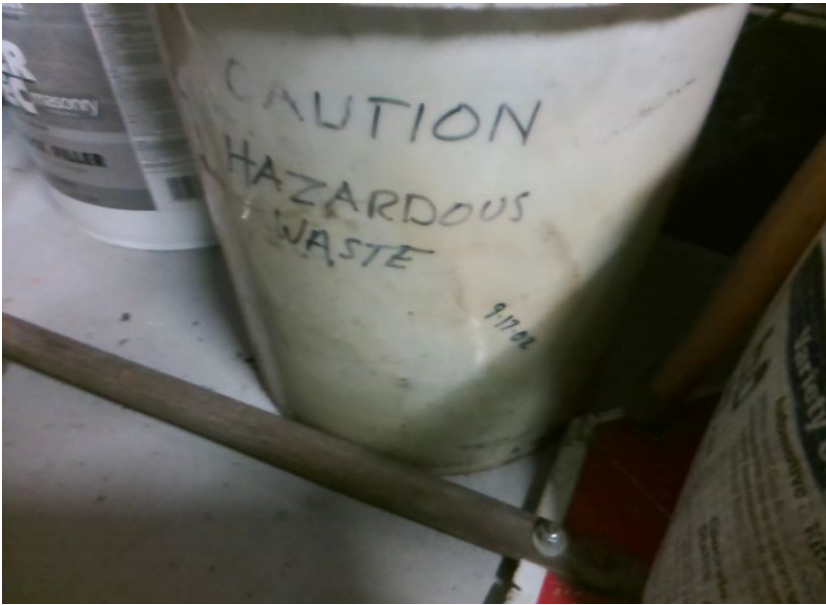
| Equipment Shop/Boiler room | |

| While in the boiler room, I saw a five-gallon container that was marked with the words "Caution Hazardous Waste" and the date 9-17-02. At the time of the inspection there was no other information available regarding the container or its contents. The container was not marked with a hazard indicator. | <b>Citation:</b> | <b>Section:</b> |

| Another close-up view of the five-gallon container that was marked with the words "Caution Hazardous Waste" and the date 9-17-02. | |

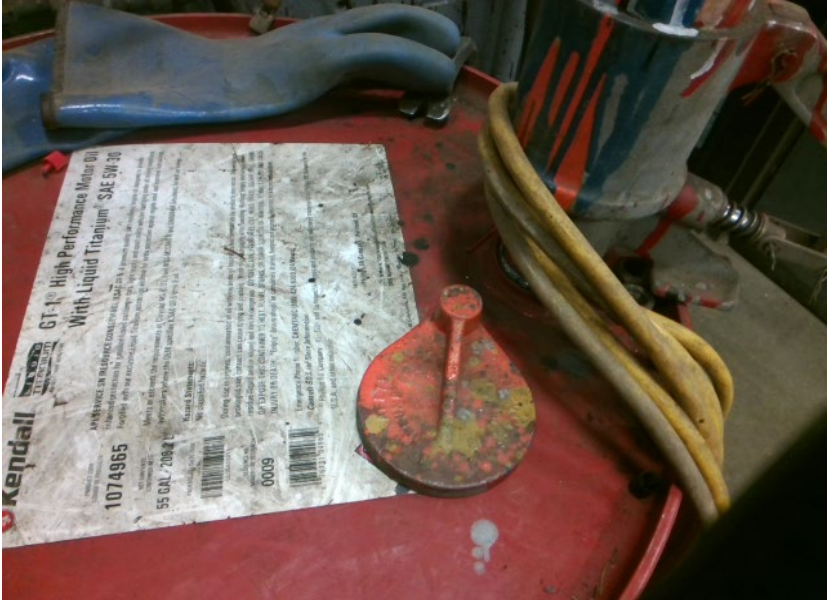
| Another view of the same SAA container showing that the aerosol can popper lid is not attached and laying on top of the container. | |

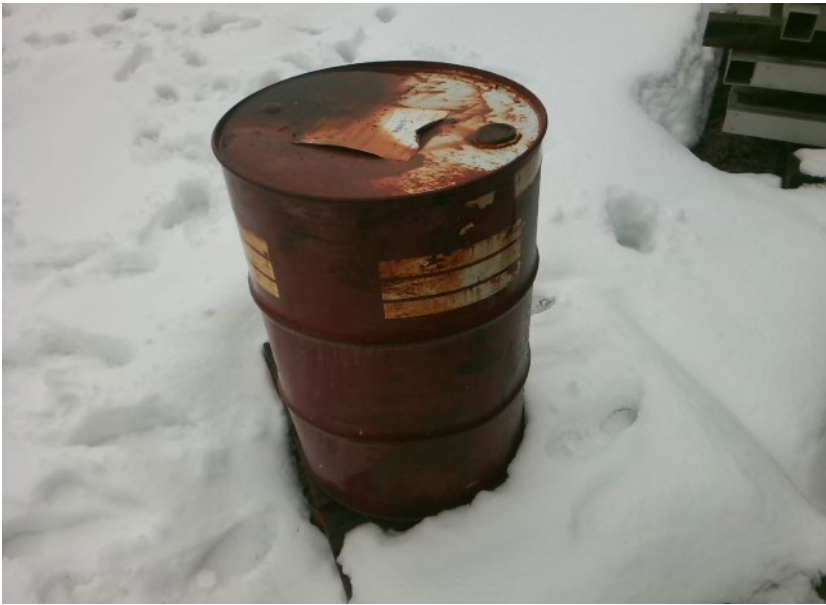
| <p>While inspecting the area west of the Cold Shed, referred to as "The Hill," I saw a lone rusty and dented 55-gallon container on a pallet that was located northwest of the Cold Shed.</p> <p>Mr. Gates told me the facility disposed of approximately 12 containers of hazardous waste through Clean Harbors during the spring 2020 (March/April). Mr. Gates stated that they intended to ship this container too, but Clean Harbors would not take it because it was an unknown waste.</p> <p>According to Mr. Gates, no weekly inspections were being conducted for this container. The container was not labeled and had no hazard indicator.</p> | |

| Another view of the rusty and dented 55-gallon container holding unknown contents. | |

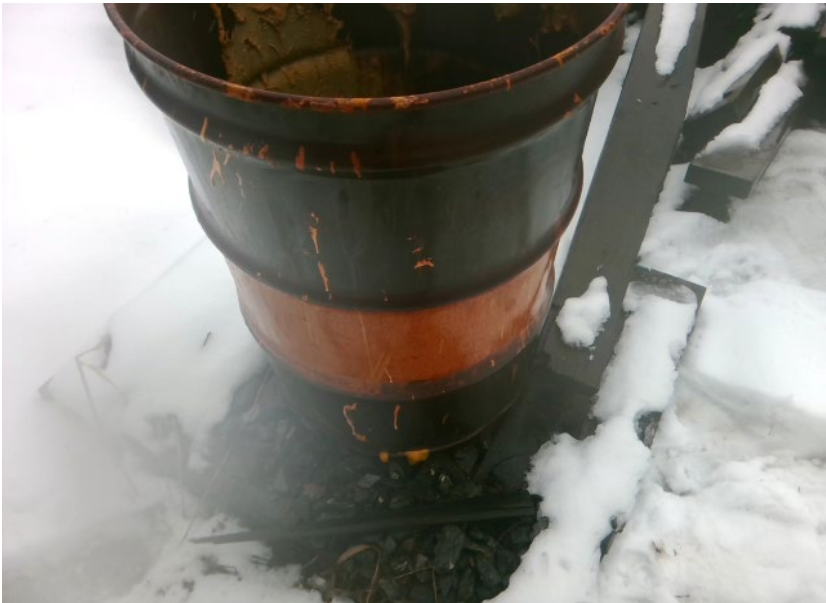
| <p>Prior to leaving "The Hill", I saw an old rusty container by the edge of the roadway. I noticed that the container was not closed, and I asked what the container held. Mr. Gates spoke up and said that it was full of chains. I went over to get a closer look and it appeared to be half full of something with water, possibly snowmelt filling the rest of the container. At first glance I was unable to determine what the container held beneath the water. I poked at the material with a stick and found it to be hard and thought it might be full of chains.</p> <p>I returned to the office to conduct the closing conference and after the closing conference I decided to go back out with Messrs. Wolfe, Gates, and Tunley to remove some of the water in the container in order to get a better look at the contents of the container. After Mr. Wolfe removed some of the standing water in the container, I could see that it contained dried yellow traffic paint. I asked for a copy of the Material Safety Data Sheet (MSDS) for the paint and I was provided with a copy during the inspection. According to the MSDS, the waste paint contained the following constituents: Lead (3% by weight) and Chromium (Hexavalent Chromium 0.69 % by weight)</p> | |

| Container of dried waste traffic paint was identified. The container was not closed, not labeled with the words Hazardous Waste, a hazard indicator, or accumulation start date. According to the MSDS, the waste paint contains lead and chromium. | <b>Citation:</b> | <b>Section:</b> |

| View of the bottom of the container, showing that at one point in time, the waste paint was leaking from the bottom of the container. | |
