Clean Water Act (CWA) Inspection Report

| <b>Inspection Entry Date/Time</b> | 01/22/2024 10:30 AM (PT) | Announced: No | | |
| <b>Type of Inspection</b> | CEI - Compliance Evaluation Inspection | | | |
| <b>Project or Site Name</b> | HD Fowler SR-3 Industrial Stock Yard | | | |

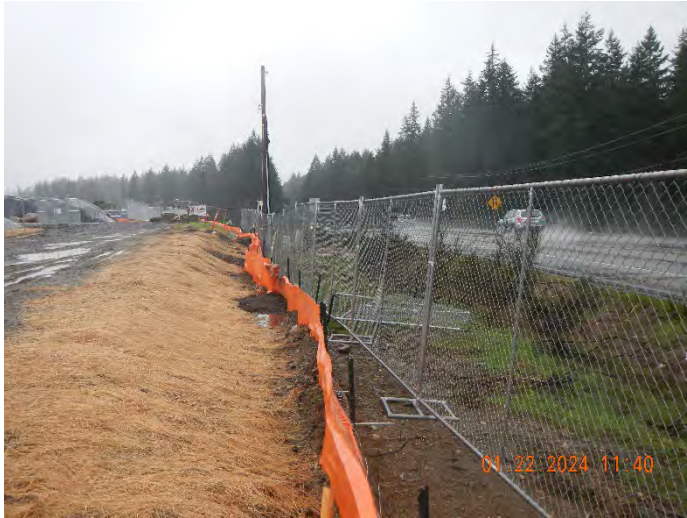
Photo #:17 (DSCN3526)

We continued southwest and continued to observe the remaining sections of the northern perimeter. In addition to the applied base rock, silt fencing and straw was being used as BMPs along the northern perimeter (**Photo 17**). We also observed two catch basins installed (**Photo 18**); Mr. Halme discussed that both catch basins were routed to the primary/permanent stormwater pond.

Description: Facing southwest, photo of north perimeter silt fencing and straw application as BMPs.

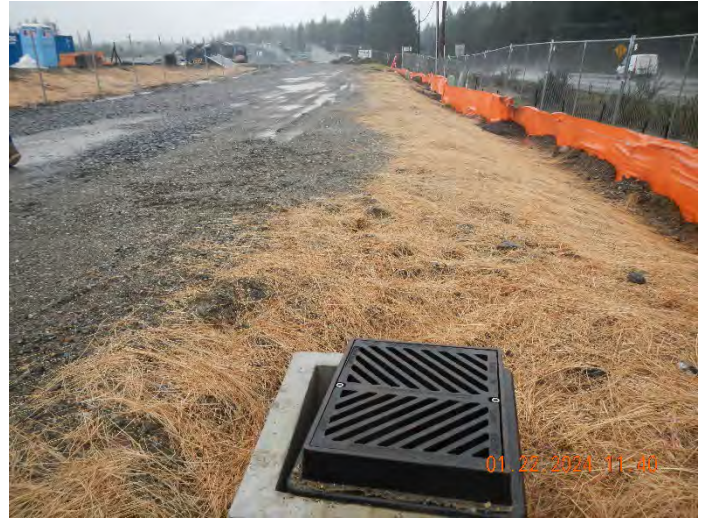
Photo #:18 (DSCN3527)

Description: Facing southwest, photo of constructed stormwater catch basin, connecting to stormwater vault and stormwater pond.

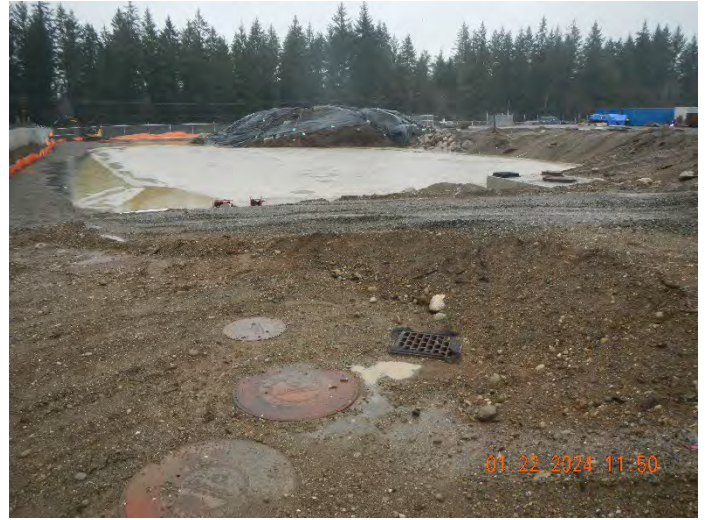
Photo #:26 (DSCN3535)

From the northwest boundary we then traveled south along the western perimeter. We observed the southern areas of the stormwater pond and several sections of broken PVC piping currently in repair **(Photo 25)**. We also observed the southern stormwater vault **(Photo 26)** and staged media for future use within vault(s) **(Photo 27)**. Along the western perimeter, we observed a section of silt fence in need of maintenance **(Photo 28)**. The adjacent property to the west was an auto wrecking business that was temporarily closed. Construction areas had generally been covered with base rock. As we continued south, we observed the secondary/temporary stormwater pond and dewatering area located within the vegetated/wooded area **(Photo 29 - Photo 32)**.

Description: Facing north, photo of southern stormwater vault and primary storm pond.

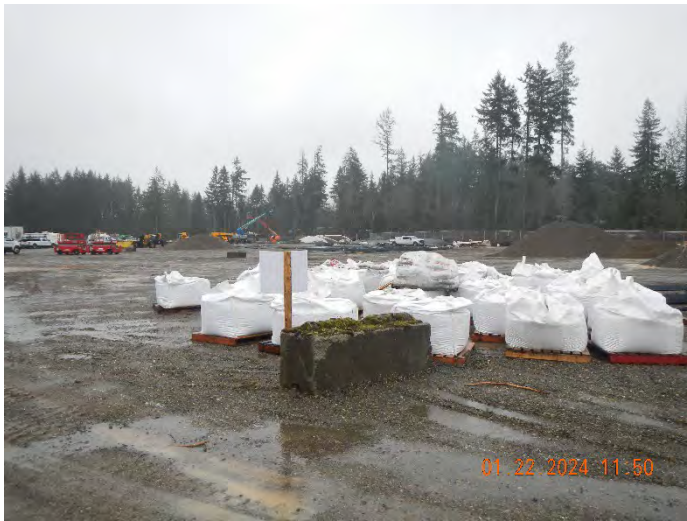
Photo #:27 (DSCN3536)

Description: Facing north, photo of media staged for the installation to stormwater vaults.

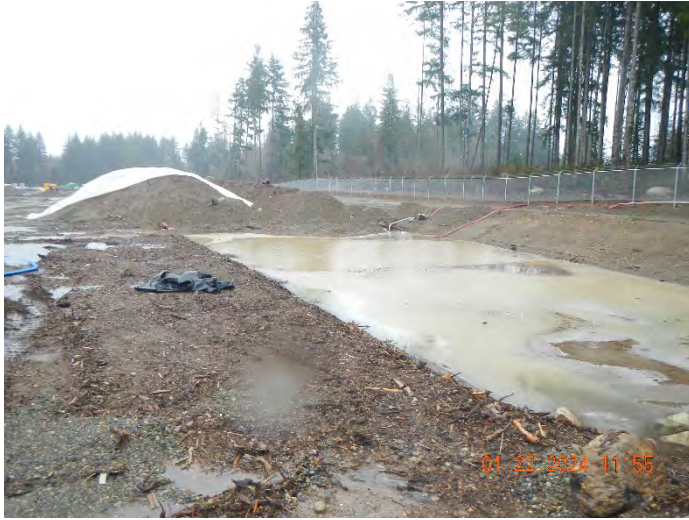
Photo #:29 (DSCN3538)

Description: Facing north, photo of secondary stormwater pond that receives stormwater from primary stormwater pond (when pumped). Stormwater from the secondary pond is pumped upslope to vegetated/wooded area to the south.

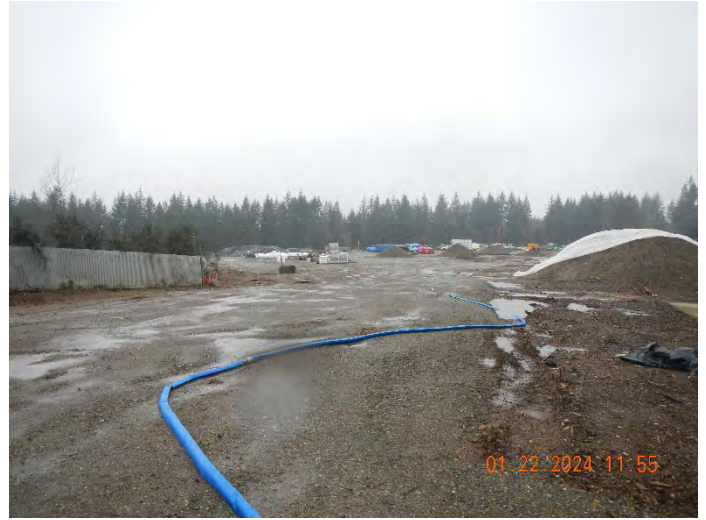
Photo #:30 (DSCN3539)

Description: Facing north, photo of secondary stormwater pond and pumping hose. Stormwater from the secondary pond is pumped upslope to a vegetated/wooded area to the south.

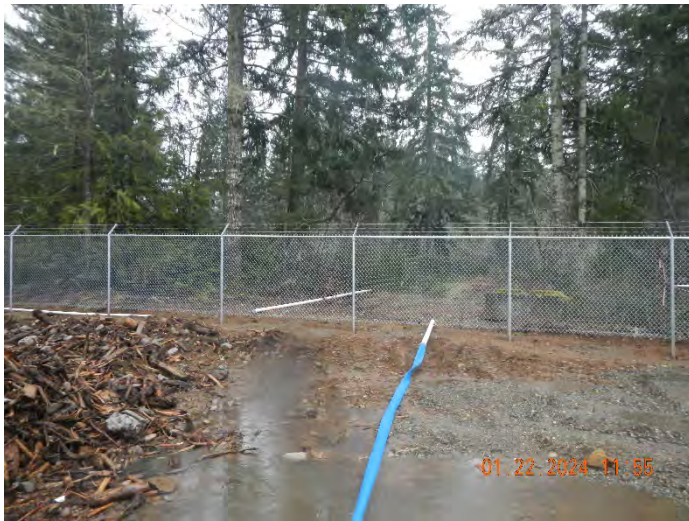
Photo #:31 (DSCN3540)

Description: Facing south, photo of pumping hose used to pump stormwater from the secondary pond to the vegetated/wooded area to the south.

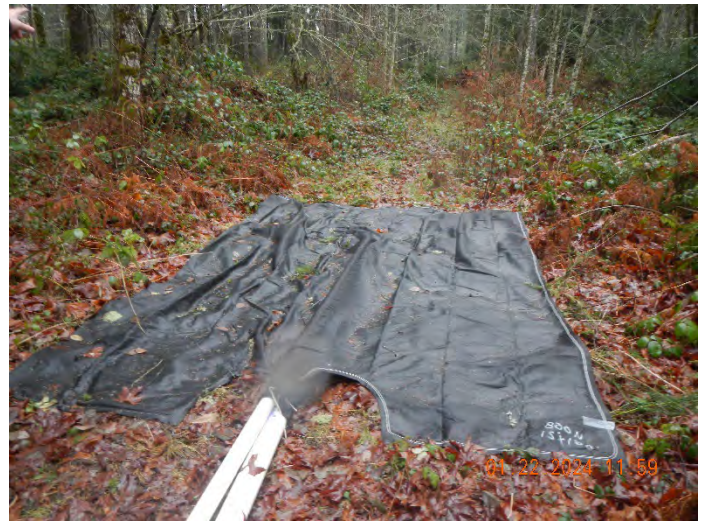
Photo #:32 (DSCN3541)

Description: Facing south, photo of sediment bag used at discharge location in vegetated/wooded area for secondary pond.

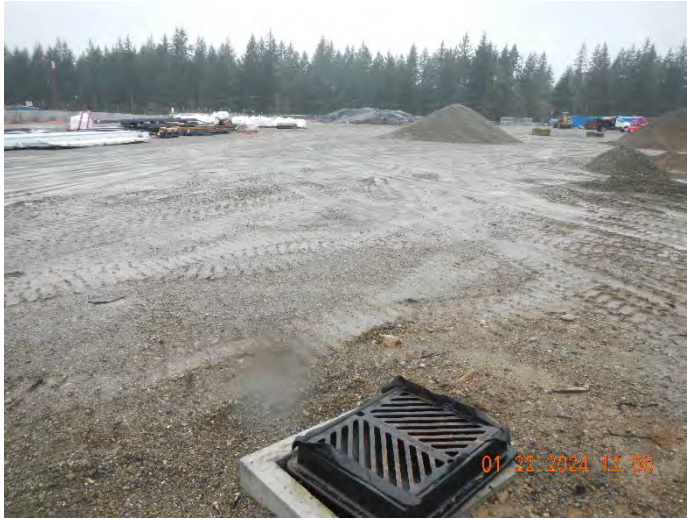
Photo #:33 (DSCN3542)

As we returned north from the vegetated wooded area, we walked along the eastern boundary and observed additional catch basins that were connected to the primary/permanent stormwater pond. Catch basins were equipped with fabric filters **(Photo 33 & Photo 34)**, construction areas were generally covered with base rock. Along the eastern perimeter, we also observed a foundation trench that had been excavated and currently full of water. Mr. Halme discussed that the Project had just received the required permitting items for that area, which had been delayed following the trenching activity. The trench had yet to be dewatered and/or connected to the stormwater collection system **(Photo 35 – Photo 37)**.

Description: Facing west, photo of stormwater catch basin within the stockpile area. Catch basin designed to route stormwater to primary stormwater pond. Catch basin equipped with fabric/filter.

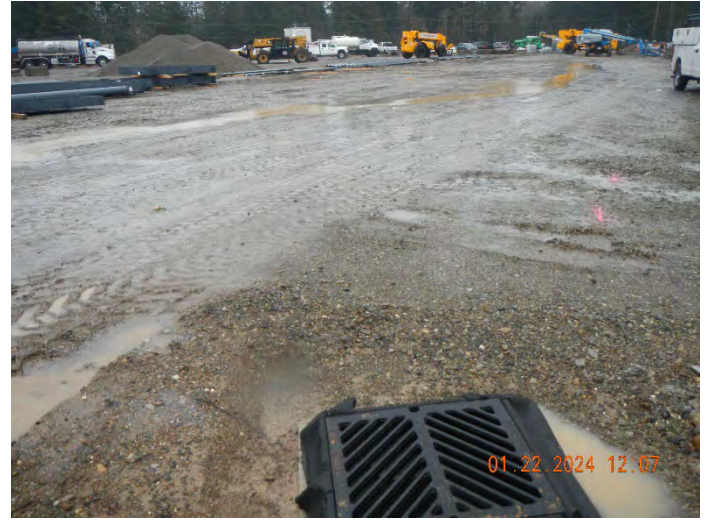
Photo #:34 (DSCN3543)

Description: Facing northwest, photo of stormwater catch basin within the stockpile area. Catch basin designed to route stormwater to primary stormwater pond. Catch basin equipped within fabric filter.

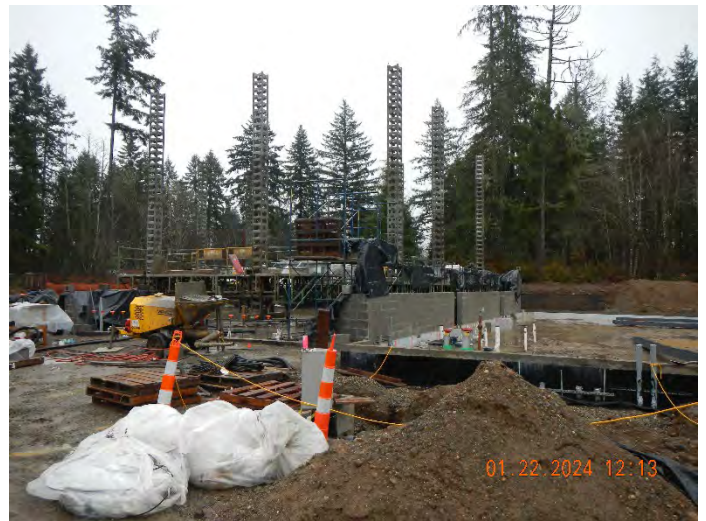
Photo #:40 (DSCN3549)

Description: Facing northeast, photo of vertical construction of future warehouse/office building.

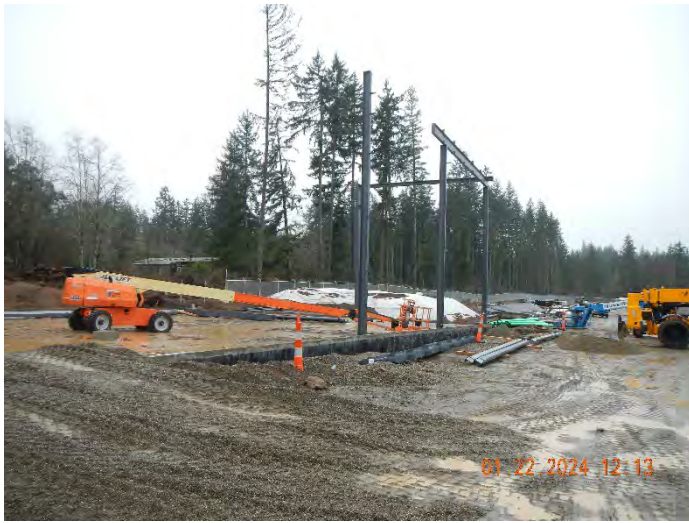
Photo #:41 (DSCN3550)

Description: Facing southeast, photo of vertical construction of future warehouse/office building.

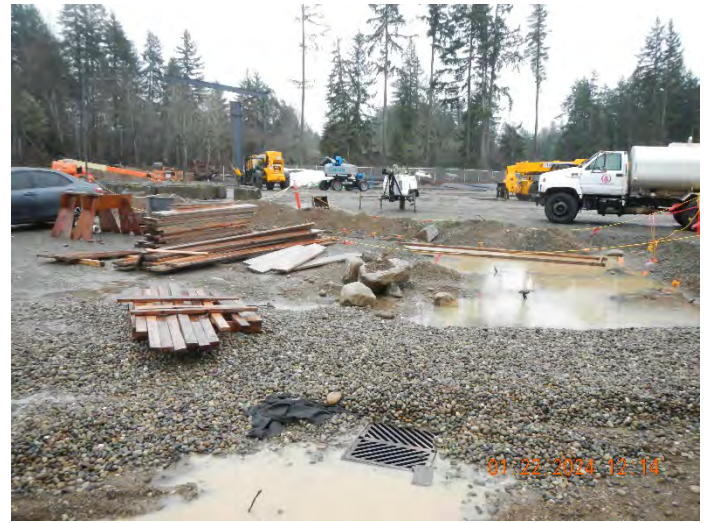
Photo #:42 (DSCN3551)

Description: Facing south, photo of area northeast of the jobsite trailer, stormwater catch basin routing to stormwater vault/primary pond.

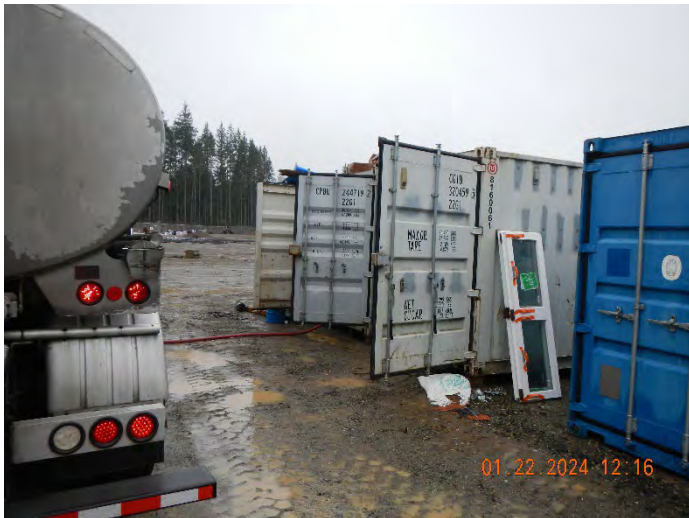
Photo #:43 (DSCN3552)

Description: Facing south, photo of conex/shipping containers used to fuel/material storage.

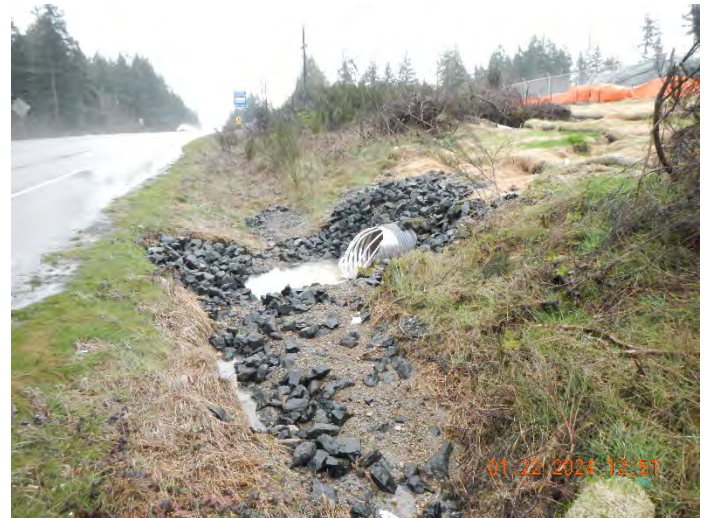
Photo #:44 (DSCN3568)

Upon arriving at the SR-3 roadside ditch and pond outfall along SR-3, we observed water within the stormwater pond’s discharge pipe and within the SR-3 roadside ditch. Rip-rap was observed at the pipe’s discharge location. Straw wattles within the SR-3 roadside ditch appeared to need maintenance. Stormwater within the SR-3 ditch was observed to be either infiltrating or ponding. No discharge to Gorst Creek was observed **(Photo 44 – 48)**.

Description: Facing northeast, photo of stormwater pond discharge location to the SR-3 roadside ditch. No flow observed at the time of inspection.

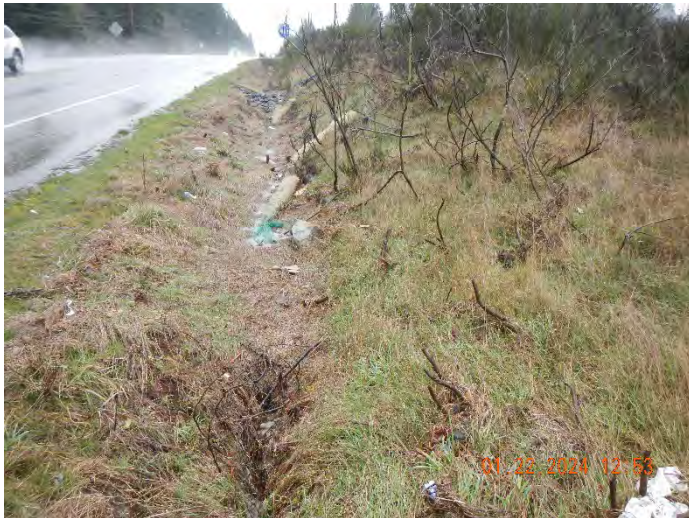
Photo #:47 (DSCN3571)

Description: Facing northeast, photo SR-3 roadside ditch downslope of stormwater pond outfall. No flow observed at the time of inspection.

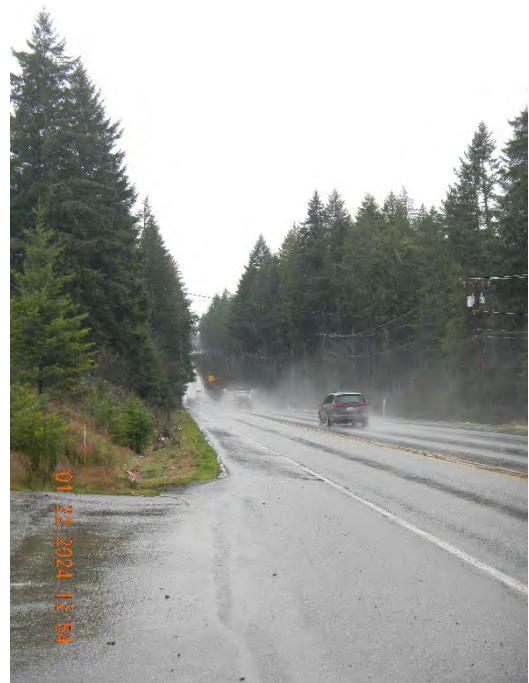
Photo #:48 (DSCN3572)

Description: Facing southwest, photo of SR-3 roadside ditch downslope of stormwater pond outfall. No flow observed at the time of inspection.
