## TROPICAL SHIPPING-CROWN BAY, NPDES Stormwater Reconnaissance Inspection (RI) Photo Album; 9-8-2022 Walkthrough

### A. Observations that revealed potential non-compliance with regulations implementing the CWA and TPDES Stormwater Rules during the RI

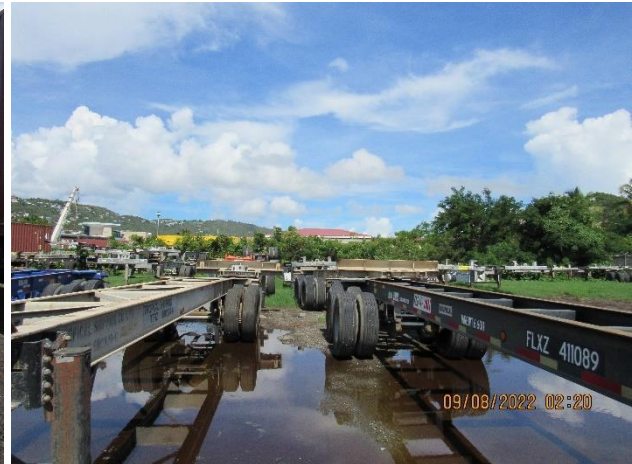
**IMG 475**-Front area of the Cancryn Field section occupied by Tropical. On-going activity observed, with no erosion control and soil retention installed.
