INSPECTION REPORT

Inspection Date(s):	08/30/2022 - 08/31/2022	Announced: Yes
Time:	Entry: 01:05 PM (ET)	Exit: 01:20 PM (ET)
Media:	Water	
Statute(s)/Program(s):	Clean Water Act, NPDES, WWTP	
Type of inspection:	CEI - Compliance Evaluation Inspection	
Access:	Granted	
Permittee Name: CITY OF KENDALLVILLE		
Facility or Site Name: CITY OF KENDALLVILLE WASTEWATER TREATMENT PLANT		
Facility/Site Physical Address: 501 WEST WAYNE STREET		
(City, state, zip code) KENDALLVILLE, IN 46755		
County/Parish: NOBLE		
Facility GPS Coordinates: 41.446444, -85.273806		
Facility/Site Identifier: 110005973900		
Permit Number: IN0020656

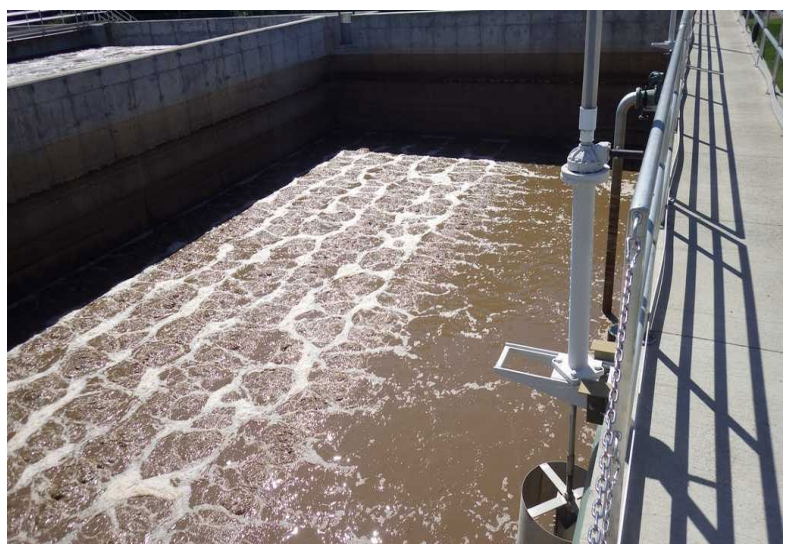
Secondary Clarifier #1
KEND0132.JPG
08/31/2022 12:23 PM (ET)
Dean Maraldo
Physical Inspection/Secondary Clarification
No CBI
No PII
Note the significant vegetation growth and debris in the effluent trough and weir notches. Also note skimmer capturing palm oil blobs on the surface of the secondary clarifier.

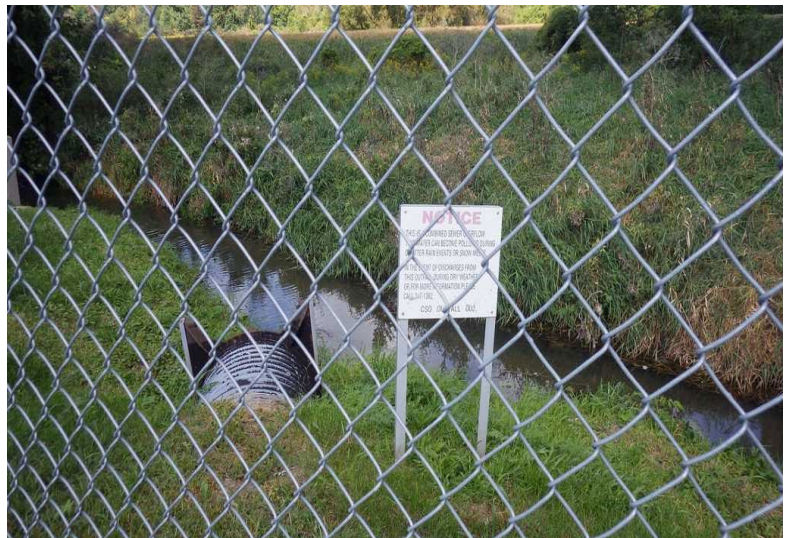
CSO Outfall #002 and signage
KEND0142.JPG
08/31/2022 12:51 PM (ET)
Dean Maraldo
Physical Inspection/CSO Outfall
No CBI
No PII

<p>Photo(s)</p> <ol style="list-style-type: none"> 1. KEND0137.JPG 2. KEND0138.JPG 3. KEND0139.JPG 	
Unit: Physical Inspection/CSO Outfall	Contains CBI: No
Observation #: DM1-OB-015	Date: 08/31/2022
<p>I observed CSO Outfall #002 (see Photo Log images KEND0141 and KEND0142). CSO Outfall #002 is located just upstream from Outfall 003, on the unnamed tributary that flows to Henderson Lake.</p>	
<p>Photo(s)</p>
