**Region 6 Compliance Assurance and Enforcement Division  
INSPECTION REPORT**

| Inspection Date(s): | 06/08/2022 | | |
| Regulatory Program(s) | NPDES | | |
| Company Name: | Farm and Ranch Heritage Museum | | |

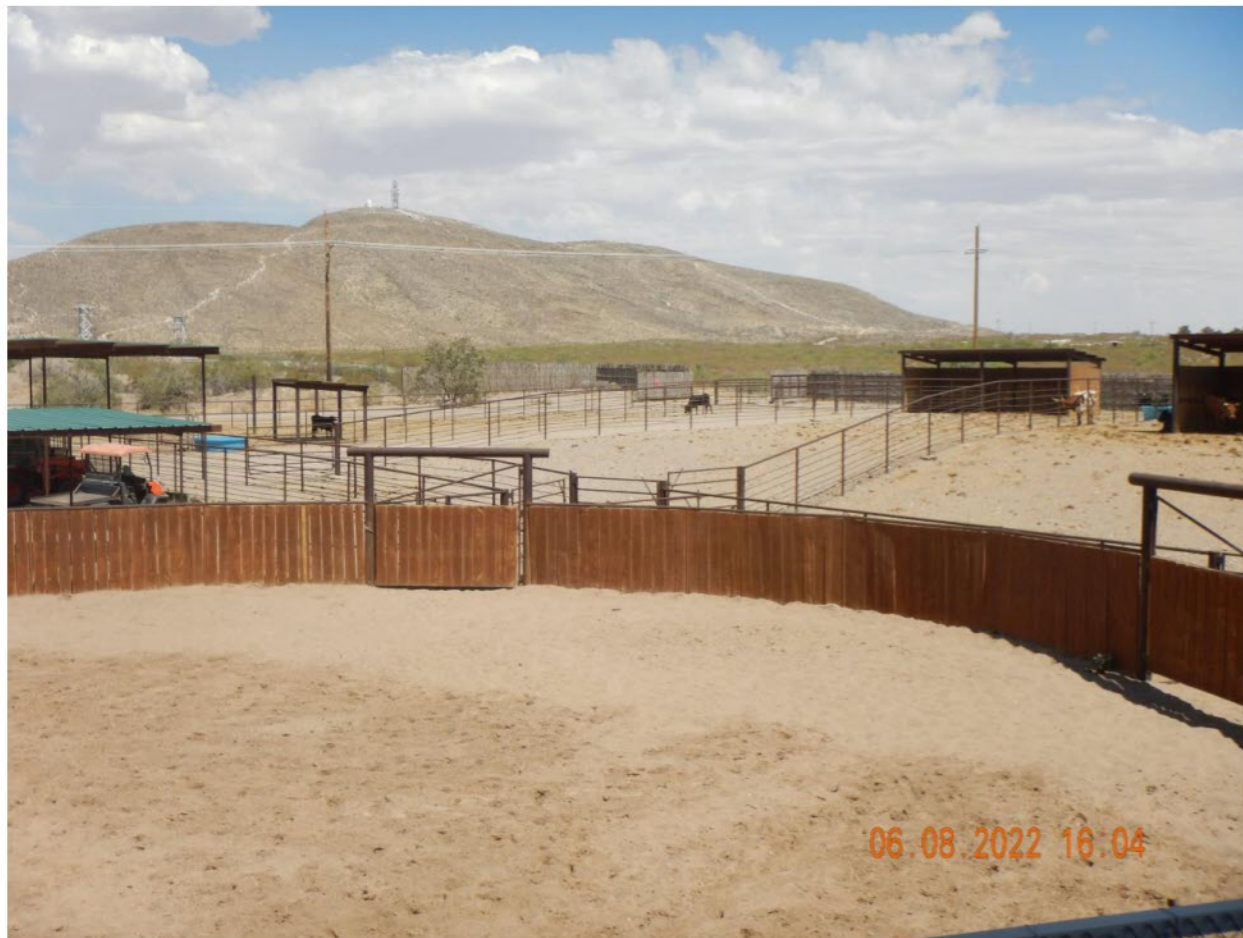
Photograph File Name: DSCN1006.JPG  
Date of Photograph: 06/08/2022  
Latitude and Longitude: 32.296955531761846, -106.71925102028219  
Orientation: S  
Map Datum: WGS-84  
Time of Photo: 16:04 PM  
Photographer: Jack Arias  
Description: This image shows the entrance of the facility.
