**Region 6 - Enforcement & Compliance Assurance Division**  
**INSPECTION REPORT**

| Inspection Date(s): | 3/2/2023 – 3/3/2023 | |
| Company Name: | Texas Molecular Svcs, LLC | |
| Facility Name: | Texas Molecular – Deer Park Facility | |

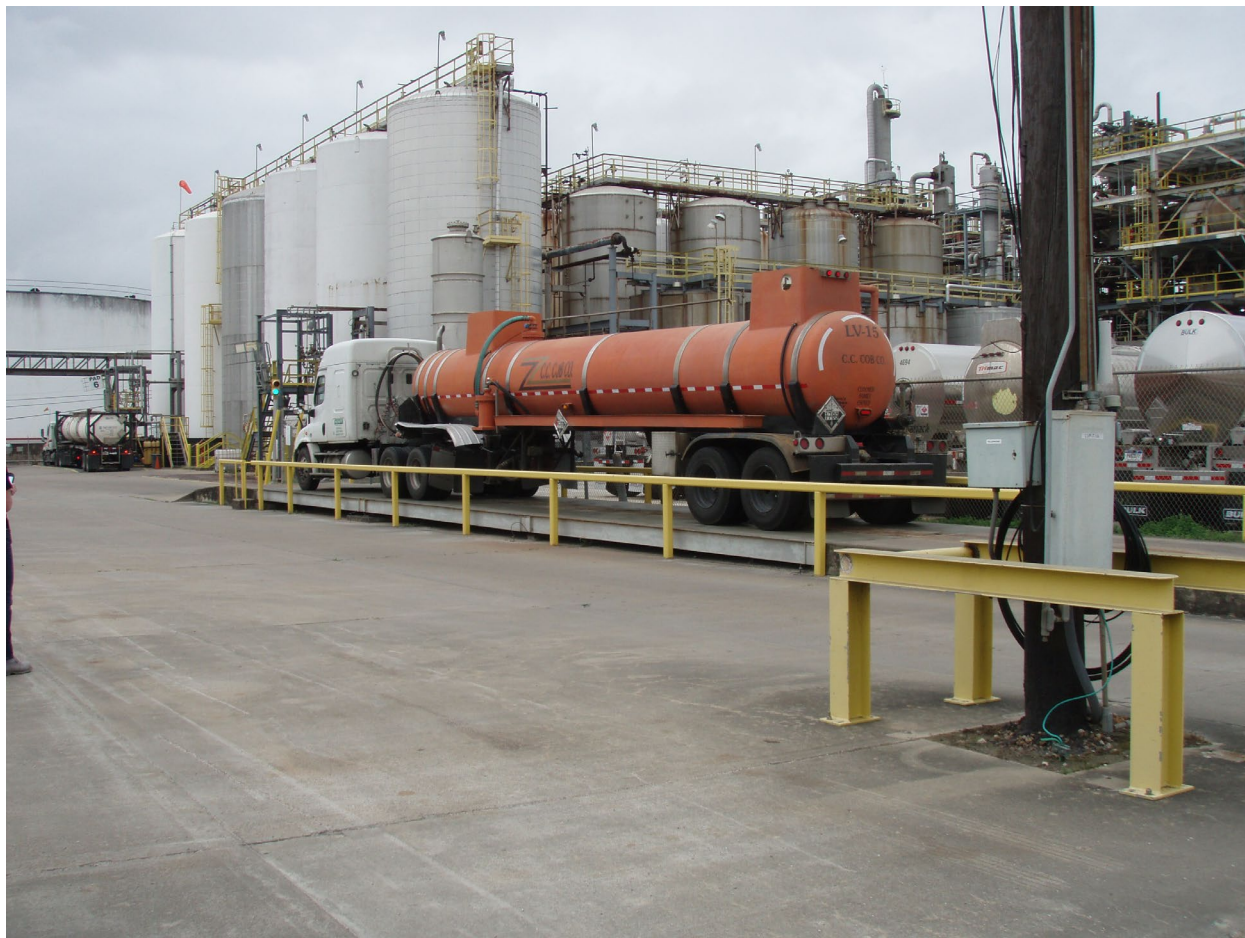
| Photo File Name: P2030002.jpg | Date of Photo: 3/2/2023 | Time: 1334 hrs |

We observed a truck entering the facility and checking in at the guardhouse. The truck was not from OH. The guard on duty cross-references the arrival with the daily schedule, calls in the arrival to the control room, and gives paperwork to the driver. Trucks are weighed when they first enter the facility and again when they leave to calculate the amount of waste unloaded (Appendix 1, Photo 1).

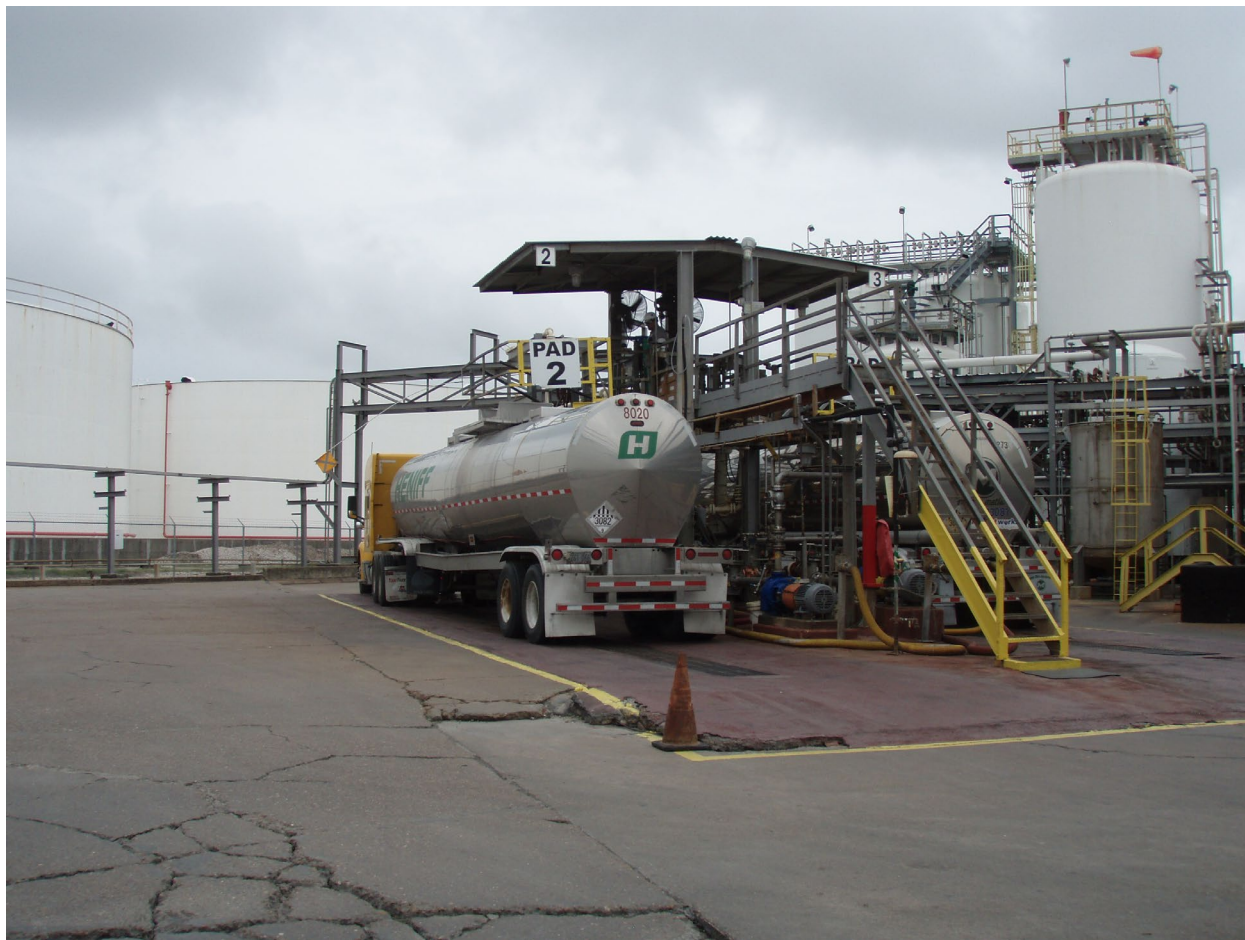
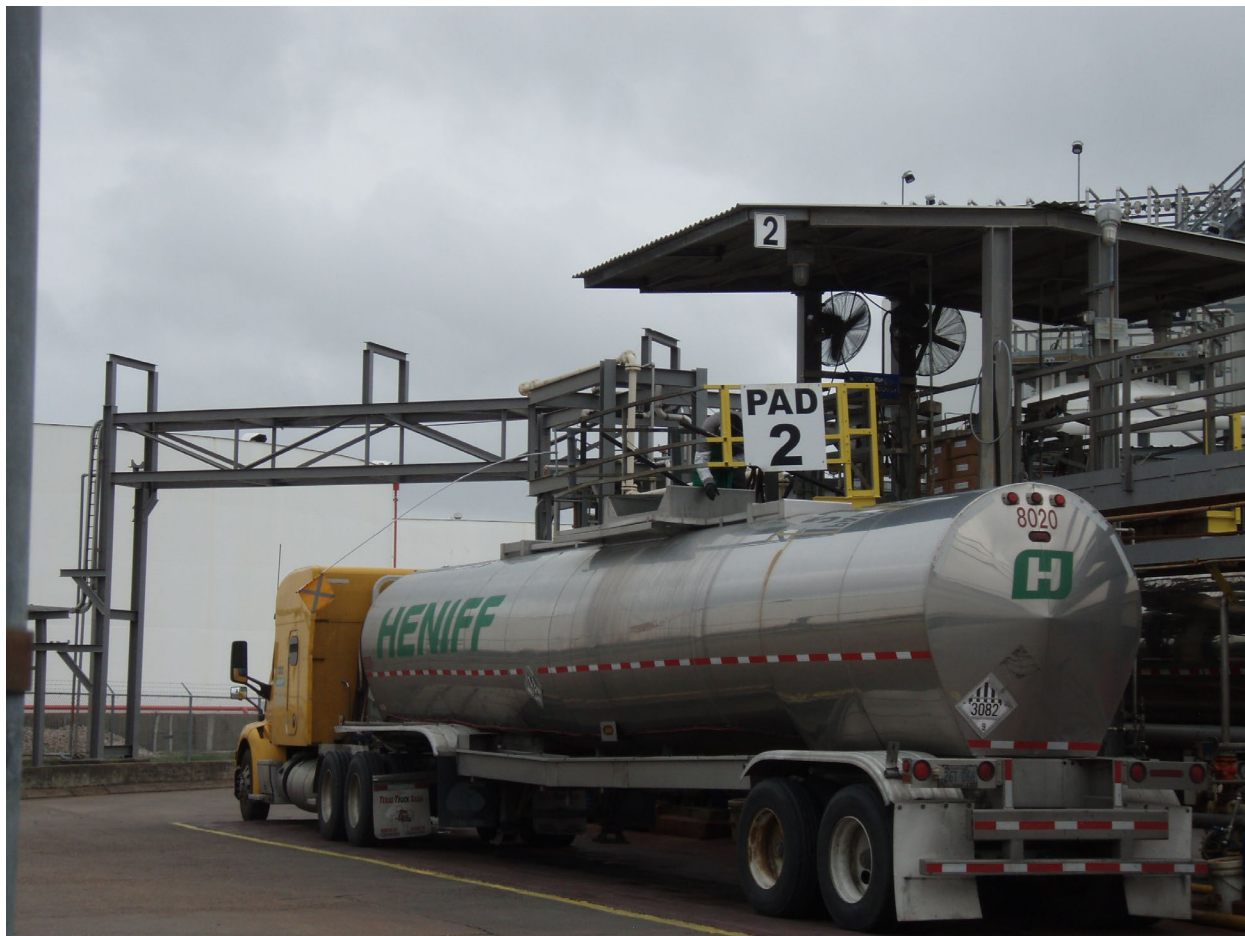
We observed workers sample a tanker truck of East Palestine wastewater. The sampler used a COLIWASA to extract two 1-liter bottles worth of material from the truck (Appendix 1, Photos 3 - 4).
