**Region 6 Compliance Assurance and Enforcement Division  
INSPECTION REPORT**

| Inspection Date(s): | 06/29/2017 | | |
| Company Name: | Cedar Hill, City of – Trinity River Authority (TRA) Member City | | |
| Facility Name: | Cedar Hill Wastewater Collection System | | |

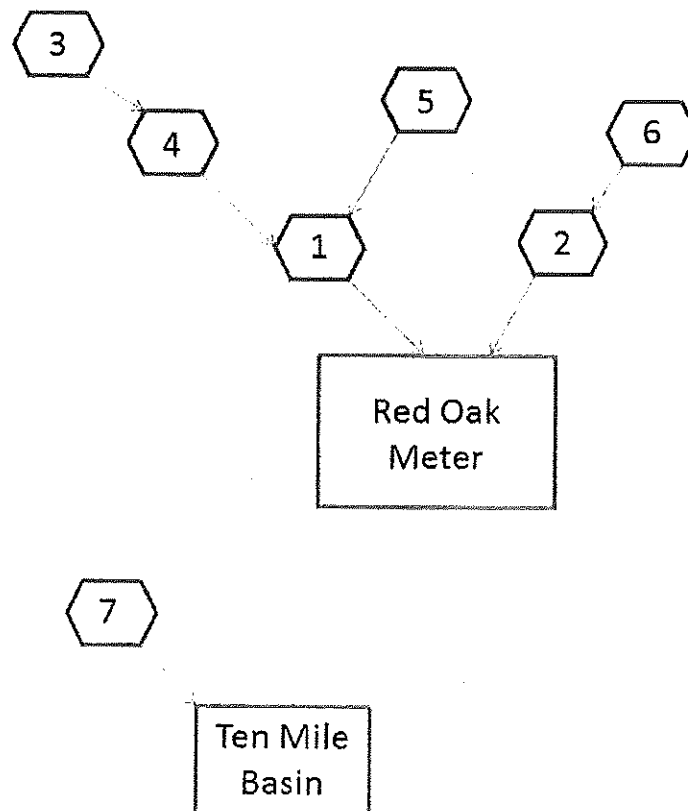
**Figure 5**  
**Flow Meter Schematic Diagram**

Figure 5 presents a wastewater schematic diagram that graphically represents the association between each flow meter placed in the collection system. This flow monitoring study consists of seven (7) meter sites. The flow meter sites determine the boundary of each monitored area. Meter sites 001 and 002 were surcharged the entire monitoring period and not included in flow analysis. No useable data was obtained due to the continuous surcharge.

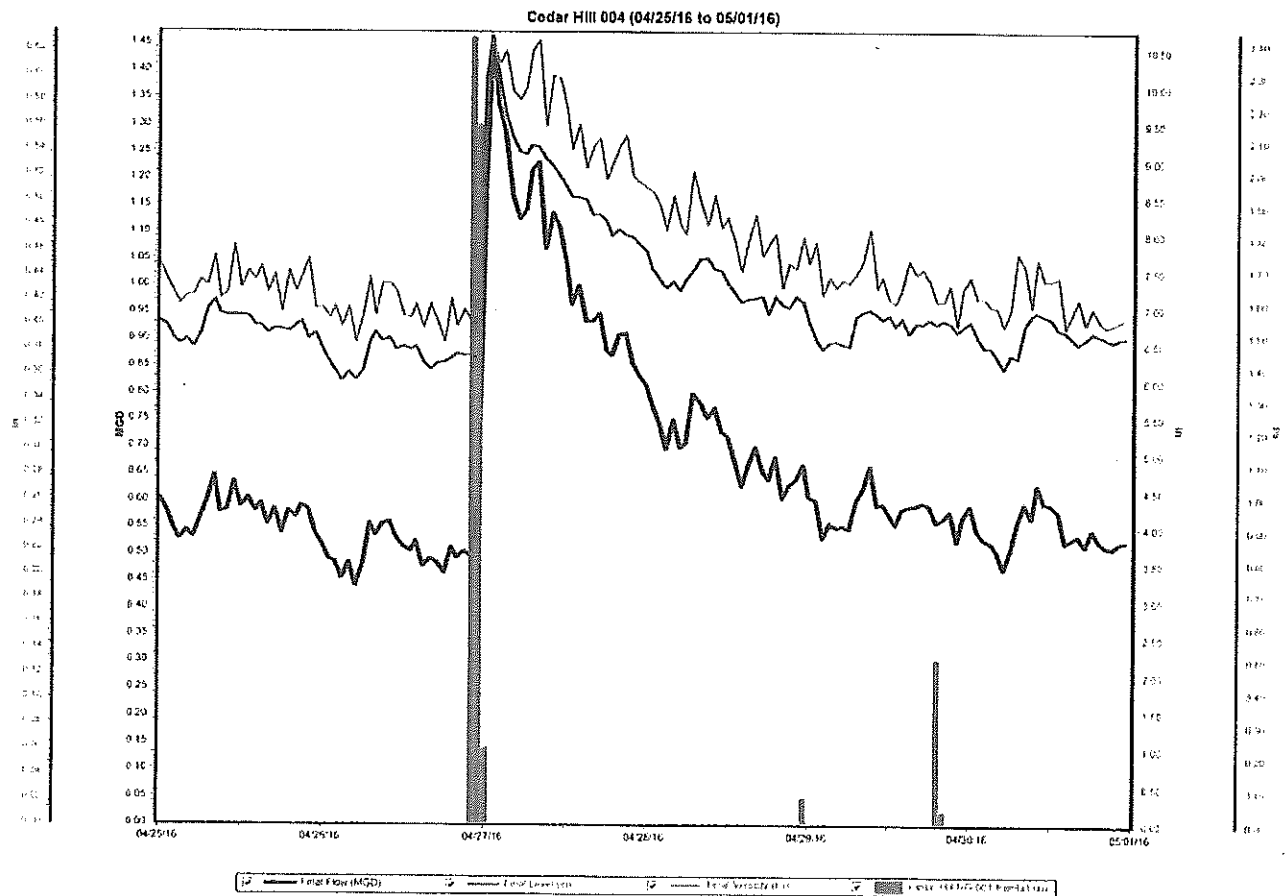
**Figure 6**  
**Wet Weather Flow**  
**Meter Site No. 004**

For the monitoring period, rainfall was recorded at four gauging sites. Five storm events ranging from 0.60 inches to 2.10 inches were used for analysis. Figure 6 presents data from Site 004 for the storm event of April 26, 2016. The high peak flows are a characteristic of wet weather inflow while the long duration for flows to return to normal is indicative of infiltration.

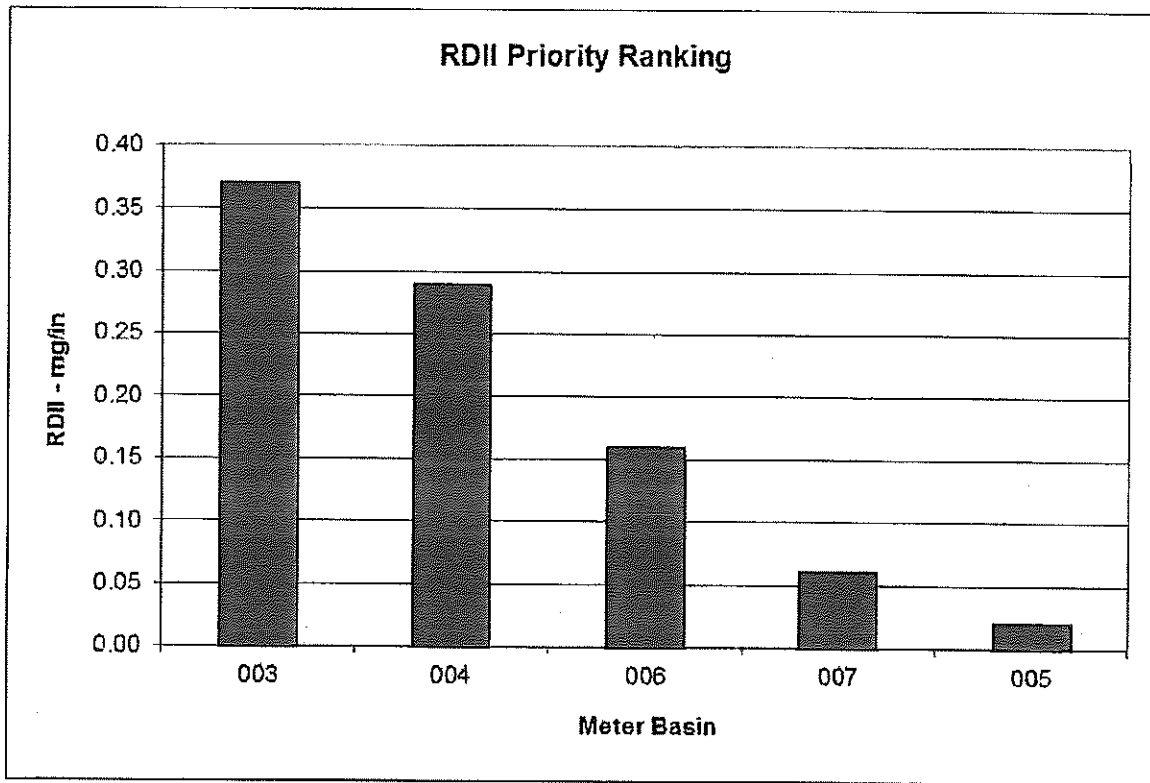
**Figure 7**  
**RDII Ranking of Meter Basins**

The wet weather analysis summarizes the system responses observed during the wet weather periods. The analysis computes the volume of wet weather I/I, also known as rainfall dependent I/I (RDII), which entered the collection system during the storm. Table 2 presents a summary of the wet weather system response and compares this response to dry weather conditions. From this data, the discrete RDII was calculated for the analyzed storm events. The total discrete RDII for each meter basin was normalized using the average rainfall which established the RDII volume per inch of rainfall. Figure 7 presents the ranking of the metered basins based on the observed wet weather flows.

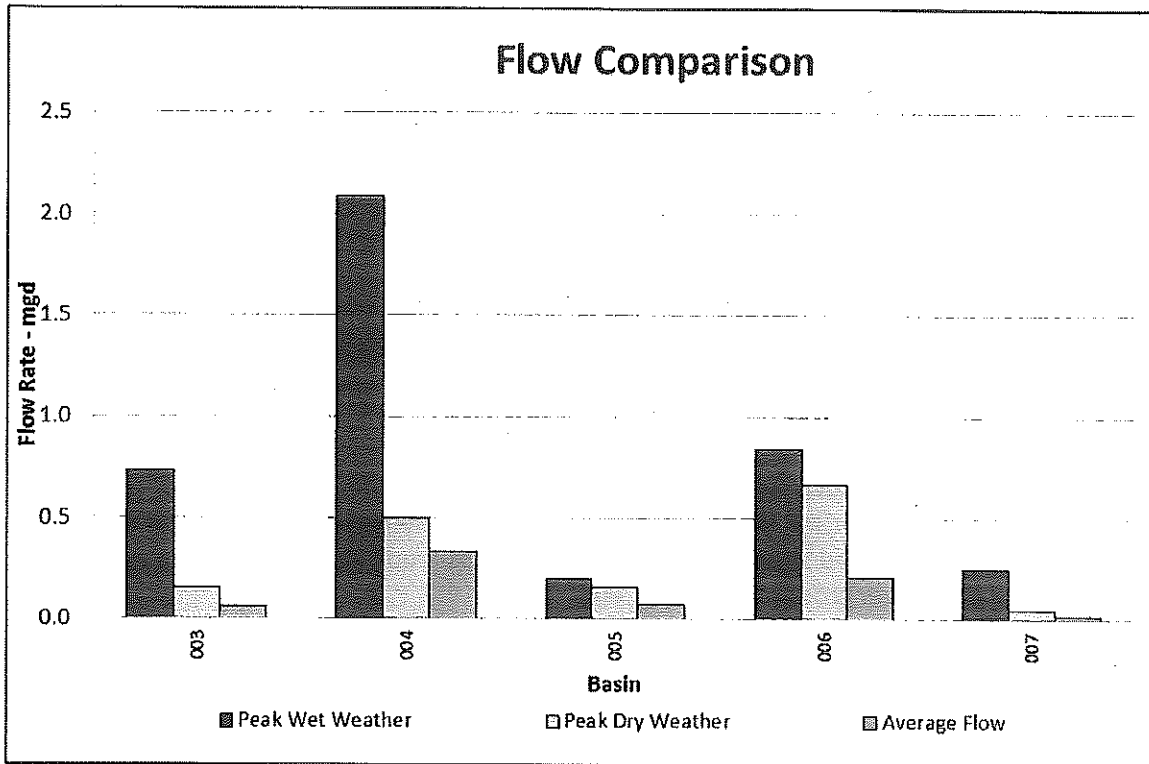
**Figure 8**  
**Peak Flow Rates**  
**Dry Weather versus Wet Weather Comparison**

The major issue with wet weather inflow is the inability of the collection system to transport the peak flow rates due to the influx of extraneous infiltration/inflow. Peak flows generally do not have long durations, but even short durations may create surcharge and the potential for SSO's (Sanitary Sewer Overflows). In addition, peak flow rates can upset the treatment plant process resulting in less than optimum treatment. Figure 8 presents a summary of peak flow rates recorded compared to a representative average dry weather day. Peak flow rates are a qualitative measure of the impact of wet weather on the collection system. Peak flow can be affected by bottlenecks in the system due to inadequate capacity, roots, broken pipe, etc. In addition, the peak flow rate will normally be reduced due to pumping stations equalizing flows (cutting off peak flow rates). High peak flows will also create elevated depth of flow in the pipelines.

Without rehabilitation, the rate of extraneous water that enters the collection system will increase over time. Defects within the collection system will continue to deteriorate and allow additional RDII to enter the system. Periodic rehabilitation will reduce (but not eliminate) RDII, restore system capacity and extend the life of the underground assets.
