**Region 6 - Enforcement & Compliance Assurance Division**  
**INSPECTION REPORT**

| Company Name: | <b>Kirtland Air Force Base, 377<sup>th</sup> Air Base Wing</b> | |
| Facility Name: | <b>Bulk Fuels Facility</b> | |
| Identification/Permit Number: | NM0031216 | |

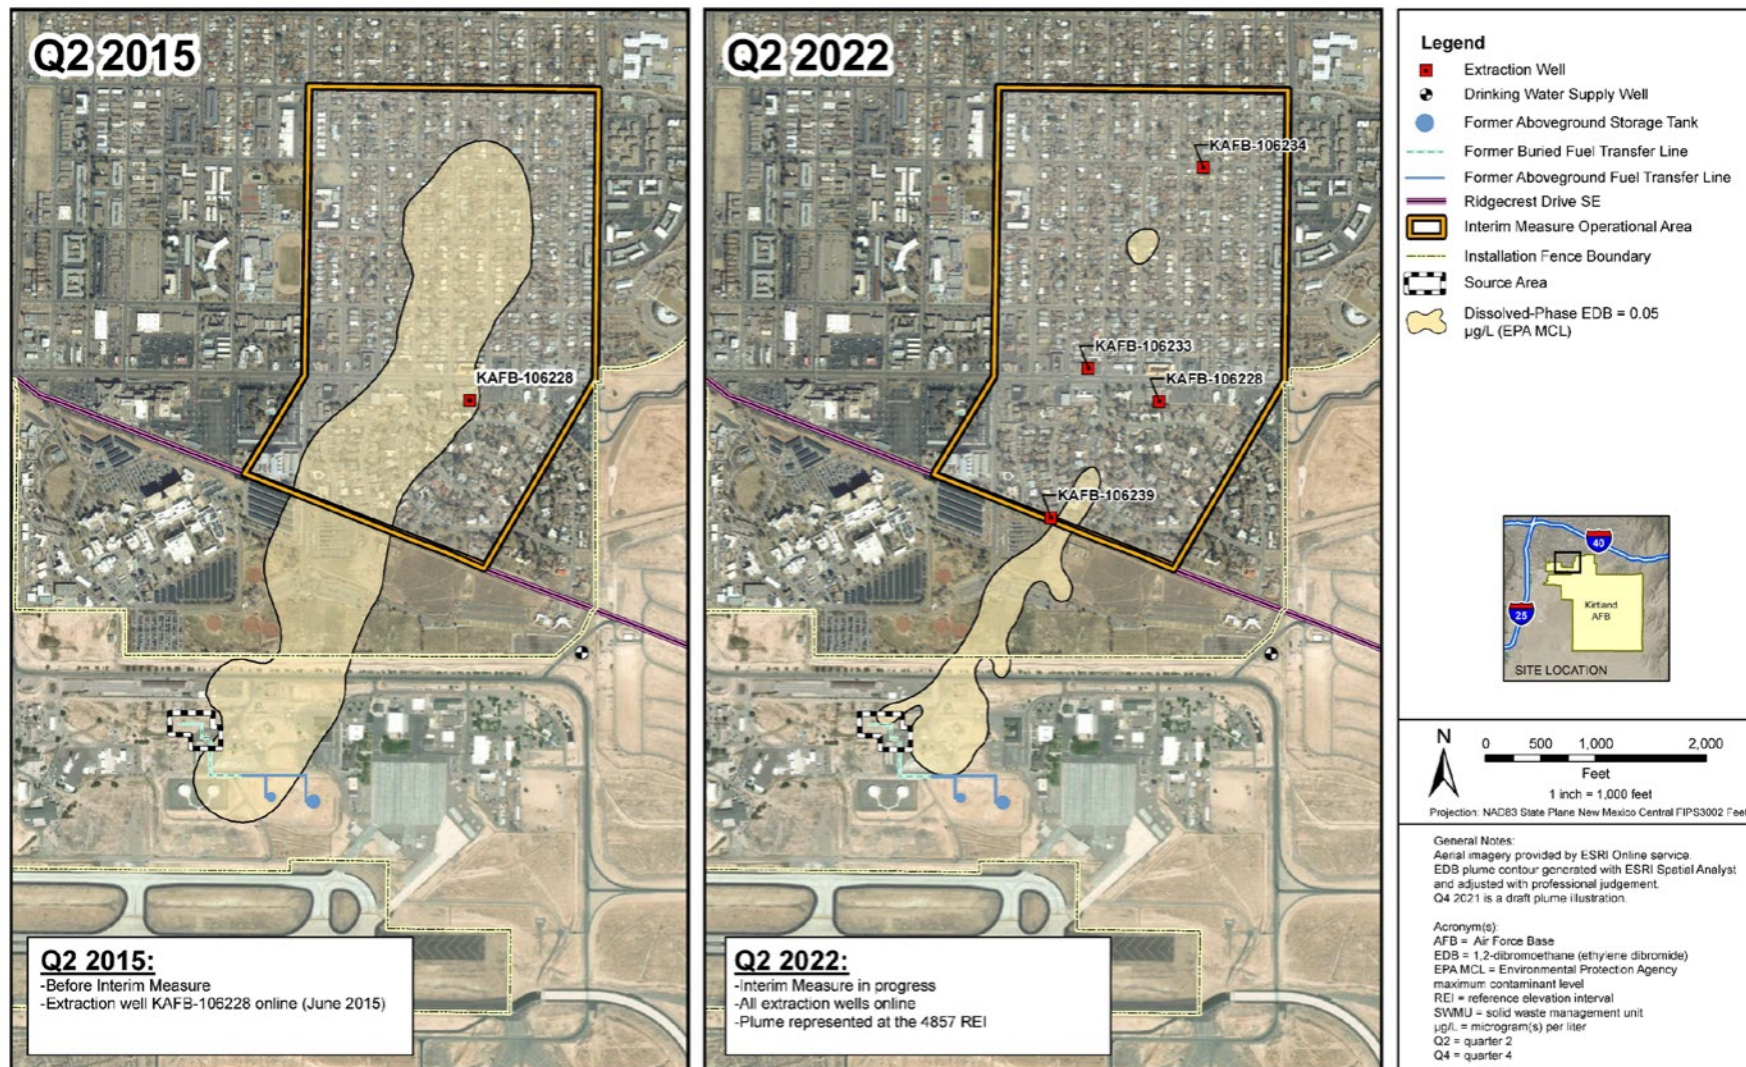
# EDB Plume Footprint (over time)

## Comparison of Dissolved-Phase EDB Collapse in the Interim Measure Operational Area Between Q2 2015 and Q2 2022
