INSPECTION REPORT

| Type of Inspection | Compliance Evaluation Inspection (CEI) | | |
| Facility or Site Name | Menominee Tribal Enterprises Sawmill | | |
| Permit Number(s) (If Applicable) | WI0046868 | | |

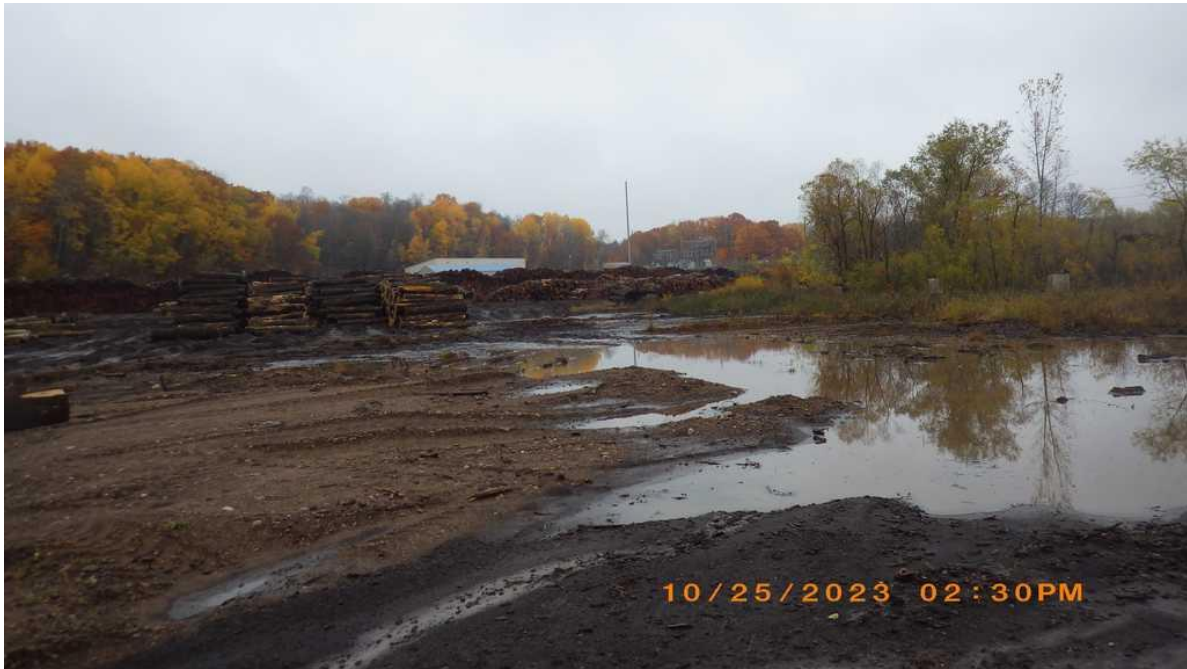
| Location 12 on Observation Location Map. | | | Log yard, location approximate |

| Note stormwater inlet grates (red arrow) partially filled and blocked by debris. | | | |

| Log yard. | | | MTES0351.JPG |
