**CWA COMPLIANCE EVALUATION INSPECTION REPORT  
U.S. ENVIRONMENTAL PROTECTION AGENCY, REGION 5**

Compliance Sampling Inspection

Schwieterman Farms  
4339 County Road 716A  
Celina, Ohio  
Mercer County, Ohio  
40.476569, -84.526512

**Date of Inspection:** 4/21/2023

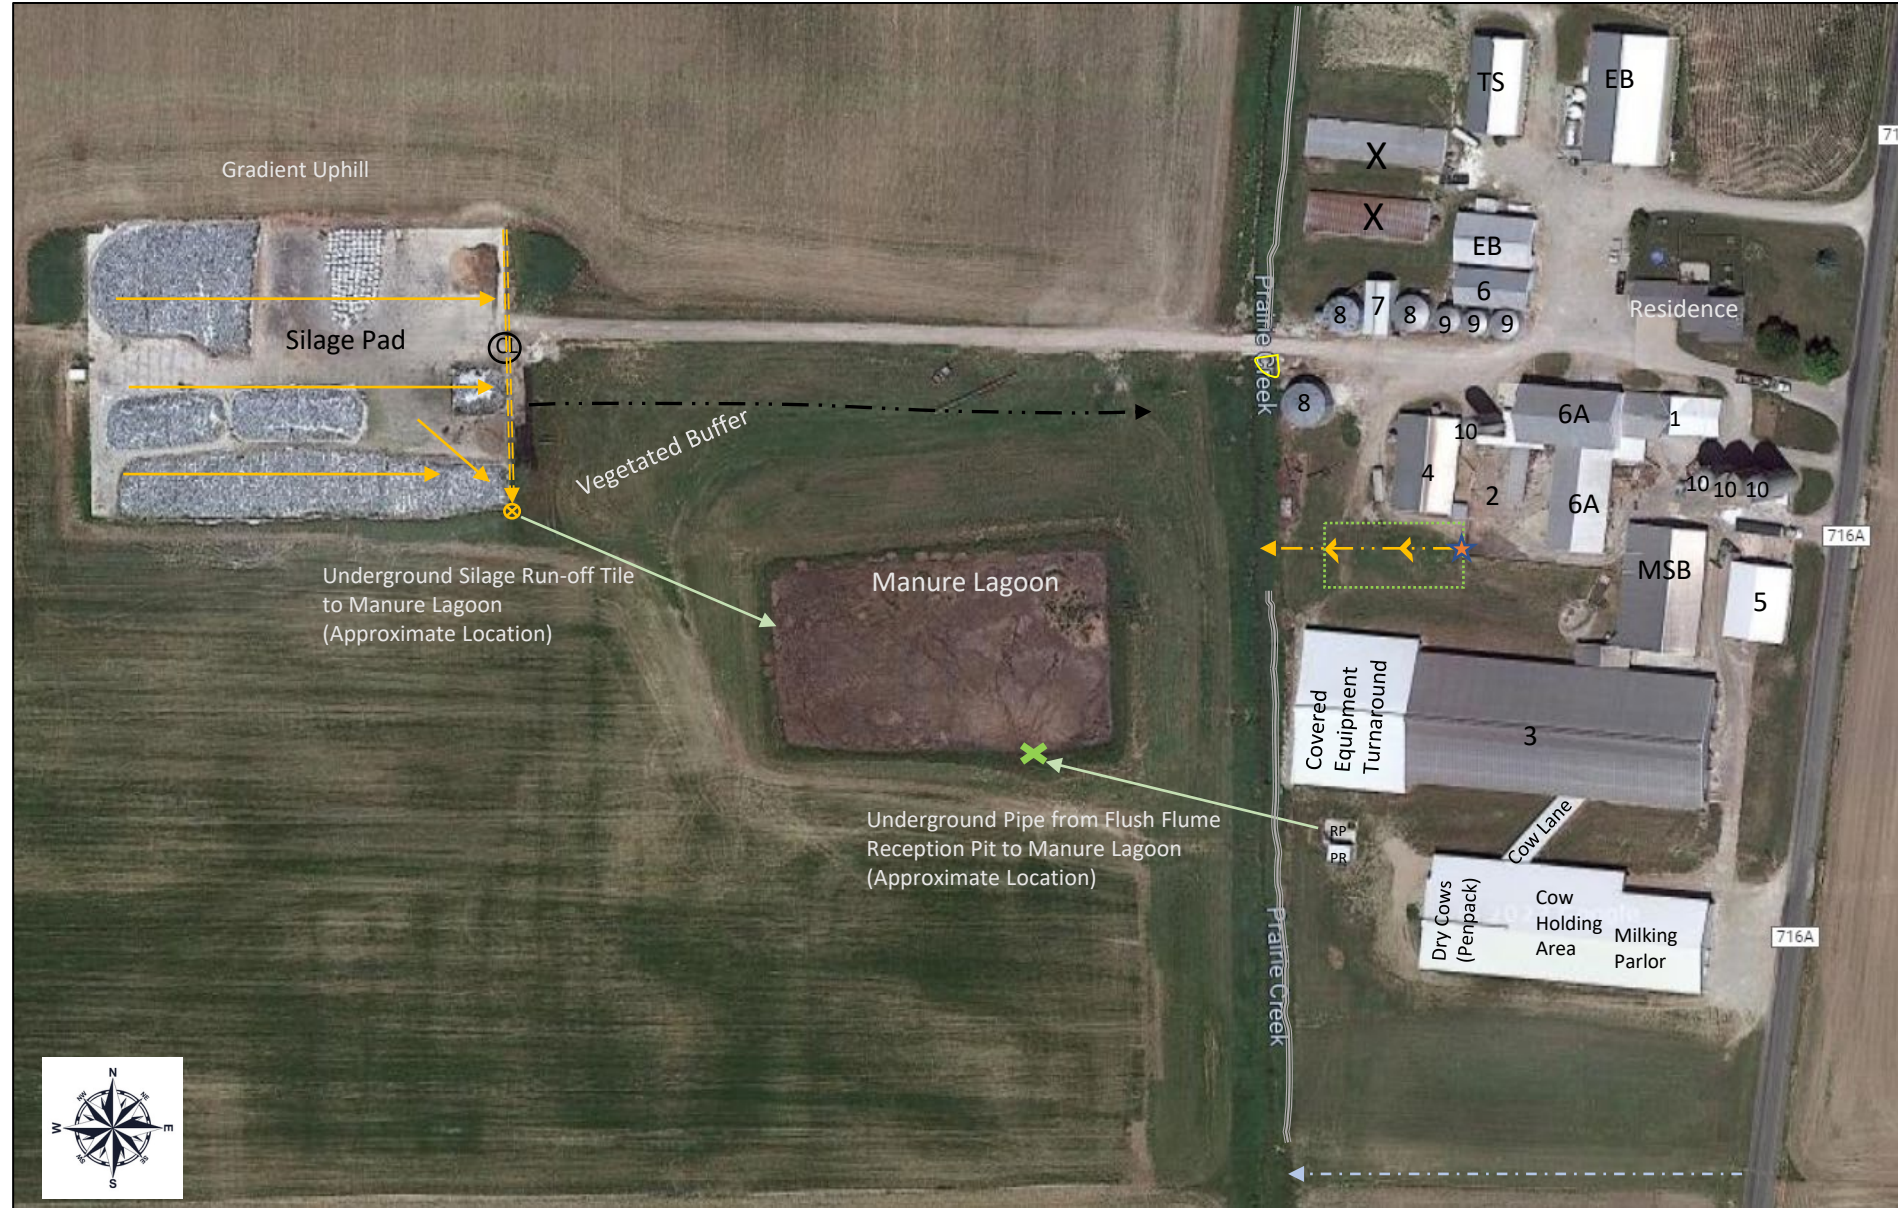
Aerial Map Annotated by Anne Marie Vincent, Multimedia Section, US EPA (June 2023)

- Area Of Bank Erosion from Driveway Stormwater Run-off
- Flush Flume Reception Pit Discharge Pipe into Manure Lagoon
- Location of Opening in Containment Wall of the Unroofed Abandoned Cow Lot

- Compacted Vegetated Berm
