**Region 6 - Enforcement & Compliance Assurance Division**  
**INSPECTION REPORT**

| <b>Inspection Date(s):</b> | 06/04/2024 through 06/06/2024 | |
| <b>System Name:</b> | City of Stillwater Public Water System (PWS) | |
| <b>PWS ID:</b> | OK1021220 | |

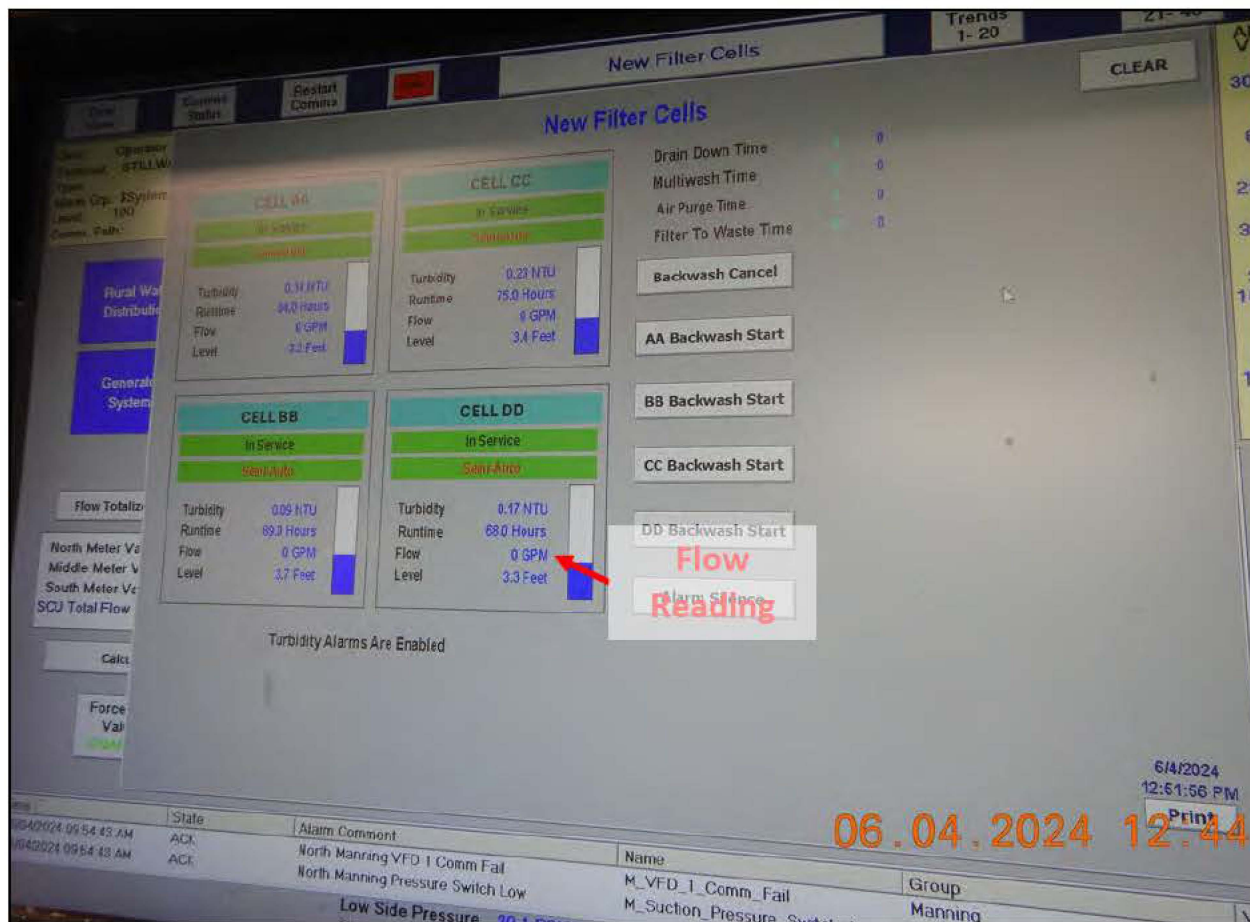
Photo No. 2

Photograph 2. 6/4/2024 12:44 PM DSCN0658.JPG

**WTP SCADA Screen** View of the City's SCADA screen showing the status of the four newer filters at the WTP. Turbidity, runtime, and level of the filters was being monitored, but flow was not monitored or recorded.

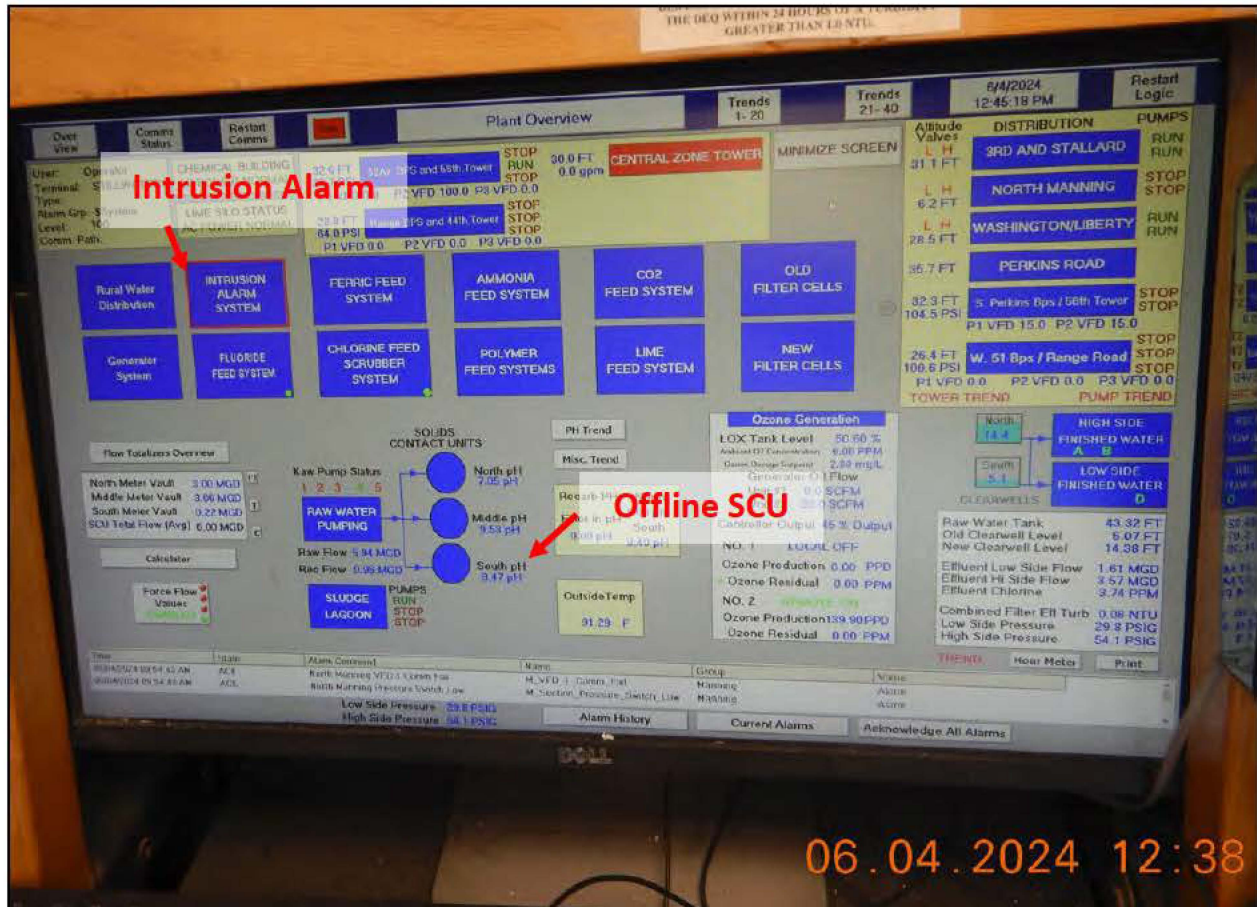
Photo No. 3

Photograph 3. 6/4/2024 12:38 PM DSCN0655.JPG

**WTP SCADA Screen** View of the City's SCADA screen showing an overview of operations at the WTP. The "Intrusion Alarm System" panel was highlighted with a red border, and the reason was unclear to the EPA Inspection Team. This photograph was taken prior to the EPA Inspection Team walking through the WTP. The SCADA screen showed that the fluoride feed system and chlorine feed scrubber system were disabled during the inspection. The South solids contact unit (SCU) was offline during the inspection, but the SCADA screen did not reflect that.

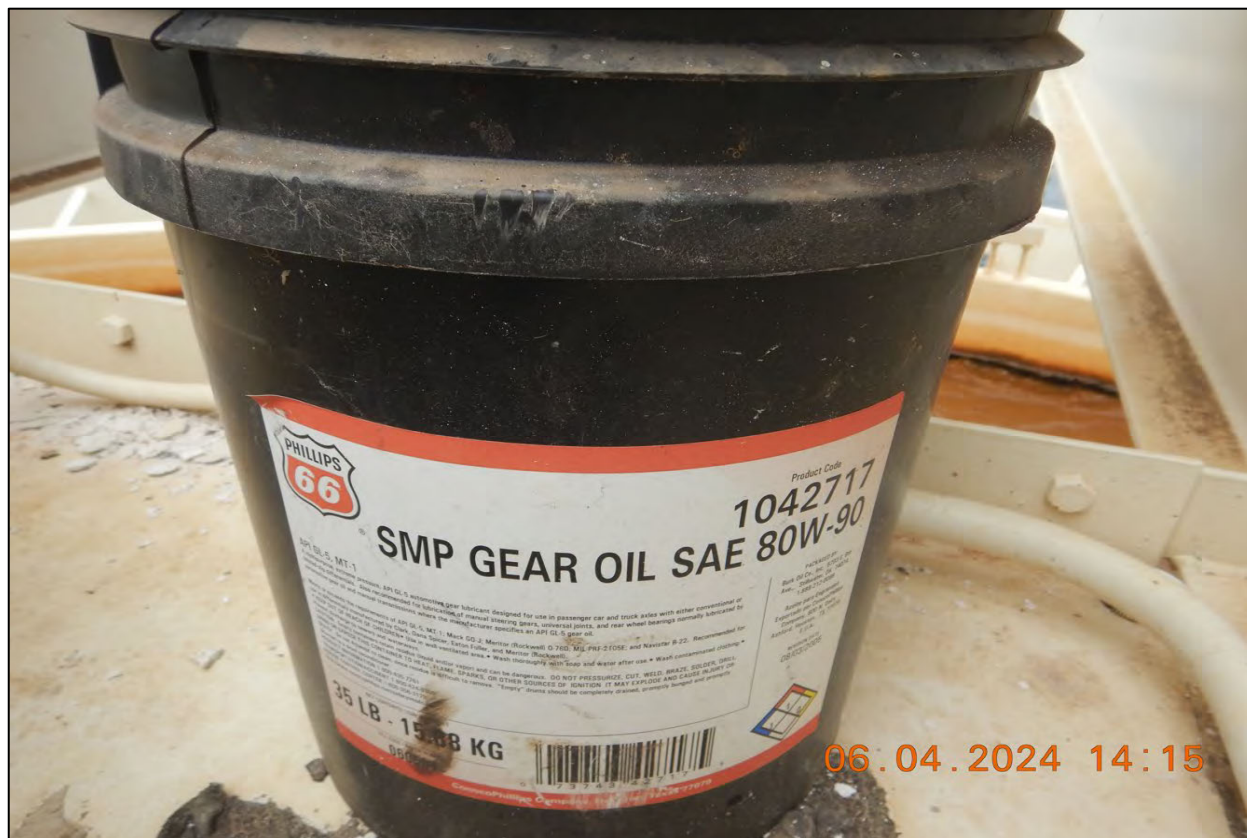
Photo No. 5

**Area of Concern 13.** The 35-pound barrel of gear oil (Phillips 66 80W-90) that was sitting on the deck of one of the solids contact units at the WTP is not listed as NSF certified (refer to Appendix 1, Photograph 5).

**Photograph 5. 6/4/2024 2:15 PM DSCN0717.JPG**

**WTP, North SCU** View of a bucket of gear oil that was positioned on the deck in the center of the North SCU. There was no NSF label on the gear oil, and a search of the NSF website showed that the oil was not listed as NSF certified. The label described the substance as an “automotive gear lubricant” used in cars and trucks.

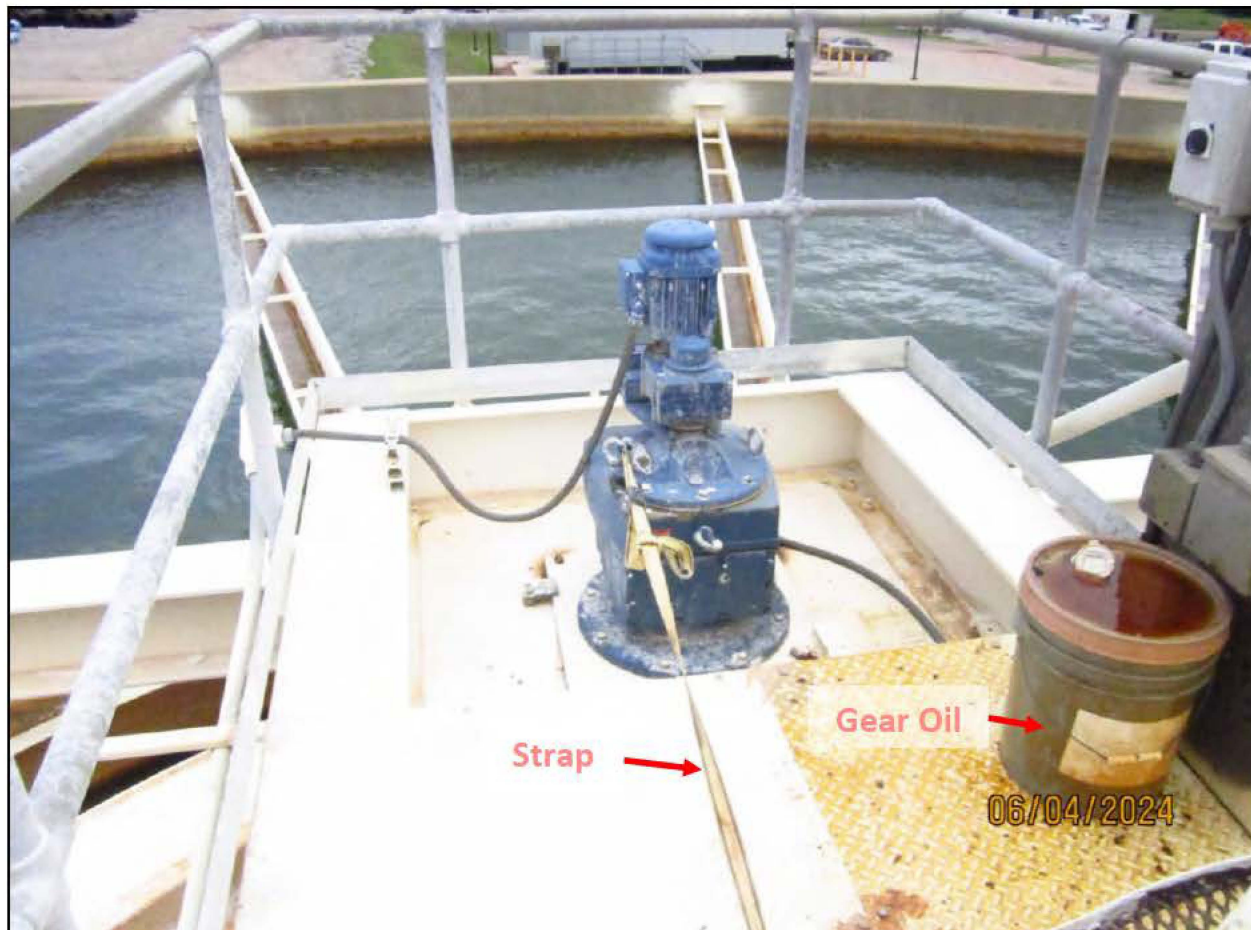
Photo No. 7

- a. There was a strap supporting the motor in the center of the offline South SCU (refer to [Appendix 1, Photograph 7](#)).
- b. There were multiple cracks in the corner of the concrete recarbonization basin that appeared to be weeping (refer to [Appendix 1, Photograph 8](#)). Other cracks in the concrete structure had been filled in with sealant to prevent weeping.
- c. System representatives stated that the flow meters associated with each of the filters were unable to be verified/calibrated due to their positioning in an underground vault, making them difficult/impossible to access (refer to [Appendix 1, Photograph 10](#)). In addition, this area is classified as a confined space, and System representatives stated it is only entered once a month.

Photograph 7. 6/4/2024 2:05 PM IMG\_0064.JPG

WTP, South SCU View of the operational deck in the middle of the offline South SCU. The motor for the rake arm appeared to be supported by a strap, and there was a bucket of gear oil sitting on the deck.

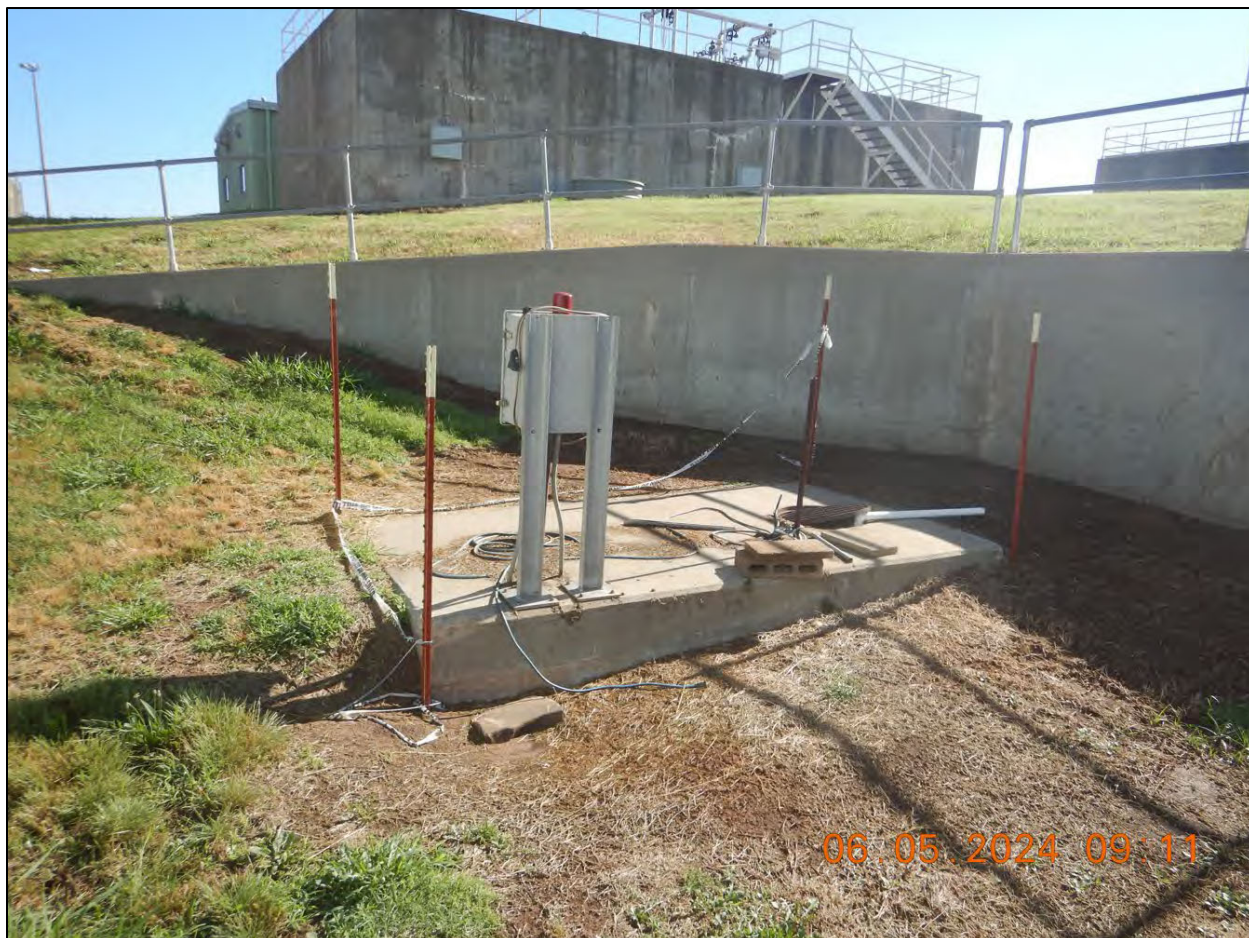
Photo No. 13

- d. There were numerous cracks in the concrete roof of the ozone basin (refer to Appendix 1, Photograph 12). It appeared that the cracks had been filled at a point in time, but there were cracks in the caulking as well.
- e. The chemical injection vault where ammonia is injected into the produced water line (downstream of the ozonation process) was completely flooded, submerging the injection port (refer to Appendix 1, Photograph 13). There was a strong ammonia smell coming from the vault.

**Photograph 13. 6/5/2024 9:11 AM DSCN0779.JPG**

**WTP, Final Chemical Injection Vault** View of the final chemical injection vault where ammonia and chlorine are injected upstream of the onsite clearwell. There was a strong ammonia smell surrounding the vault, and the vault was full of water, leaving the injection lines completely submerged.

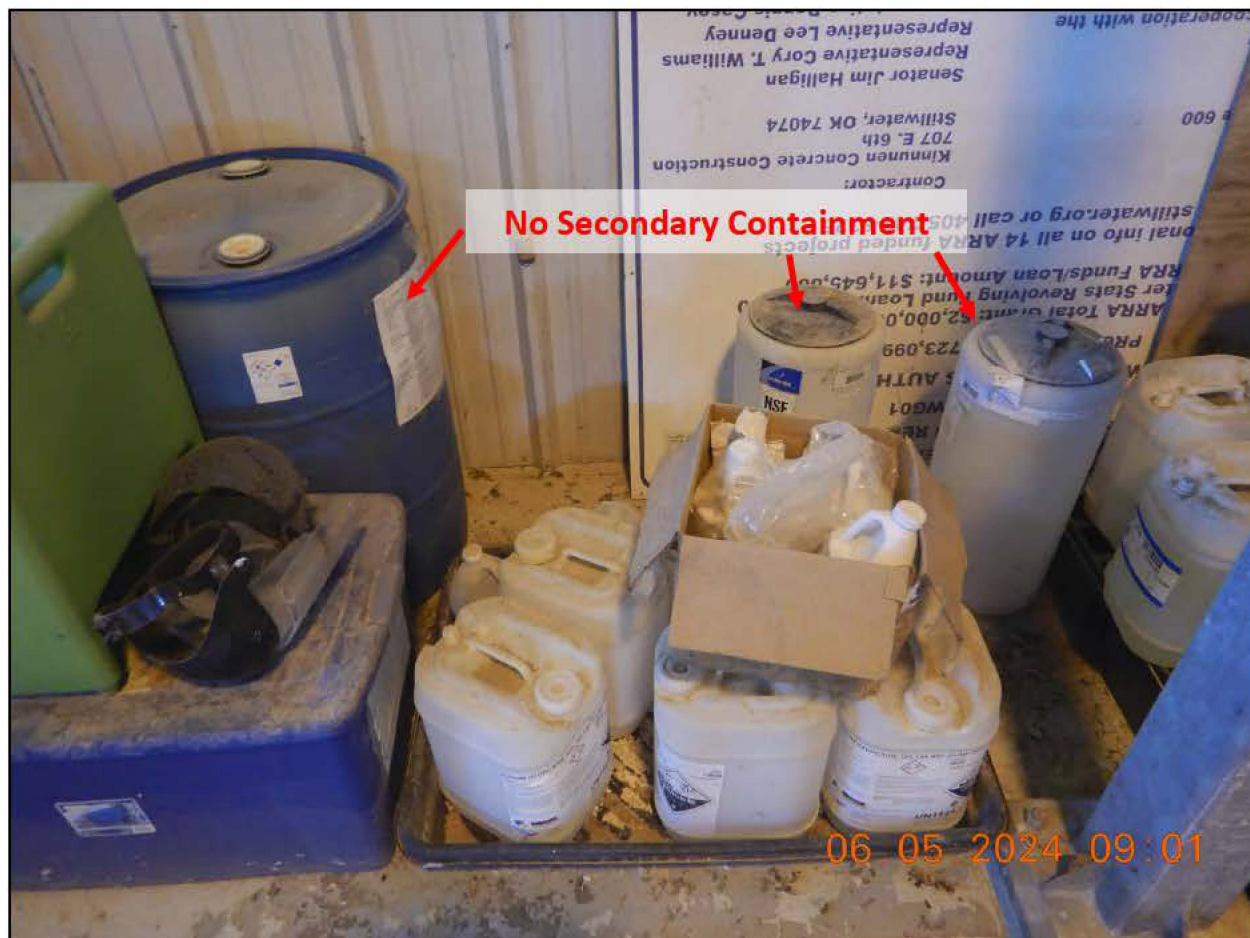
Photo No. 15

- a. There were 35-pound buckets of petroleum based gear oil sitting on decks of the North and South SCUs at the WTP (refer to Appendix 1, Photographs 5 and 7).
- b. There were multiple chemical barrels and containers being stored on the ground without secondary containment, inside of the high service pump station (refer to Appendix 1, Photograph 15). The chemical barrels appeared to be empty at the time of the inspection.

Photograph 15. 6/5/2024 9:01 AM DSCN0773.JPG

WTP, High Service Pump Station View of multiple chemical barrels in the high service pump station that were not being stored on secondary containment. The chemical barrels appeared to be empty at the time of the inspection.

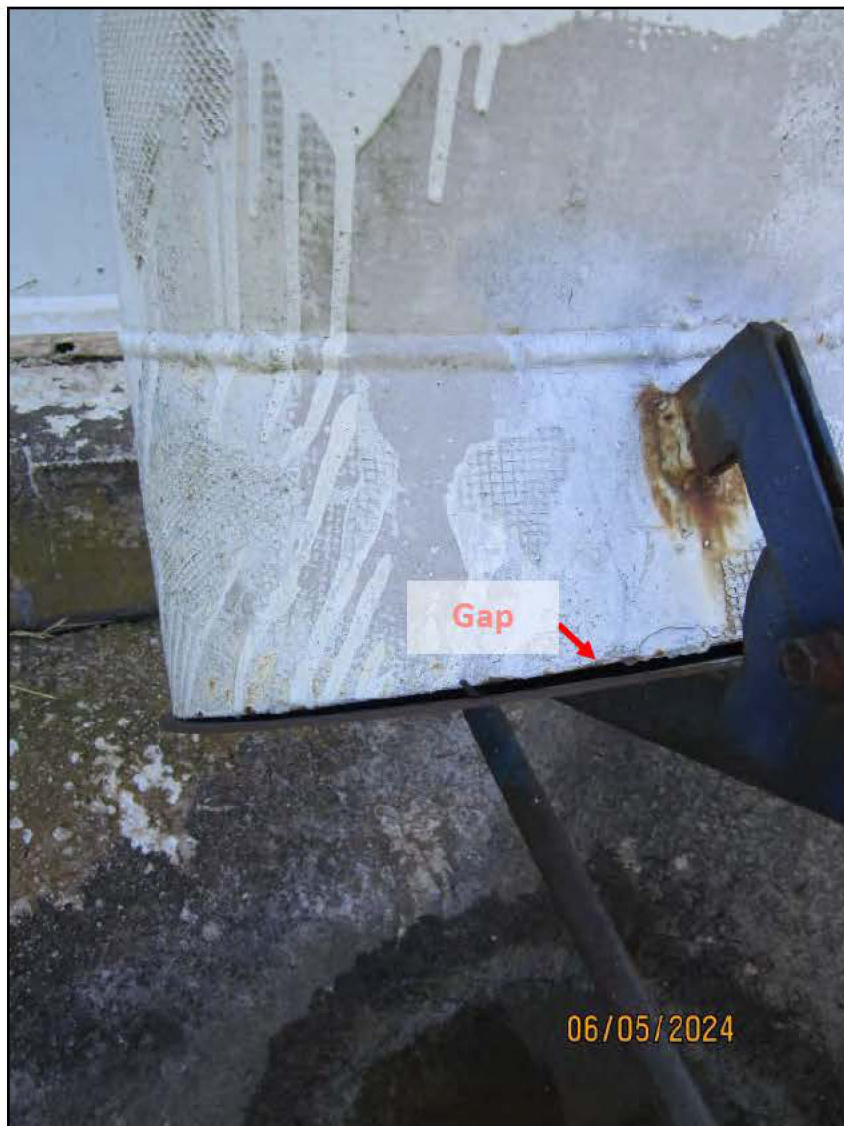
Photo No. 18

- Area of Concern 21.** The following observations were made regarding overflow lines at water storage tanks in the distribution system:
- a. The flex gate covering the overflow line of the North Perkins Water Tower did not form a tight seal (refer to [Appendix 1, Photograph 18](#)). There was an approximately 0.5-inch gap between the end of the pipe and the flapper.

Photograph 18. 6/5/2024 9:56 AM IMG\_0058.JPG

North Perkins Water Tower View of the end of the overflow pipe at the North Perkins Water Tower. The flex gate covering the overflow line of the North Perkins Water Tower did not form a tight seal. There was an approximately 0.5-inch gap between the end of the pipe and the flex gate.

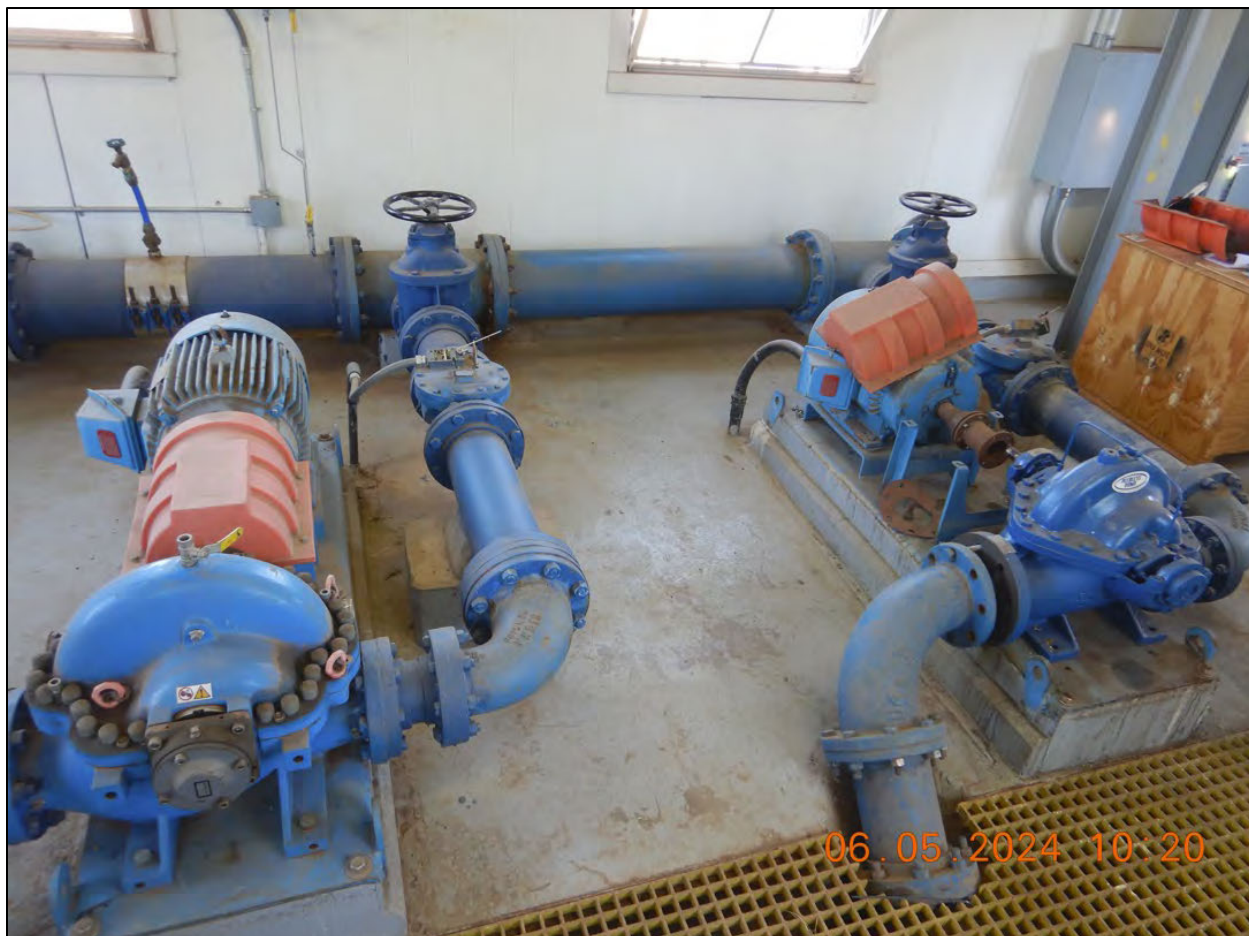
Photo No. 20

**Aera of Concern 16.** There was only one functional pump present inside of the Manning Pump Station (offline; refer to Appendix 1, Photograph 20).

**Photograph 20. 6/5/2024 10:20 AM DSCN0800.JPG**

**Manning Pump Station** View of the two pumps inside of the Manning Pump Station. The pump on the right side of the image was inoperable at the time of inspection, leaving only one functional pump in the pump station. The pump station was offline during the inspection.

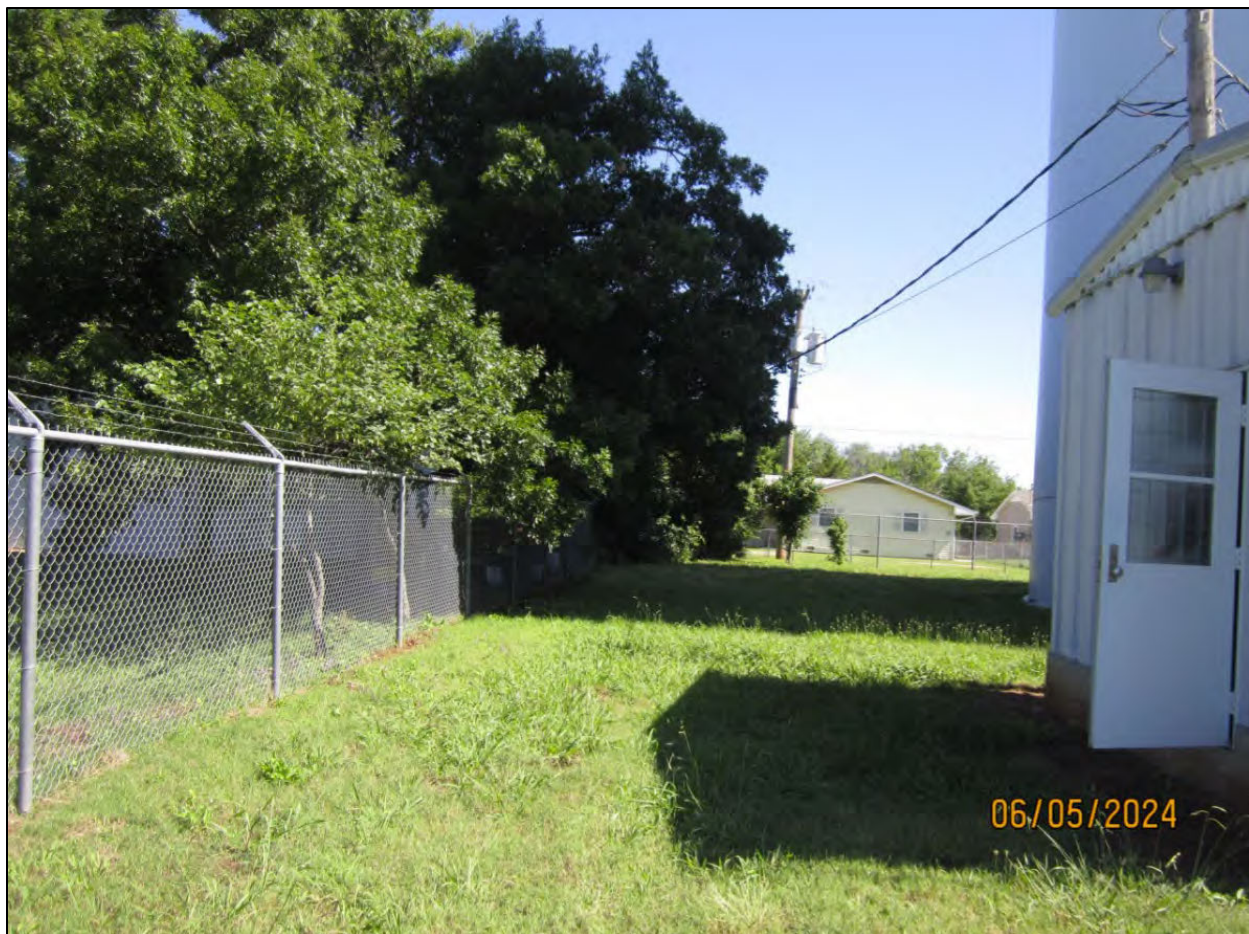
Photo No. 21

- a. There was vegetation growing around and against the perimeter security fence at the WTP in multiple places.
- b. There were golf balls and broken glass near the base of the Third and Stallard Water Tower (refer to Appendix 1, Photograph 24). System representatives stated that the residents of the house directly next to the tank would throw bottles over the fence against the side of the tank, and that people would hit golf balls toward the tank. System representatives also stated that the police had dealt with the security issues coming from the house next to the tank. There were also tree branches growing over the perimeter fence surrounding the Third and Stallard Tower and pump station (refer to Appendix 1, Photograph 21).
- c. There were trees/vegetation growing on and around the perimeter fence surrounding the Tan-Tara Water Tower (offline) (refer to Appendix 1, Photograph 70).

**Photograph 21. 6/5/2024 10:33 AM IMG\_0079.JPG.JPG**

**Third and Stallard Water Tower/Pump Station** View of the perimeter fence surrounding the Third and Stallard Water Tower and pump station. There was vegetation growing over/against the fence, creating a security threat.

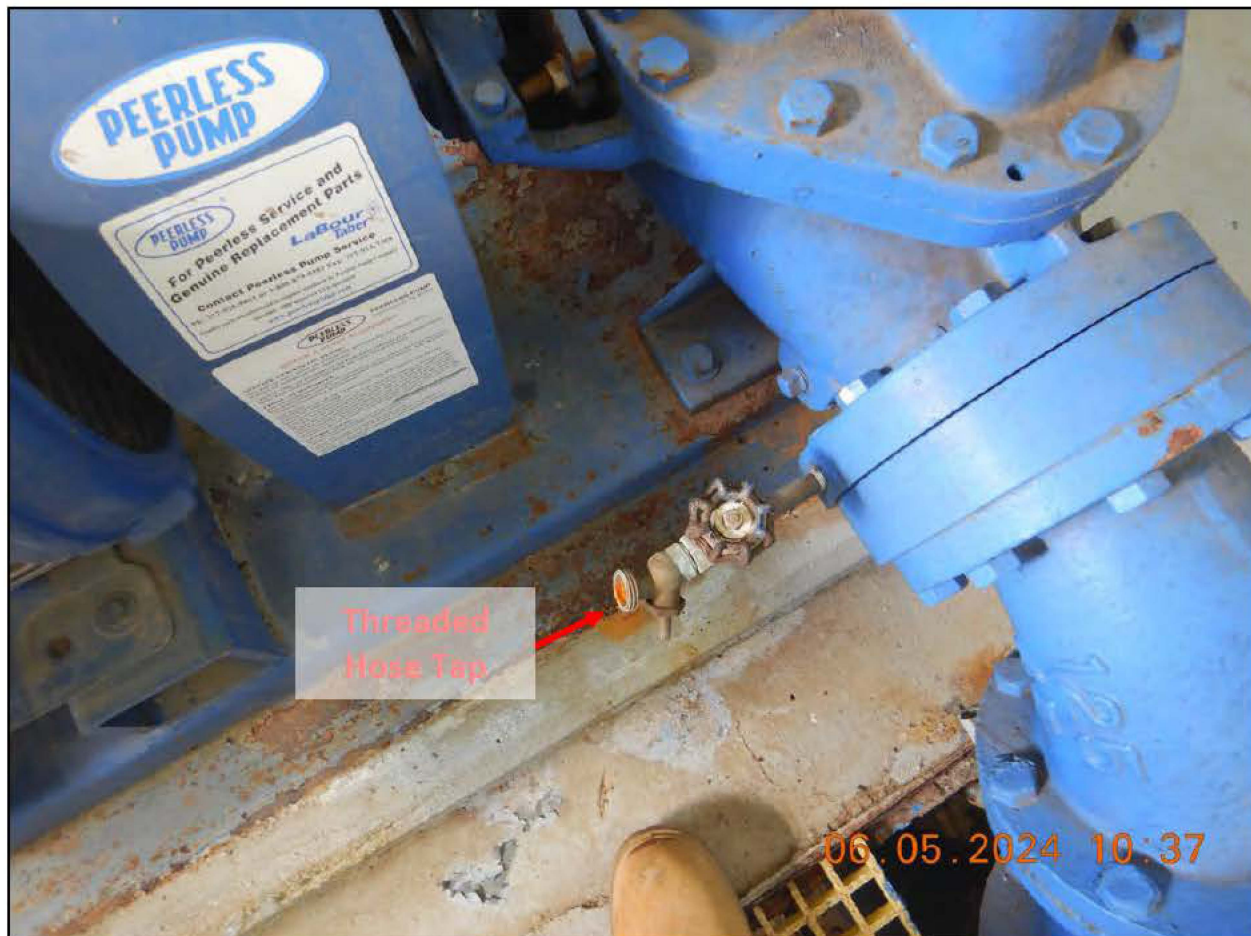
Photo No. 26

- b. There were multiple threaded hose taps without backflow prevention extending off of the pump lines inside of the Third and Stallard pump station (refer to Appendix 1, Photographs 26 and 27). One of the taps had a hose attached to it without backflow prevention.

Photograph 26. 6/5/2024 10:37 AM DSCN0819.JPG

Third and Stallard Pump Station View of a threaded hose tap without backflow prevention that extended off of one of the pump lines inside of the Third and Stallard Pump Station.

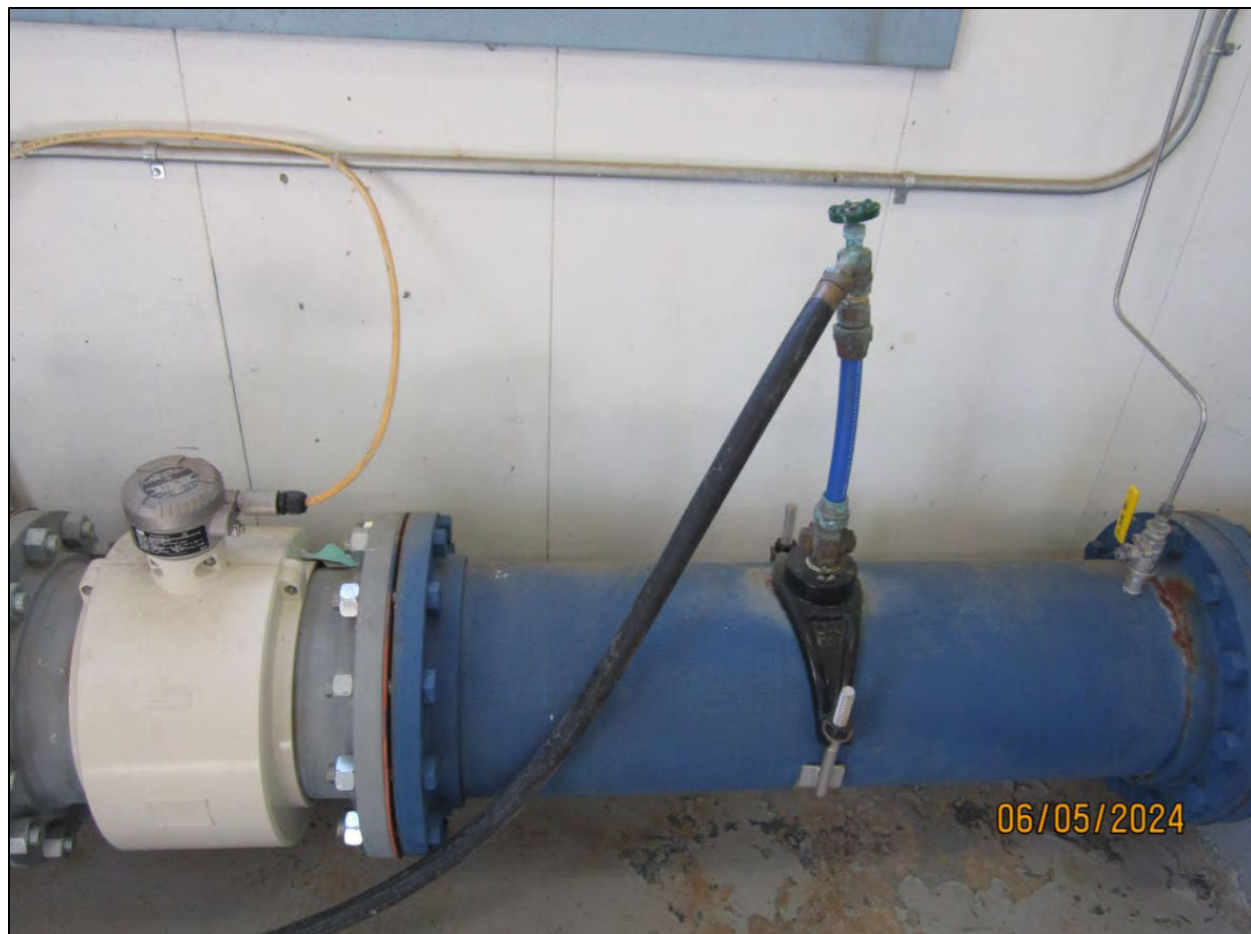
Photo No. 27

**Photograph 27. 6/5/2024 10:40 AM IMG\_0089.JPG**

**Third and Stallard Pump Station** View of an additional threaded hose tap at the Third and Stallard Pump Station that had a hose attached to it. The hose did not have backflow prevention.

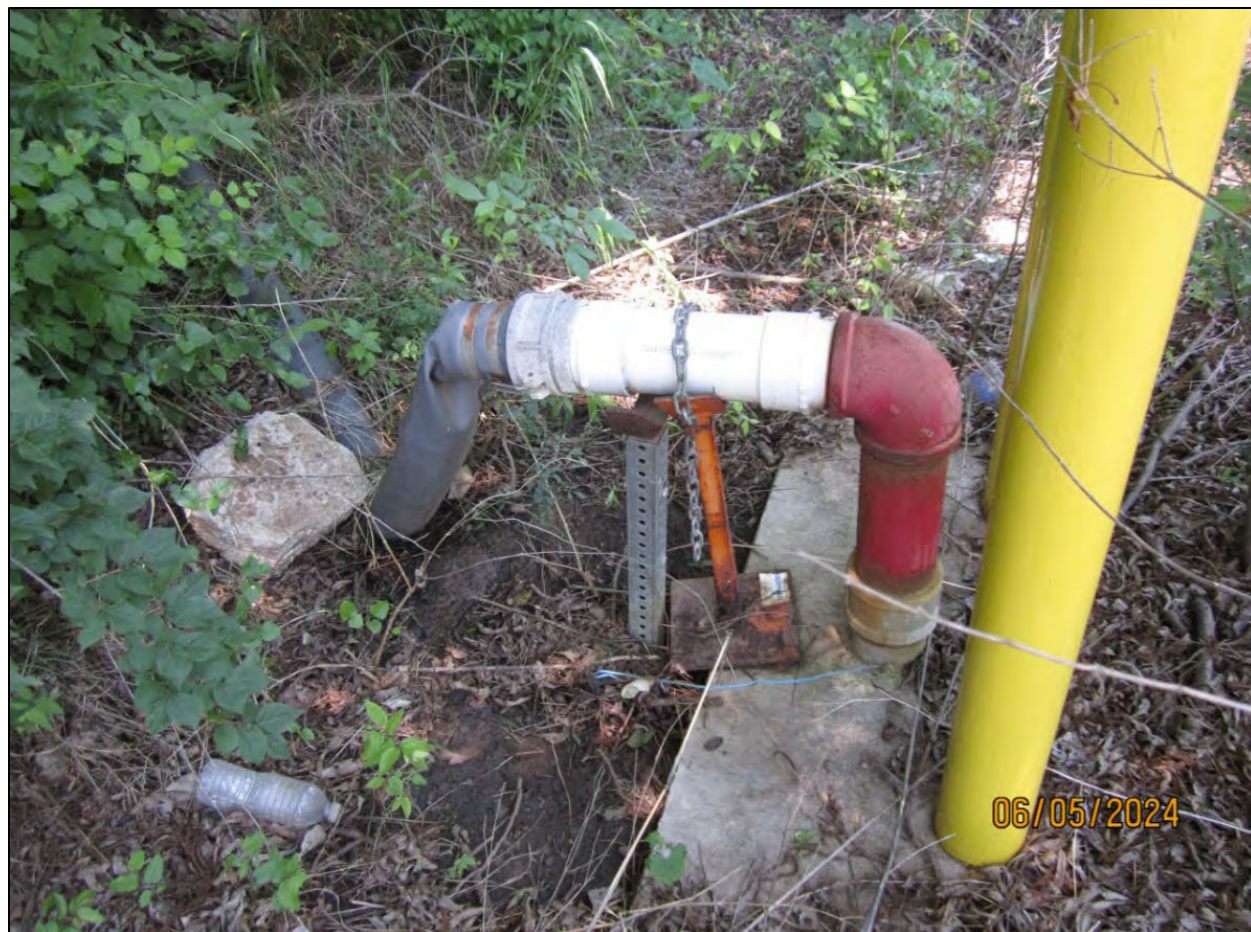
Photo No. 32

**Photograph 32. 6/5/2024 1:00 PM IMG\_0146.JPG**

**S Western Road Flushing Line** View of an above ground flushing line that was positioned approximately 100 yards south of the intersection of S. Western Road and W. 32<sup>nd</sup> Avenue. System representatives stated that the line was attached to a finished water transmission line running parallel to the road. There was a rubber hose attached to the end of the PVC line. System representatives stated that the hose was being used to divert water away from the concrete platform to prevent erosion. The hose extended several feet through the woods and into a stream flowing through a plastic corrugated pipe that extended under the road. This image was taken on June 5, 2024, the second day of the inspection. Google Earth street view imagery from S. Western Road shows that the hose was attached to the flushing line when the image was taken in March 2022 (refer to [Appendix 2, Exhibit 5, Flushing Line Photo – March 2022](#)).

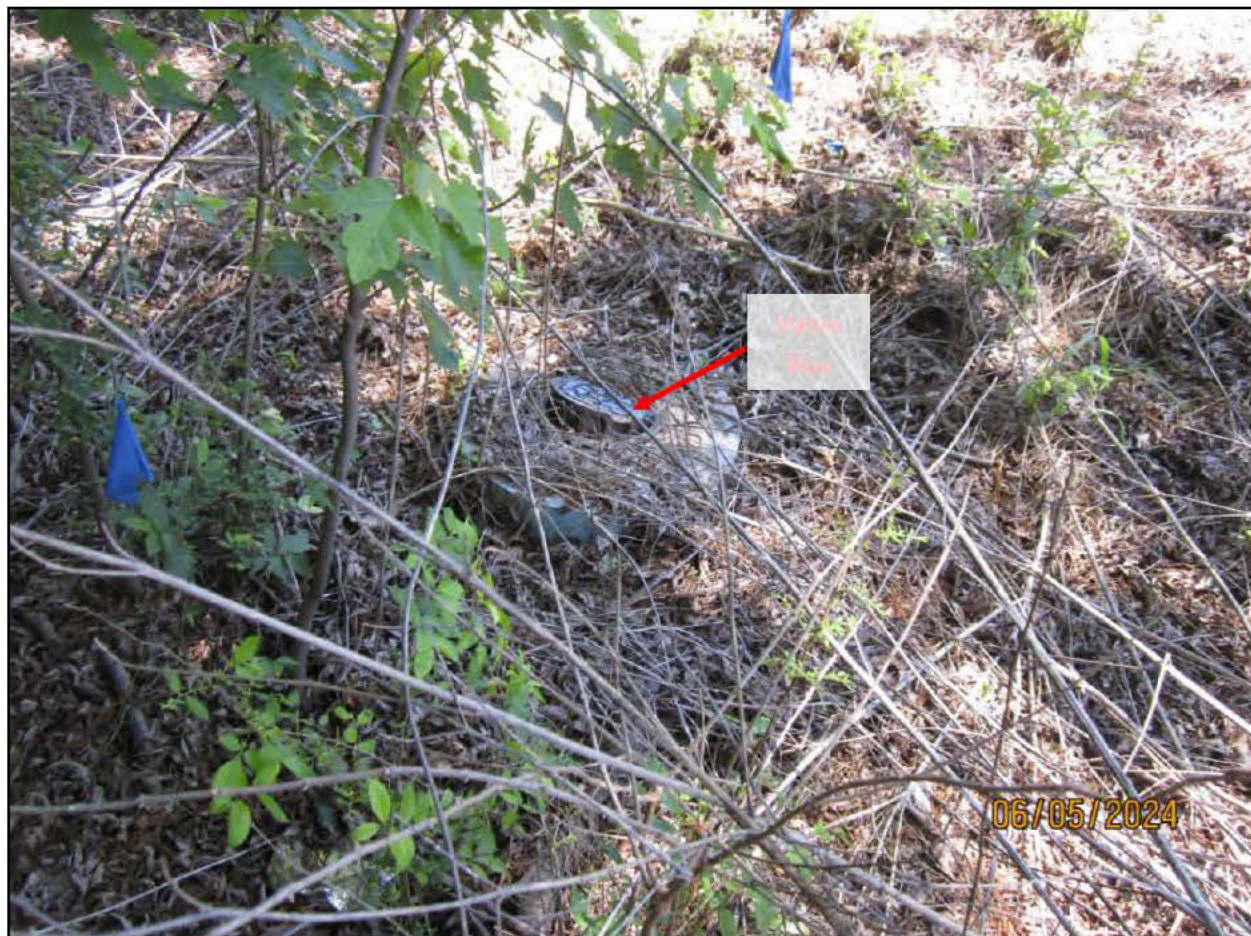
Photo No. 33

**Photograph 33. 6/5/2024 1:01 PM IMG\_0147.JPG**

**S Western Road Flushing Line** View of the valve box associated with the flushing line next to S. Western Road. Note, the cover of the valve box was offset, and the valve was in the "open" position allowing water to flow through the flushing line.

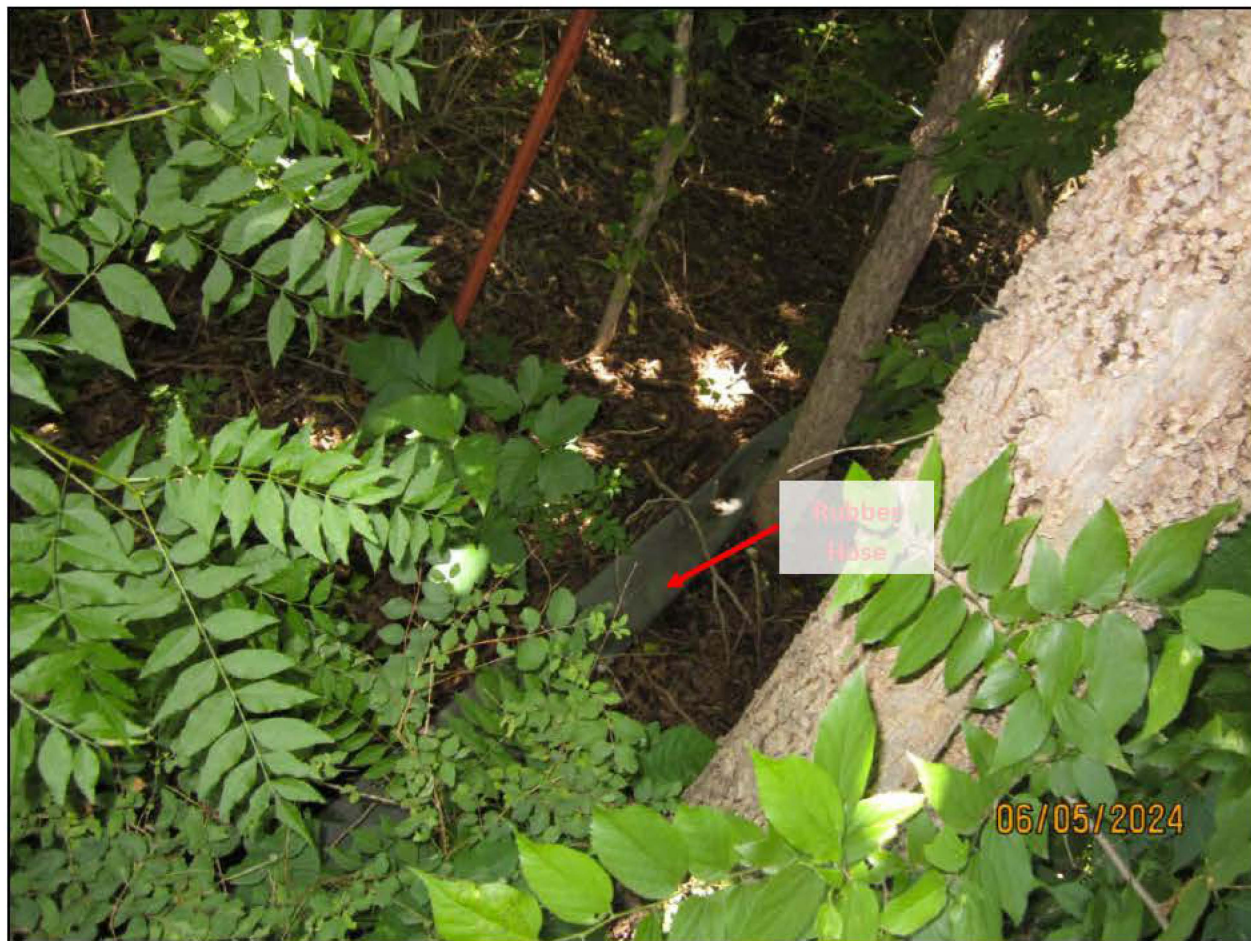
Photo No. 34

Photograph 34. 6/5/2024 1:02 PM IMG\_0149.JPG

S Western Road Flushing Line View of the rubber hose that was attached to the above ground PVC flushing line. The hose extended several feet through the woods and terminated in a below ground plastic corrugated pipe that extended under the road and had water running through it.

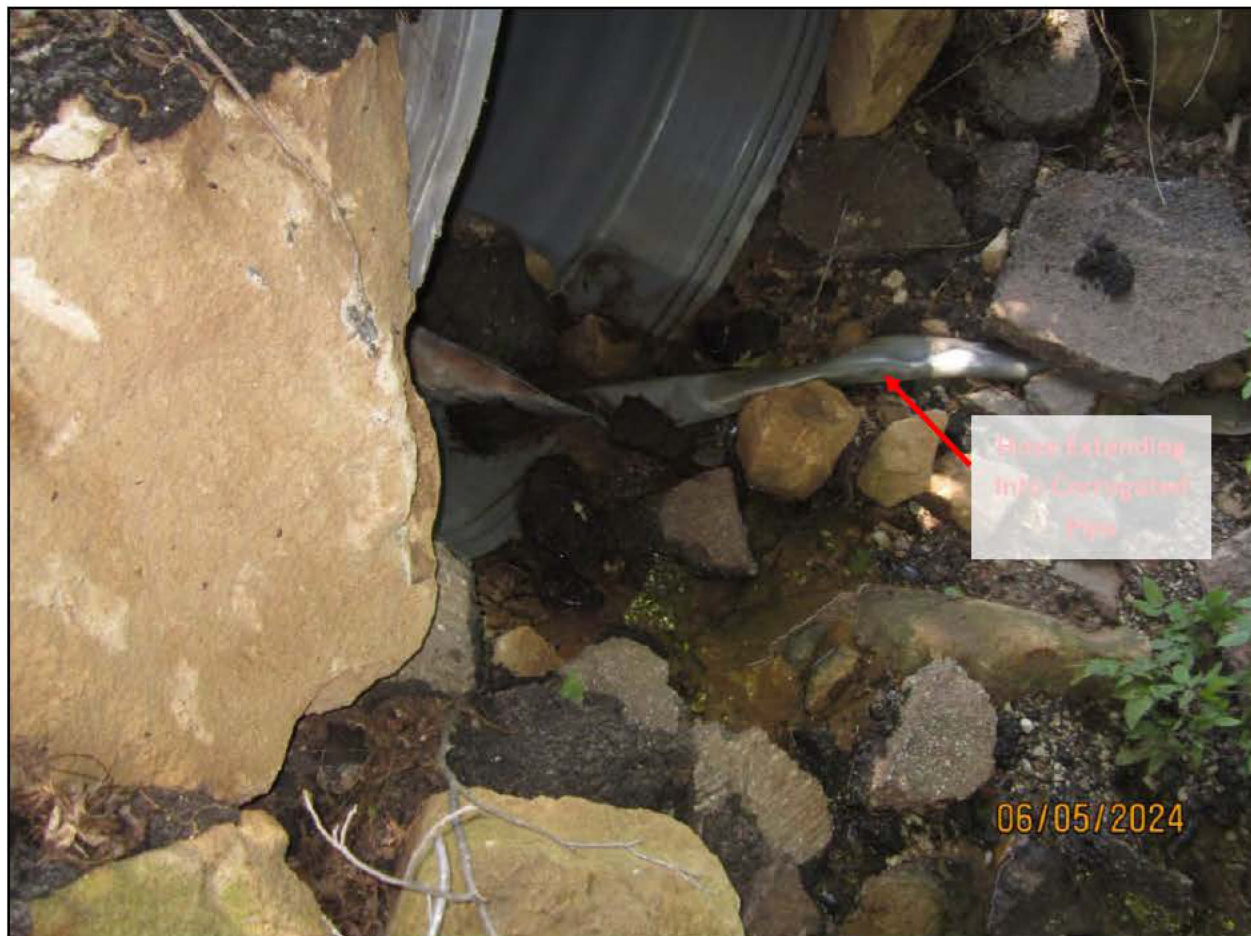
Photo No. 35

Photograph 35. 6/5/2024 1:02 PM IMG\_0150.JPG

S Western Road Flushing Line View of the rubber hose that was attached to the PVC flushing line next to S. Western Road extending into a below ground plastic corrugated pipe that extended under the road and had water running through it.

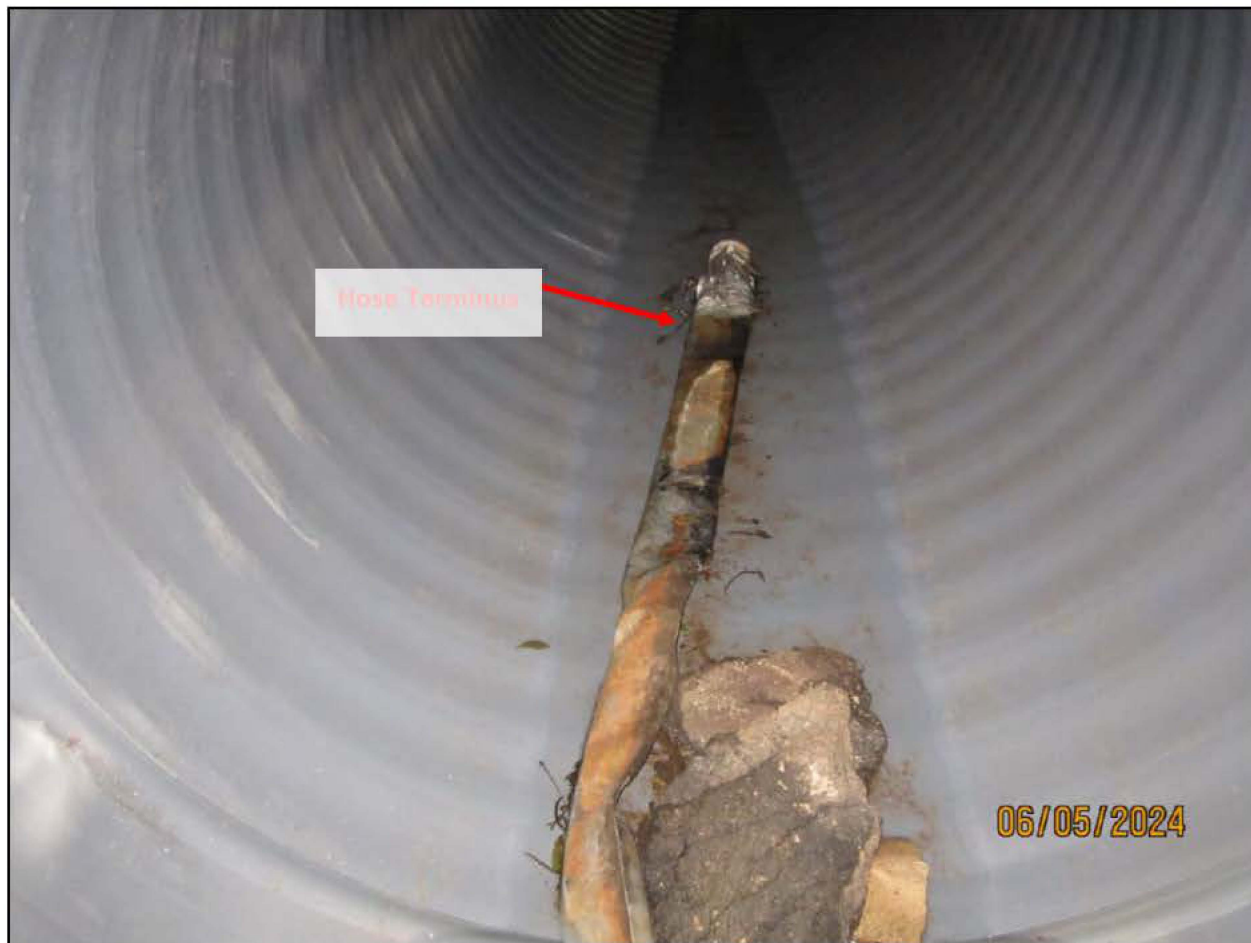
Photo No. 36

Photograph 36. 6/5/2024 1:03 PM IMG\_0151.JPG

S Western Road Flushing Line View of the rubber hose that was attached to the PVC flushing line discharging approximately eight feet into the corrugated pipe into a stream.

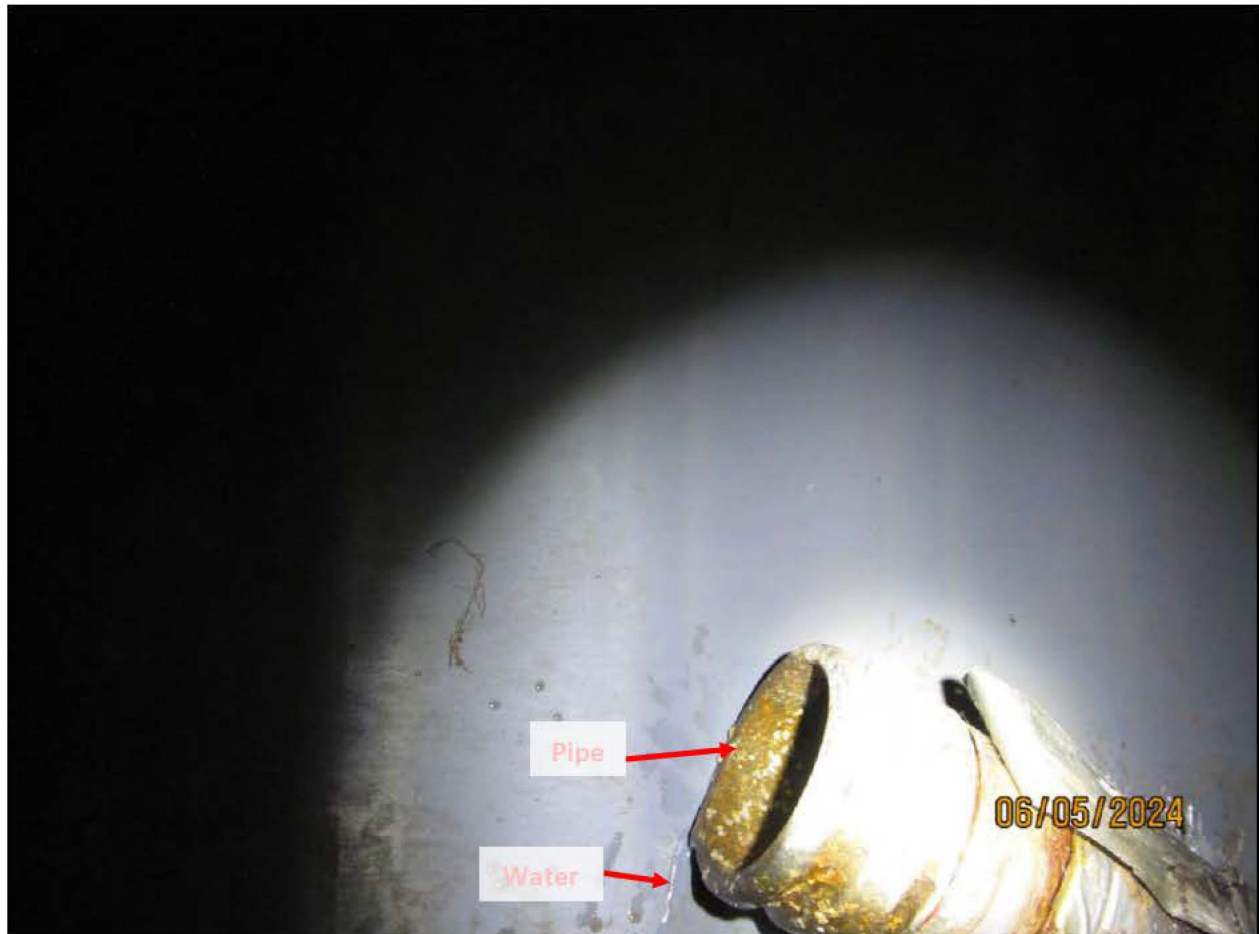
Photo No. 37

Photograph 37. 6/5/2024 1:05 PM IMG\_0152.JPG

S Western Road Flushing Line View of the quick connector at the end of the rubber hose that was elevated above the stream by approximately ten inches. The hose was filled with water, and some water was spilling out of the end of the pipe.
