**Region 6 - Enforcement & Compliance Assurance Division**  
**INSPECTION REPORT**

| <b>Inspection Date(s):</b> | 06/04/2024 through 06/06/2024 | |
| <b>System Name:</b> | City of Stillwater Public Water System (PWS) | |
| <b>PWS ID:</b> | OK1021220 | |

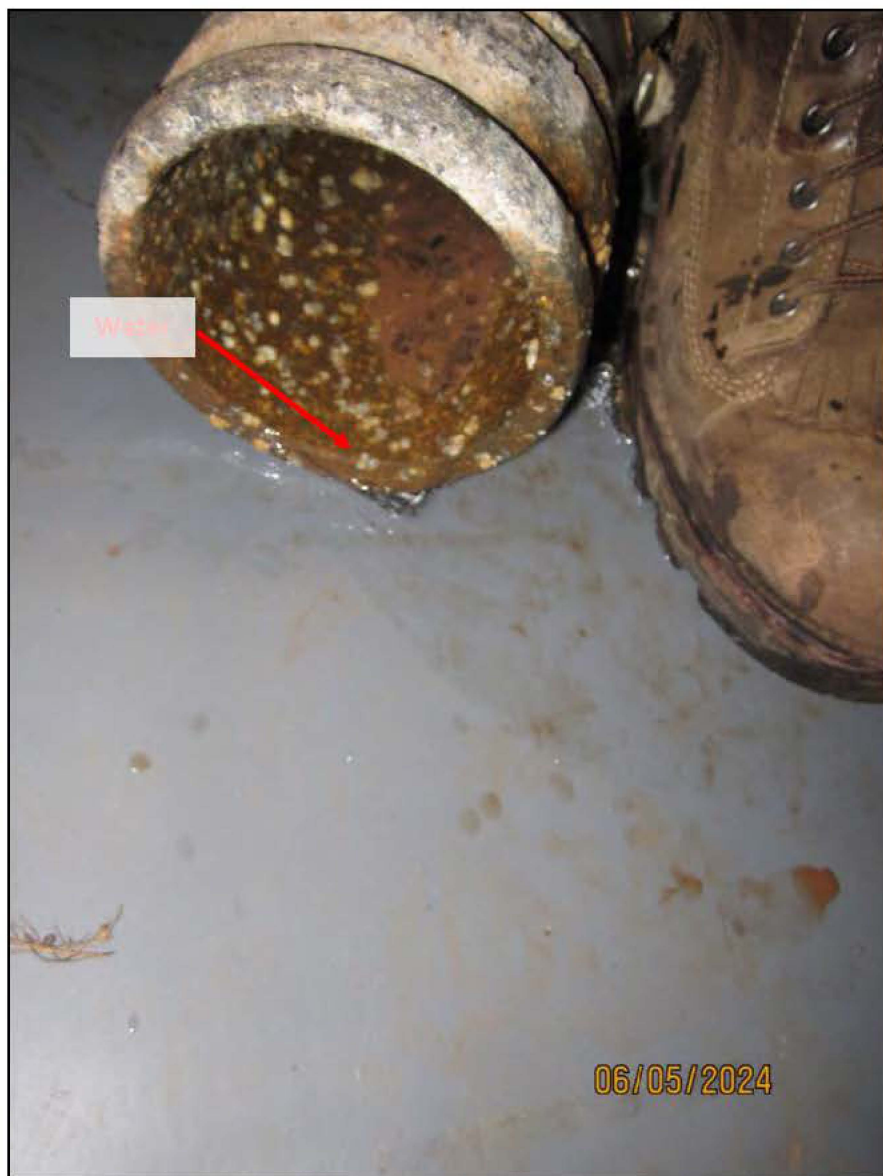
Photo No. 38

Photograph 38. 6/5/2024 1:05 PM IMG\_0153.JPG

S Western Road Flushing Line Additional view of the quick connector at the end of the rubber hose that was elevated above the stream by approximately ten inches. The hose was filled with water, and the water was overflowing from the hose into the stream.

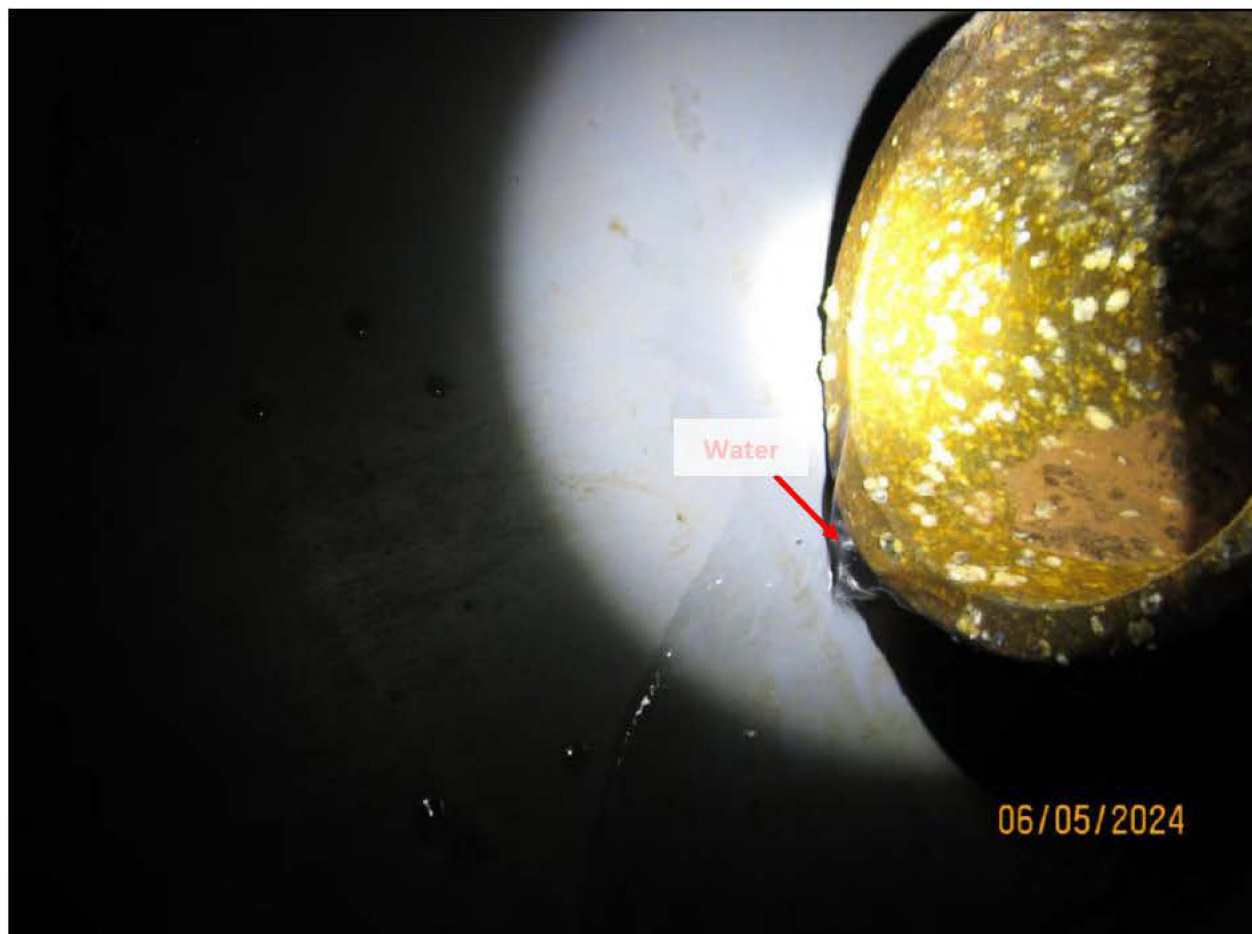
Photo No. 39

Photograph 39. 6/5/2024 1:06 PM IMG\_0154.JPG

S Western Road Flushing Line Close-up view of water being released from the quick connector at the end of the rubber hose.

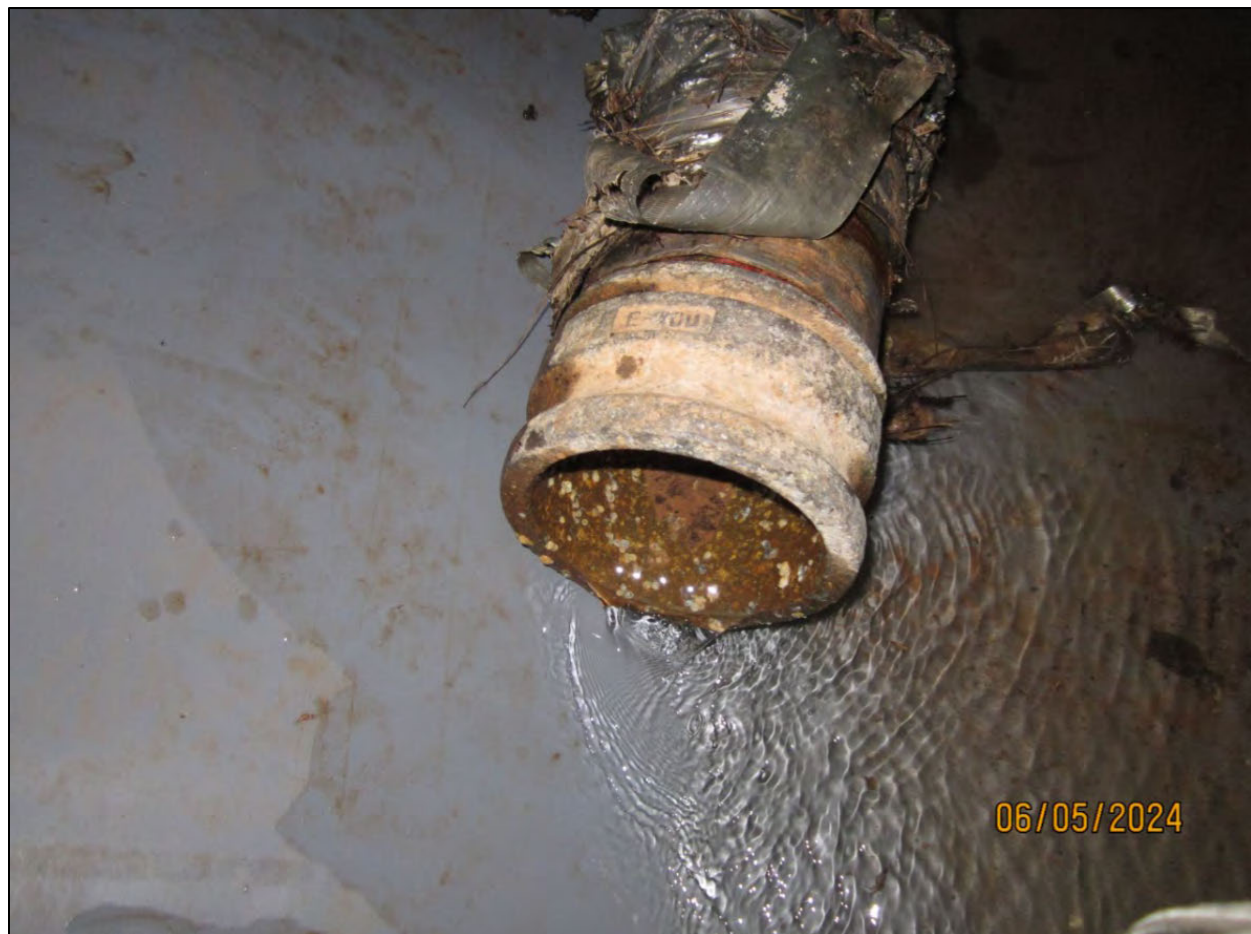
Photo No. 40

**Photograph 40. 6/5/2024 1:07 PM IMG\_0155.JPG**

**S Western Road Flushing Line** View of water being released from the quick connector at the end of the rubber hose after the inspector had lifted the hose to see if water would collect in the hose, and then set the hose back down. The water being released had collected in the hose while the hose was being held up at approximately 10 inches above stream.

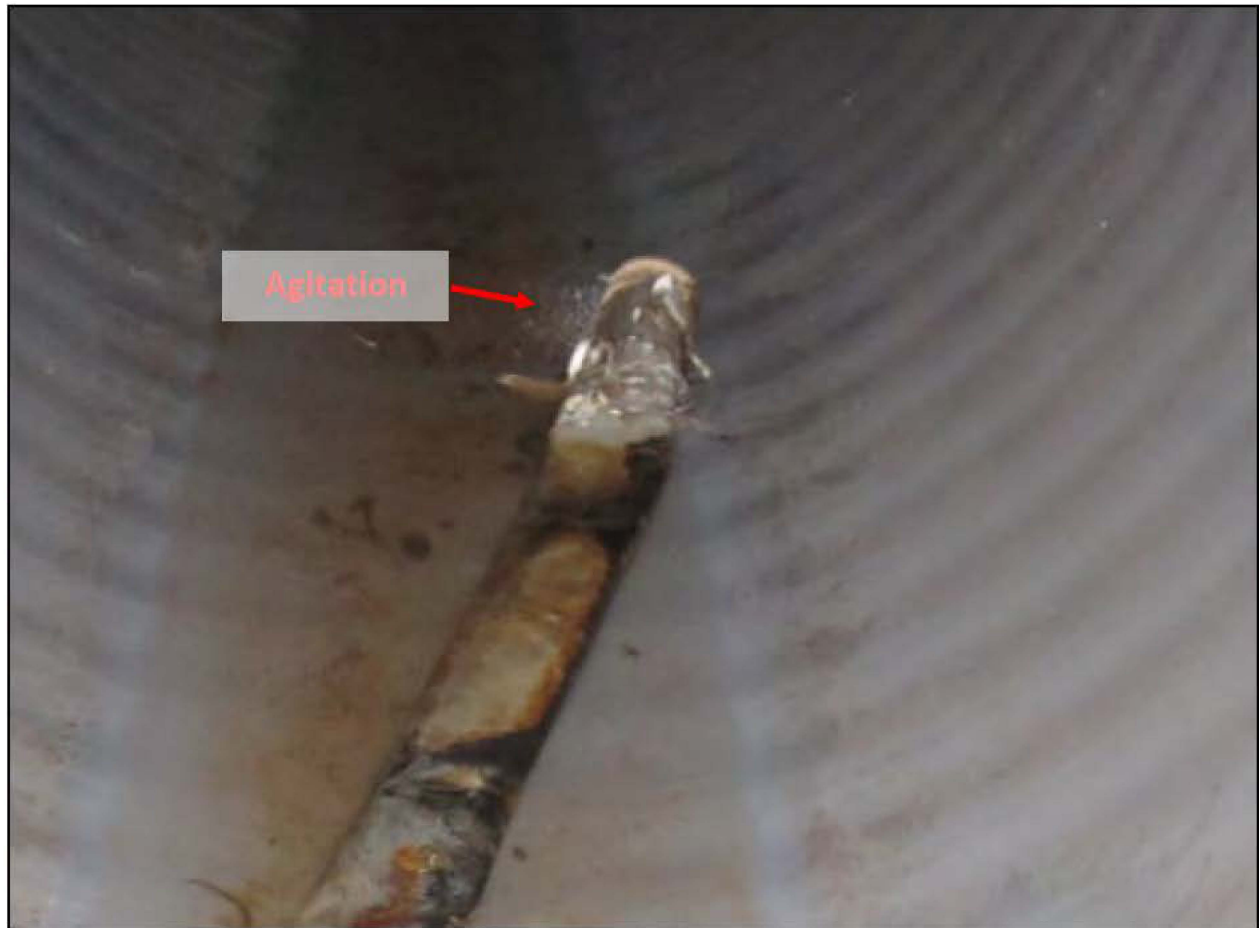
Photo No. 41

Photograph 41. 6/5/2024 1:08 PM IMG\_0156.JPG

S Western Road Flushing Line View from behind the hose of water being released from the quick connector at the end of the rubber hose after the inspector had lifted the hose to see if water would collect in the hose, and then set the hose back down. Agitation from the releasing water can be seen in the receiving stream.

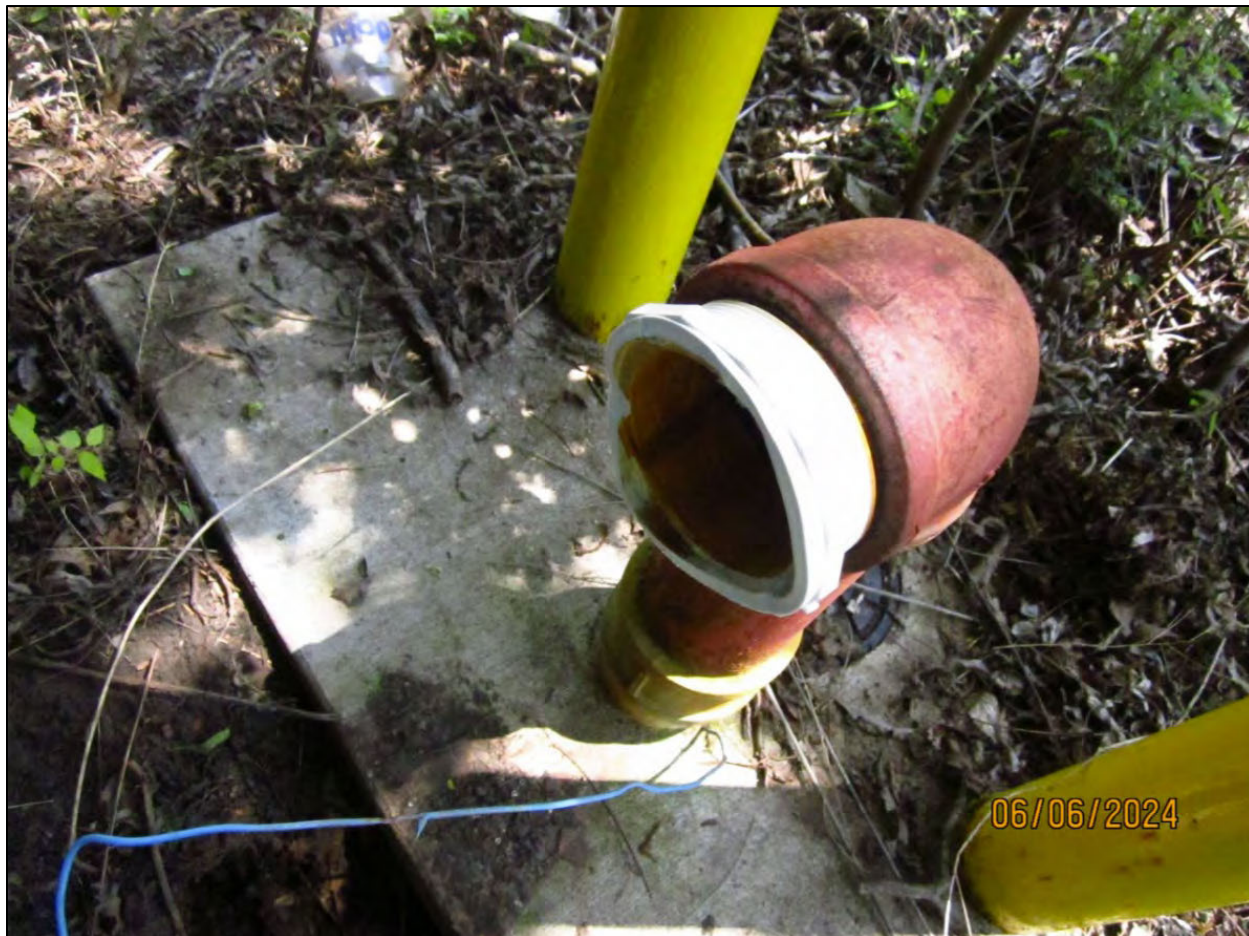
Photo No. 42

**Photograph 42. 6/6/2024 12:17 PM IMG\_0123.JPG**

**S Western Road Flushing Line** View of the above ground flushing line that was positioned next to S. Western Road, taken on June 6, 2024, the third day of the inspection. The image was taken after the observation regarding the hose/potential cross connection was made to System representatives. The plastic piping that had connected the PVC flushing line to the rubber hose had been broken off.

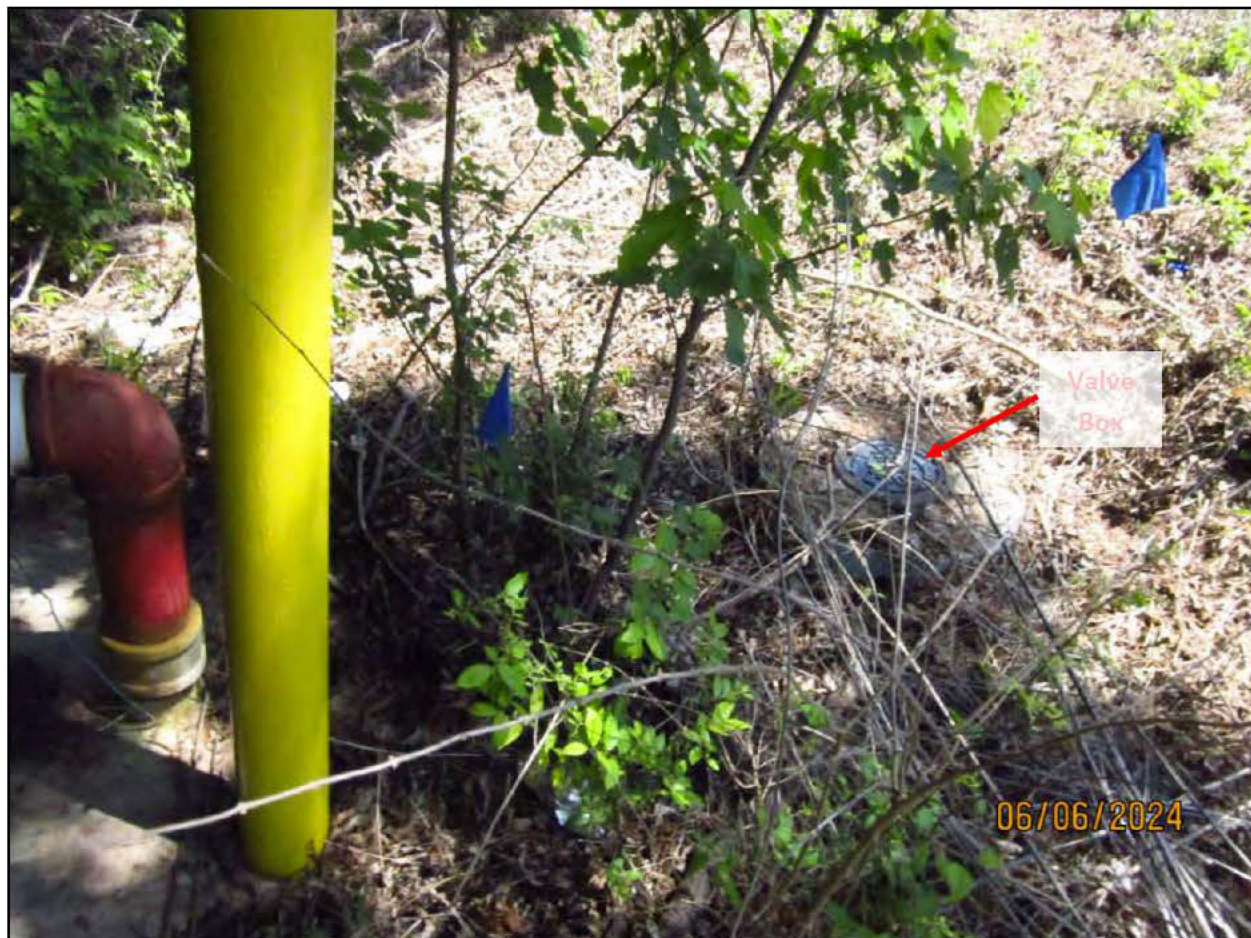
Photo No. 43

Photograph 43. 6/6/2024 12:20 PM IMG\_0124.JPG

S Western Road Flushing Line View of the valve box associated with the flushing line next to S. Western Road. This image was taken on June 6, 2024, after the potential cross connection was observed. The lid of the valve box was properly closed.

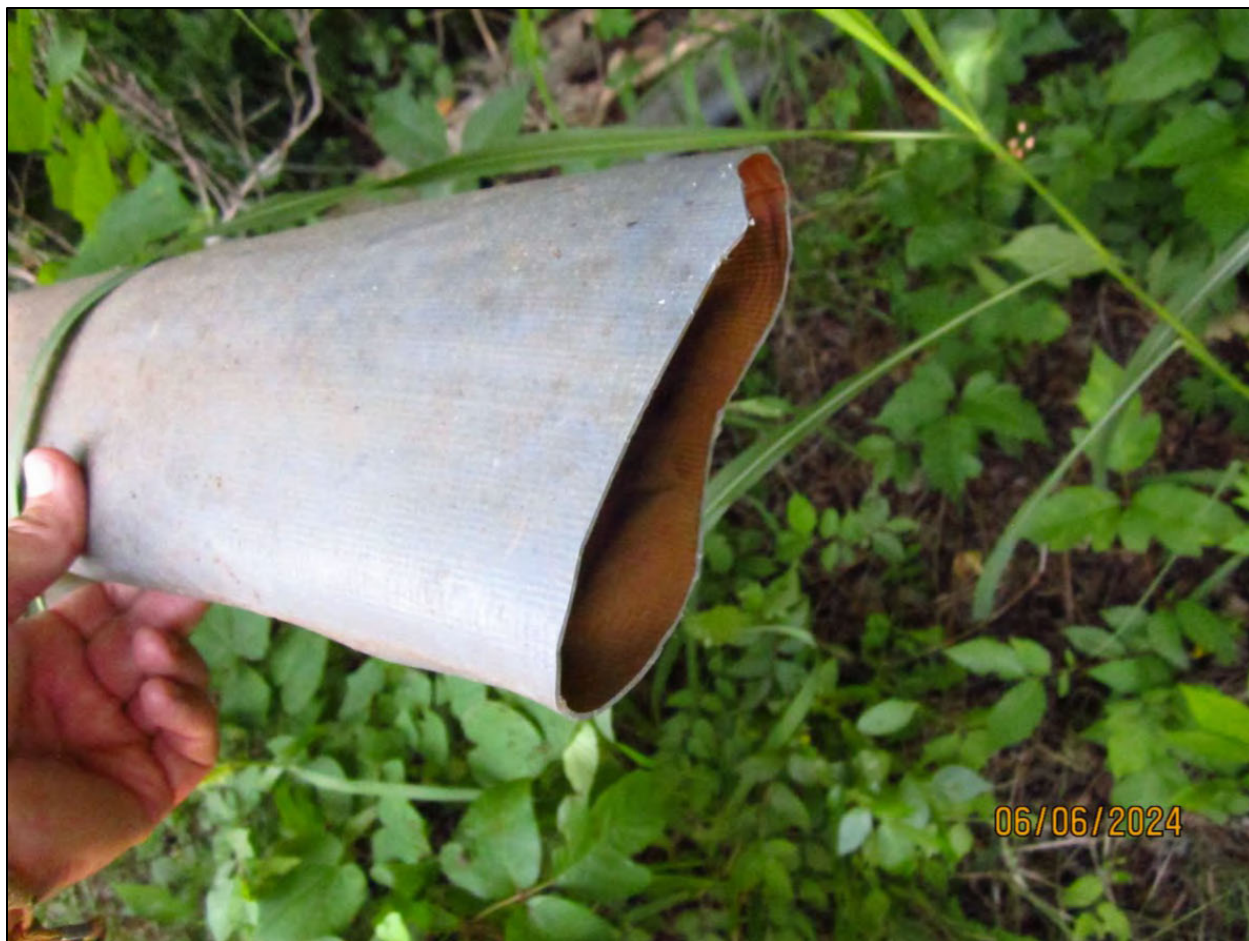
Photo No. 44

**Photograph 44. 6/6/2024 12:20 PM IMG\_0125.JPG**

**S Western Road Flushing Line** View of the rubber hose that had been attached to the PVC flushing line the day prior to this image being taken (June 5, 2024). It appeared that distribution team members had cut the hose and left it in the woods after the potential cross connection had been observed.

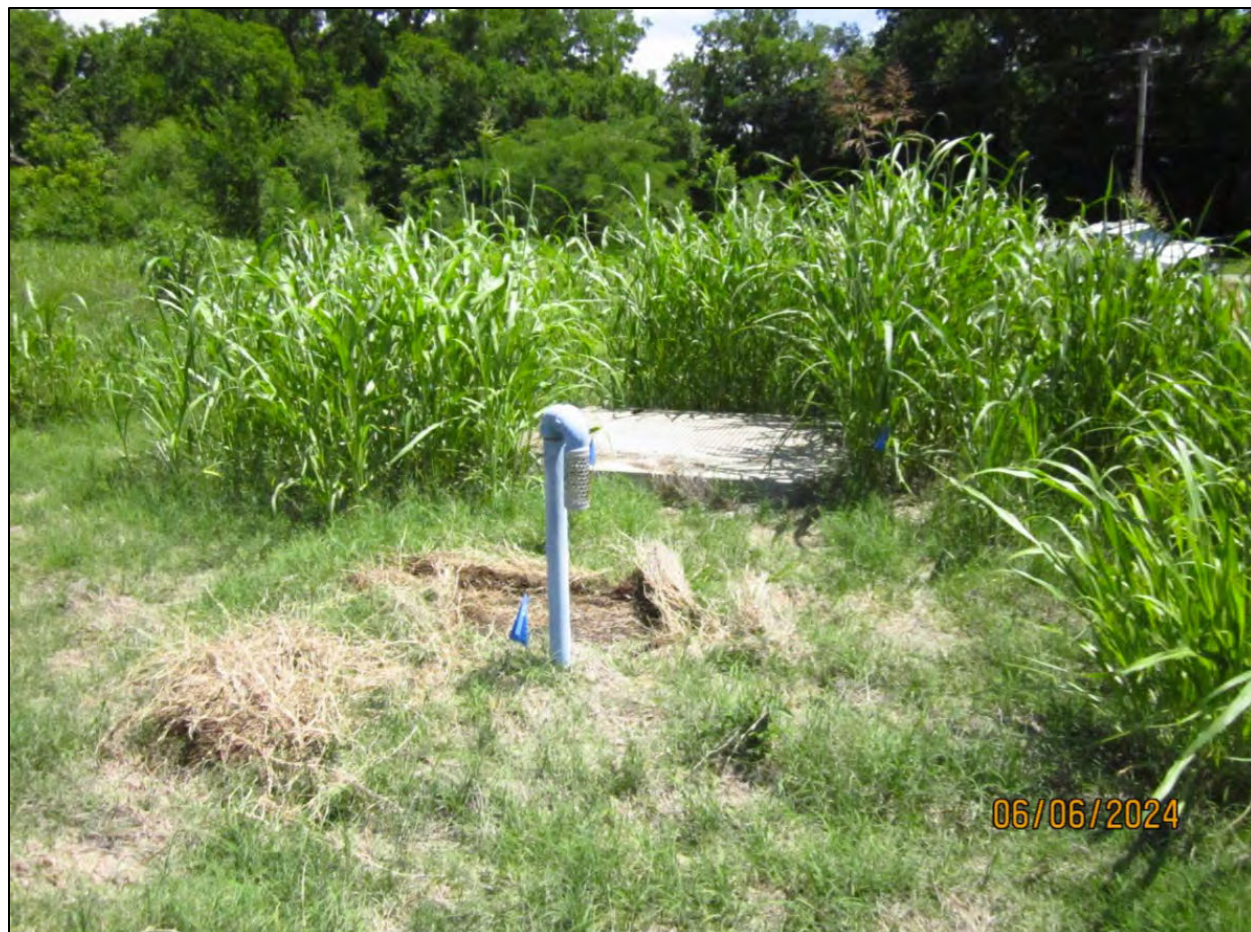
Photo No. 45

**Photograph 45. 6/6/2024 12:22 PM IMG\_0126.JPG**

**Air Relief Valve Release Pipe** View of an air relief valve release pipe that extended off the distribution system. The pipe was located approximately 50 yards from the S. Western Road flushing line with hose.

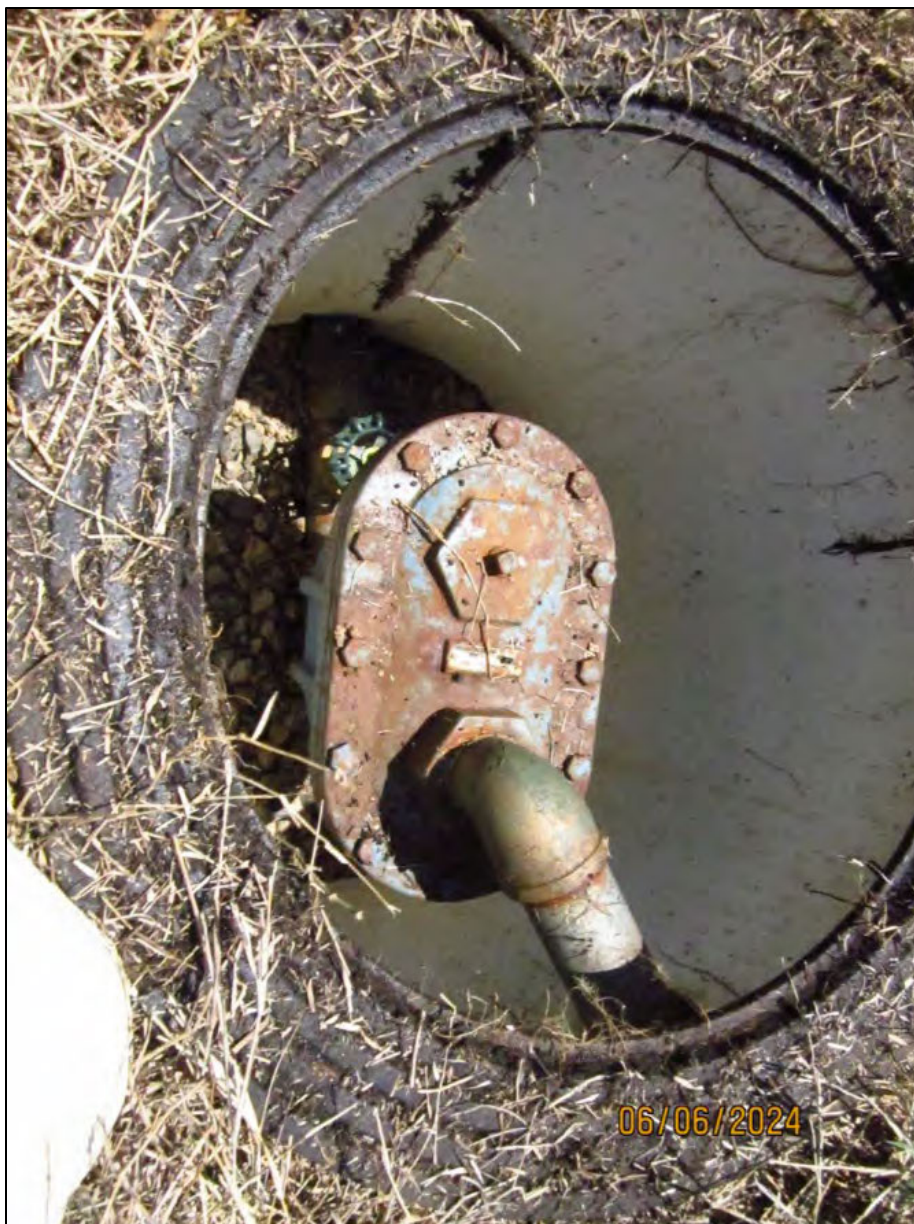
Photo No. 46

**Photograph 46. 6/6/2024 12:26 PM IMG\_0127.JPG**

**Air Relief Valve Release Pipe** View of the underground components associated with the air relief pipe seen in the above image.

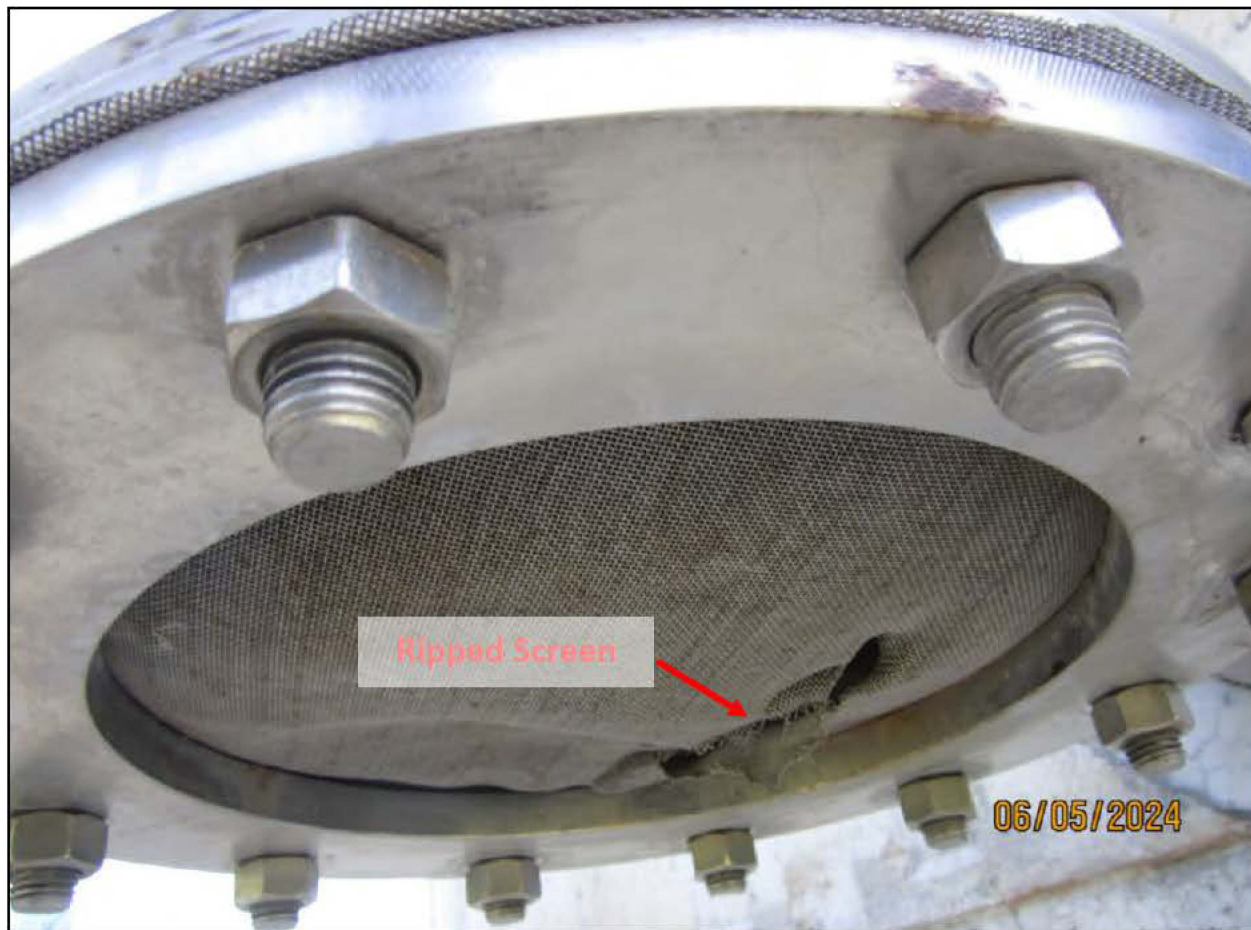
Photo No. 48

- c. The overflow pipe at the 44<sup>th</sup> St. Water Tower was downturned and contained a mesh screen, but it was not equipped with a flex gate (refer to [Appendix 1, Photograph 48](#)). The mesh screen was ripped.

Photograph 48. 6/5/2024 1:47 PM IMG\_0167.JPG

44<sup>th</sup> St. Water Tower View of the end of the overflow pipe extending from the 44<sup>th</sup> St. Water Tower. The pipe was missing a flex gate and the mesh screen covering the pipe was ripped.

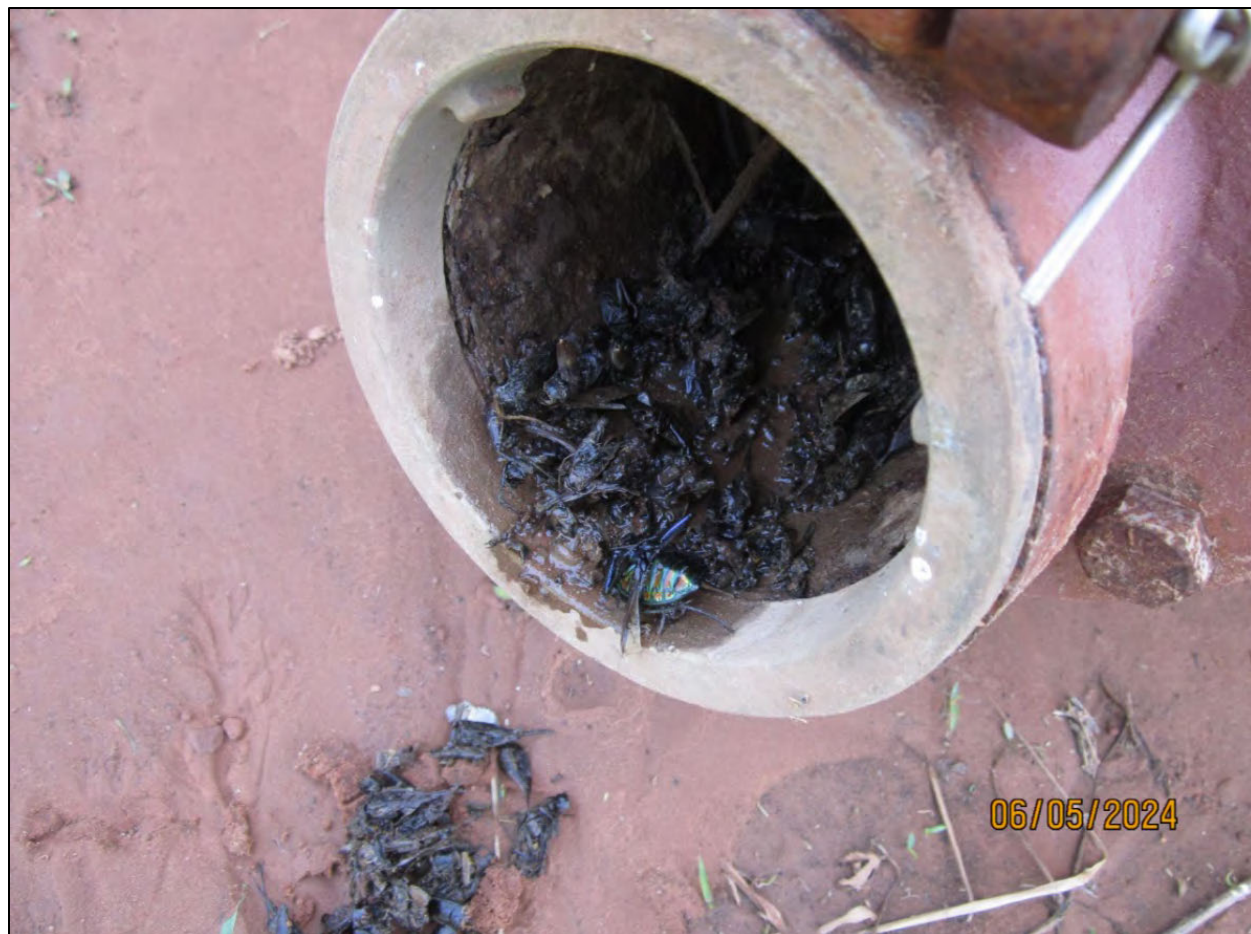
Photo No. 49

- b. The floor of the 19<sup>th</sup> Ave. Pump Station was cracked and appeared to be settling and separating from the wall due to ground settling.
- c. A drainpipe extending from the floor of the 44<sup>th</sup> St. Water Tower was filled with black insects (refer to Appendix 1, Photograph 49). It appeared that the flapper for the drain line had been wired open previously. When this observation was made, the wire was removed, and the flapper was seated tightly to the pipe.

**Photograph 49. 6/5/2024 1:49 PM IMG\_0171.JPG**

**44<sup>th</sup> St. Water Tower** View of the drainpipe from the floor inside of the 44<sup>th</sup> St. Water Tower that extended outside of the water tower. The flex gate covering the drainpipe appeared to have been wired open in past, allowing black insects to enter the pipe. After this observation was made, the wire was removed, and the flex gate was seated tightly over the end of the drainpipe.

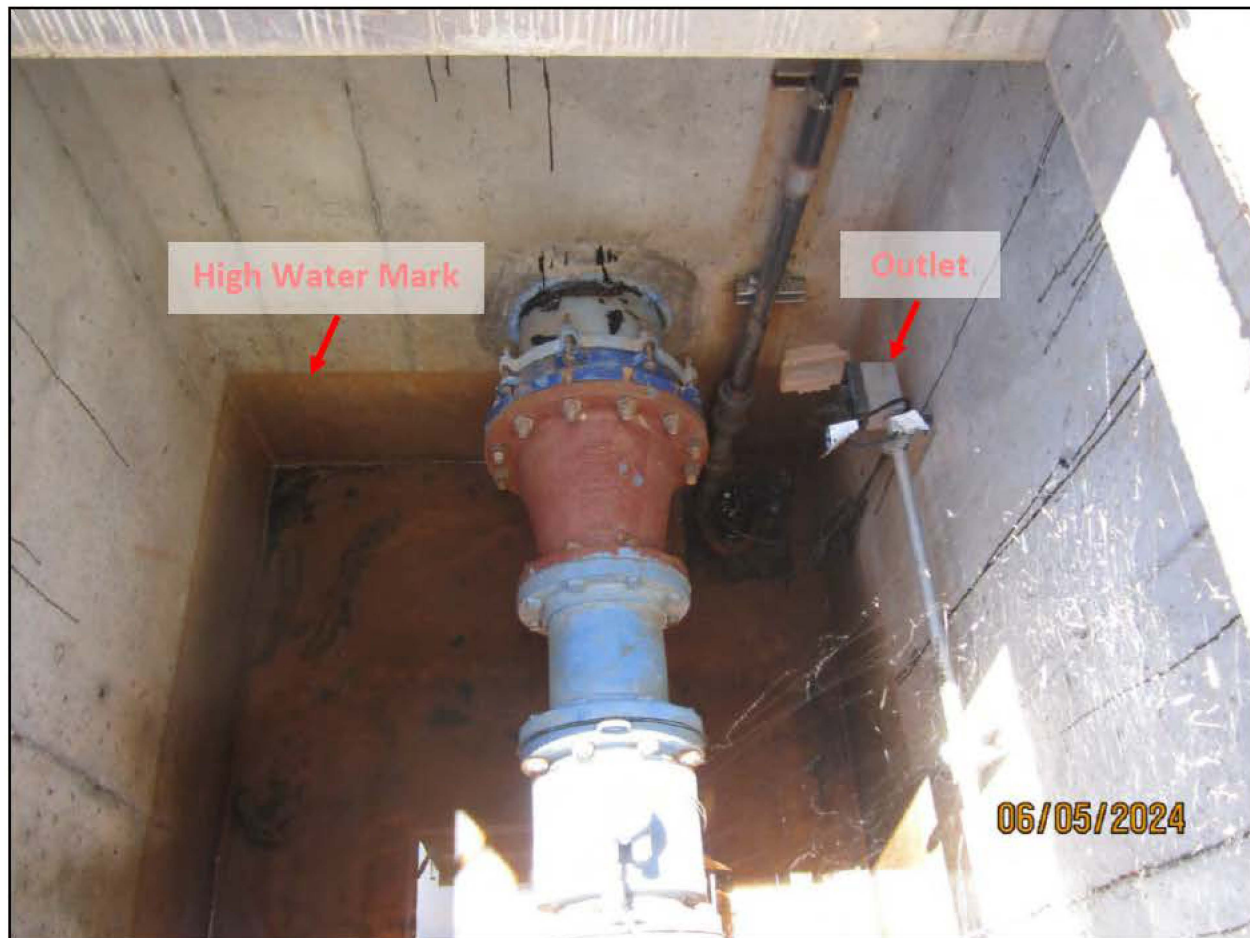
Photo No. 50

- d. The meter vault outside of the 44<sup>th</sup> St. Water Tower had one inch of standing water inside of it and staining on the walls of the vault indicated past water level heights of 12-16 inches high (refer to Appendix 1, Photograph 50). It was unclear why the vault was flooding, since a sump pump was present inside of the vault. The high water marks inside of the vault were approximately 12 inches from an electrical outlet inside of the meter vault.

Photograph 50. 6/5/2024 2:03 PM IMG\_0176.JPG

**44<sup>th</sup> St. Water Tower** View inside of the meter vault next to the 44<sup>th</sup> St. Water Tower. The meter vault had one inch of standing water inside of it, but staining on the walls of the vault indicated past water level heights of 12-16 inches high. It was unclear why the vault was flooding, since a sump pump was present inside of the vault. The high water marks inside of the vault were approximately 12 inches from an electrical outlet inside of the meter vault.

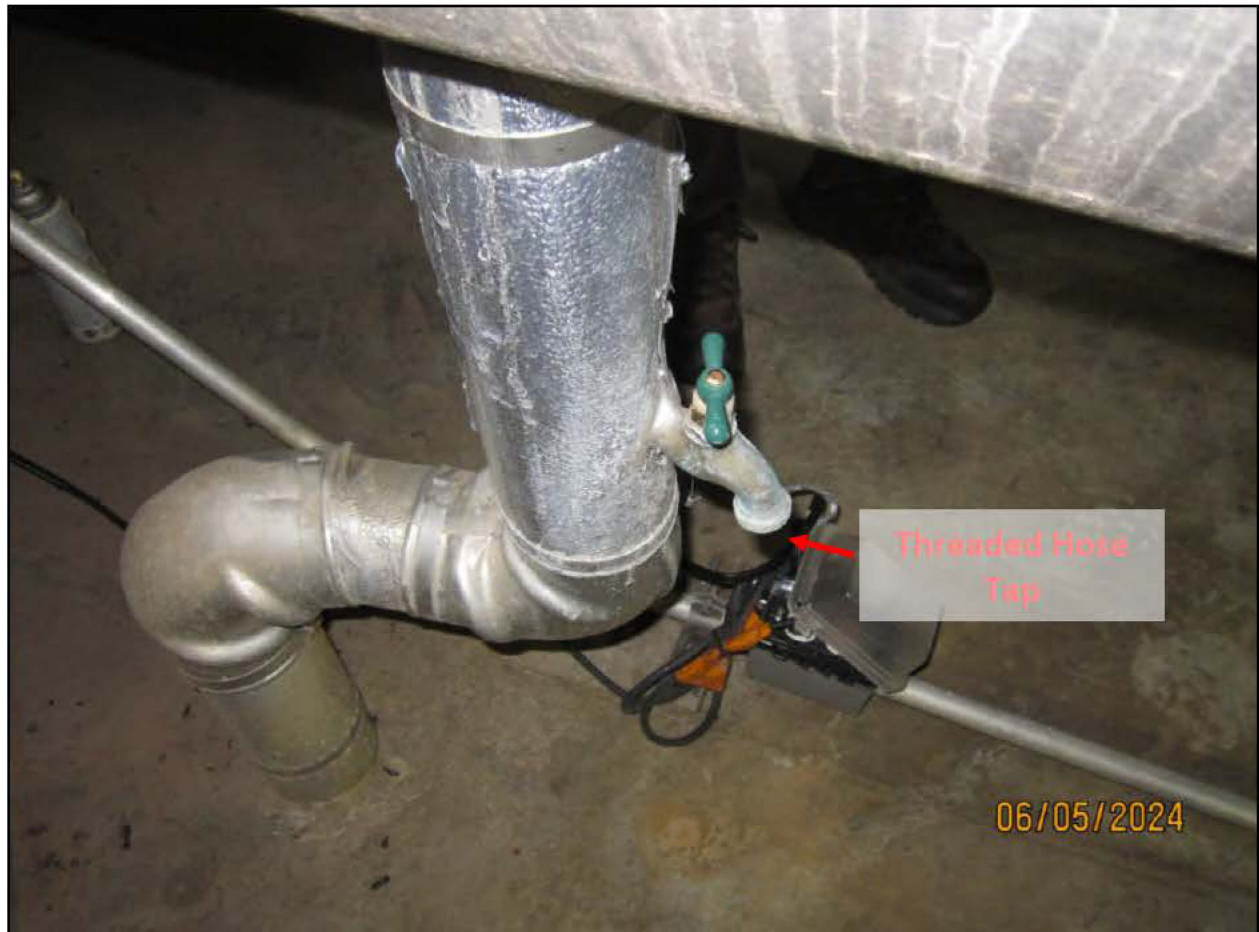
Photo No. 51

44<sup>th</sup> St. Water Tower View of a threaded hose tap without backflow prevention on one of the lines inside the base of the 44<sup>th</sup> St. Water Tower.

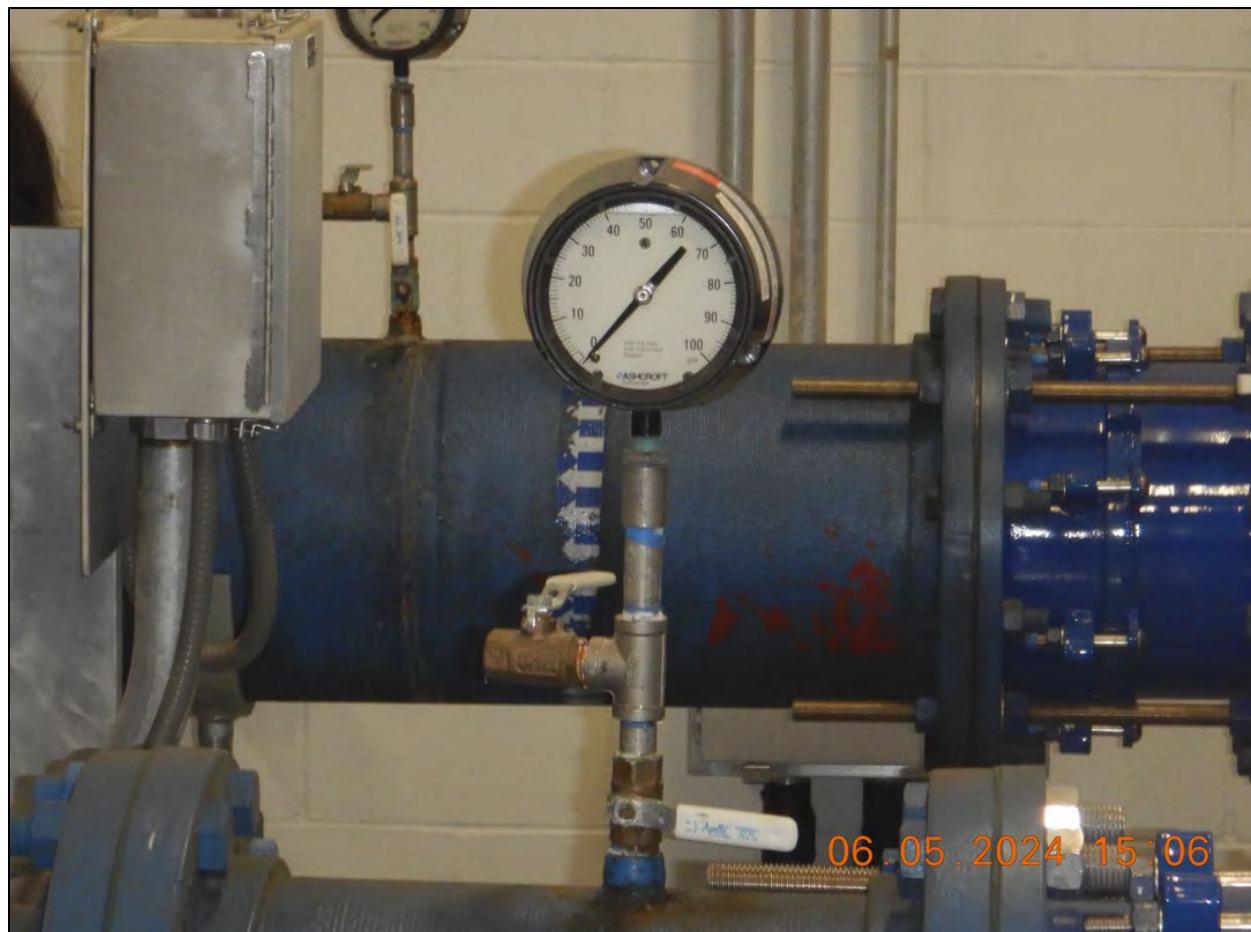
Photo No. 53

**West Highway 51 Pump Station** View of one of the pressure gauges on the suction side of one of the pump lines was not functional. An operator opened both valves and a sample tap on the line to verify that water was flowing through the discharge line, and it was confirmed that the line was pressurized even though the pressure gauge was reading <0 psi.

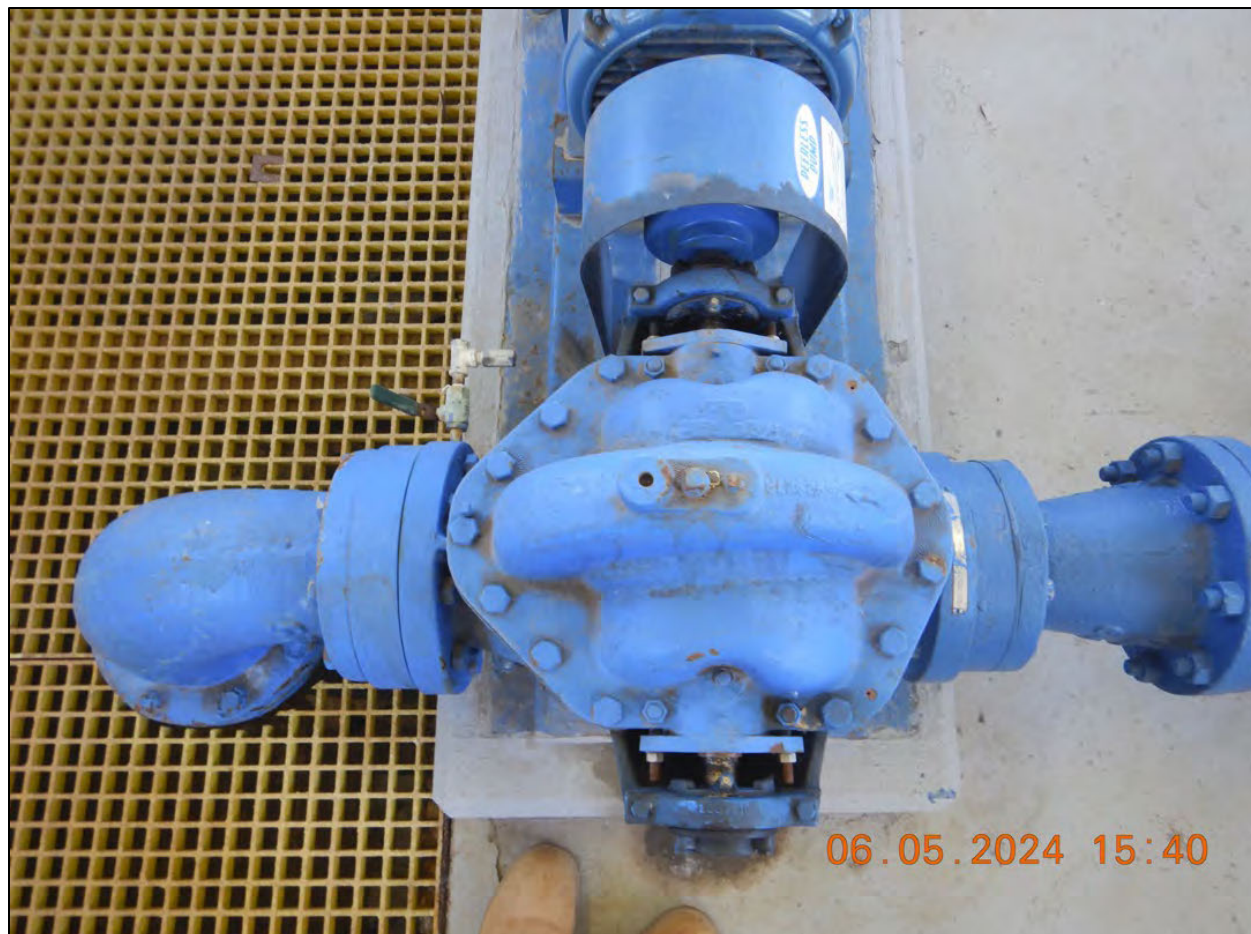
Photo No. 54

**Washington and Liberty Pump Station** View of one of the pumps and pump lines inside of the Washington and Liberty Pump Station. The pump line was missing both suction and discharge side pressure gauges.

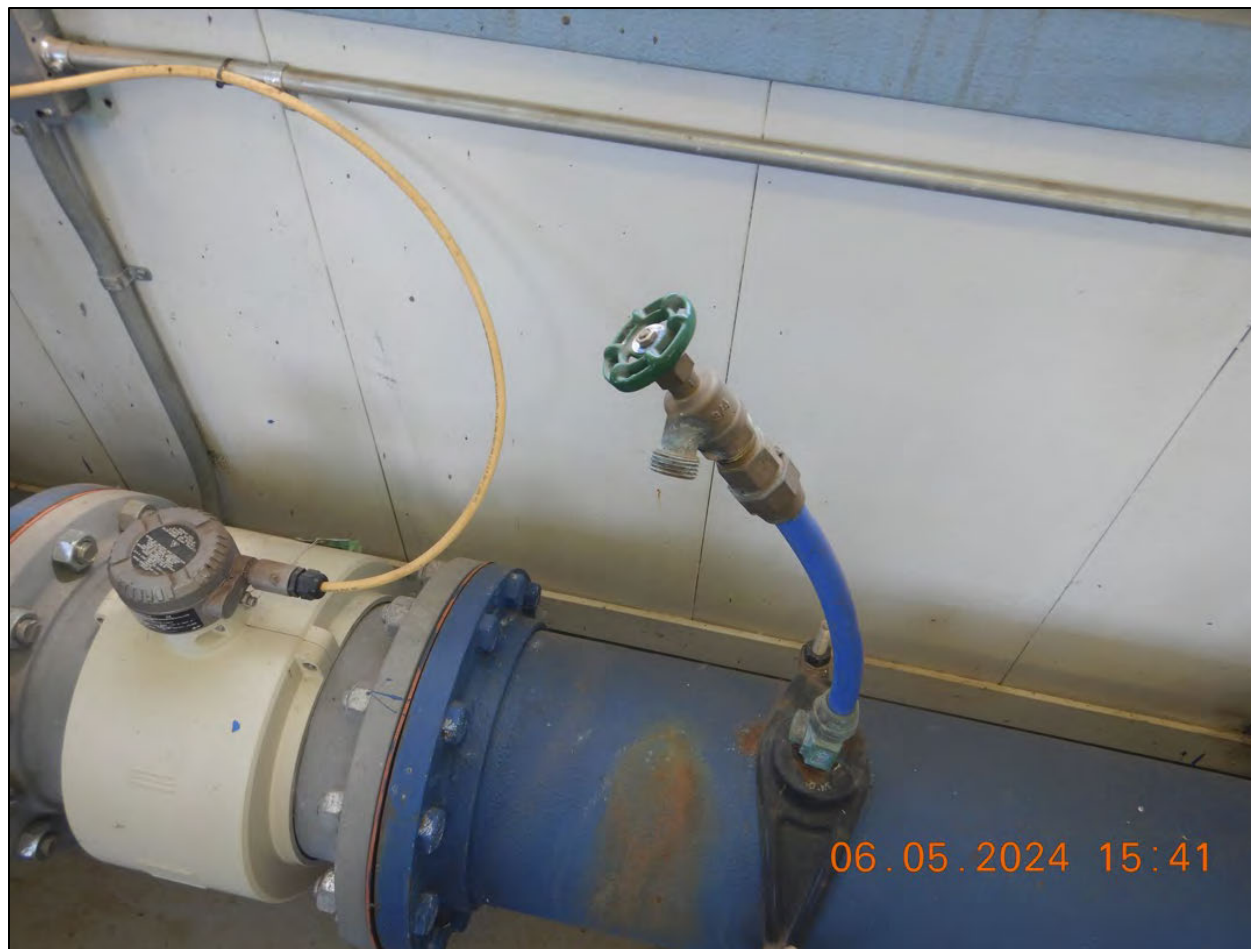
Photo No. 55

**Washington and Liberty Pump Station** View of a threaded hose tap without backflow prevention on the pump line inside of the Washington and Liberty Pump Station.

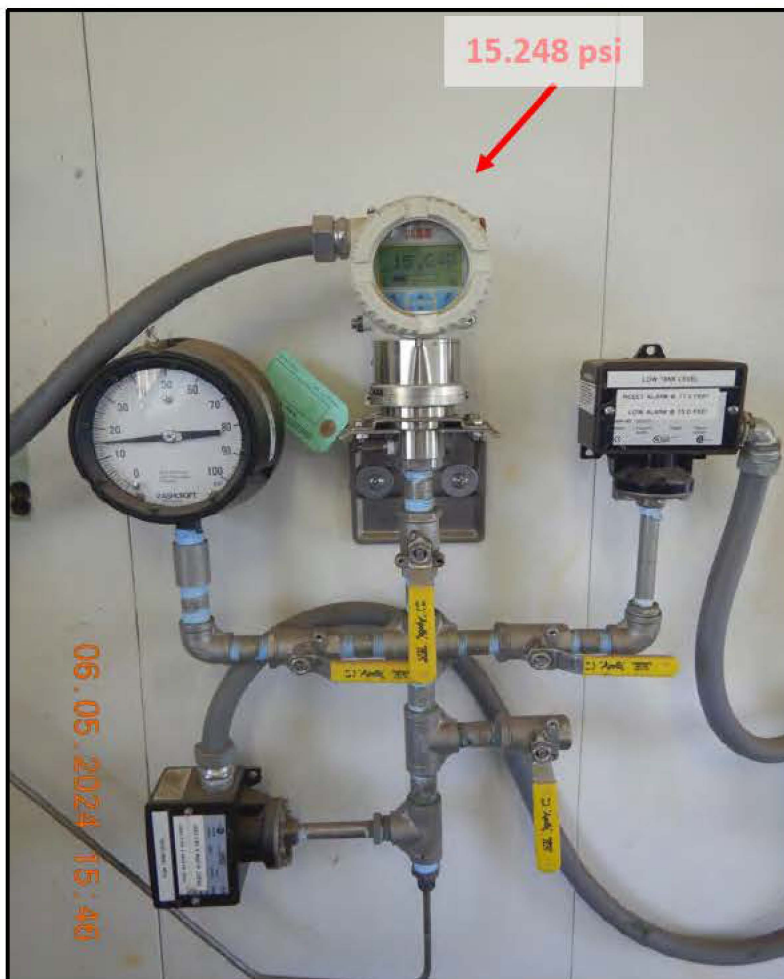
Photo No. 56

- a. A pressure gauge on the wall of the Washington and Liberty pump station was reading 15.248 psi during the inspection (refer to [Appendix 1, Photograph 56](#)). System representatives could not confirm where the pressure reading was coming from, but it appeared that the pressure was being read from the suction line entering the pump station.
- b. The suction side pressure gauge at the Yost pump station was showing a pressure that appeared to be just below 25 psi (based on photographic imagery from outside the confined space of the vault) (refer to [Appendix 1, Photograph 61](#)).

**Washington and Liberty Pump Station** View of a pressure gauge on the wall inside of the Washington and Liberty Pump Station that was reading 15.248 psi at 3:46 p.m. on June 5, 2024. System representatives could not confirm where the pressure reading was coming from, but it appeared that the pressure was being read from the suction line entering the pump station.

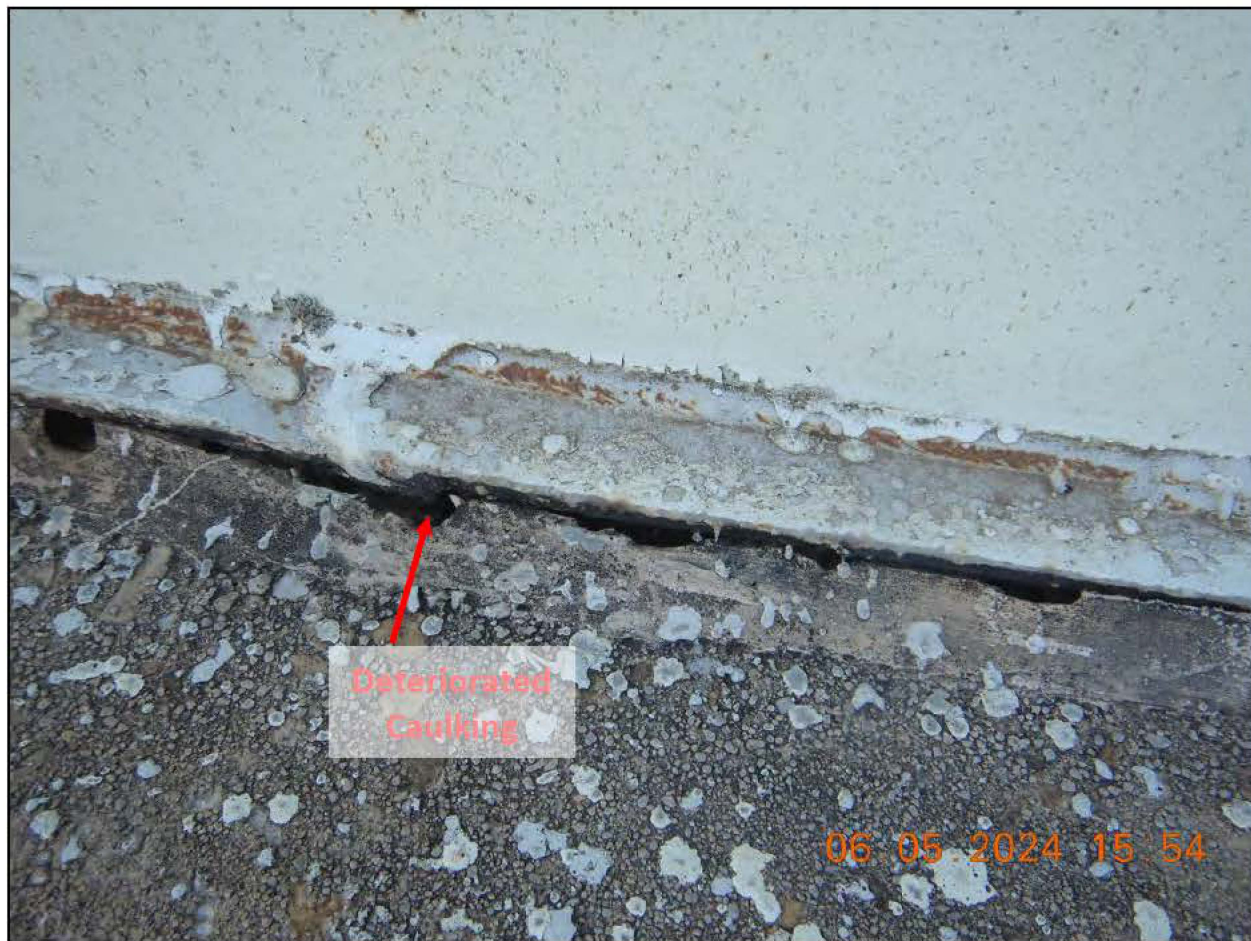
Photo No. 57

- b. The caulking surrounding the base of the Washington and Liberty Tank was worn away and had failed in places (refer to [Appendix 1, Photograph 57](#)).

Washington and Liberty Water Tower View of deteriorated caulking and mortar between the metal bottom plate of the Washington and Liberty Water Tower and the concrete base.
