**Region 6 - Enforcement & Compliance Assurance Division**  
**INSPECTION REPORT**

| <b>Inspection Date(s):</b> | 06/04/2024 through 06/06/2024 | |
| <b>System Name:</b> | City of Stillwater Public Water System (PWS) | |
| <b>PWS ID:</b> | OK1021220 | |

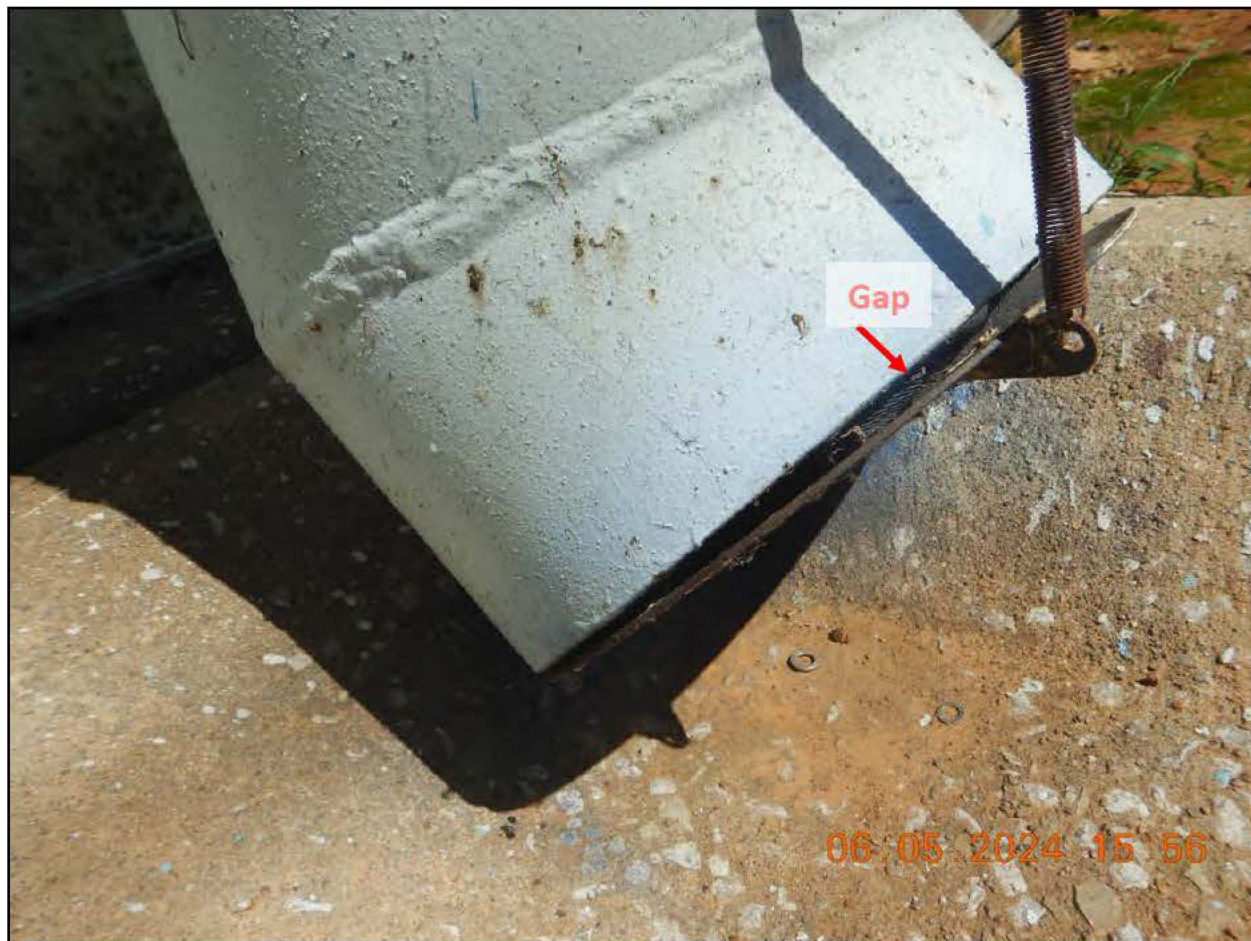
Photo No. 58

- d. The overflow pipe at the Range Water Tower was downturned and contained a mesh screen, but it was not equipped with a flex gate.
  - e. The flex gate at the end of the overflow line of the Washington and Liberty Tank was not seated properly (refer to [Appendix 1, Photograph 58](#)). There was an approximately 1-inch wide gap between the flapper and the pipe. There were animal/insect nests inside of the overflow pipe (refer to [Appendix 1, Photograph 59](#)). It appeared the mesh screen that was covering the end of the overflow pipe had ripped and fallen off.

- Area of Concern 22.** The following observations were made regarding splash pads beneath the terminus of overflow lines at water storage tanks in the distribution system:
- a. The overflow pipe for the Washington and Liberty Water Tower terminated approximately 2 inches above the concrete splash pad (refer to [Appendix 1, Photograph 58](#)).
  - b. There was no splash pad beneath the end of the overflow pipe at the Yost Water Tower (refer to [Appendix 1, Photograph 66](#)).

**Washington and Liberty Water Tower** View of the end of the overflow pipe for the Washington and Liberty Water Tower. The end of the pipe was approximately 2 inches above the concrete splash pad. Also visible in this image is the flex gate at the end of the overflow pipe that was not seated properly. There was an approximately 1-inch wide gap between the flex gate and the pipe. There were animal/insect nests inside of the overflow pipe.

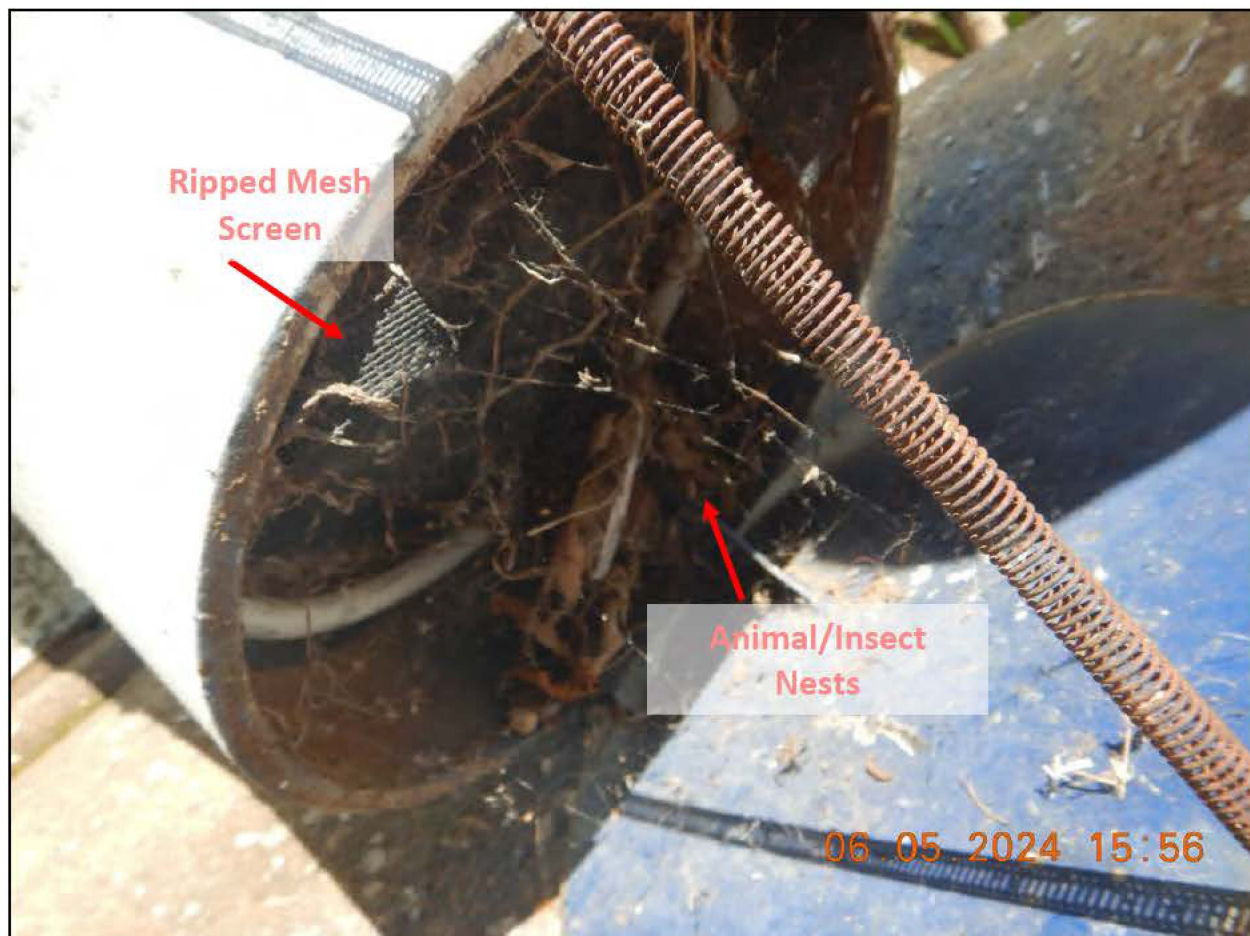
Photo No. 59

Washington and Liberty Water Tower View of the inside of the overflow pipe at the Washington and Liberty Tower. There were insect/animal nests inside of the pipe, and it appeared that the mesh screen had ripped and fallen off.

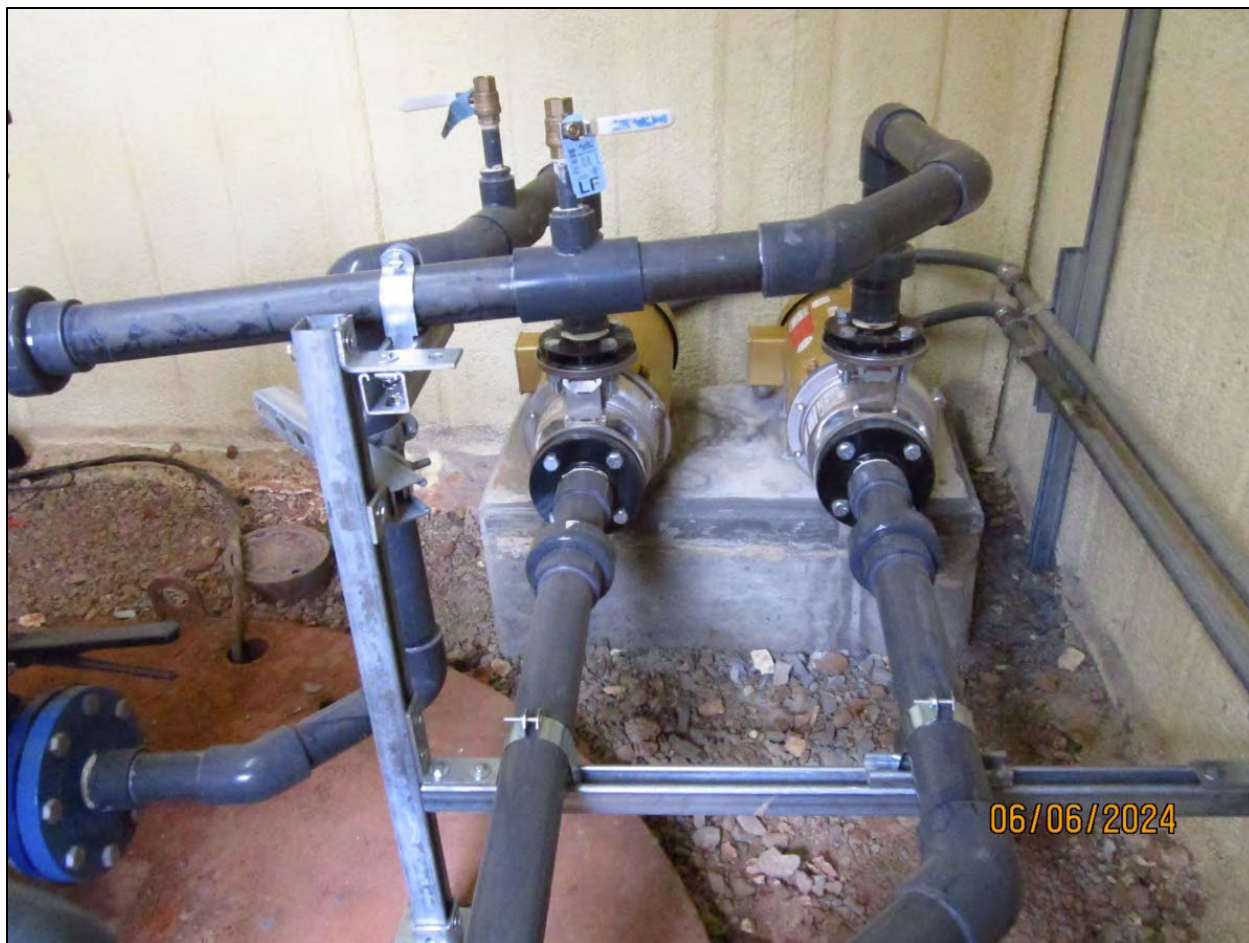
Photo No. 60

**Yost Pump Station** View inside of the Yost Pump Station vault. The pump lines lacked air relief ports and downturned exhaust lines.

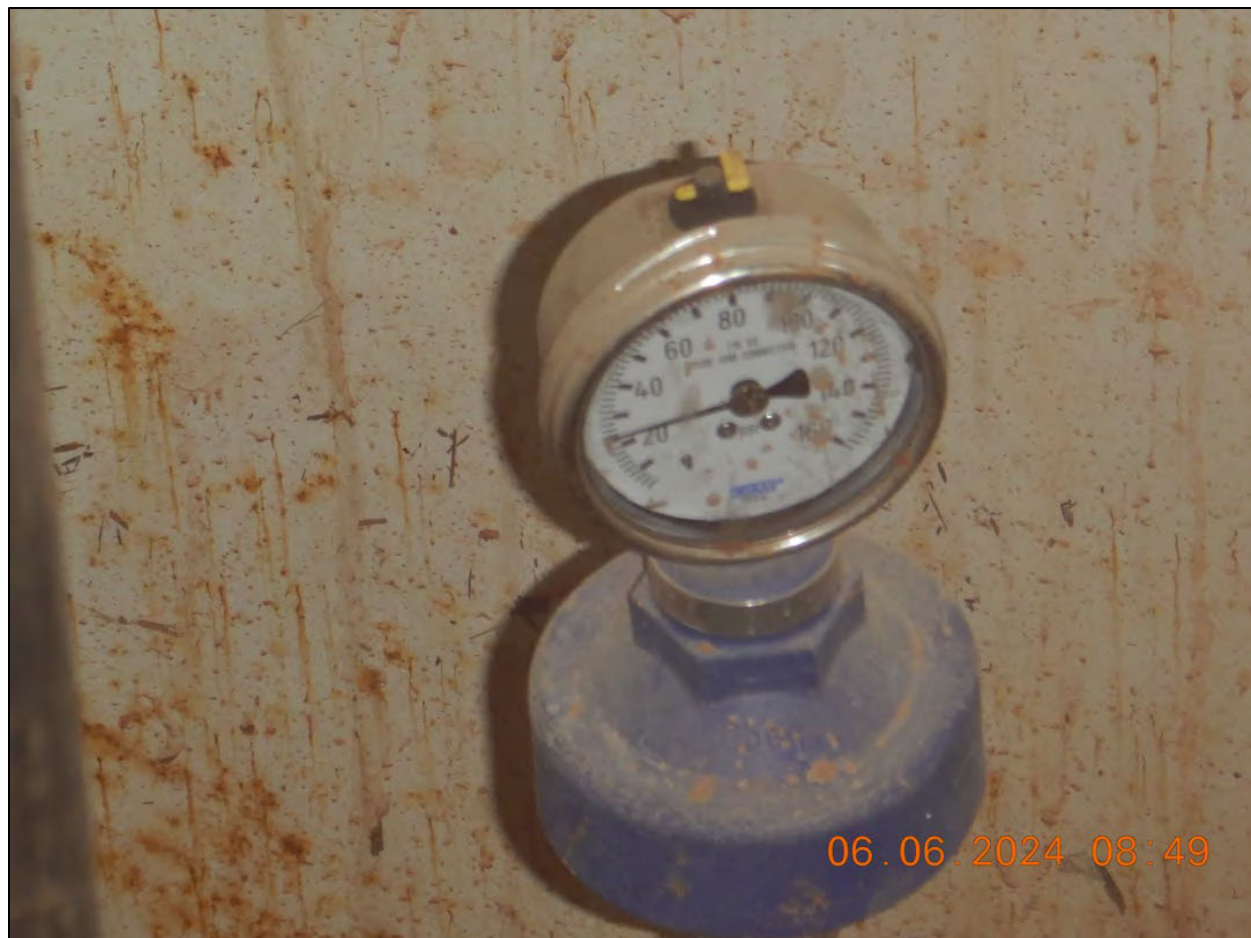
Photo No. 61

**Yost Pump Station** View of the suction side pressure gauge at the Yost Pump Station that was showing a pressure that appeared to be just below 25 psi (based on photographic imagery from outside the confined space of the vault).

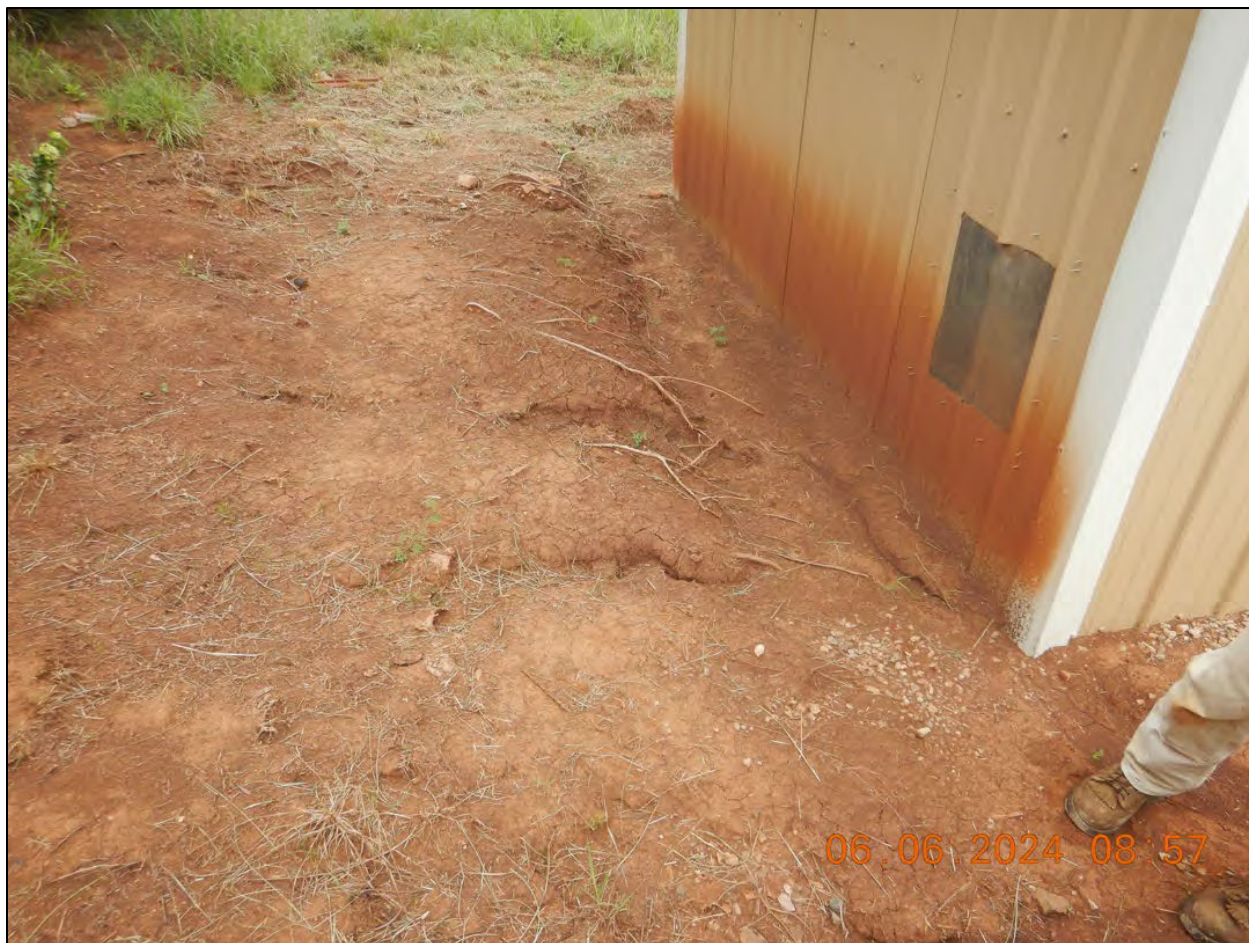
Photo No. 62

**Yost Pump Station** View of a hill slope behind the Yost Pump Station. It appeared that water flowed down the slope toward the pump station during rain events. There was erosion behind and next to the pump station.

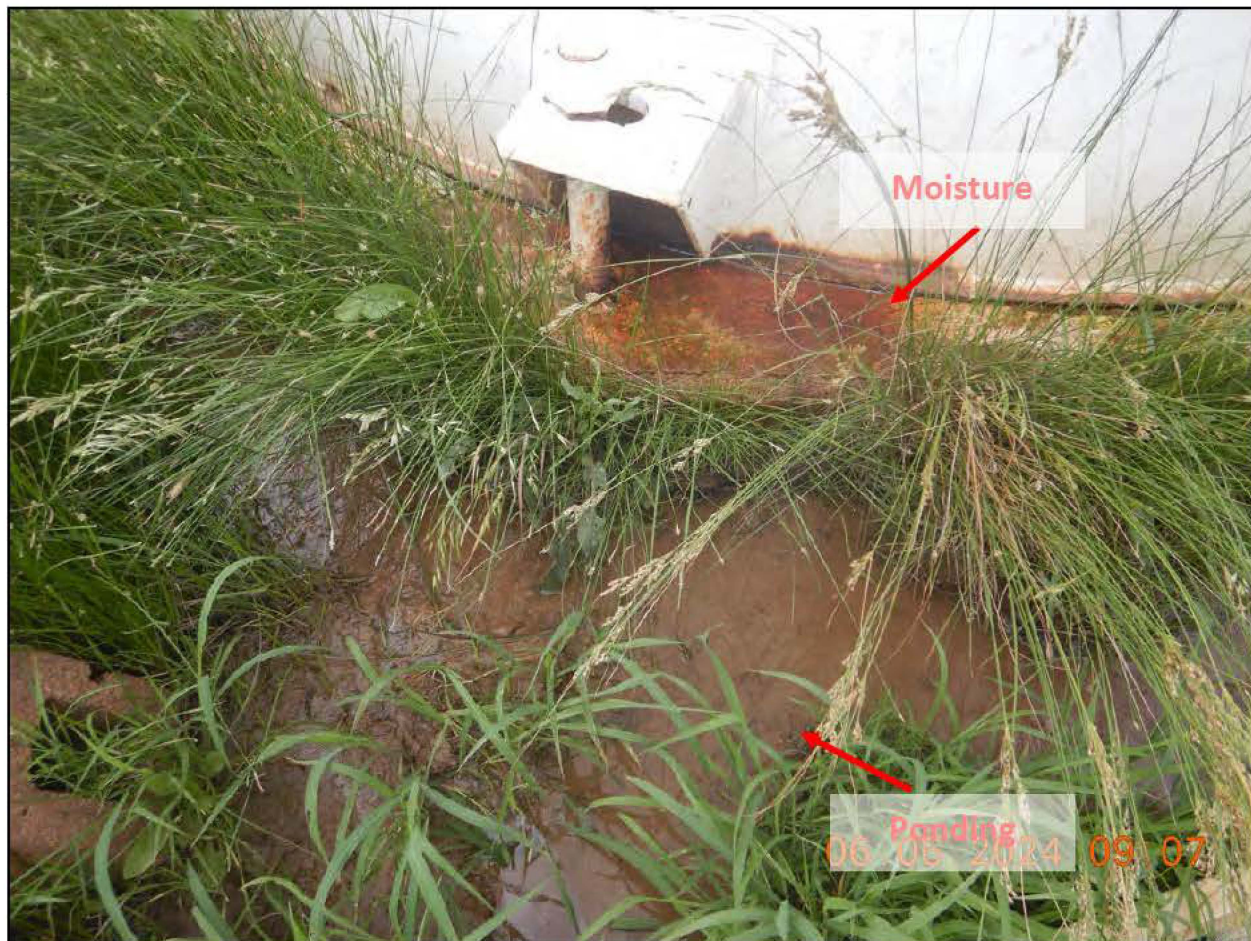
Photo No. 63

- Area of Concern 23.** The following observations were made regarding the sidewalls and bases of water storage tanks in the distribution system:
- a. There was moisture accumulating at the metal base of the Yost Water Tower and the concrete pad that the tank was sitting on (refer to [Appendix 1, Photographs 63 and 64](#)). It appeared that the tank was leaking from the base, but this was unable to be verified. The base of the tank lacked caulking or a seal.

**Yost Water Tower** View of moisture that was accumulating at the metal base of the Yost Water Tower and the concrete pad that the tank was sitting on. It appeared that the tank was leaking from the base plate, but this was unable to be verified. The base of the tank lacked caulking or a seal. Also visible in this image is ponding that was occurring around the tank foundation.

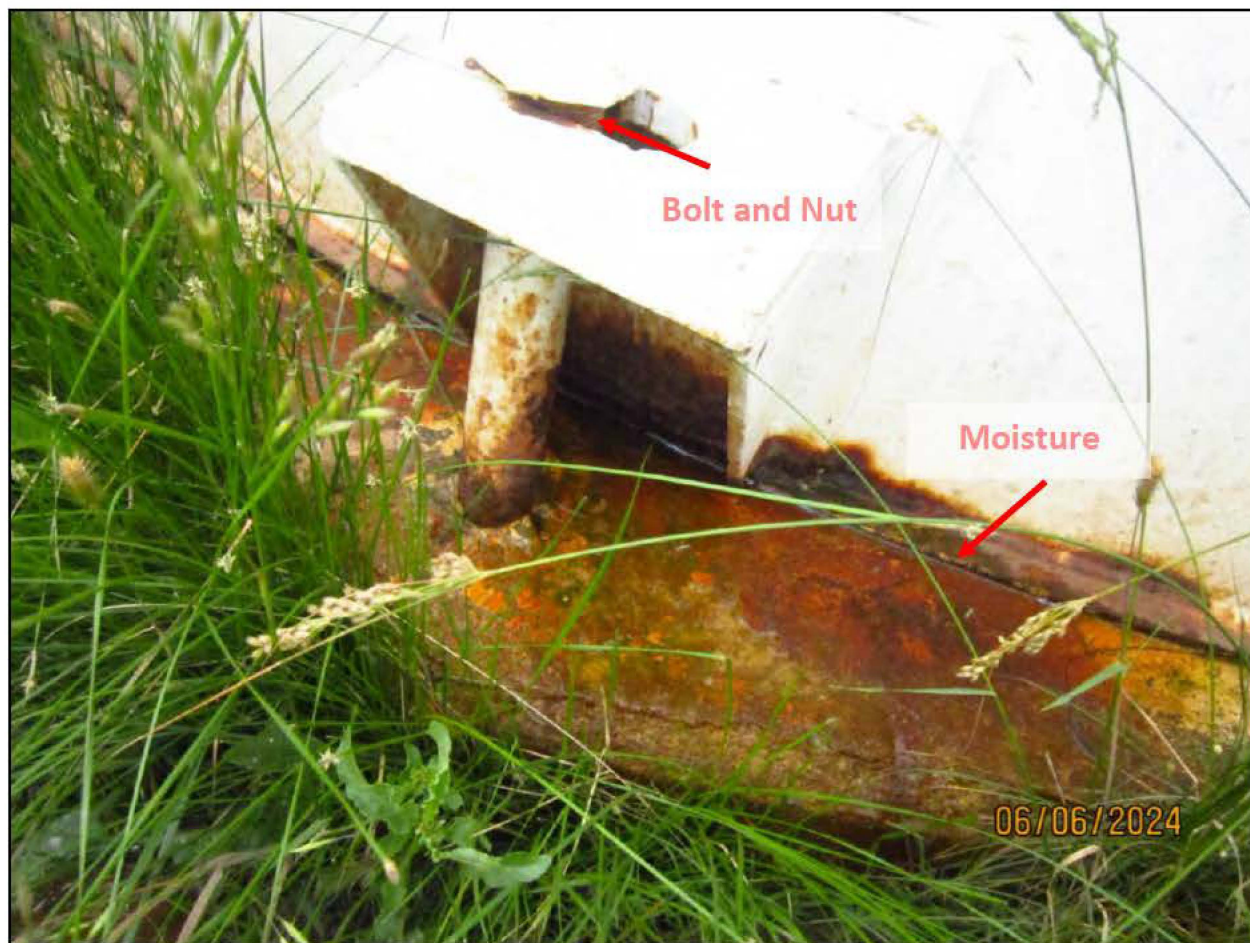
Photo No. 64

**Yost Water Tower** Close-up view of moisture that was accumulating at the bottom plate of the Yost Water Tower. Also visible in this image is a structural bolt and nut that did not appear to be properly seated on the tank anchor.

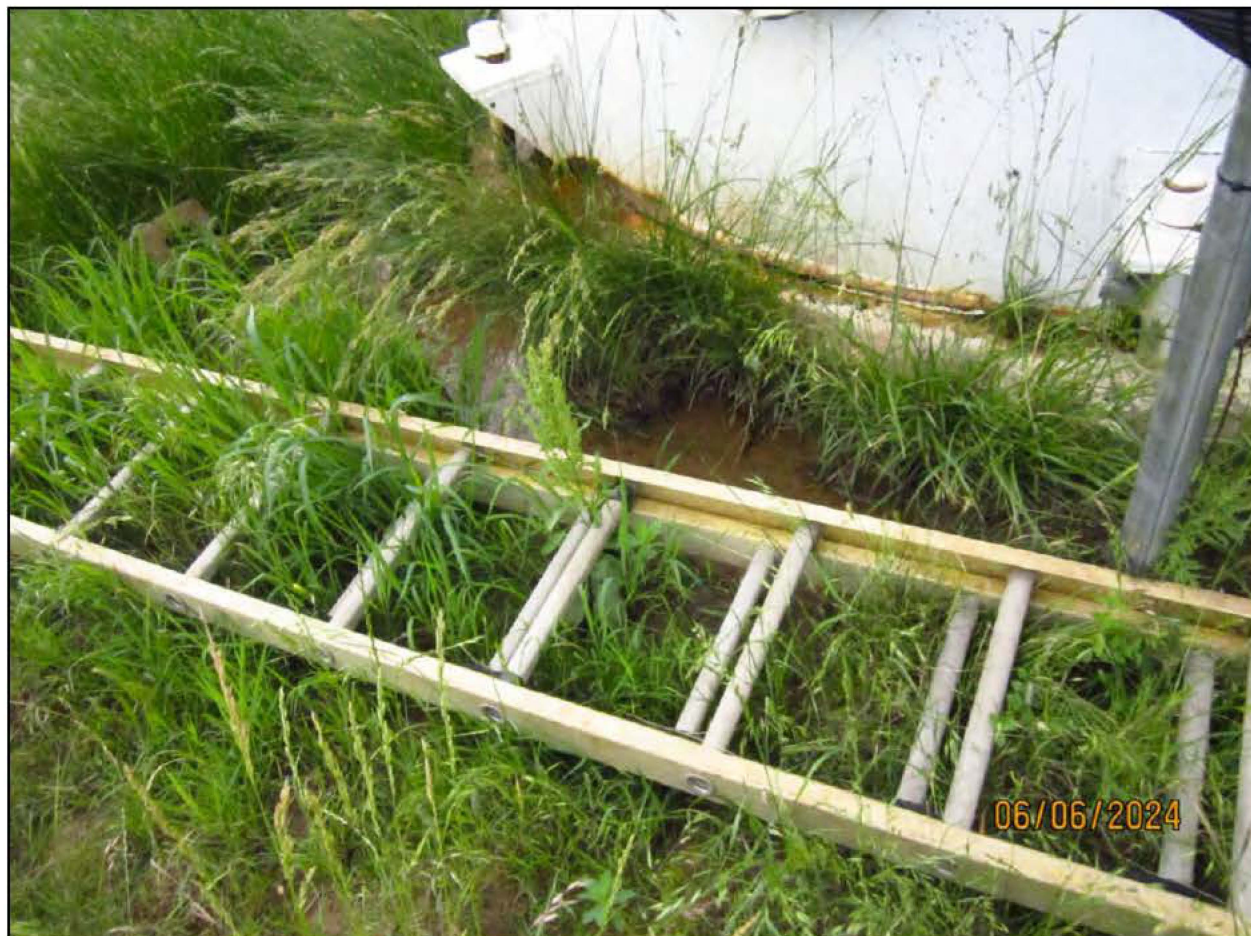
Photo No. 65

Yost Water Tower View of a ladder that was sitting on the ground next to the base of the Yost Water Tower. It was unknown what the ladder was used for.

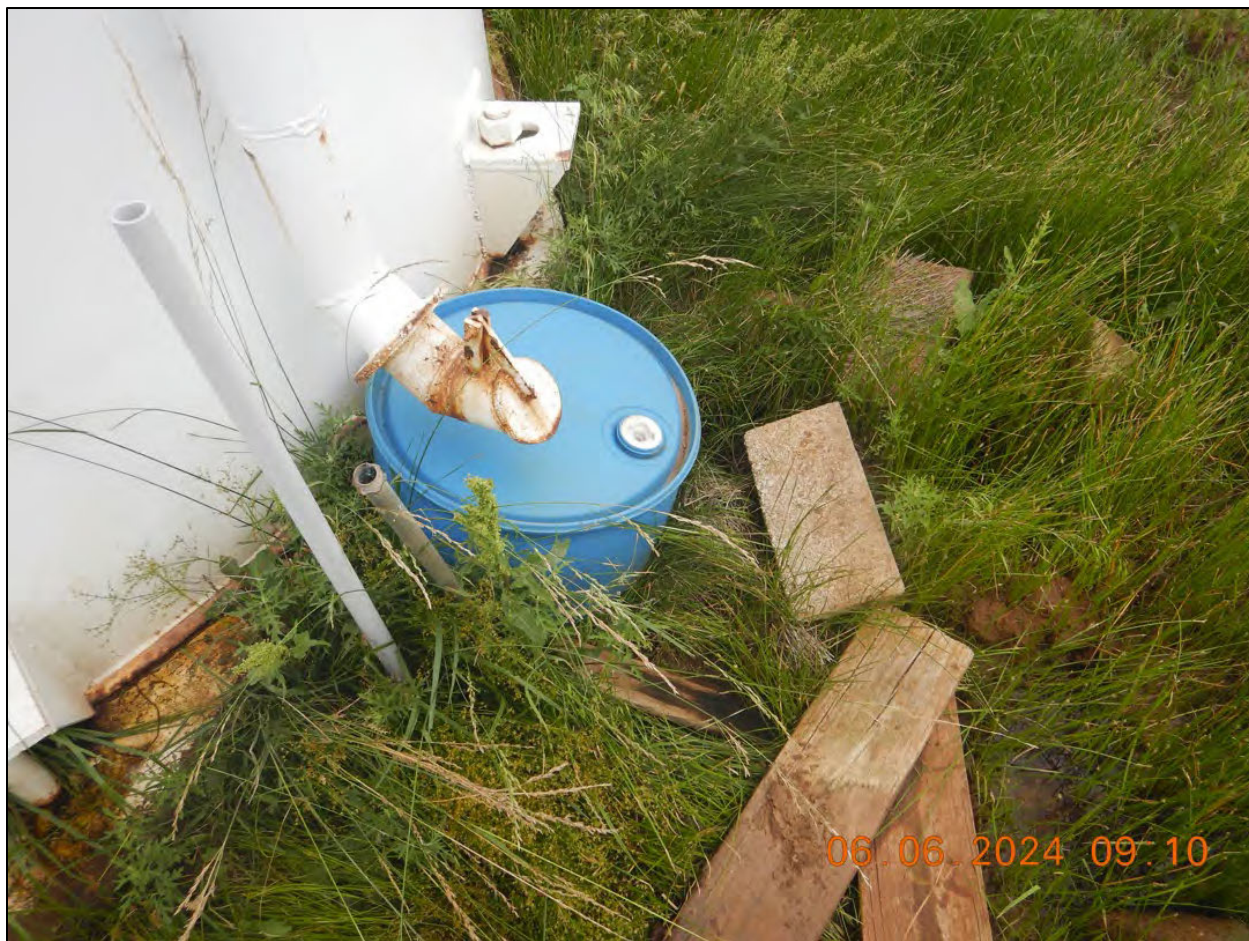
Photo No. 66

**Yost Water Tower** View of the terminus of the overflow pipe of the Yost Water Tower. There was no splash pad beneath the pipe, but the top of a plastic barrel had been placed under the pipe to protect the tank's discharge valve from cow's scratching activities.

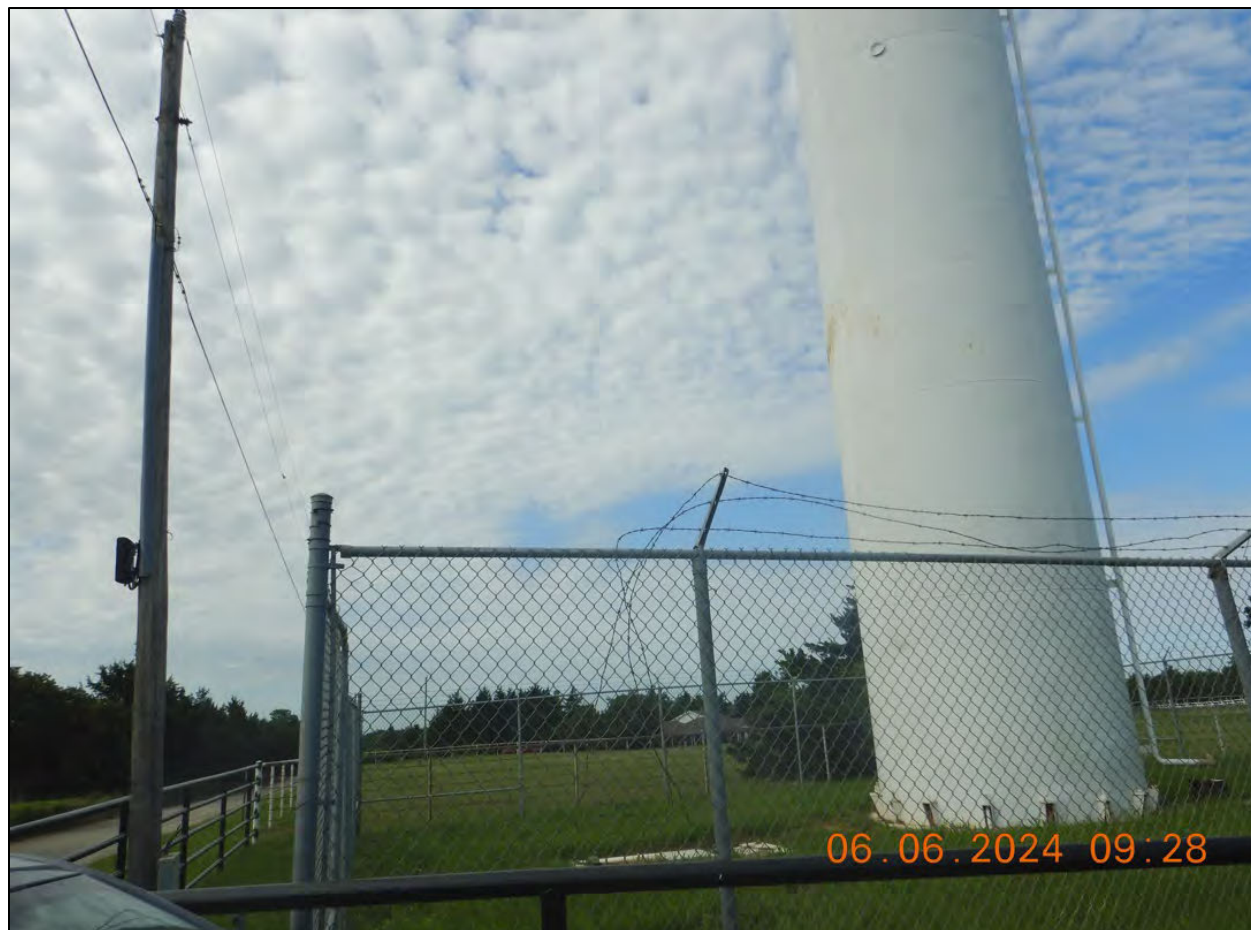
Photo No. 68

**Ricebeck Water Tower** View of the Ricebeck Water Tower and the perimeter fence that surrounded it. The tower lacked a local level indicator and was also not tied telemetrically to SCADA. The barbed wire at the top of the fence was damaged/missing in places. The water tower was offline during the inspection.

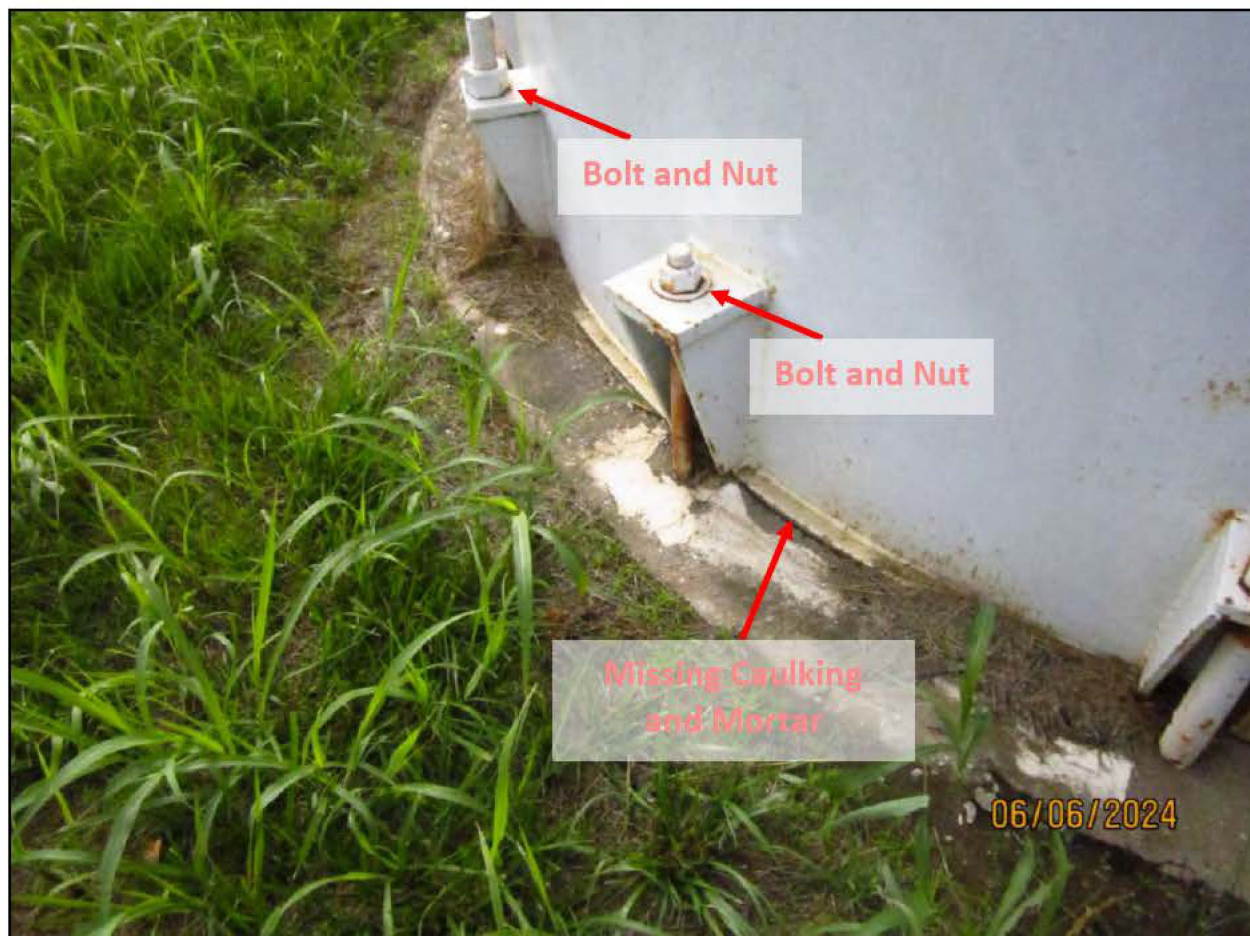
Photo No. 69

- c. Caulking was missing from the joint between the metal base of the Ricebeck Water Tower (offline) and the concrete pad it was sitting on (refer to [Appendix 1, Photograph 69](#)).

**Ricebeck Water Tower** View of the base of Ricebeck Tower. The ground was sloping toward the concrete foundation of the tank, and the concrete was level with the ground in some areas. Multiple structural bolts and nuts did not appear to be properly seated on the tank anchors. Caulking and mortar was also missing in some areas between the bottom plate of the tank and the concrete foundation. The water tower was offline during the inspection.

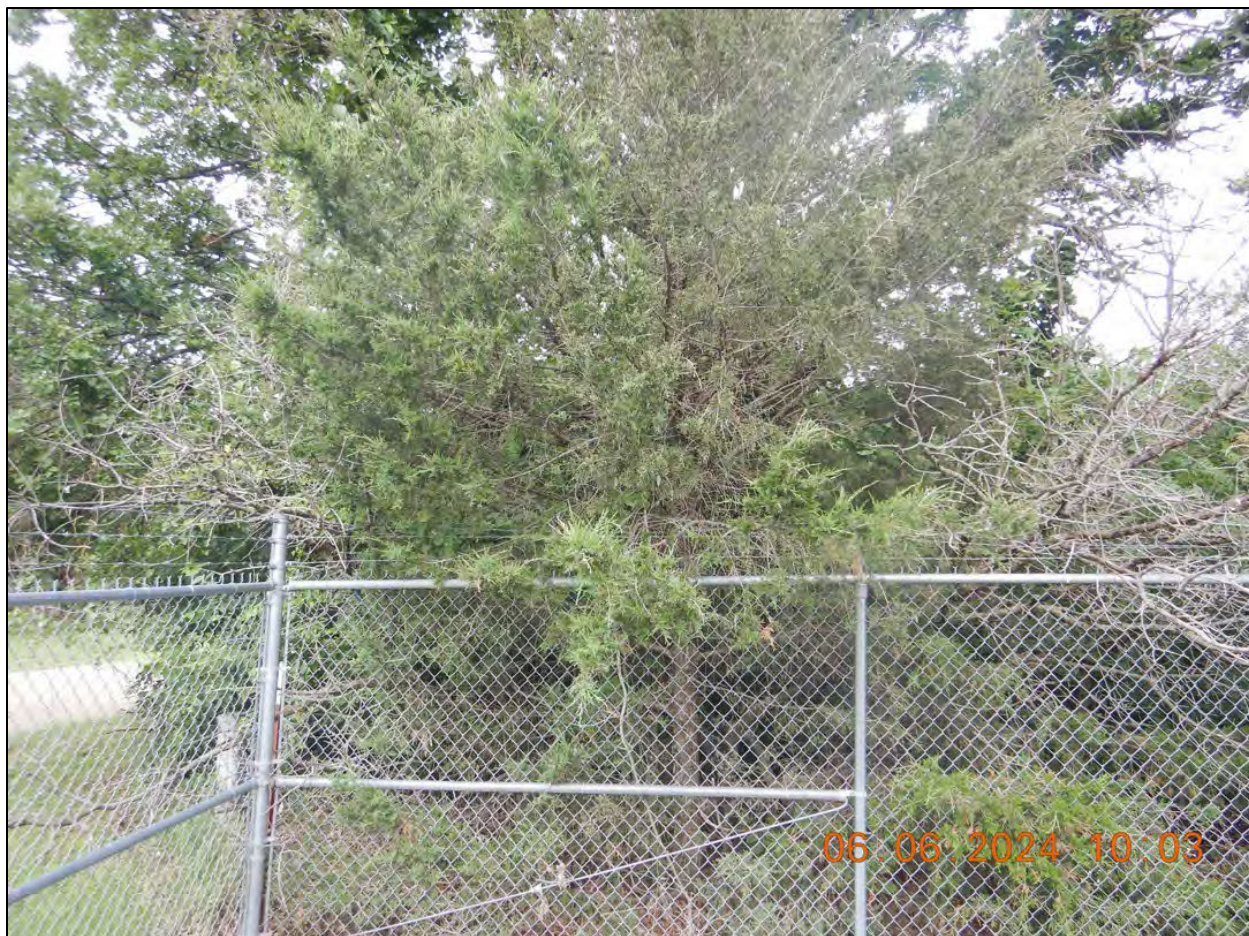
Photo No. 70

**Tan-Tara Water Tower** View of the vegetation that was growing on/over the perimeter security fence at the Tan-Tara Water Tower. The water tower was offline during the inspection.

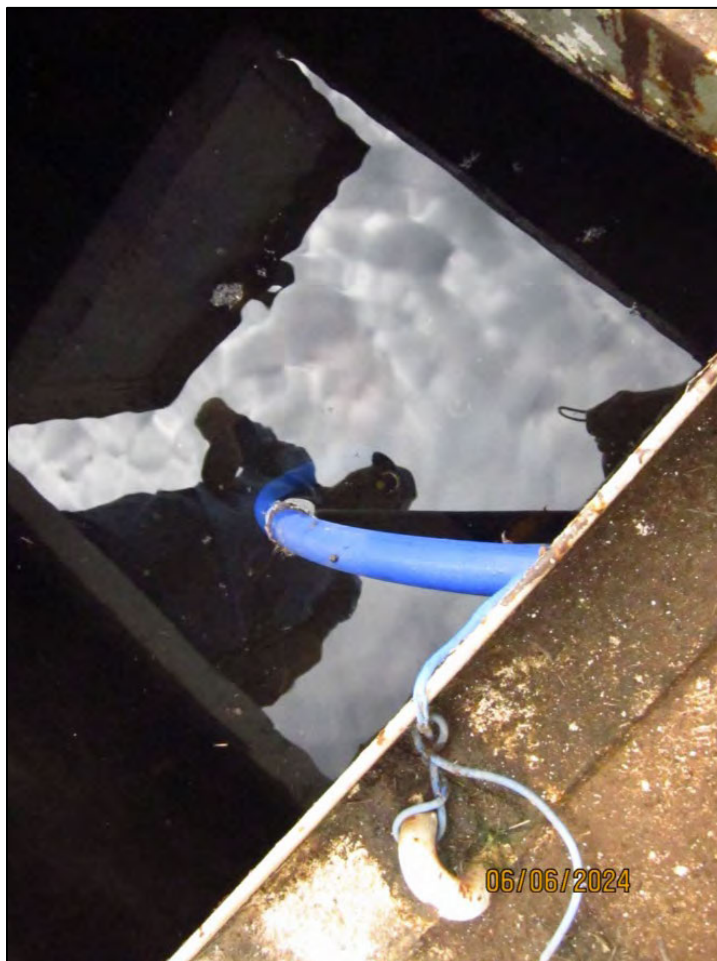
Photo No. 71

**Tan-Tara Water Tower** View of the meter vault that was positioned next to the Tan-Tara Water Tower. The vault was completely flooded during the inspection, submerging the assets inside of the vault. The water tower was offline during the inspection.

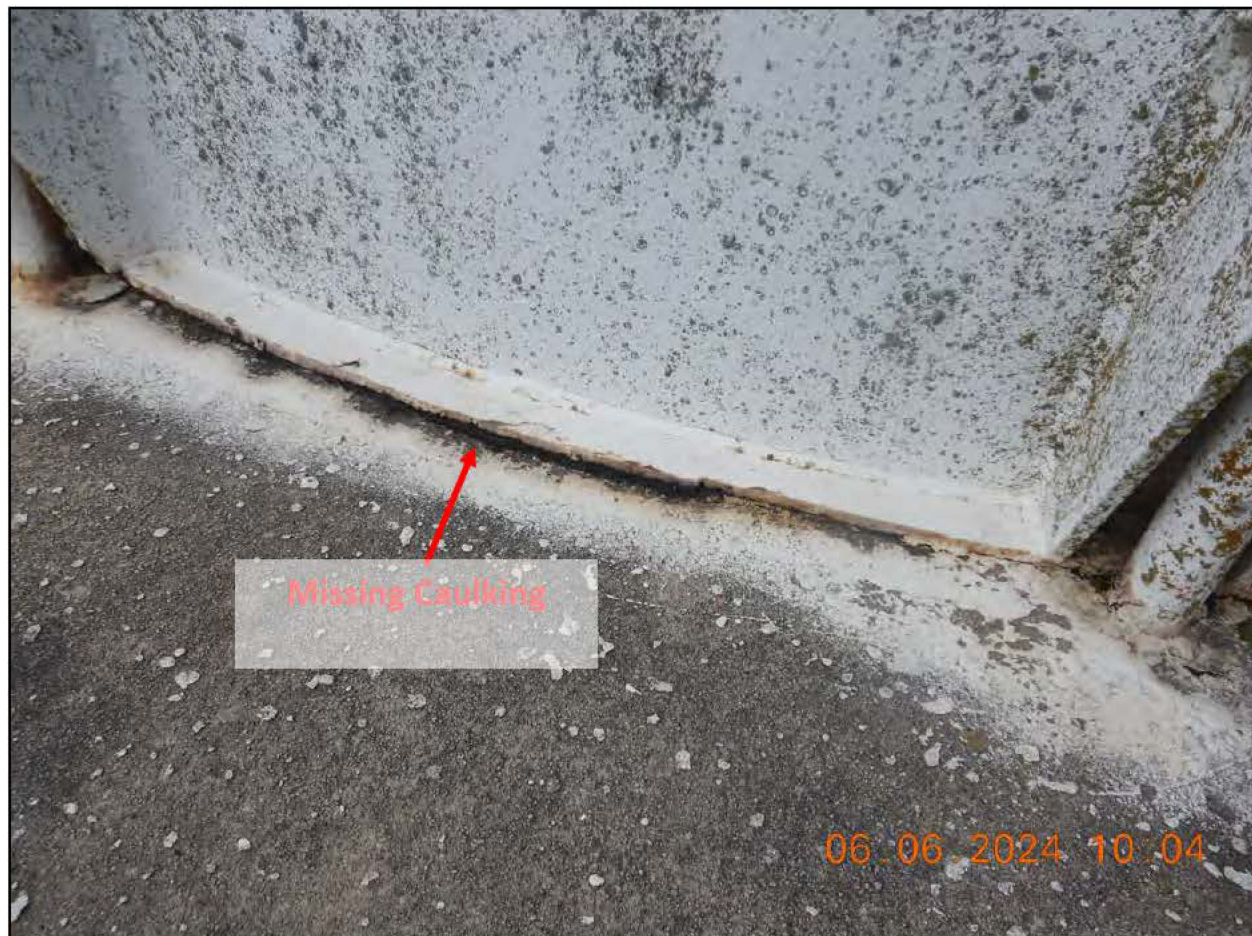
Photo No. 72

- d. Caulking was missing from the joint between the metal base of the Tan-Tara Water Tower (offline) and the concrete pad it was sitting on (refer to [Appendix 1, Photograph 72](#)).

**Tan-Tara Water Tower** View of the metal bottom plate of the Tan-Tara water tower. There was caulking missing between the bottom plate of the tank and the concrete foundation. The water tower was offline during the inspection.

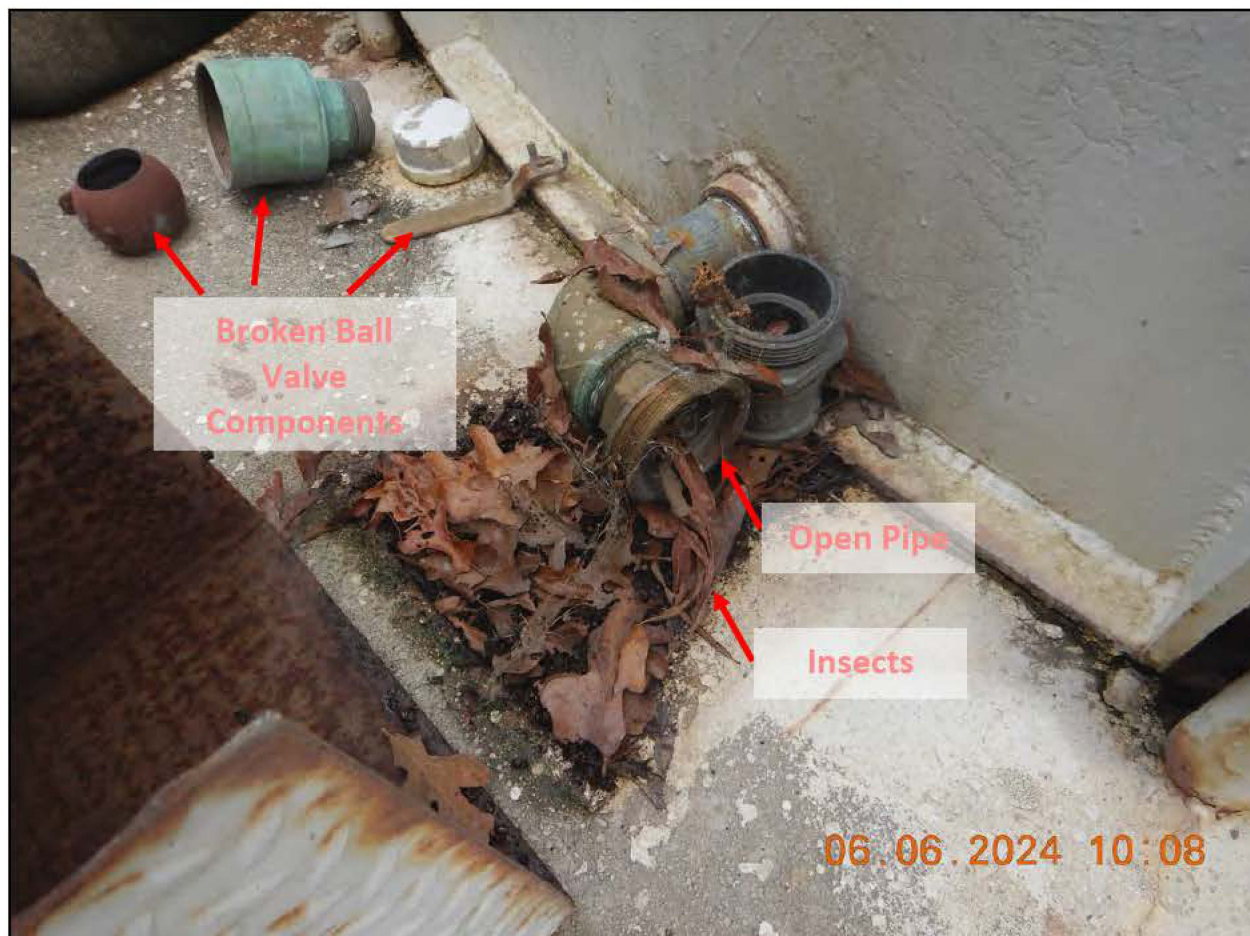
Photo No. 73

- e. There was an open pipe at the base of the Tan-Tara Water Tower (offline) that provided direct access into the tank (refer to [Appendix 1, Photograph 73](#)). A broken casing and ball valve were sitting next to the open pipe. Insects were observed crawling around and into the pipe.

Tan-Tara Water Tower View of an open pipe that provided direct access into the water tower. A broken ball valve (three components) were sitting next to the open pipe. Insects were observed crawling around and into the pipe. The water tower was offline during the inspection.

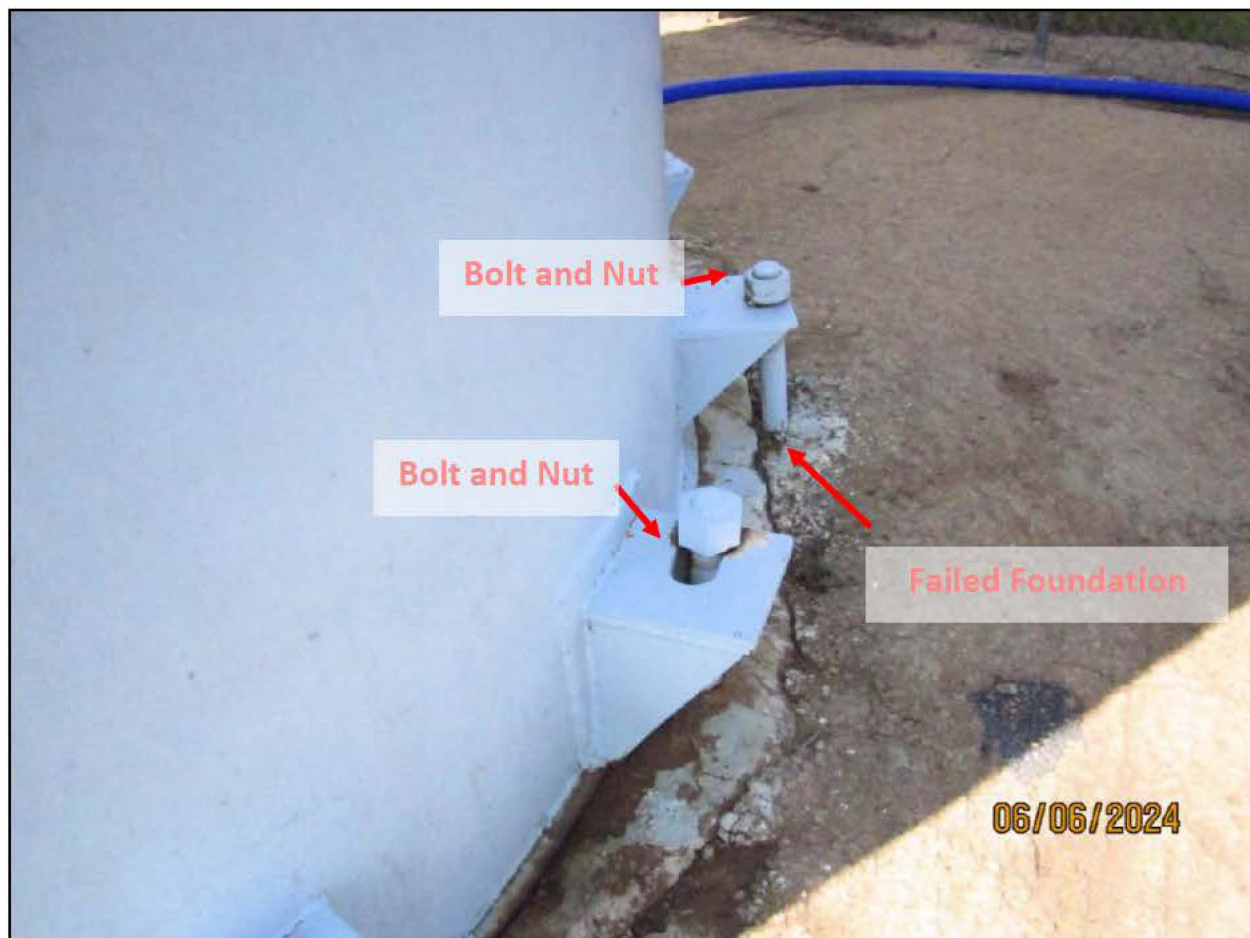
Photo No. 74

- f. Caulking was missing from the joint between the metal base of the Coyle Water Tower (offline) and the concrete pad it was sitting on (refer to [Appendix 1, Photograph 74](#)).

**Coyle Water Tower** View of the Coyle Water Tower base. Multiple structural bolts and nuts did not appear to be properly seated on the tank anchors. Caulking and mortar was also missing in some areas between the bottom plate of the tank and the concrete foundation. The water tower was offline during the inspection.

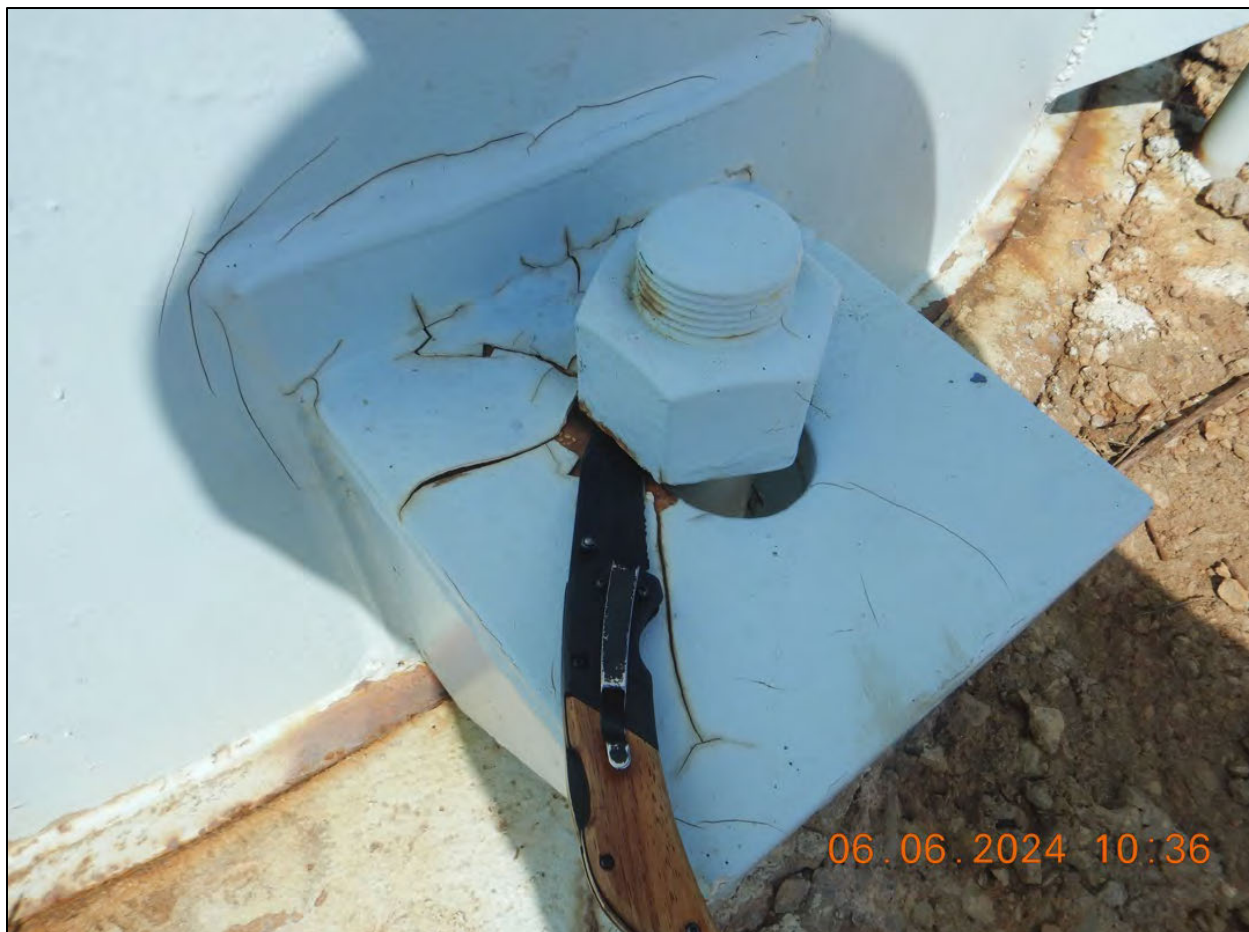
Photo No. 75

**Coyle Water Tower** Close-up view of one of the structural bolts and nuts that did not appear to be properly torqued down. There was also some corrosion/chipping paint around the tank anchor. The water tower was offline during the inspection.

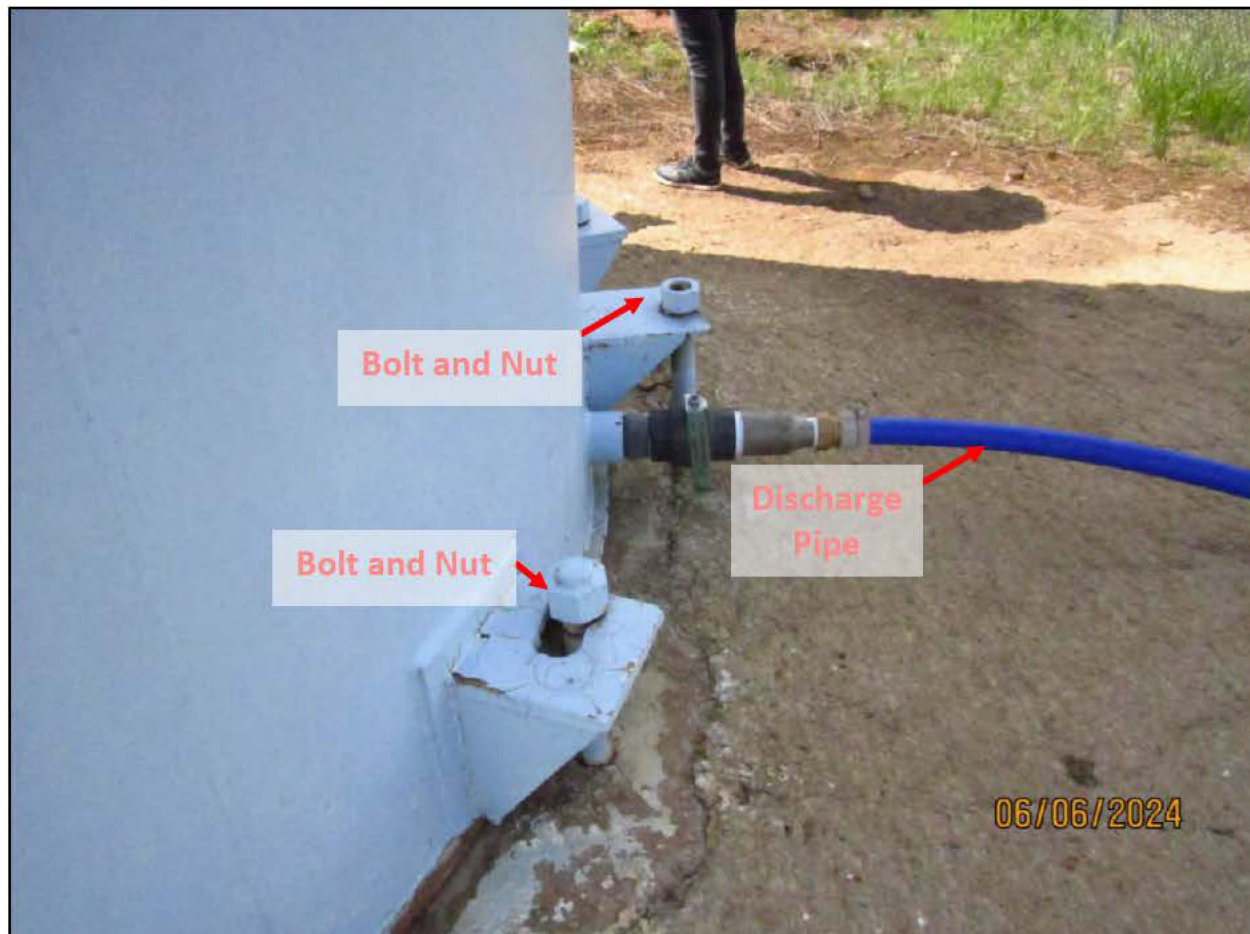
Photo No. 76

**Coyle Water Tower** View of a temporary discharge pipe that was attached to the tank, as well as additional bolts and anchors that were not seated properly. The water tower was offline during the inspection.
