**Region 6 - Enforcement & Compliance Assurance Division**  
**INSPECTION REPORT**

| <b>Inspection Date(s):</b> | 06/04/2024 through 06/06/2024 | |
| <b>System Name:</b> | City of Stillwater Public Water System (PWS) | |
| <b>PWS ID:</b> | OK1021220 | |

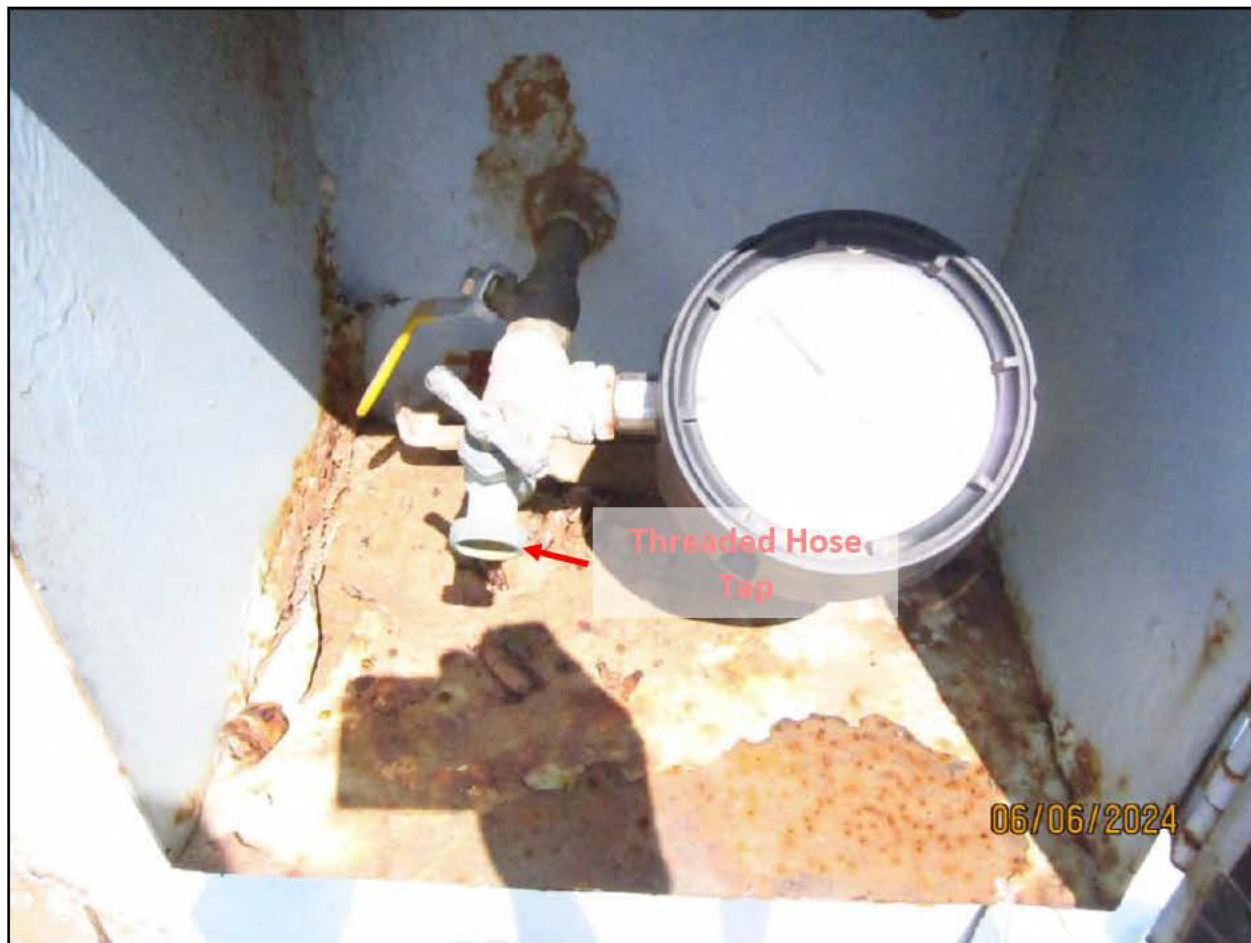
Photo No. 77

Coyle Water Tower View of a threaded hose tap without backflow prevention that was present at the Coyle Water Tower. The water tower was offline during the inspection.

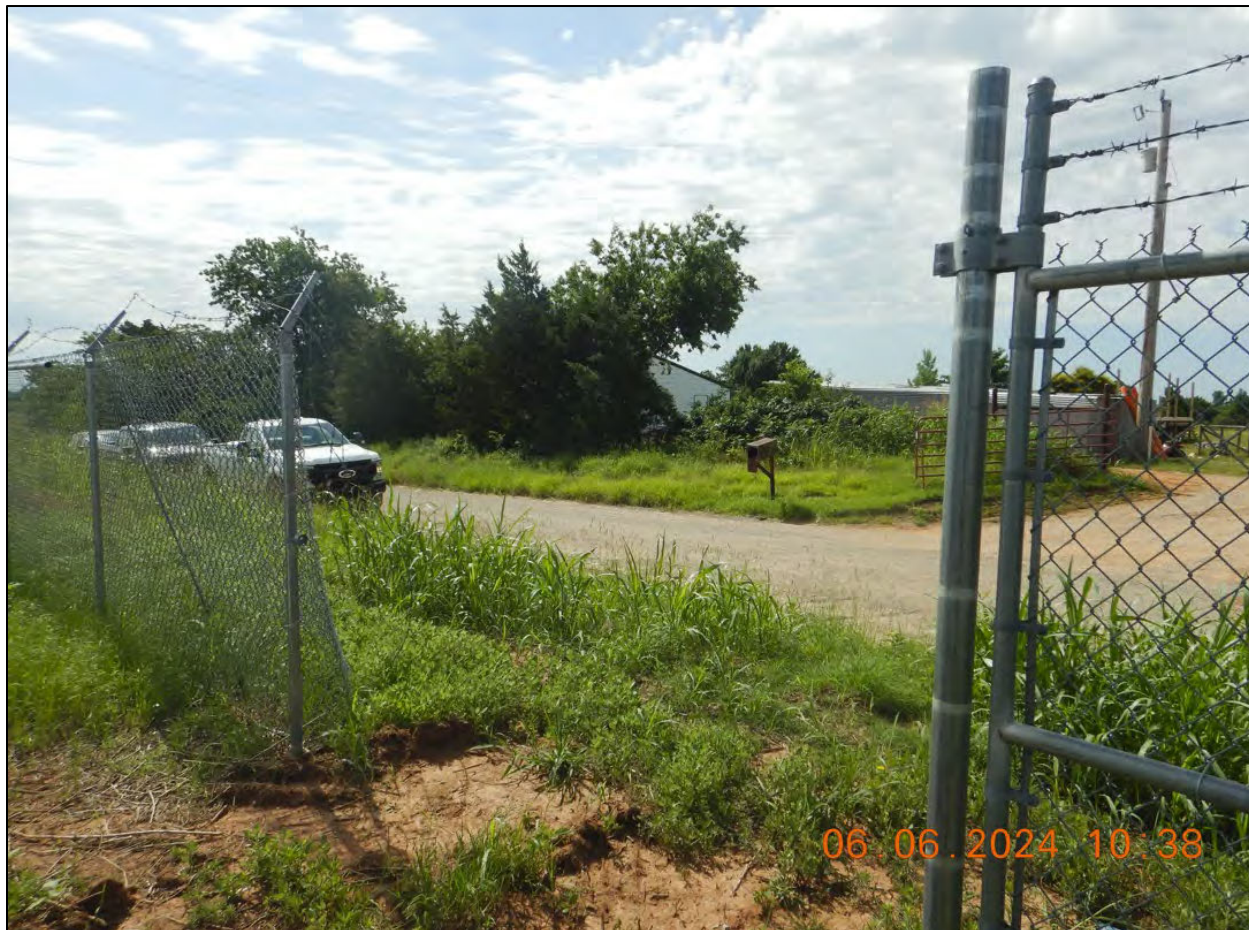
Photo No. 78

**Coyle Water Tower** View of the damaged/missing perimeter fence surrounding the Coyle Water Tower. Parts of the fence had been removed due to ongoing construction that was occurring at the Water Tower. The water tower was offline during the inspection.

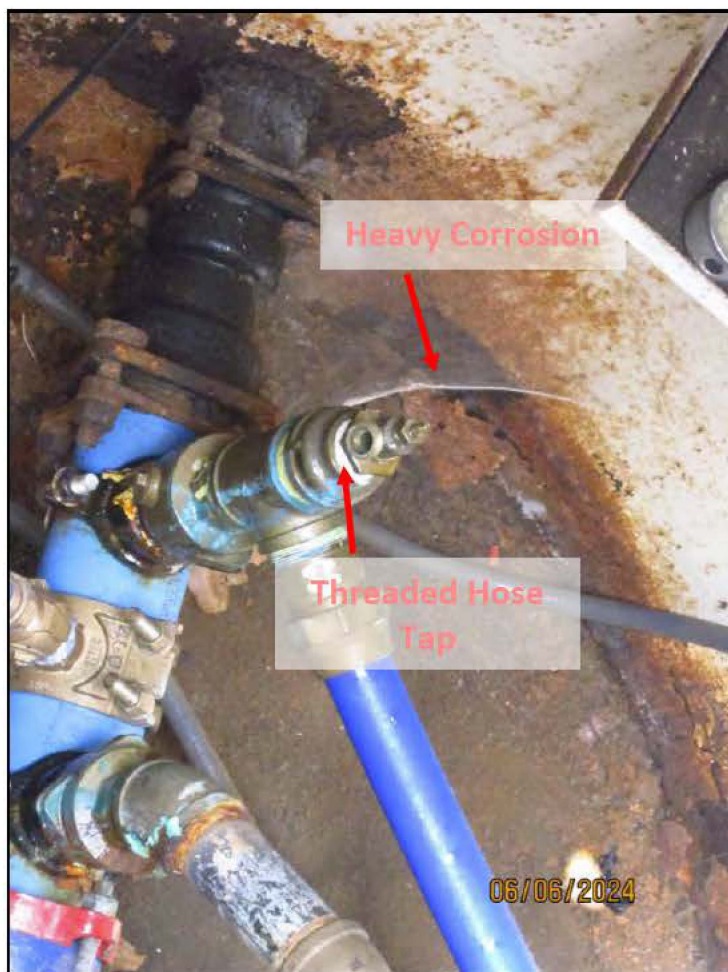
Photo No. 79

**Karsten Creek Pump Station** View of a threaded hose tap without backflow prevention that was present at the Karsten Creek pump station. Also visible in this image is heavy corrosion at the base of the vault, causing the potential for structural failures and flooding of equipment.

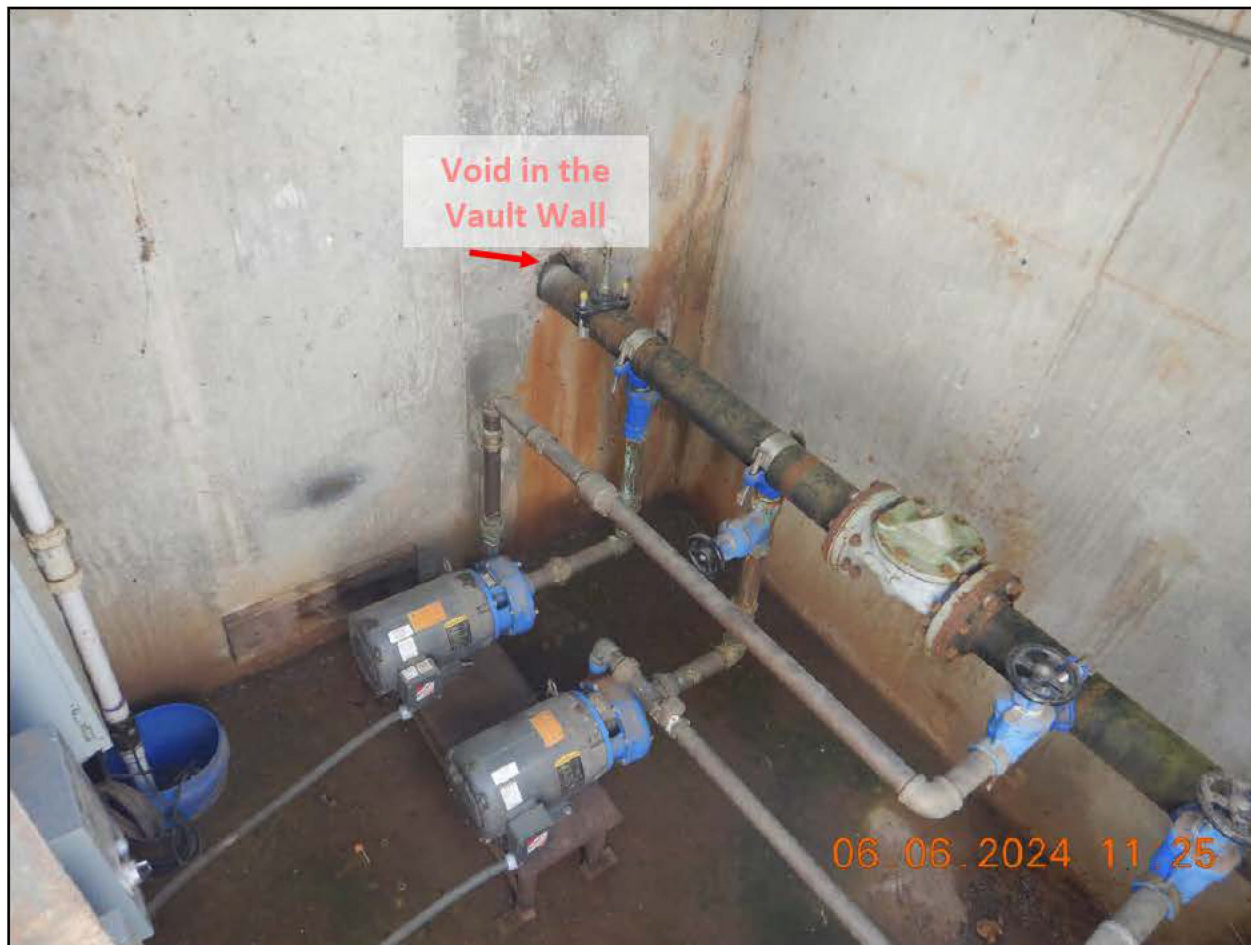
Photo No. 80

**Hilltop Pump Station** View of the inside of the Hilltop Pump Station vault. There were voids in the concrete walls surrounding the pump line. The voids created a possible entry point for water into the pump station vault, and the electric motors for the pumps were positioned near the base of the vault. The pump station was offline.

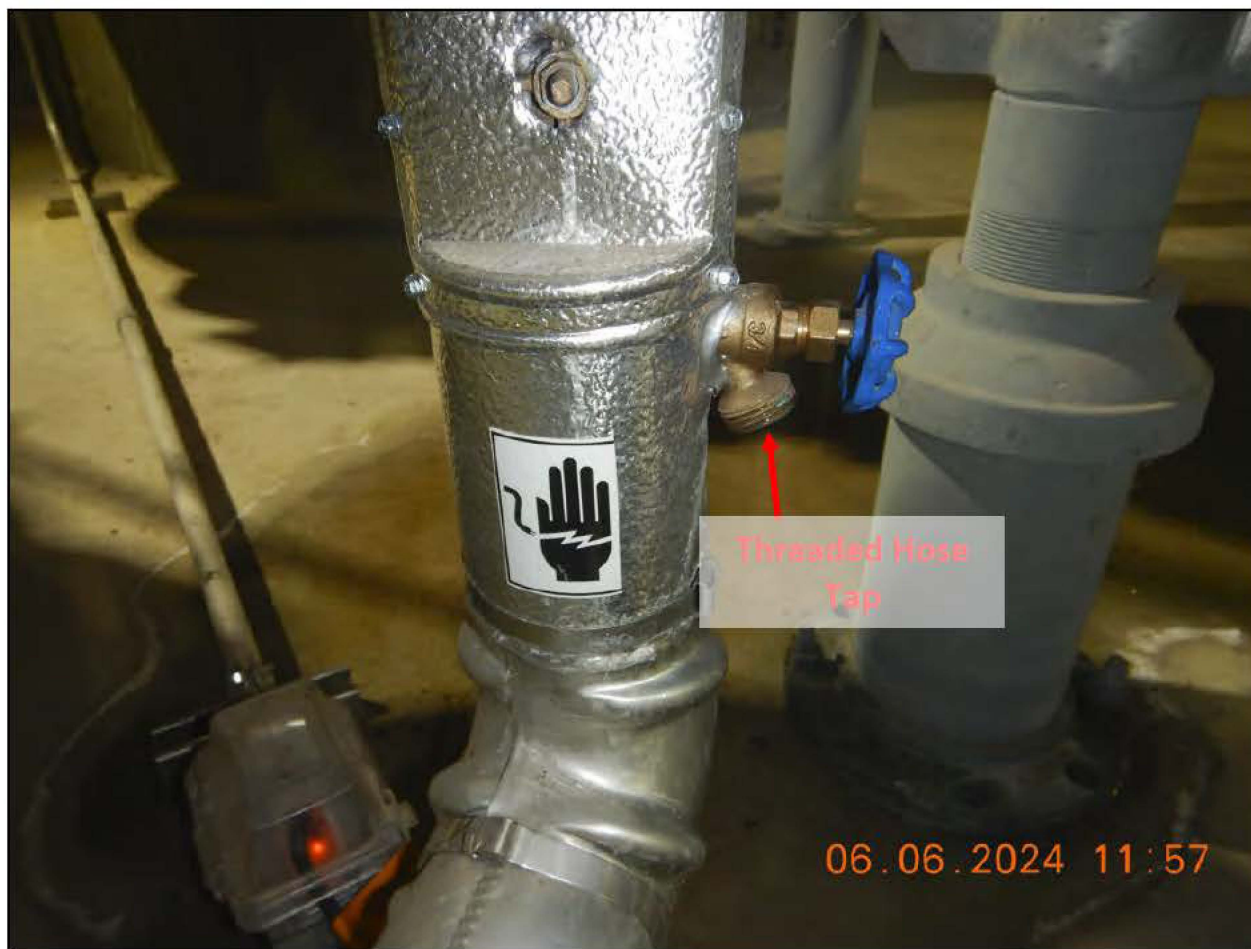
Photo No. 81

Central Water Tower View of a threaded hose tap without backflow prevention inside of the Central Water Tower.

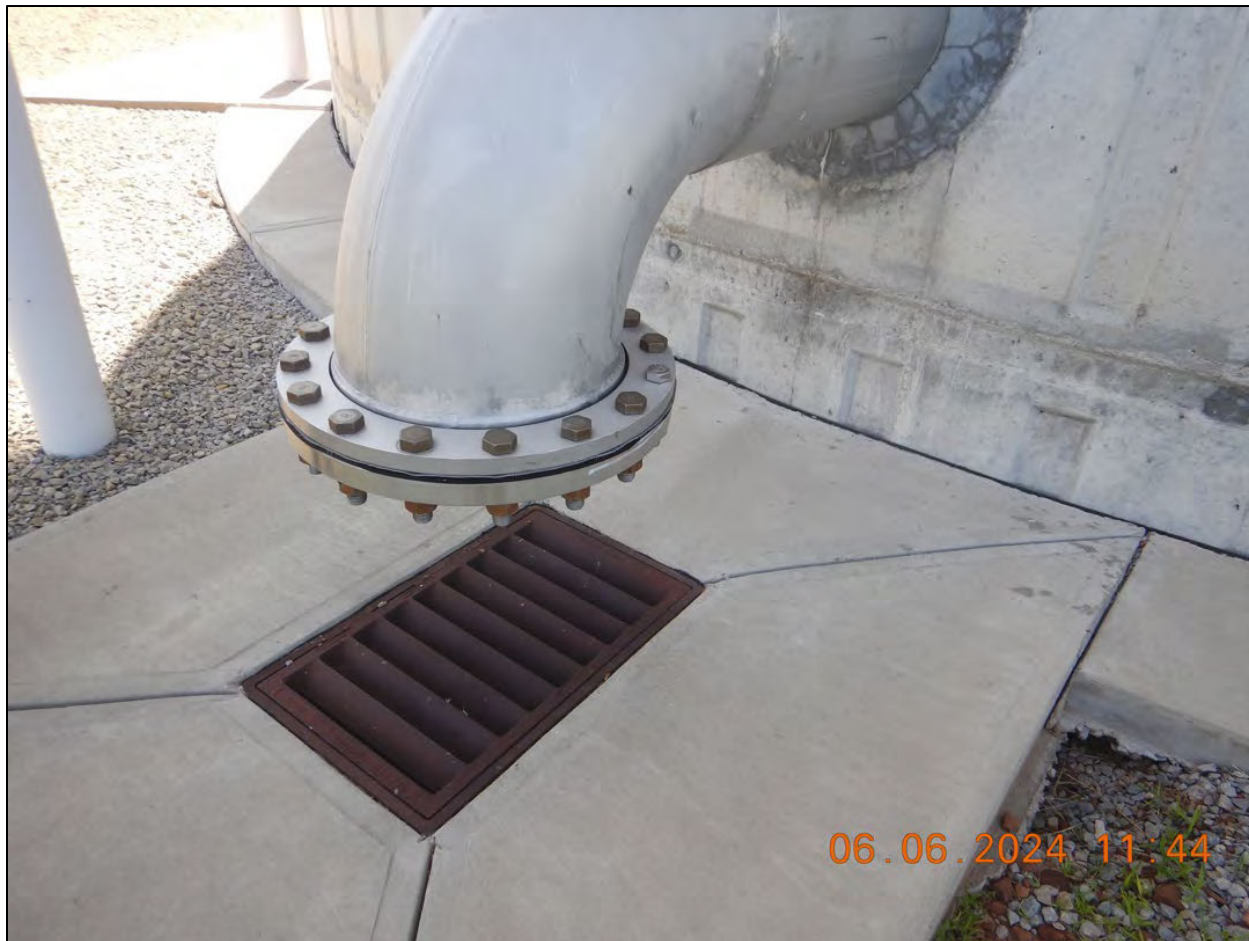
Photo No. 82

- f. The overflow pipe at the Central Water Tower was downturned and contained a mesh screen, but it was not equipped with a flex gate (refer to [Appendix 1, Photograph 82](#)).

**Central Water Tower** View of the end of the overflow pipe extending from the Central Water Tower. The pipe was downturned and contained a mesh screen but was missing a flex gate.

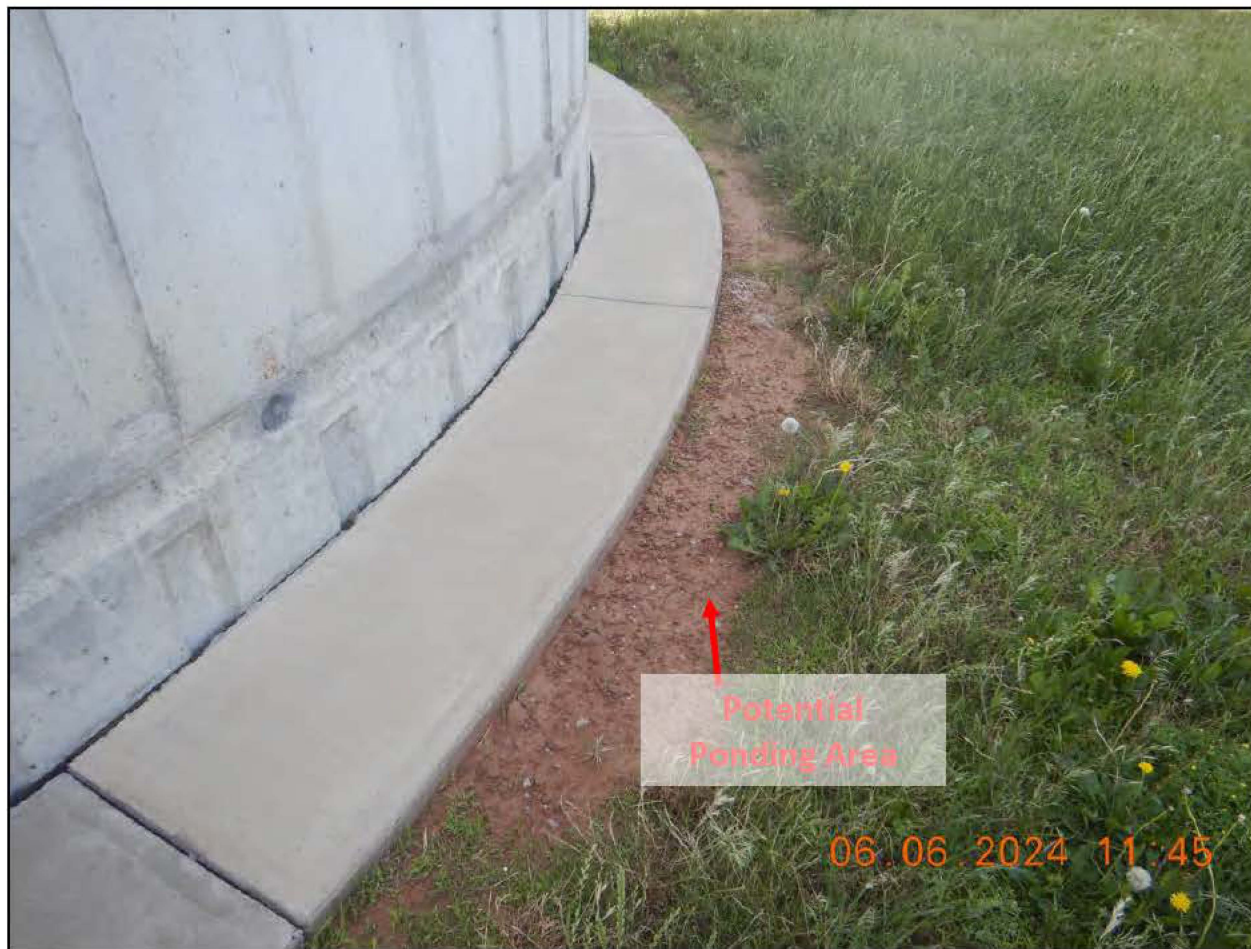
Photo No. 83

- a. There was water pooling on the concrete drainage pad next to the North Perkins Water Tower, and it appeared that the concrete had settled so that it was sloped toward the tank (refer to [Appendix 1, Photograph 17](#)).
- b. Ponding of water was occurring near the base of the Third and Stallard Water Tower (refer to [Appendix 1, Photograph 22](#)). Water was also pooling in the concrete drainage pad next to the tower (refer to [Appendix 1, Photograph 23](#)).
- c. Ponding water was observed near the base of the Yost Water Tower (refer to [Appendix 1, Photograph 63](#)).
- d. The ground surrounding the base of the Ricebeck Water Tower (offline) was sloped toward the tower (refer to [Appendix 1, Photograph 69](#)).
- e. The ground surrounding the base of the tower was sloped toward the Central Water Tower in areas (refer to [Appendix 1, Photograph 83](#)).

Photograph 83. 6/6/2024 11:45 AM DSCN1000.JPG

**Central Water Tower** View of the ground at the base of the Central Water Tower. The ground sloped toward the concrete foundation of the tank in areas, and it appeared that ponding would occur in the area next to the concrete foundation.
