**Region 6 - Enforcement & Compliance Assurance Division**  
**INSPECTION REPORT**

| Regulatory Program(s) | NPDES CAFO | |
| Company Name: | Van Der Jagt Dairy | |

## **Section I – INTRODUCTION**

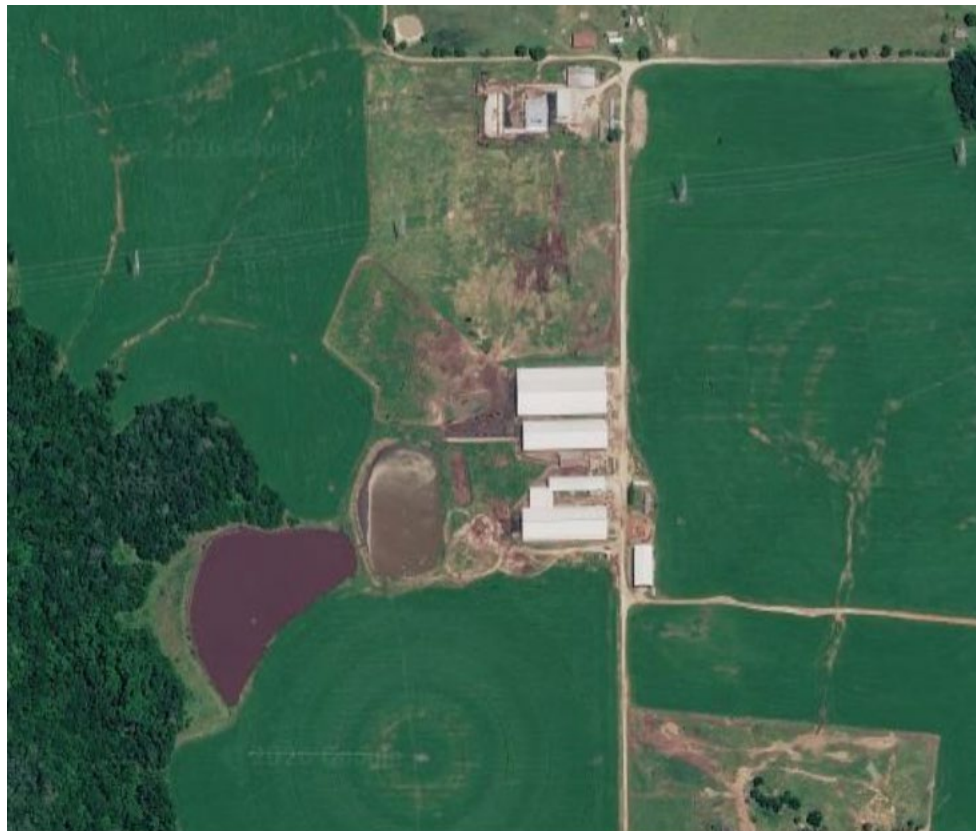
Photo No. 1

There are three settling basins, one solid separating screen, and two wastewater lagoons located in the production area. The solid separating screen is directly west of the freestalls (Appendix 1, Photo 1). Two concrete lined settling basins follow the screen (Appendix 1, Photo 9). The third settling basin is earthen lined and is west of the freestalls directly before RCS 1 (Appendix 1, Photo 8). RCS (Retention Control Structure) 1 and RCS 2 are located west of the freestalls (Appendix 1, Photos 2 & 6). The facility has 6 LMUs (Land Management Unit): 1 - 56 acres, 2 - 53 acres, 3 - 32 acres, 4 - 56 acres, 5 - 22 acres, 6 - 34 acres. The facility plants coastal Bermudagrass and SG for hay and silage. Wastewater and manure can be applied to all LMUs using center pivots and draghose.

All the RCSs for the facility are designed to receive the production area wastewater runoff done by Jerry Kendall on 06-15-17. RCS 1 required capacity is 17.5 acre/ft with actual capacity of 18.0 acre/ft, RCS 2 required capacity is 33.5 acre/ft with actual capacity of 33.5 acre/ft. All the RCSs have a permeability rating greater than  $1 \times 10^{-7}$ . There were no signs of erosion in the embankments and cattle are unable to access the lagoons. All pole markers showed adequate freeboard and are below the 25-yr/24-hr rain event mark. The facility uses gravity flow to route all runoff to RCS (Appendix 1, Photos 1, 3, 4, & 7).

Photo 1: Aerial photo, sourced from Google Earth, depicting the facility and surrounding areas.
