## Region 6 - Enforcement & Compliance Assurance Division

### INSPECTION REPORT

| <b>System Owner:</b> | City of Sherman | |
| <b>System Name:</b> | City of Sherman Public Water System (PWS) | |

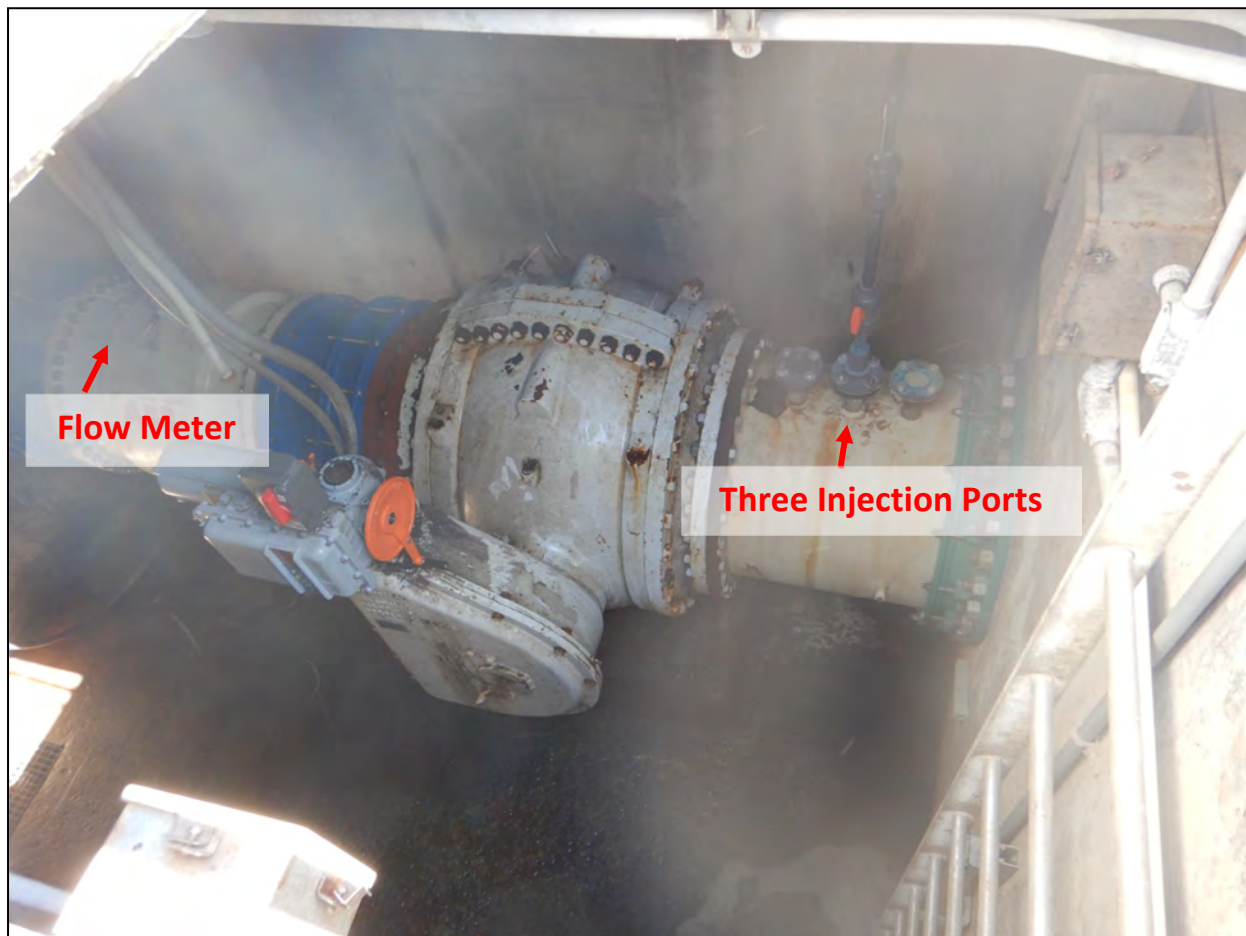
Photo No. 1

- a. There were three chemical injection ports into the raw water influent line, and the only port that had a chemical line attached to it (the copper sulfate line) was unlabeled.
- b. Water was leaking into the conventional plant pre-sedimentation basin at a rate of approximately a few gallons per minute on the first day of the inspection even though the influent gate valve leading to the basin was supposed to be closed, indicating a lack of

**Photograph 1. 2/13/2024 12:53 PM DSCN9214.JPG**

**Conventional Plant, Raw Water Meter Vault** View of the raw water influent line inside the raw water meter vault. There were three injection ports present on the line but only one had a chemical line attached to it (copper sulfate). The other two injection lines had been disconnected. The injection ports were downstream of the flow meter.

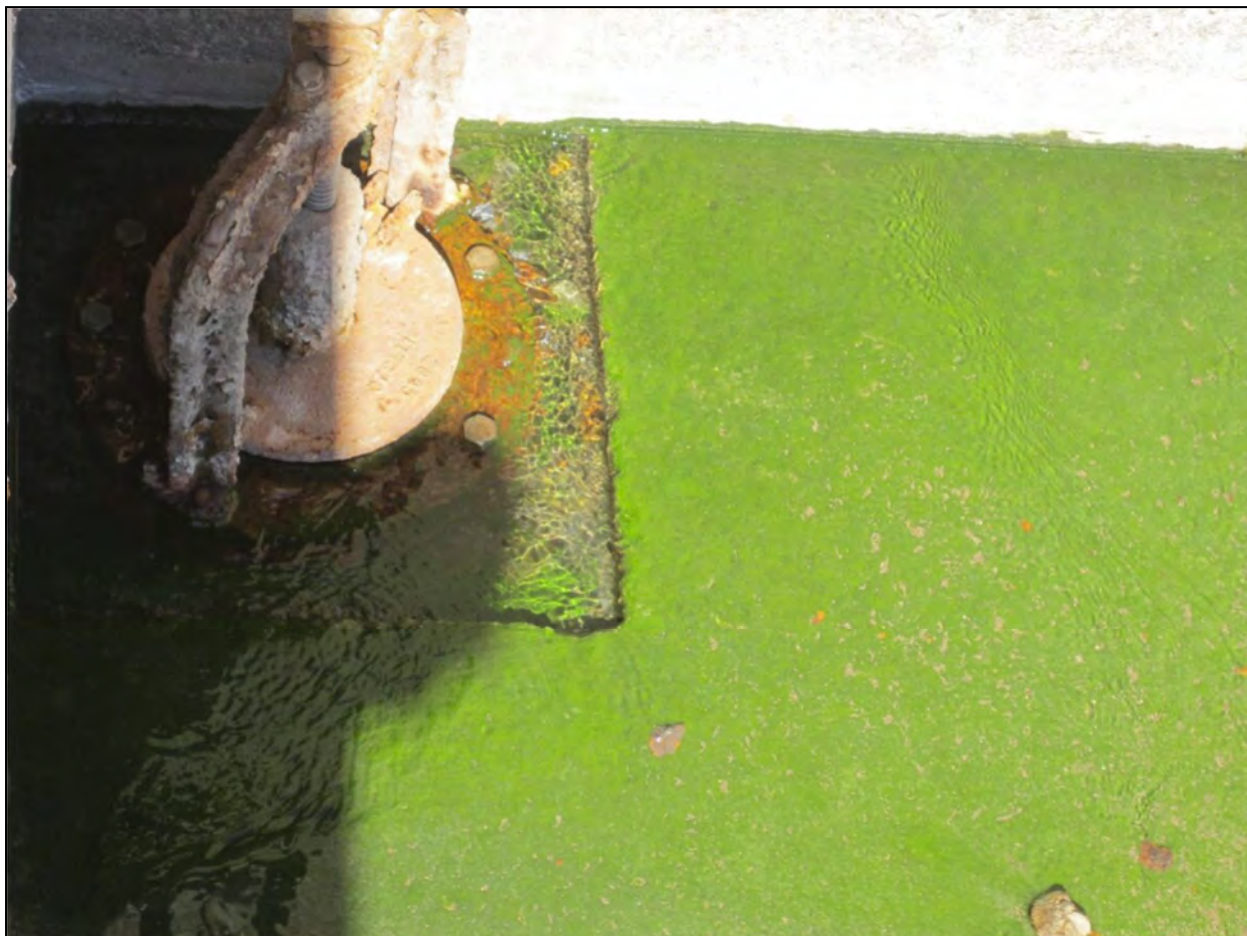
Photo No. 3

maintenance on the valve (refer to [Appendix 1, Photographs 2 and 3](#)). The water was draining to the sanitary sewer through an open gate in the corner of the basin. This gate was designed to drain the basin as well as to remove solids as required. When System representatives were made aware of the leak, the valve was fully closed, and the leak stopped. A potential cross connection between the sanitary sewer and this basin was not evaluated but could potentially present a concern. It was unclear to the EPA Inspection Team if there was an intermediate asset between the pre-sedimentation basin and the sanitary sewer, or if the pre-sedimentation basins drained to the on-site sludge ponds.

**Photograph 3. 2/13/2024 1:01 PM IMG\_0005.JPG**

**Conventional Plant, Pre-Sedimentation Basin** View of water flowing through a partially open gate. It was unclear to the EPA Inspection Team how the sanitary sewer was connected to the basin or if there was a structure between the basin and the sanitary sewer. System representatives stated that the water flowed to the sanitary sewer. The EPA Inspection Team did not evaluate cross-connection controls associated with this line.

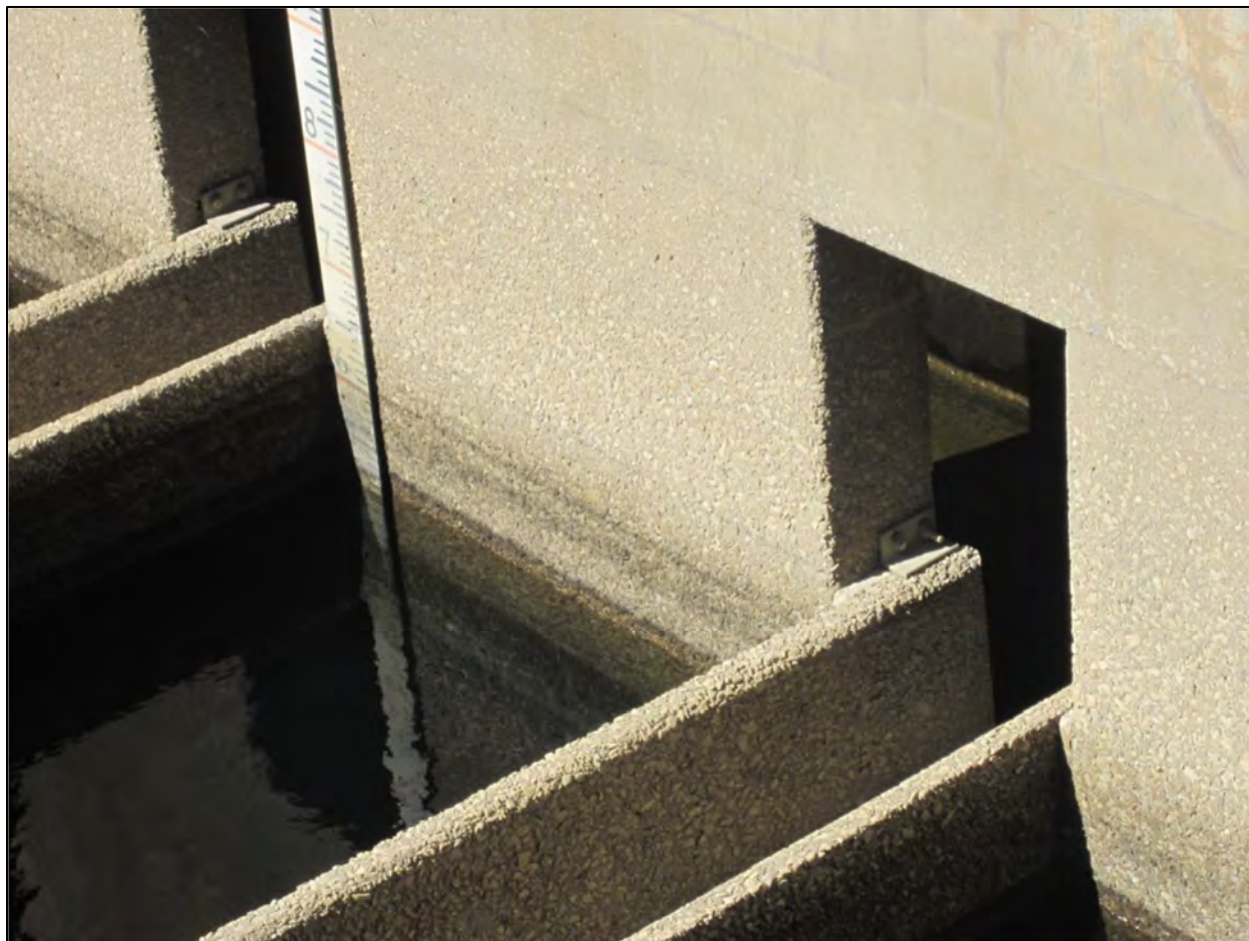
Photo No. 7

**Photograph 7. 2/13/2024 1:28 PM IMG\_0020.JPG**

**Conventional Plant, Dual Media Filters** View inside Filter No. 1. The structure had some concrete loss, and some aggregate was exposed.

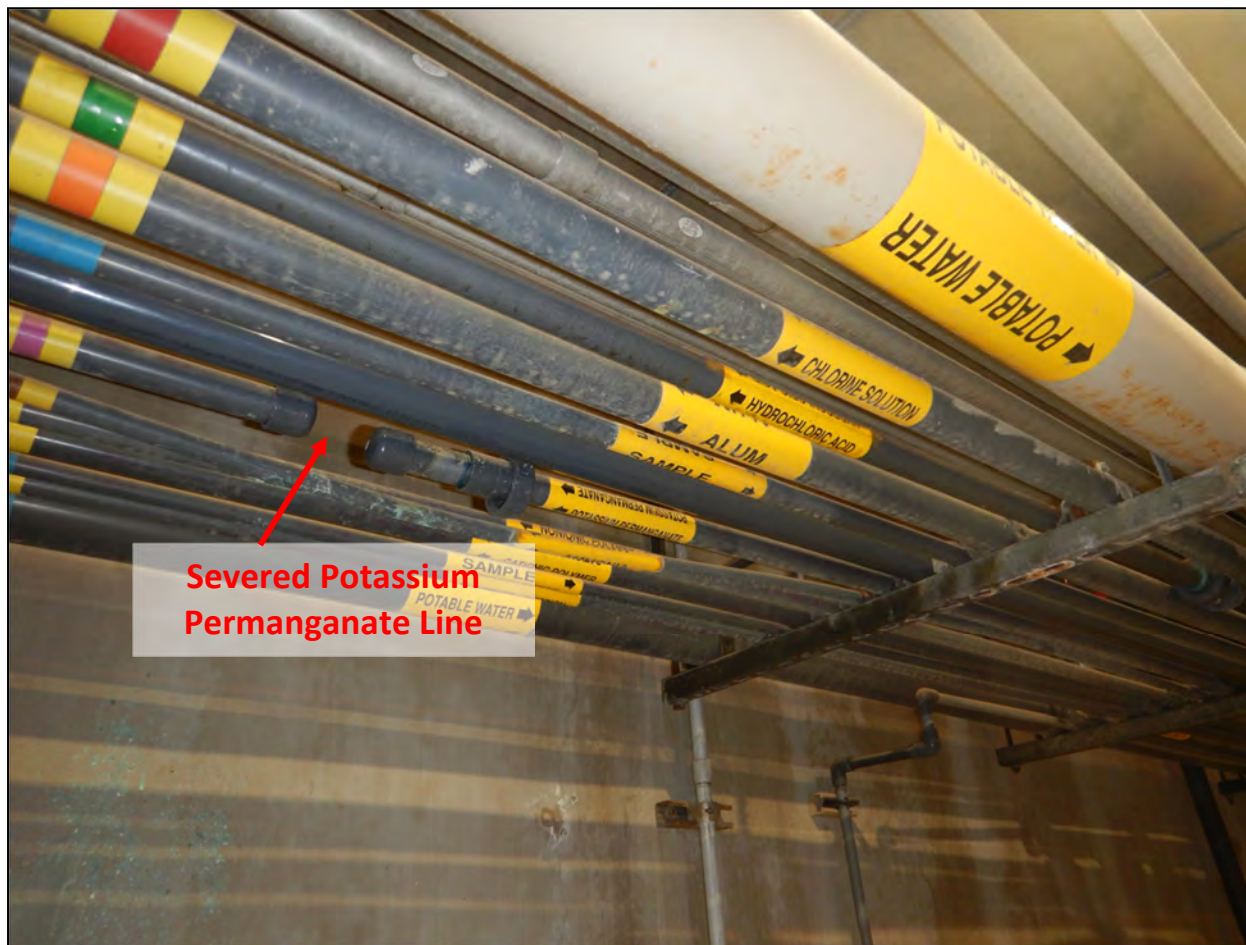
Photo No. 10

**Photograph 10. 2/13/2024 1:59 PM DSCN9260.JPG**

**Conventional Plant, Pipe Gallery** View of the chemical lines in the pipe gallery. The potassium permanganate line had been severed and therefore could not be used. There were multiple severed/disconnected chemical feed lines inside the pipe gallery in addition to the severed potassium permanganate line.

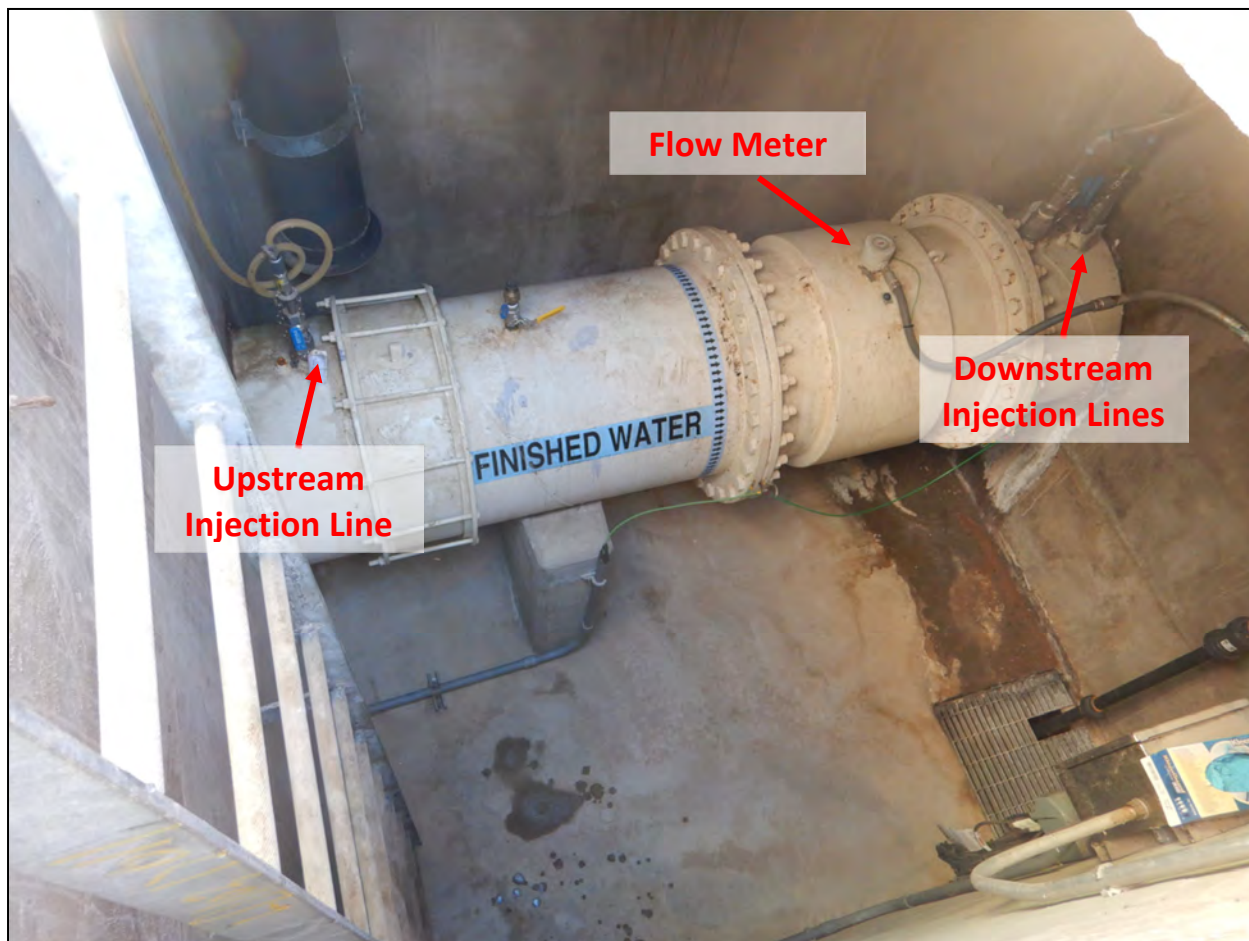
Photo No. 20

- b. Three unlabeled chemical injection points were present on the 84-inch produced water line that conveys water from the UF/RO break tank to the North and South clearwells (refer to [Appendix 1, Photograph 20](#)). Operators were unsure which injection point was for which chemical. A process flow diagram of the UF/RO treatment plant provided by TCEQ indicates that fluoride, phosphate, and caustic are injected following the finished water flow meter. However, the EPA Inspection Team observed that one of the chemical injection points was positioned upstream of the flow meter and the other two were downstream of the flow meter.

**Photograph 20. 2/13/2024 3:47 PM DSCN9347.JPG**

**Clearwell Meter Vault** View inside the clearwell meter vault where produced water flows from the UF/RO plant into the North and South clearwells. There were three unlabeled chemical lines attached to the water line, one upstream of the flow meter and two downstream of the flow meter. Caustic, fluoride, and phosphate are injected into this line, but system representatives were unsure which chemical line injected which chemical.

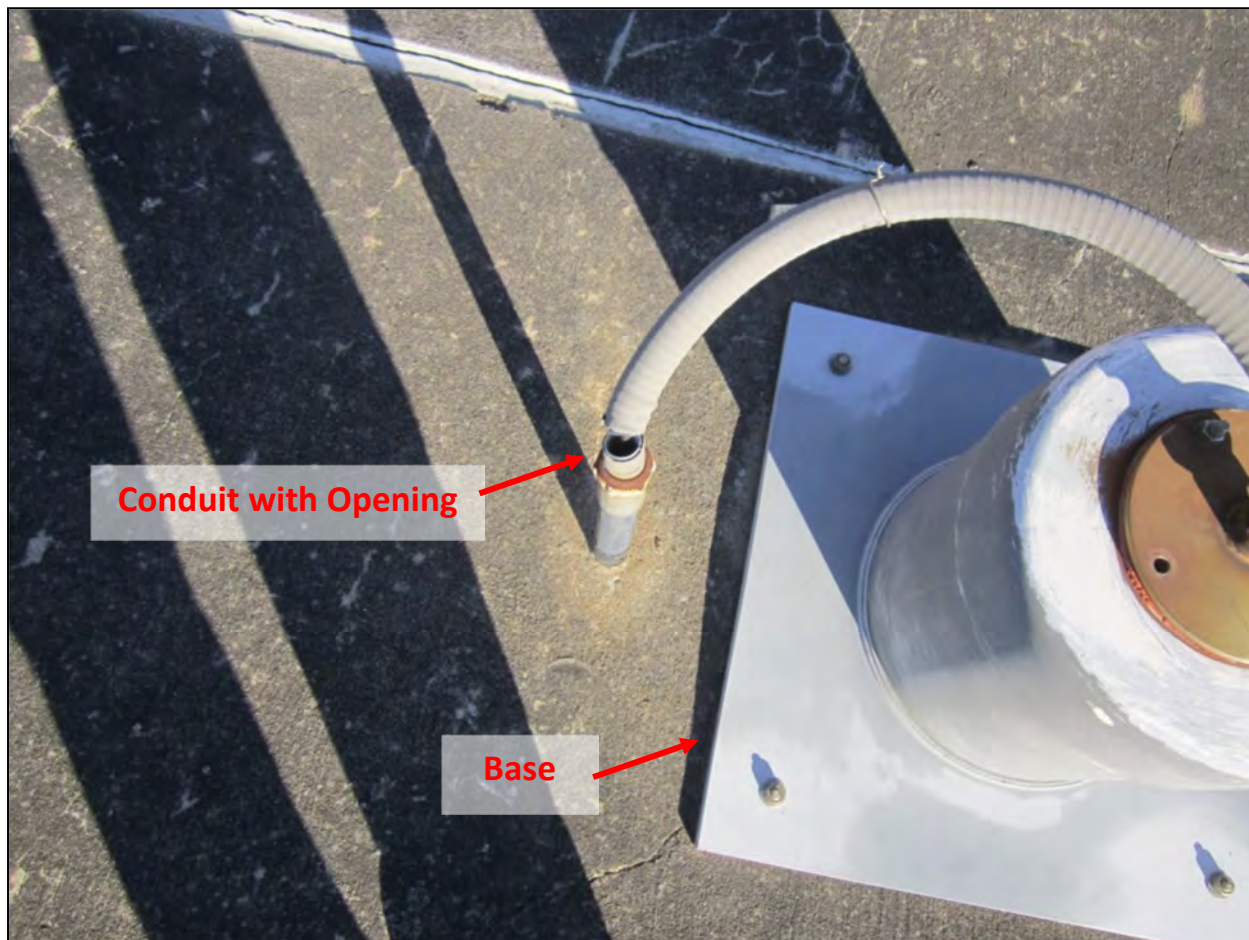
Photo No. 23

- b. There were ultrasonic level sensors with electrical equipment on the surface of the clearwells that contained electrical conduits with openings, providing direct access for contaminants to enter the clearwells (refer to [Appendix 1, Photograph 23](#)). Additionally, it was unclear if there was a sealed gasket beneath the equipment, and there were gaps beneath the platform that the equipment was positioned on (refer to [Appendix 1, Photograph 24](#)). After the electrical conduit openings were observed, System representatives covered the conduit with electrical tape and provided a photo to the EPA Inspection Team (refer to [Appendix 4, Follow-Up Material](#)).

**Photograph 23. 2/13/2024 4:09 PM IMG\_0126**

**North and South Clearwells** View of a conduit for ultrasonic level sensor equipment on top of the North clearwell. There was a gap in the electrical conduit providing direct access to the water inside of the clearwell. When this observation was made to System representatives, the electrical conduit was covered in electrical tape (refer to [Appendix 4, Follow-Up Material](#)). A close-up view of the base can be seen in the next photograph.

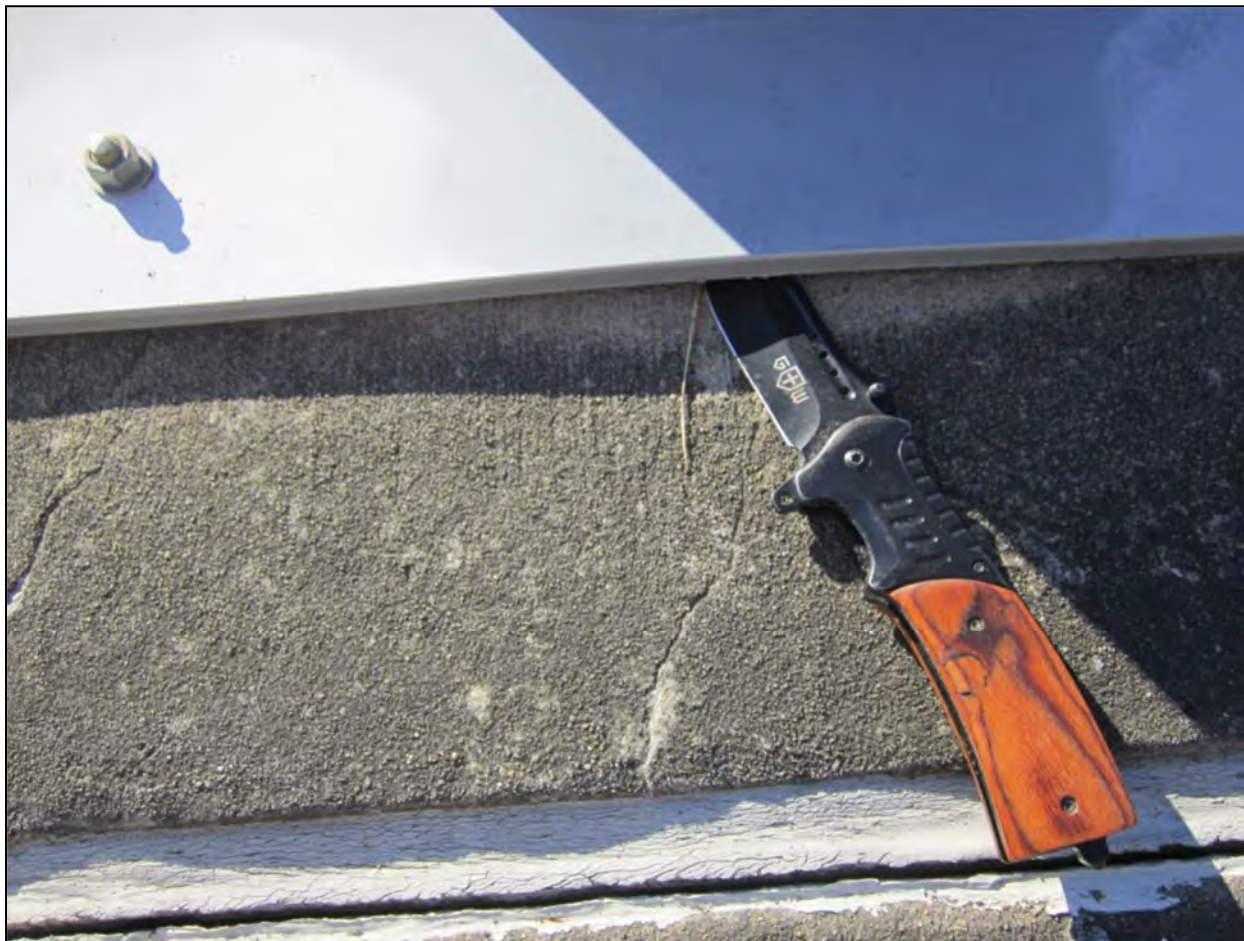
Photo No. 24

**Photograph 24. 2/13/2024 4:10 PM IMG\_0131.JPG**

**North and South Clearwells** View of the base of the equipment associated with the ultrasonic level indicator on top of the North clearwell. There was a gap between the base of the equipment and the top of the clearwell and it was unclear if a sealed gasket was present to prevent the entry of contaminants to the clearwell.

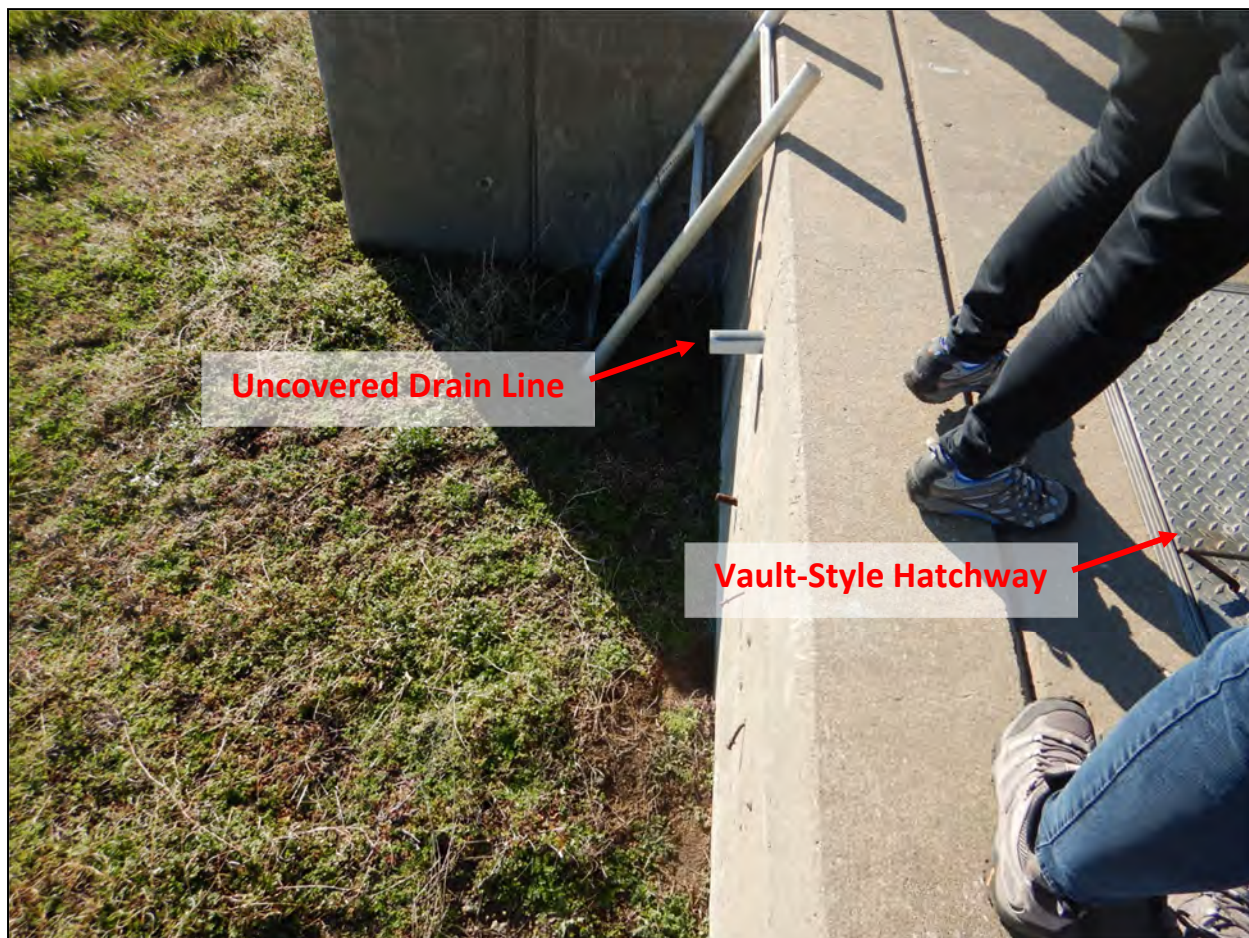
Photo No. 25

- a. There was no screen covering a drainpipe that extended from the inside of one of the vault-style hatchways on top of the North clearwell (refer to [Appendix 1, Photograph 25](#)). A screen was placed over the drainpipe after this observation was made to System representatives, and a photo was provided to the EPA Inspection Team (refer to [Appendix 4, Follow-Up Material](#)).

**Photograph 25. 2/13/2024 4:03 PM DSCN9353.JPG**

**North and South Clearwells** View of the vault-style hatchway leading to the clearwell and the uncovered drainage line extending off the side of the clearwell. The drainage line is for the interior of the vault-style hatchway. When this observation was made, System representatives placed a screen over the end of the line and provided a picture to the EPA Inspection Team (refer to [Appendix 4, Follow-Up Material](#)).

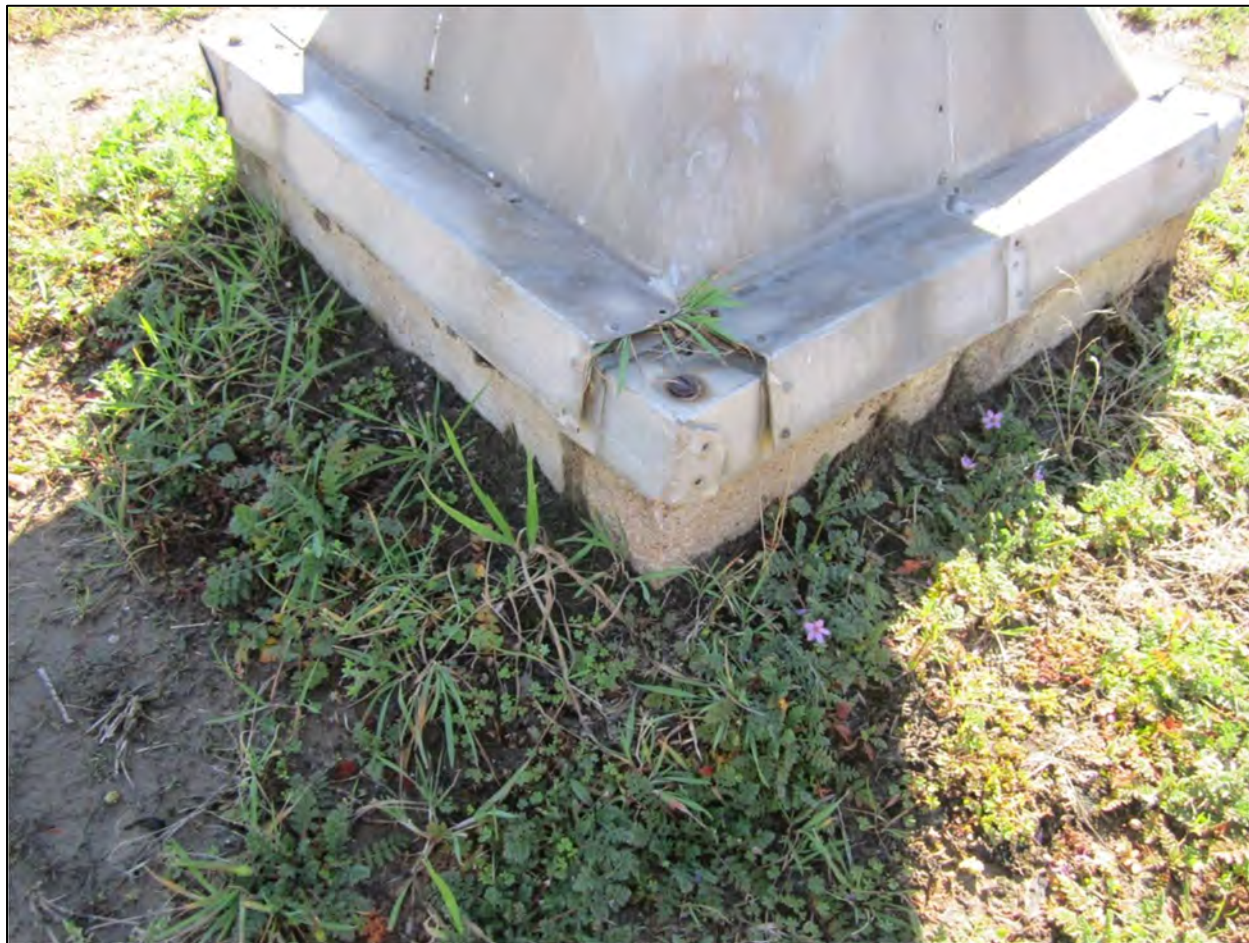
Photo No. 33

- a. The bases of the vent structures to the Fairview Tank were constructed out of multiple pieces of sheet metal and had voids in areas, allowing grass to grow through (refer to Appendix 1, Photograph 33). The vent structures appeared to be covering a pipe that was encased by a concrete pad. No sanitary seal or gasket material was observed between the metal bases and the concrete pads that the vents were positioned on. The concrete pads supporting the vent structures had multiple ant hills and ants positioned under the sheet metal structures (refer to Appendix 1, Photograph 34).
- b. Manholes/accessways on top of the Fairview Tank did not provide adequate protection to the finished water. The EPA Inspection Team observed the following potential threats to the finished water quality:

**Photograph 33. 2/14/2024 10:50 AM IMG\_0016.JPG**

**Fairview Tank** View of the base of one of the vents on top of the Fairview Tank. The bases of the vents were constructed of metal that appeared to have voids and lacked sanitary seals.

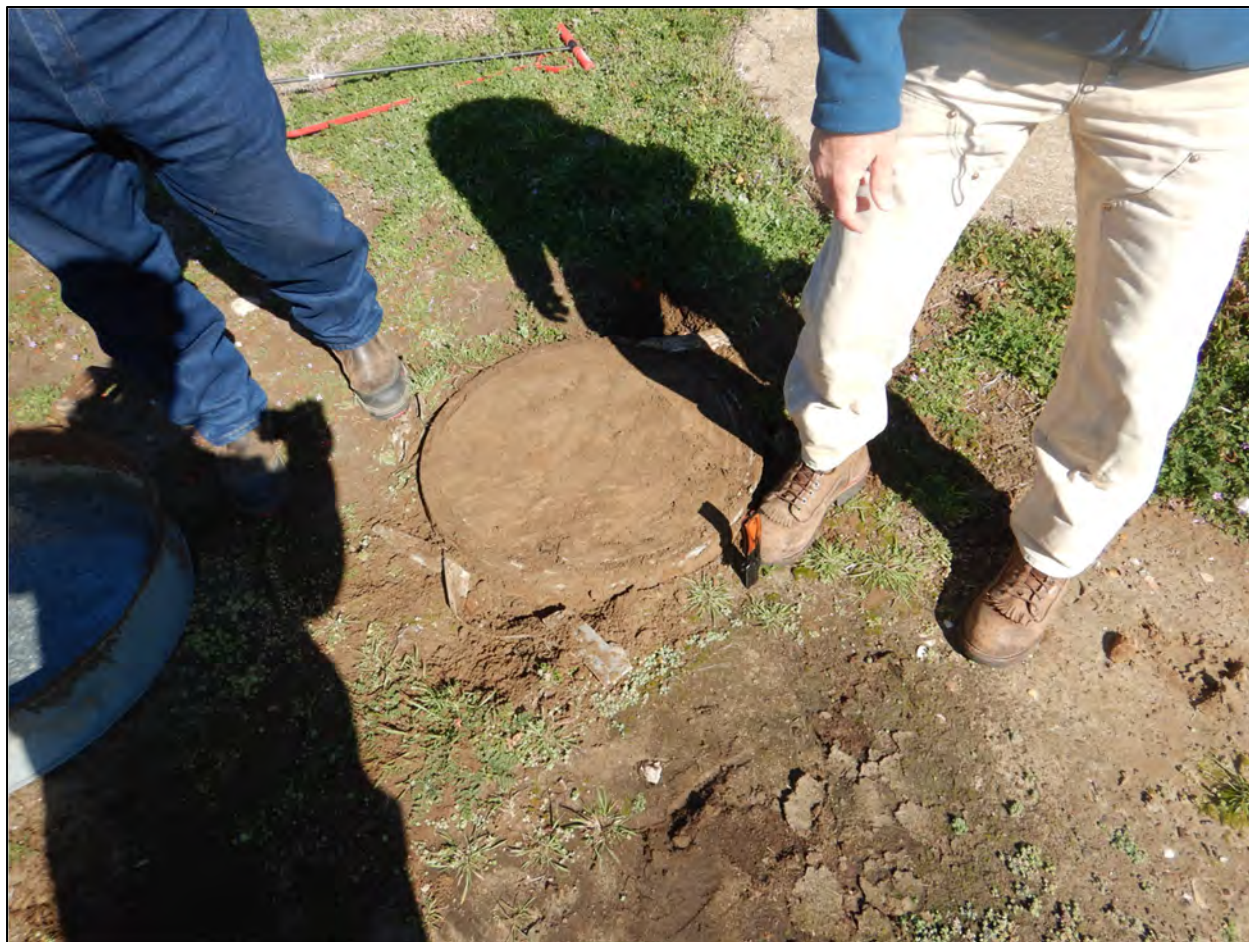
Photo No. 35

- The manhole covers had varying heights associated with the dirt and grass in the area, and some areas had less than four inches of clearance (refer to [Appendix 1, Photograph 35](#)).

**Photograph 35. 2/14/2024 11:03 AM DSCN9427.JPG**

**Fairview Tank** View of one manholes for accessing the interior of the Fairview Tank. The manhole was constructed of a metal ring and cover similar to a sanitary sewer manhole. The manhole structures were approximately 1 to 2 inches above the ground.

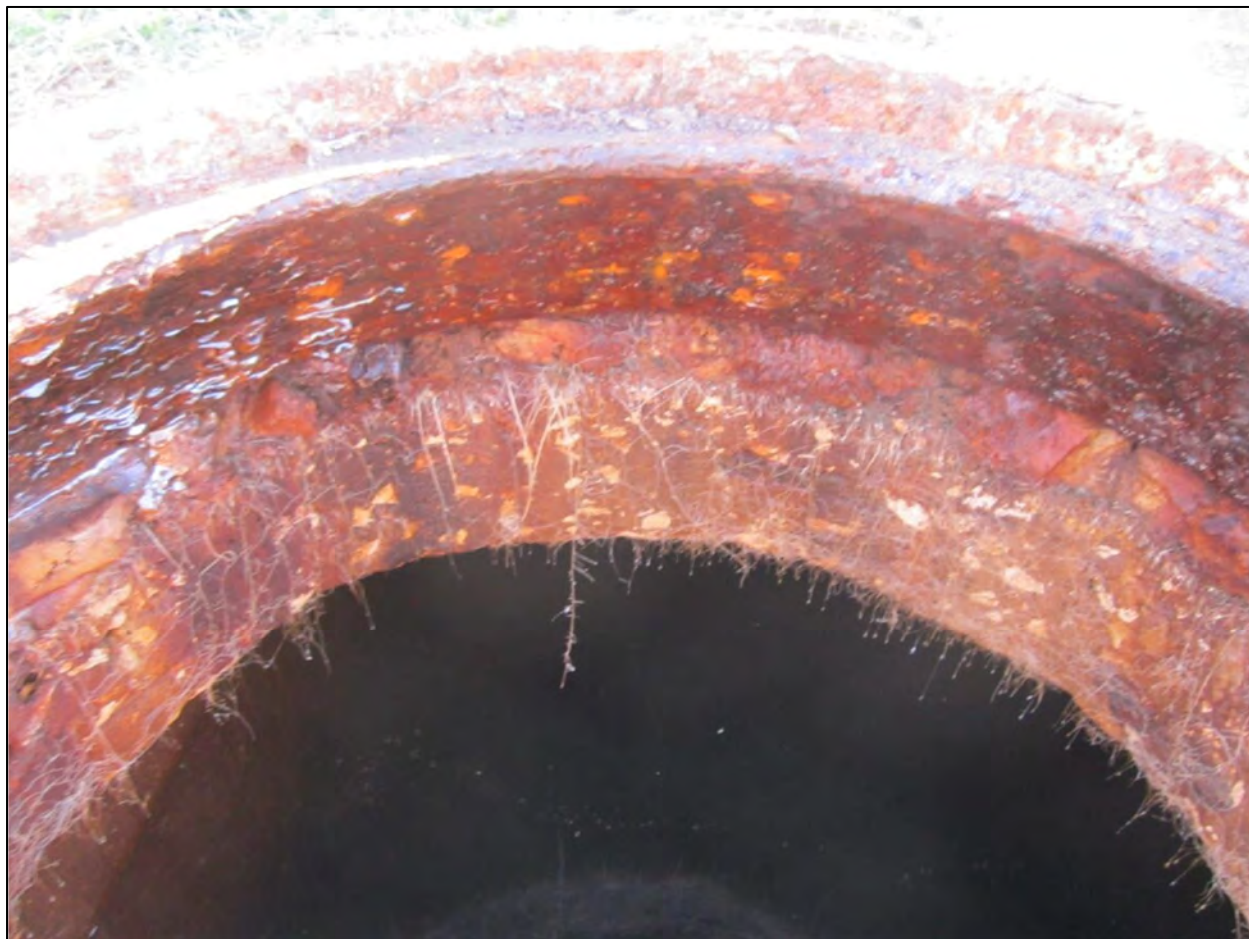
Photo No. 39

- Roots were seen growing through the inside of the concrete structures of the manholes, and some were touching the surface of the water (refer to [Appendix 1, Photograph 39](#)). There was also heavy corrosion and condensation (moisture) on the metal components of the manholes (refer to [Appendix 1, Photograph 38](#)).

**Photograph 39. 2/14/2024 11:19 AM IMG\_0041.JPG**

**Fairview Tank** View of roots growing through the manhole structure toward the water surface inside the Fairview Tank.

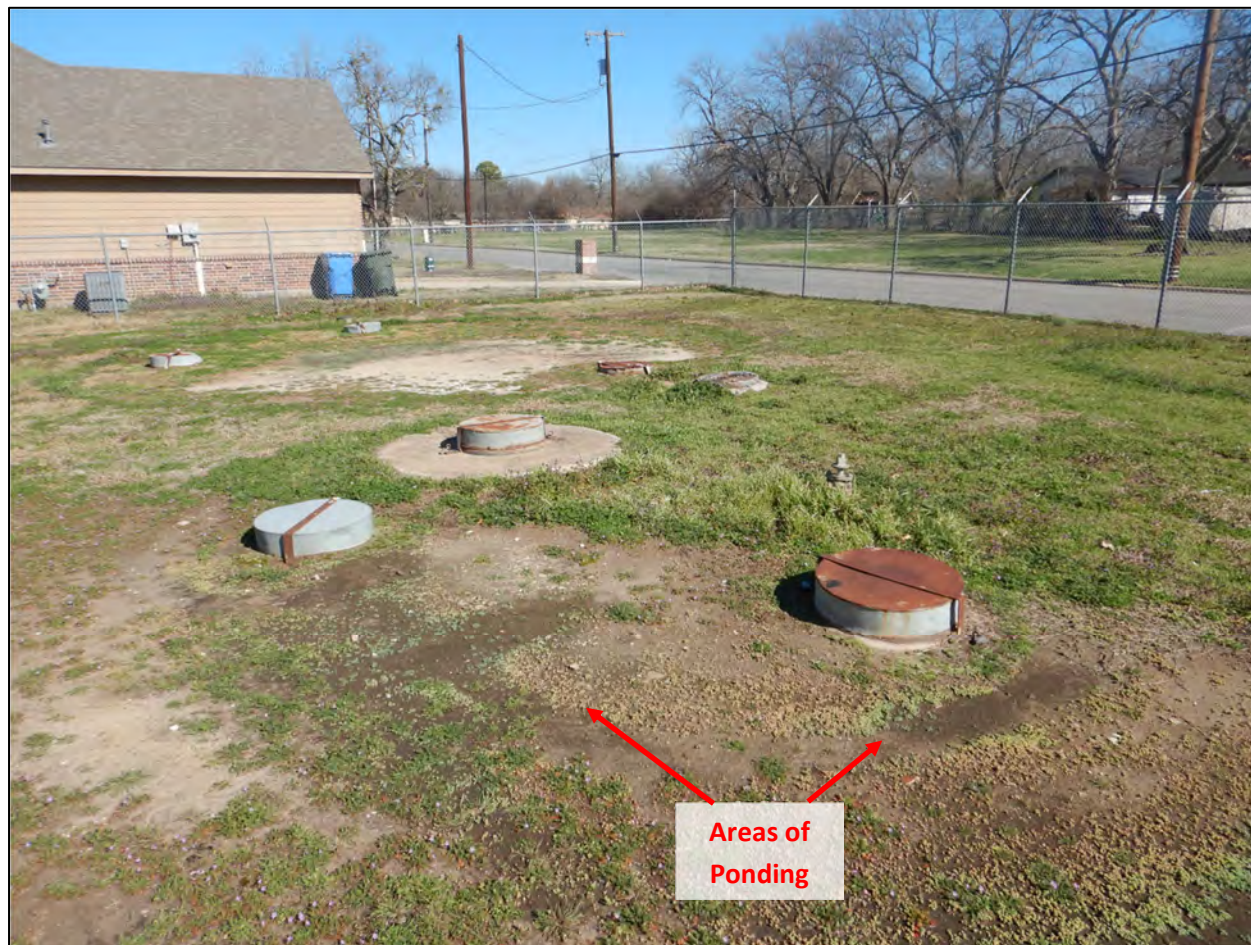
Photo No. 40

- The manhole structures appeared to be in lower laying areas that appeared to pond water during wet weather events (refer to [Appendix 1, Photograph 40](#)).

**Photograph 40. 2/14/2024 10:52 AM DSCN9421.JPG**

**Fairview Tank** Close-up view of low area with evidence of ponding adjacent to two manholes for the Fairview Tank. The two manholes provide access to the interior of the Fairview Tank.

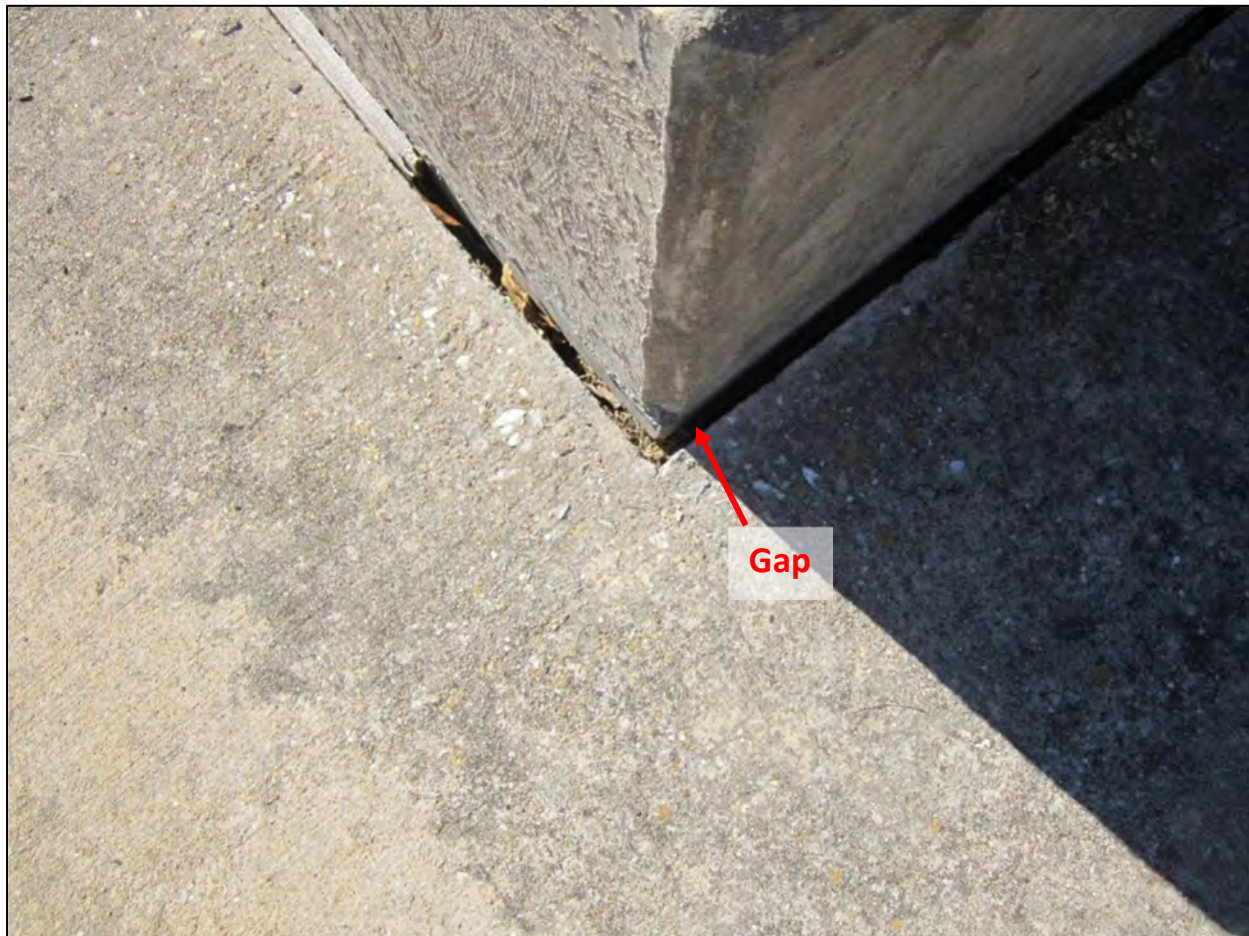
Photo No. 45

- d. There was a gap between the base of the well pedestal and the well pad (refer to [Appendix 1, Photograph 45](#)).
- e. There was an unattached open port inside of the chlorine injection vault next to the Fairview Tank, and operators were unsure of the port's use (refer to [Appendix 1, Photograph 48](#)). There were also signs of past flooding and/or water accumulation inside of the vault (i.e., water marks, mud cracks).

**Photograph 45. 2/14/2024 11:30 AM IMG\_0051.JPG**

**Fairview Site, Well G0910006Q** View of the base of the well pedestal for Well G0910006Q where it meets the well pad. There was a gap between the well pedestal and the pad.

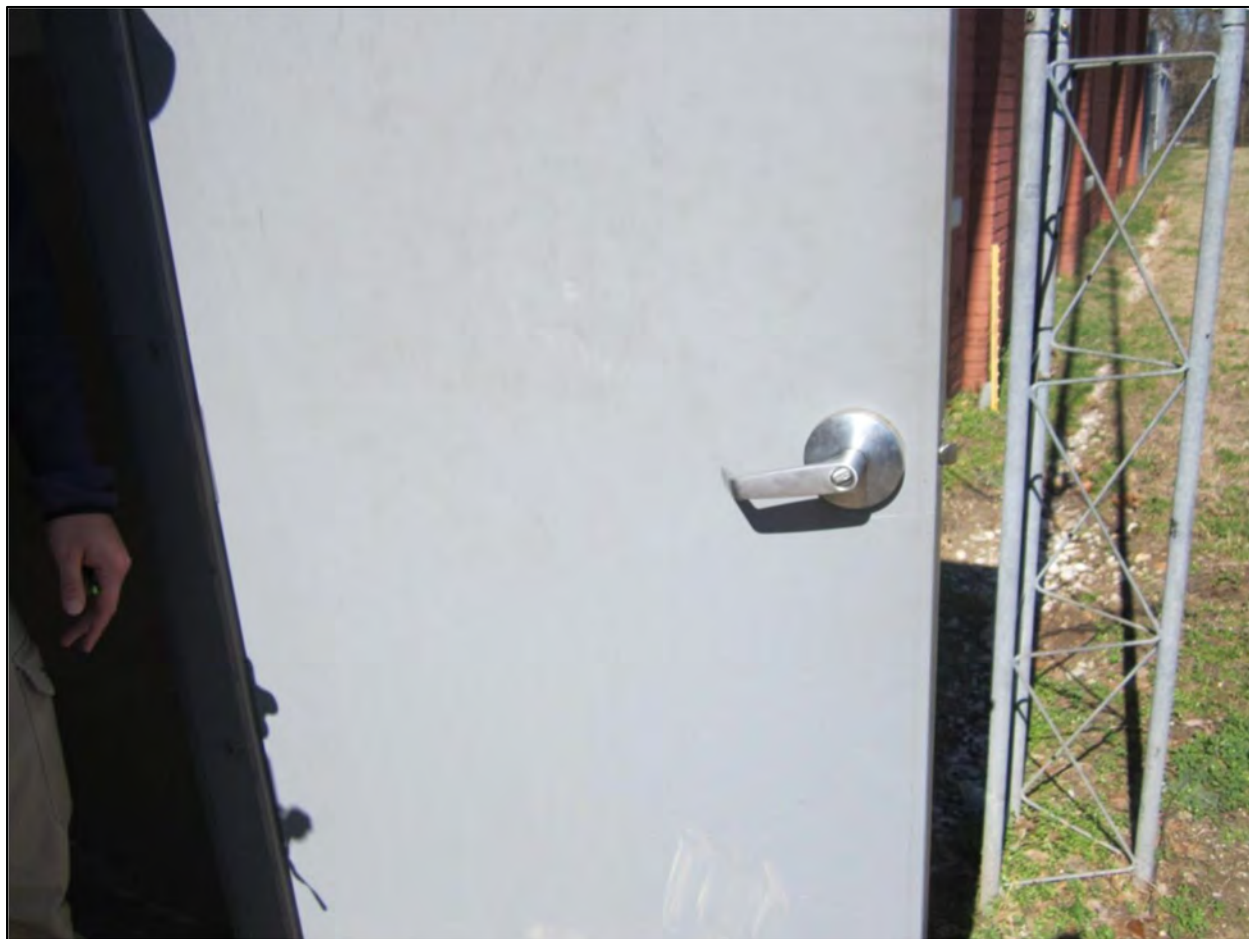
Photo No. 46

- g. There was no full-face self-contained breathing apparatus outside of the chlorine storage room at the Fairview site. Additionally, the door of the chlorine storage room at the Fairview site lacked a crash bar and observation window (refer to [Appendix 1, Photograph 46](#)). No alarm system was present to indicate a chlorine leak inside of the room.

**Photograph 46. 2/14/2024 11:39 AM IMG\_0072.JPG**

**Fairview Site, Chlorine Injection Room** View of the door to the chlorine injection room that lacked a crash bar and observation window. In addition, a respirator was not available at this location.

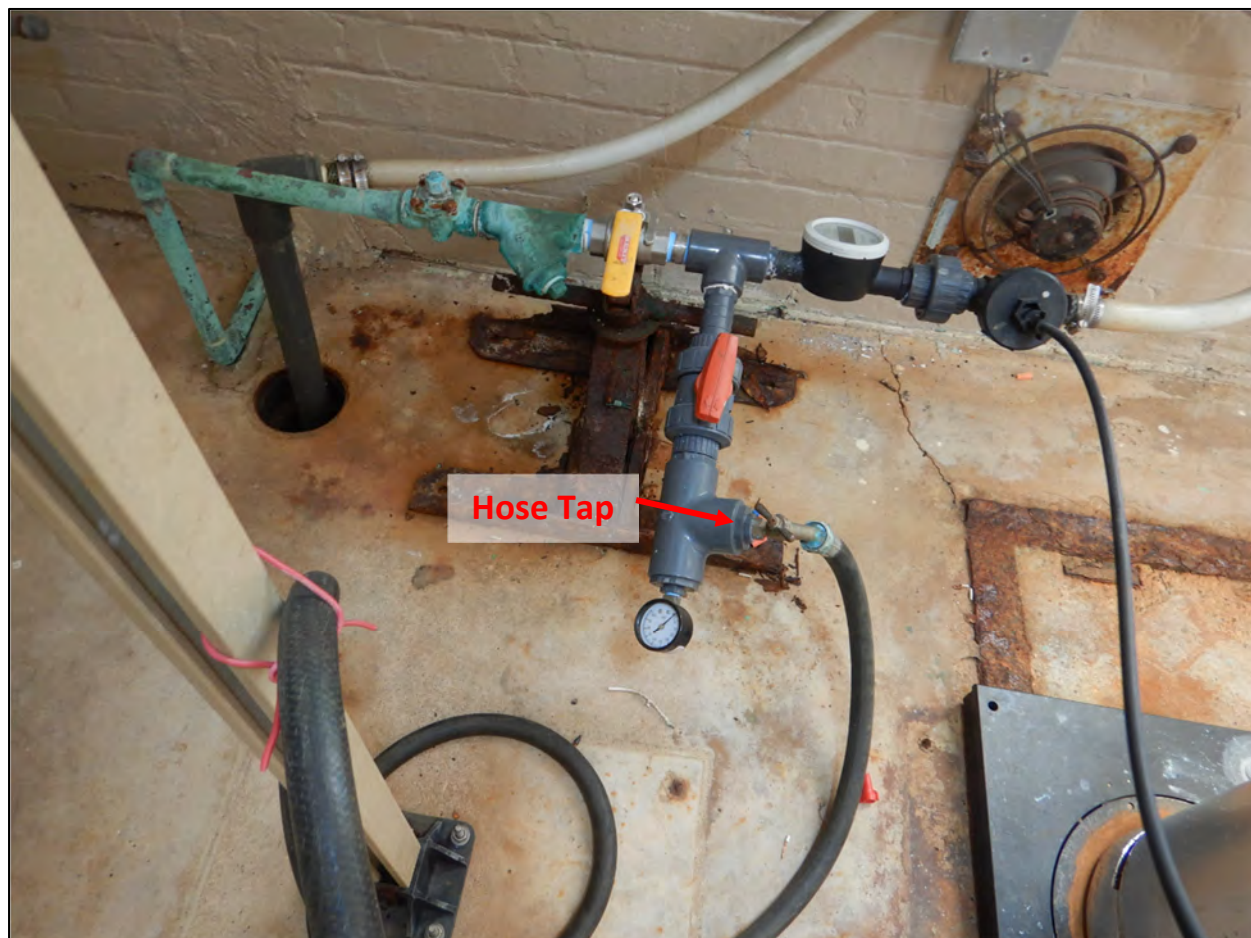
Photo No. 47

- h. A threaded hose tap without backflow prevention extended off of a finished water line (used to supply carry water for chlorine injection) inside of the chlorine storage room at the Fairview site (refer to [Appendix 1, Photograph 47](#)). The hose was disconnected upon The EPA Inspection Team's field discussion with City staff.

**Photograph 47. 2/14/2024 11:35 PM DSCN9454.JPG**

**Fairview Site, Chlorine Injection Room** View of a threaded hose tap without backflow prevention with an attached hose inside of the chlorine injection room at the Fairview site. The tap was attached to a line that is supplying finished water. It is unknown if the line had backflow prevention. The hose was unattached when this observation was made to System representatives.

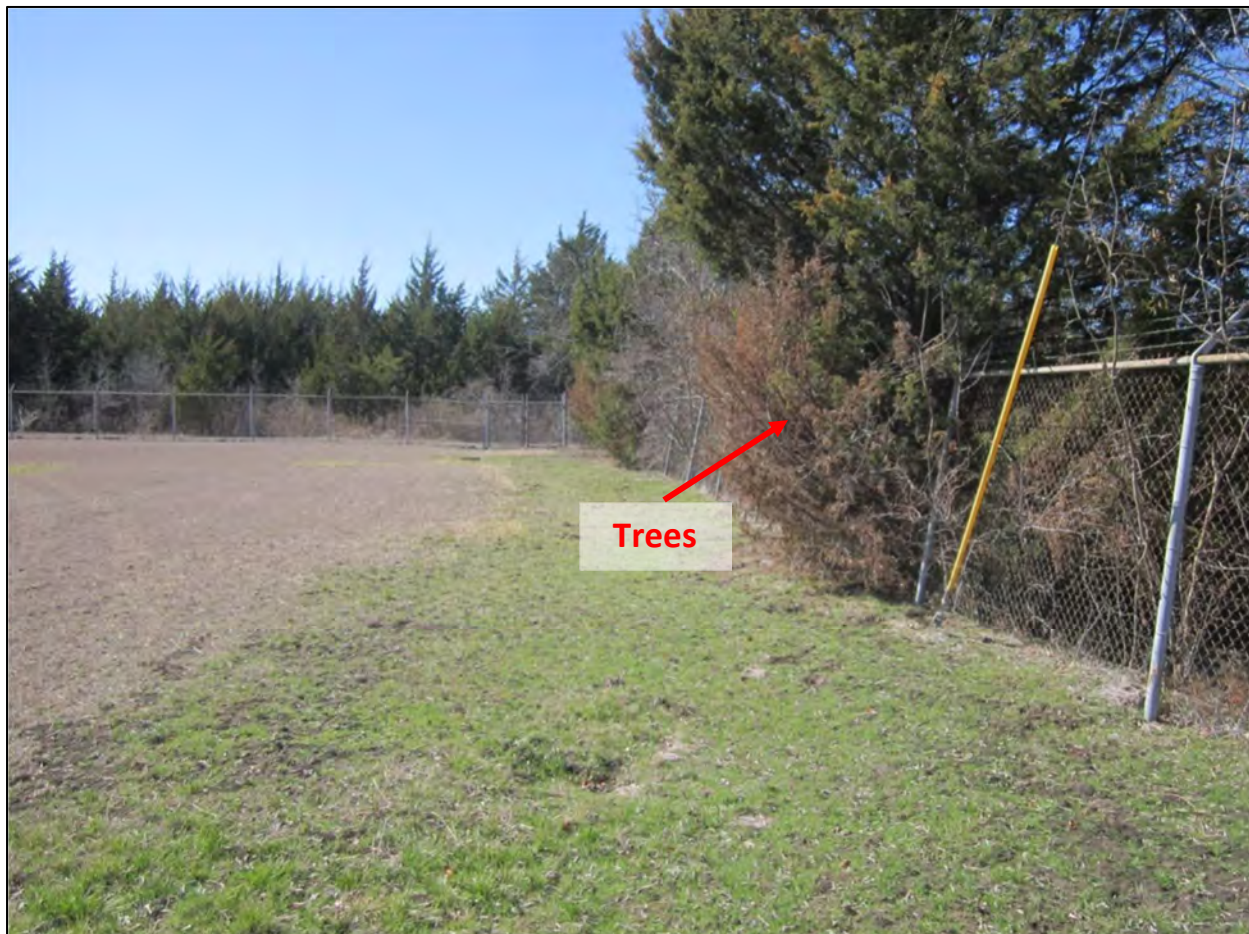
Photo No. 49

- c. There was graffiti that had been painted over on the side of the Stephens Tank. System representatives indicated that they had experienced challenges with intruders at the Stephens site in the past. There were multiple trees growing around/through the fence line at the Stephens site, potentially compromising the intruder resistance of the fence (refer to Appendix 1, Photograph 49). The Stephens tank ladder lacked a locked ladder shield, and the ladder extended all the way to the ground.

**Photograph 49. 2/14/2024 1:32 PM IMG\_0079.JPG**

**Stephens Site, Perimeter Fence** View of the perimeter fence surrounding the Stephens site. There were multiple trees growing through and around the fence, potentially compromising the integrity of the fence and security of the site.
