## Region 6 - Enforcement & Compliance Assurance Division

### INSPECTION REPORT

| <b>System Owner:</b> | City of Sherman | |
| <b>System Name:</b> | City of Sherman Public Water System (PWS) | |

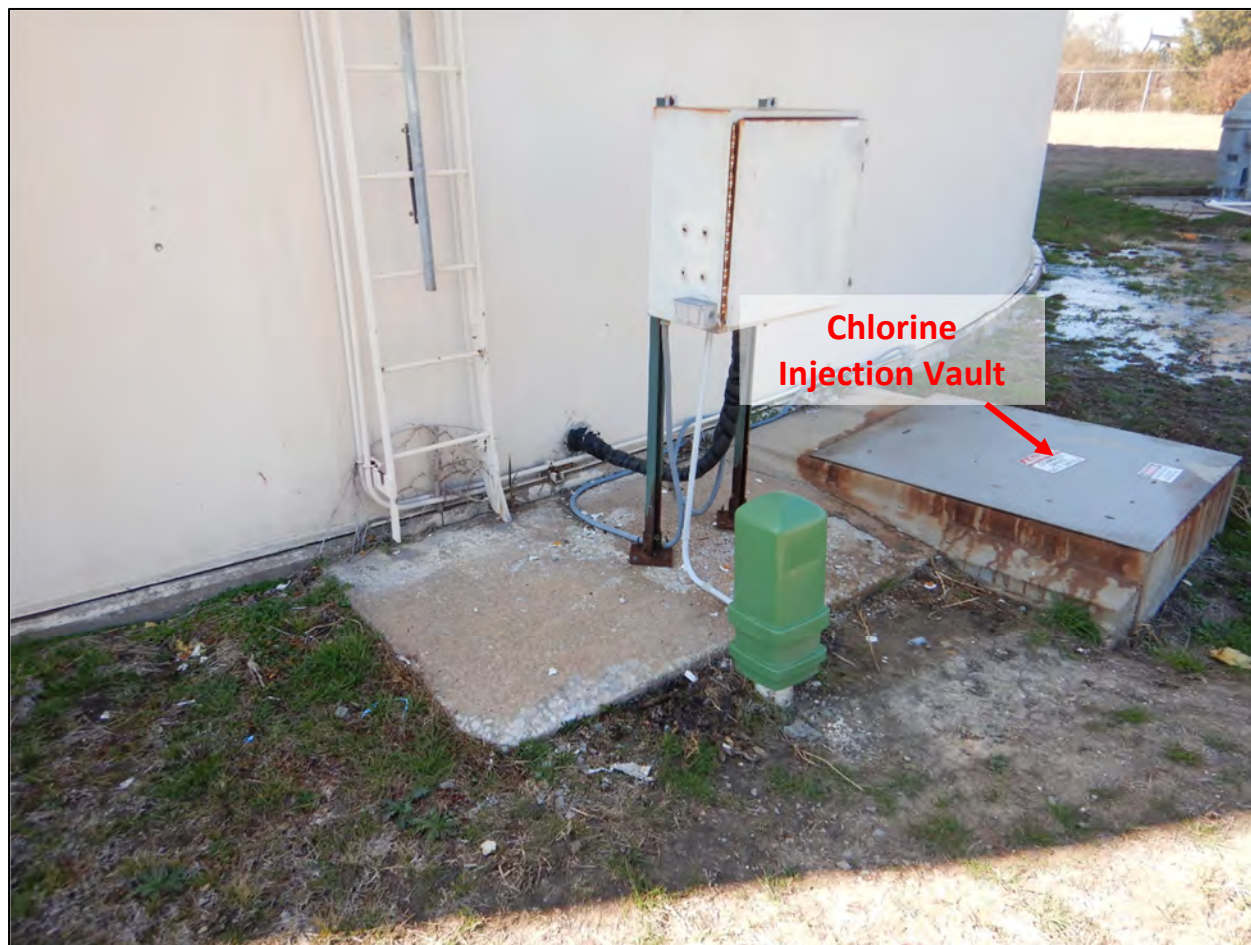
Photo No. 53

- c. There was graffiti that had been painted over on the side of the Stephens Tank. System representatives indicated that they had experienced challenges with intruders at the Stephens site in the past. There were multiple trees growing around/through the fence line at the Stephens site, potentially compromising the intruder resistance of the fence (refer to Appendix 1, Photograph 49). The Stephens tank ladder lacked a locked ladder shield, and the ladder extended all the way to the ground.

**Photograph 53. 2/14/2024 1:50 PM DSCN9515.JPG**

**Stephens Tank** View of the access ladder for the Stephens Tank. The ladder lacked a ladder shield and extended to the ground. . The chlorine injection vault was flooded.

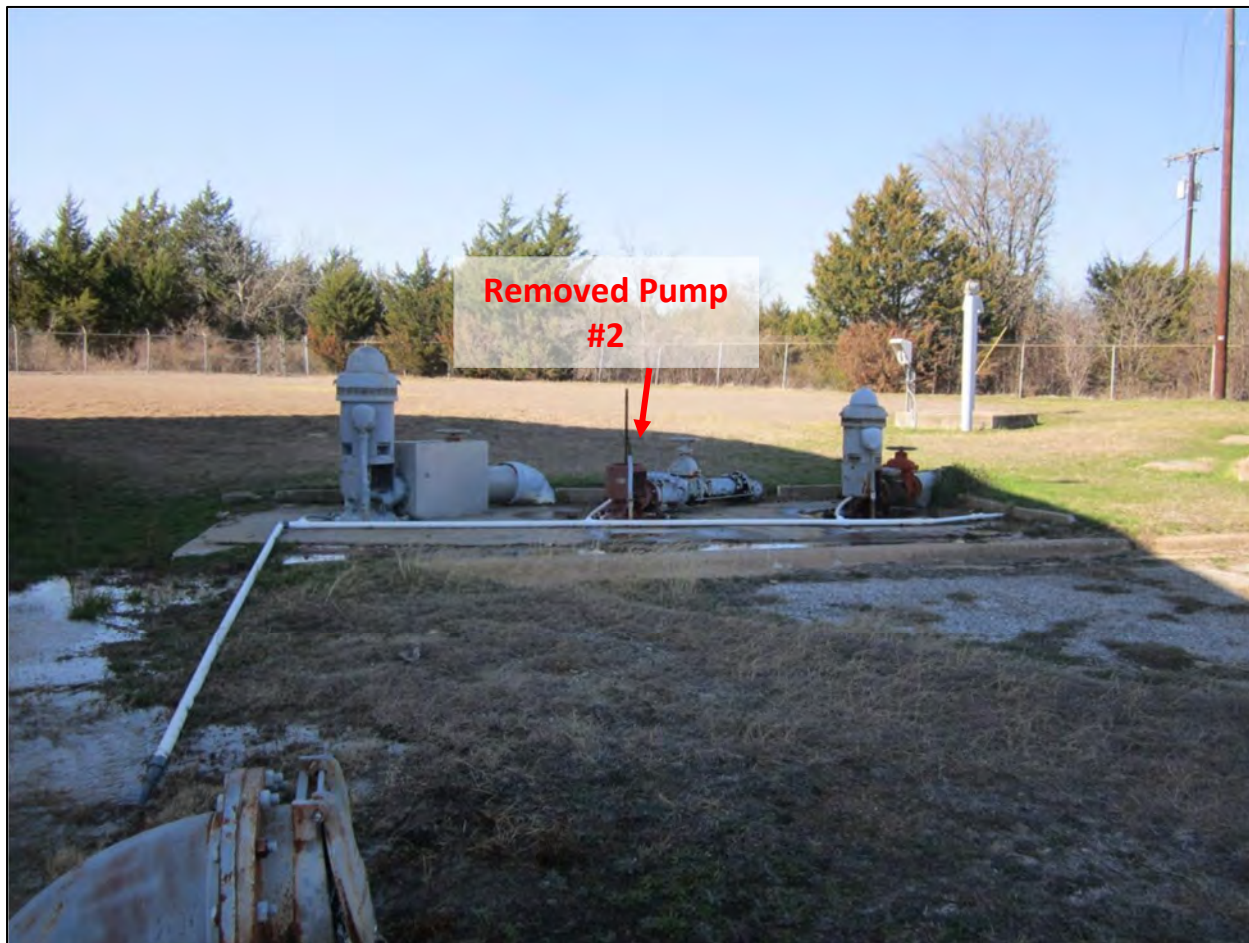
Photo No. 55

The Stephens Pump Station has three pumps, one of which was out of service due to a pump motor that had been removed for maintenance (refer to [Appendix 1, Photograph 55](#)). Of the two remaining in-service pumps, System representatives indicated that the 1,350 GPM pump was the primary pump and the 2,500 GPM pump was a backup pump that hadn't been used in approximately 20 years. System representatives stated that both groundwater wells were operational. Components of the well motor for well G0910006U had various unattached electrical wires. Additionally, it was unclear if the food-grade oil barrel used for lubrication at the well contained oil (refer to [Appendix 1, Photograph 56](#)). There were also two sand separators present at the Stephens site used to support the wells (refer to [Appendix 1, Photograph 57](#)).

**Photograph 55. 2/14/2024 1:53 PM IMG\_0088.JPG**

**Stephens Site, Pump Station** View of the pump station at the Stephens site. One of the three pumps (Pump #2) was out of service and had been removed for maintenance. The work order for its repair was created on October 9, 2023. The shaft was scheduled to be pulled on October 11, 2023. The work order 'Ticket Status' states that the repair is 'In Progress.'

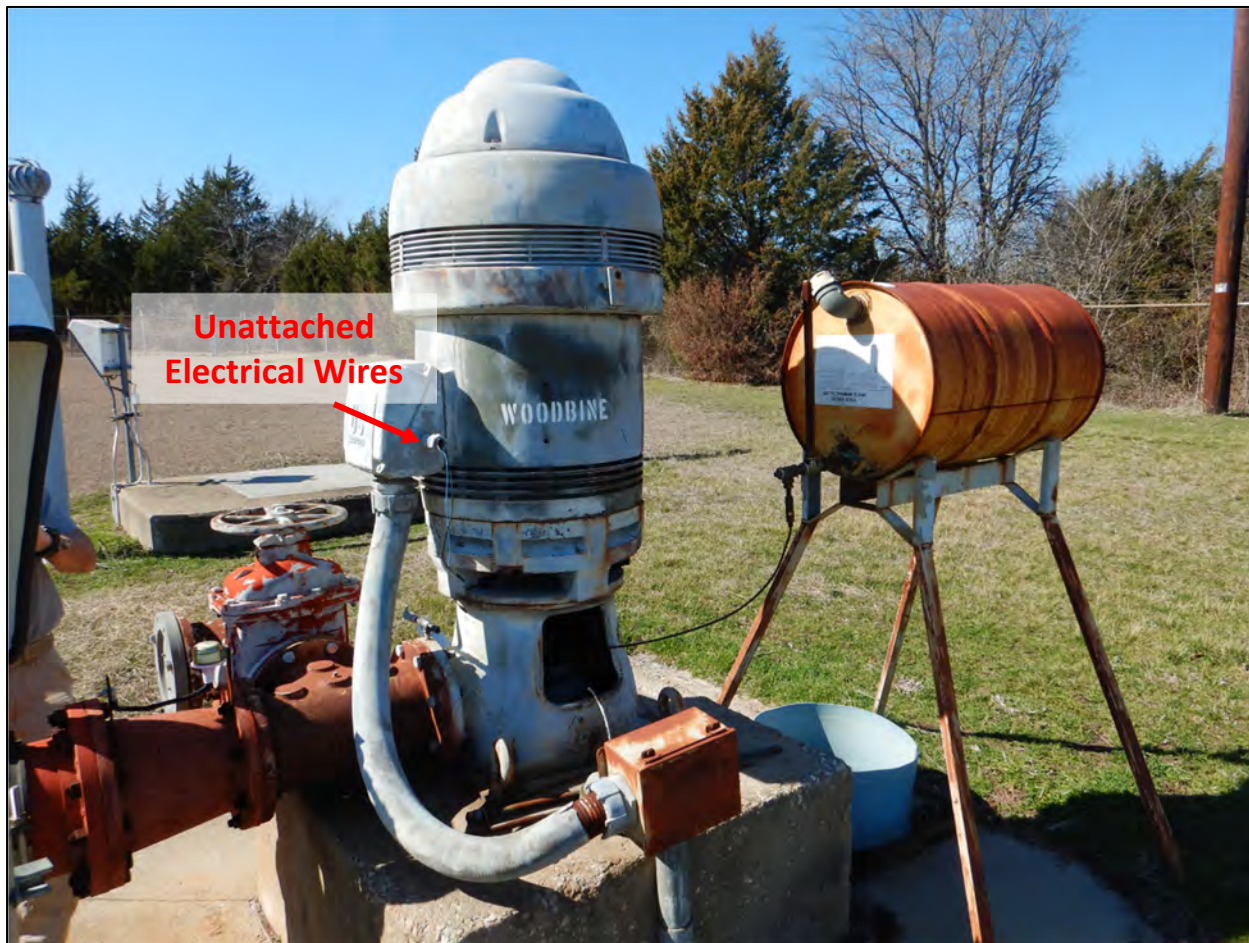
Photo No. 56

**Photograph 56. 2/14/2024 1:32 PM DSCN9506.JPG**

**Stephens Site, Well G0910006U** View of Well G0910006U at the Stephens site. Components of the well motor had various unattached electrical wires. It was unclear if the food-grade oil barrel used for lubrication (right of the image) at the well contained oil.

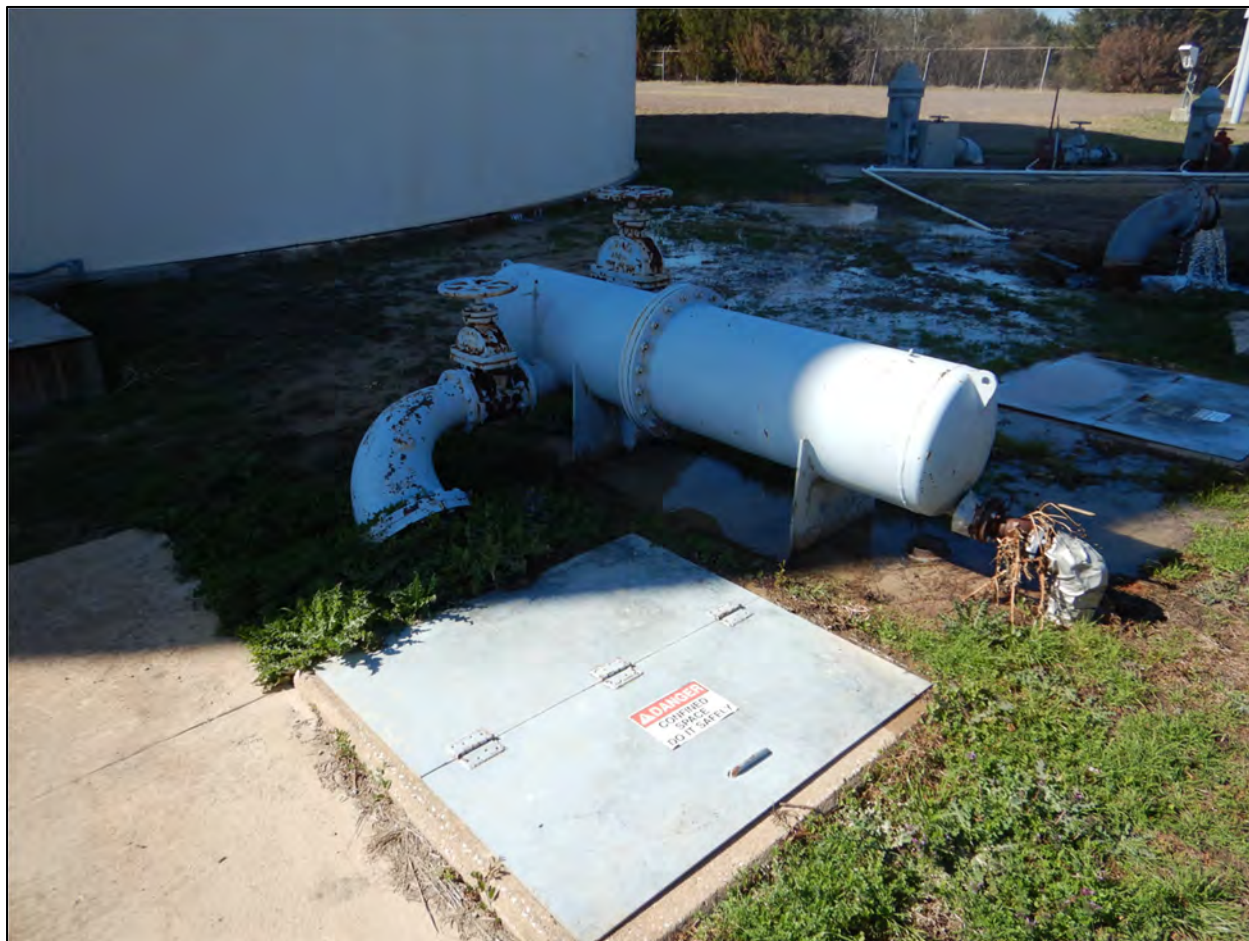
Photo No. 57

**Photograph 57. 2/14/2024 2:01 PM DSCN9523.JPG**

**Stephens Site, Sand Separator** View of one of the two sand separators at the Stephens site.

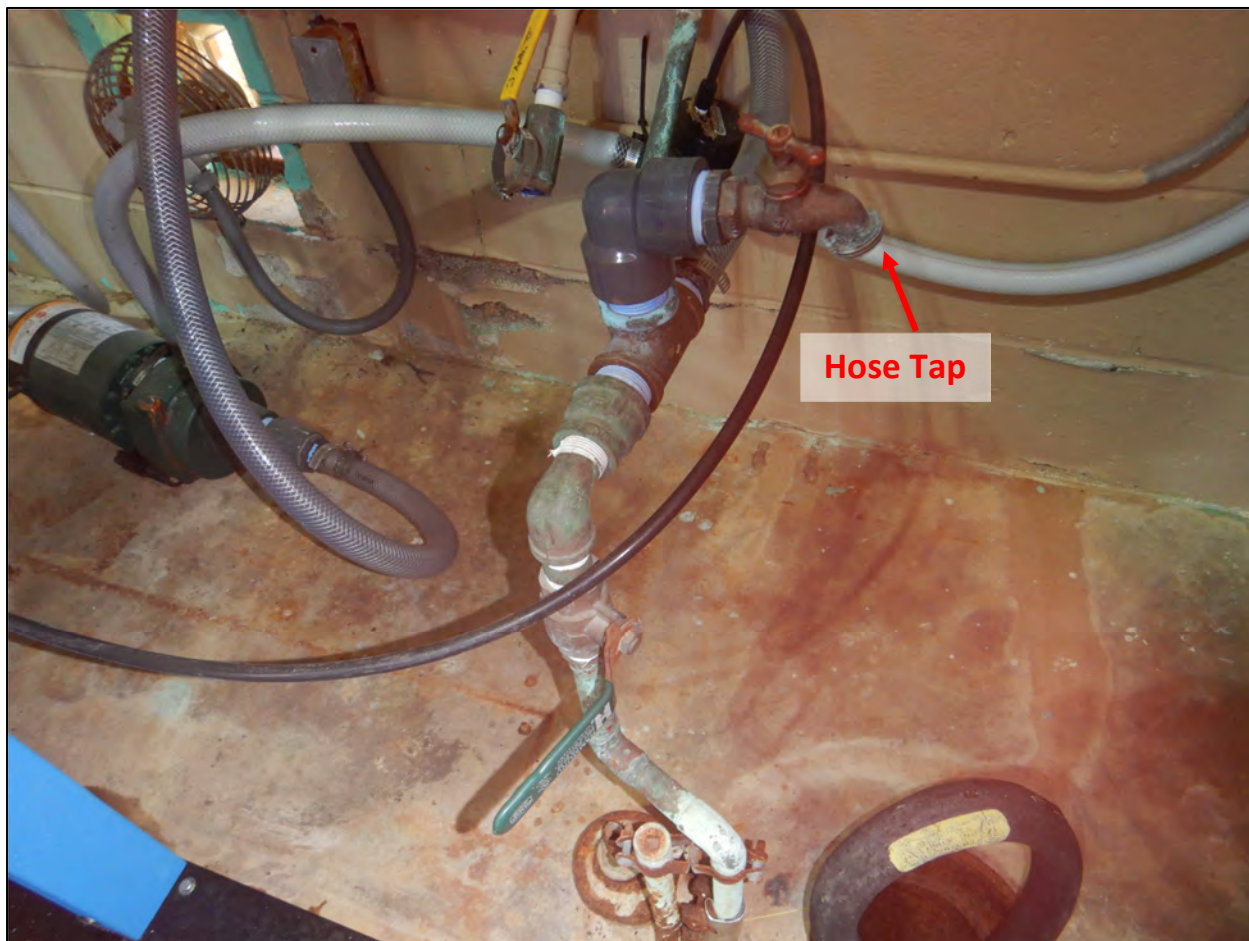
Photo No. 58

- f. A threaded hose tap without backflow prevention extended off of a finished water line (used to supply carry water for chlorine injection) inside of the chlorine storage room at the Stephens site (refer to Appendix 1, Photograph 58).

**Photograph 58. 2/14/2024 2:24 PM DSCN9533.JPG**

**Stephens Site, Chlorine Injection Room** View of a threaded hose tap without backflow prevention inside of the chlorine injection room at the Stephens site. The tap was attached to a line that is supplying finished water. It is unknown if the line had backflow prevention.

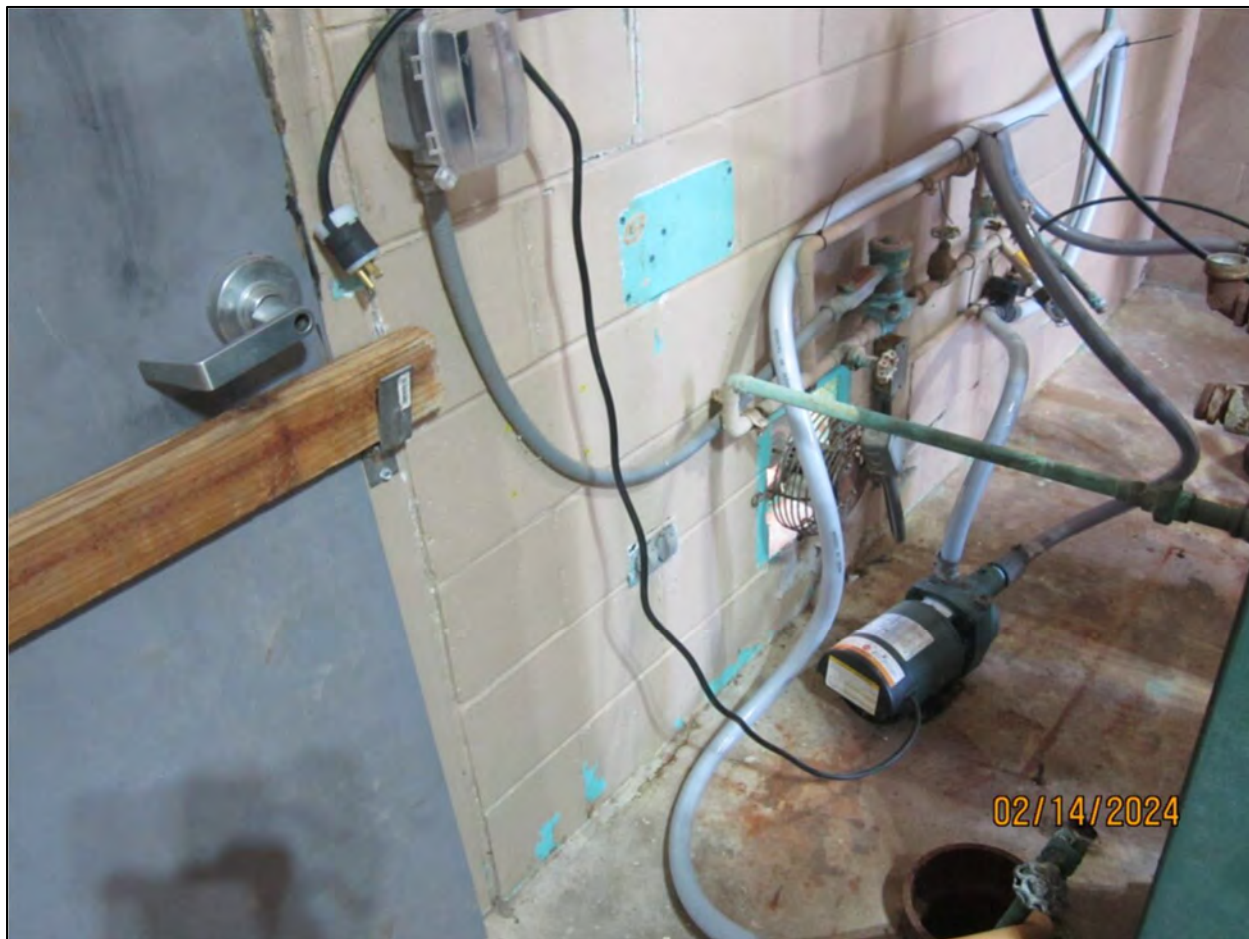
Photo No. 59

The chlorine storage and injection room were observed at the Stephens site. The door to the chlorine room lacked a crash bar and observation window. The room also lacked an alarm system, and a self-contained breathing apparatus or supplied air respirator was not present outside of the room. A threaded hose tap without backflow prevention was observed extending from a finished water line in the chlorine room (refer to [Appendix 1, Photograph 58](#)). During the inspection, the chlorination pump had been manually turned off (unplugged and closed valve) due to the water leak from the tank (refer to [Appendix 1, Photograph 59](#)).

**Photograph 59. 2/14/2024 2:24 PM IMG\_0110.JPG**

**Stephens Site, Chlorine Injection Room** View of the chlorine pump that had been unplugged inside of the chlorine injection room at the Stephens site. The pump was unplugged because the System representatives were in the process of draining the Stephens Tank during the inspection.

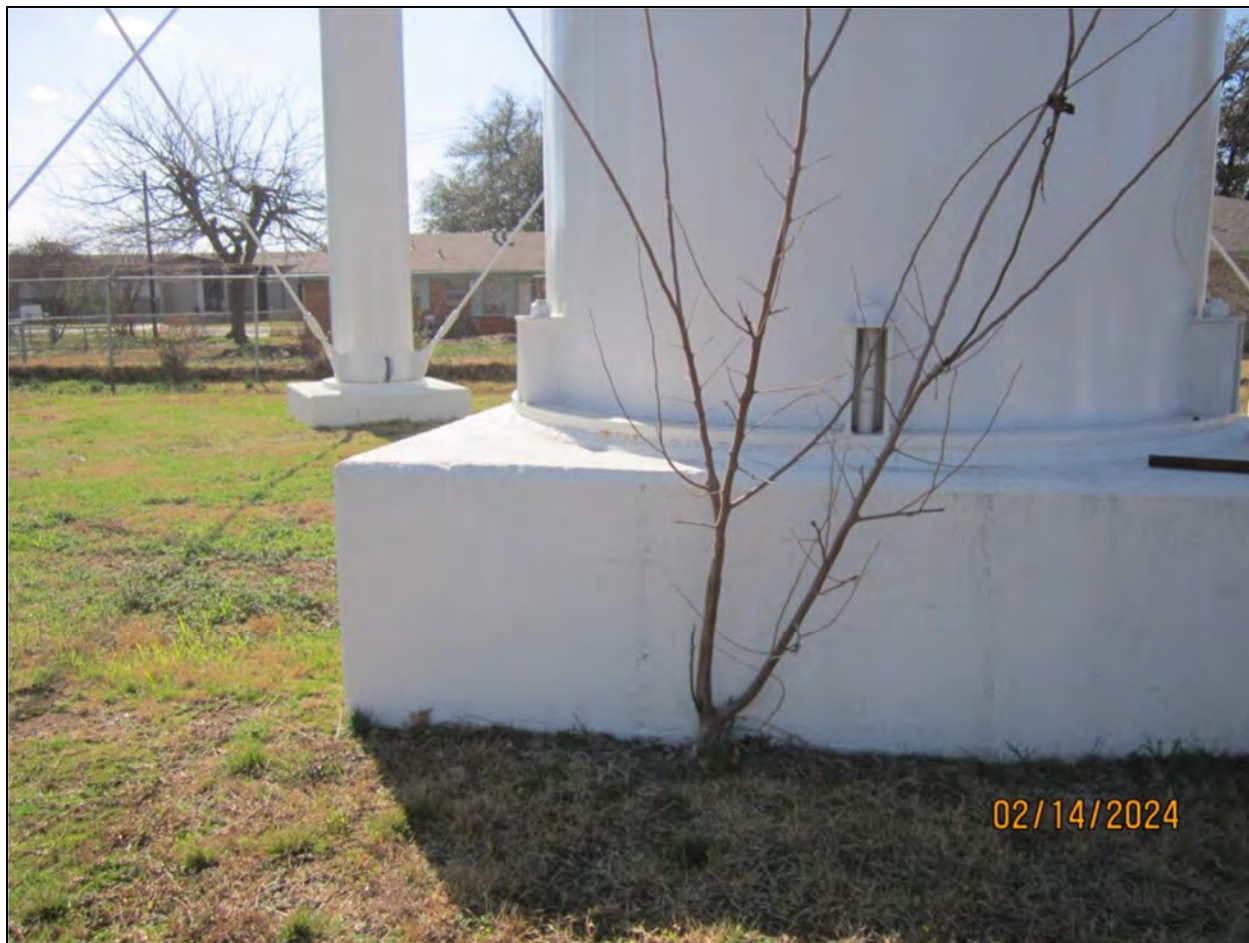
Photo No. 60

The 1 MG elevated Fairview Tower was observed next. The tower was surrounded by a locked perimeter fence with barbed wire. There were multiple small tree branches growing through the ground near the base of the tank, as well as along the fence surrounding the tower (refer to Appendix 1, Photographs 60 and 61). When this observation was made to System representatives, the trees and branches were removed (refer to Appendix 1, Photographs 62 and 63).

**Photograph 60. 2/14/2024 2:49 PM IMG\_0124.JPG**

**Fairview Elevated Tank** View of a small tree growing against the base of center column for the Fairview Elevated Storage Tank.

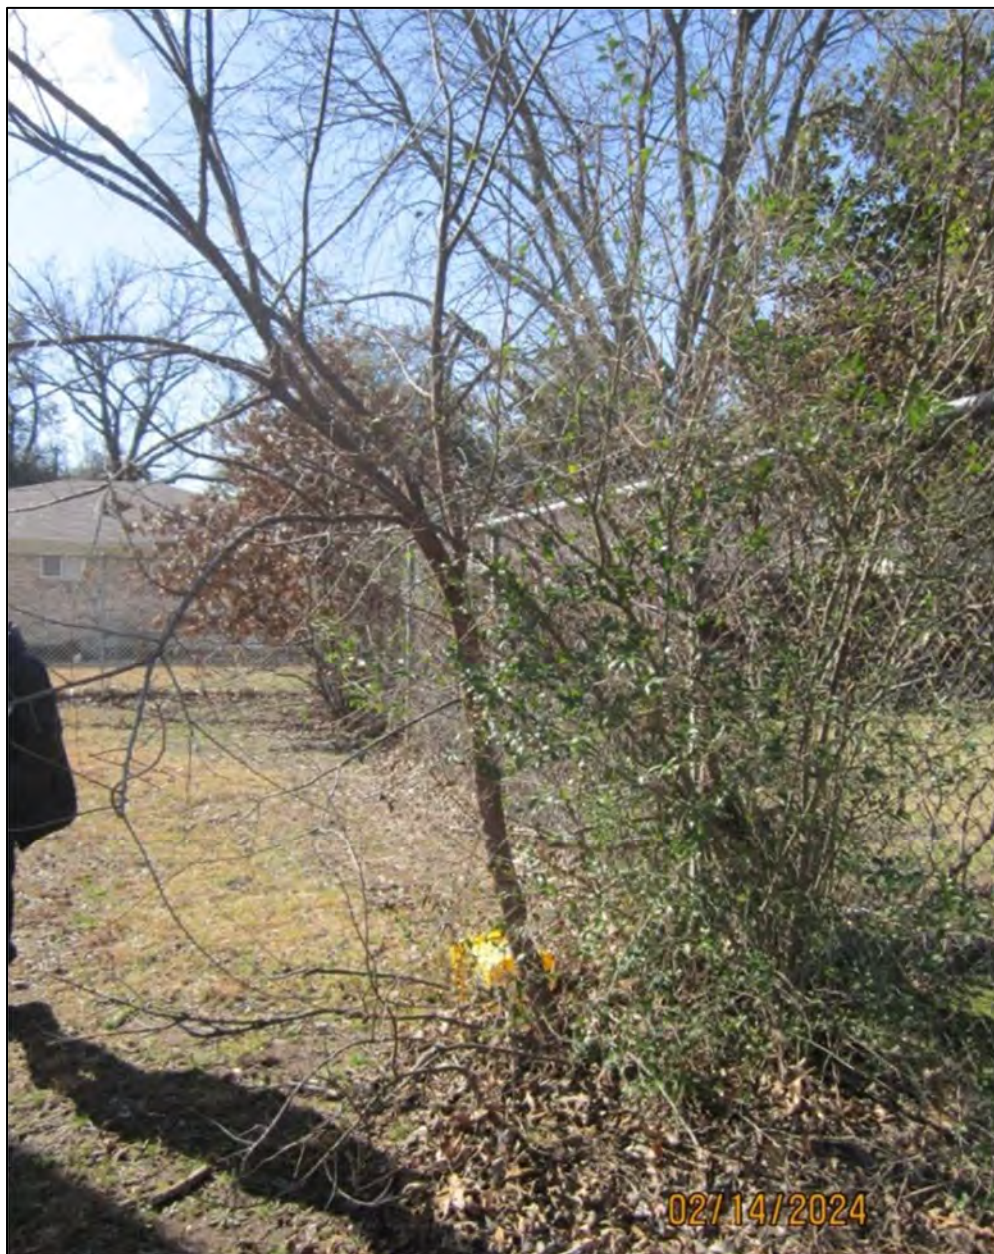
Photo No. 61

**Photograph 61. 2/14/2024 2:50 PM IMG\_0121.JPG**

**Fairview Elevated Tank** View of a tree growing against the fence surrounding the Fairview Elevated Storage Tank.

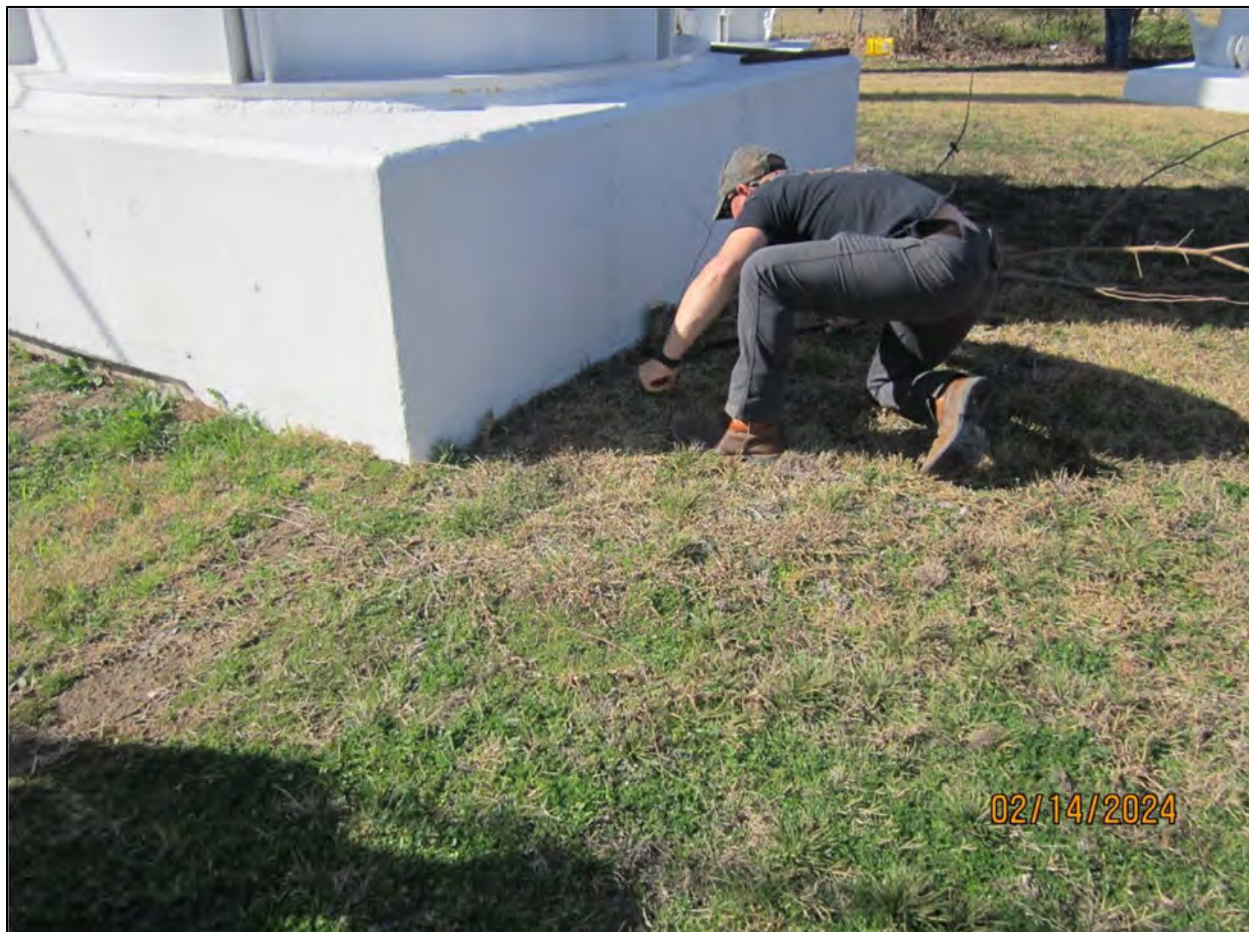
Photo No. 62

**Photograph 62. 2/14/2024 2:52 PM IMG\_0125.JPG**

**Fairview Elevated Tank** View of the tree around the base of the Fairview Elevated Storage Tank being removed.

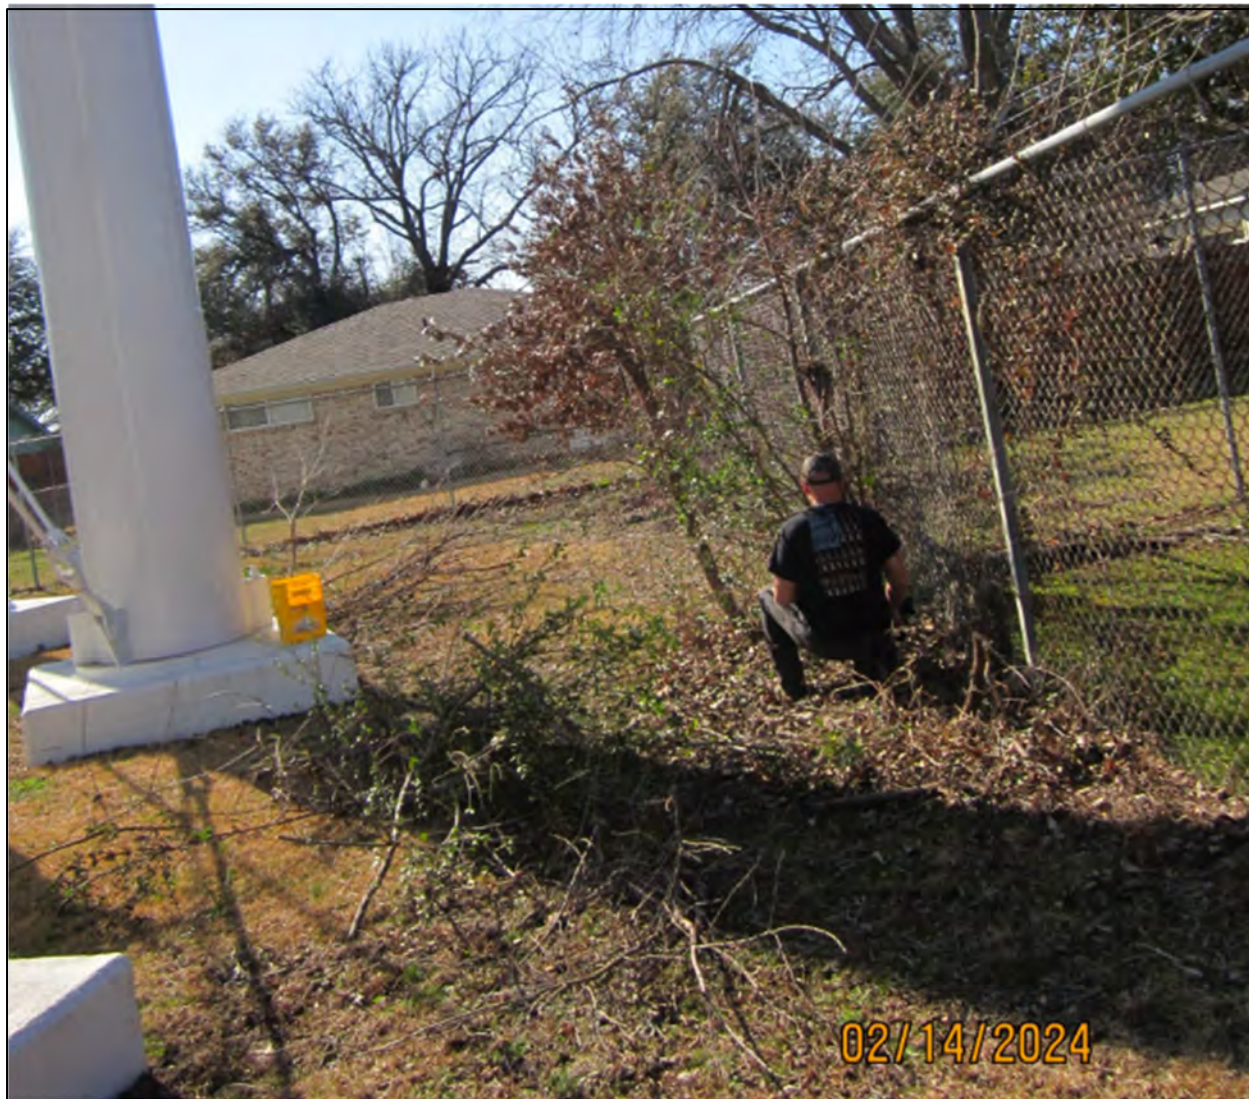
Photo No. 63

**Photograph 63. 2/14/2024 2:55 PM IMG\_0132.JPG**

**Fairview Elevated Tank** View of the tree around the perimeter fence surrounding the Fairview Elevated Storage Tank being removed.

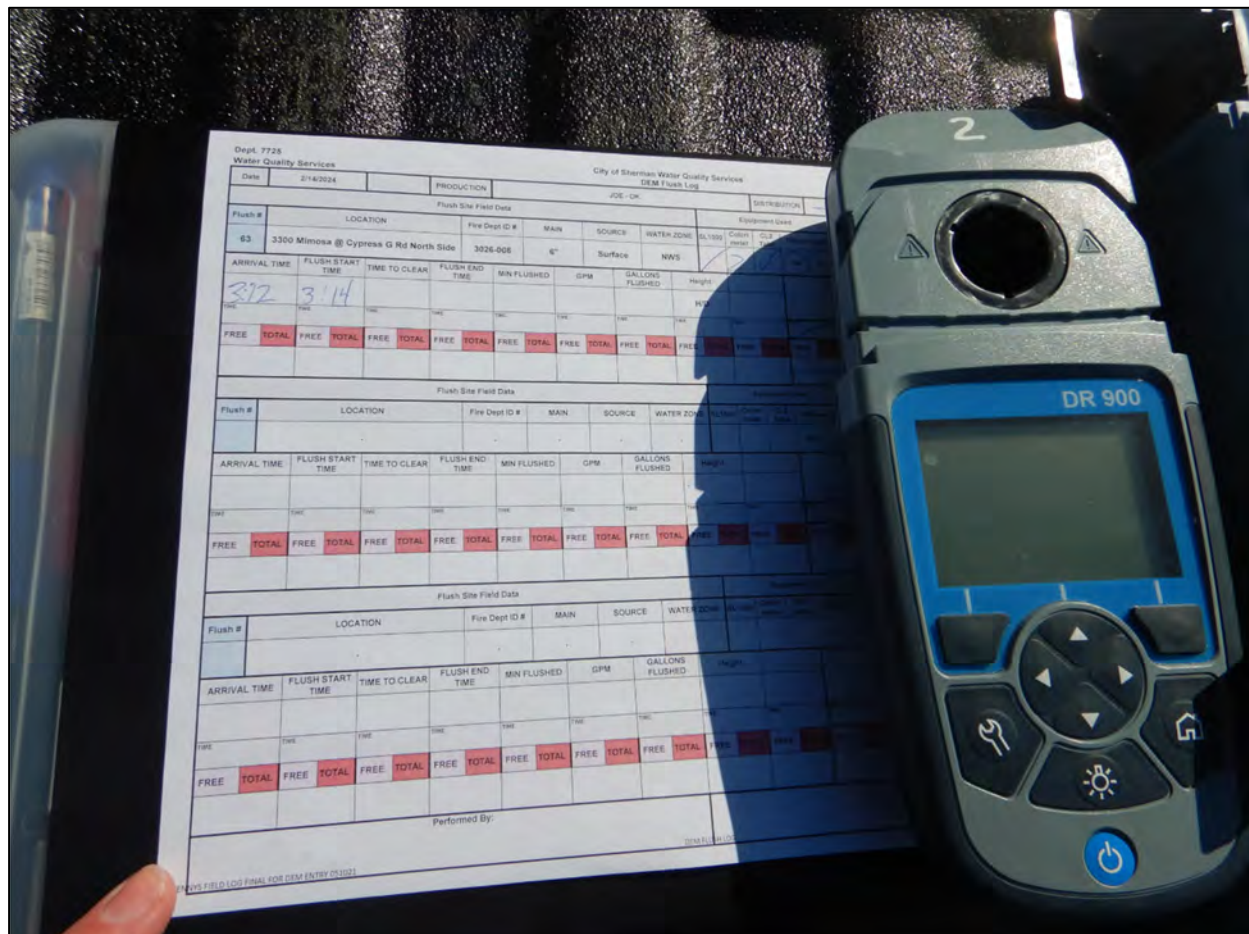
Photo No. 64

As a component of the inspection, the EPA Inspection Team observed a hydrant flushing at the “3300 Mimosa @ Cypress G Rd North Side” hydrant. An operator completed a flushing log during the flushing event (refer to Appendix 1, Photograph 64). A dechlorination diffuser was attached to the hydrant prior to the beginning of the flush. At the start of the flushing event, the water was slightly cloudy but became clear within a minute (refer to Appendix 1, Photograph 65). A Total Chlorine measurement, obtained by the operator after the hydrant had been flushing for multiple minutes, documented a total chlorine residual of 2.95 mg/L (refer to Appendix 1, Photograph 66).

**Photograph 64. 2/14/2024 3:12 PM DSCN9546.JPG**

**Hydrant Flushing Event** View of the flushing log that was filled out by System representatives during the flushing of the "3300 Mimosa @ Cypress G Rd North Side" hydrant.

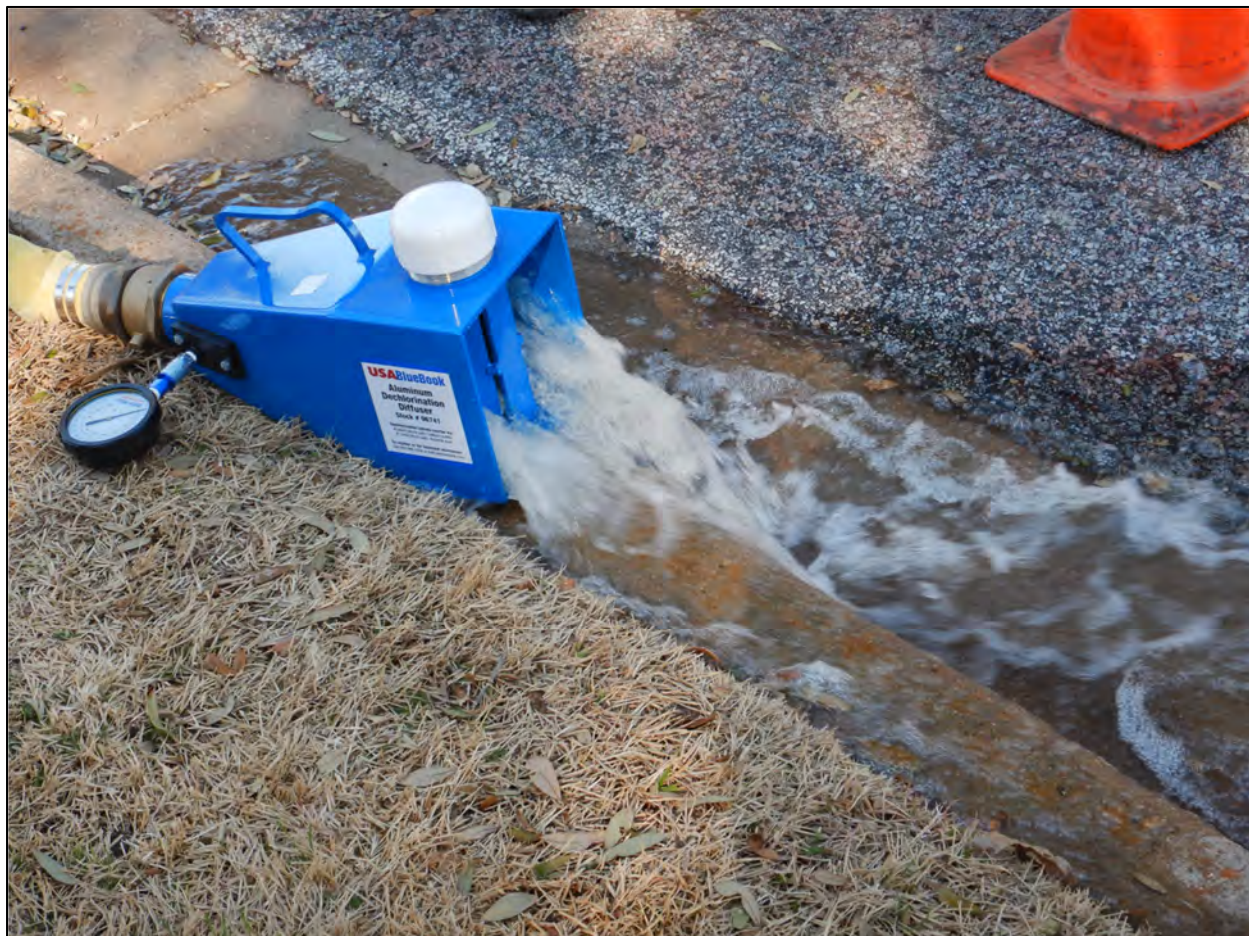
Photo No. 65

**Photograph 65. 2/14/2024 3:12 PM DSCN9553.JPG**

**Hydrant Flushing Event** View of the dechlorinator that was used during the hydrant flushing event observed by the EPA Inspection Team during the inspection. The water that was flushed in the beginning of the event was slightly cloudy but became clear within a minute.

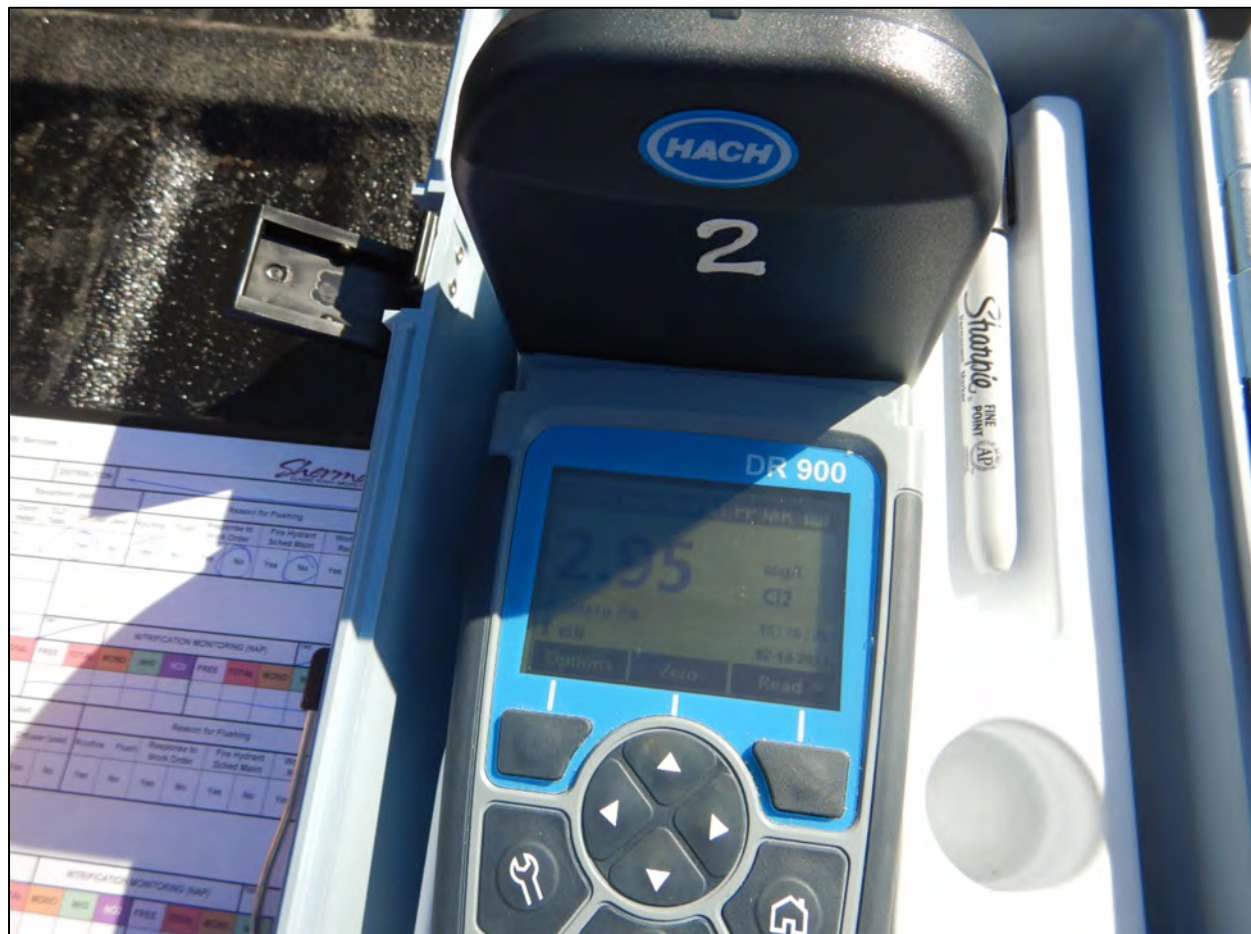
Photo No. 66

**Photograph 66. 2/14/2024 3:18 PM DSCN9562.JPG**

**Hydrant Flushing Event** View of the Total Chlorine result taken at 3:19 p.m. (CT) at the “3300 Mimosa @ Cypress G Rd North Side” hydrant during the flushing event. The Total Chlorine result was 2.95 mg/L.

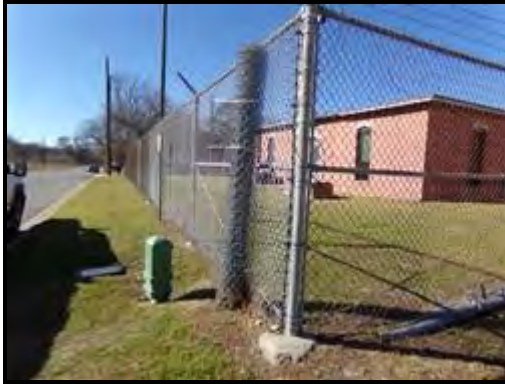
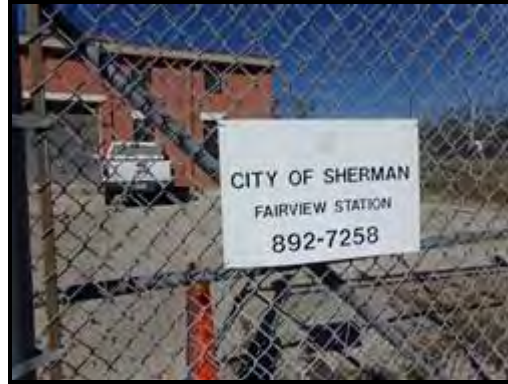
### Security Fence:

This facility is surrounded with a 6-foot chain link and barbed wire security fence that was in good condition at the time of inspection. No abnormalities were reported.

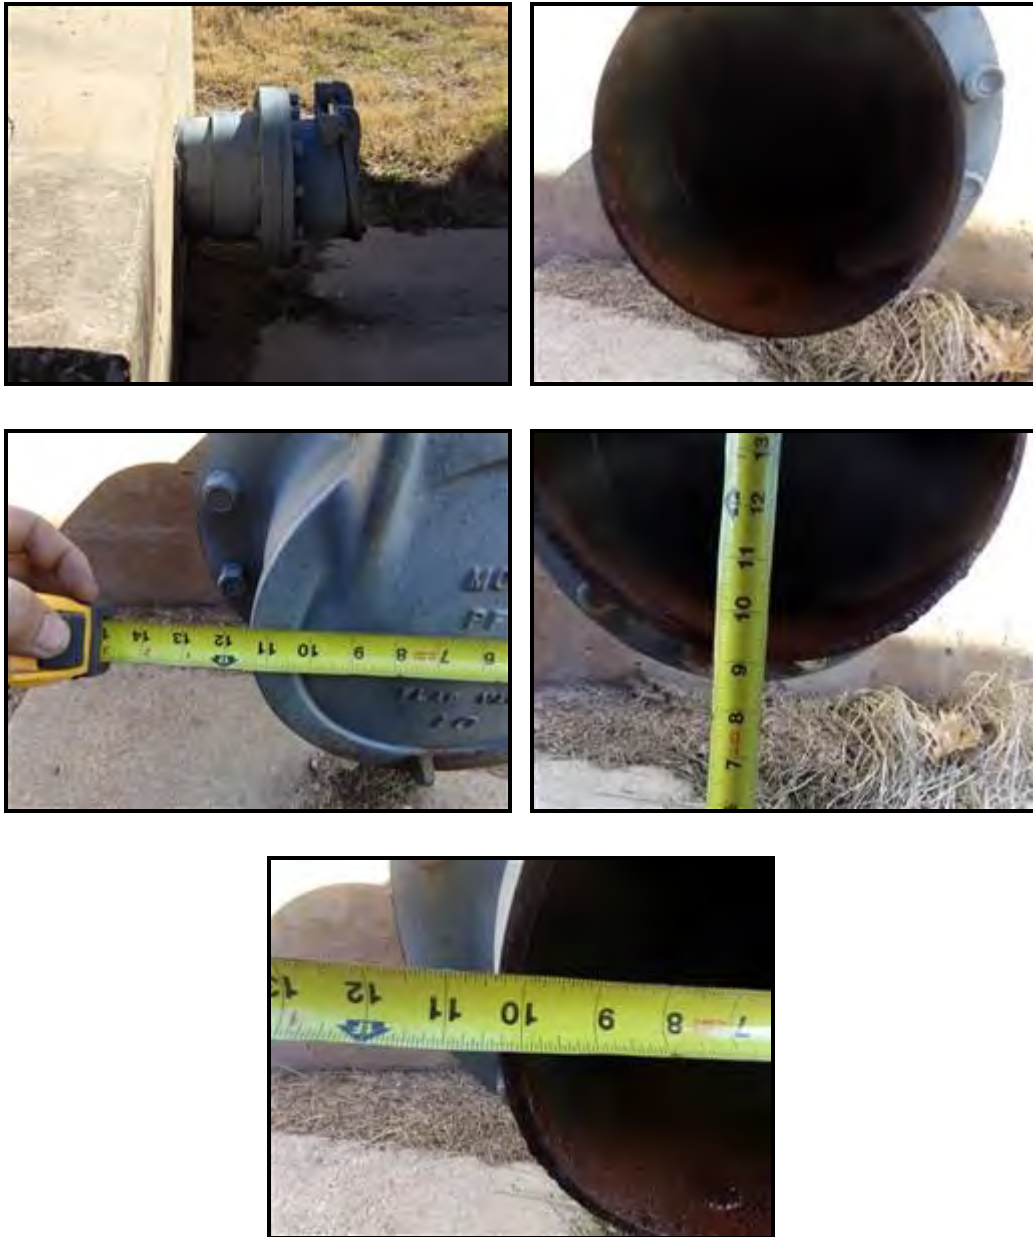
### Overflow Pipe and Flapper:

The overflow pipe and flapper were in fair to good condition. They are located at the ten o'clock position of the facility. The pipe measures 10 inches in diameter and it discharges 9 inches from the ground. The flapper measures 13 inches in diameter and maintains a good seal. Moderate staining was reported inside of the pipe. No abnormalities were reported.

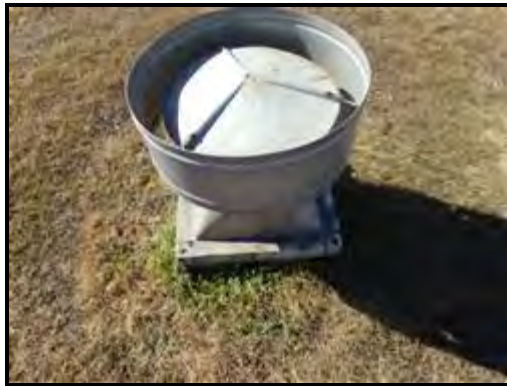
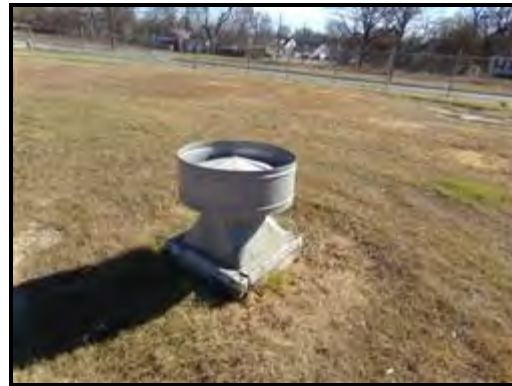
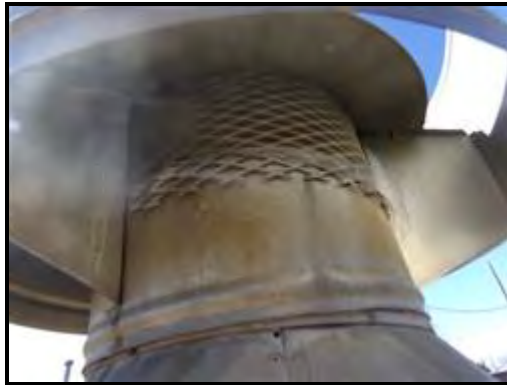
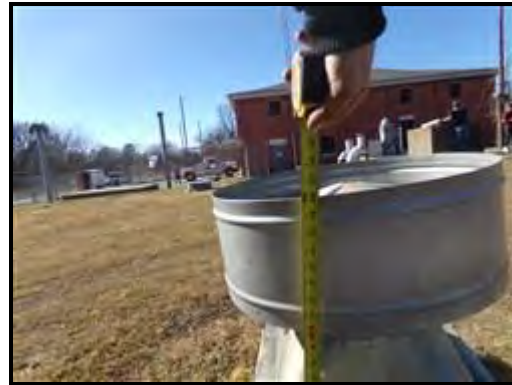
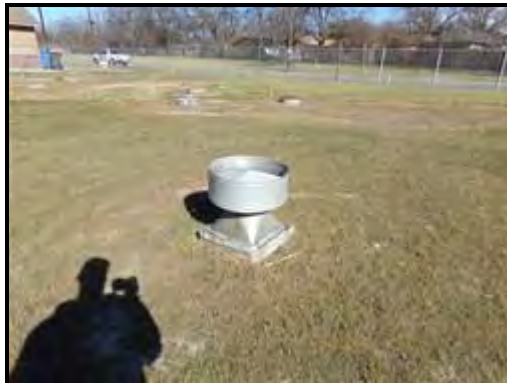
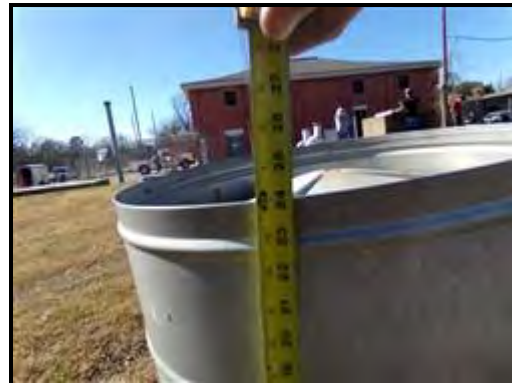
### **Roof Ventilation Structures:**

The two roof ventilation structures were in good condition at the time of inspection. They measure 22 x 22 inches. They are each equipped with a 16-mesh screen that is also in good condition. Light staining was noted. No other abnormalities were reported.

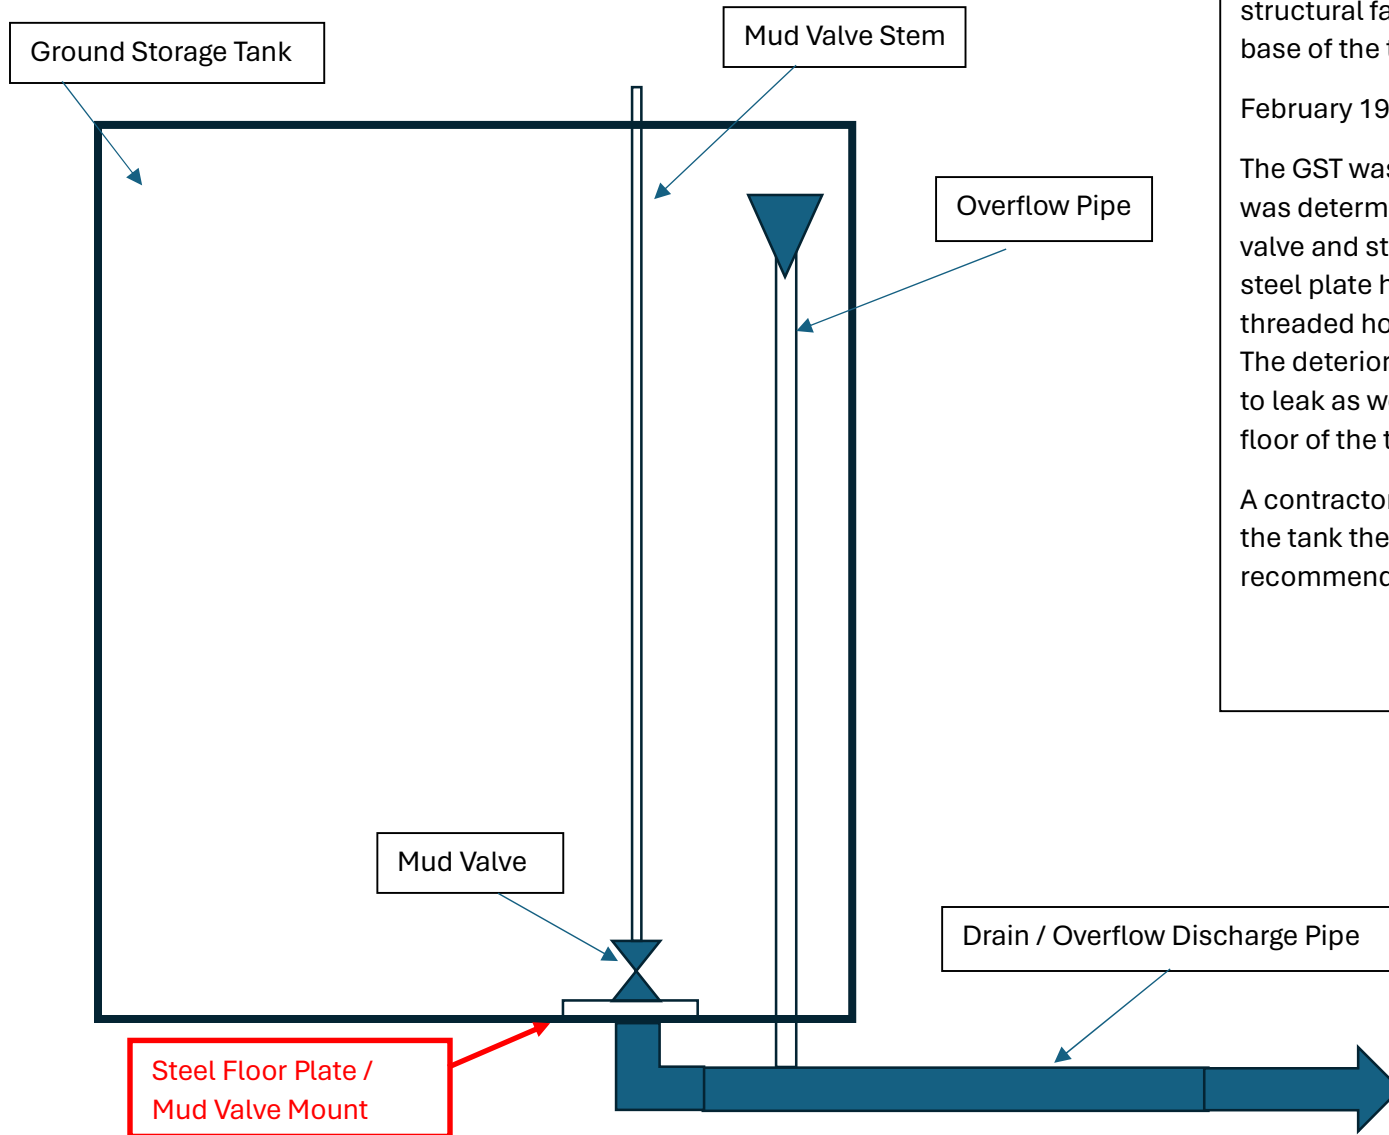
Stephens Pump Station – Ground Storage Tank Leak

Stephens Pump Station GST experienced a structural failure and water was leaking at the base of the tank.

A contractor has been scheduled to inspect the tank the week of 3/4/24 and provide recommendations for the repair.
