## Region 6 - Enforcement & Compliance Assurance Division

### INSPECTION REPORT

| <b>System Owner:</b> | City of Sherman | |
| <b>System Name:</b> | City of Sherman Public Water System (PWS) | |

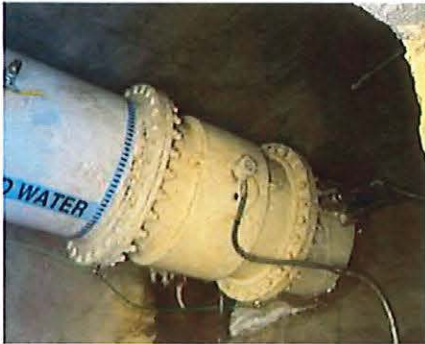
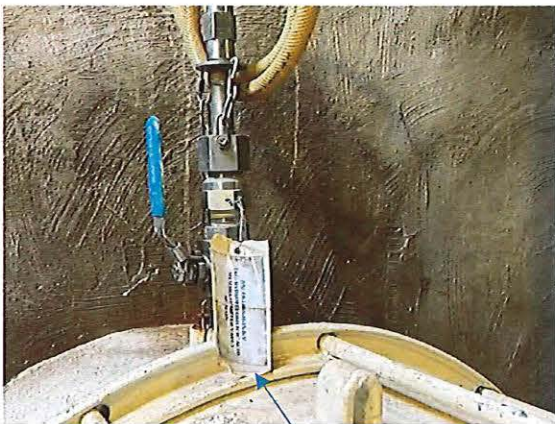
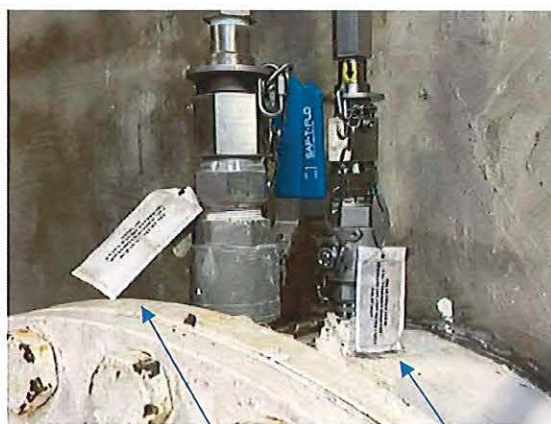
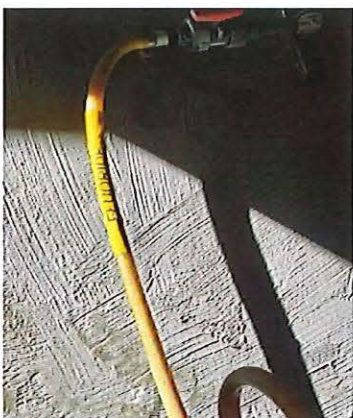
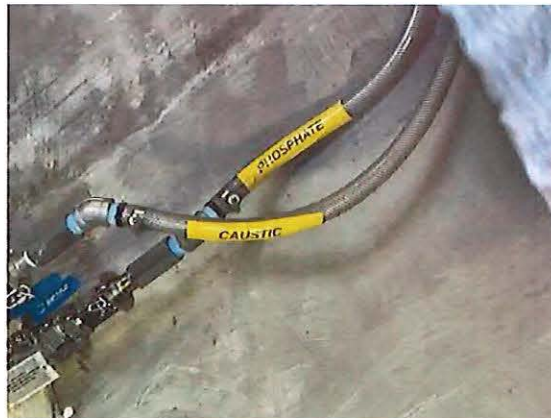
MEMBRANE EFFLUENT VAULT: Chemical injection lines appear to not be labeled

Chemical injection lines had tags labeling the chemical injection during inspection but difficult to see from the hatch.

North – Fluoride Injection Tag

South – Caustic Injection Tag

South – Phosphate Injection Tag

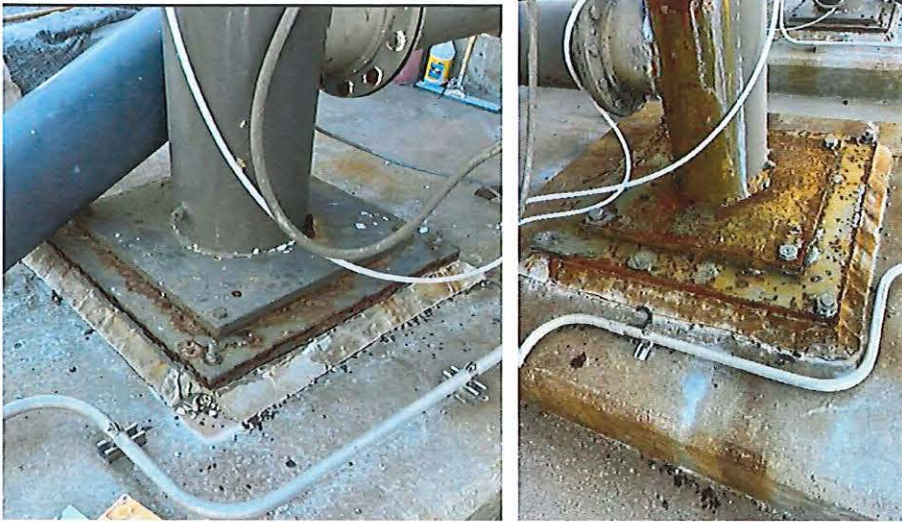
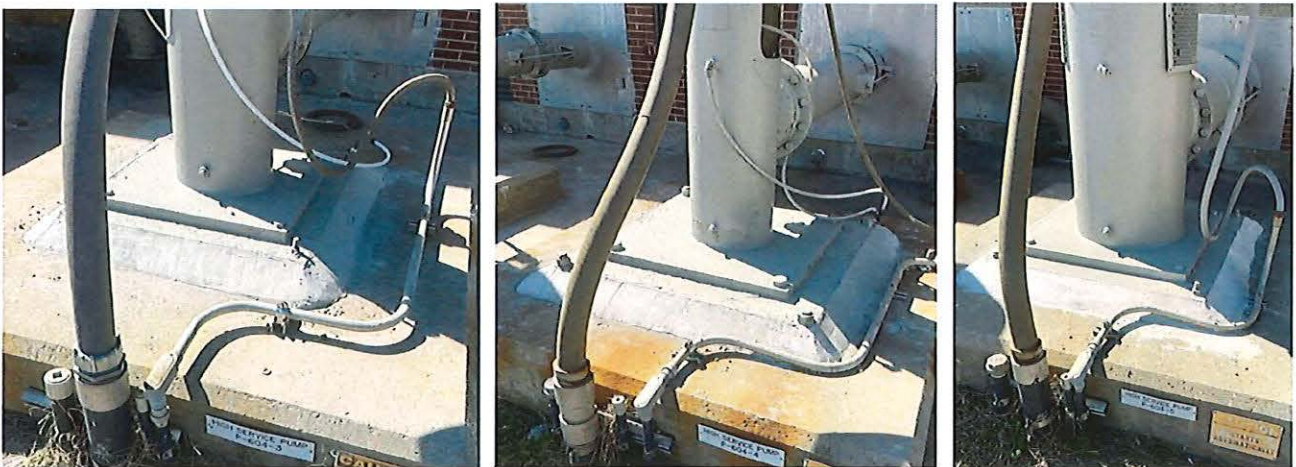
HSP 4-5

HIGH SERVICE PUMPS: Grout deterioration and paint flaking

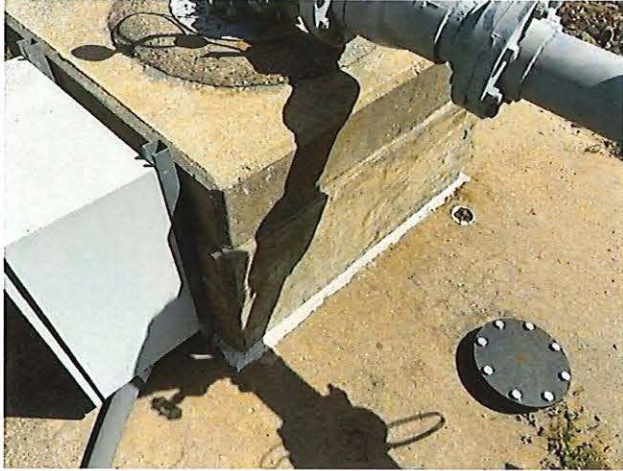
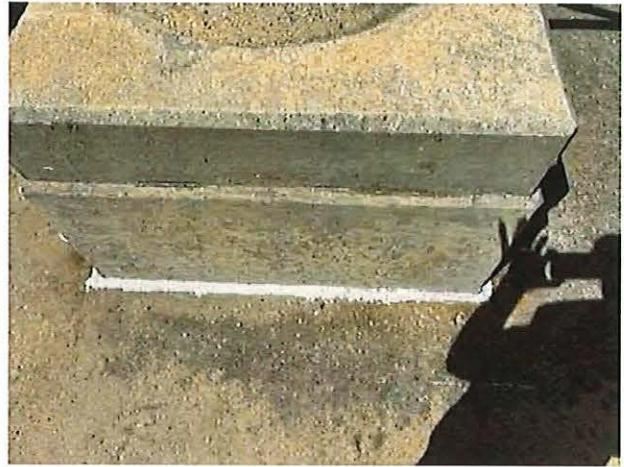
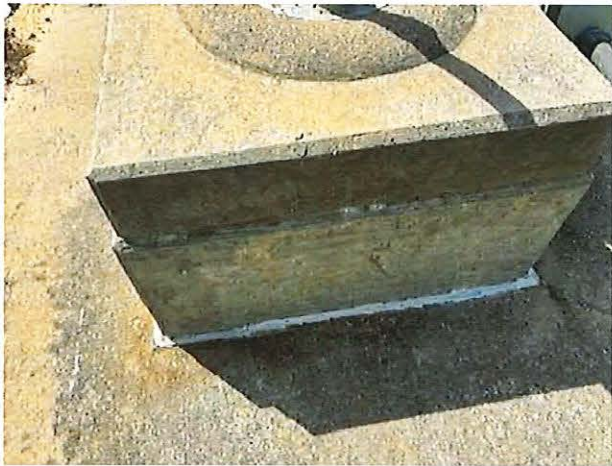
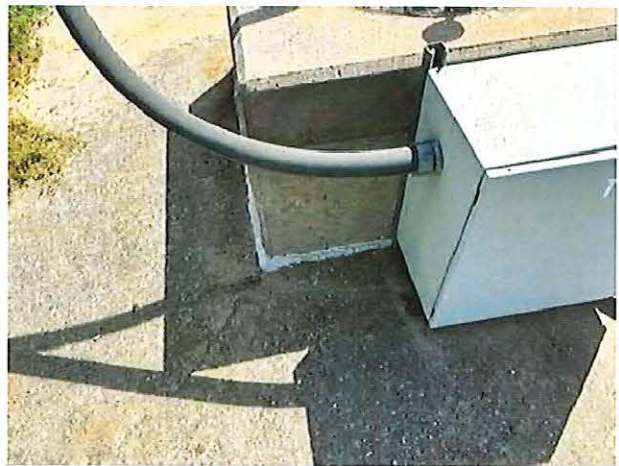
Following the Fairview Tank, Well G0910006Q was observed at the Fairview site (refer to [Appendix 1, Photograph 44](#)). The well was operational but not in use during the inspection. There was a gap between the base of the well pedestal and the well pad (refer to [Appendix 1, Photograph 45](#)).

- d. There was a gap between the base of the well pedestal and the well pad (refer to [Appendix 1, Photograph 45](#)).
- e. There was an unattached open port inside of the chlorine injection vault next to the Fairview Tank, and operators were unsure of the port's use (refer to [Appendix 1, Photograph 48](#)). There were also signs of past flooding and/or water accumulation inside of the vault (i.e., water marks, mud cracks).

Fairview Site – Gap between the base of the well pedestal and well pad

Before: See EPA Inspection Report Appendix 1 Photo Log–Photo 45

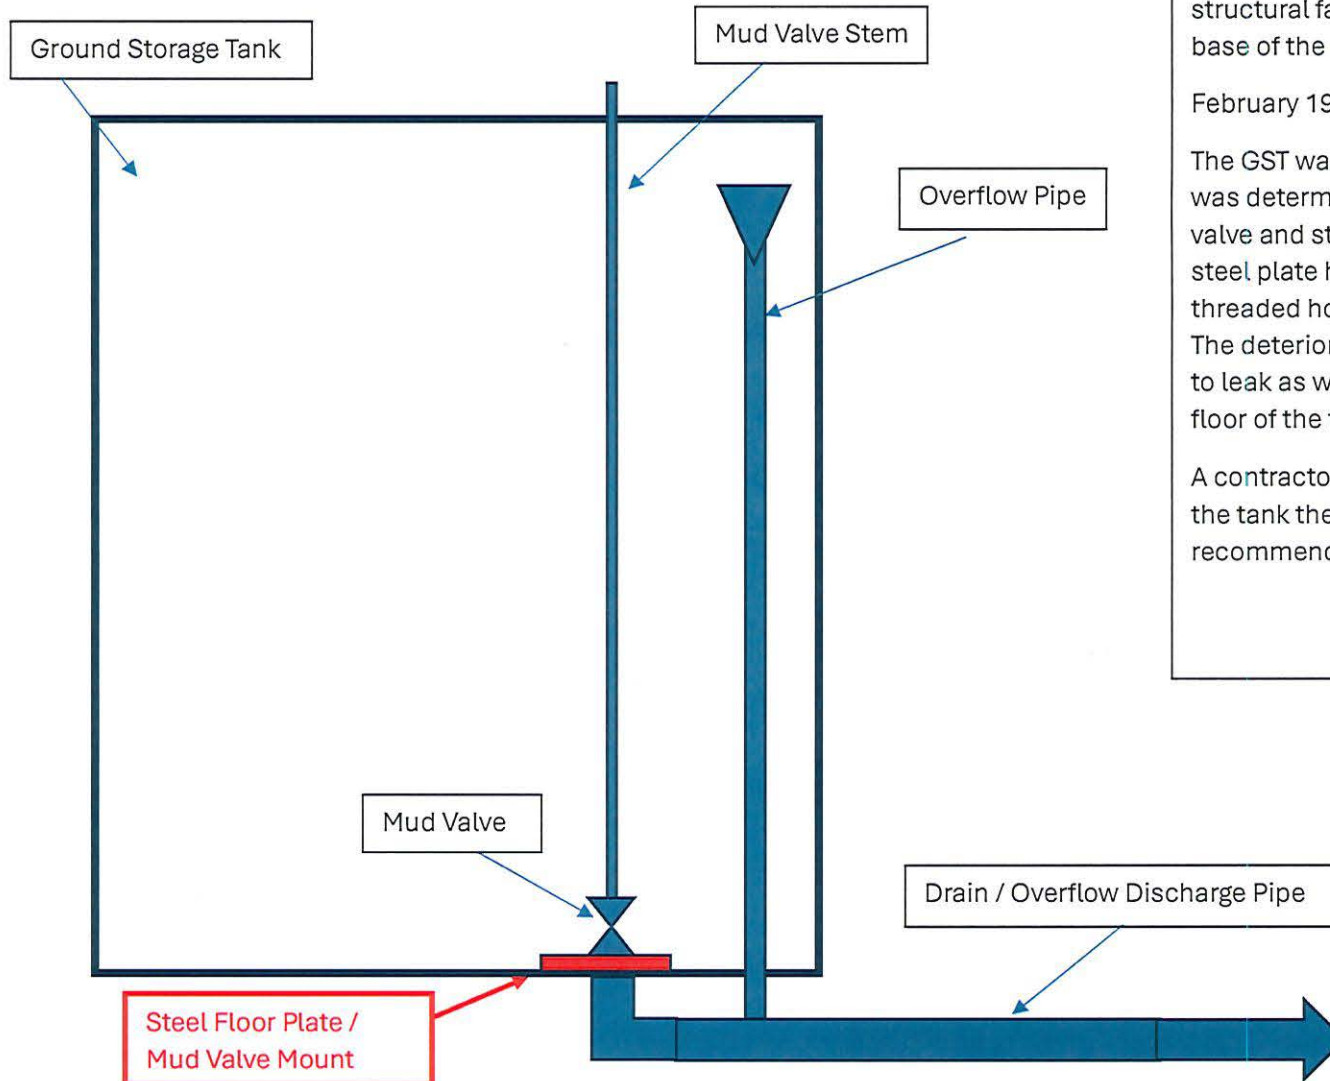
Stephens Pump Station – Ground Storage Tank L

Stephens Pump Station GST experienced a structural failure and water was leaking at the base of the tank.

The GST was drained for inspection. The leak was determined to be at the base of the mud valve and steel floor plate. It appears that the steel plate has deteriorated at and around the threaded holes used to fasten the mud valve. The deterioration allowed the mud valve seal to leak as well as water to pass through the floor of the tank.

A contractor has been scheduled to inspect the tank the week of 3/4/24 and provide recommendations for the repair.

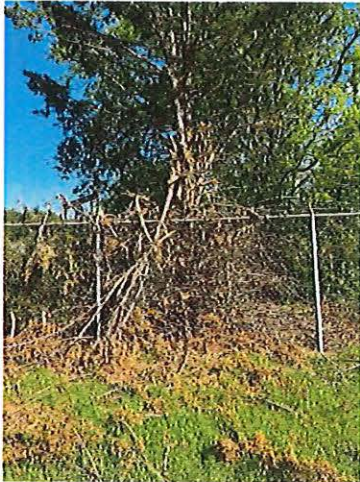
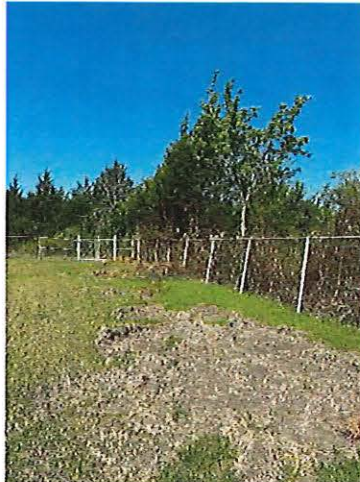
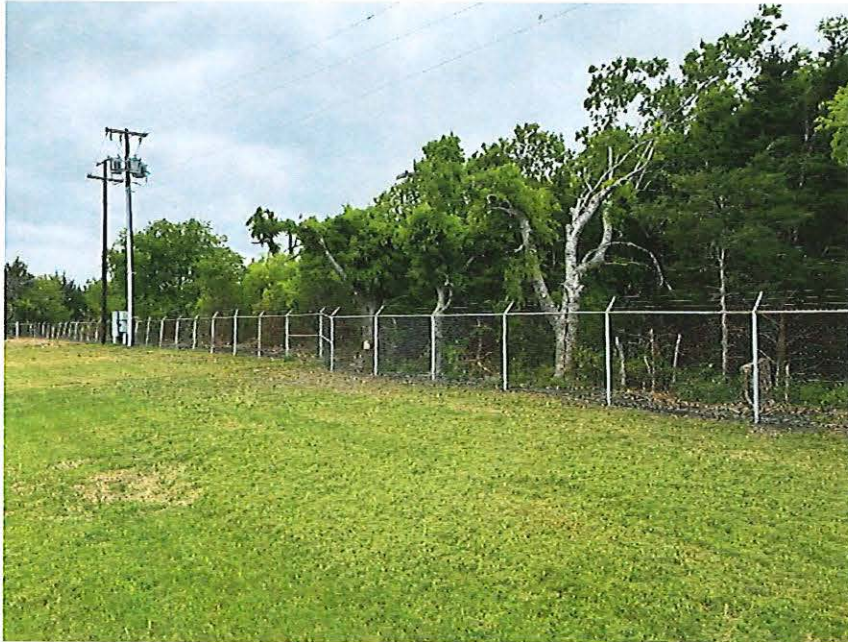
- c. There was graffiti that had been painted over on the side of the Stephens Tank. System representatives indicated that they had experienced challenges with intruders at the Stephens site in the past. There were multiple trees growing around/through the fence line at the Stephens site, potentially compromising the intruder resistance of the fence (refer to Appendix 1, Photograph 49). The Stephens tank ladder lacked a locked ladder shield, and the ladder extended all the way to the ground.

Stephens GW Pump Station Security Improvement – Vegetation in/on the fence

Action: The vegetation growing through and on the security fence has been removed.
