## RCRA COMPLIANCE EVALUATION INSPECTION REPORT

TAV Holdings, Inc.  
3311 Empire Boulevard SW  
Atlanta, Georgia 30354  
EPA ID # GAD033537663

October 6, 2021

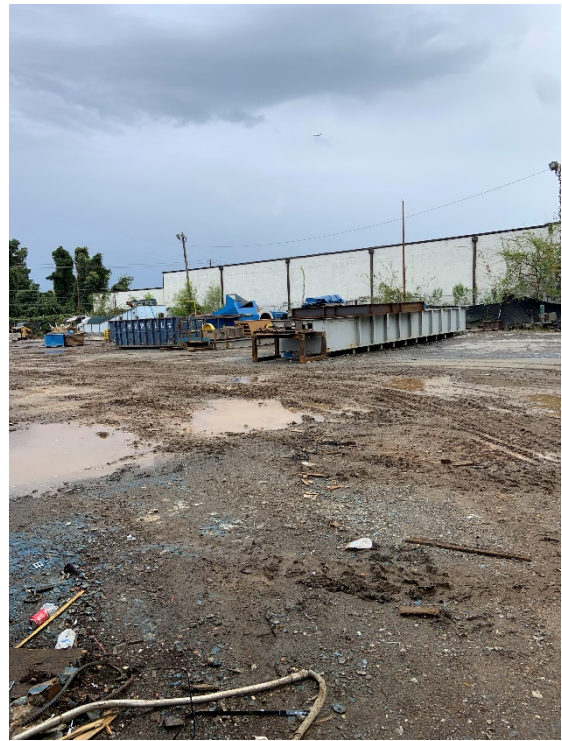
*Figure 13: IMG\_3082.jpg – Staining on ground of Fabrication*

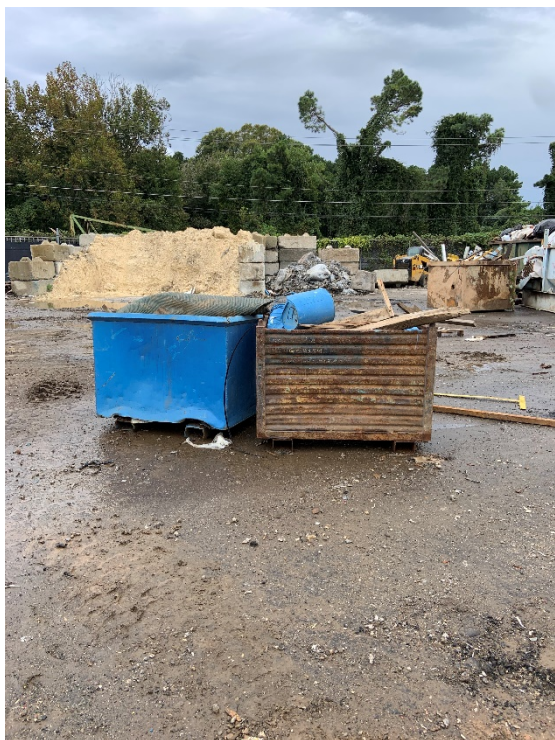
*Figure 18: IMG\_3087.jpg- Contents of Dumpster in rear of Fabrication Building*

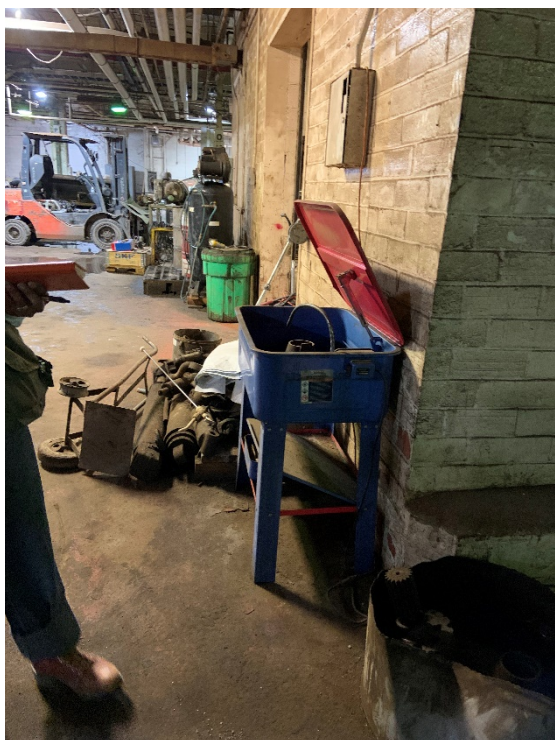
*Figure 24: IMG\_3093.jpg – Lead acid batteries*

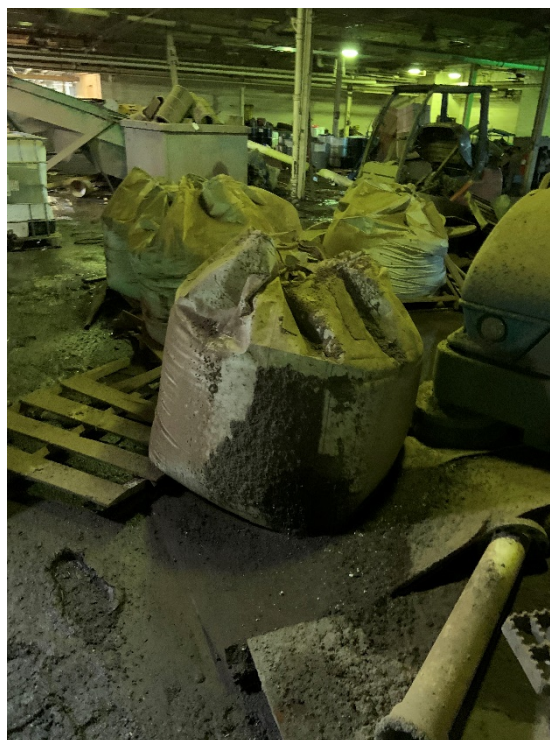
*Figure 41: IMG\_3110.jpg- Containers of unknown waste in the Keebler Building*

*Figure 42: IMG\_3111.jpg- Containers of unknown waste in the Keebler Building*

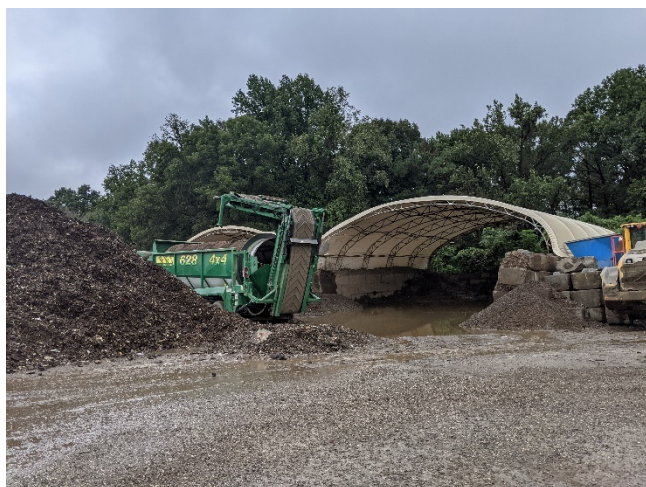
The facility tour began in the receiving area. Several piles of ASR, solid waste, were observed in this area (Figures 48 and 49). The solid waste in this area is stored in open piles that are exposed to weather elements. The area had received rainfall in the days prior to the inspection and the solid waste piles were wet. Water contaminated with small particles was observed flowing from the south to the north where the outdoor processing, storage and Receiving Area are located. The water was observed to be pooling in the area immediately east of the Receiving Area (Figures 87 and 88). This area is known as the Jig Storage.

Figure 48: PXL\_20211006\_140722625.jpg – Receiving Area

*Figure 49: PXL\_20211006\_140801482.jpg –  
Receiving Area*

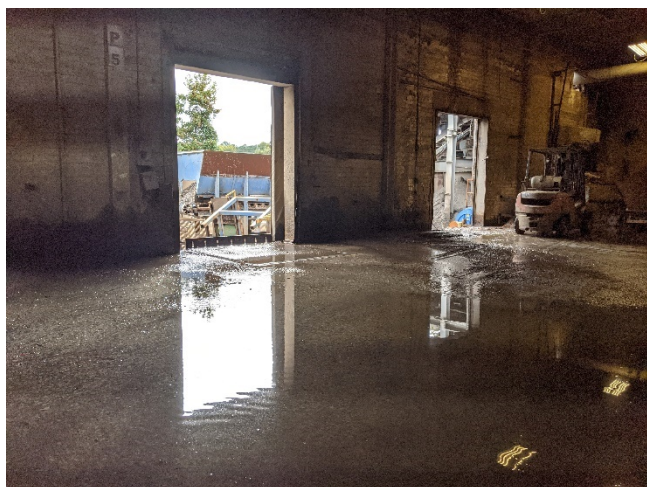
The processes all include the use of water. The facility collects stormwater in several areas at the facility and uses it in the processes. Much of the process water is swept out the doors of the process building, where it accumulates in low lying areas and it is pumped to a tank where flocculant is added to aid in the precipitation of solids from the water. The solids are removed by a backhoe and placed back into the processing. From the clarifier the water is pumped to a large tank. At the time of the CEI, the clarifier and the tank were observed to be overflowing. The secondary containment in the Wastewater Treatment (WWT) Area could not be properly inspected due to the accumulation of sludge on the surface. Figures 71 – 79 illustrate the condition of this area at the time of the CEI.

*Figure 57: PXL\_20211006\_143449364.jpg – Process wastewater leaving the building*

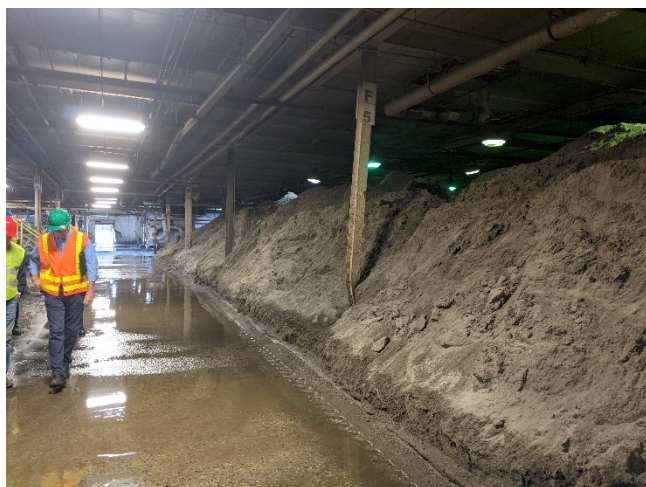
The area to the northwest of the WWT Area is used to store this material. The facility claims that the solid waste material continues to contain recoverable metals. However, the inspectors observed that the material is being allowed to wash offsite with stormwater. The facility has failed to manage the material as a commodity.

*Figure 60: PXL\_20211006\_145602623.jpg – Solid Waste stored near the Wastewater Treatment area*

*Figure 61: PXL\_20211006\_145612675.MP.jpg – Solid Waste stored near the Waste Water Treatment area*

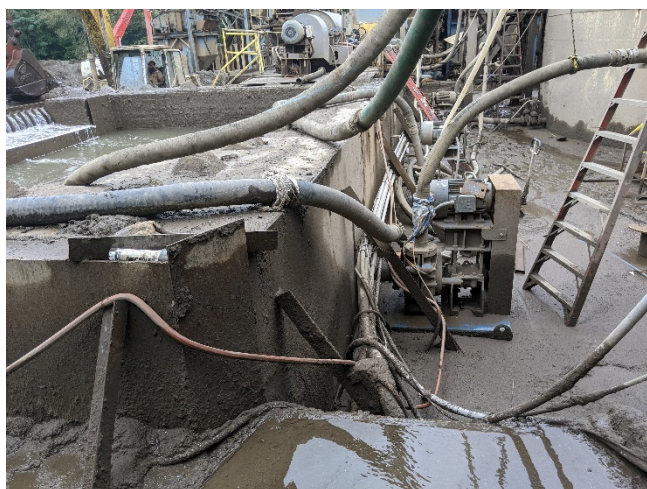
*Figure 66: PXL\_20211006\_145946590.jpg – Process wastewater and sludge flowing from the process onto the ground in the wastewater treatment area*

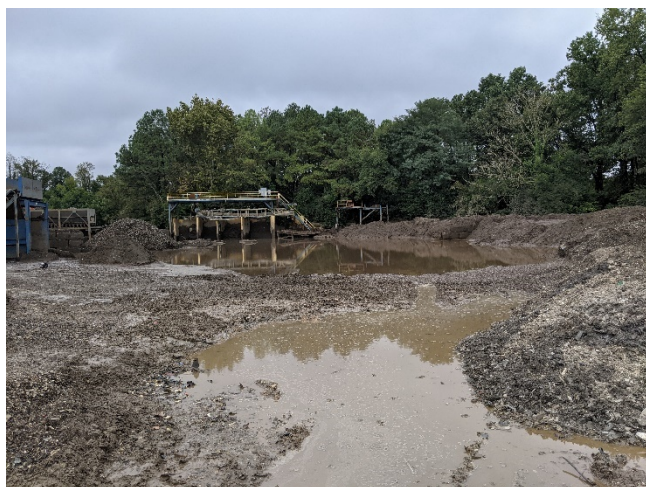
*Figure 86: PXL\_20211006\_152333693.jpg –  
Plugged up Stormwater drain*

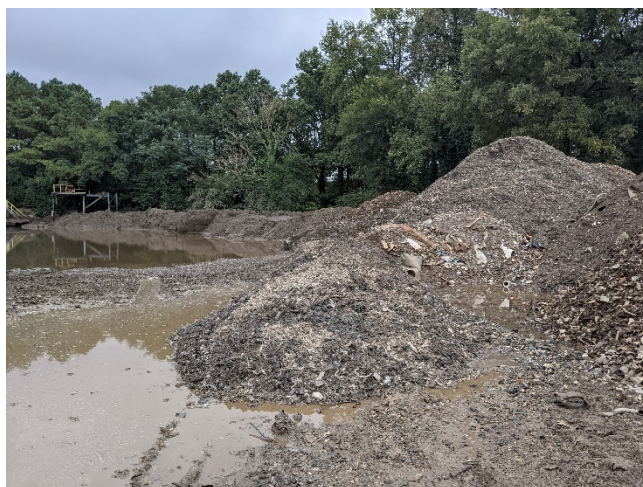
*Figure 87: PXL\_20211006\_153116223.jpg –  
Receiving Area*

The inspectors reviewed the sources of the water and found that stormwater and operation process water, from the processing of the solid waste, was being swept out of the building. Due to holes in the roof and inadequate containment, both sources of water flow through the facility from south to north and collect in the asphalt area seen in Figures 87 and 88.

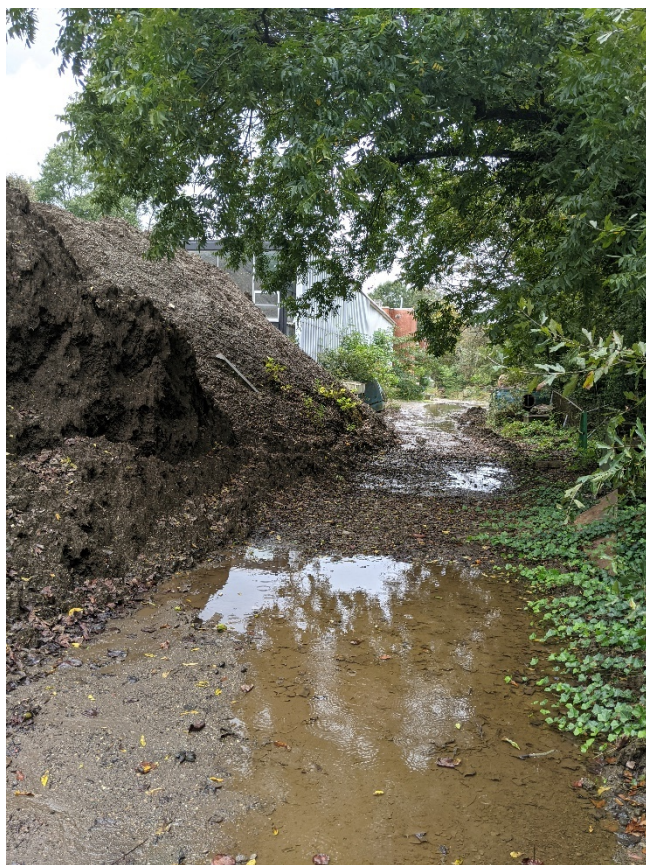
*Figure 96: PXL\_20211006\_180949101.jpg - Rear side of solid waste pile near Outfall 3*

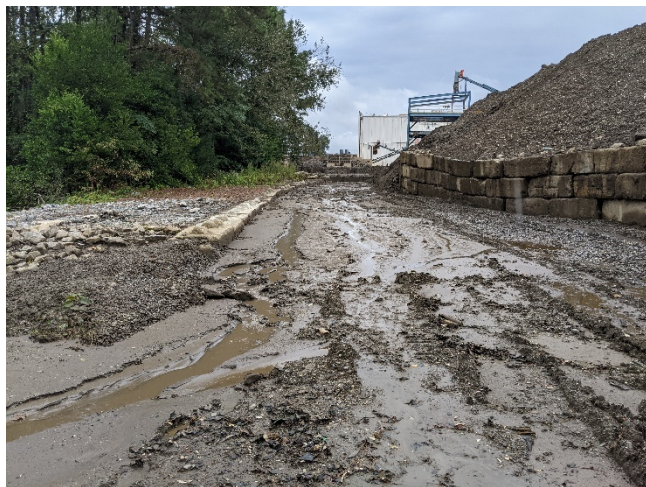
*Figure 100: PXL\_20211006\_181257842.jpg –  
Outfall 3*

The inspectors observed Outfall 003. The area had a large concrete tank/settling basin that appeared to be used to separate solids from liquids. At the time of the CEI the basin was completely full of sludge. Evidence of stormwater and sludge overflowing the basin and by-passing the Outfall can be seen in Figures 100-106.
