**Region 6 Compliance Assurance and Enforcement Division  
INSPECTION REPORT**

| Inspection Date(s): | 4/25/2024 | | |
| Company Name: | <b>Entergy Louisiana, LLC</b> | | |
| Facility Name: | <b>Perryville Generating Station (PGP)</b> | | |

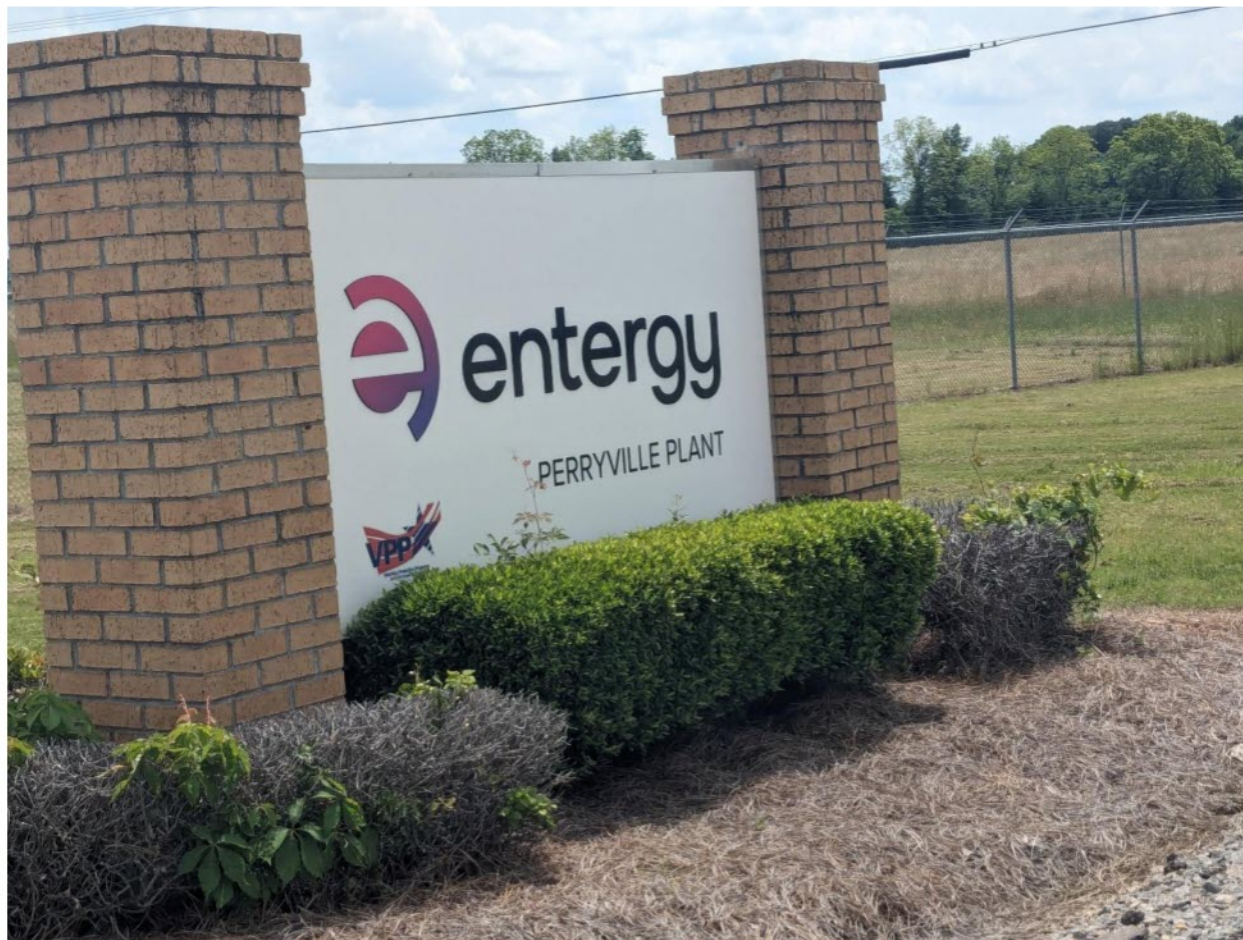
Photo No. 1

Photograph File Name: EntryFacility.JPG  
Date of Photograph: 04/25/2024  
Latitude and Longitud: 32.692274 -92.020441  
Orientation: N  
Map Datum: WGS-84  
Time of Photo: 09:00 AM  
Photographer: Jack Arias  
Description: This image shows the name and entrance of the facility.

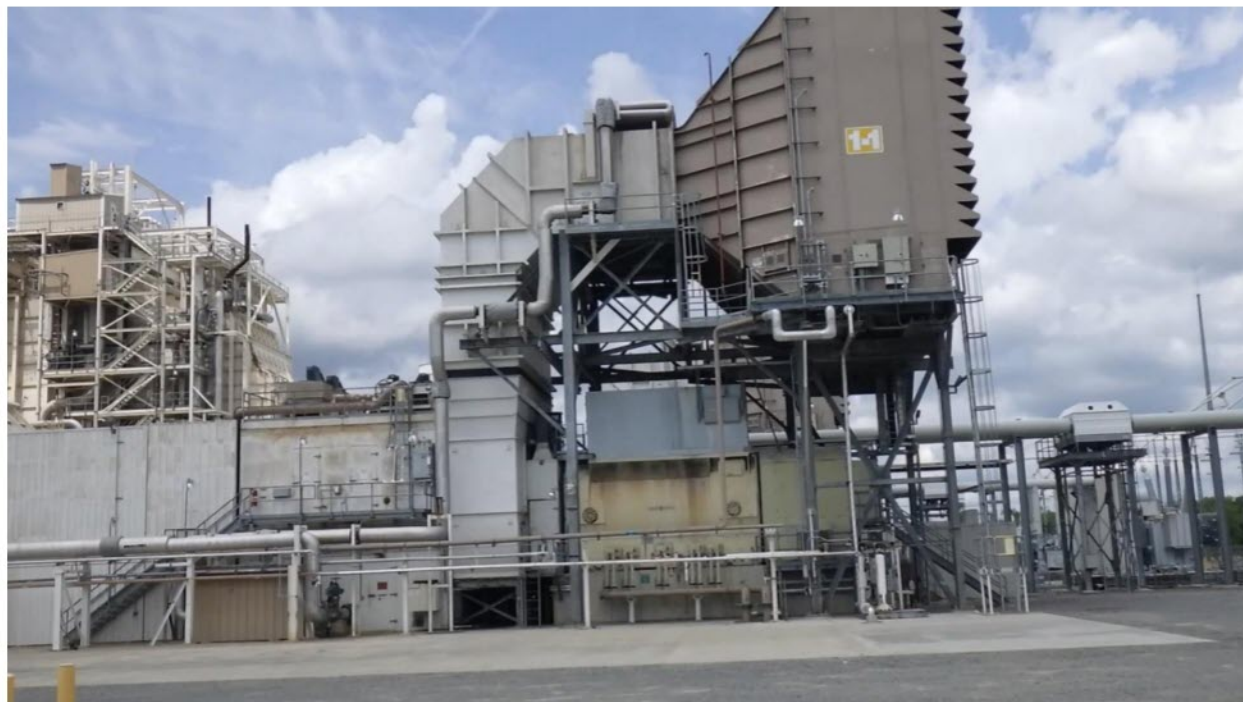
Photograph File Name: CombustionSystem.JPG  
Date of Photograph: 04/25/2024  
Latitude and Longitud: 32.691122 -92.017733  
Orientation: SW  
Map Datum: WGS-84  
Time of Photo: 11:04 AM  
Photographer: Jack Arias  
Description: This image shows the combustion system.
