**U.S. ENVIRONMENTAL PROTECTION AGENCY  
REGION III WATER BRANCH, ENFORCEMENT  
AND COMPLIANCE ASSURANCE DIVISION  
CLEAN WATER ACT  
COMPLIANCE INSPECTION REPORT**

**Name of Facility:** Shenandoah Wastewater Treatment Plant  
**Facility Address:** 3 Mount Olive Blvd. Shenandoah, PA 17976  
**Mailing Address:** 424 Raven Run Rd. Shenandoah, PA 17976

Report Prepared on: December 21, 2023 By: Mike Beck,  
Date Signature

**DSB-ID:** ECAD-5366

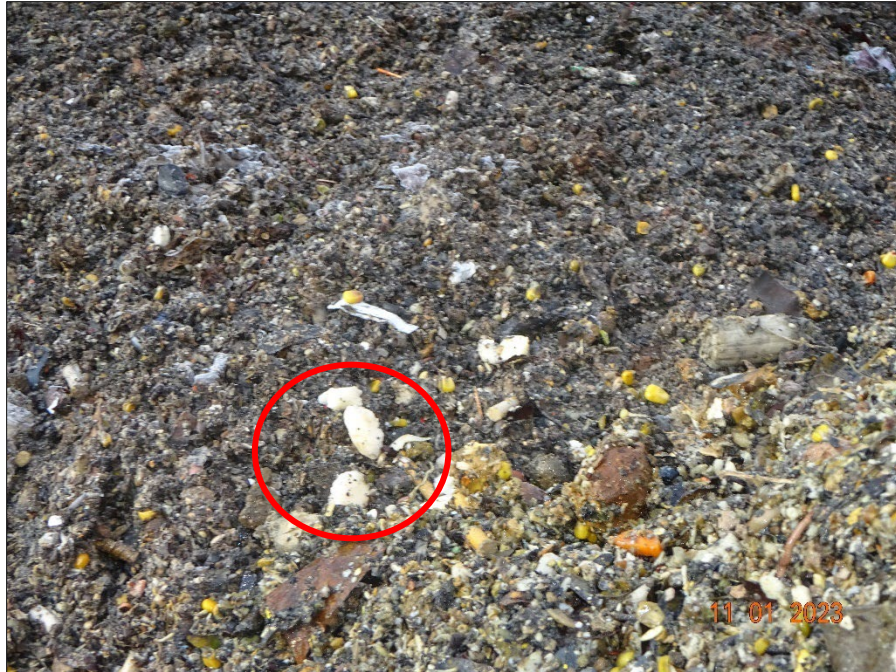
Photograph 5. DSC04870.JPG

**Observation 12.** Significant industrial user: Mrs. T's Pierogies actively contributes to the system. Some monitoring has been done by SMSA and Mrs. T's however the Plant is periodically receiving full pierogies at the influent bar screen. Additionally, SMSA does not always receive the discharge report from the discharger (see Appendix B Photograph 5 and Photograph 47). SMSA reports that some limits have been enforced mostly through surcharges, but minimal enforcement has been undertaken.

Description: Mrs. T's Perogies collected at the influent bar screen.

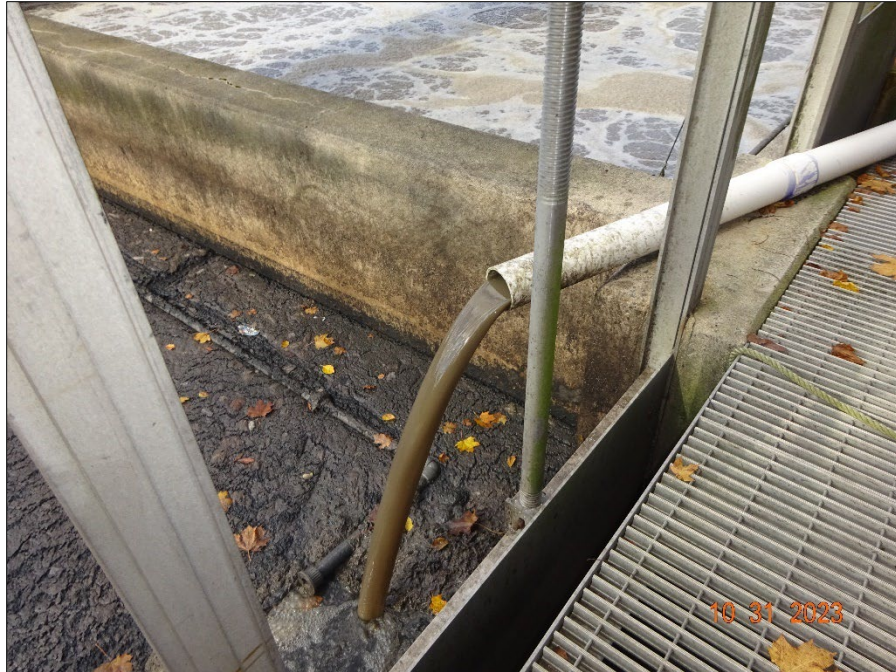
**Observation 3.** At the time of inspection, the sludge press was offline, Aeration Basin 2 was currently being used for sludge holding and decant thickening before the sludge is sent to the anaerobic digesters or hauled offsite (see Appendix B Photograph 14). Portable pumps and temporary lines were used to move wastewater and sludge to the digesters and Aeration Basin 2. Per the operational staff, both digester units have been reported to be down since the summer.

Photograph 15. DSC04782.JPG  
Description: WAS line draining into Aeration Basin 2.

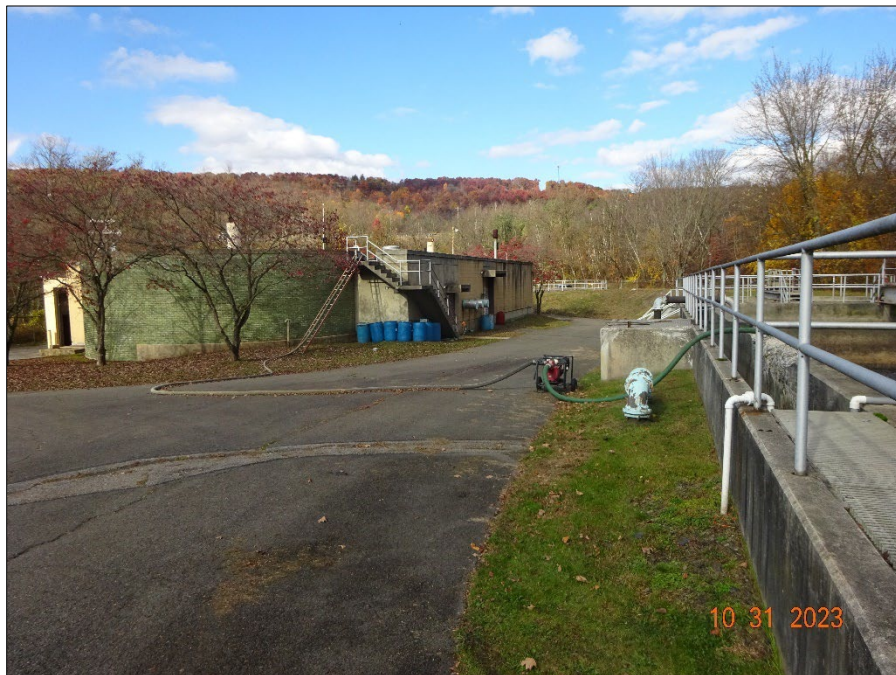
Photograph 16. DSC04785.JPG  
Description: Temporary transfer line to move contents of Aeration Basin 2 to the anaerobic digesters.

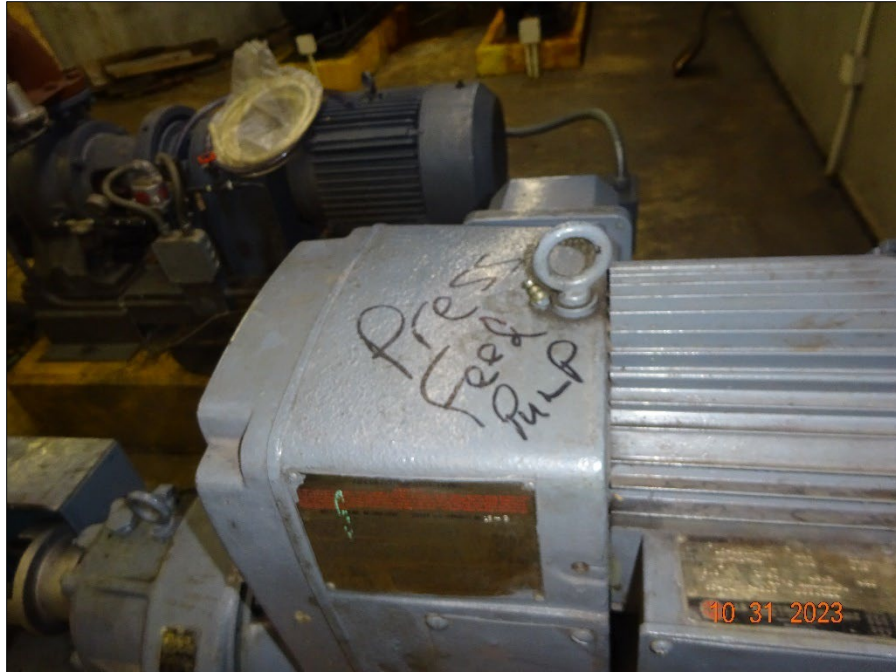
Photograph 19. DSC04848.JPG  
Description: Feed pump to the sludge press.

**Observation 2.** Multiple critical pieces of equipment were out of service at the time of inspection including the primary clarifier and sludge press. With the primary clarifier offline, the wastewater bypassed the clarifier and flowed directly to Aeration Basin 1. Operational staff said they are waiting on a replacement feed pump for the sludge press (see Appendix B Photograph 12, Photograph 18).

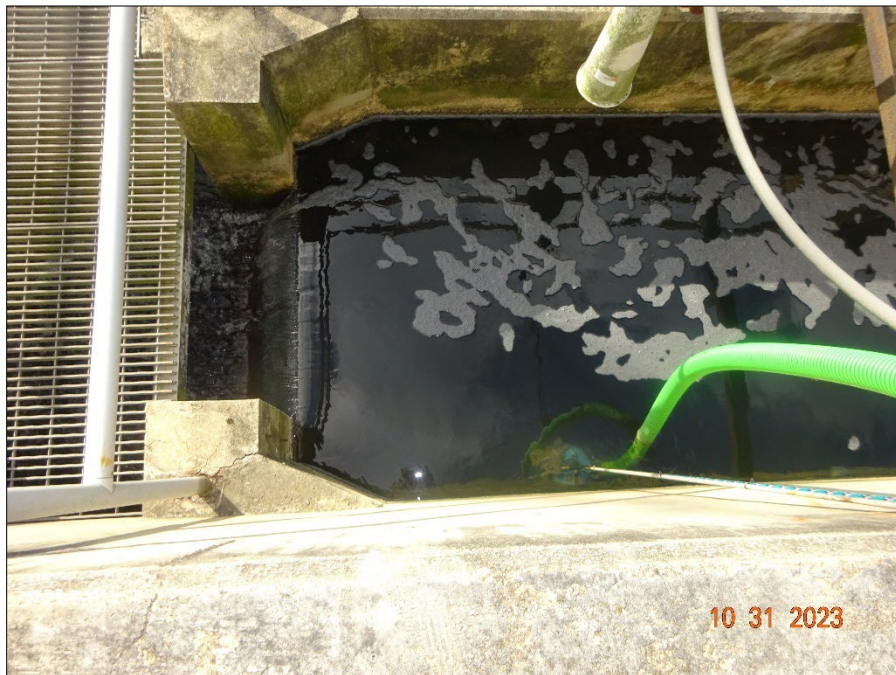
Photograph 24. DSC04801.JPG

- Observation 10.** The effluent sample was captured by actively pumping water from the end of the Chlorine Contact Basin near the sidewall, over forty feet into a flow through five-gallon bucket from where the effluent composite sampler would draw and deposit into a bottle. The water in the five-gallon bucket is likely not representative of effluent discharge conditions due to transit time and exposure to contamination in the line/bucket (see Appendix B Photograph 24, Photograph 25, Photograph 26, Photograph 27, and Photograph 28).

Description: Effluent sample withdraw line at the end of the Chlorine Contact Basin.

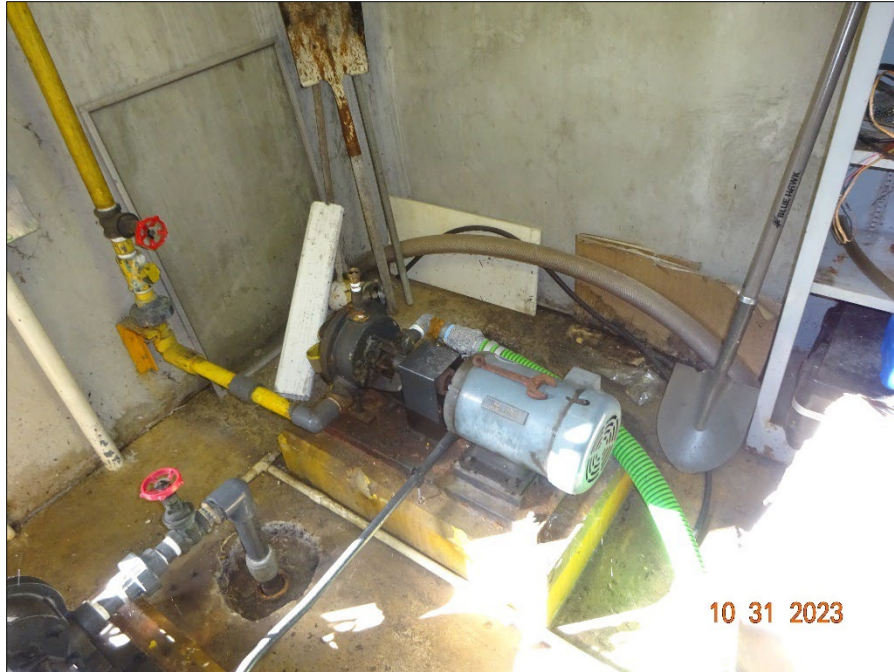
Photograph 25. DSC04804.JPG  
Description: Effluent sample withdraw pump.

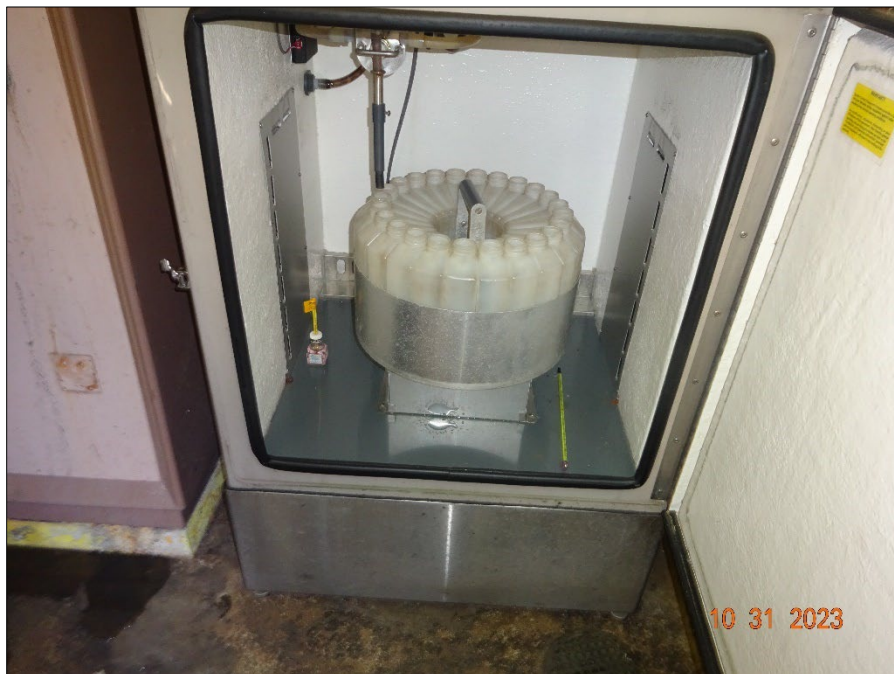
Photograph 28. DSC04807.JPG  
Description: Effluent Composite Sampler.

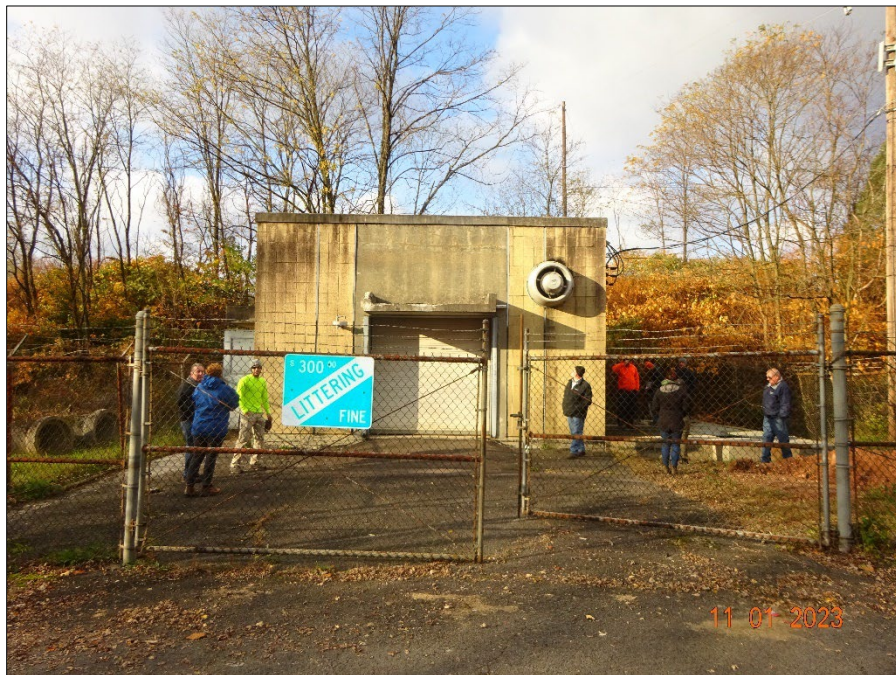
The Inspection Team started at Pump Station 1 (see Appendix B Photograph 34). Maintenance and operations of Pump Station 1 are conducted on an as-needed basis with no standard operating procedure (SOP) developed. Pump Station 1 does not have remote monitoring for offsite notification of issues. Staff are alerted of issues only during site visits performed at least once per day. The pump station has three pumps that cycle based on flow. All pumps were reported as functional at the time of inspection. Operators manually clean the bar screen as needed and are required to enter the channel by ladder (see Appendix B Photograph 35 and Photograph 36). The onsite generator is load-tested twice monthly.

Photograph 34. DSC04873.JPG  
Description: Pump Station 1.

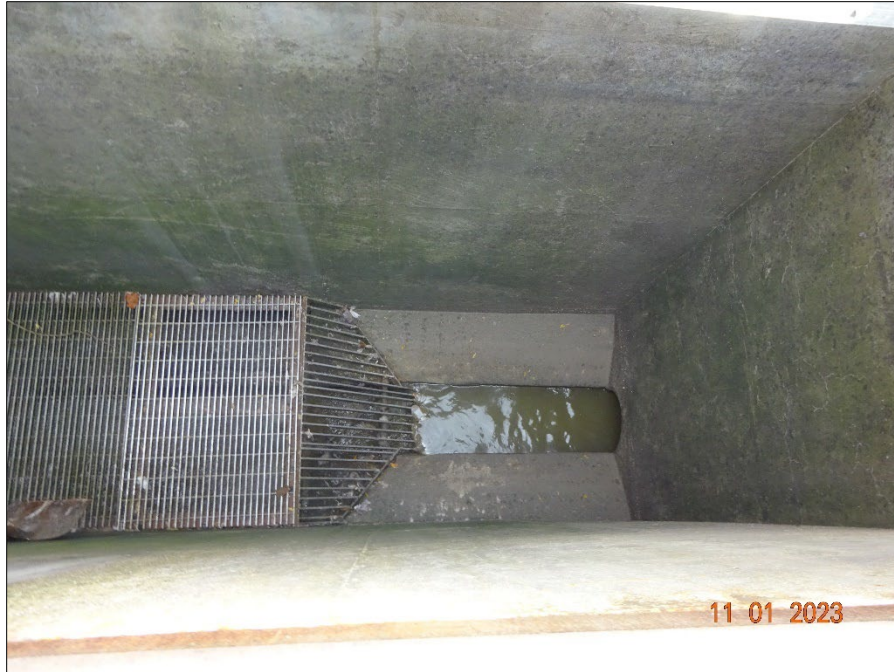
Photograph 35. DSC04874.JPG  
Description: Pump Station 1 Bar screen.

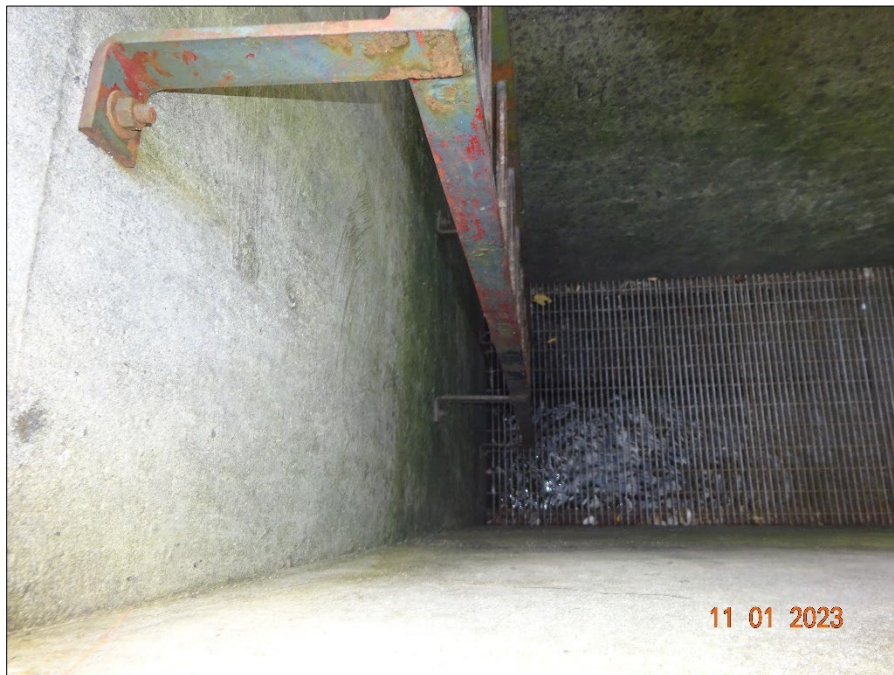
Photograph 36. DSC04875.JPG  
Description: Ladder to Pump Station 1 influent channel.

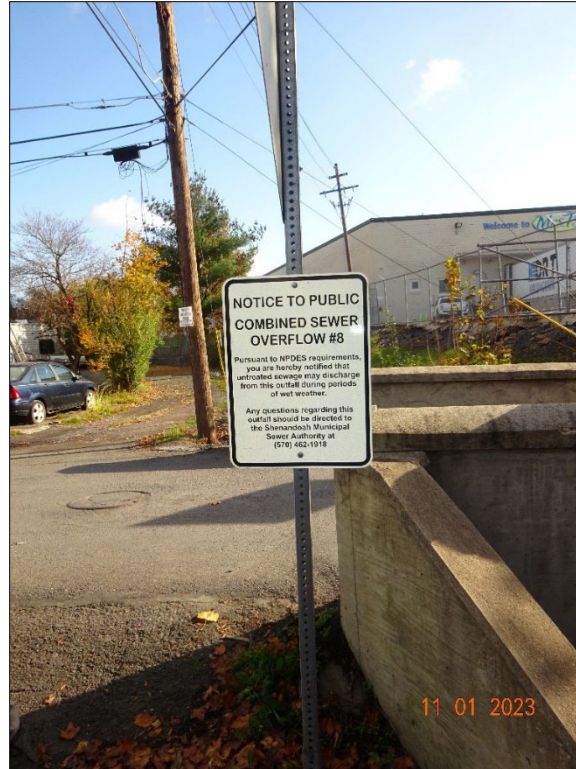
Outfall 014 was the first CSO visited by the Inspection Team. Neither SMSA staff nor the Inspection Team was able to physically locate the outfall as it entered the receiving water. SMSA staff were uncertain of the actual location since they reported only observing the outfall as represented by the nearest manhole (see Appendix B Photograph 37 and Photograph 38). Outfall 008 and Outfall 009 were also unable to be located physically by SMSA staff and the Inspection Team (see Appendix B Photograph 39,

Photograph 39. DSC04902.JPG  
Description: CSO Outfall 008 Signage.

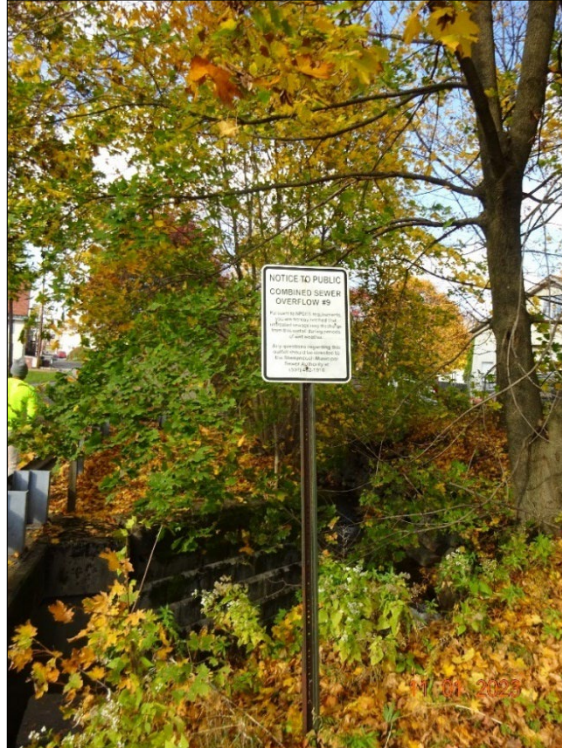
Photograph 41. DSC04916.JPG  
Description: CSO Outfall 009 signage.
