**Clean Water Act (CWA) Inspection Report**

| <b>Permittee Name:</b> North Country Dairy, LLC | <b>NPDES/ICIS No.:</b> NY0002763 |
| <b>Facility Inspected:</b><br>North Country Dairy<br>22 County Route 52<br>North Lawrence, NY 12967 | |

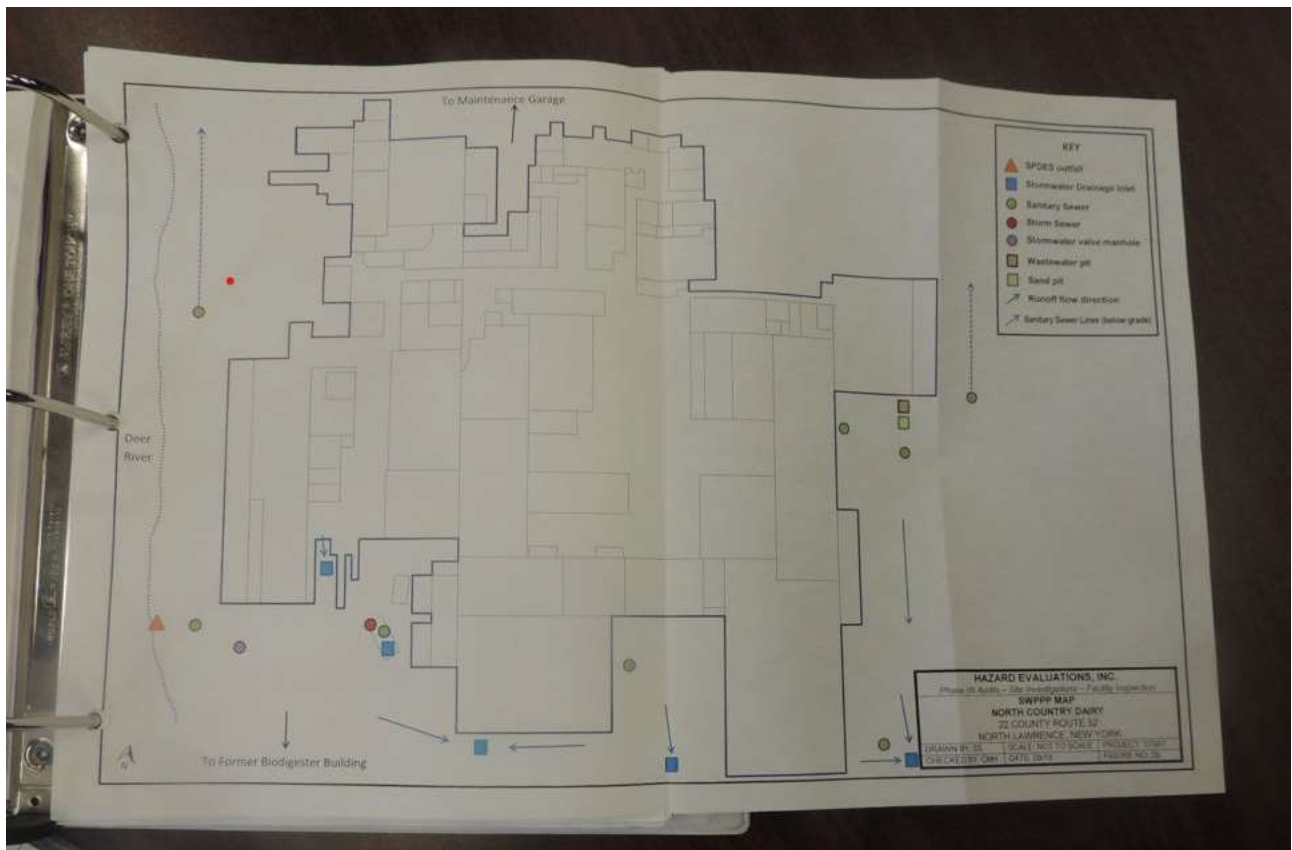
The Facility is located east of the Deer River and the main portion of the Facility is south of County Route 52. The Facility has one process wastewater outfall (Outfall 001) designated for the discharge of treated process and non-contact cooling water. The Facility also has another outfall, (002) that is permitted to discharge stormwater and artesian well water. Both outfalls discharge into the Deer River which is a tributary of the St. Regis River. The St. Regis River flows into the St. Lawrence River. Outfall 001 is located on the west side of the Facility. Outfall 002 is located on the southwest corner of the Facility (see plant diagram below). Upon arrival, EPA Inspector Murray Lantner presented his credentials to the Facility representative (Matthew Thompson). EPA representative Christina Palmrose-Krieger, and NYSDEC Region 6 representative Brian Boyer, were also in attendance. There was no rainfall during the inspection.
