## **RCRA Inspection Report**

Safety-Kleen Systems, Inc.  
120 Richardson Drive  
Jackson, Mississippi 39209

February 25, 2025, 9:15 a.m.

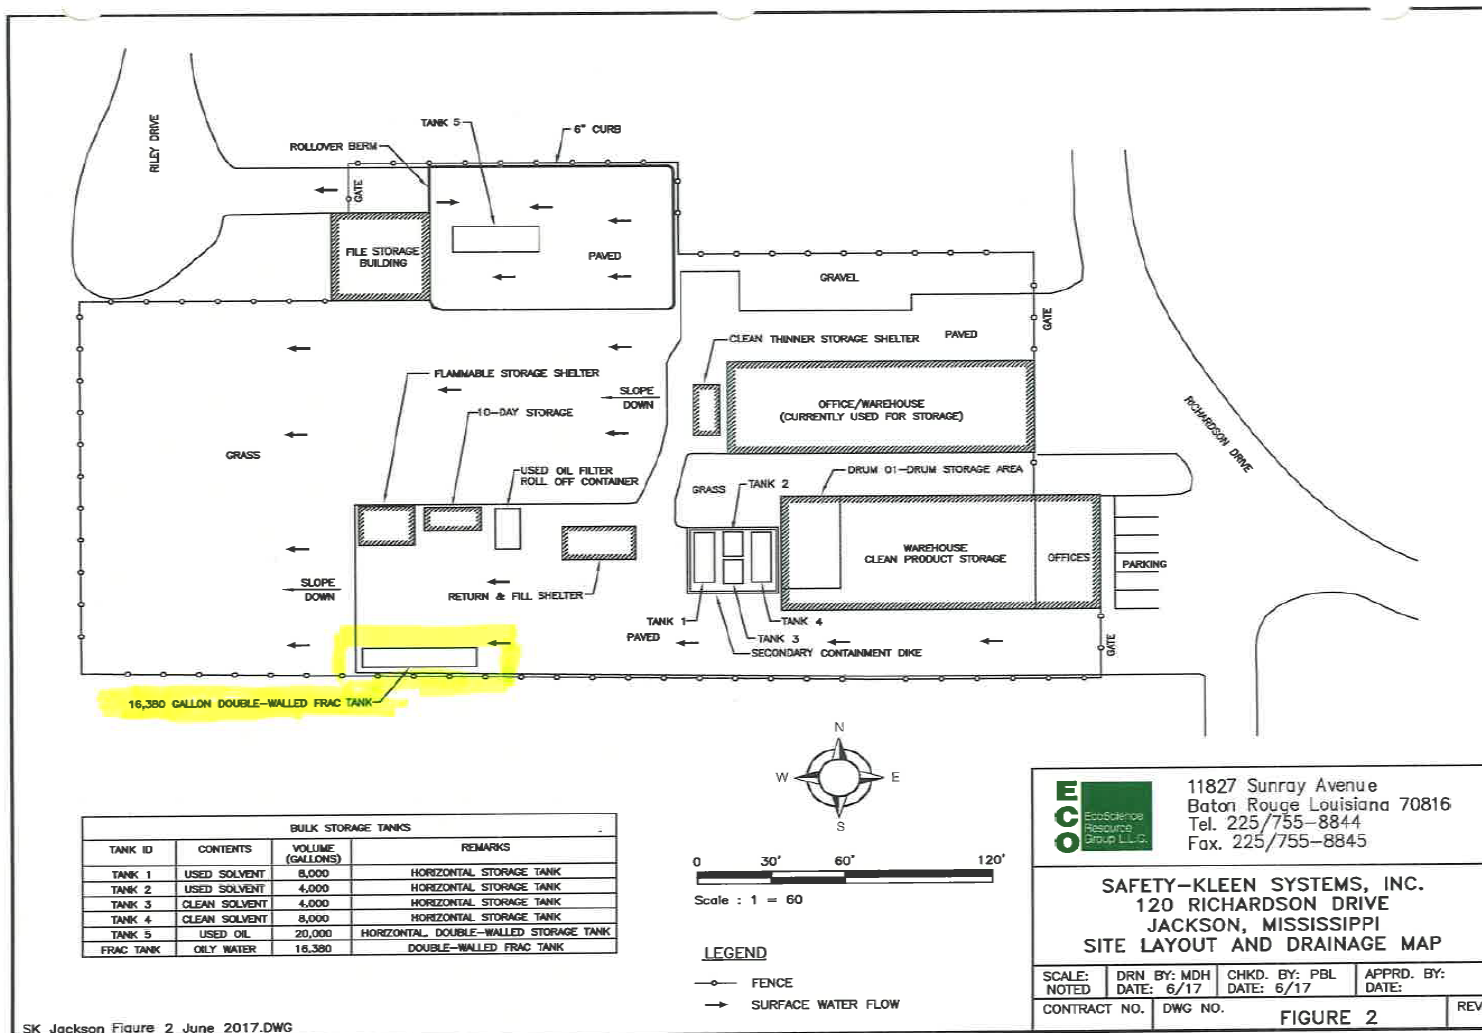
Figure 2 SPCC Plan: Site Layout/Emergency Evacuation Plan

Although this is shown on the **Site Layout and Drainage Map, Figure 2** (Page-33), this building was not observed on the day of inspection. Safety-Kleen explained that in 2017 the ceilings and walls were removed and disposed, but the containment base remained (Photo-37). The Site Layout and Drainage Map, Figure 2 had not been revised. As stated in Safety Kleen’s Contingency Plan **4.2.5 Government Agencies and Local Authorities to be Notified**, arrangements are to be made to familiarize the police department, fire department and local emergency response teams with the layout of the service center. By not amending the map immediately and providing the updated Contingency Plan to the government agencies and local authorities, the emergency response team were not made aware of the layout changes.

The designated storage area for the parts washers is not identified on the Site Layout and Drainage Map, Figure 2. The Site Layout and Drainage Map has not been revised. By not amending the map immediately and providing the updated Contingency Plan to government agencies, and local authority, the emergency response team were not made aware of the layout changes.

Although the 10-day Storage Shelter is shown on the Site Layout and Drainage Map, Figure 2, this building was not observed on the day of inspection. The Site Layout and Drainage Map had not been revised. By not amending the map immediately and providing the updated Contingency Plan to government agencies, and local authority, the emergency response team were not made aware of the layout changes.

Although the Used Oil Filter Roll Off Container is shown on the Site Layout and Drainage Map, Figure 2 adjacent to the 10-day Storage Shelter, this building was not observed on the day of inspection. The Site Layout and Drainage Map had not been revised. By not amending the map immediately and providing the updated Contingency Plan to government agencies, and local authority, the emergency response team were not made aware of the layout changes.

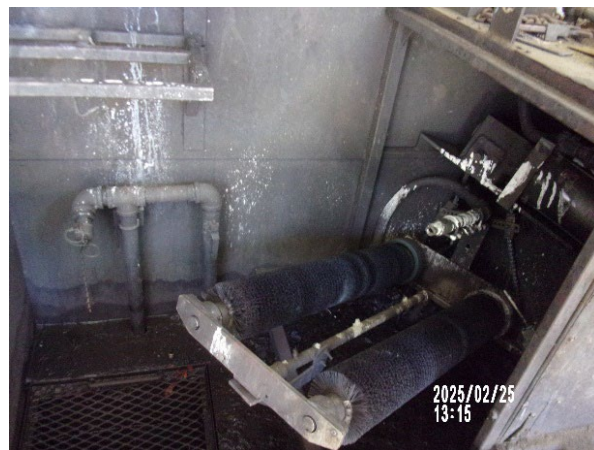
Photo-33 Drum Washer/Wet Dumpster

spray system, and then refill the drums with a clean recycled or virgin solvent product (Photo-33). Waste solvent from the Solvent Return and Fill Station is pumped into Tank #1, an 8,000-gallon hazardous waste solvent storage tank located in the Tank Farm. There was no activity on going during the inspection at the Solvent Return and Fill Station. Inspectors observed a SAA containing one 55-gallon container of hazardous waste in this area (Photo-34). The container was observed to be closed, labeled as “Hazardous Waste,” and marked with an indication of the hazards of the contents. The Solvent Return and Fill Station was equipped with a fire extinguisher.

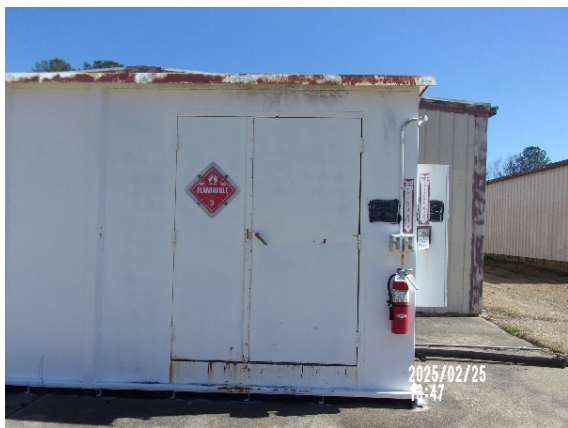
Photo-35 Container Storage Flammable Storage Shelter

The storage shelter had a sign at the entrance “Flammable” and a fire extinguisher (Photo-35). The storage shelter is constructed of steel with a steel door and a steel grated floor over a two-foot-deep metal secondary containment system. The inspectors observed several containers of paint thinner products and waste flammable containers inside the storage shelter (Photo-36). Used lacquer thinner (waste) is typically stored in this shed in 5-, 16-, 30- and 55-gallon containers due to its flammable nature. SK also stores 5-gallon cans of paint thinner which are returned to the Facility due to damage. The paint thinners are considered to be a product because it is unused. All the containers were observed to properly closed, labeled and dated. No leaks or spills were observed in the storage shelter.

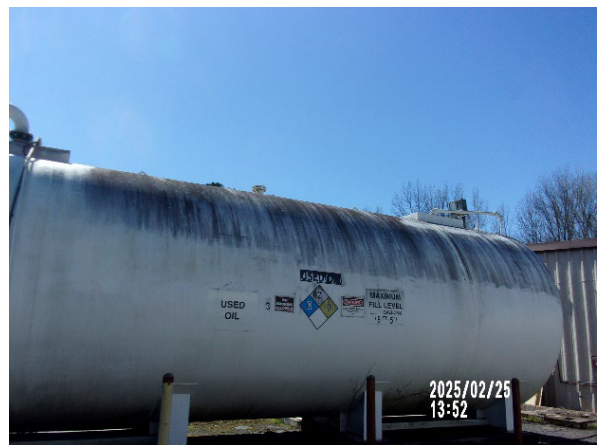
Photo-38 20,000-gallon Used Oil Tank

Used oil is accumulated in a 20,000-gallon aboveground storage tank (AST) (Photo-38). Inspectors observed the tank was closed and labeled as "Used Oil." This AST is also of double-walled carbon steel construction. The inspectors observed a metal containment system with a lid is in place to contain the tank's hose connection couplings. The inspectors observed oily sheen on a stormwater puddle on the north and oily debris on the west side of the used oil tank (Photo-39, Photo-40 and Photo-41). The inspectors observed absorbent material spread across much of the area to capture the oil on the gravel-internal containment. Based on the site observation and discussion with Keith Miller, it appeared that source of the leaks and spills appeared to be primarily during the tanker loading/unloading operation. The inspectors discussed about better housekeeping using drip pans, spill trays and prompt cleanup upon detecting a spill.
