**Region 6 Compliance Assurance and Enforcement Division  
INSPECTION REPORT**

| Company Name: | International Paper Co | | |
| Facility Name: | Mansfield Mill | | |
| Identification/Permit Number: | LA0056651 (AI No. 328) | | |

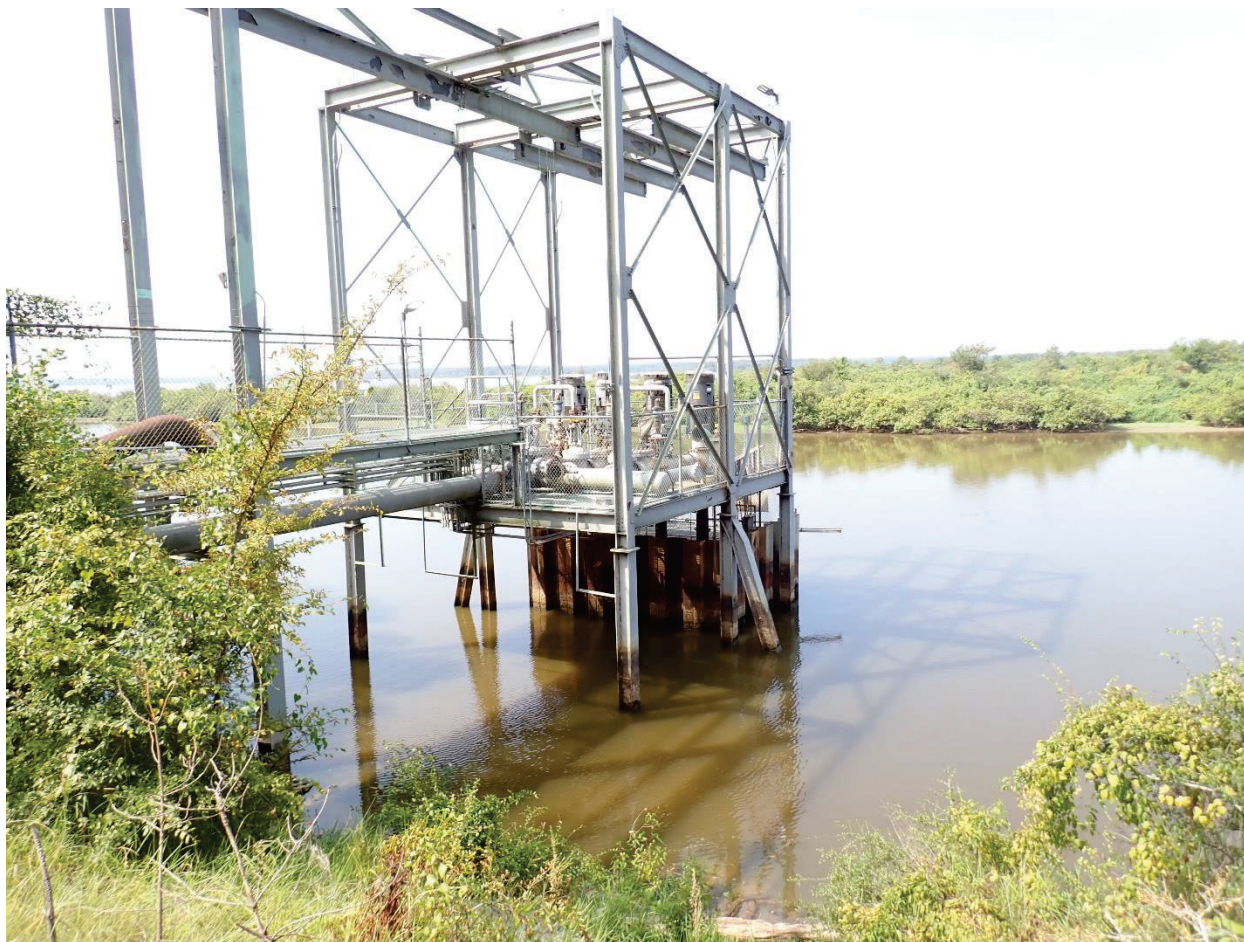
Photo No. 2

Photograph File Name: P8220143.JPG  
Date of Photograph: 08/22/2024  
Latitude and Longitude: 31.892353 -93.897206  
Orientation: SW  
Map Datum: WGS-84  
Time of Photo: 10:00 AM  
Photographer: Jack Arias  
Description:

This image shows the Water Intake Structure that intake fresh water from Toledo Bend Reservoir for the cooling and industrial processes at the facility. The design intake flow of the system is 18.8 MGD and the actual intake flow is 17.1 MGD.

1. Facility should provide the 316b application file that includes information about the integrity and maintenance of the cooling water intake structure (CWIS). This file should include intake structure dimensions, maintenance records in case of corrosion (stainless-steel trash rack wall structures) and others, drawings and maintenance records of screened caisson structure that prevent large organism or debris from entering the system, drawings and maintenance records of smaller mesh screened structure that reduce impingement of small organism or further restrict smaller debris manual backflush.

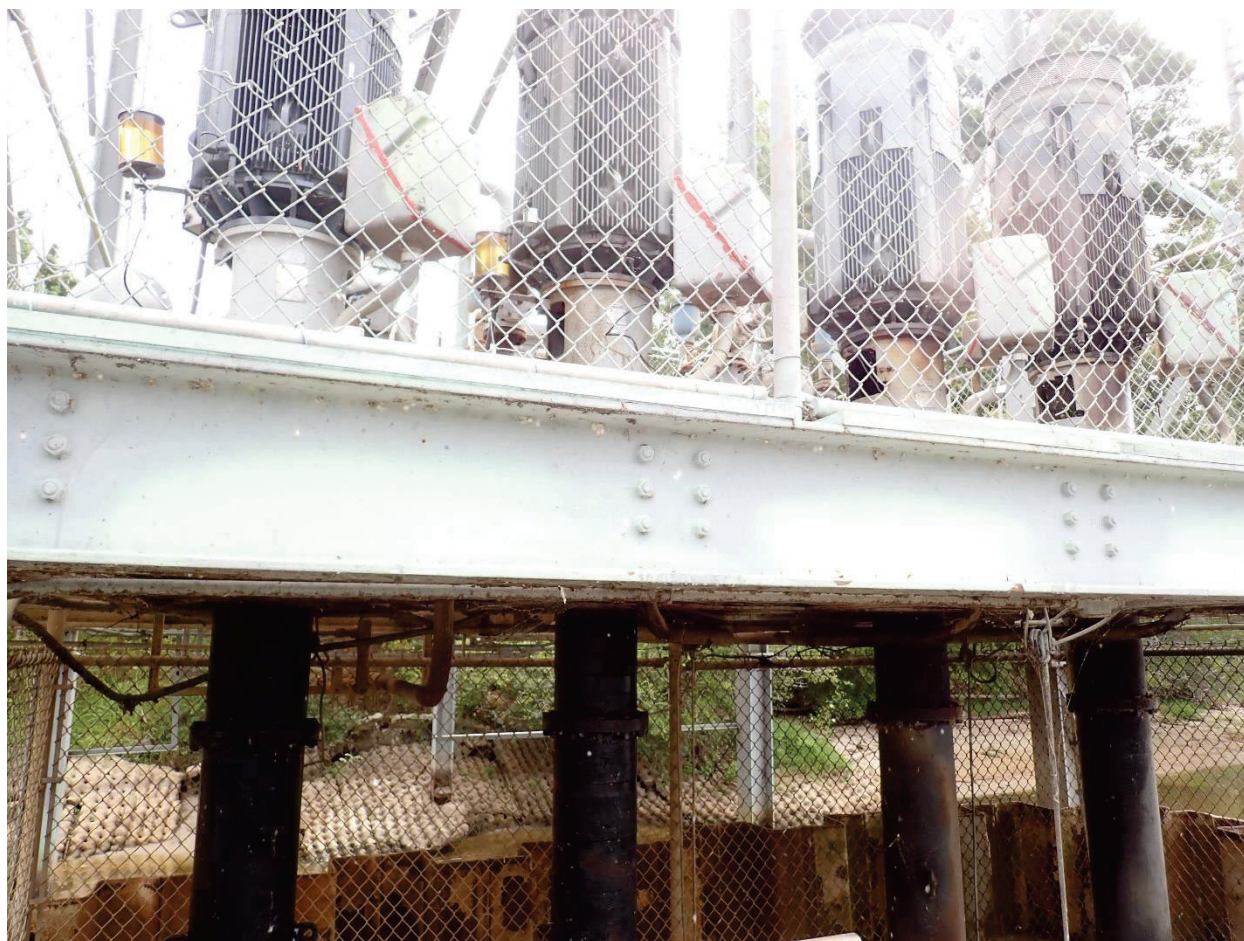
Photo No. 3

Photograph File Name: P8220133.JPG  
Date of Photograph: 08/22/2024  
Latitude and Longitud: 31.892353 -93.897206  
Orientation: SW  
Map Datum: WGS-84  
Time of Photo: 9:39 AM  
Photographer: Jack Arias  
Description:

This image shows four pumps with trash racks that are used to intake fresh water from Toledo Bend Reservoir. The bottoms of the trash racks are approximately 25 to 30 feet below the reservoir surface water level.

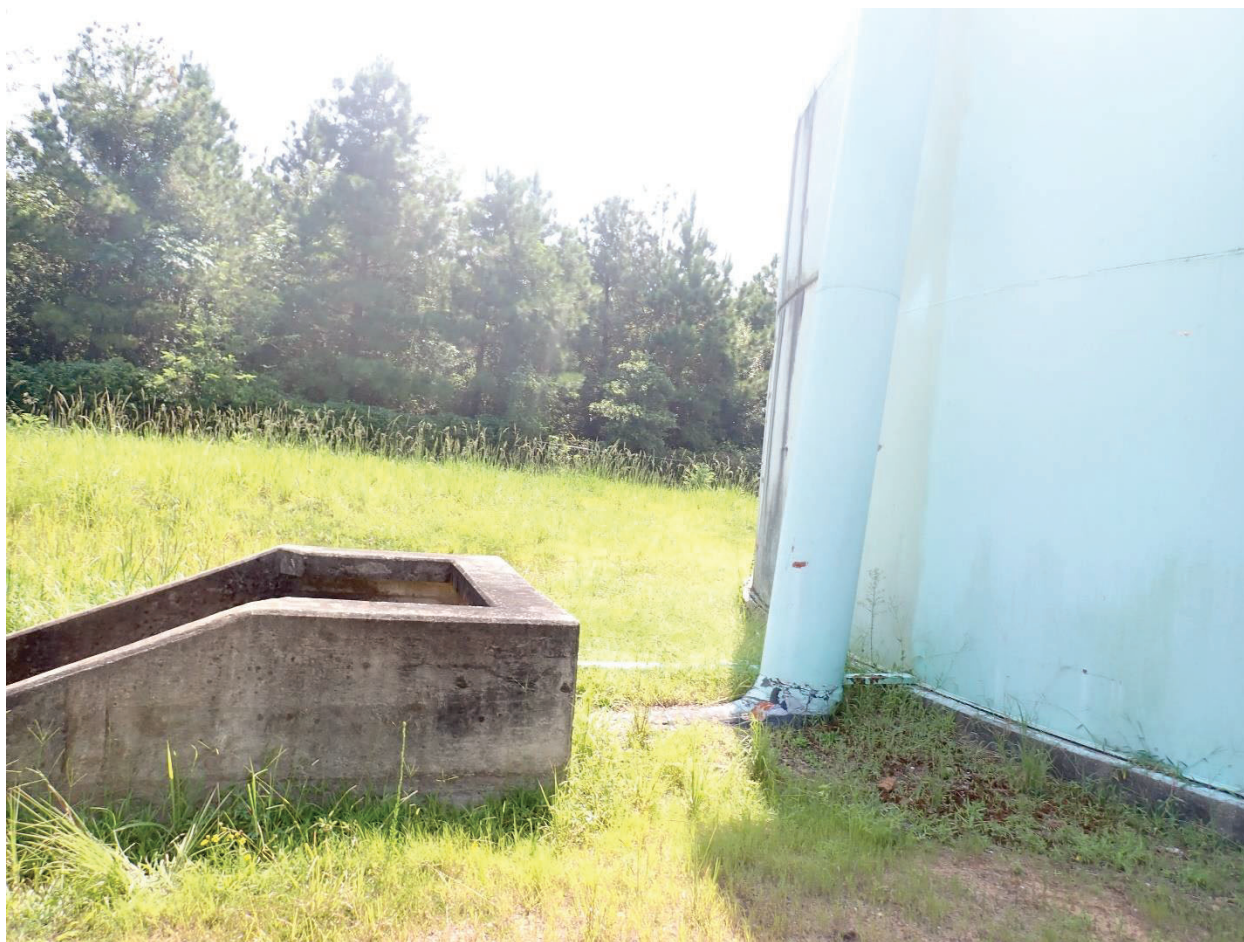
Photograph File Name: P8220152.JPG  
Date of Photograph: 08/22/2024  
Latitude and Longitud: 32.023692 -93.759556  
Orientation: SW  
Map Datum: WGS-84  
Time of Photo: 10:47 AM  
Photographer: Jack Arias  
Description:

This image shows the head tank which is part of the water intake structure system (CWIS). Its purpose is to store water and provide capacity water to maintain facility operations for specific period of times.

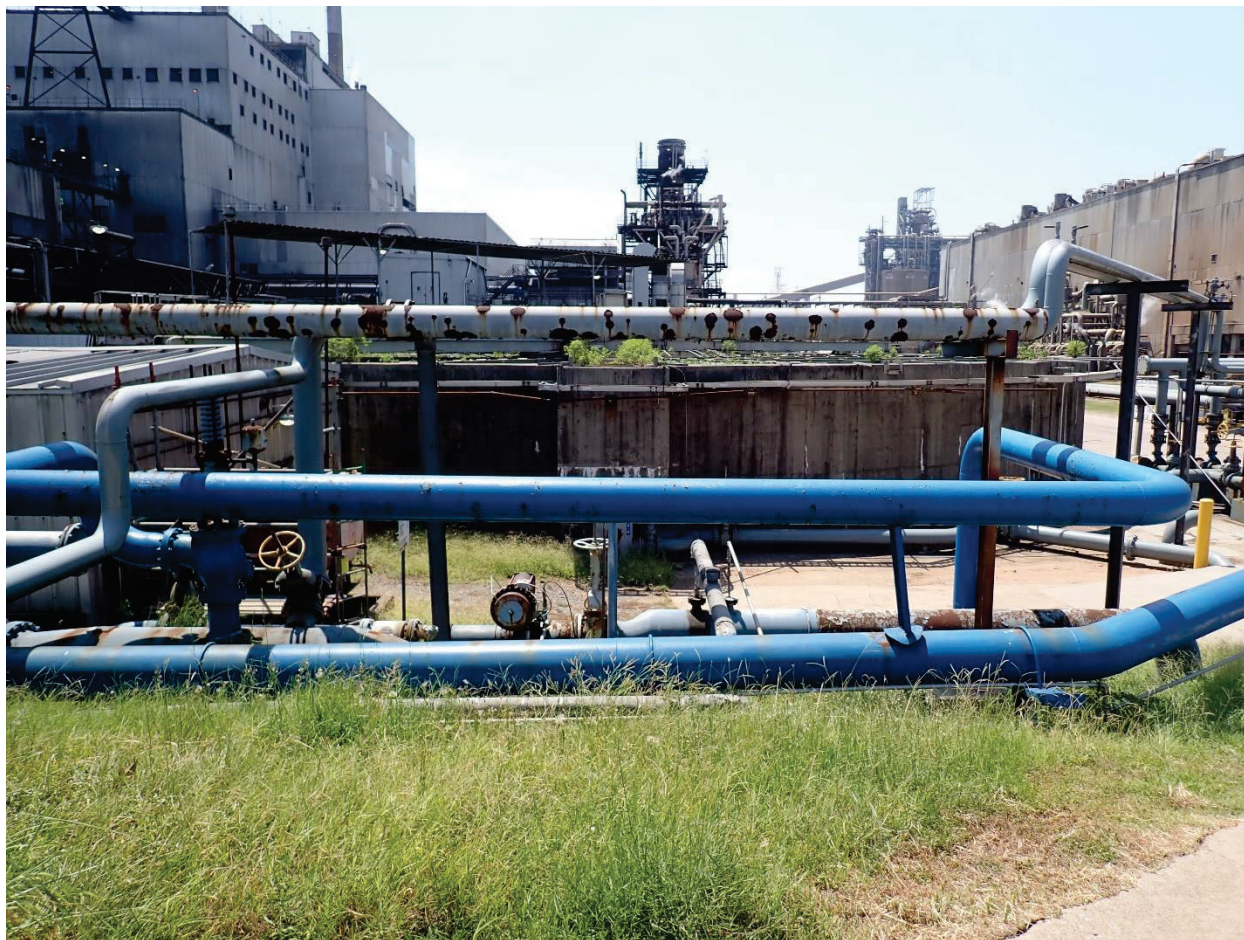
Photo No. 9

Make-up water for use at the Mansfield Mill is obtained from Toledo Bend Reservoir and from several groundwater production wells. Intake water from Toledo Bend Reservoir is treated in two clarifiers (south and north clarifiers) prior to being routed to the treated water reservoir for use in utilities and mill process units. Groundwater from several production wells is routed directly to the treated water reservoir. At the time of the inspection, we observed plants and algae layers inside the south and north clarifier systems. These plants and algae layers could potentially impact the treatment process and integrity of the clarifier systems (See Photo Nos. 9 – 11 in Appendix 1).

Photograph File Name: P8210061.JPG  
Date of Photograph: 08/21/2024  
Latitude and Longitude: 32.1592963 -93.5568618  
Orientation: E  
Map Datum: WGS-84  
Time of Photo: 11:29 PM  
Photographer: Jack Arias  
Description: This image shows the south clarifier that received and treated water from the intake water from Toledo Bend Reservoir prior to being routed to the treated water reservoir for use in utilities and mill process units.

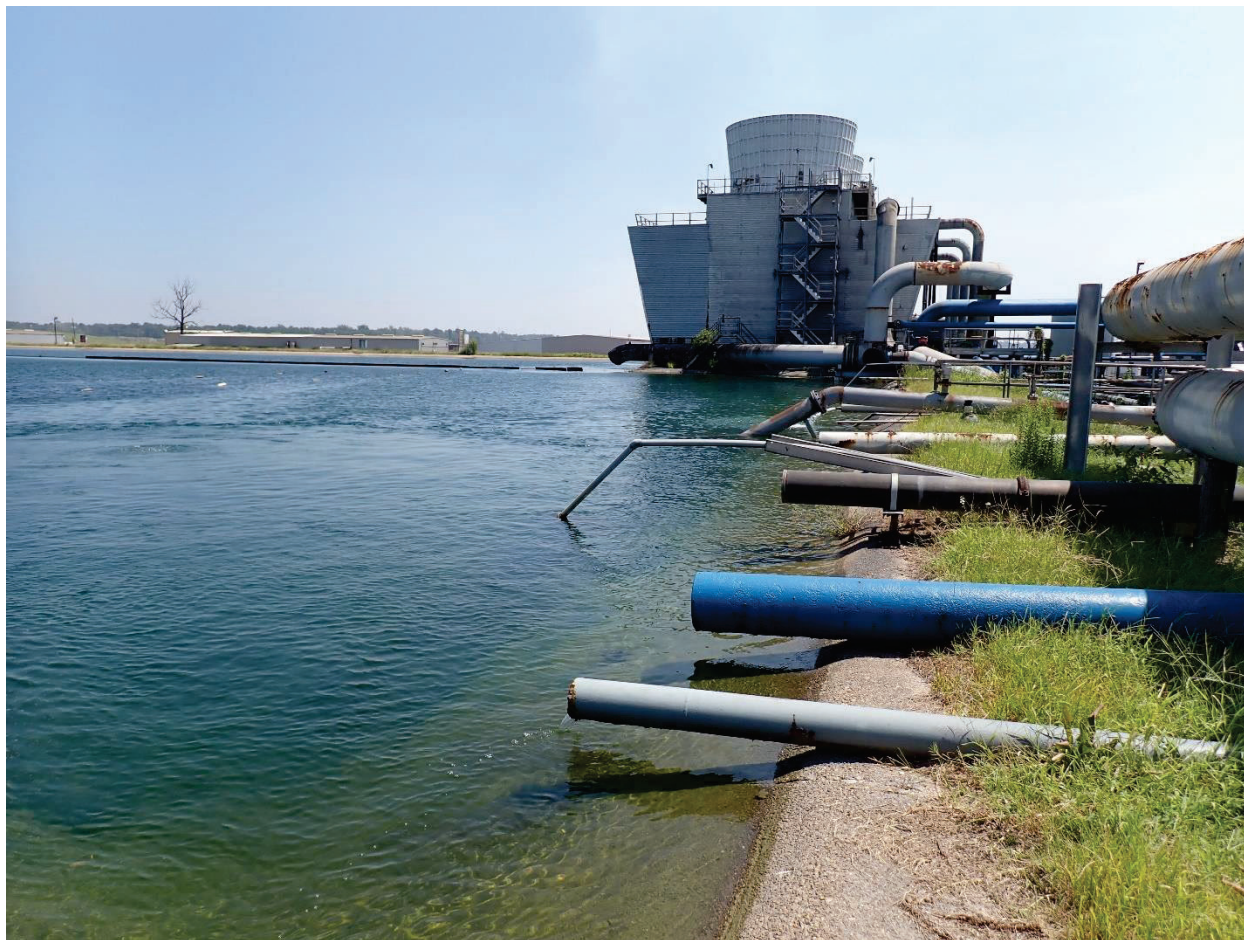
Photo No. 12

Photograph File Name: P8210060.JPG  
Date of Photograph: 08/21/2024  
Latitude and Longitud: 32.691122 -92.017733  
Orientation: E  
Map Datum: WGS-84  
Time of Photo: 11:29 AM  
Photographer: Jack Arias  
Description: This image shows the Cooling Water Systems. Cooling water is recirculated to the treated water reservoir for water conservation.

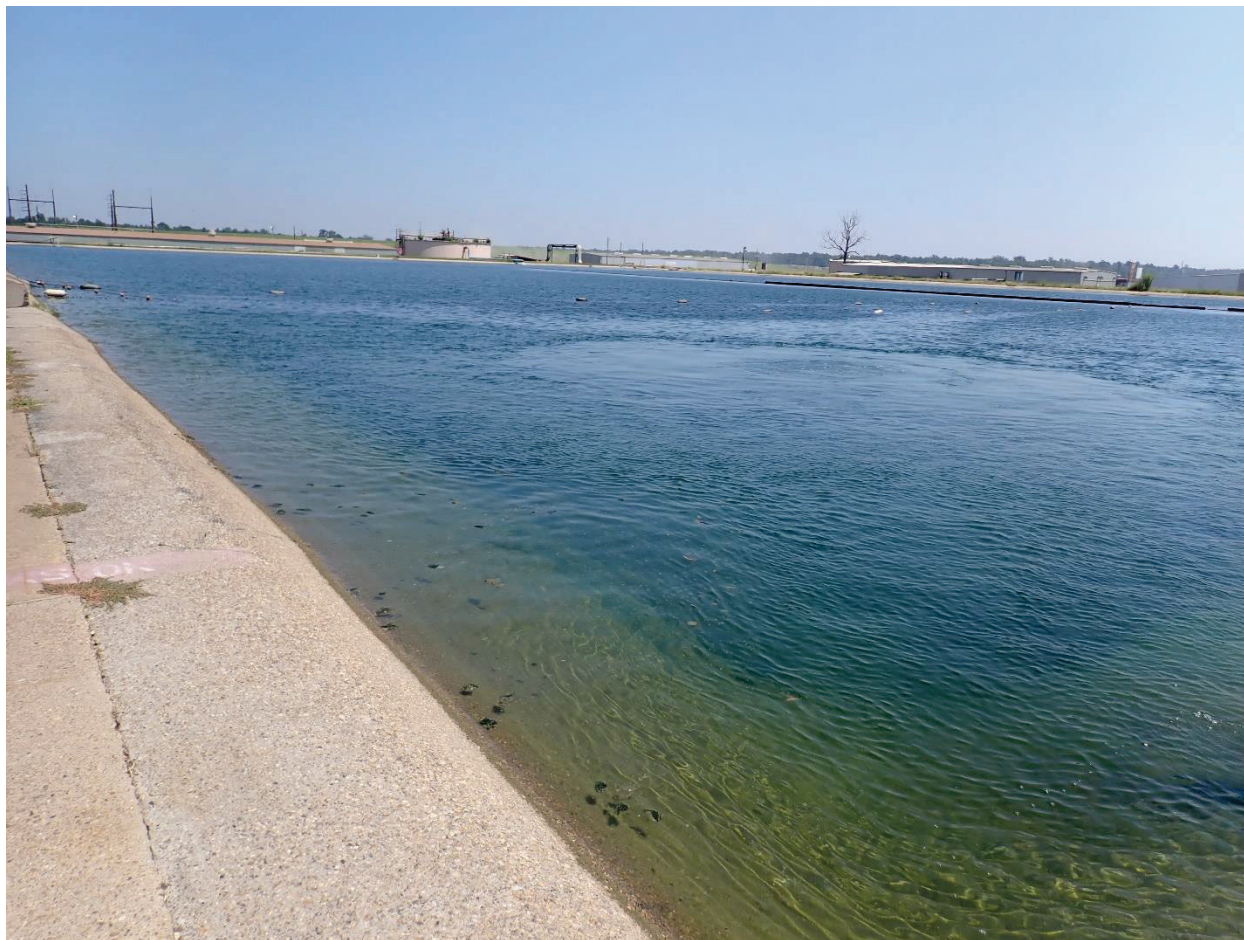
Photograph File Name: P8210059.JPG  
Date of Photograph: 08/21/2024  
Latitude and Longitude: 32.159595 -93.556836  
Orientation: N  
Map Datum: WGS-84  
Time of Photo: 11:30 AM  
Photographer: Jack Arias  
Description:

This image shows the treated water reservoir received water from Toledo Bend Reservoir. Its main purpose is to provide capacity water to maintain facility operations for specific period of times.

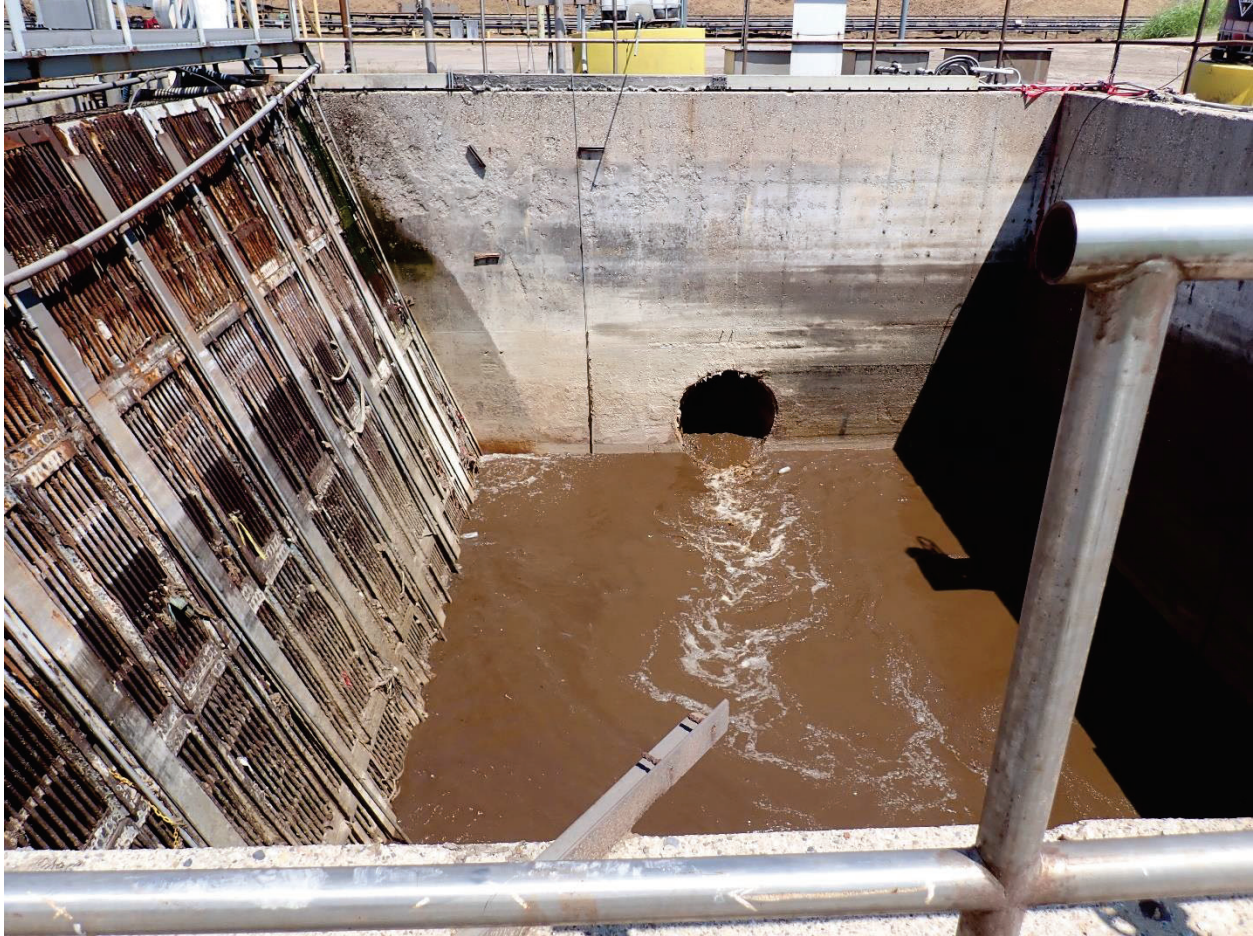
Photograph File Name: P8210055.JPG  
Date of Photograph: 08/21/2024  
Latitude and Longitude: 32.156380 -93.554439  
Orientation: SE  
Map Datum: WGS-84  
Time of Photo: 11:05 AM  
Photographer: Jack Arias  
Description:

This image shows the lift pit system which is part of the wastewater treatment system. This system received and collected wastewater from trenches, sewers, and hard piping wastewater.

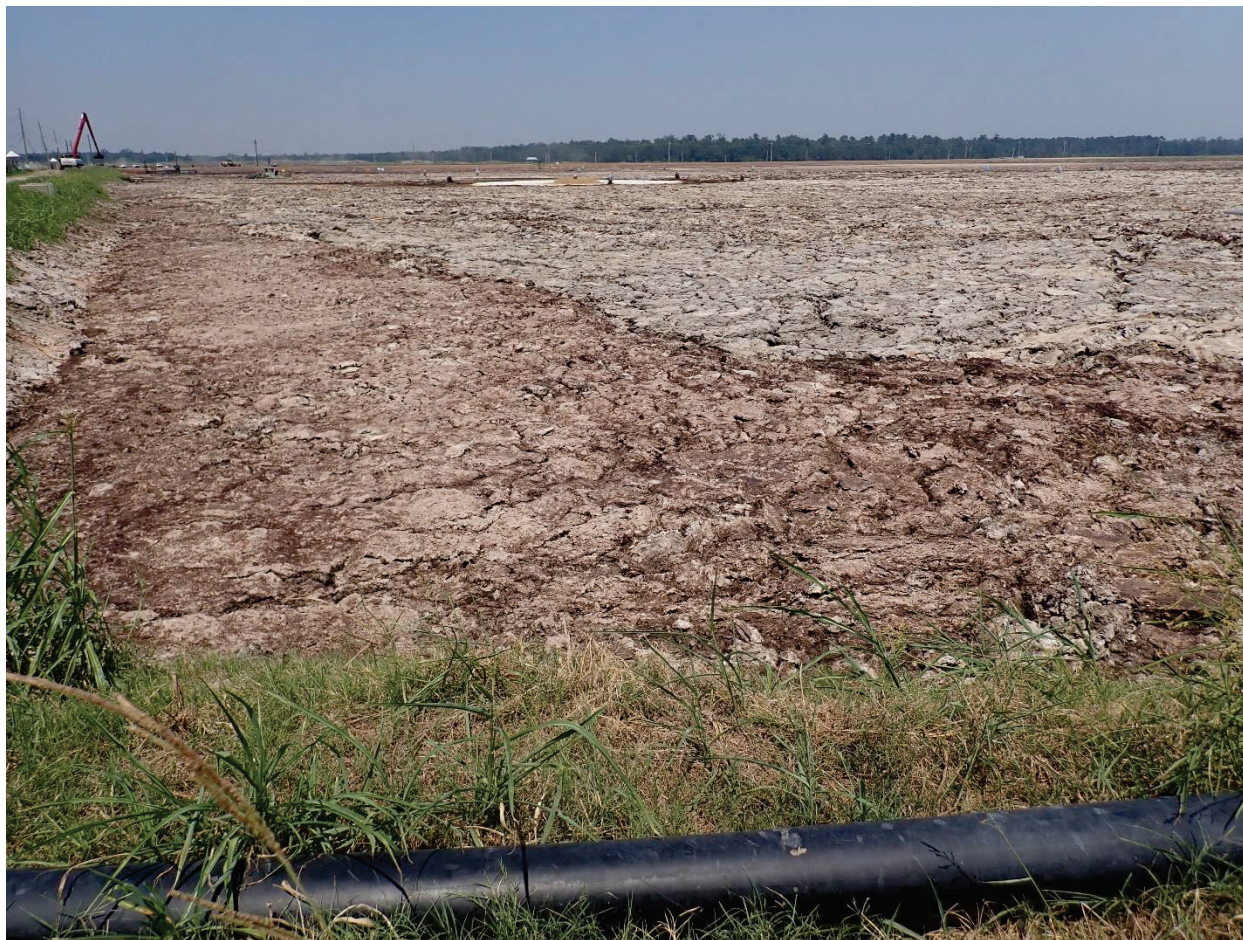
Photograph File Name: P8210103.JPG  
Date of Photograph: 08/21/2024  
Latitude and Longitud: 32.160163 -93.551060  
Orientation: SE  
Map Datum: WGS-84  
Time of Photo: 12:55 PM  
Photographer: Jack Arias  
Description:

This image shows the surge basin system. This system is the greatest part of the wastewater treatment system. This system received and treated various process wastewater streams from the mill procedures.

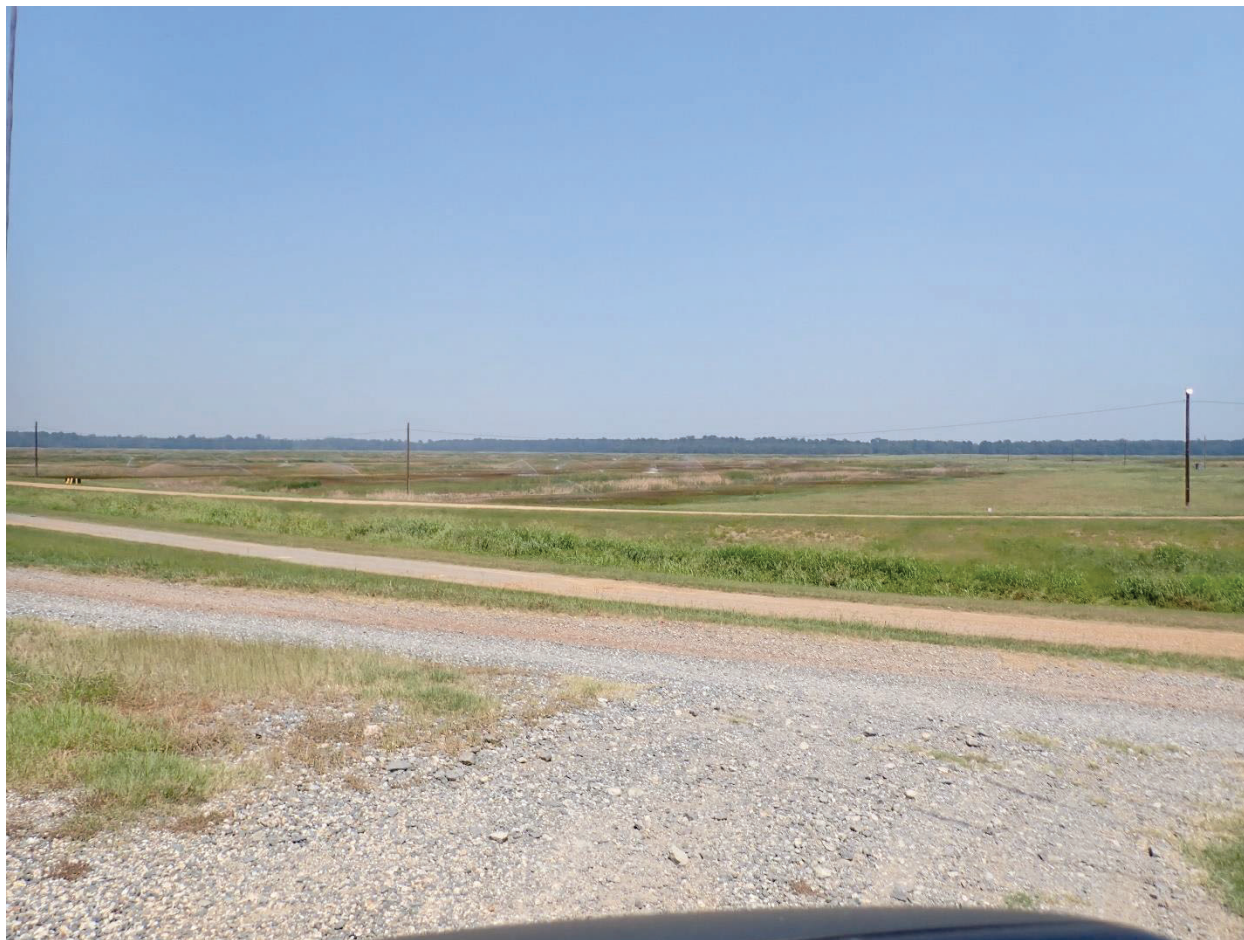
Photograph File Name: P8210113.JPG  
Date of Photograph: 08/21/2024  
Latitude and Longitude: 32.156593 -93.543281  
Orientation: SE  
Map Datum: WGS-84  
Time of Photo: 1:24 PM  
Photographer: Jack Arias  
Description:

This image shows the overland flow treatment system. Here the wastewater is sprayed onto terraced fields where biodegradation takes place in the soil.

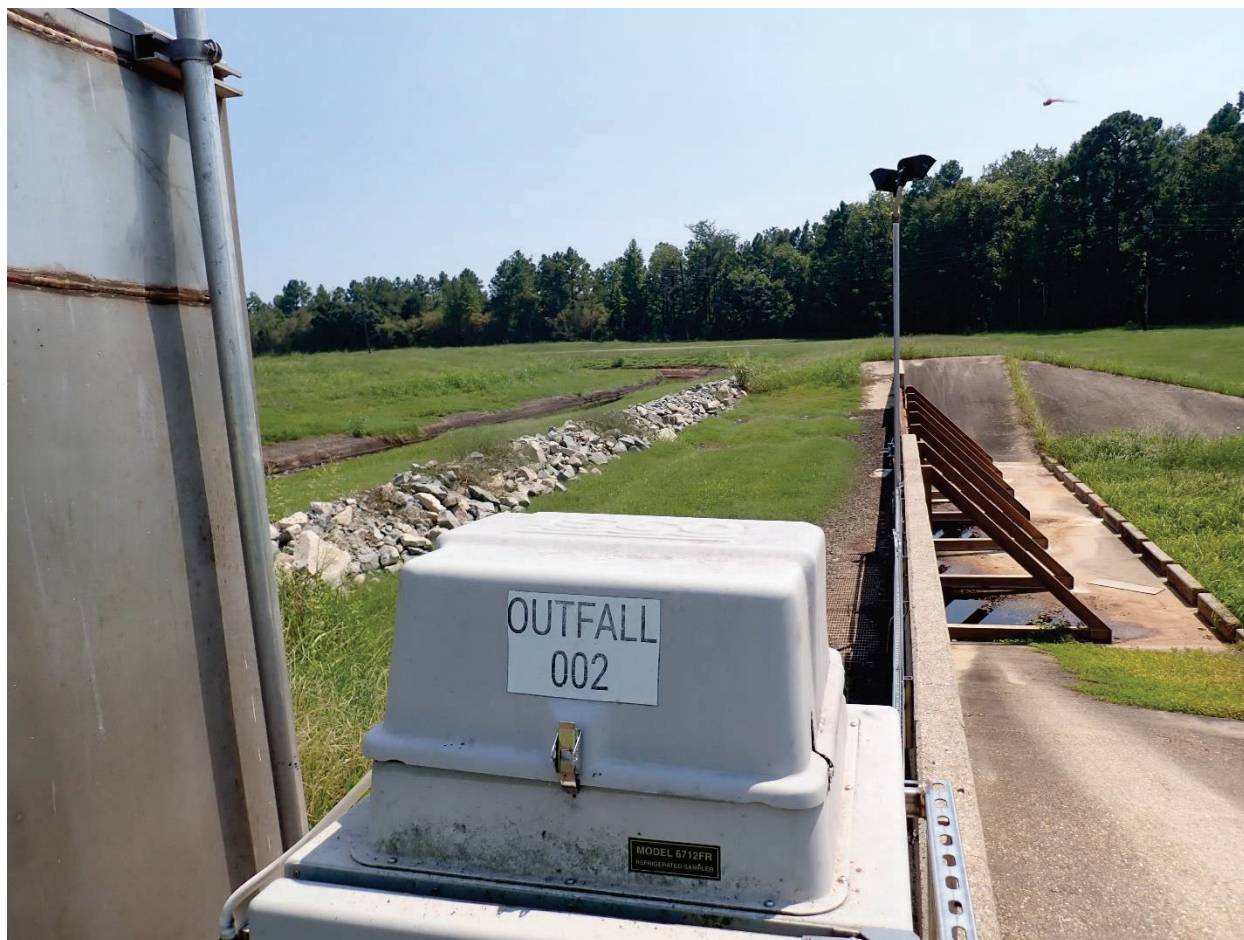
Photograph File Name: P8210115.JPG  
Date of Photograph: 08/21/2024  
Latitude and Longitud: 32.160163 -93.551060  
Orientation: SE  
Map Datum: WGS-84  
Time of Photo: 1:24 PM  
Photographer: Jack Arias  
Description:

This image shows outfall 002 that receives and includes an intermittent overflow of treated combined process wastewater, process area storm water runoff, landfill leachate, utility wastewater, miscellaneous wastewater, non-process area stormwater runoff, and monitored treated sanitary wastewater from internal outfalls 101 and 201.

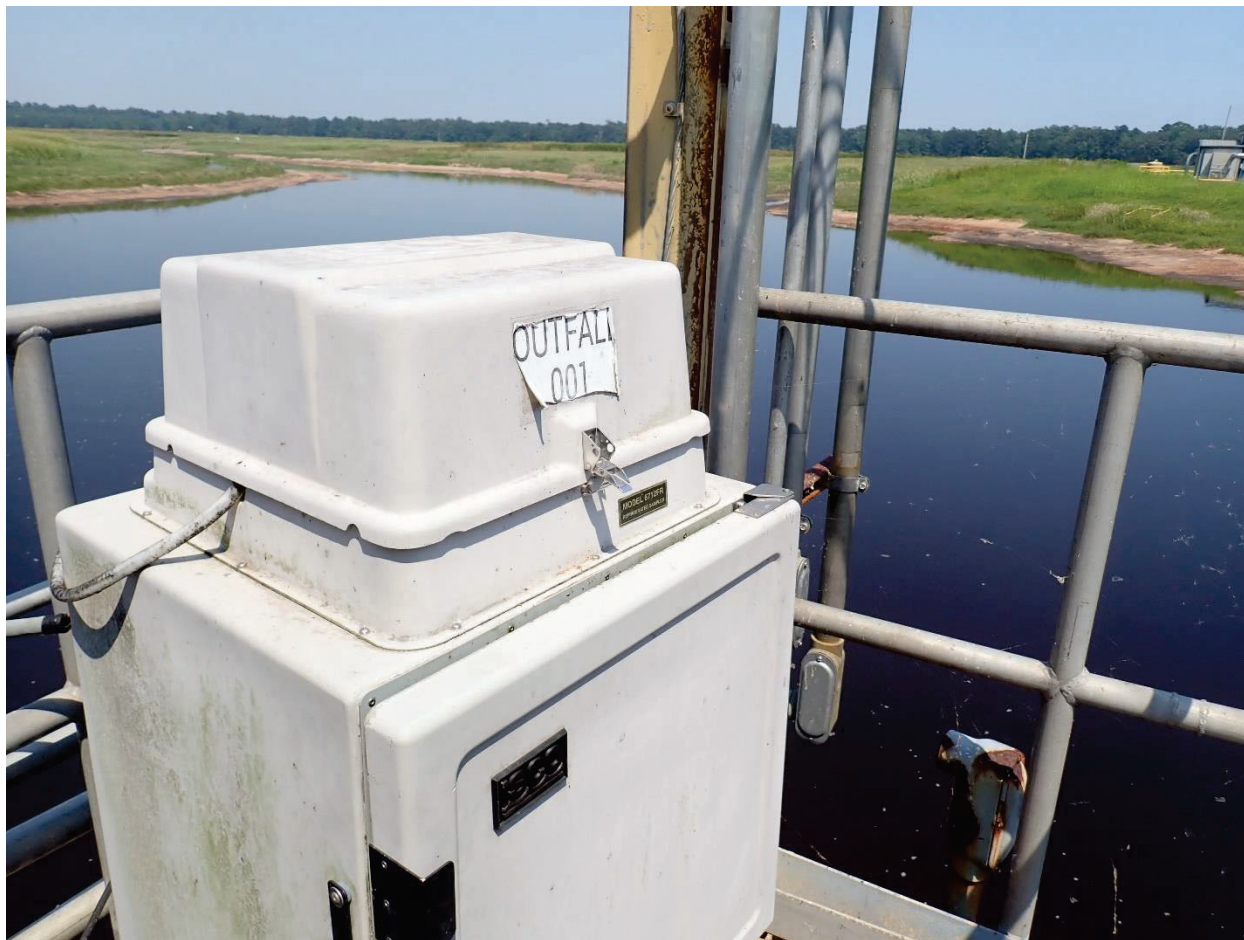
Photograph File Name: P8210118.JPG  
Date of Photograph: 08/21/2024  
Latitude and Longitud: 32.146420 -93.537589  
Orientation: SE  
Map Datum: WGS-84  
Time of Photo: 1:30 PM  
Photographer: Jack Arias  
Description:

This image shows outfall 001 that includes continuous discharge of treated combined process wastewater, process area storm water runoff, landfill leachate, utility wastewater, miscellaneous wastewater, non-process area storm water runoff, and monitored treated sanitary wastewater from internal outfalls 101 and 201
