| <b>Inspection Date(s):</b> | 2/13/2025 | |
| <b>Media Program:</b> | Drinking Water | |
| <b>System Owner:</b> | City of Galena Park | |
| <b>PWS ID:</b> | TX1010009 | |

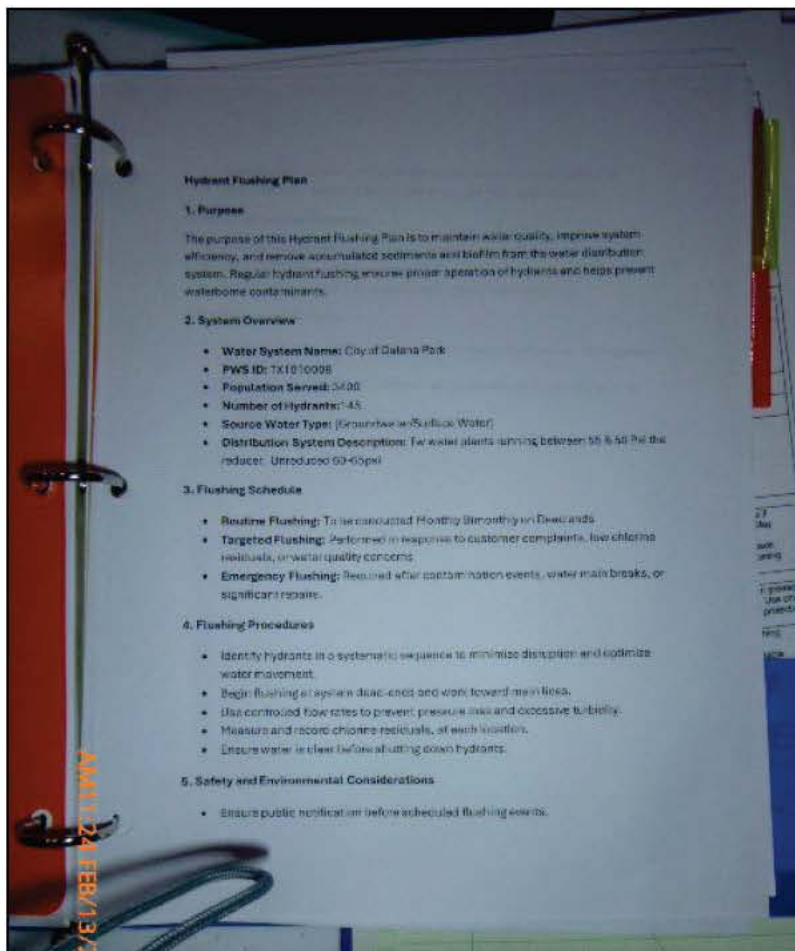
Photograph 1. 2/13/2025 11:24 am P1010238.JPG

Description: Records review. Written hydrant flushing program maintained by the System representative.

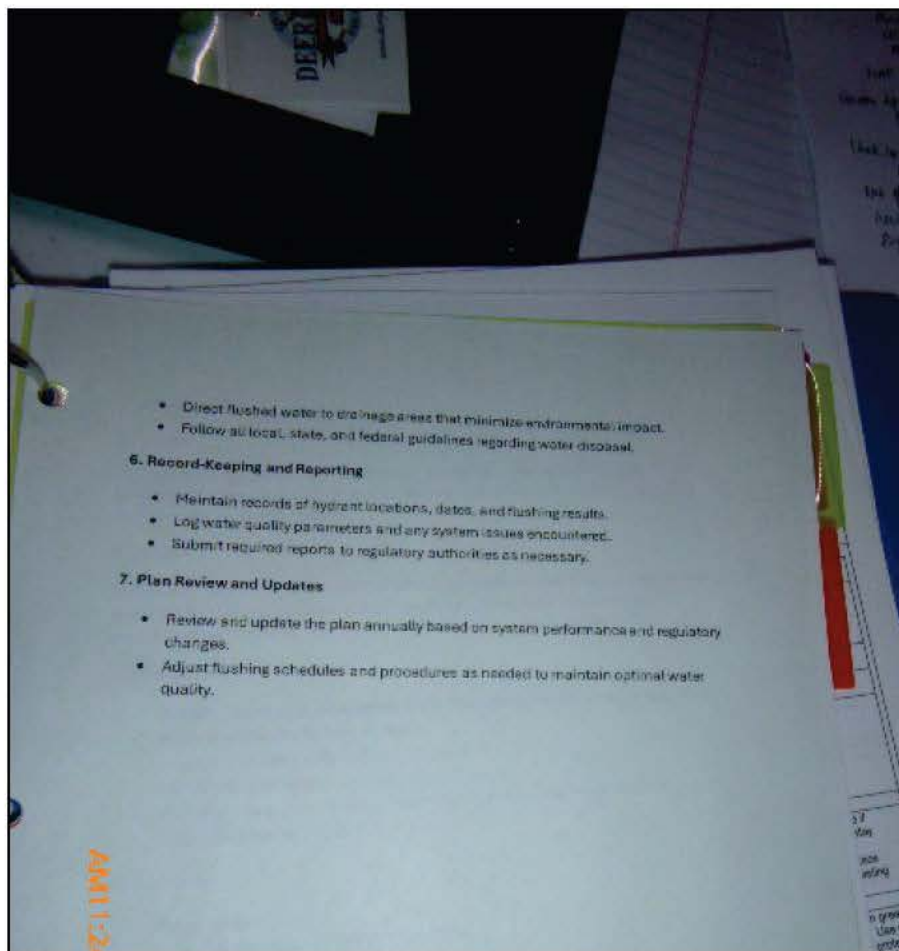
Photograph 2. 2/13/2025 11:24 am P1010239.JPG

Description: Records review. Written hydrant flushing program maintained by the System representative.

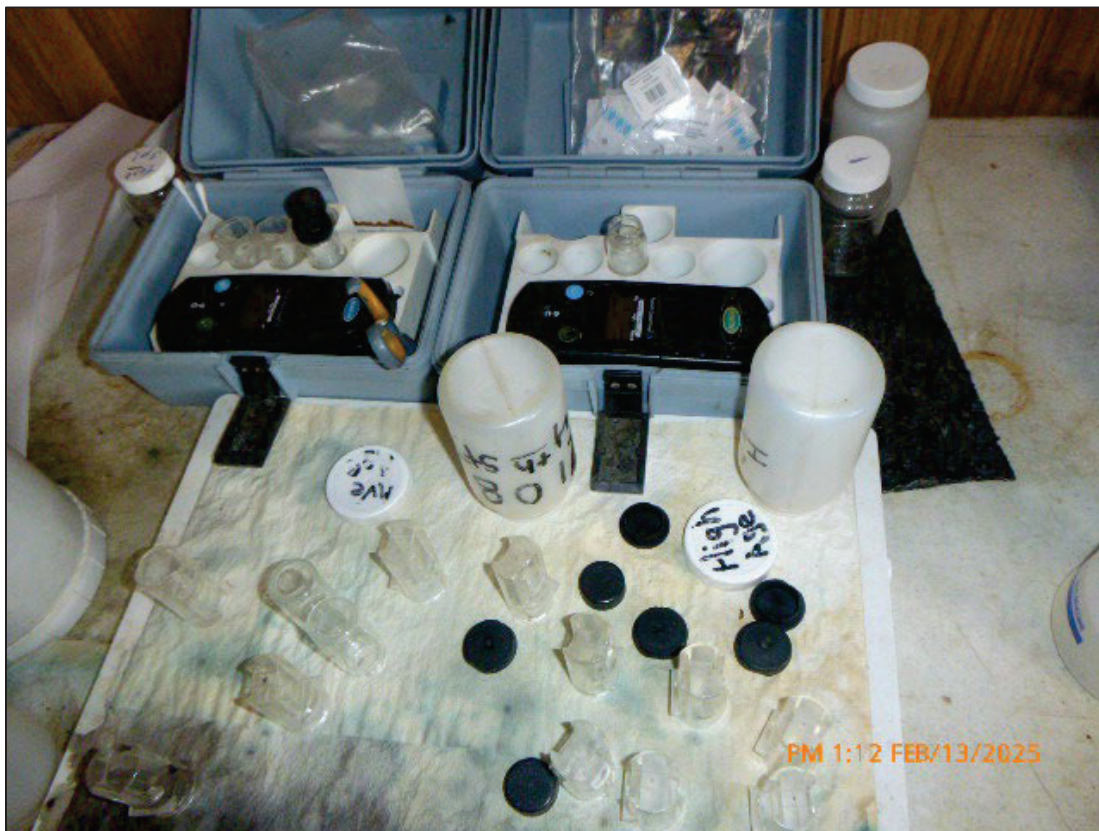
Photograph 3. 2/13/2025 1:12 pm P1010245.JPG

Description: Plant #1. Chlorine, monochloramine, and free ammonia test kits.

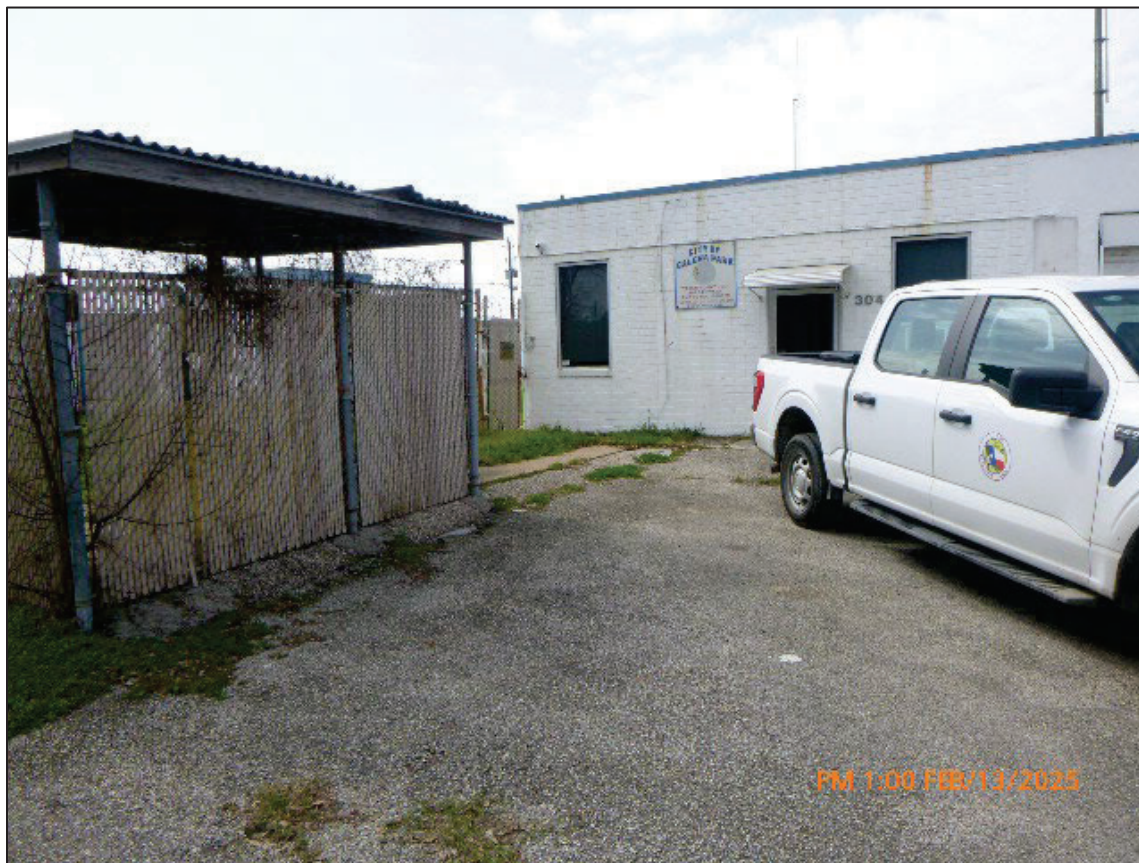
The EPA inspection team visited Plant #1 (designated at EP001 in TCEQ's database) starting at 1:00 PM local time. The front door to the office was locked and equipped with an intrusion alarm. The entire site is fenced with a locked gate (see [Appendix 3, Photograph 8](#)). The office is equipped with Hach Colorimeter II benchtop test kits for total chlorine, monochloramine, and free ammonia. The System takes daily total chlorine samples of the water prior to entry to distribution. The System takes weekly monochloramine and free ammonia samples. All sampling efforts are conducted manually and recorded on daily log sheets (see [Appendix 3, Photograph 9](#)). The free ammonia reagent was past its expiration date of December 2024. The System representative discarded the reagent and replaced with new reagent while the EPA inspection team was onsite. The EPA inspection team did not observe the use of polyphosphate, chemical feed pumps for polyphosphate feed, or an injection point on the piping for polyphosphate during the inspection.

Photograph 8. 2/13/2025 1:00 pm P1010240.JPG  
Description: Plant #1. Office building and fence around facilities.

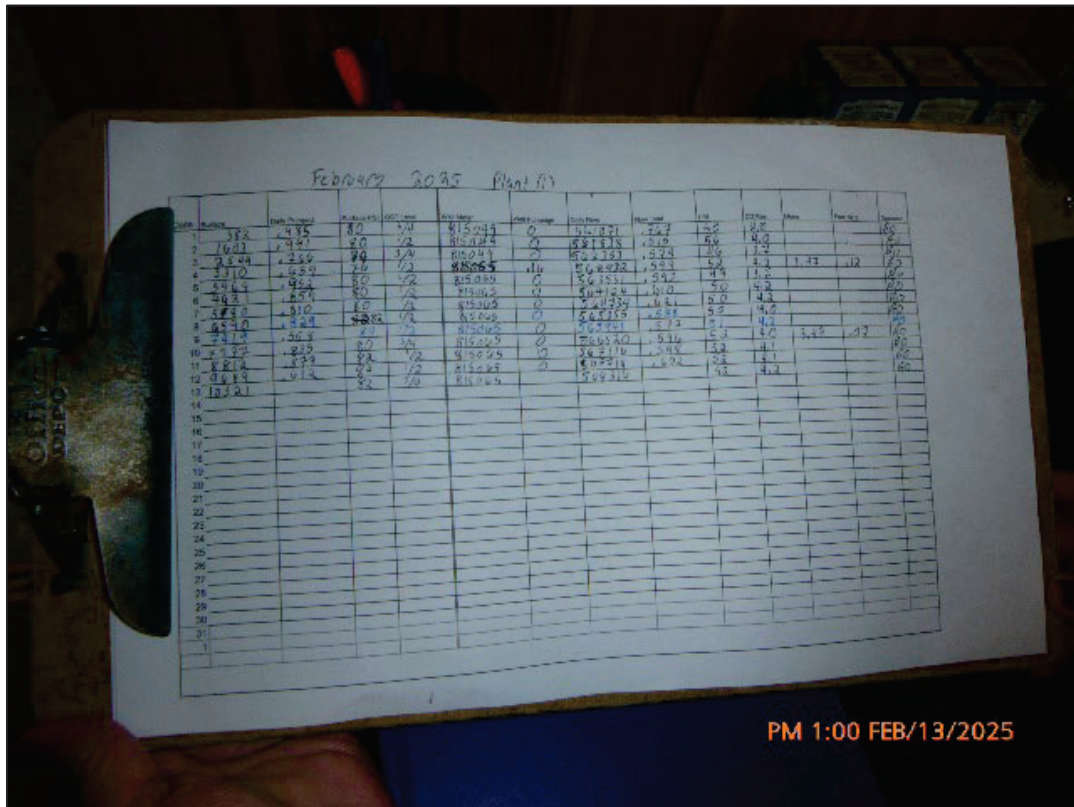
Photograph 9. 2/13/2025 9:04 am P1010243.JPG

Description: Plant #1. Daily log sheet kept by operators for Plant #1, February 2025.

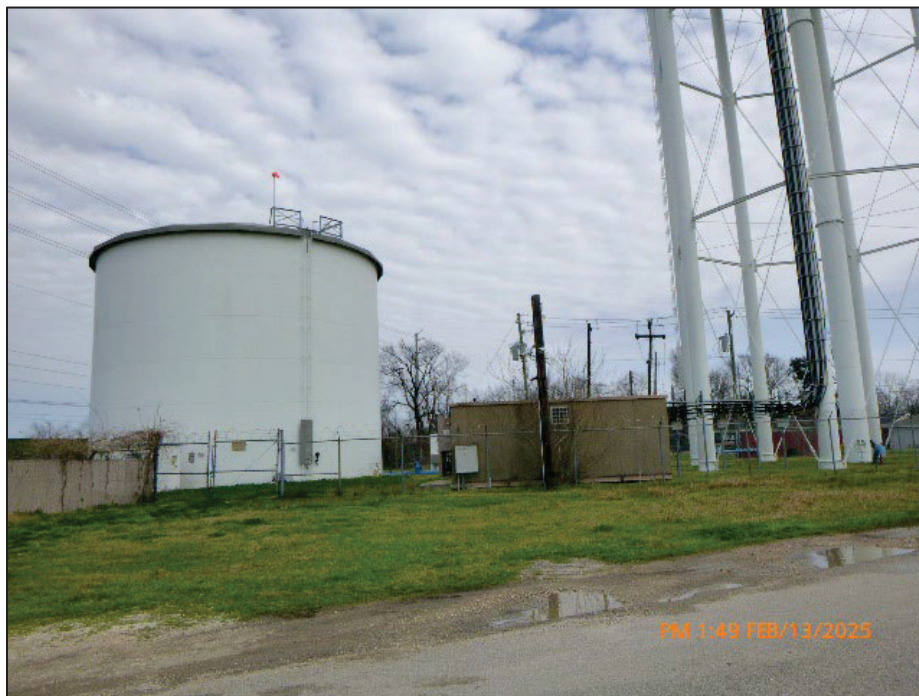
The EPA inspection team visited Plant #2 starting at 1:45 PM local time. The entire site is fenced with a locked gate (see [Appendix 3, Photograph 18](#)). The System takes daily total chlorine samples of the water prior to entry to distribution. The System takes weekly monochloramine and free ammonia samples. All sampling efforts are conducted manually and recorded on daily log sheets (see [Appendix 3, Photograph 19](#)).

Photograph 18. 2/13/2025 1:49 pm P1010266.JPG  
Description: Plant #2. Fenced area with locked gate at Plant #2.

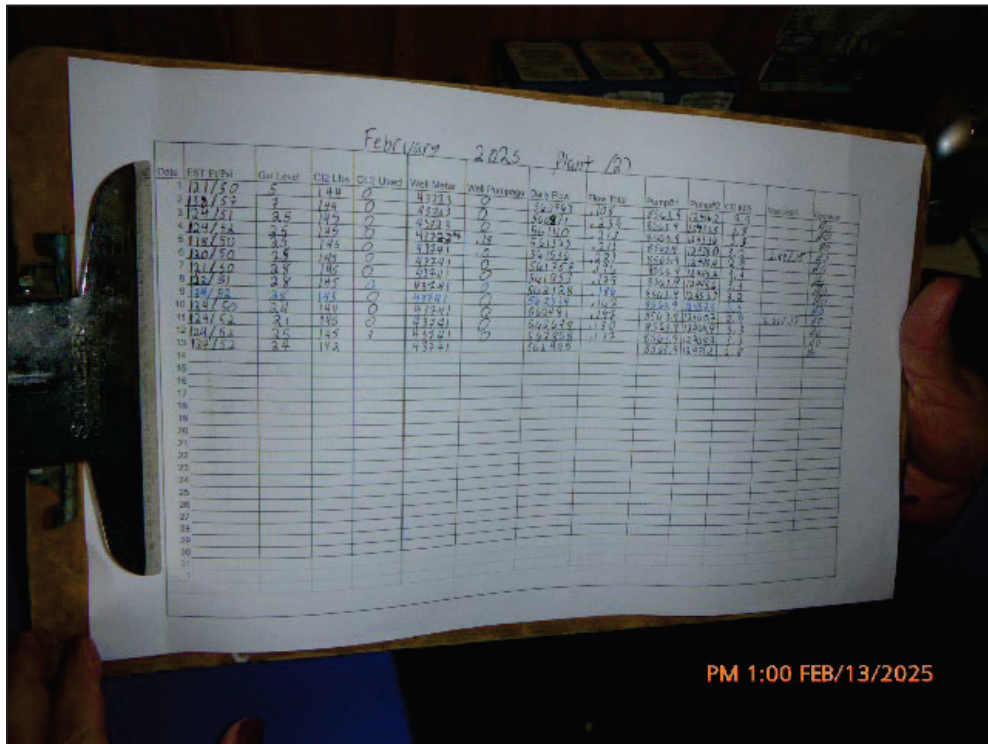
Photograph 19. 2/13/2025 1:00 pm P1010244.JPG

Description: Plant #2. Daily log sheet kept by operators for Plant #2, located at the Plant #1 office.  
February 2025.
