**Region 6 - Enforcement & Compliance Assurance Division**  
**INSPECTION REPORT**

| Inspection Date(s): | 3/12/2024 | |
| Company Name: | <b>RCP Production, LLC</b> | |
| Facility Name: | <b>TD Murphy B-3 SWD Tank Battery</b> | |

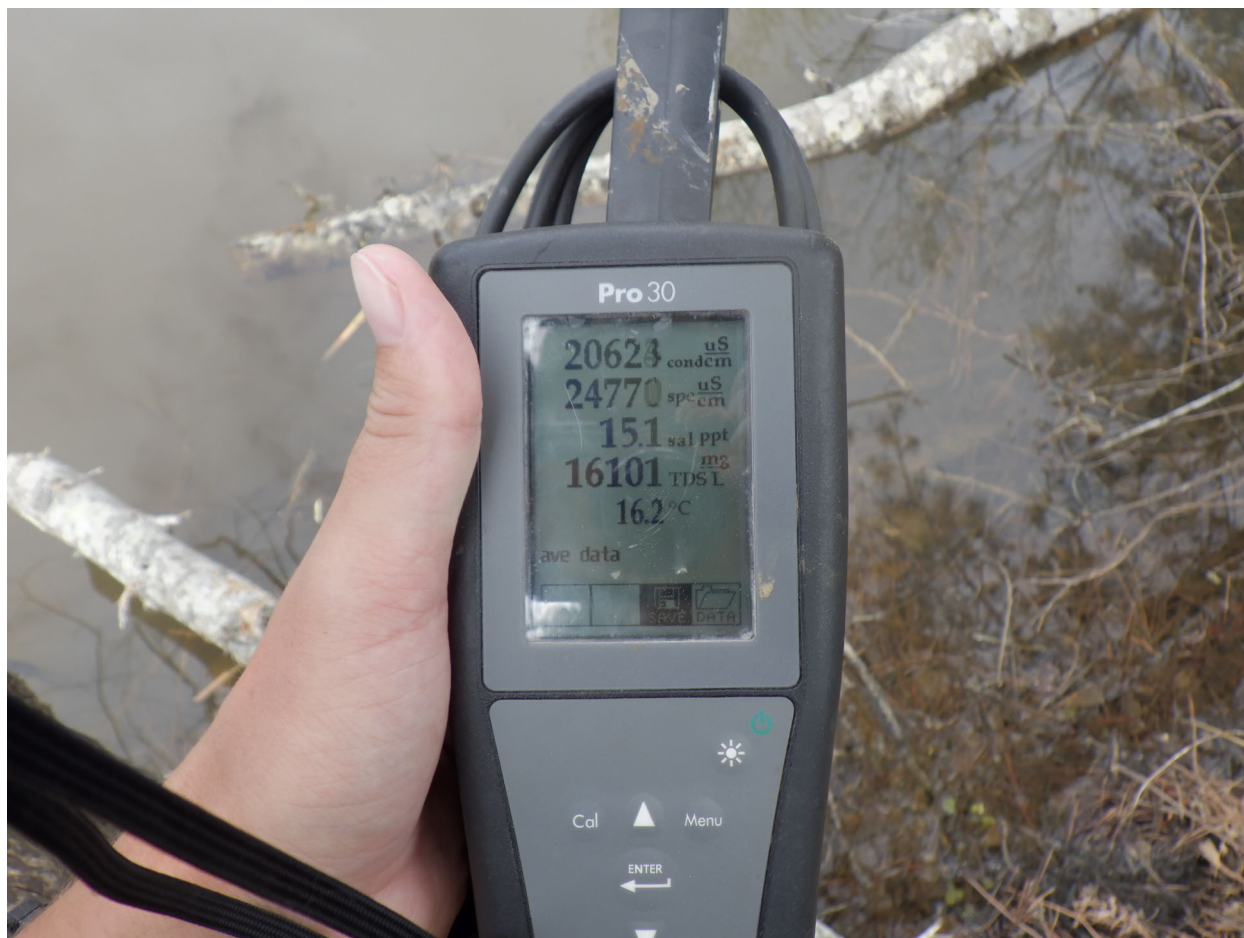
At the oil lease road crossing, I observed a TDS reading of 16,101 mg/L as well as wetland characteristics, see photo No. 25 through photo No. 27.

**Description:** This photo was taken showing a TDS reading of 16,101 mg/L at the oil lease road crossing a day after the release.

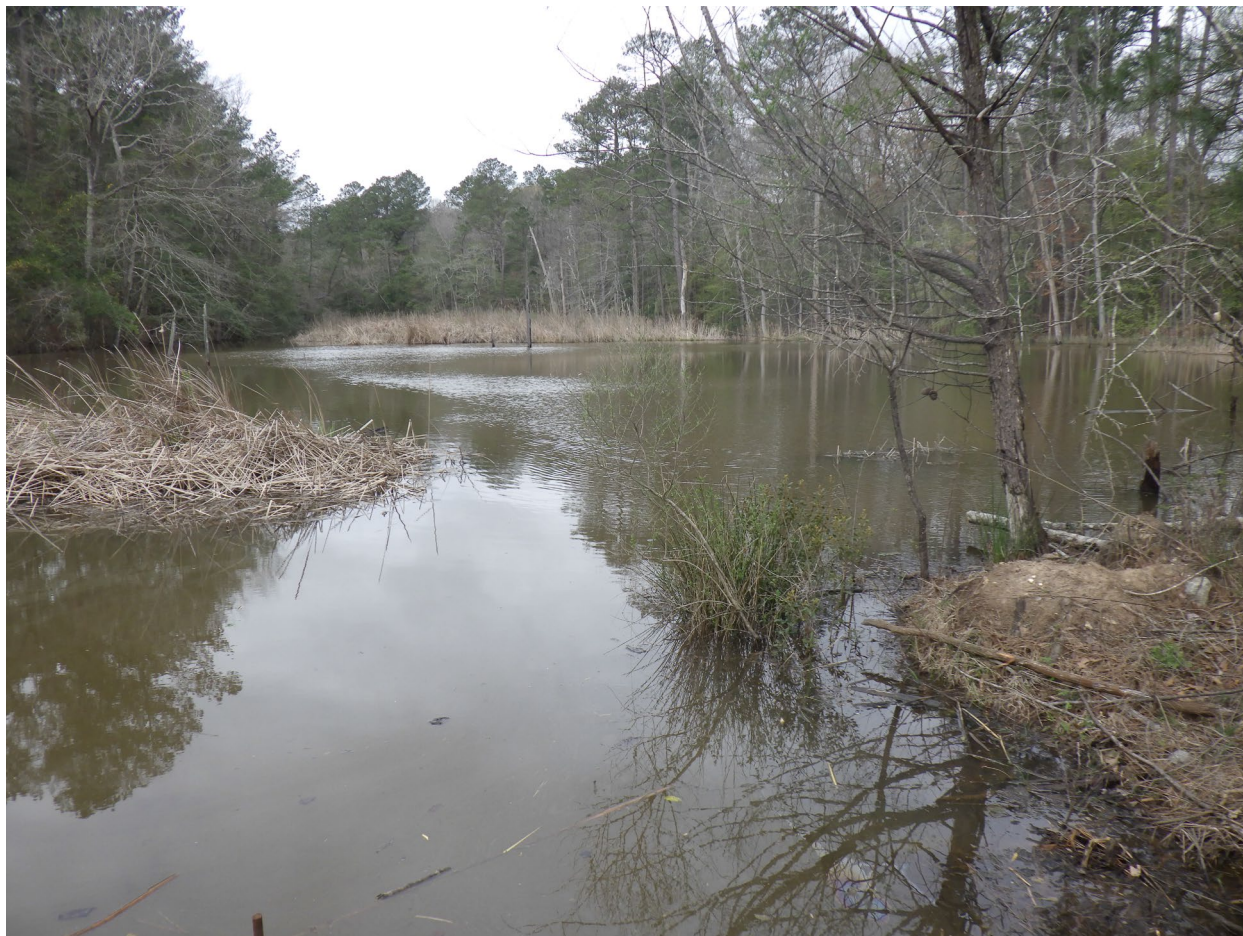
Photo No. 26

**Description:** This photo was taken at the same location as photo No. 25 looking upstream WNW showing sheen, vegetation, and topography of the wetland.

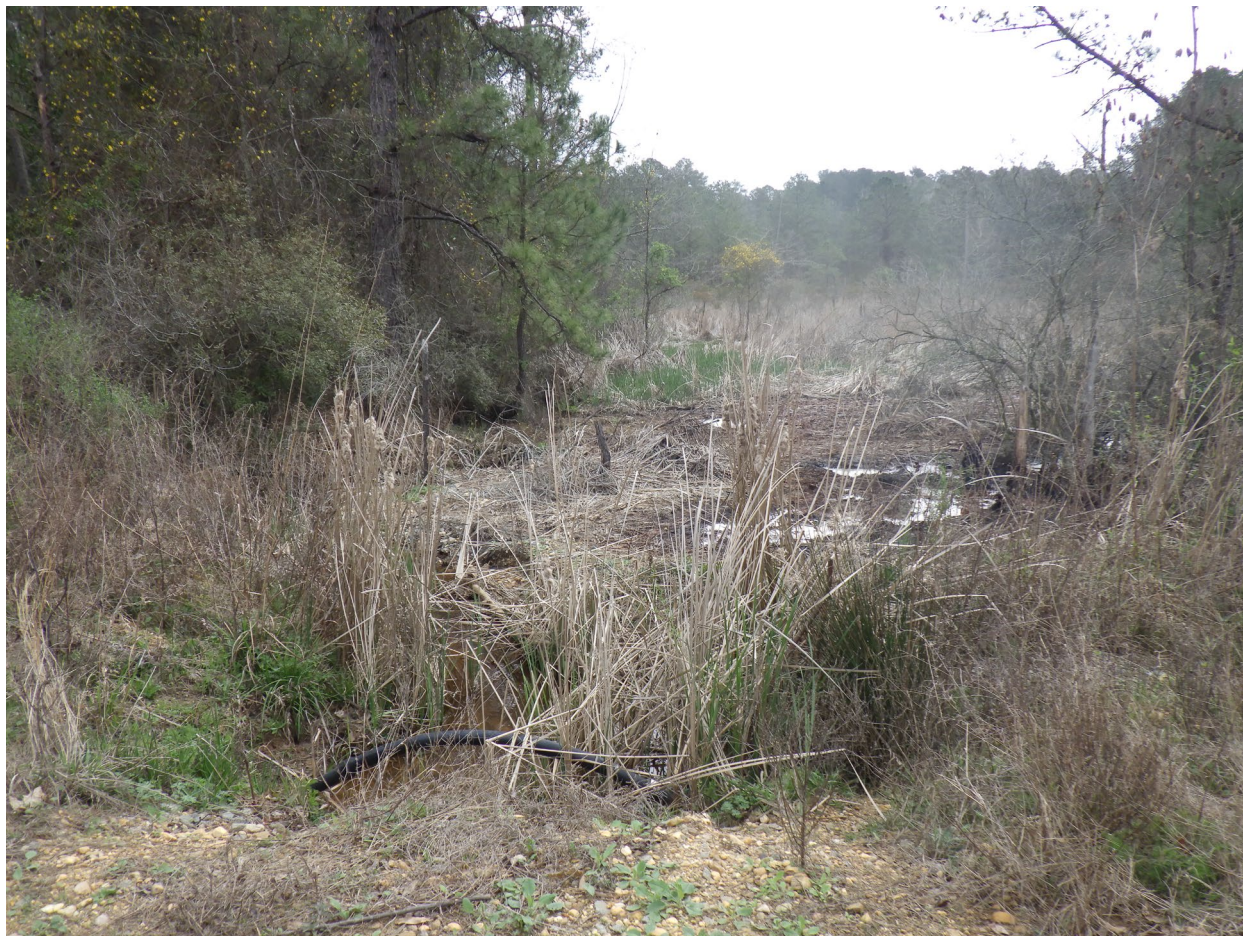
Photo No. 27

**Description:** This photo was taken at the same location as photo No. 25 looking downstream E showing vegetation and topography of the wetland.

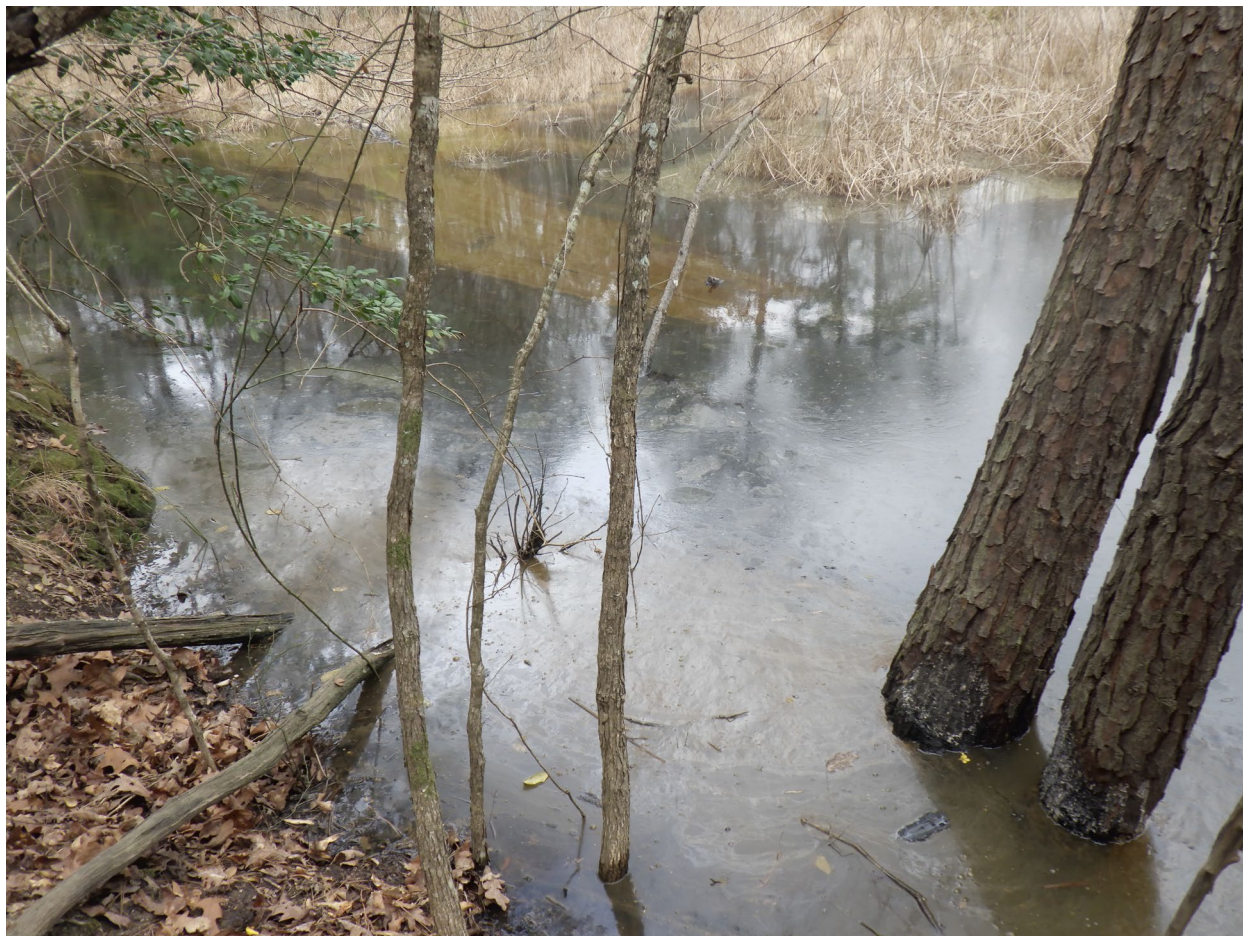
Photo No. 28

I observed oil gathering in the wetland upstream from the oil lease road crossing, see photo No. 28.

**Description:** This photo was taken looking NW showing oil collecting in the wetland.

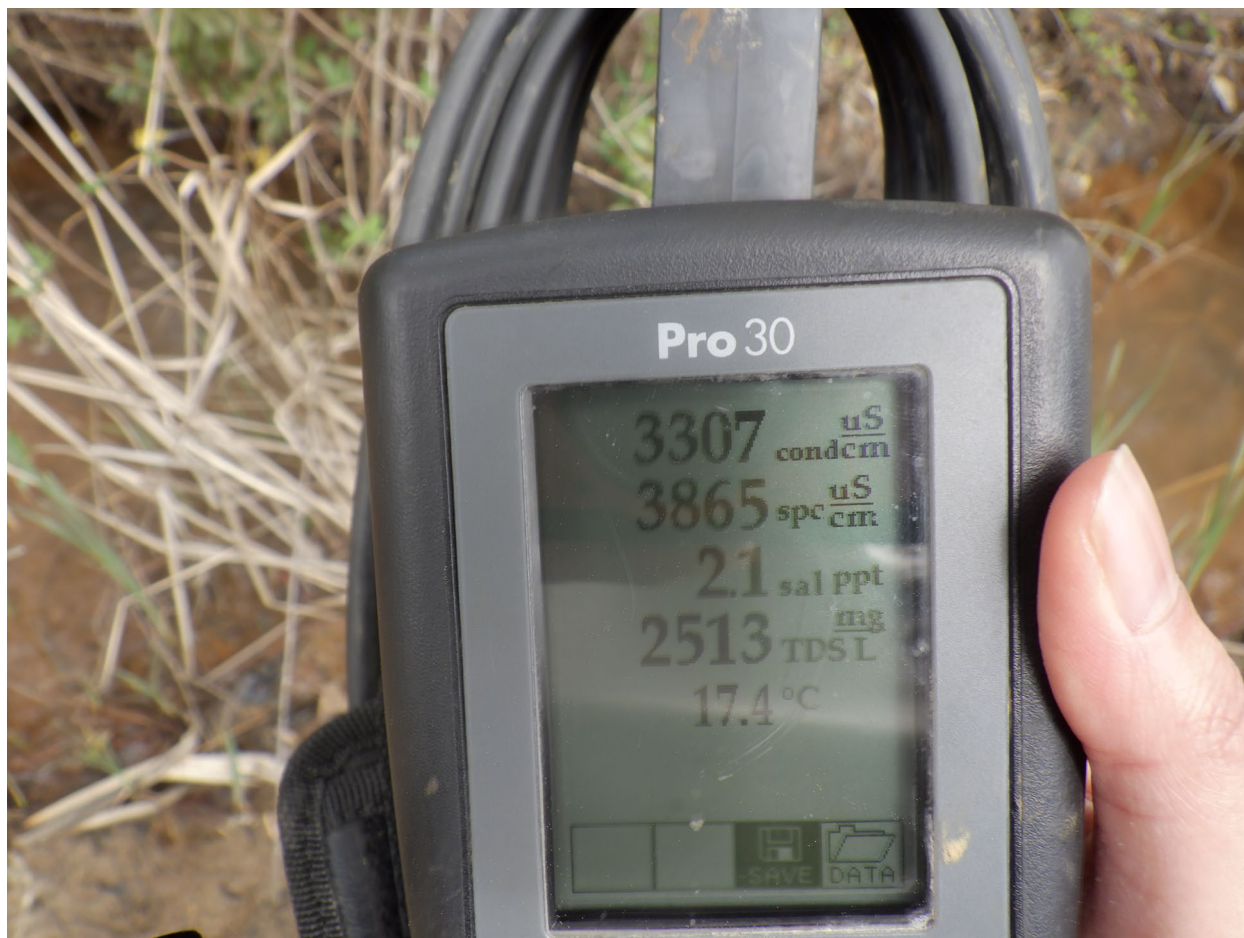
Photo No. 29

Downstream from the oil lease road crossing, I observed a TDS reading of 2,513 mg/L as well as wetland characteristics, see photo No. 29 through photo No. 31.

**Description:** This photo was taken showing a TDS reading of 2,513 mg/L downstream from the oil lease road crossing a day after the release.

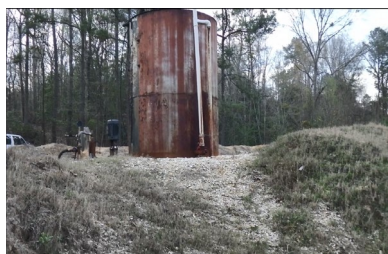
Description: This video was taken looking E showing produced water and oil flowing out of the tank into secondary containment. The secondary containment valve was left open releasing the spill outside of secondary containment.
