**UNITED STATES ENVIRONMENTAL PROTECTION AGENCY  
REGION 8  
RESOURCE CONSERVATION AND RECOVERY ACT**

**Facility Name:** US Magnesium, LLC

**Date of Inspection:** April 27, 2023

**Type and Purpose of Inspection:** Compliance Schedule Evaluation (CSE)

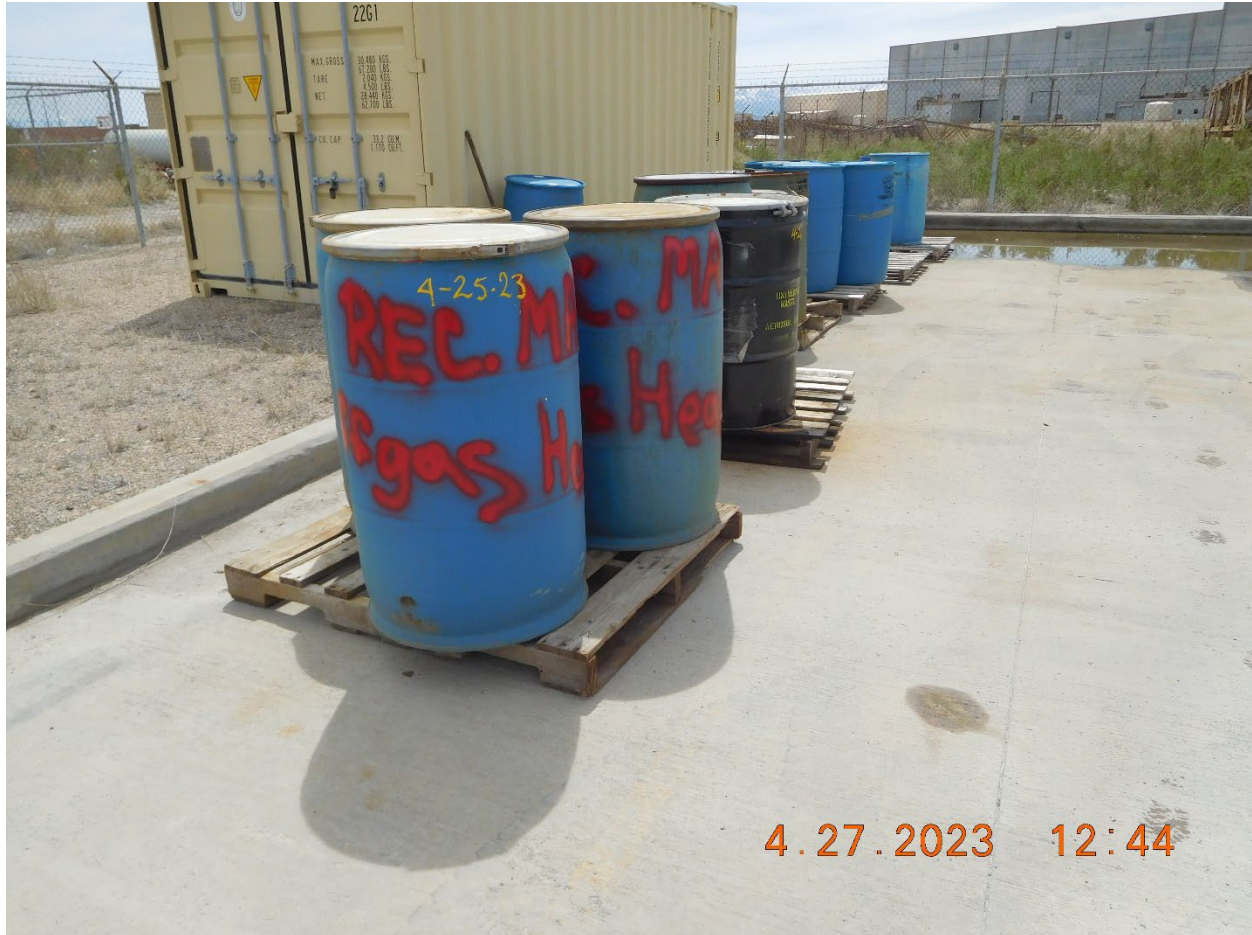
**Photo Number:** 4, DSCN1858.jpg

**Photo Description:** Photo of waste stored in the hazardous waste central accumulation area on the eastern portion of the concrete pad.

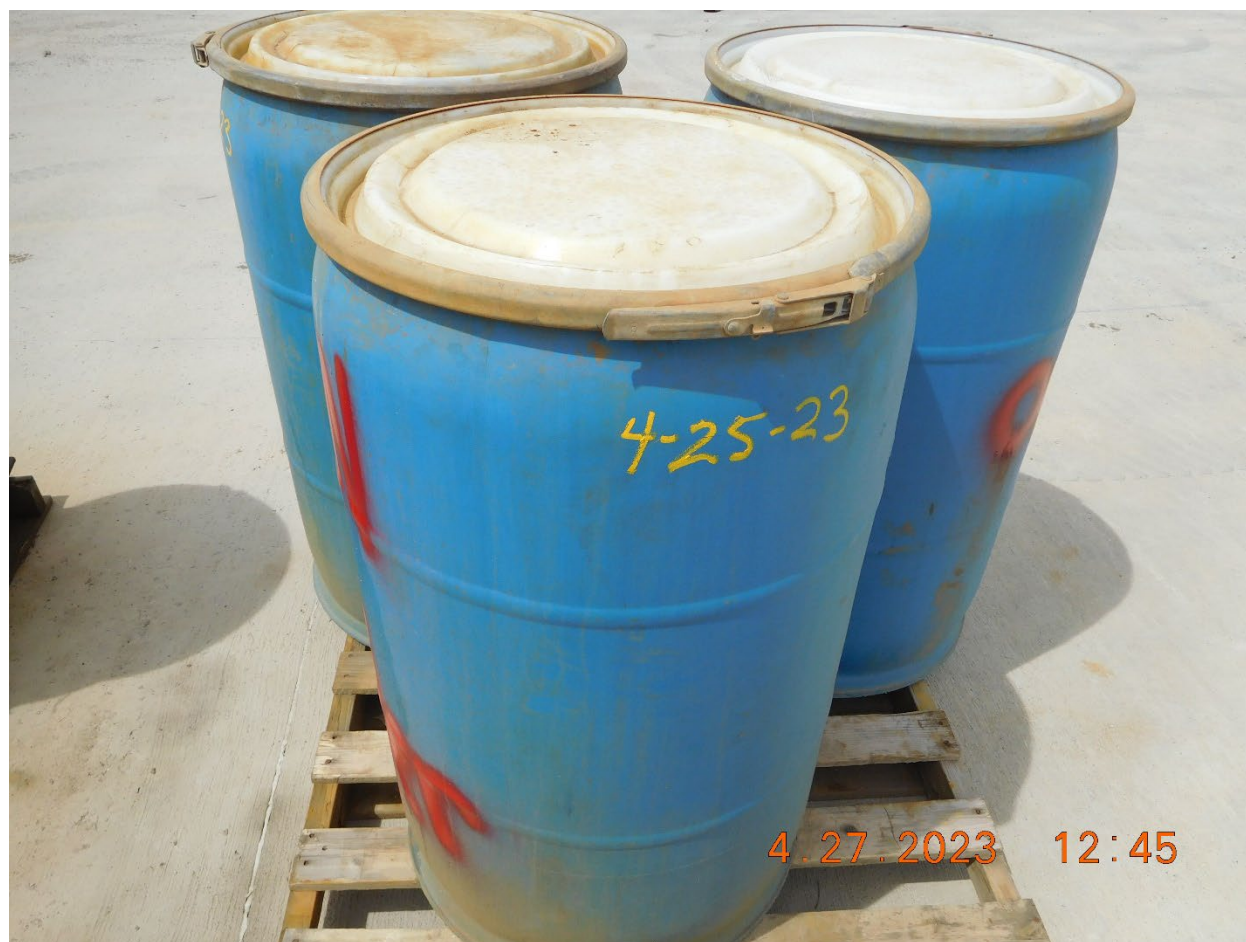
**Photo Number:** 6, DSCN1860.jpg

**Photo Description:** Additional photo of the drums shown in Photo 5.

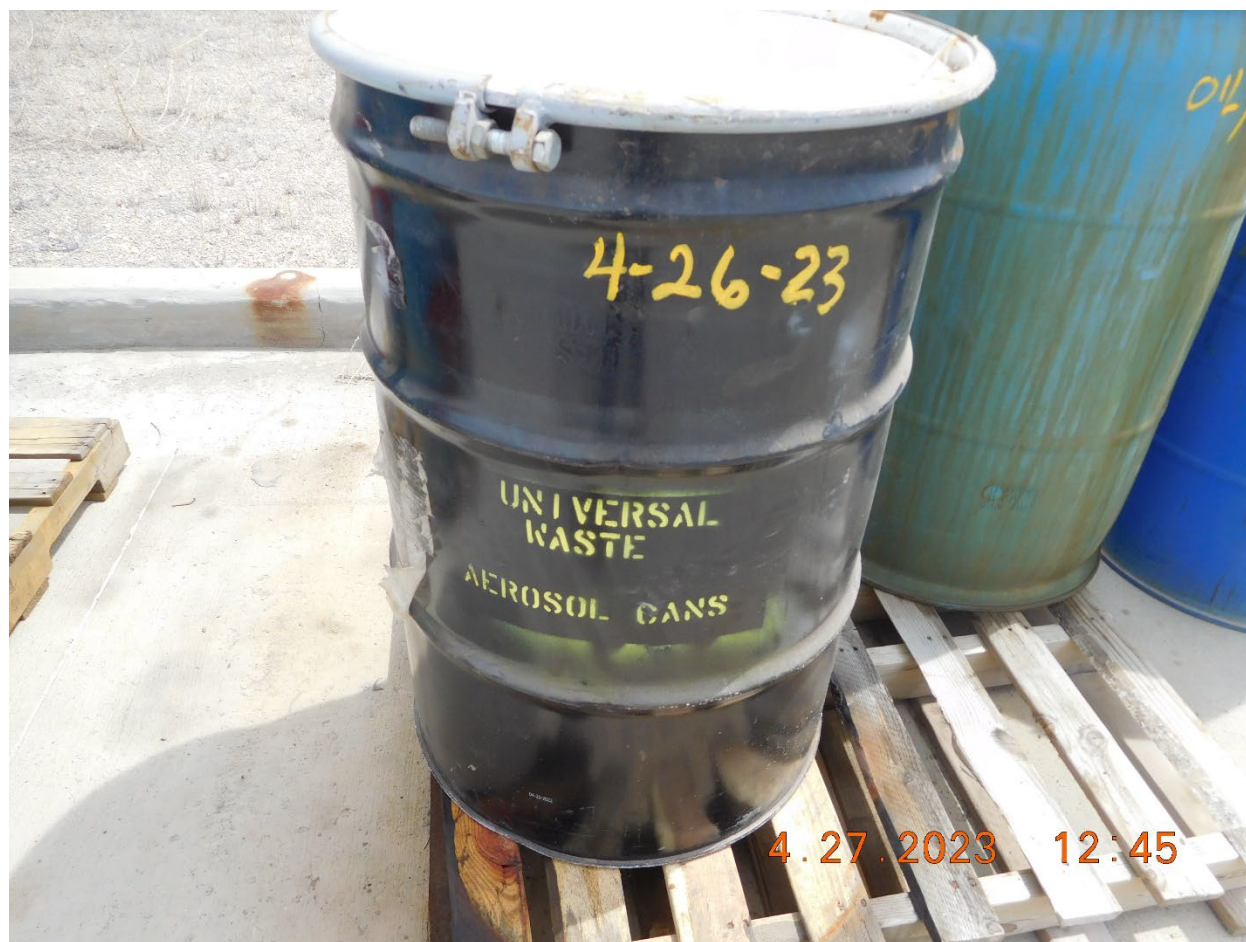
**Photo Number:** 7, DSCN1861.jpg

**Photo Description:** Photo of a drum of universal waste aerosol cans.

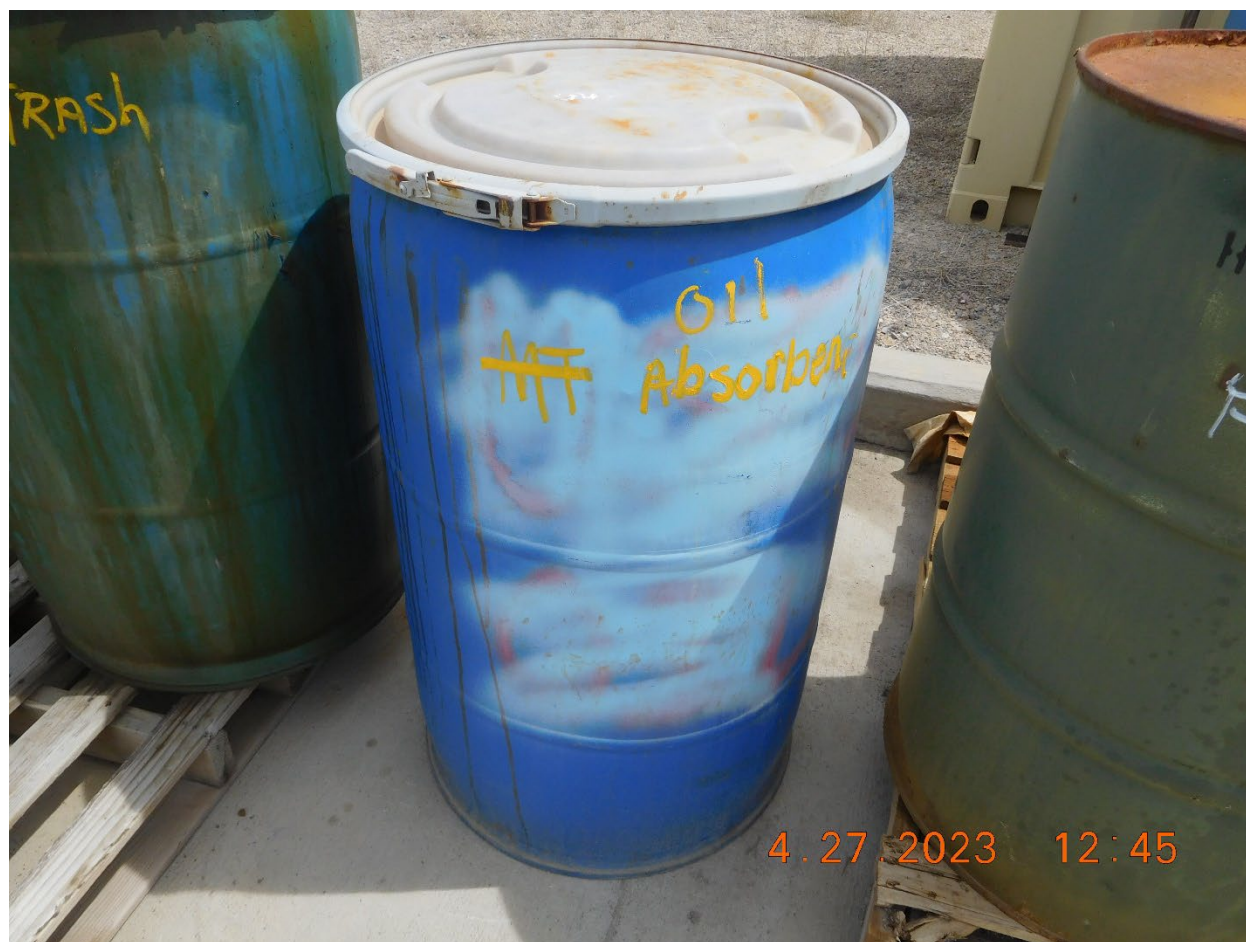
**Photo Number:** 9, DSCN1863.jpg

**Photo Description:** Photo of an empty drum labeled “Oil Absorbent”

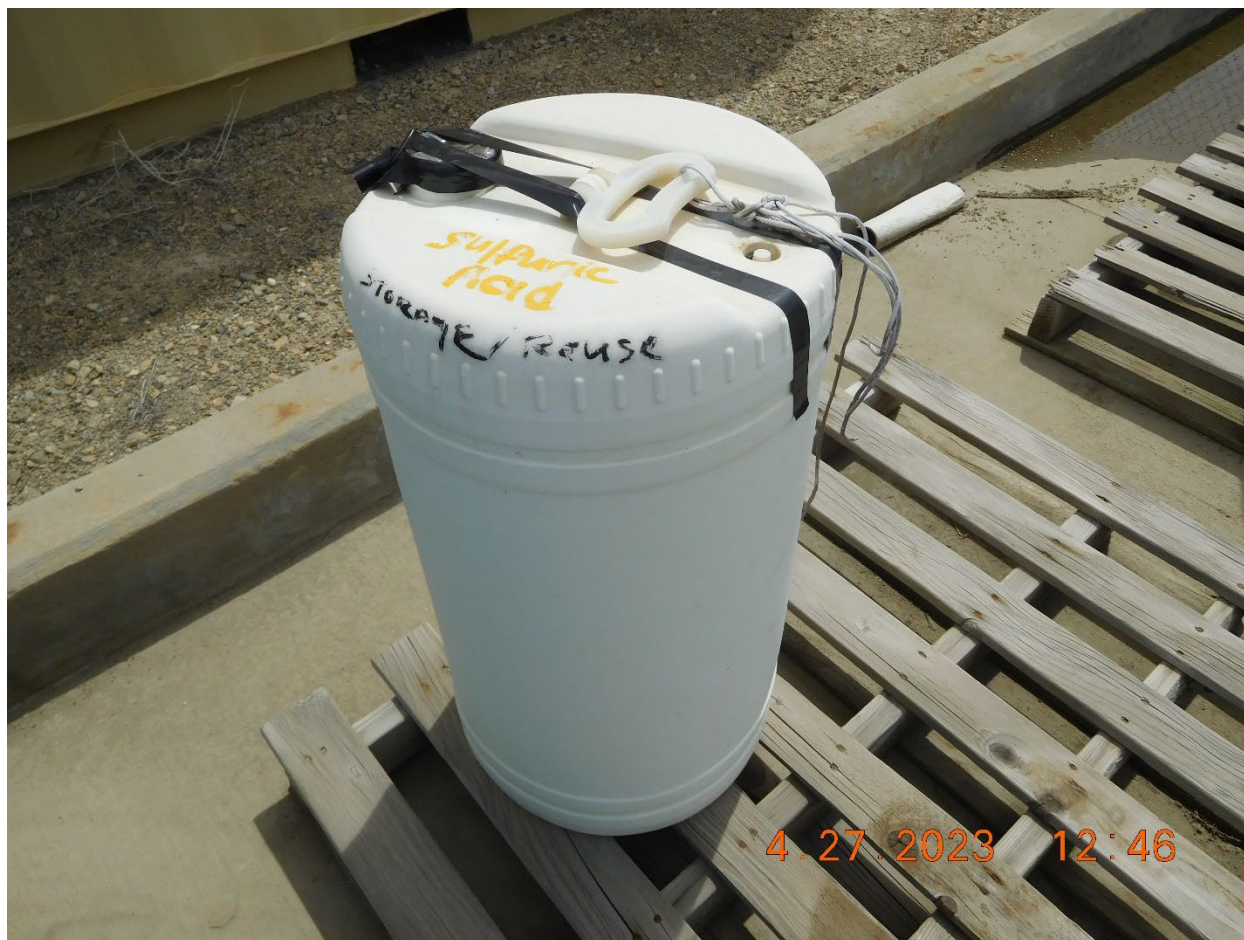
**Photo Number:** 14, DSCN1868.jpg

**Photo Description:** Photo of a storage container for sulfuric acid awaiting reuse.

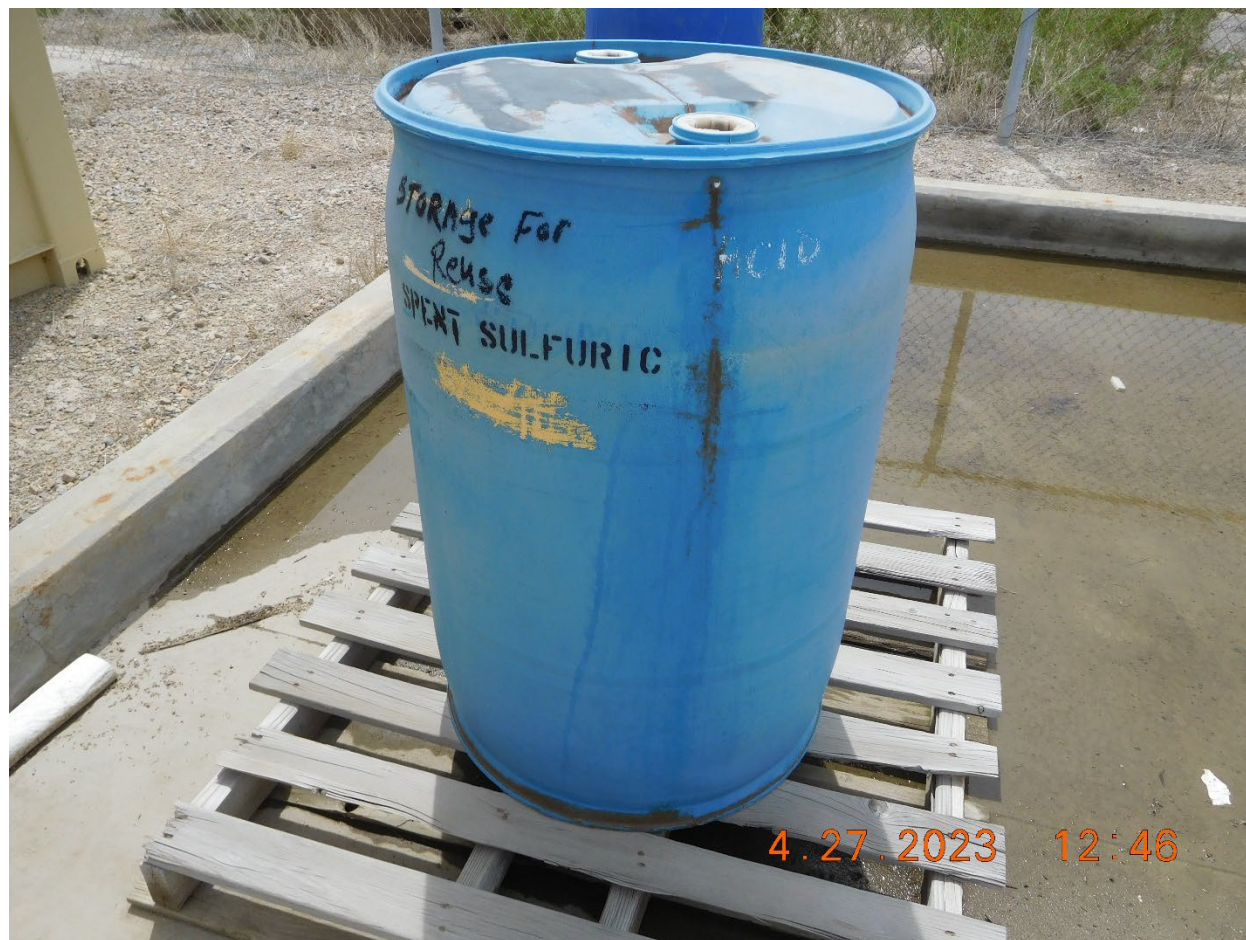
**Photo Number:** 15, DSCN1869.jpg

**Photo Description:** Photo of a storage container for sulfuric acid awaiting reuse.

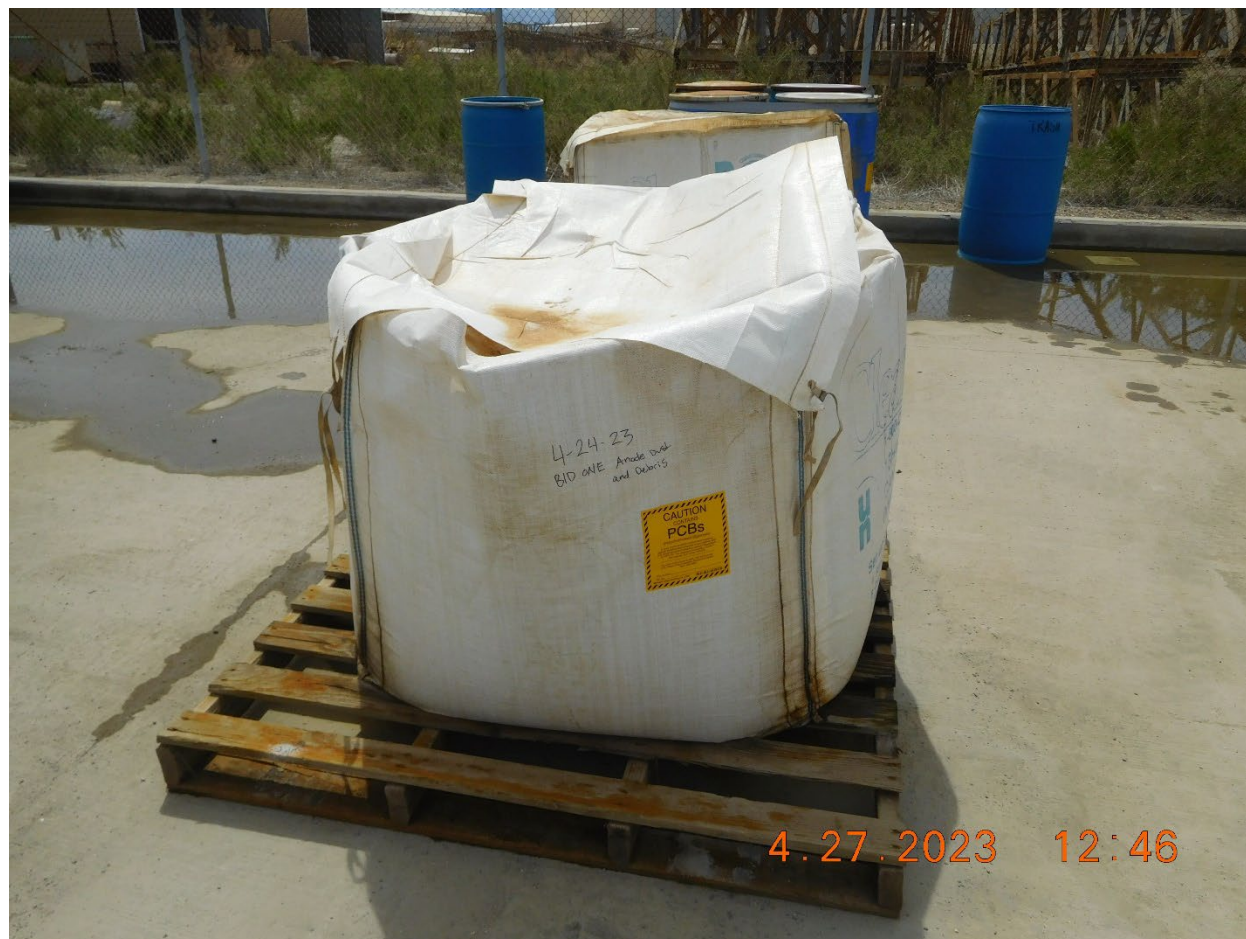
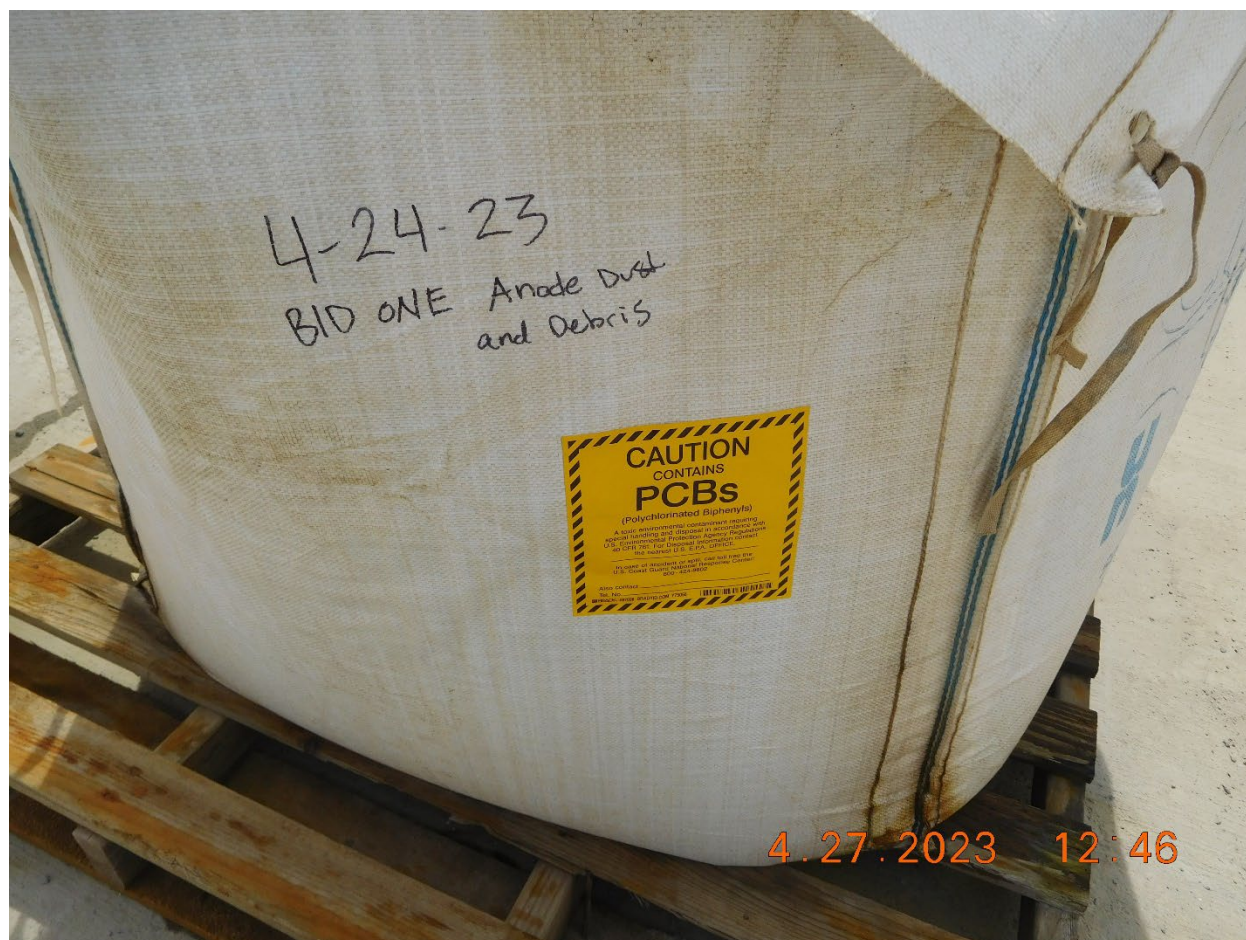
**Photo Number:** 16, DSCN1870.jpg

- 1 white supersack marked “Bld one anode dust and debris” and labeled “Caution Contains PCBs” (photos 16 and 17)
- 1 white supersack marked “Bldg 4 Grizzly Anode Dust and Debris Hazardous Material” and labeled “Caution Contains PCBs” (photo 18); this container appeared to be leaking

**Photo Description:** Photo of a supersack containing PCB-containing anode dust and PPE, marked "Bldg One Anode Dust and Debris".

**Photo Description:** Close-up of the supersack shown in Photo 16.

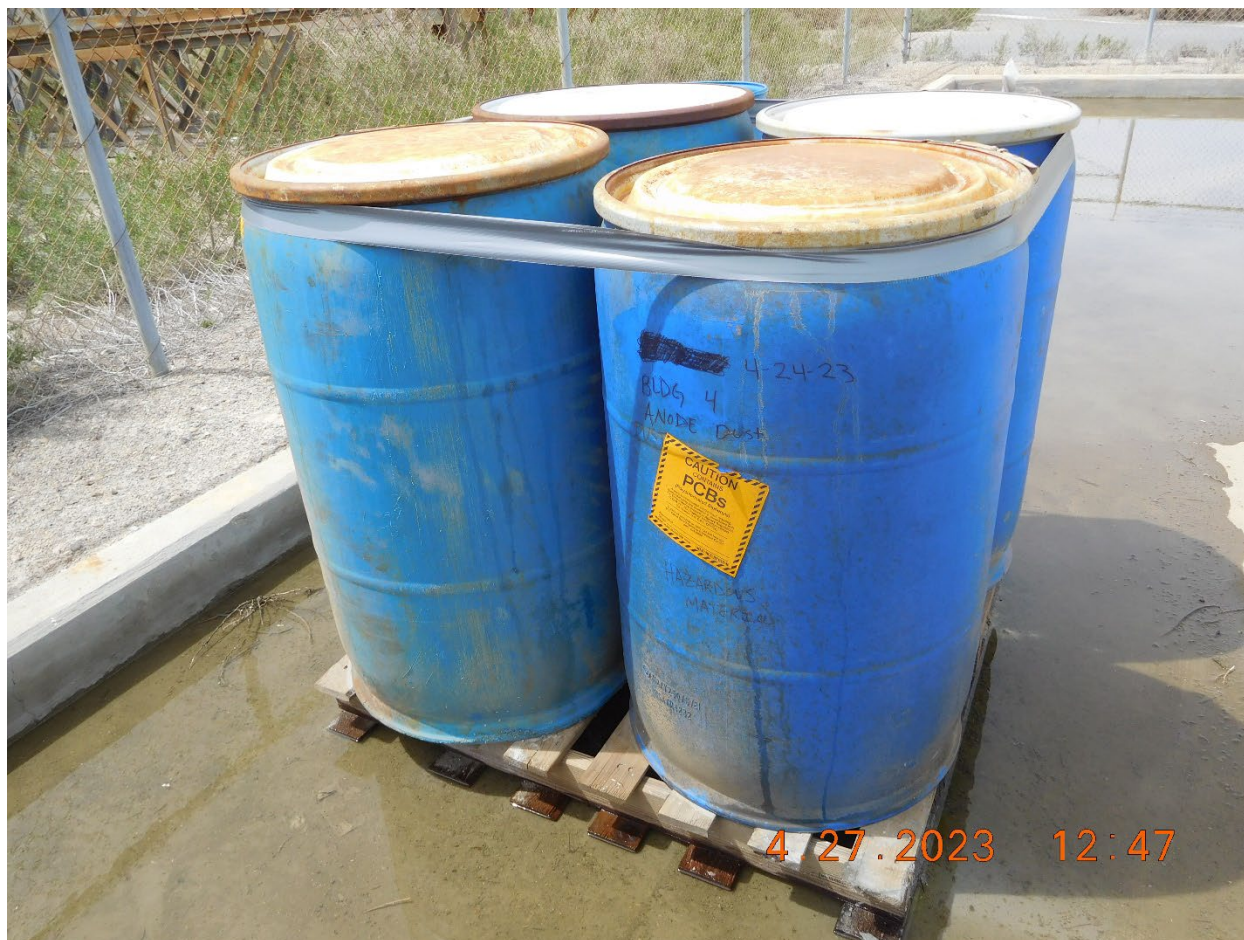
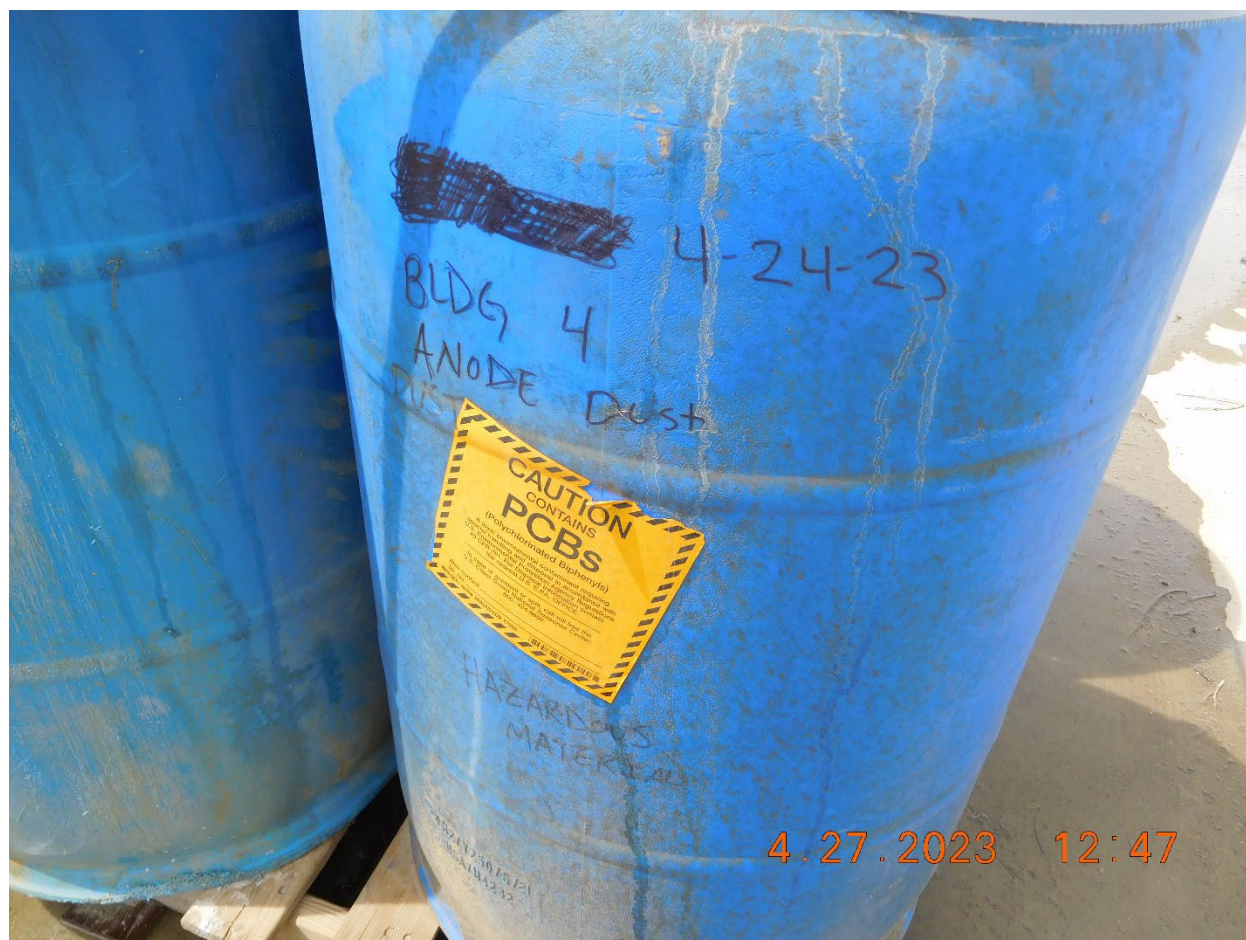
**Photo Number:** 19, DSCN1873.jpg

- 1 blue poly 55-gallon drum marked “Bldg 4 Anode Dust” and “Hazardous Material” labeled “Caution Contains PCBs” and dated 4-24-23 (photos 19 and 20)
- 1 blue poly 55-gallon drum marked “Bld One Anode Dust and Debris” and dated 4-24-23

**Photo Description:** Photo of four drums containing PCB-containing anode dust.

**Photo Description:** Close-up of one of the drums shown in Photo 19.

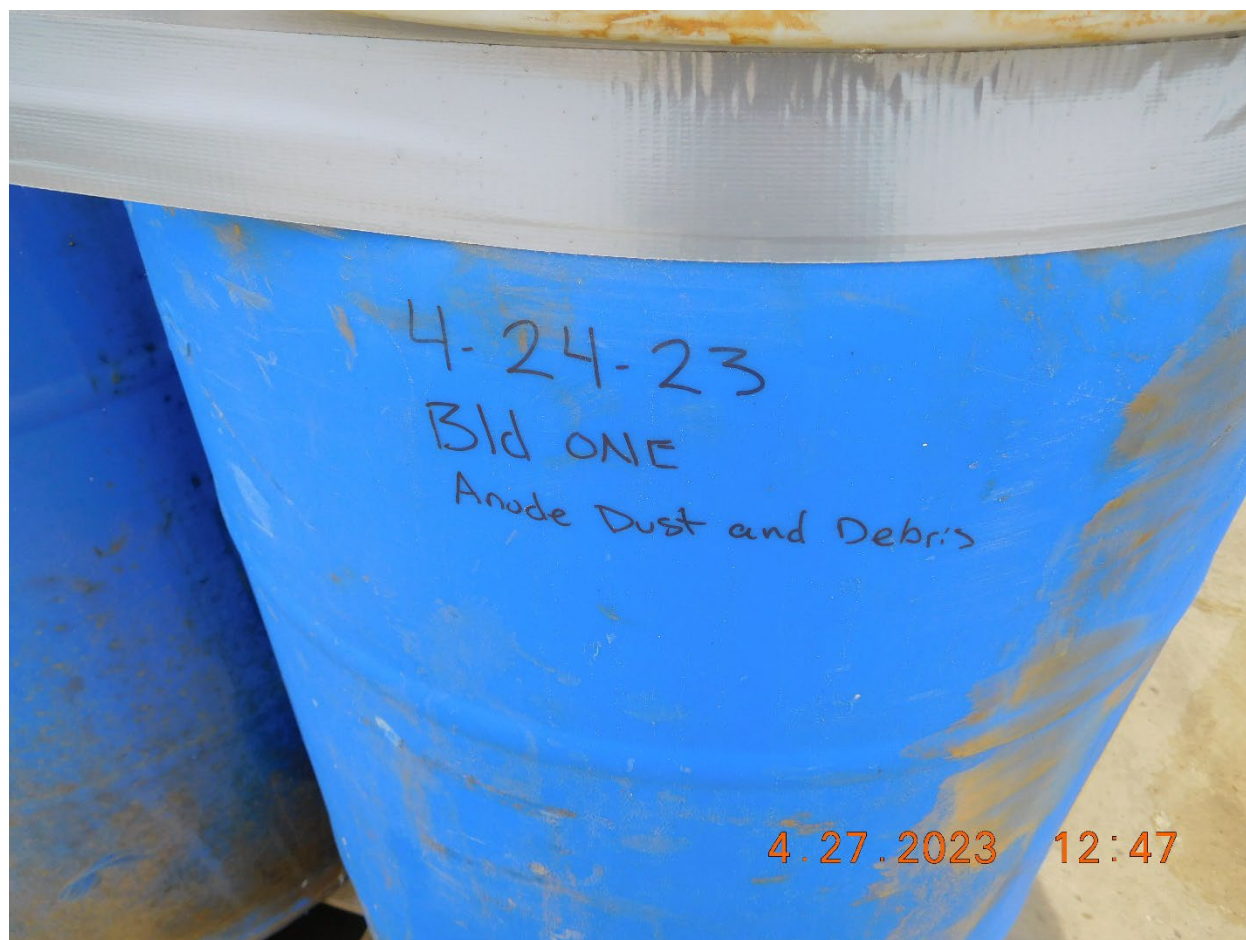
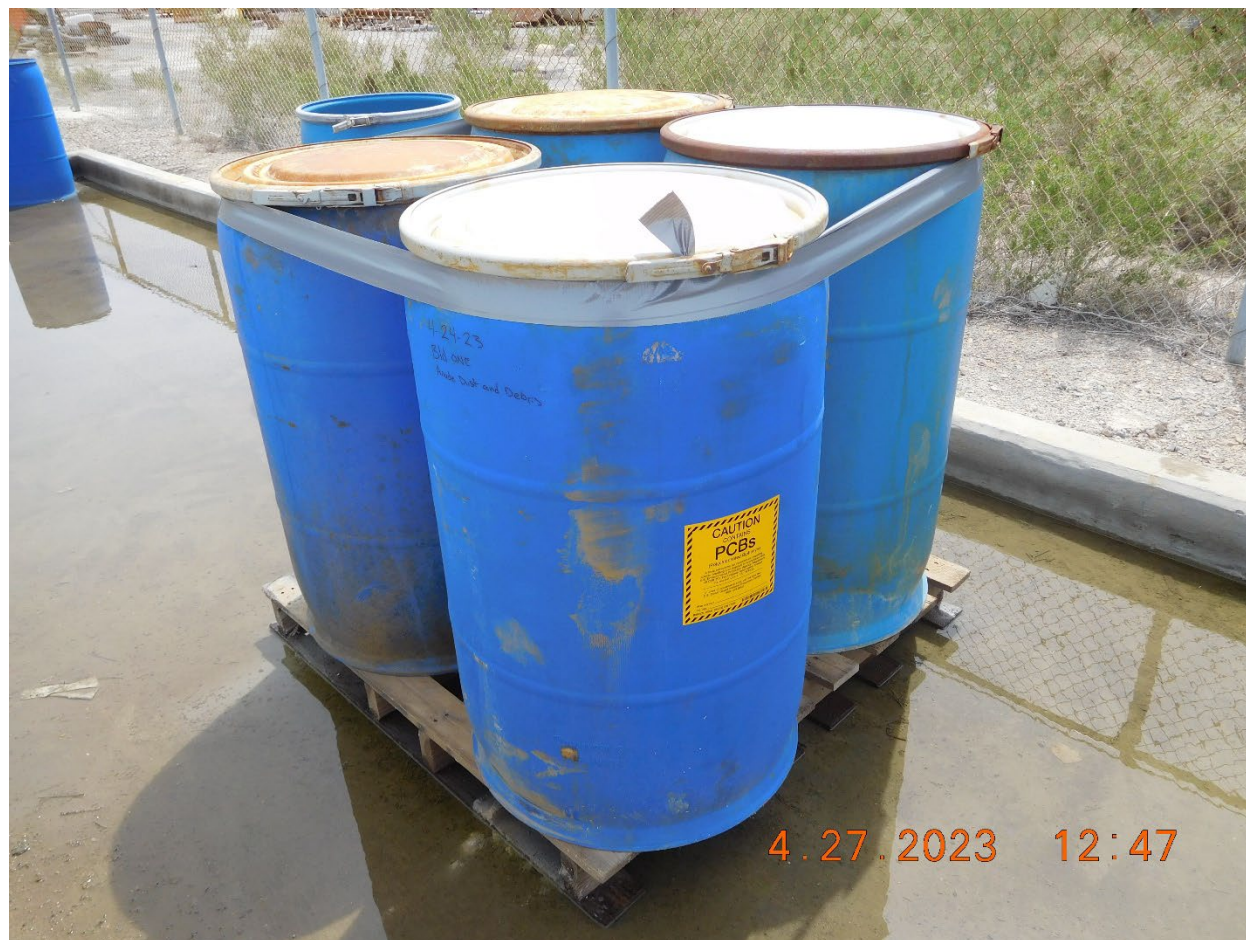
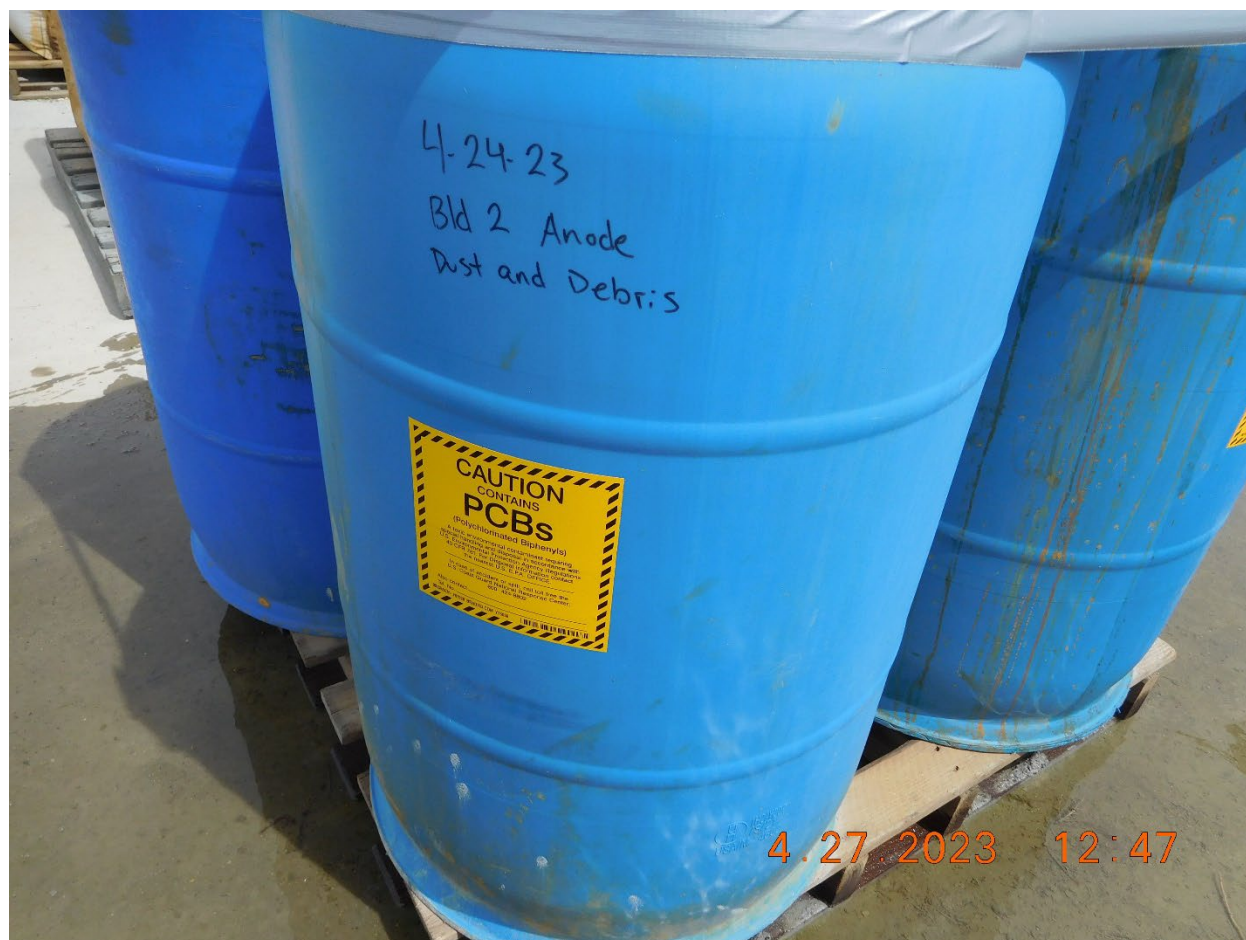
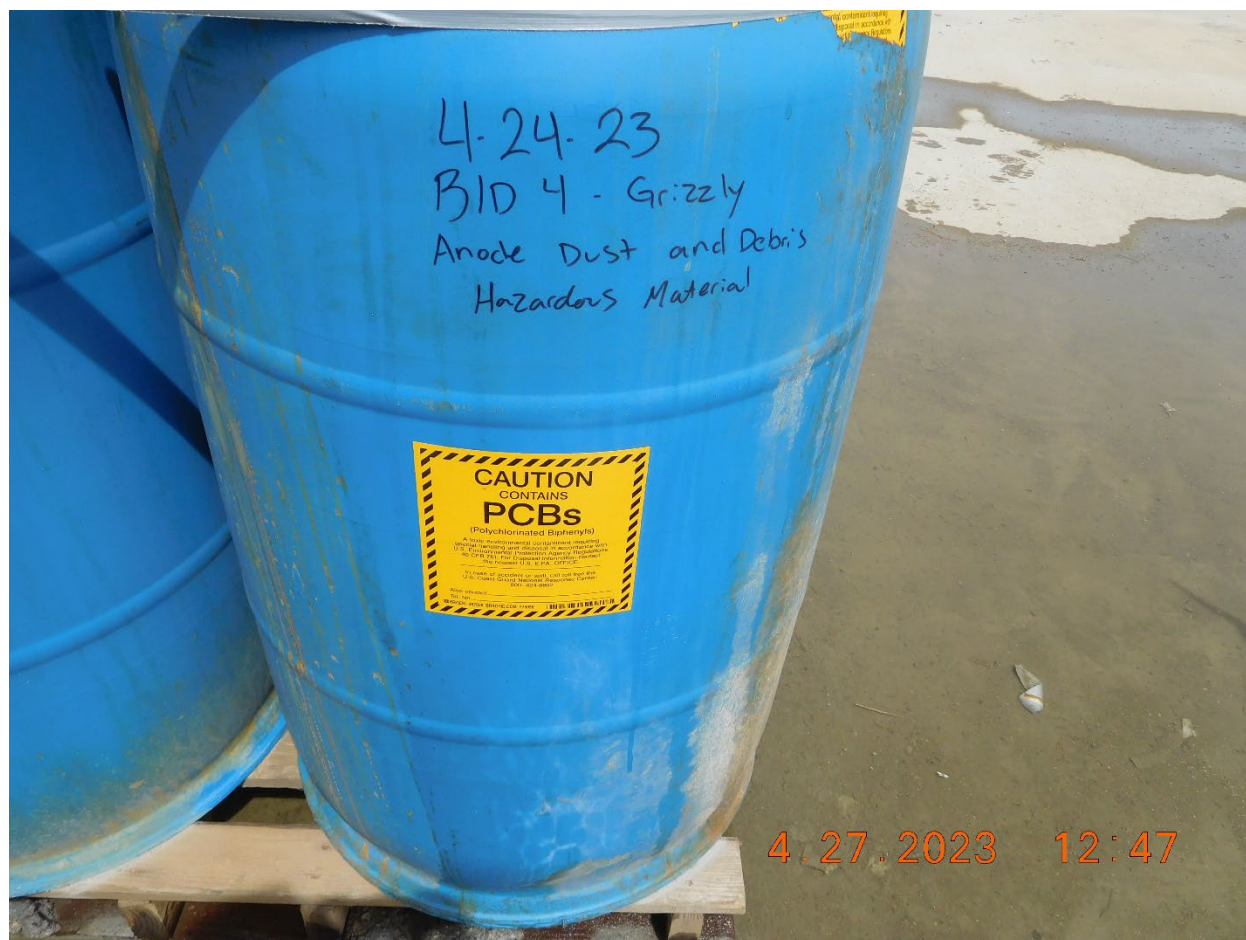
**Photo Description:** Close-up of one of the drums shown in Photo 19.

**Photo Description:** Photo of the same drums shown in Photo 19.
