**UNITED STATES ENVIRONMENTAL PROTECTION AGENCY  
REGION 8  
RESOURCE CONSERVATION AND RECOVERY ACT**

**Facility Name:** US Magnesium, LLC

**Date of Inspection:** April 27, 2023

**Type and Purpose of Inspection:** Compliance Schedule Evaluation (CSE)

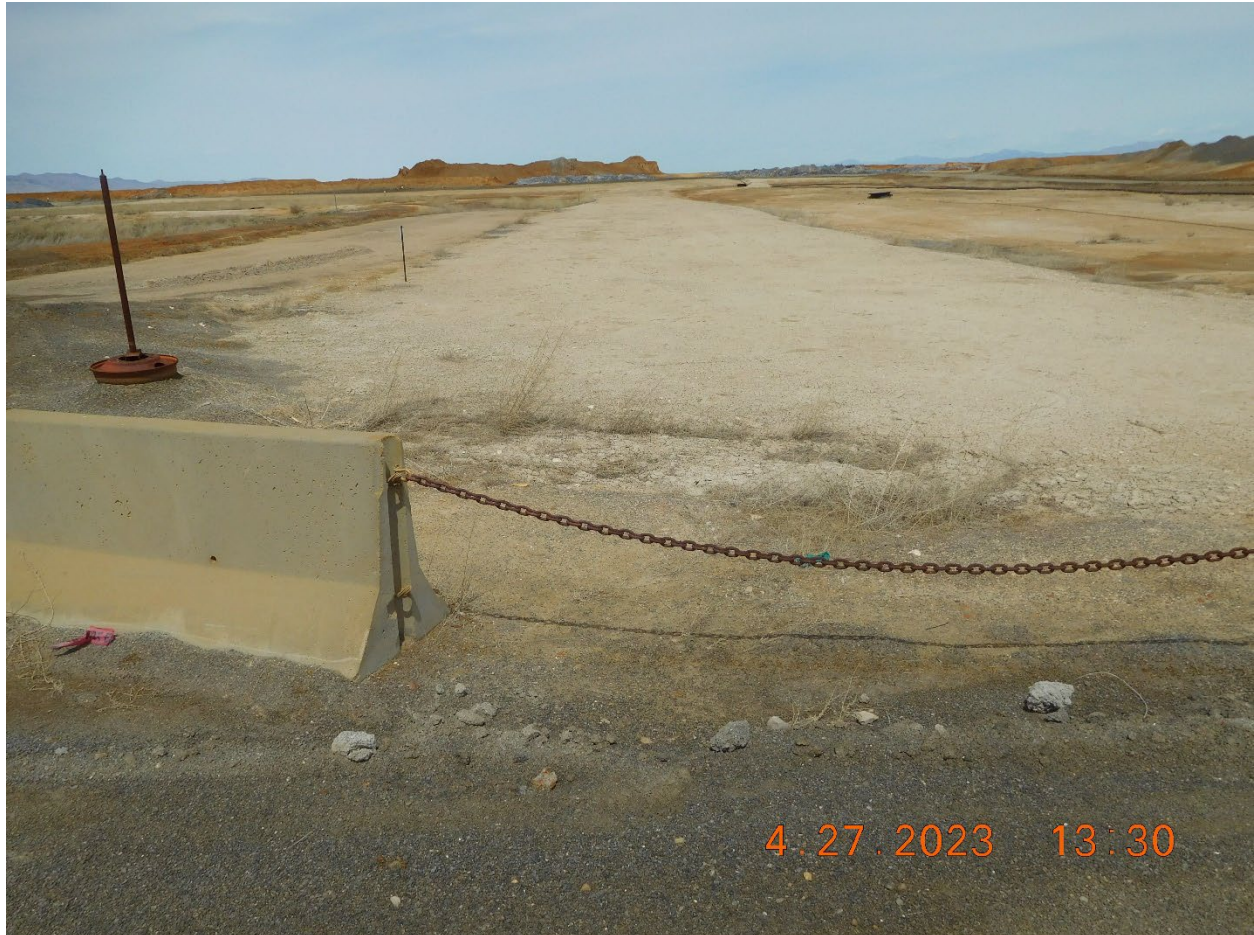
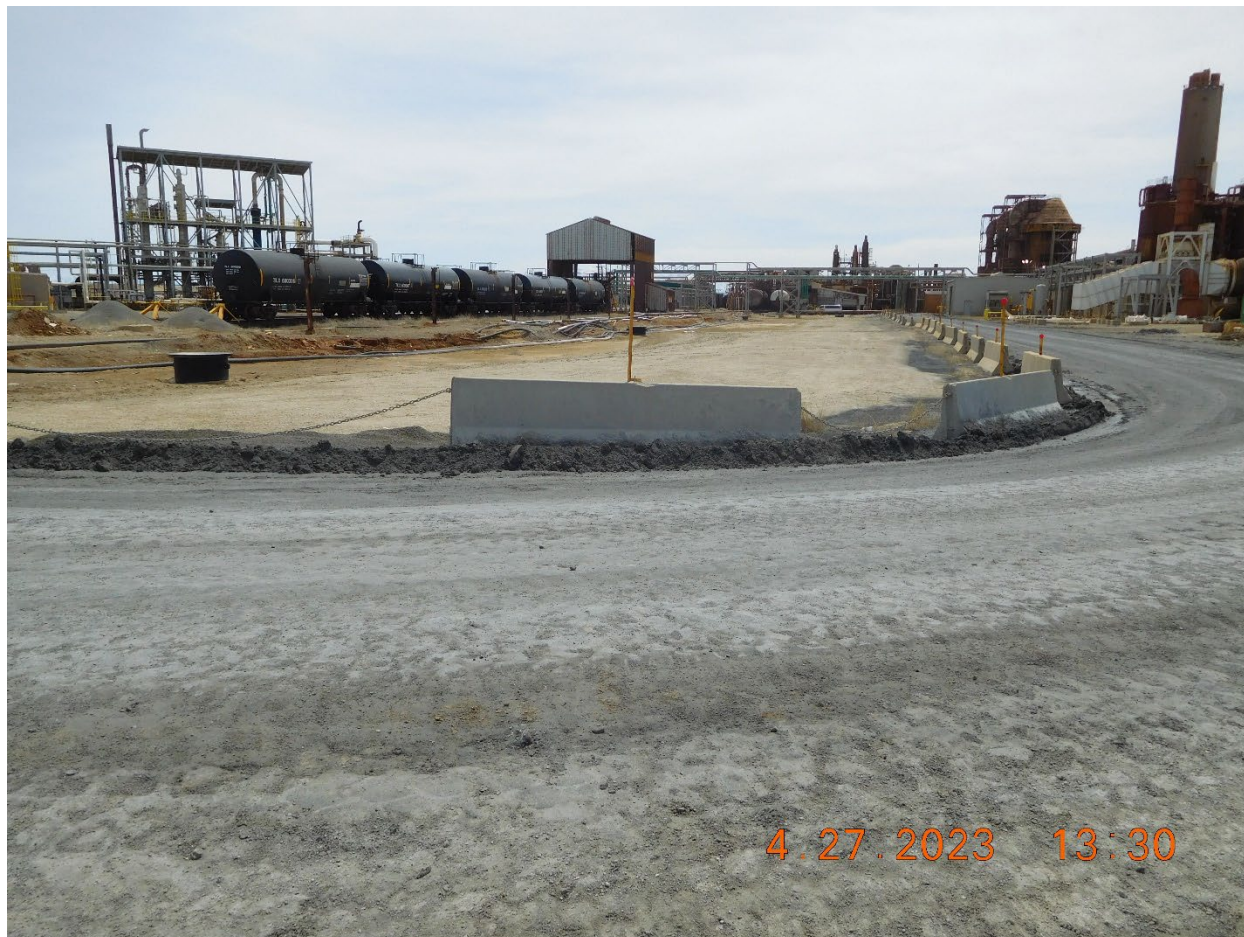
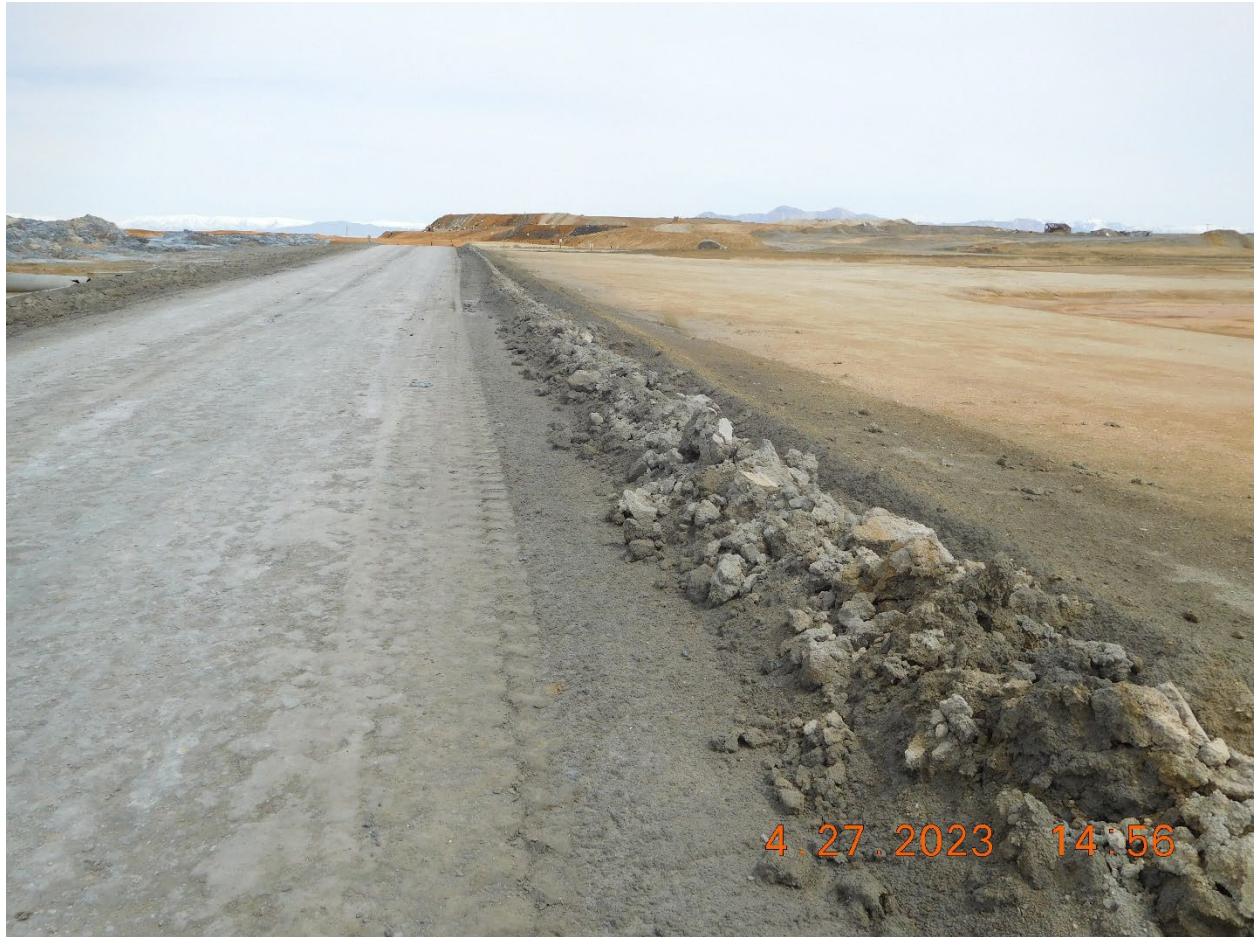
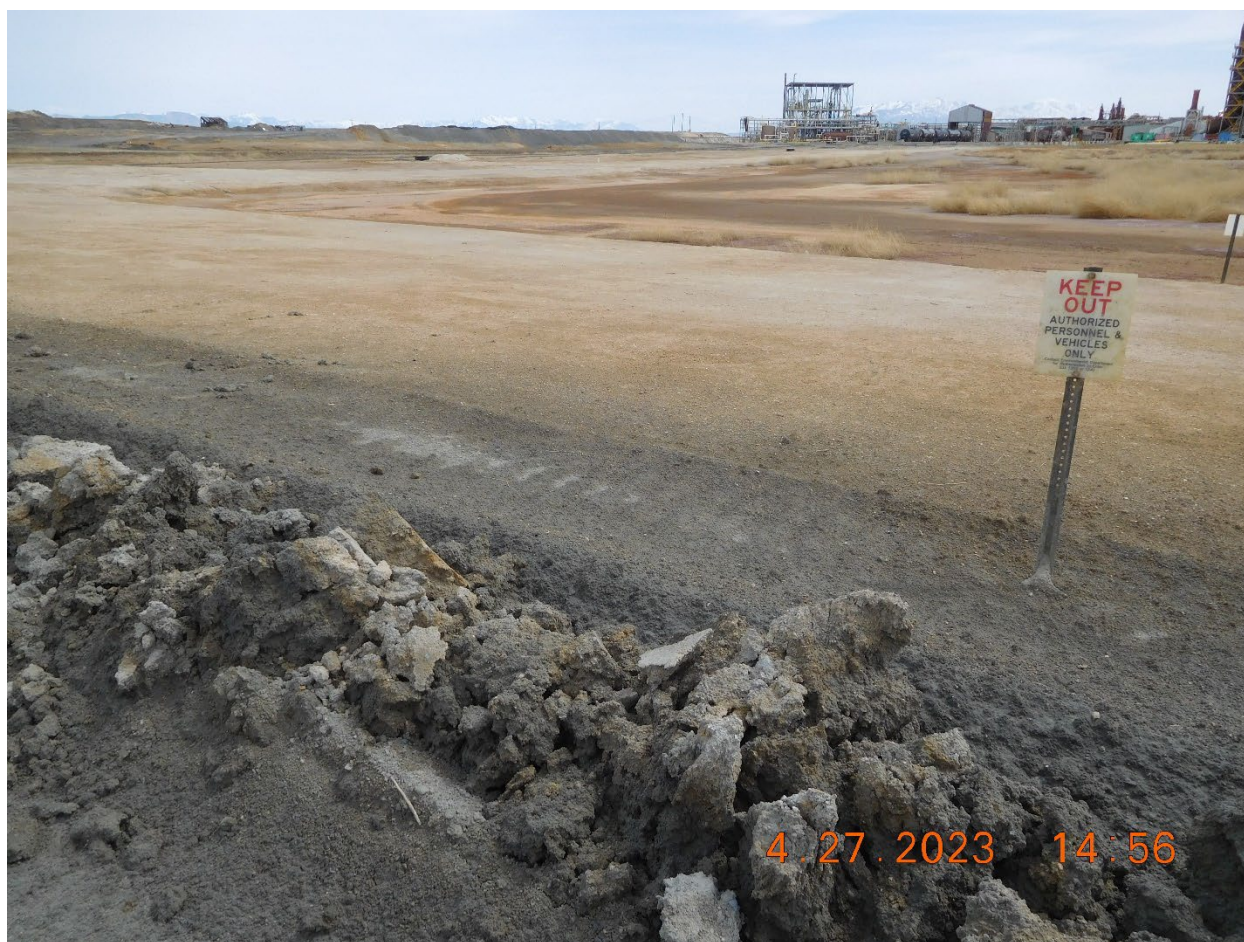
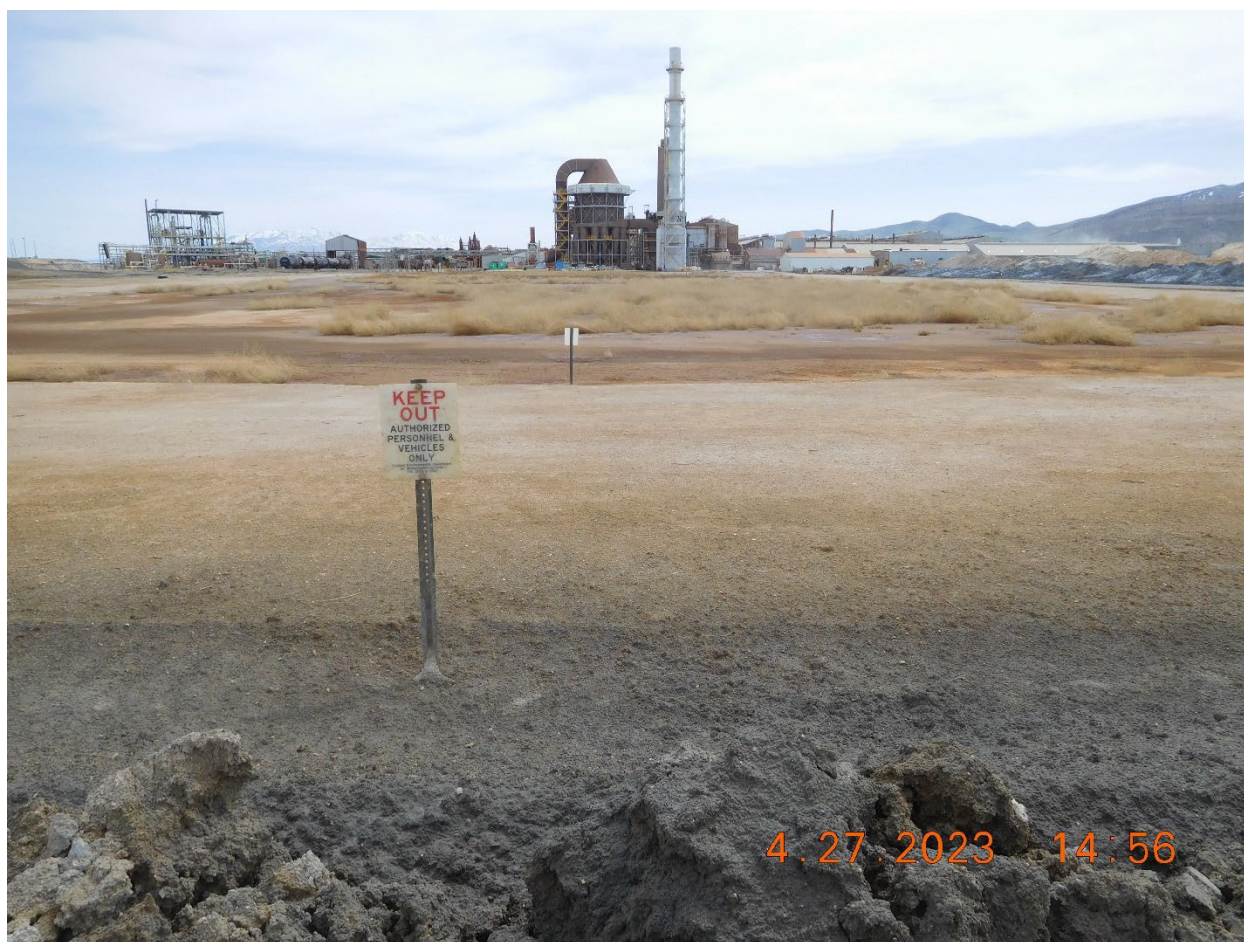
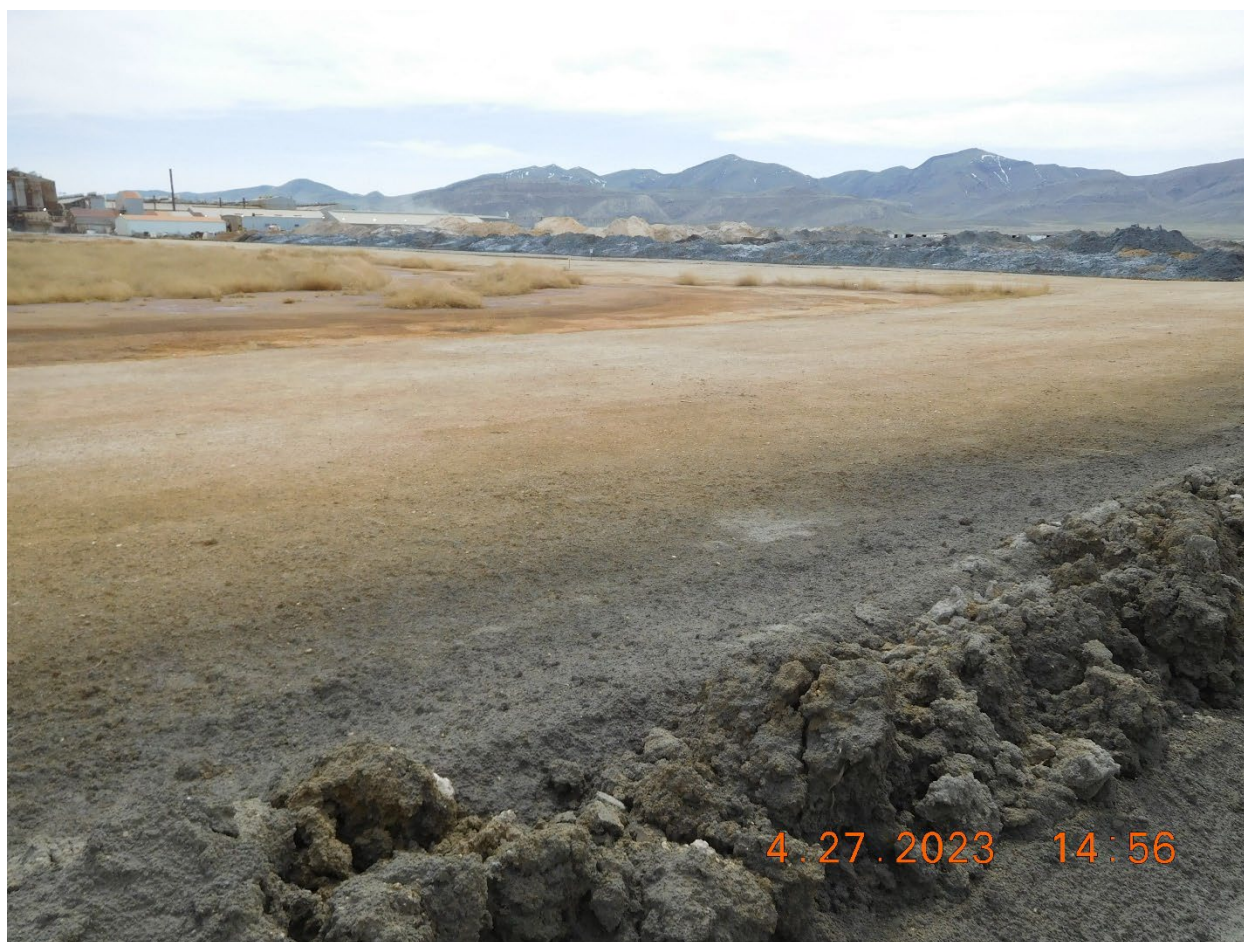
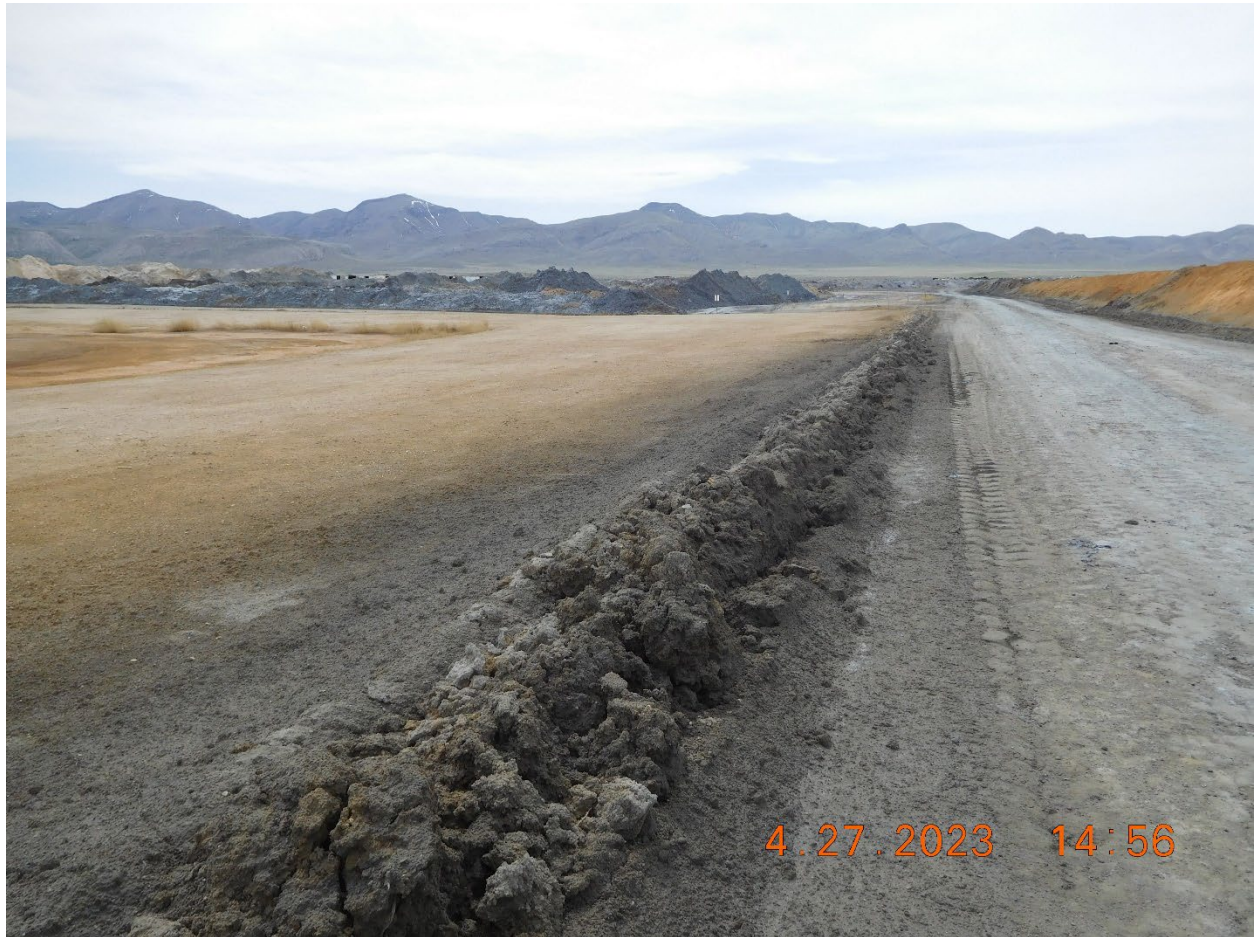
At the previous ditches capped pursuant to the RCRA Administrative Order on Consent, Docket No. RCRA-08-2016-0004 (photos 29-30 and 45-49), I observed that the caps appeared to be in good condition. At the western ditch cap near the lithium carbonate plant, additional soil has been placed to accommodate vehicles driving over the cap to obtain smut for processing in the lithium carbonate plant as source/ore material. During the inspection, I did not observe evident damage to the cap from this vehicle traffic, but this is an area of potential damage to the cap that should be carefully monitored. As stated in the Soil Cap Monitoring and Maintenance Plan, any areas of the cap where tracks are observed that are two inches or greater in depth compared to the surrounding cap surface must be repaired as soon as practicable, and inspection records are to be maintained in the on-site Operating Record.

**Photo Description:** Photo of a ditch cap taken near the southeast portion of the sanitary lagoon, facing north.

**Photo Description:** Photo of a ditch cap taken near the southeast portion of the sanitary lagoon, facing south.

**Photo Description:** Photo of an east-west running ditch cap, taken facing east from a point located north of the sanitary lagoon, just south of the gypsum stack.

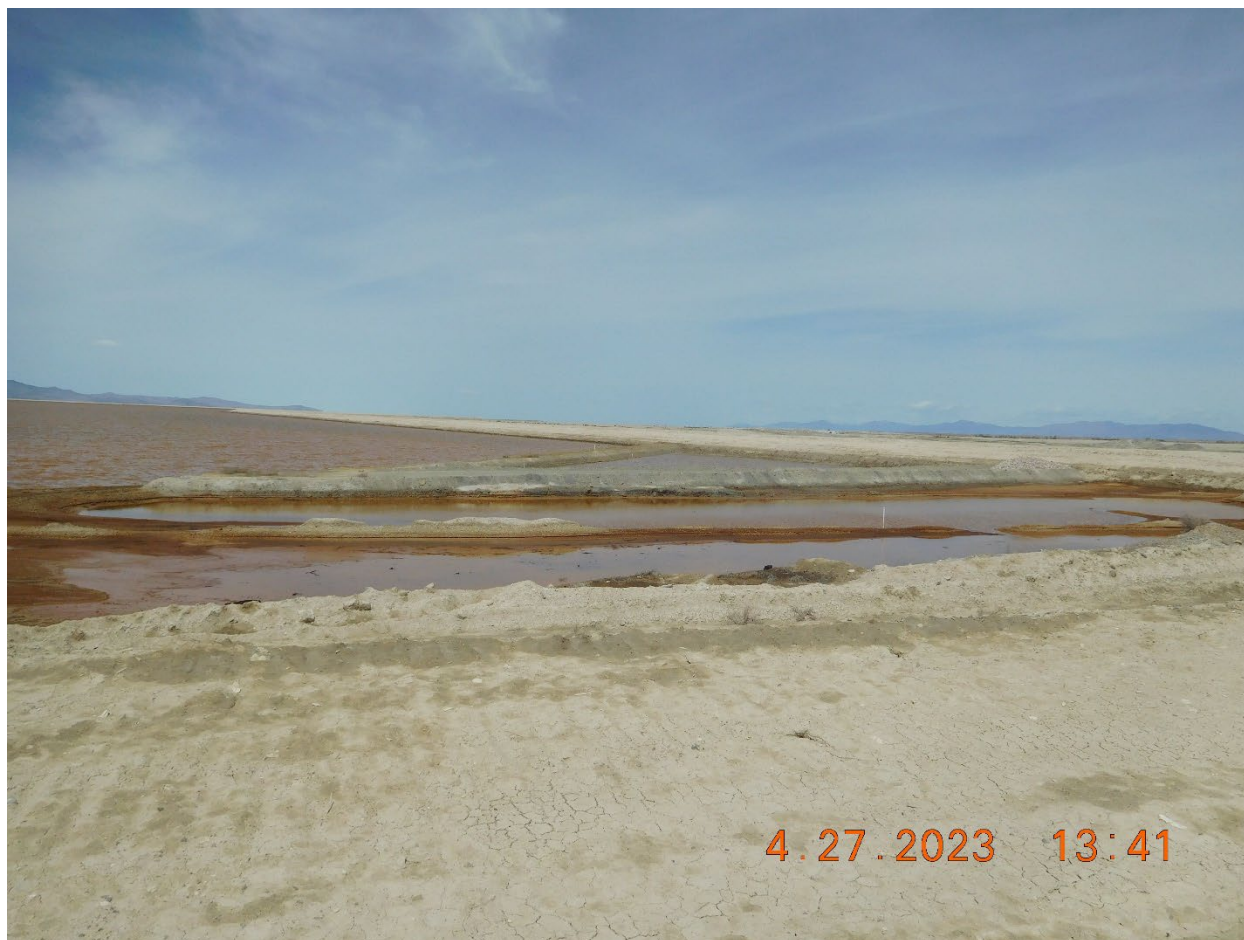
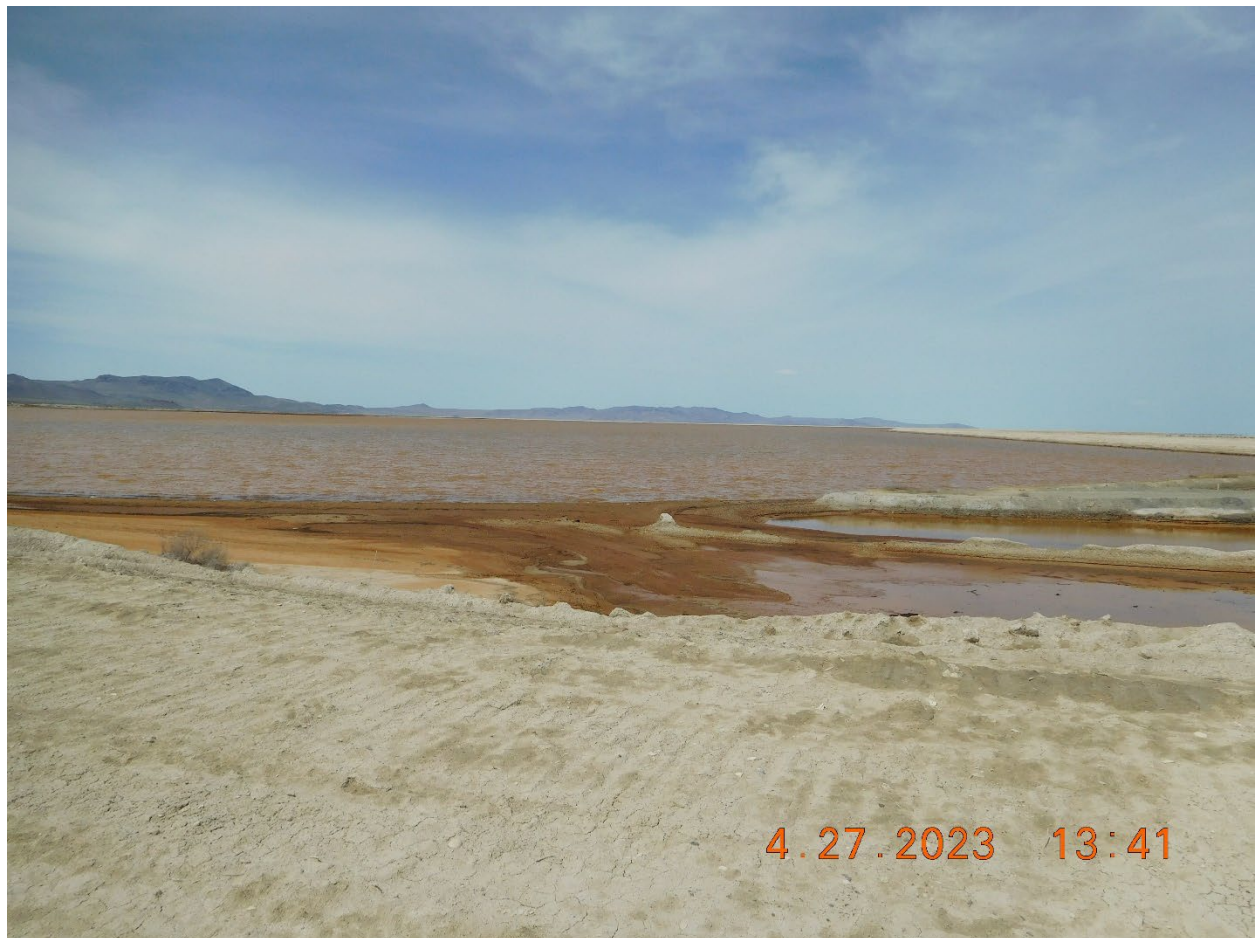
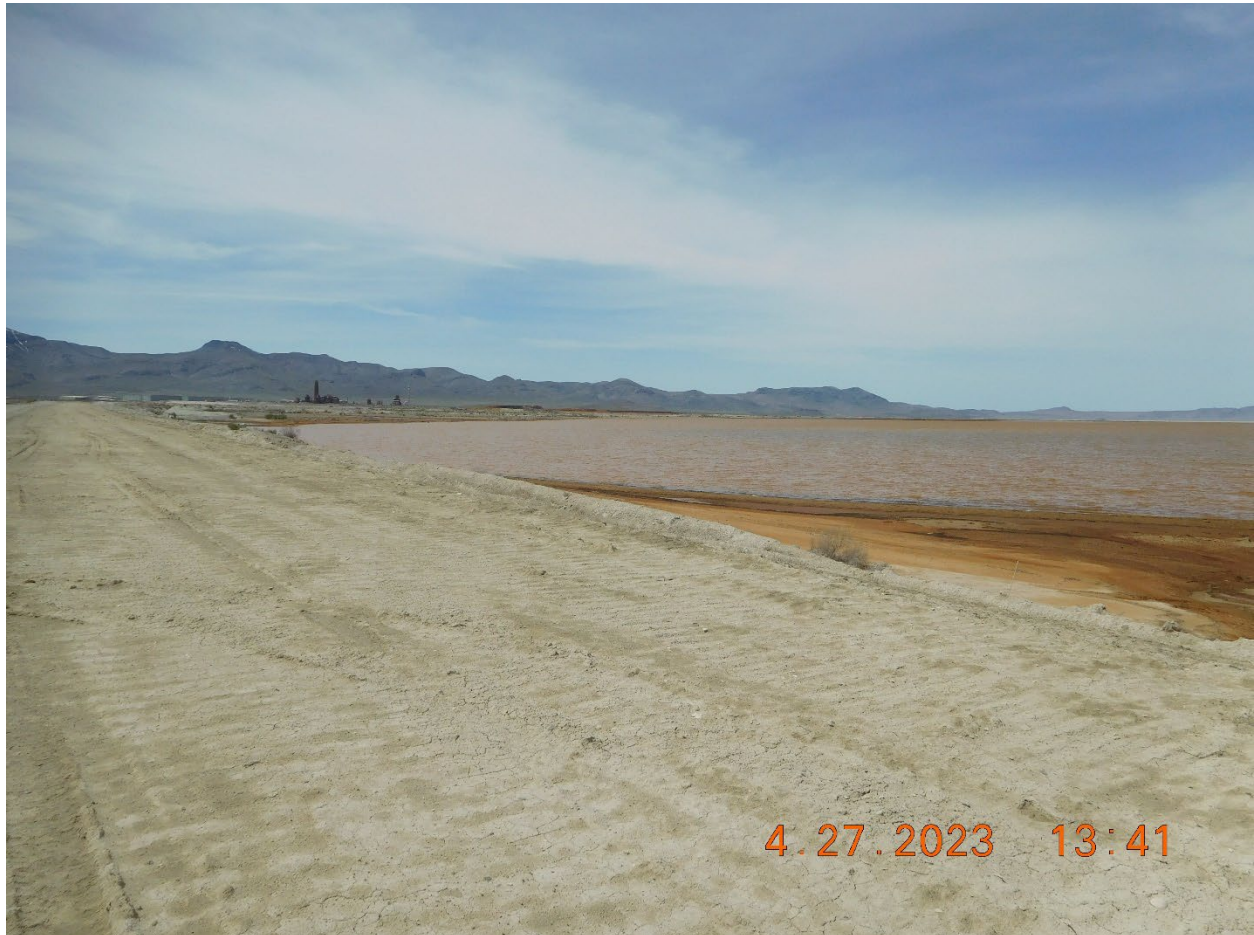
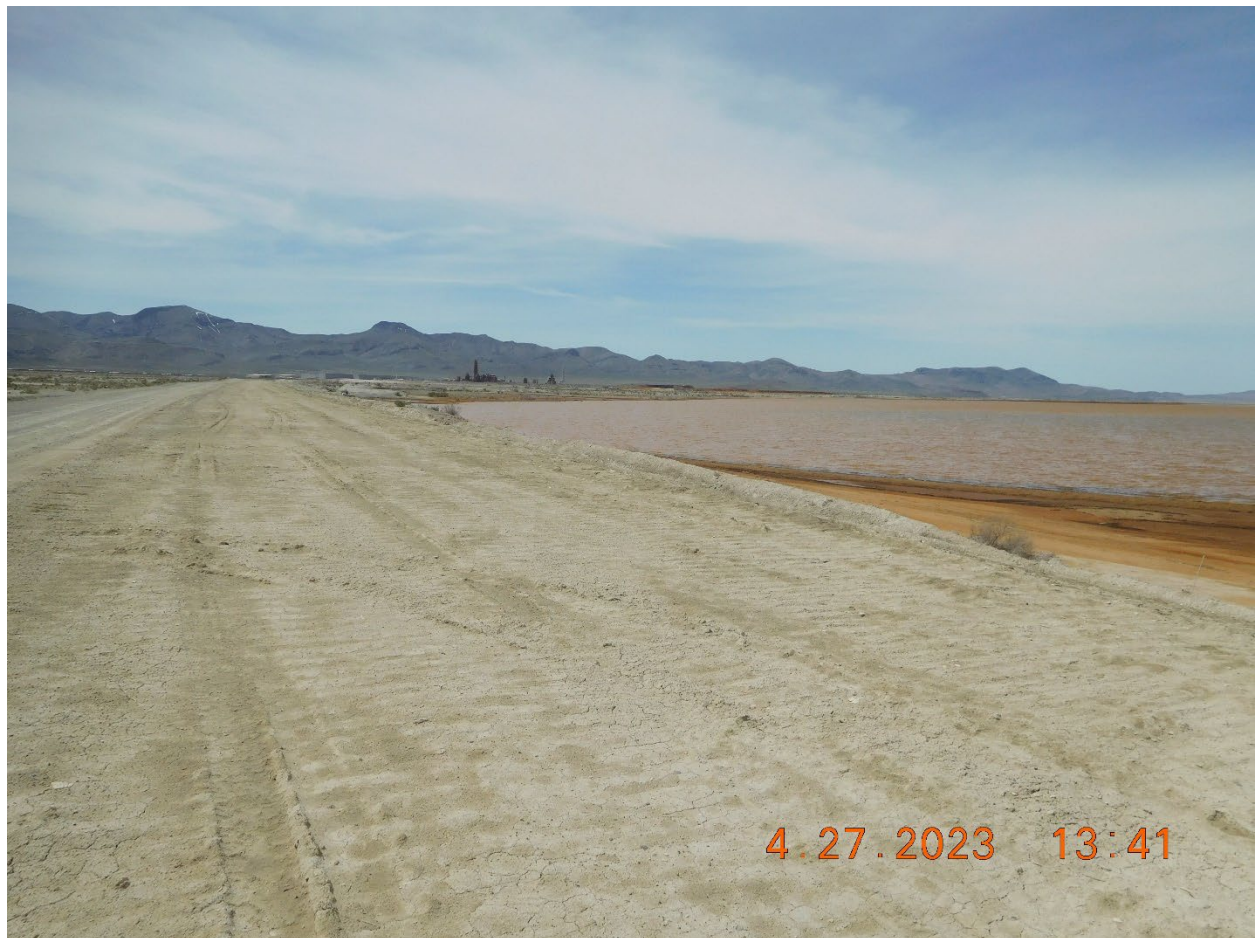
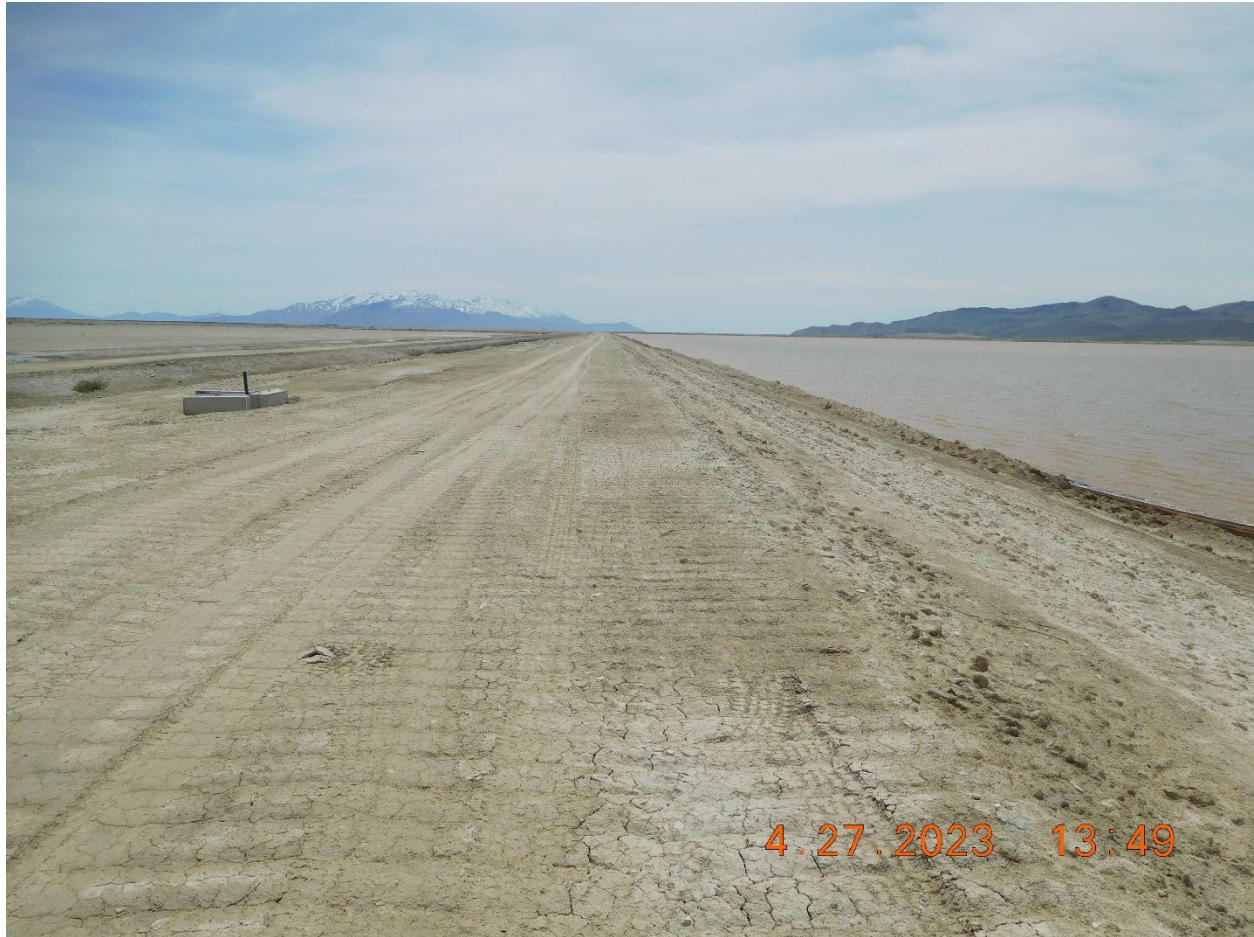
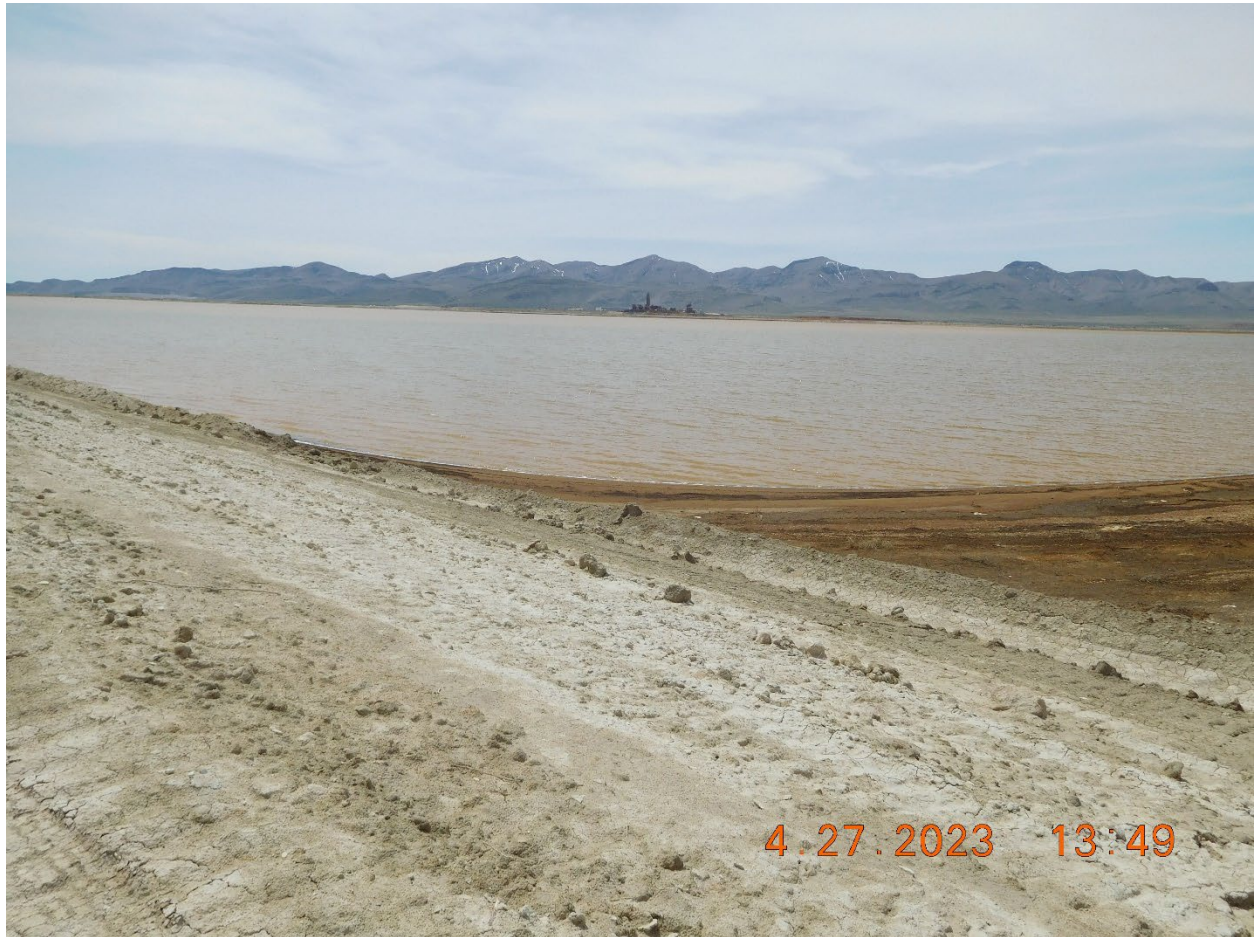
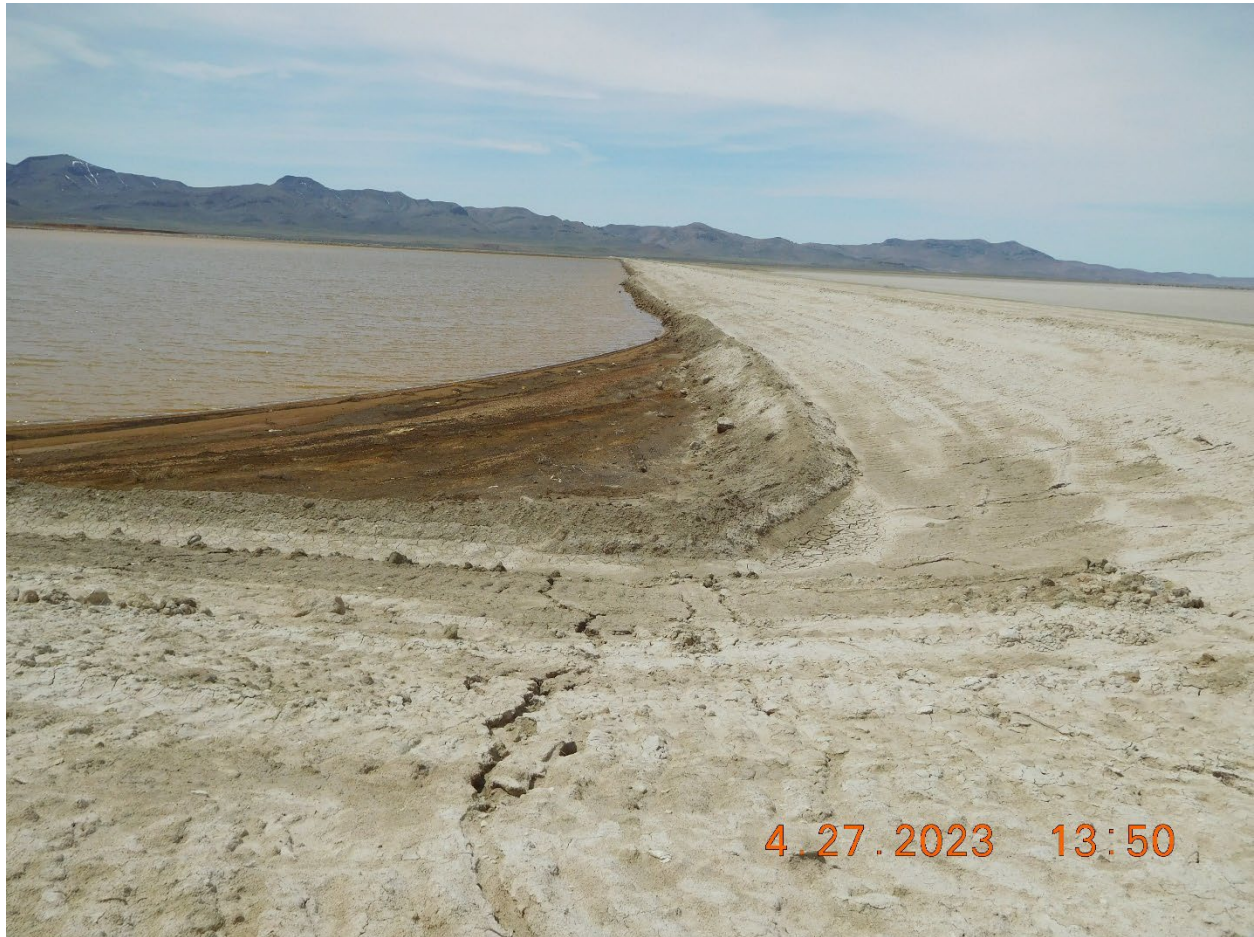
At the berm work completed as phase 1 of the Retrofitted Waste Pond project, I observed that the berm was in good condition with no evident points of deterioration (photos 31-37). I did not observe the vicinity of the overflow pipe located in between the Current Waste Pond and the Old Waste Pond, but Mr. Francom stated that it has been blocked off because of sinkhole formation in the vicinity. He also stated that a contractor working on groundwater sampling and other tasks on the day of the inspection reported to him that, as he recalled from the conversation with the contractor, the pH of the discharge from the plant to the Current Waste Pond was approximately 5 and the pH of the Current Waste Pond was approximately 9. In the northwestern portion of the Old Waste Pond, I observed two plover-like birds foraging in the dry sediment.

**Photo Description:** Photo of the old waste pond, taken from the southeast corner facing north.

**Photo Description:** Photo of the old waste pond and berm, taken from the northeast corner facing south.
