**UNITED STATES ENVIRONMENTAL PROTECTION AGENCY  
REGION 8  
RESOURCE CONSERVATION AND RECOVERY ACT**

**Facility Name:** US Magnesium, LLC

**Date of Inspection:** April 27, 2023

**Type and Purpose of Inspection:** Compliance Schedule Evaluation (CSE)

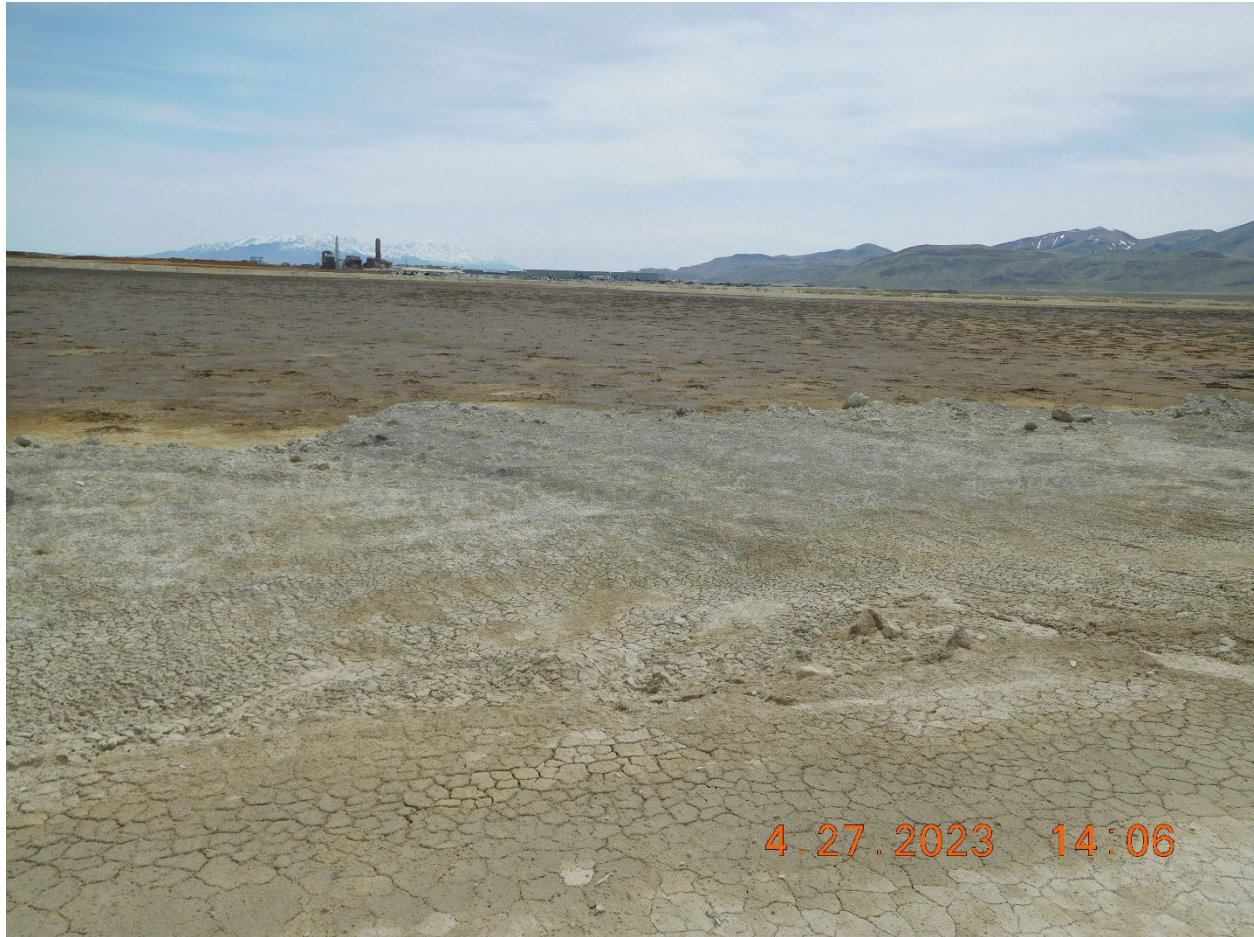
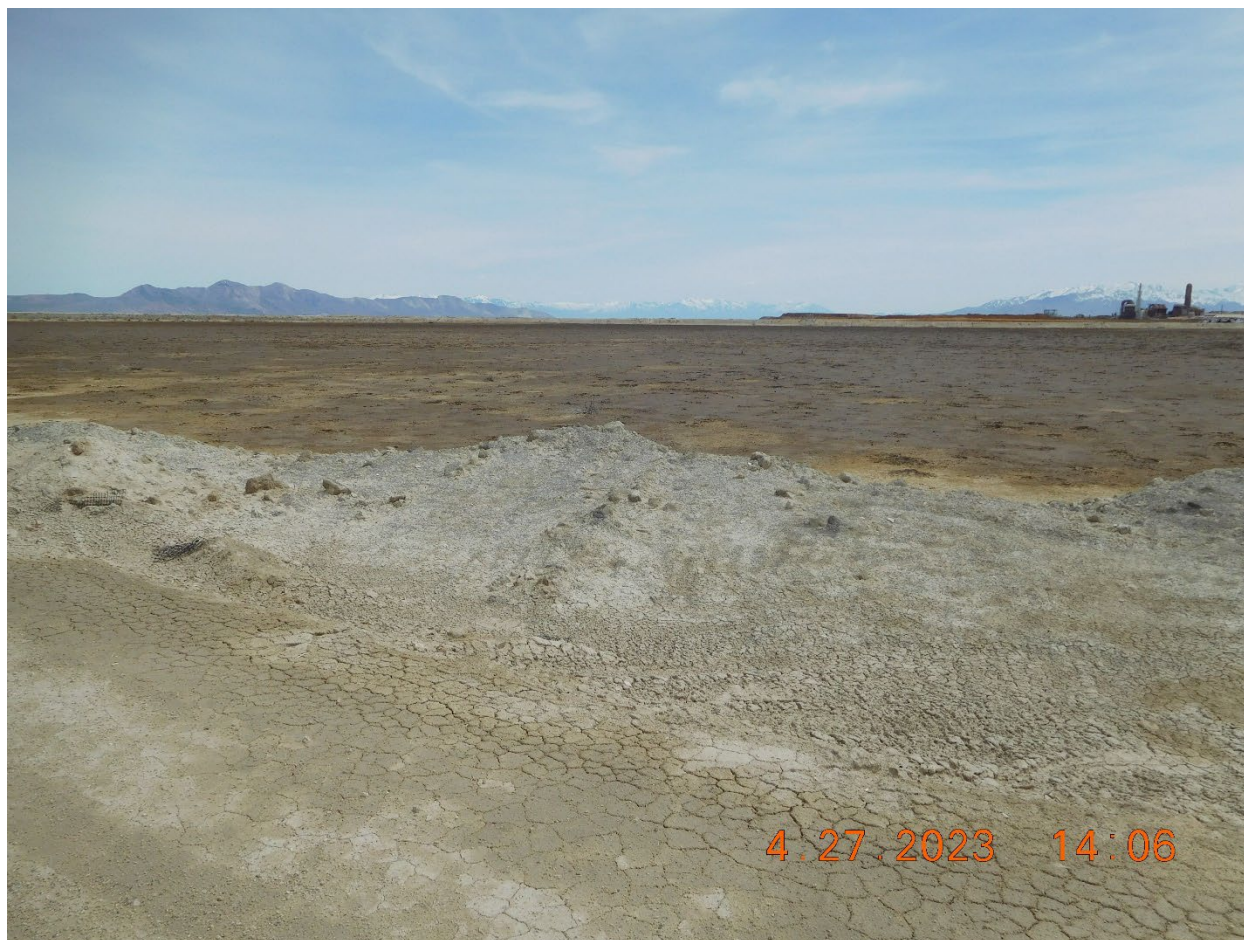
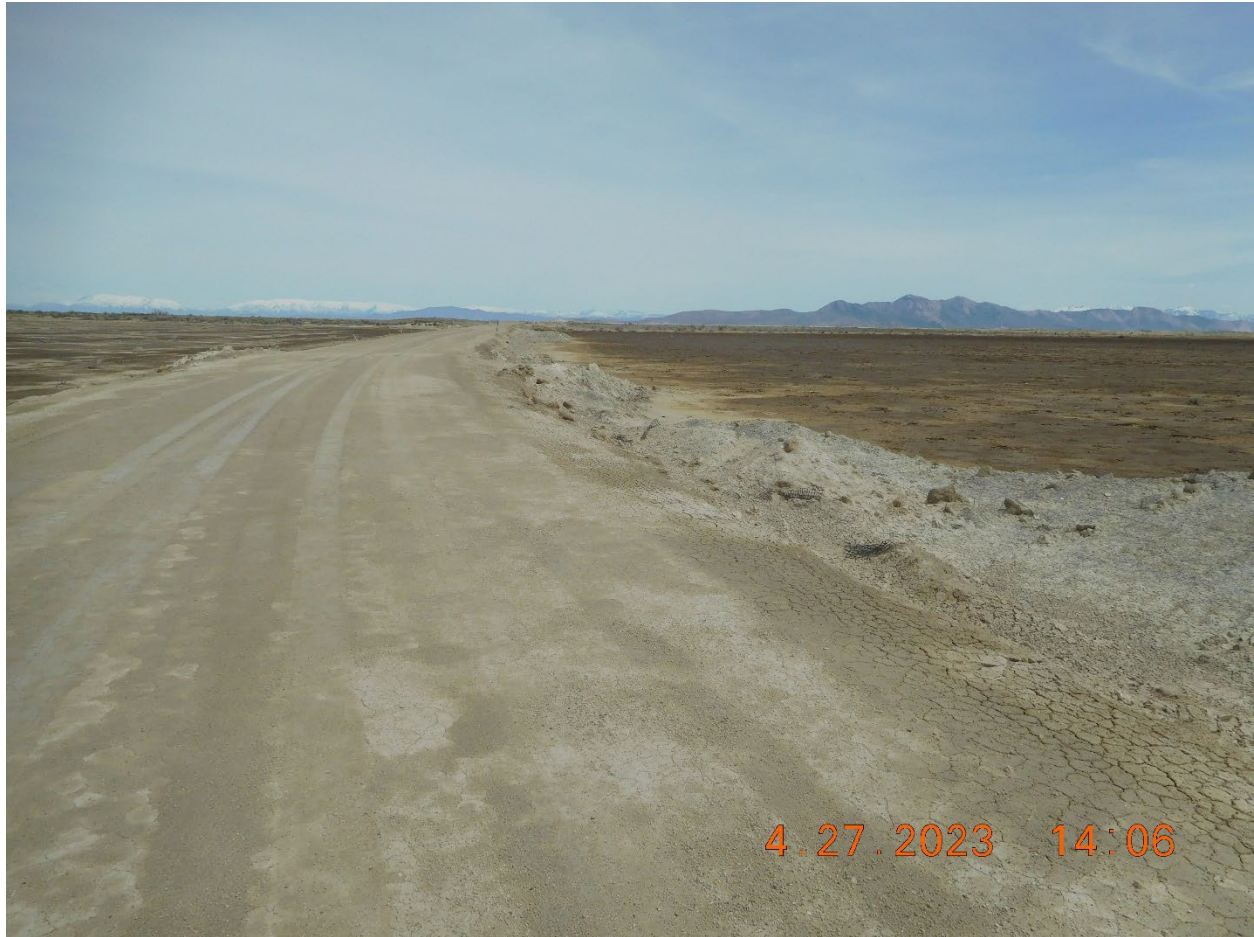
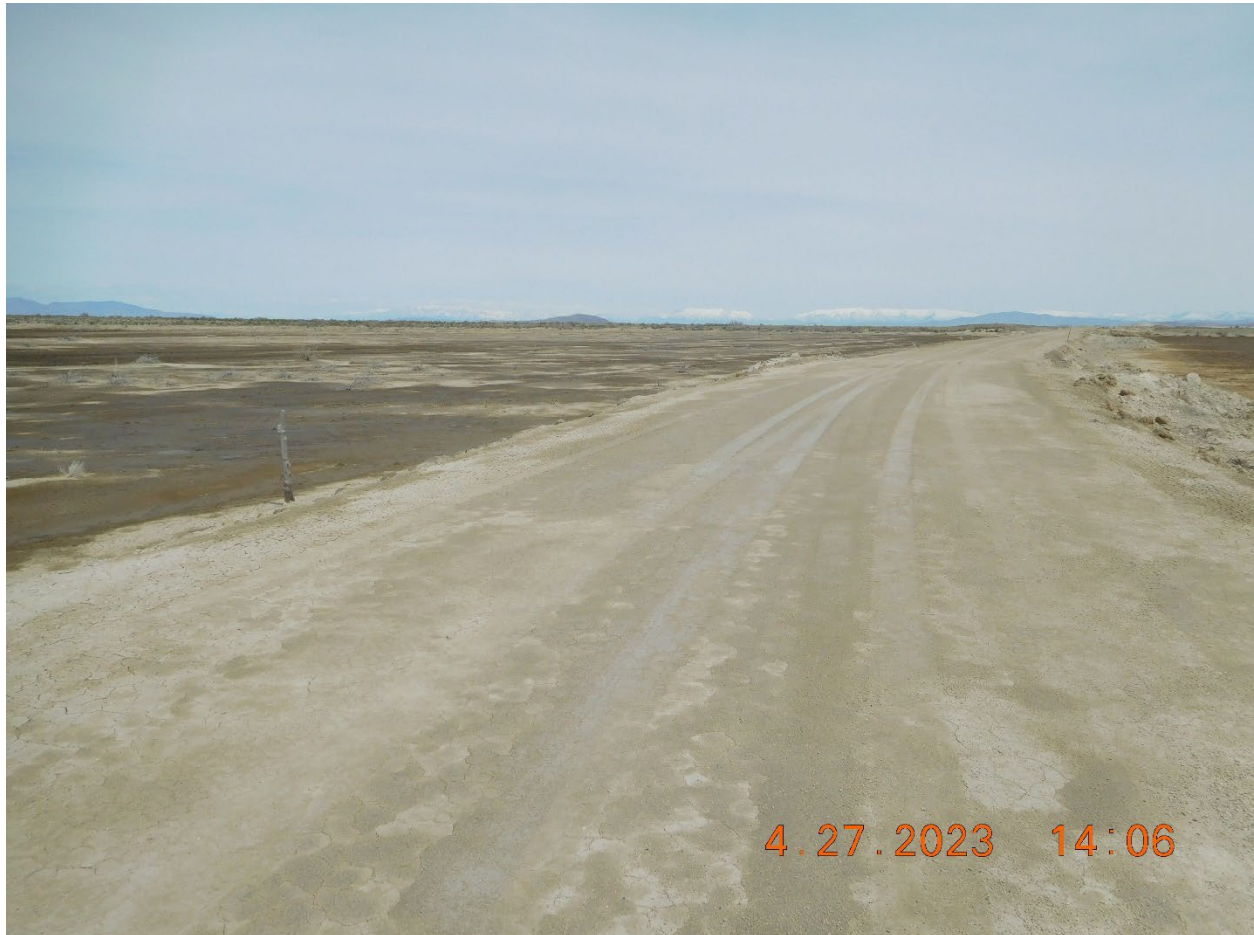
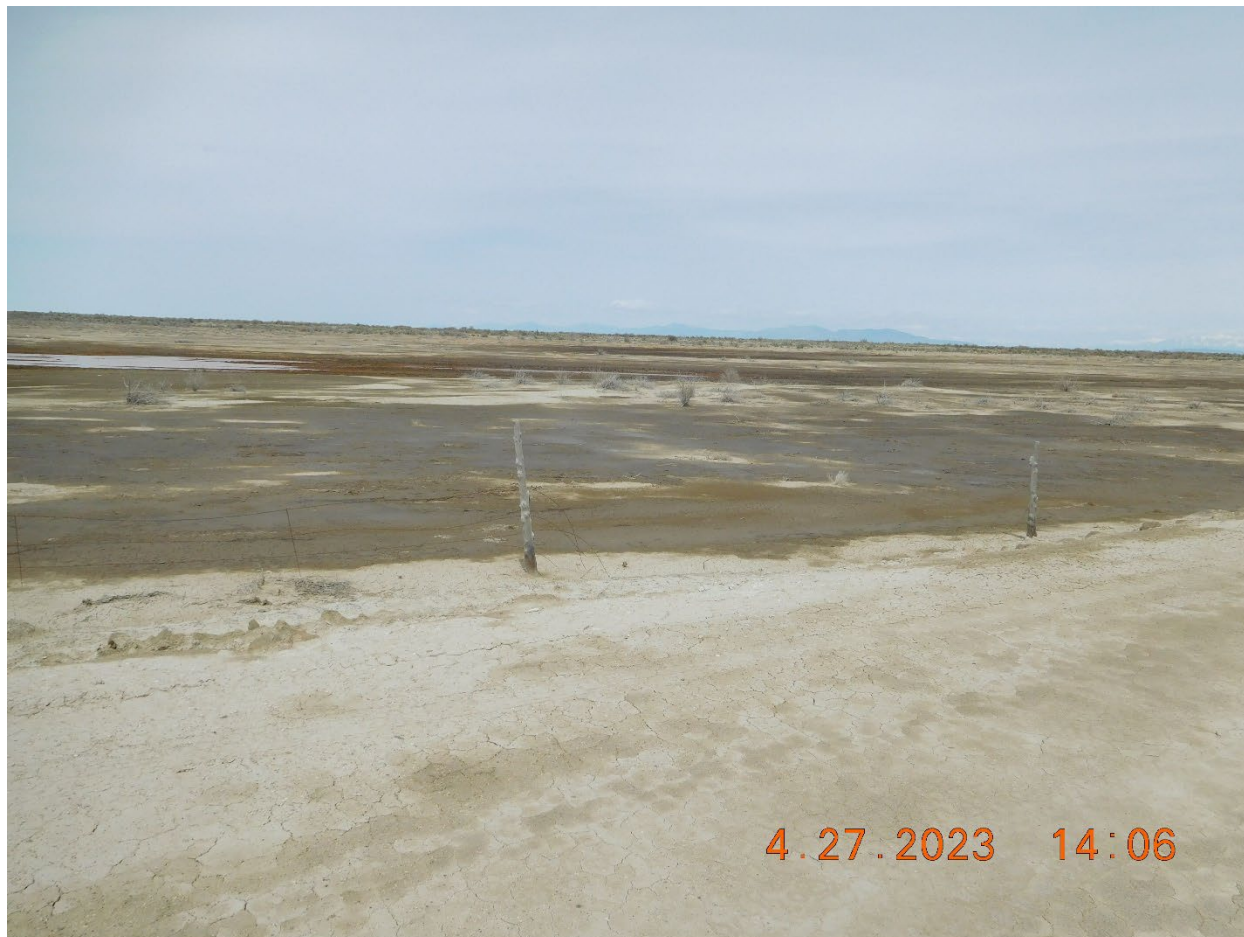
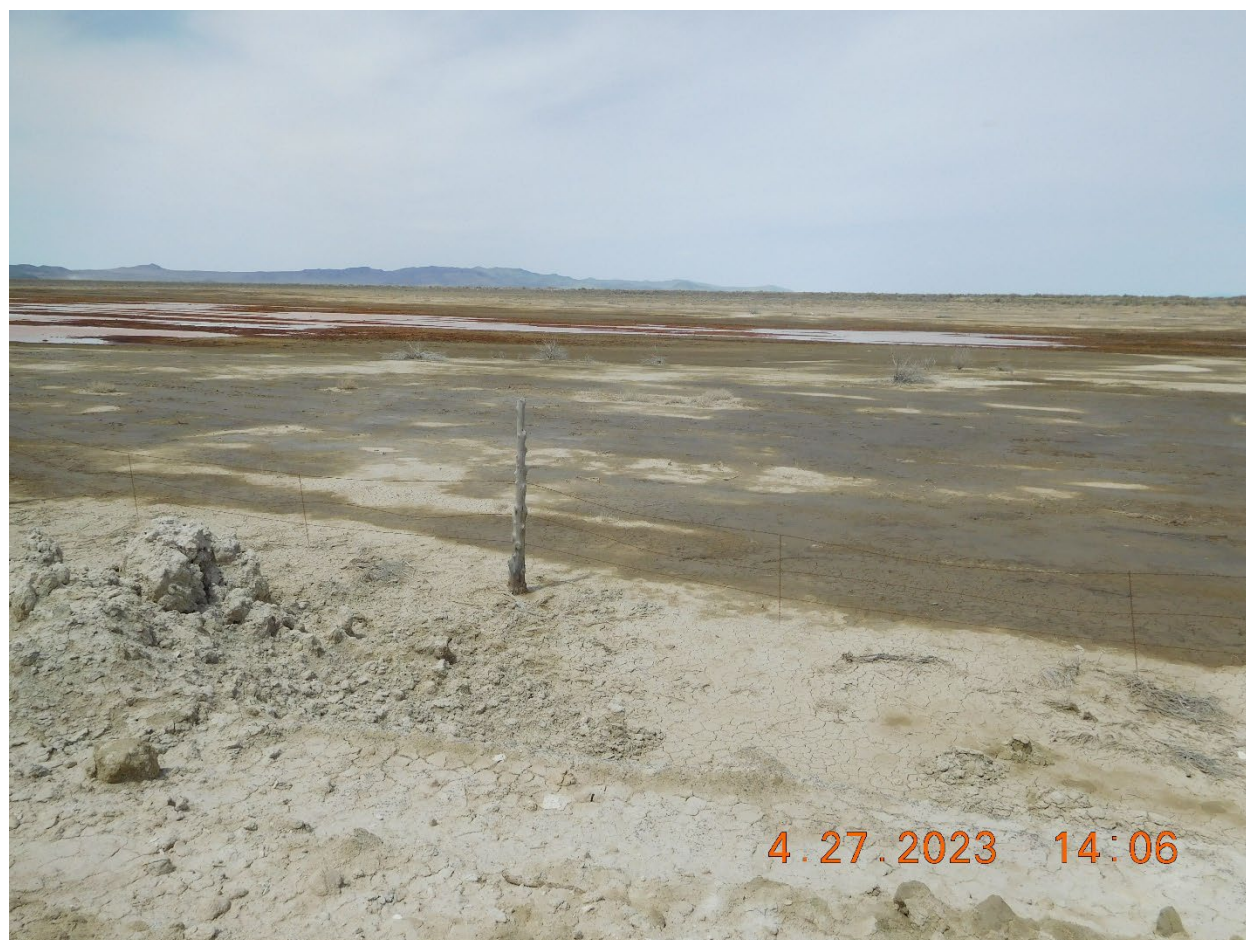
At the northwest portion of the operating area where breaches to impoundment berms had previously occurred resulting in spills of liquid waste onto BLM land to the north, which were the subject of the RCRA 7003 Administrative Order on Consent, Docket No. RCRA-08-2014-0001, I observed that no liquid waste was being held in the section of former impoundment area immediately to the south (photos 38-40). The area adjacent to and including the affected BLM land appeared to be in the same status as that observed in previous inspections (photos 41-44). Ponding from recent precipitation was present in the BLM land area.

**Photo Description:** Photo of the area near the BLM land at the northeast portion of the waste ponds where spills onto BLM land had previously occurred. Photo taken facing south/southeast showing former waste pond area.

**Photo Description:** Photo of the same area shown in photos 38 and 39, panned left showing the road and berm between the former pond area and the BLM land area.
