**CWA COMPLIANCE EVALUATION INSPECTION REPORT  
U.S. ENVIRONMENTAL PROTECTION AGENCY, REGION 5**

Compliance Sampling Inspection

Conrad Farms LLC  
19900 Indian Hollow Road  
Grafton, Ohio  
Lorain County, Ohio  
41.192011, -82.101401

**Date of Inspection:** 4/18/2022

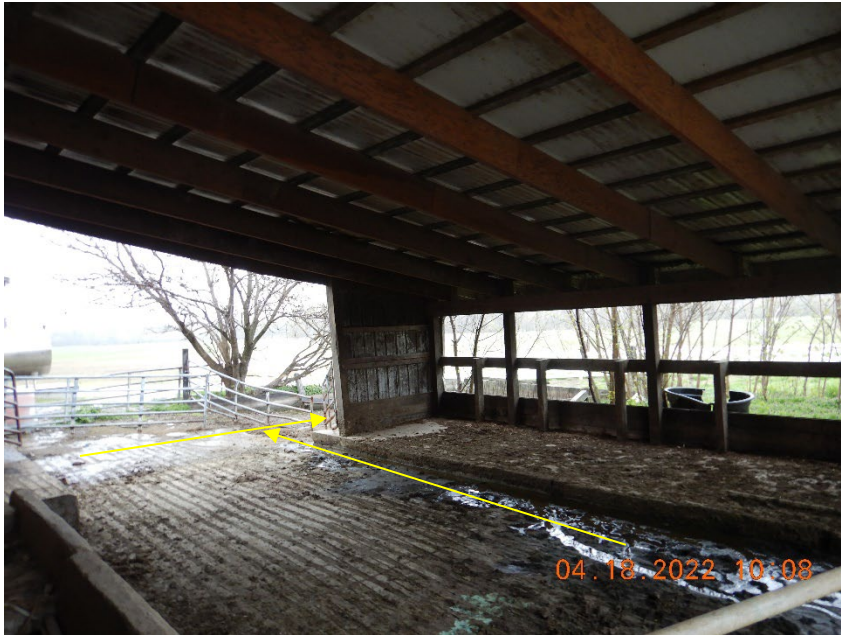
1: DSCN3674

**Description:** The animal treatment area is used for activities that would require the cows to be restrained in a catch chute. The animal treatment area has both a roofed section and unroofed section. Process wastewater flows into the grassed swale that directs flow into the series of three sediment pods.

**Location:** Exterior east side of milking parlor building.

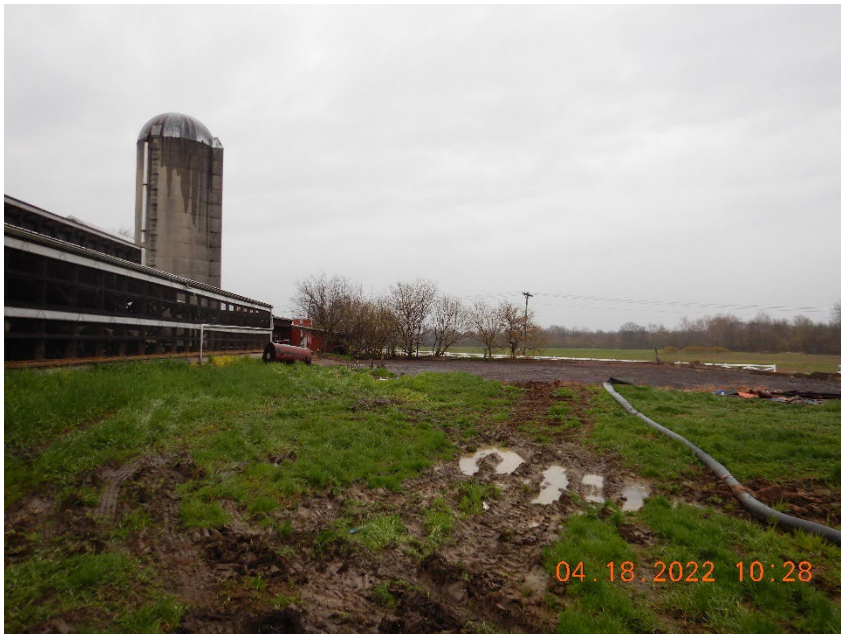
4: DSCN3677

**Description:** View of the smaller north manure lagoon.

**Location:** Northeast corner of the east freestall barn.

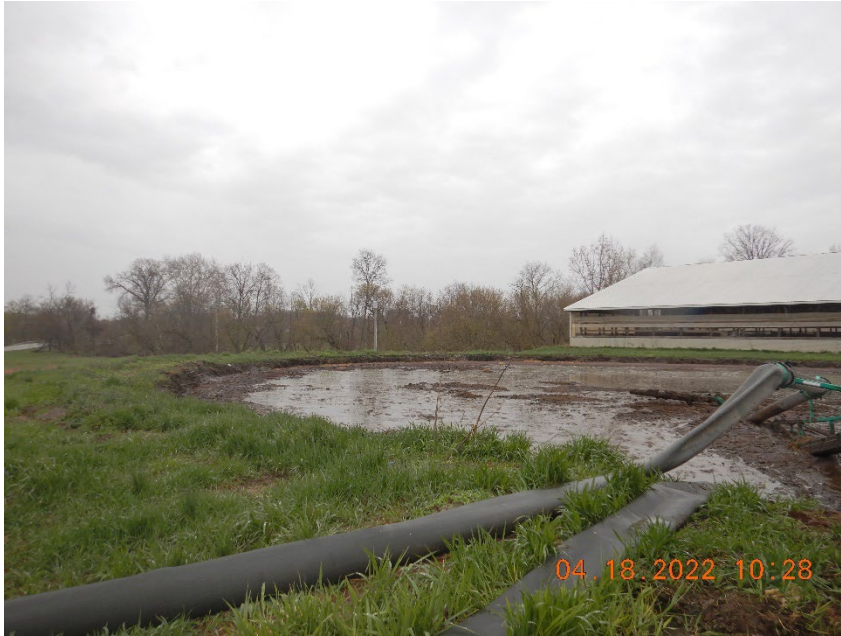
5: DSCN3678

**Description:** Larger south manure lagoon. Pumps and hoses set up for manure withdrawal for land application. View of the heifer barn in background.

**Location:** Southeast corner of the east freestall barn, north of the heifer barn.

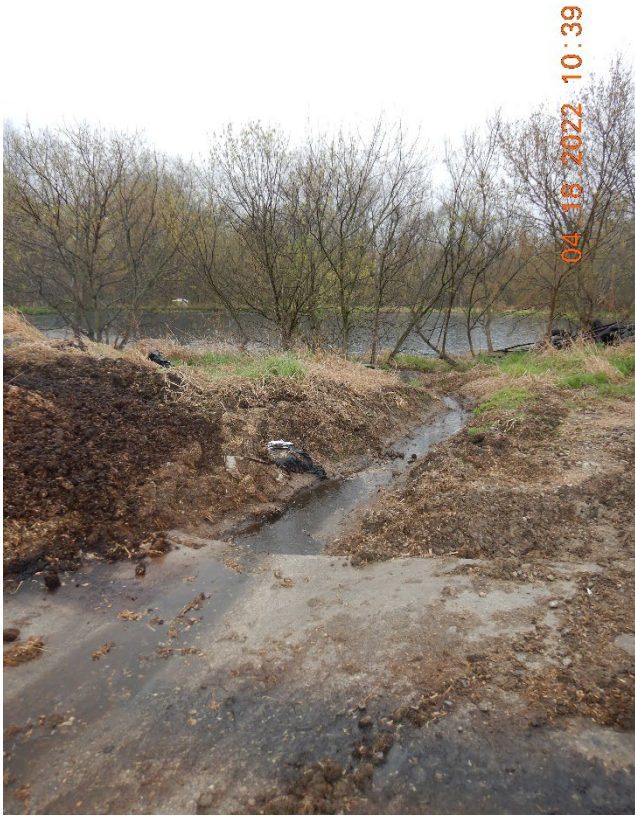
7: DSCN3680

**Description:** Process wastewater run-off from the silage/feed storage pad is designed to flow from the southeast corner of the silage/feed storage pad, south into the south retention pond.

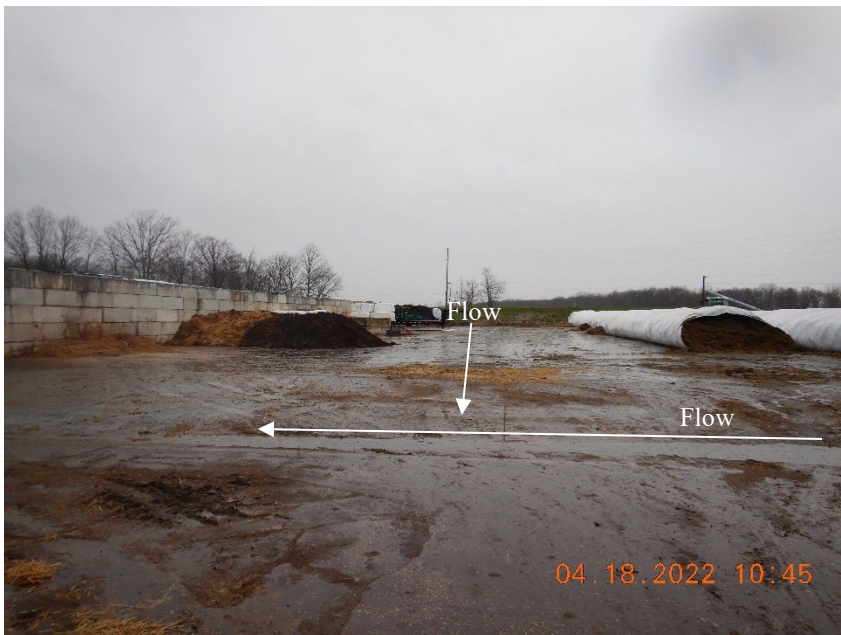
9: DSCN3682

**Description:** View of one of the bunkers on the concrete silage/feed storage pad where used pen-pack (to the left in the photograph) has been temporarily stored.

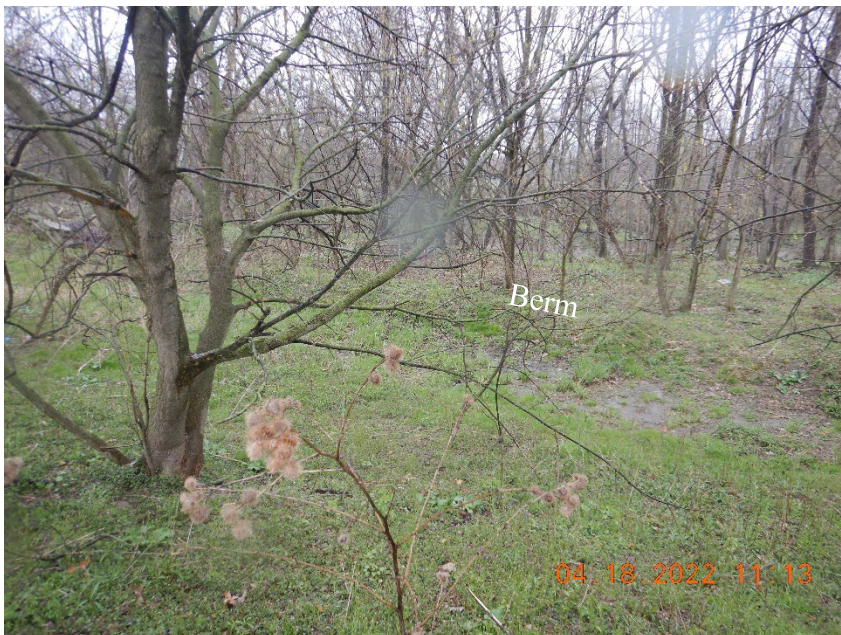
23: DSCN3696

**Description:** View from the east edge of the south retention pond. Note the secondary raised earthen berm southeast of the south retention pond.

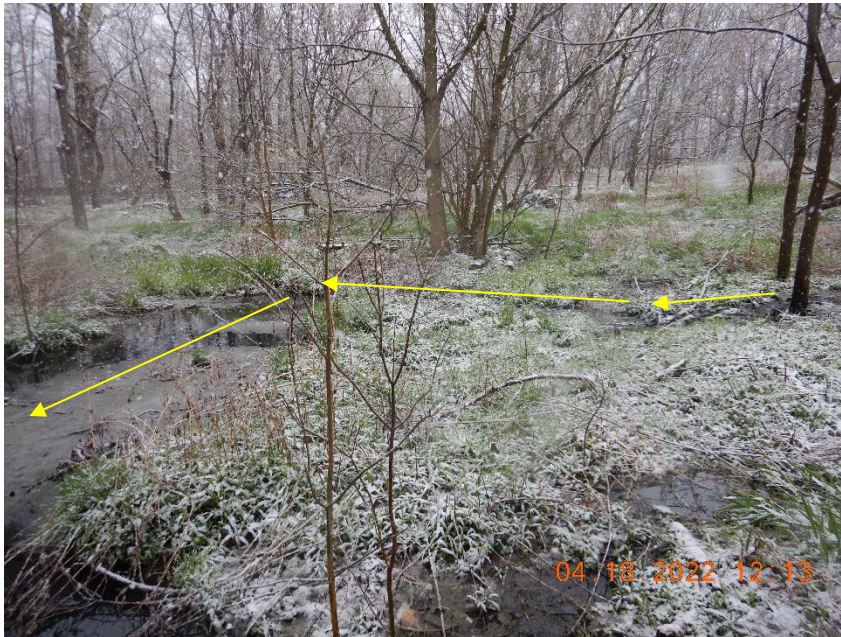
37: DSCN3710

**Description:** Flow pathway of the process wastewater discharge through the woods, next section of flow in sequence after Photograph DSCN3709. Flow direction from center-right of photograph (between the two trees) to the lower left edge of the photograph. Arrows show general direction of flow.

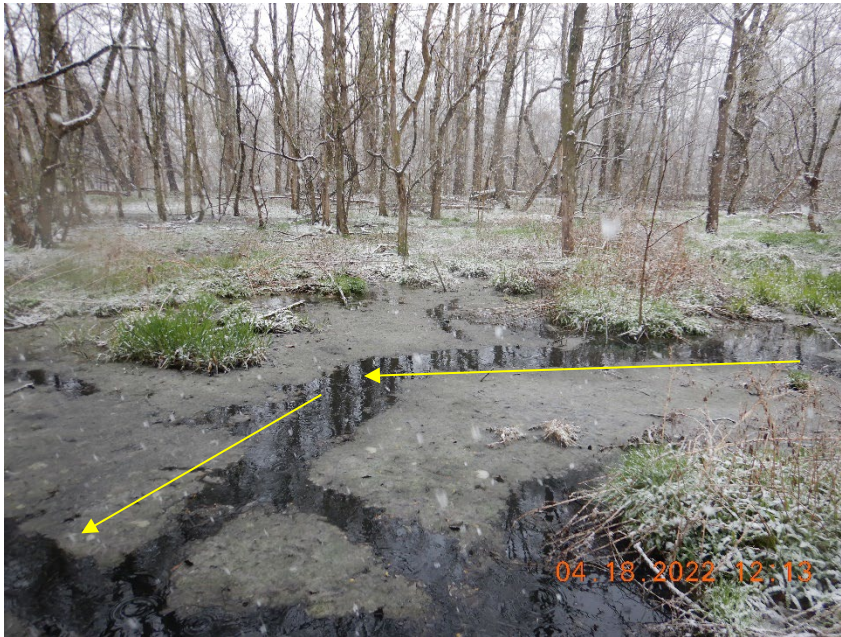
38: DSCN3711

**Description:** Flow pathway of the process wastewater discharge through the woods, next section of flow in sequence after Photograph DSCN3710. Flow direction from center-right of photograph to the lower left edge of the photograph. Arrows show general direction of flow.

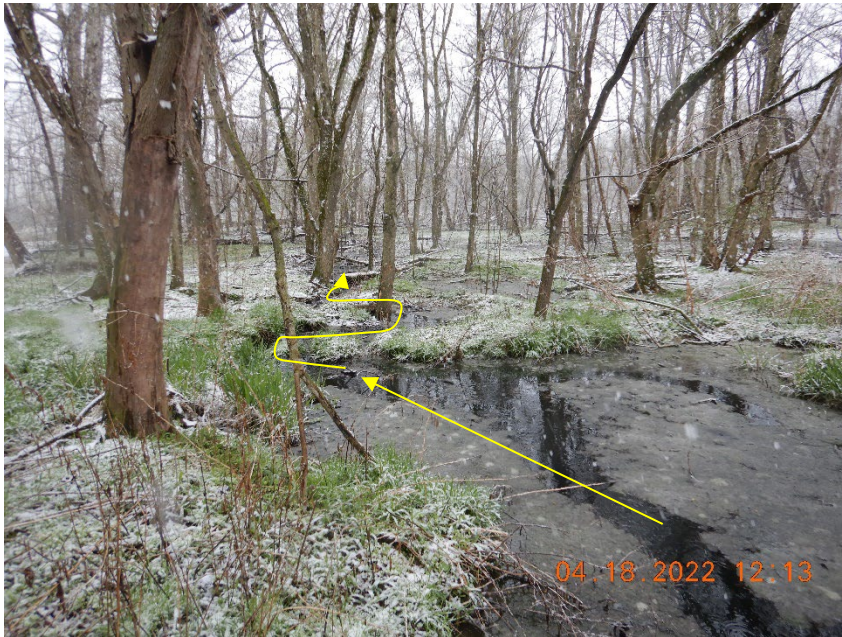
39: DSCN3712

**Description:** Flow pathway of the process wastewater discharge through the woods, next section of flow in sequence after Photograph DSCN3711. Flow direction from the lower-right quadrant of the photograph, through the center of the photograph towards the upper left quadrant of the photograph. Arrows show general direction of flow.

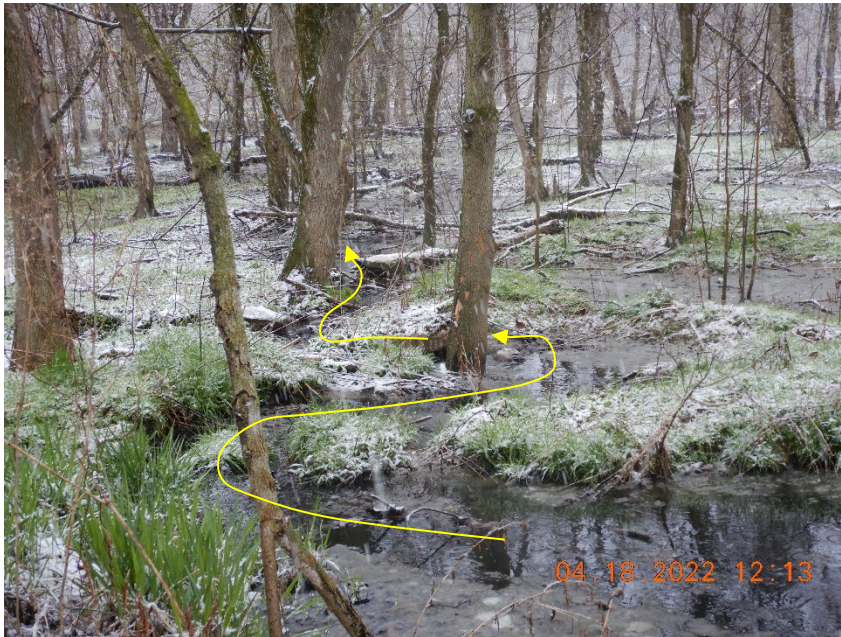
40: DSCN3713

**Description:** Flow pathway of the process wastewater discharge through the woods, close-up view of section of flow winding through trees from Photograph DSCN3712. Flow direction from lower-right of photograph through the center of the photograph. Arrows show general direction of flow.

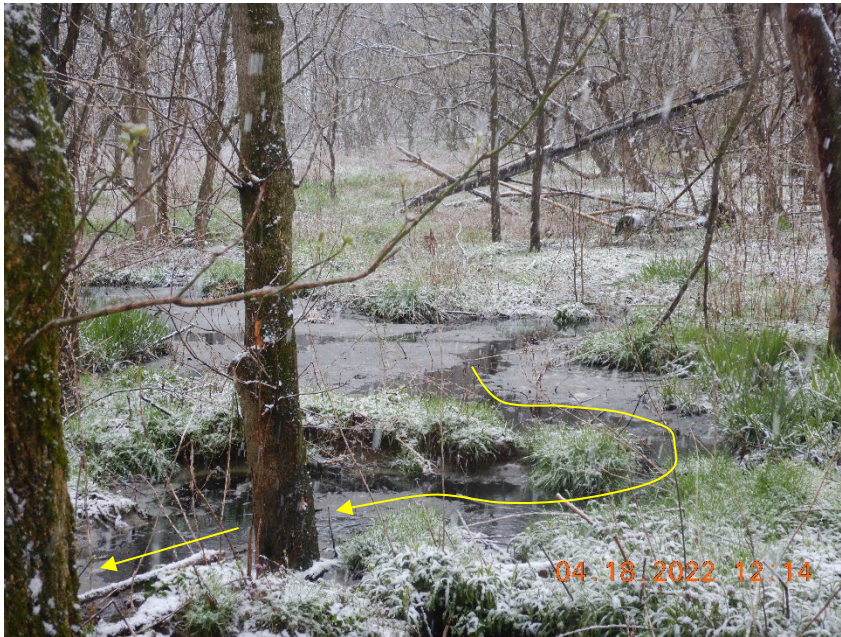
41: DSCN3714

**Description:** Flow pathway of the process wastewater discharge through the woods, looking upstream towards the location of Photograph DSCN3712. Arrows show general direction of flow.

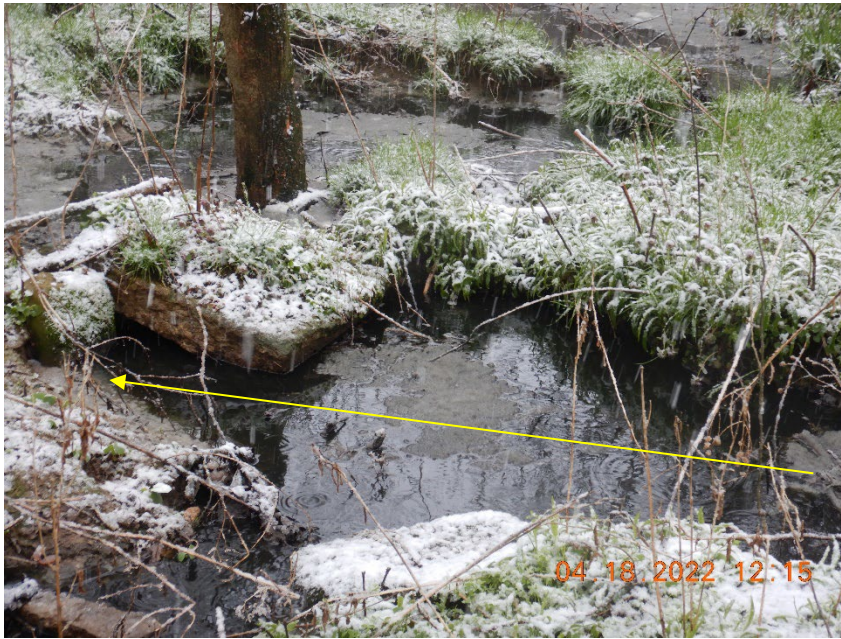
42: DSCN3715

**Description:** Flow pathway of the process wastewater discharge through the woods, next section of flow in sequence after Photograph DSCN3713. An arrow shows the general direction of flow.

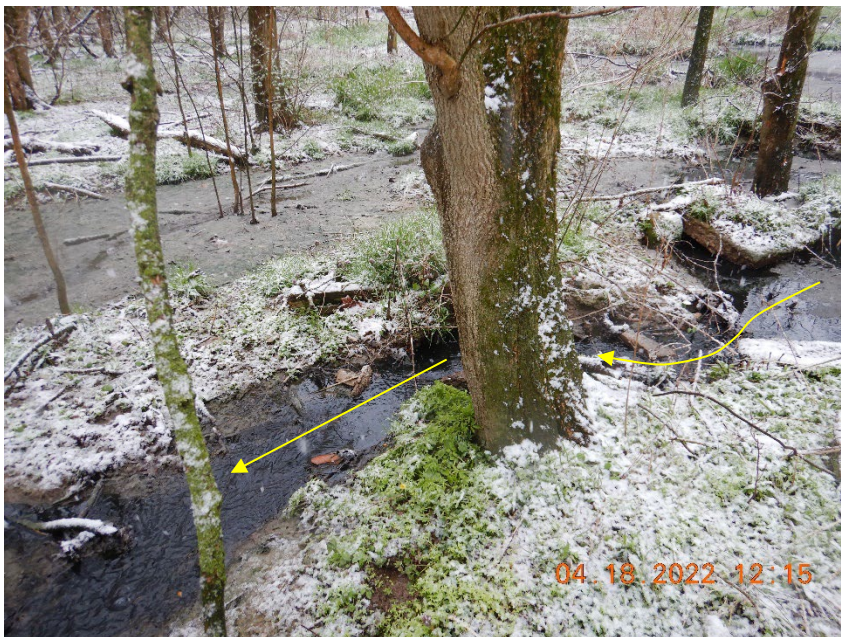
43: DSCN3716

**Description:** Flow pathway of the process wastewater discharge through the woods, next section of flow in sequence after Photograph DSCN3715. Arrows show general direction of flow.

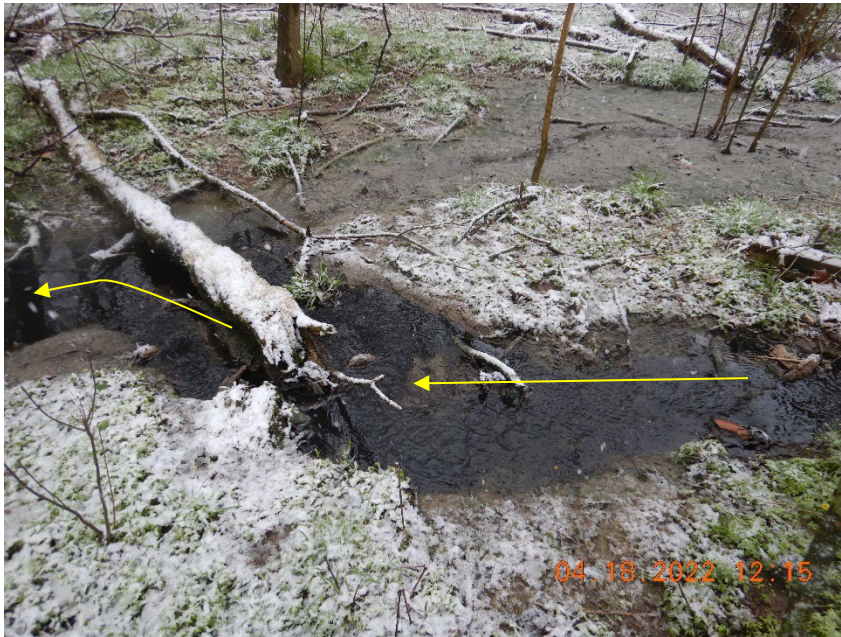
44: DSCN3717

**Description:** Flow pathway of the process wastewater discharge through the woods, next section of flow in sequence after Photograph DSCN3716. Arrows show general direction of flow.

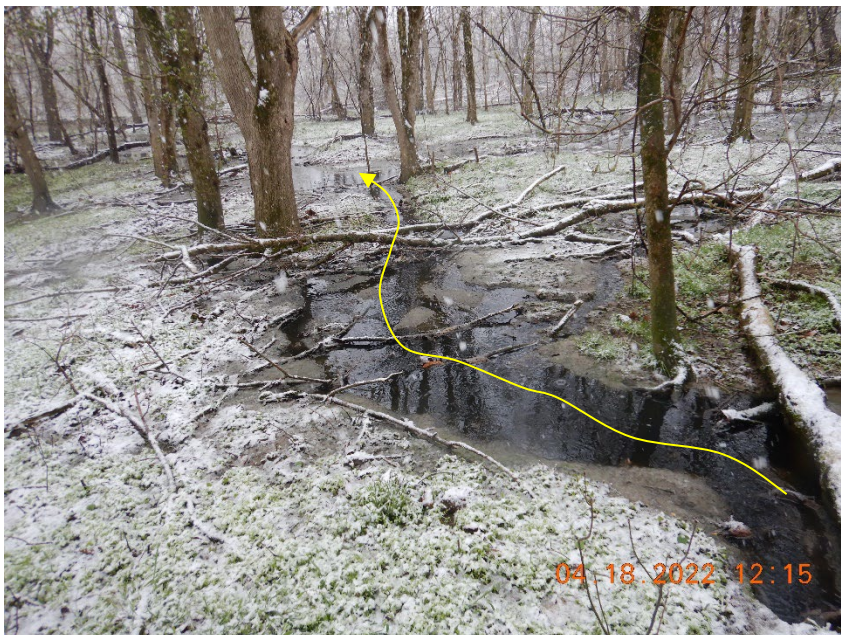
45: DSCN3718

**Description:** Flow pathway of the process wastewater discharge through the woods, next section of flow in sequence after Photograph DSCN3717. An arrow shows the general direction of flow.

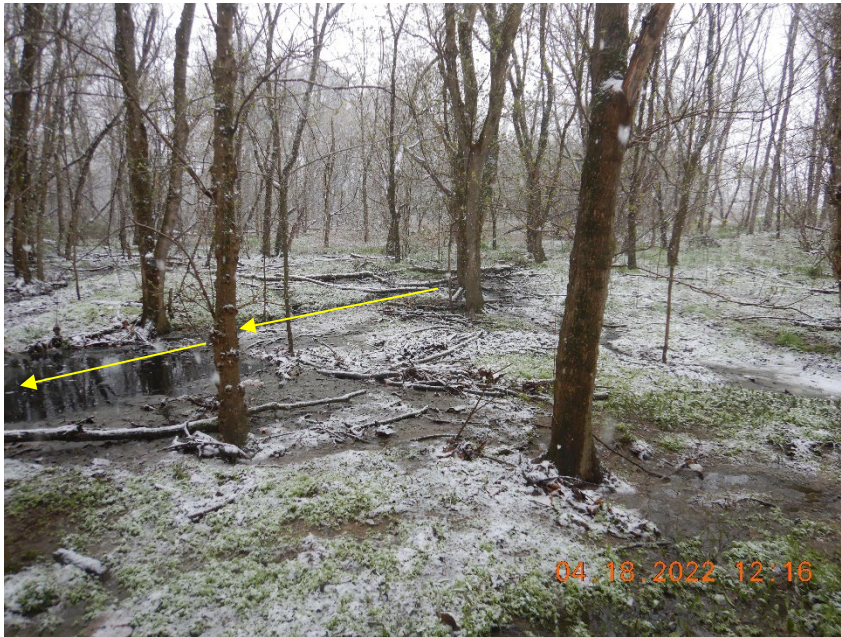
46: DSCN3719

**Description:** Flow pathway of the process wastewater discharge through the woods, next section of flow in sequence after Photograph DSCN3718, looking upstream towards location of Photograph DSCN3718. Arrows show general direction of flow.

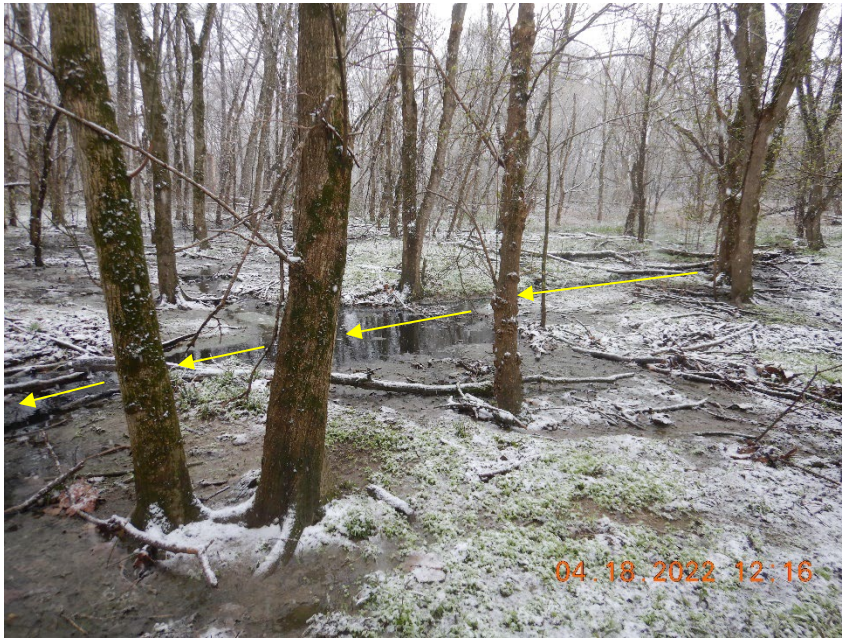
47: DSCN3720

**Description:** Flow pathway of the process wastewater discharge through the woods, next section of flow in sequence after Photograph DSCN3719. Arrows show general direction of flow.

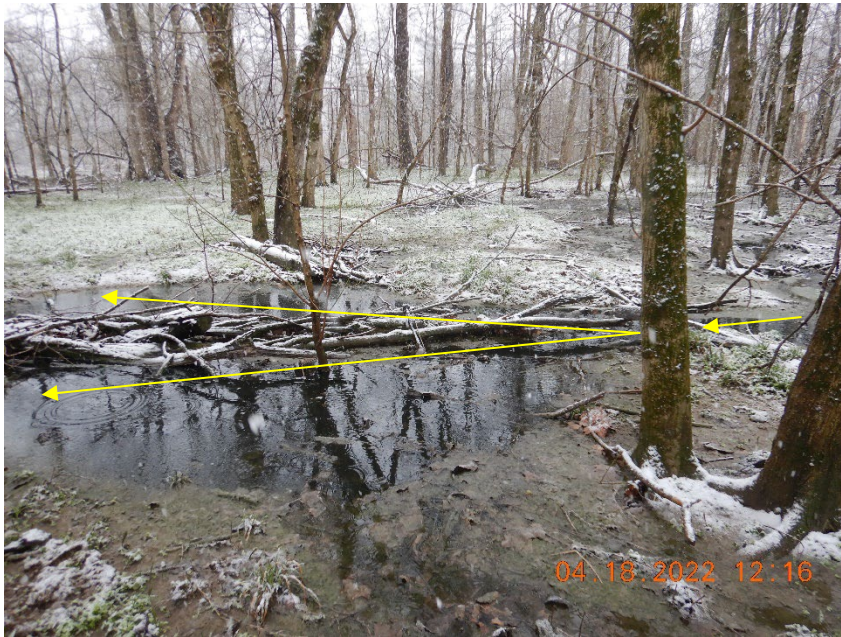
48: DSCN3721

**Description:** Flow pathway of the process wastewater discharge through the woods, next section of flow in sequence after Photograph DSCN3720. Flow direction from right to left in the photograph. Arrows show general direction of flow. **Location:** Woods south/southeast of south retention pond.

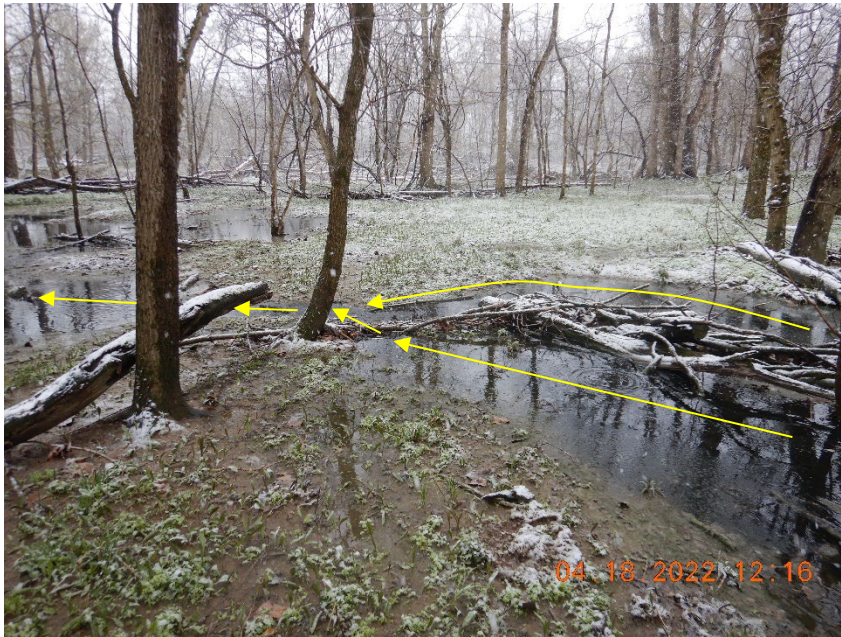
49: DSCN3722

**Description:** Flow pathway of the process wastewater discharge through the woods, next section of flow in sequence after Photograph DSCN3721. Arrows show general direction of flow.

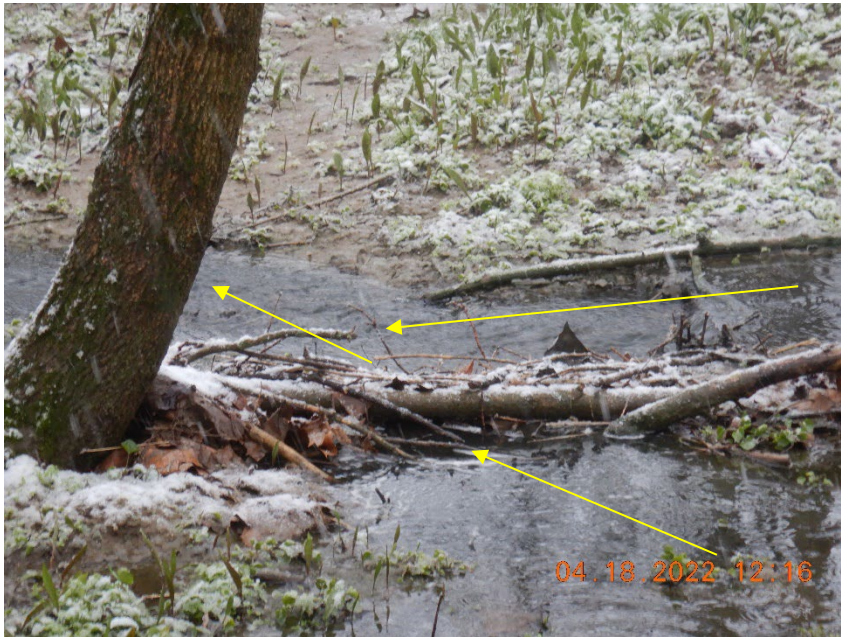
50: DSCN3724

**Description:** Close-up view of the process wastewater discharge flow pathway from Photograph DSCN3722 to show ripples of flow movement. Arrows show general direction of flow.

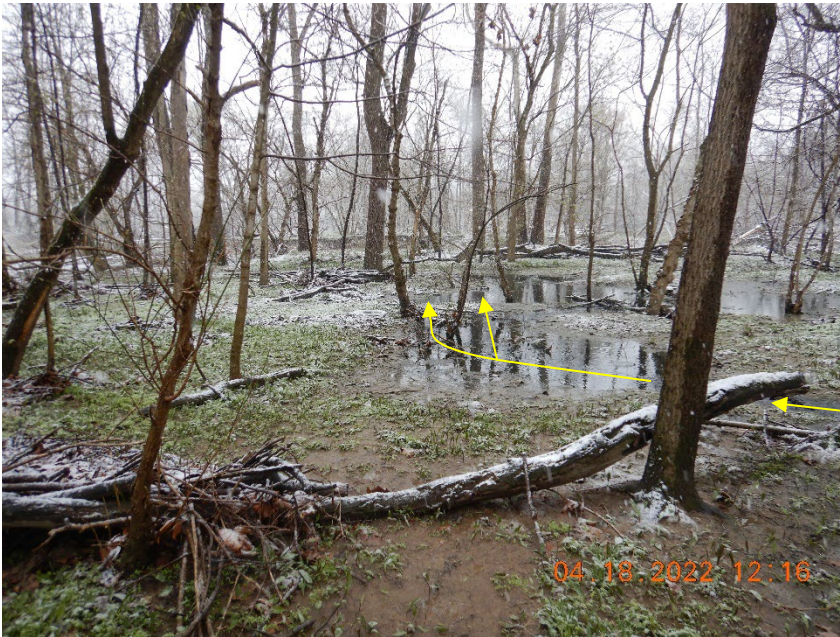
51: DSCN3725

**Description:** Flow pathway of the process wastewater discharge through the woods, next section of flow in sequence after Photograph DSCN3724. Arrows show general direction of flow.

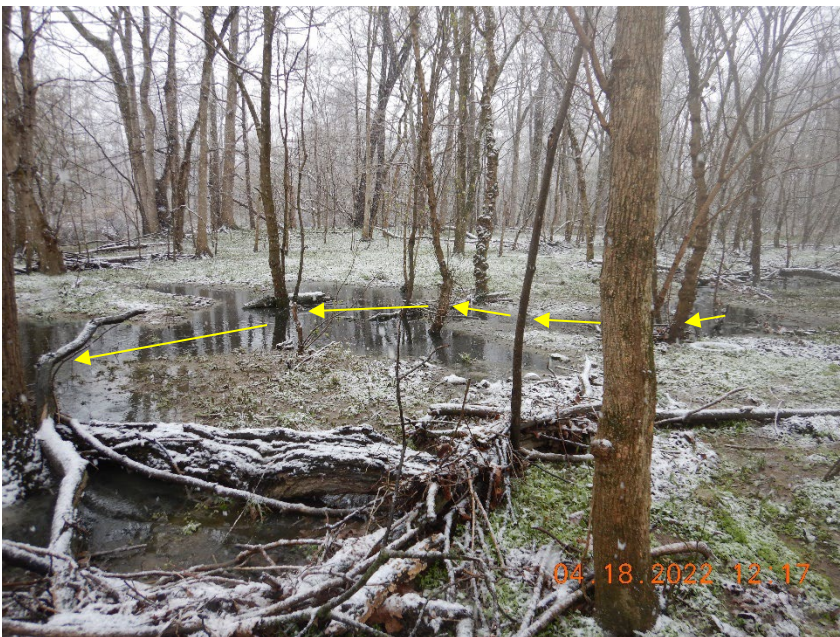
52: DSCN3726

**Description:** Flow pathway of the process wastewater discharge through the woods, next section of flow in sequence after Photograph DSCN3725. Arrows show general direction of flow.

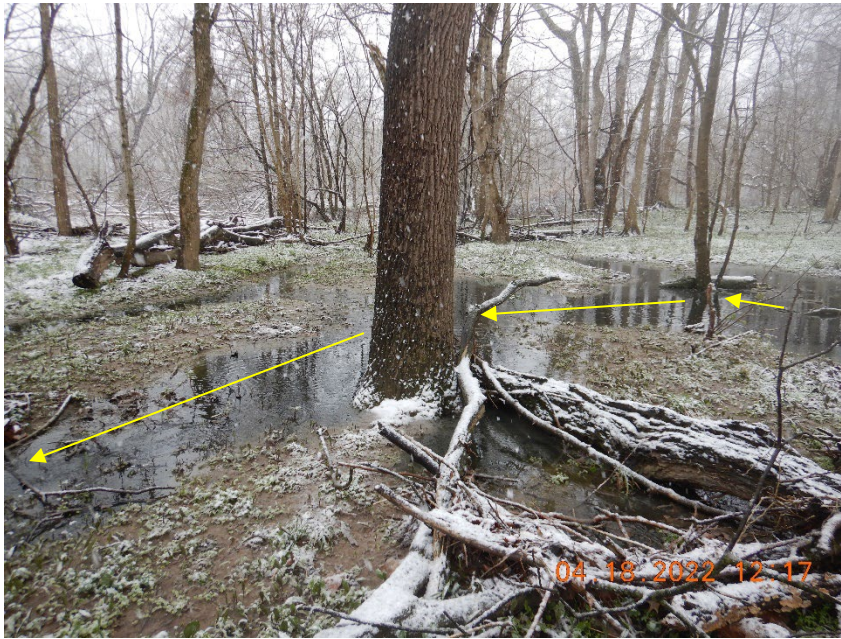
53: DSCN3727

**Description:** Flow pathway of the process wastewater discharge through the woods, next section of flow in sequence after Photograph DSCN3726. Flow direction from right towards lower left corner in the photograph as flow begins to head east towards the river. Arrows show general direction of flow.

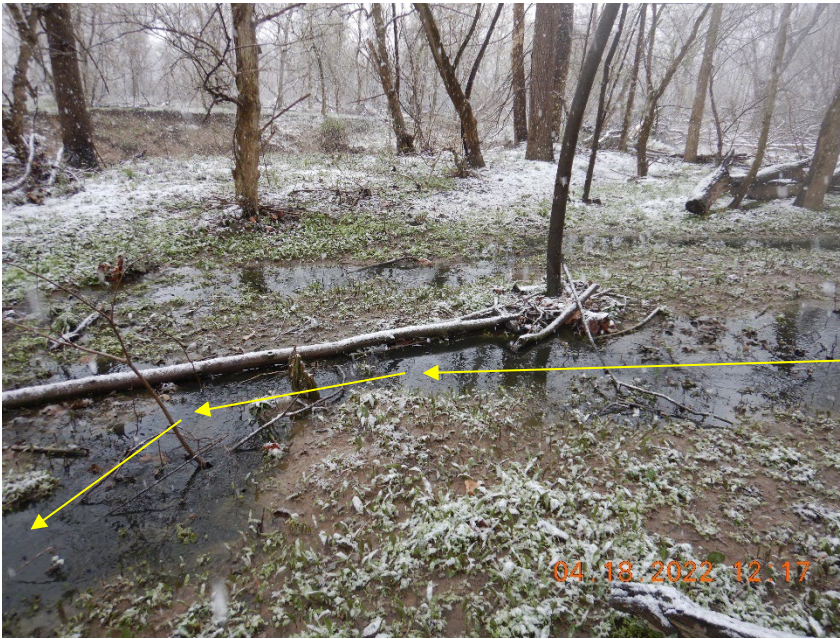
54: DSCN3728

**Description:** Flow pathway of the process wastewater discharge through the woods, next section of flow in sequence after Photograph DSCN3727. Flow direction from right to left in the photograph, headed east towards the river. Arrows show general direction of flow.

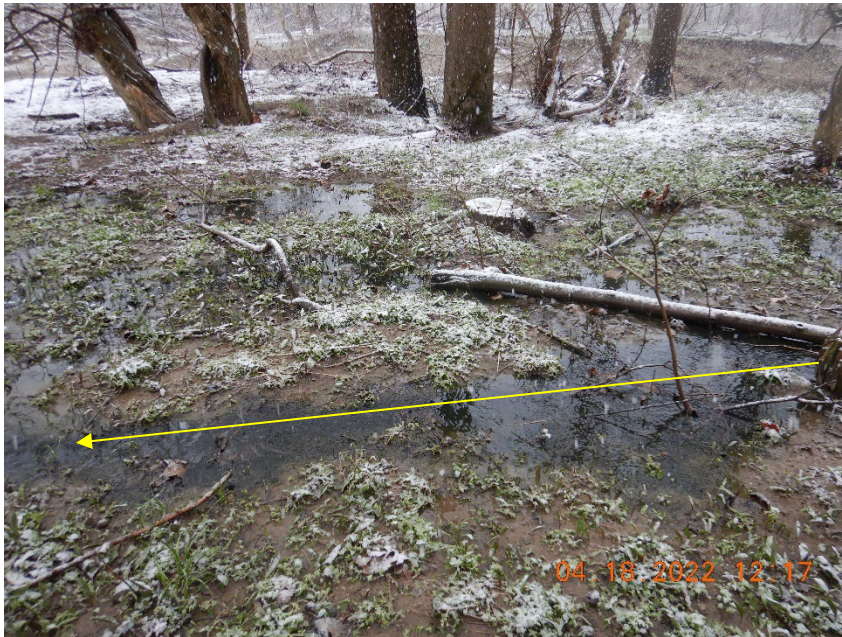
55: DSCN3729

**Description:** Flow pathway of the process wastewater discharge through the woods, next section of flow in sequence after Photograph DSCN3728. Arrow shows general direction of flow.

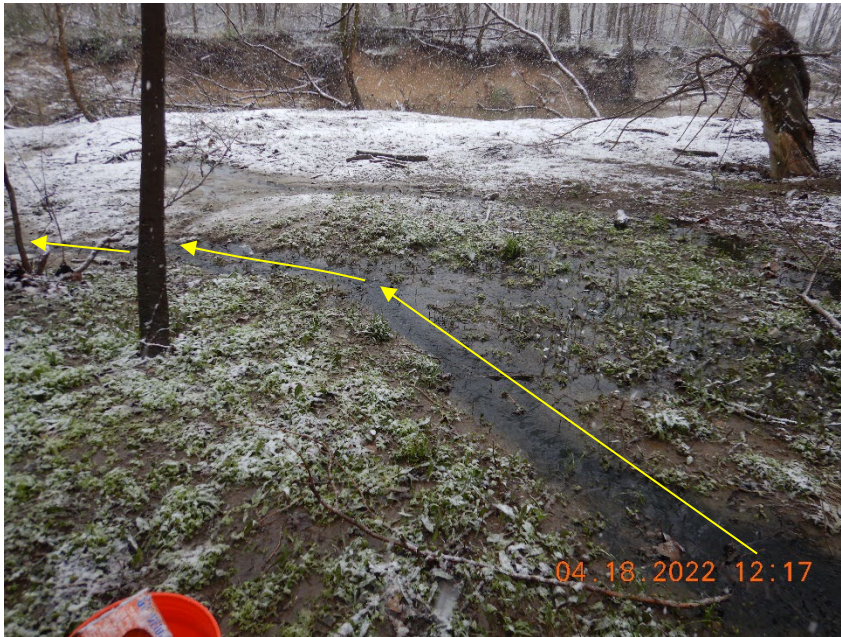
56: DSCN3730

**Description:** Flow pathway of the process wastewater discharge through the woods, next section of flow in sequence after Photograph DSCN3729 as flow begins to turn north/northwest along the edge of the woods adjacent to the bank of the East Branch Black River. Arrows show general direction of flow.

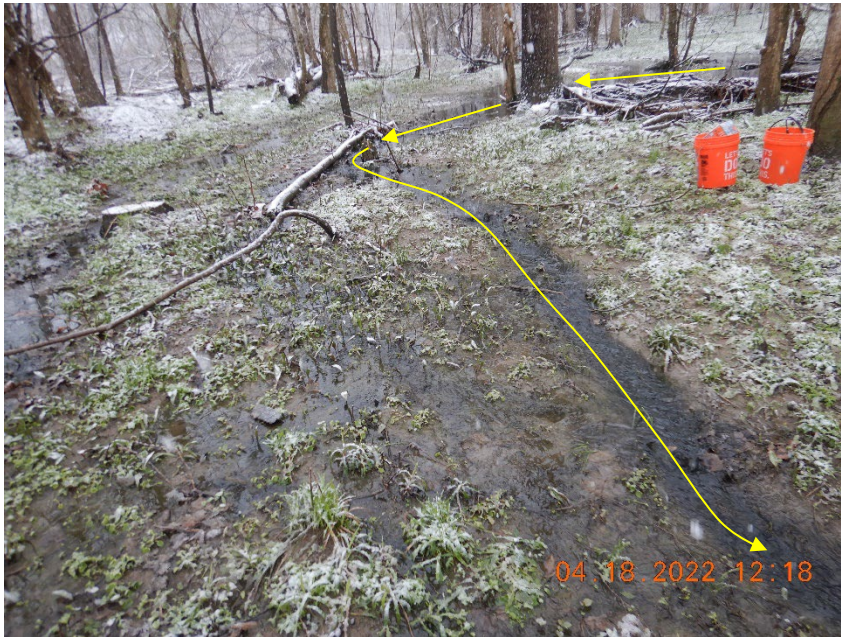
57: DSCN3731

**Description:** View of the Flow pathway of the process wastewater discharge looking upstream just before the flow begins to head north/northwest along the edge of the woods adjacent to the bank of the East Branch Black River. Arrows show general direction of flow.

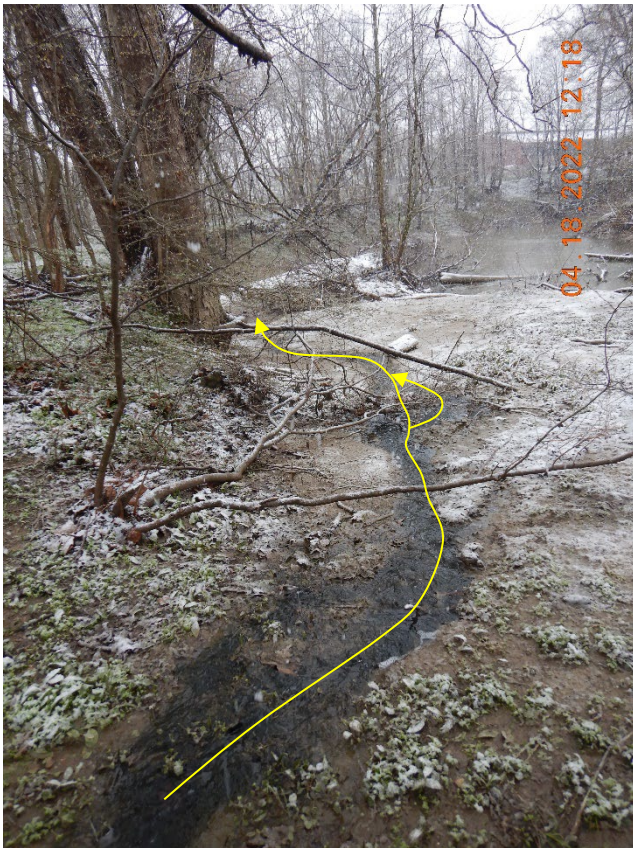
58: DSCN3732

**Description:** This is the next section of flow (looking downstream) in the flow pathway of the process wastewater discharge sequence after Photograph DSCN3730 as flow exits the woods and curves north/northwest, flowing along the east edge of the woods, adjacent to the East Branch Black River. Arrows show general direction of flow.

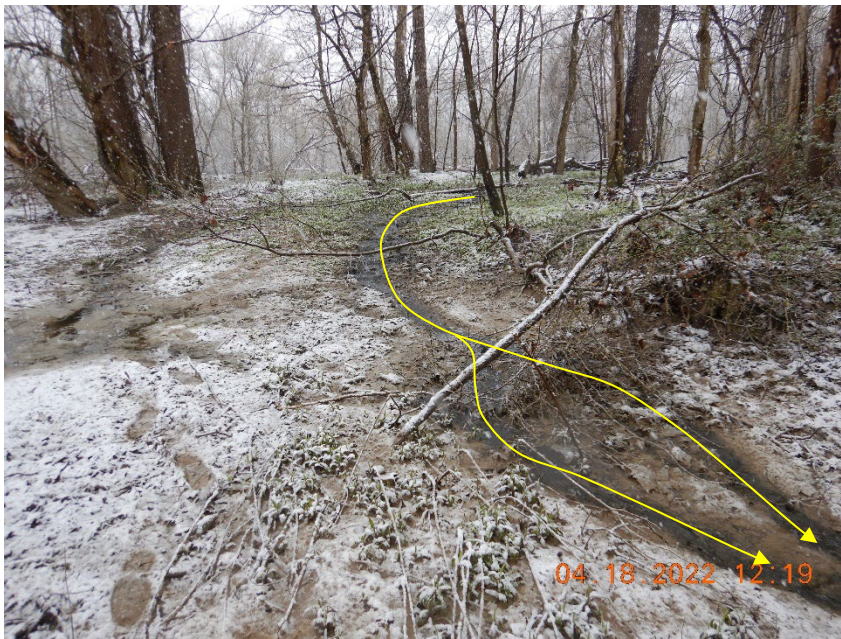
59: DSCN3733

**Description:** Additional view looking upstream at the flow pathway of the process wastewater discharge from the location for Photograph DSCN3732 as the flow exits the woods and curves north/northeast, flowing along the east edge of the woods, adjacent to the East Branch Black River. Arrows show general direction of flow.

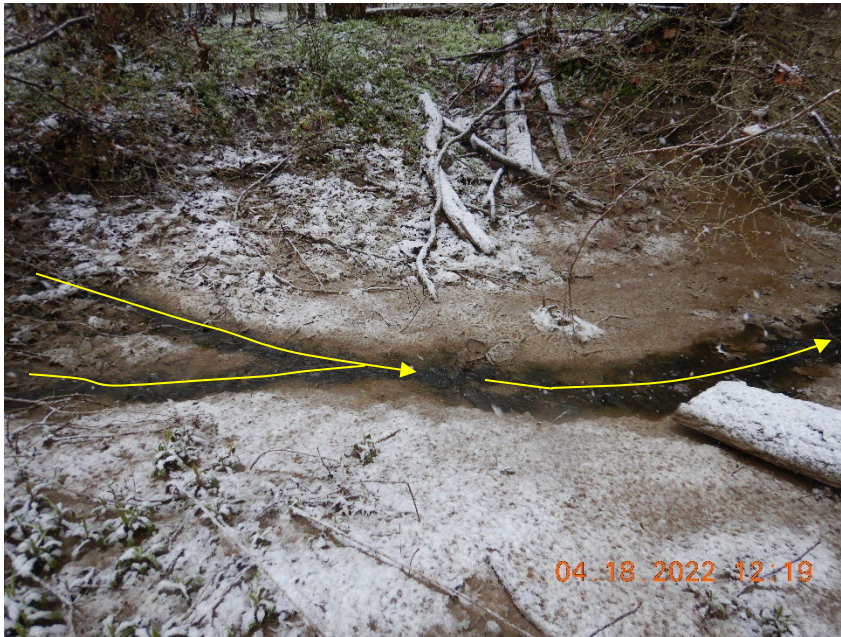
60: DSCN3734

**Description:** Flow pathway of the process wastewater discharge along the east edge of the woods adjacent to the bank of the East Branch Black River, next section of flow in sequence after Photograph DSCN3733. Arrows show general direction of flow.

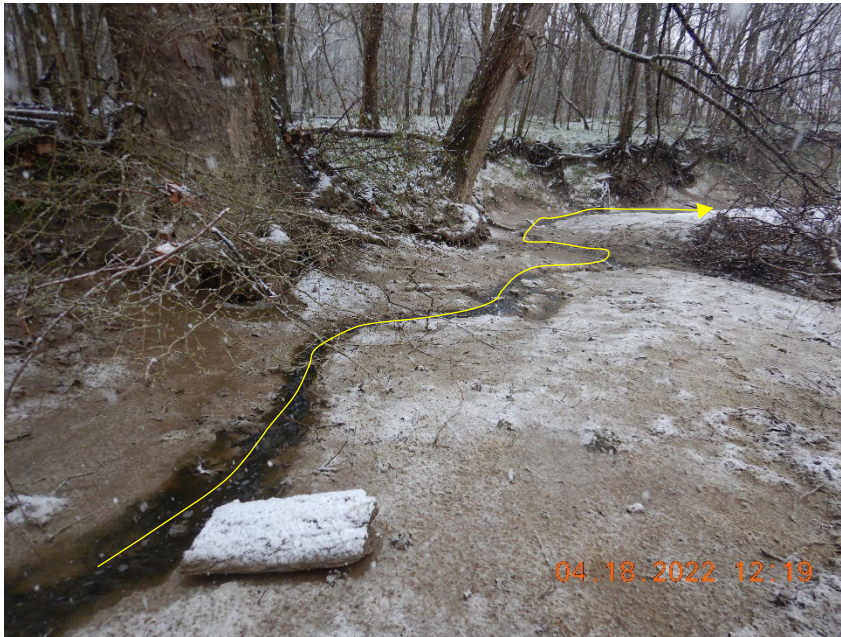
61: DSCN3735

**Description:** Flow pathway of the process wastewater discharge along the east edge of the woods adjacent to the bank of the East Branch Black River, next section of flow in sequence after Photograph DSCN3734. Arrow shows general direction of flow.

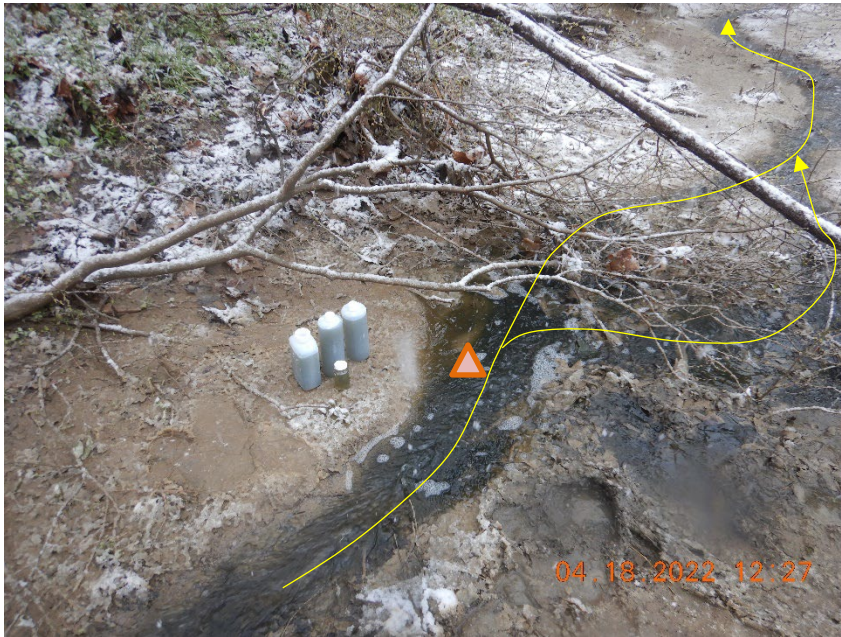
62: DSCN3736

**Description:** Sample S02 was collected from the process wastewater discharge pathway after it turns to head north/northwest along the east edge of the woods along the bank of the East Branch Black River. Photographs DSCN3733 and DSCN3732 also provide a general overview of the sample location for S02. Arrows show general direction of flow. An orange triangle identifies the approximate location of sampling in the flow.

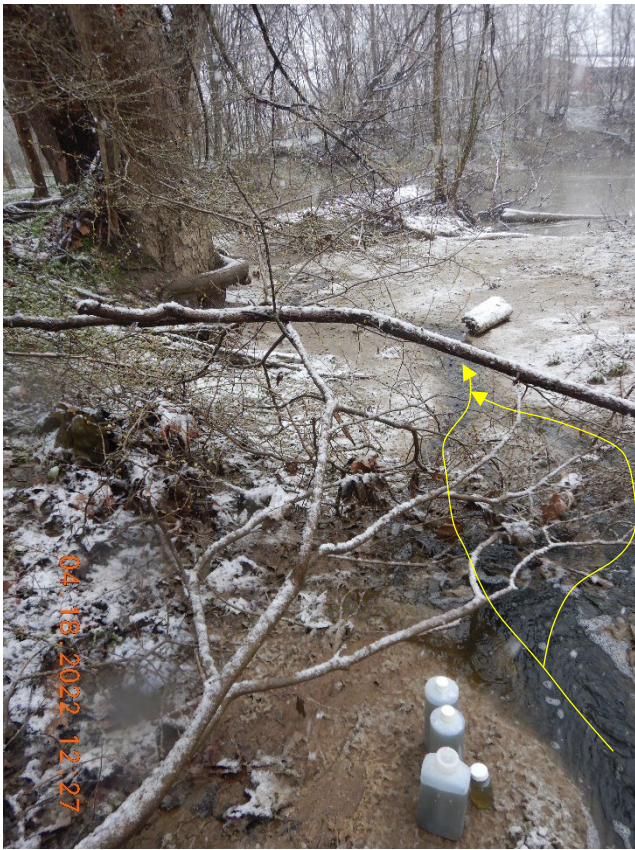
63: DSCN3737

**Description:** Additional photograph of sample location S02 from the flow pathway of the process wastewater discharge after it curves to head north/northwest along the east edge of the woods along the bank of the East Branch Black River. Photographs DSCN3733 and DSCN3732 also provide a general overview of the sample location for S02. Arrows show general direction of flow.

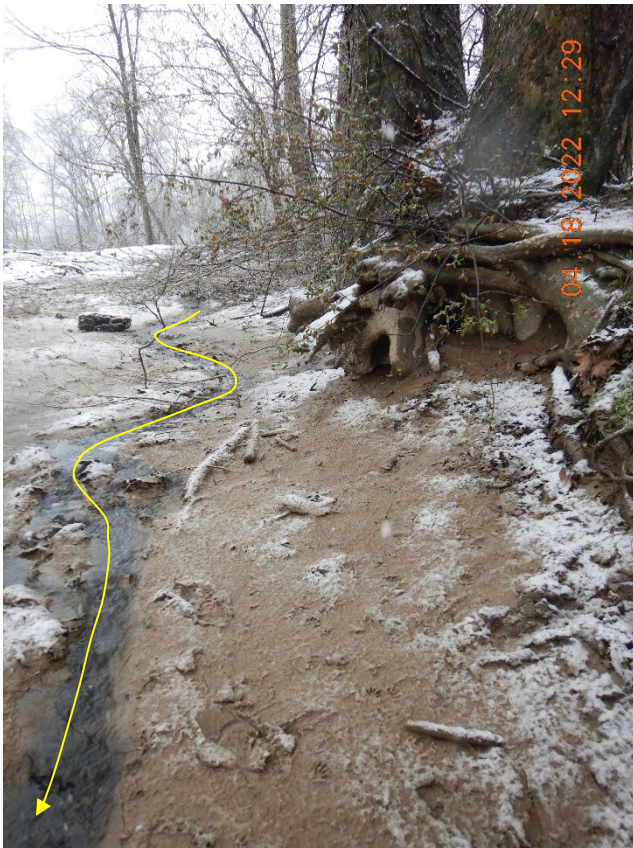
64: DSCN3738

**Description:** Flow pathway of the process wastewater discharge (looking upstream towards sample location S02) along the east edge of the woods adjacent to the bank of the East Branch Black River. This section of flow was captured Photograph DSCN3735 looking downstream. An arrow shows the general direction of flow.

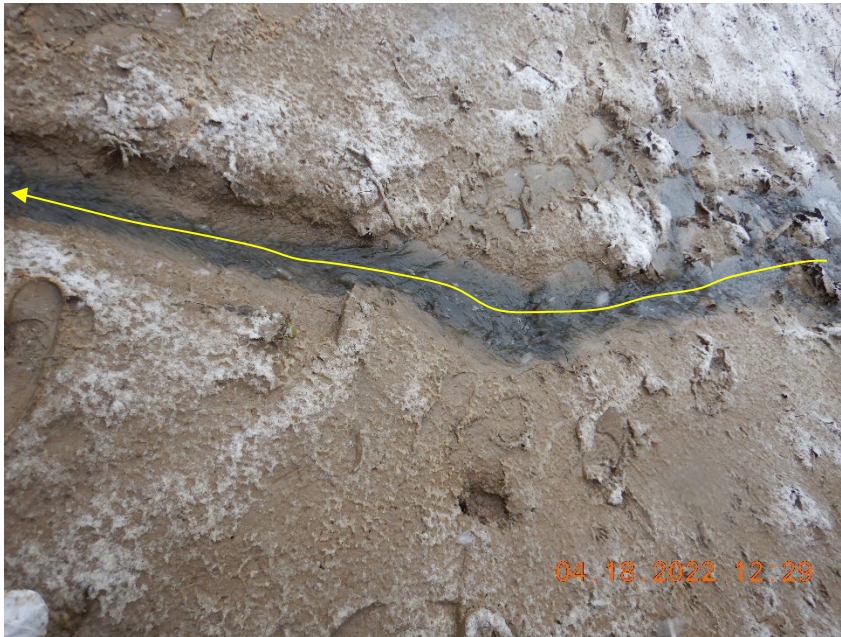
65: DSCN3739

**Description:** Flow pathway of the process wastewater discharge along the east edge of the woods adjacent to the bank of the East Branch Black River, next section of flow in sequence after Photograph DSCN3738. An arrow shows the general direction of flow.

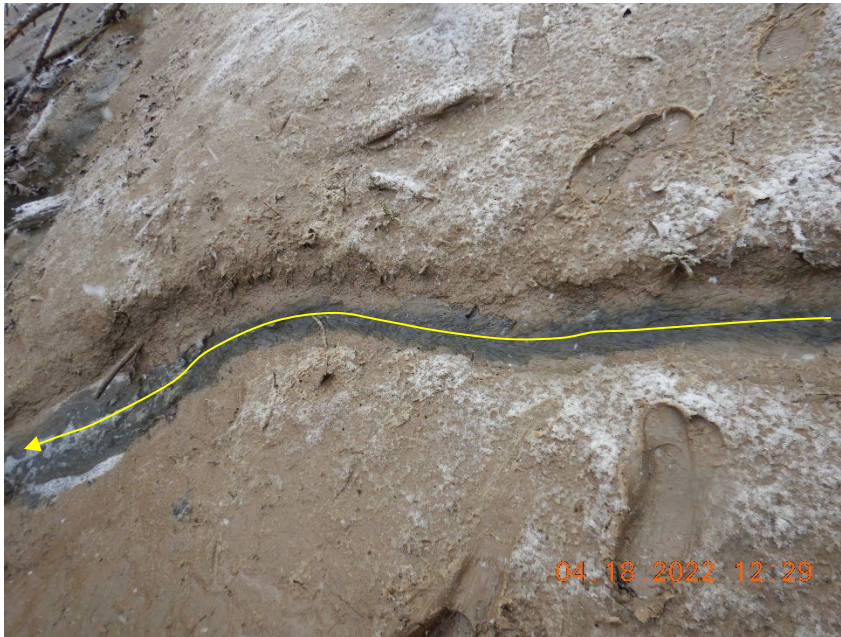
66: DSCN3740

**Description:** Flow pathway of the process wastewater discharge along the east edge of the woods adjacent to the bank of the East Branch Black River, next section of flow in sequence after Photograph DSCN3739. An arrow shows the general direction of flow.

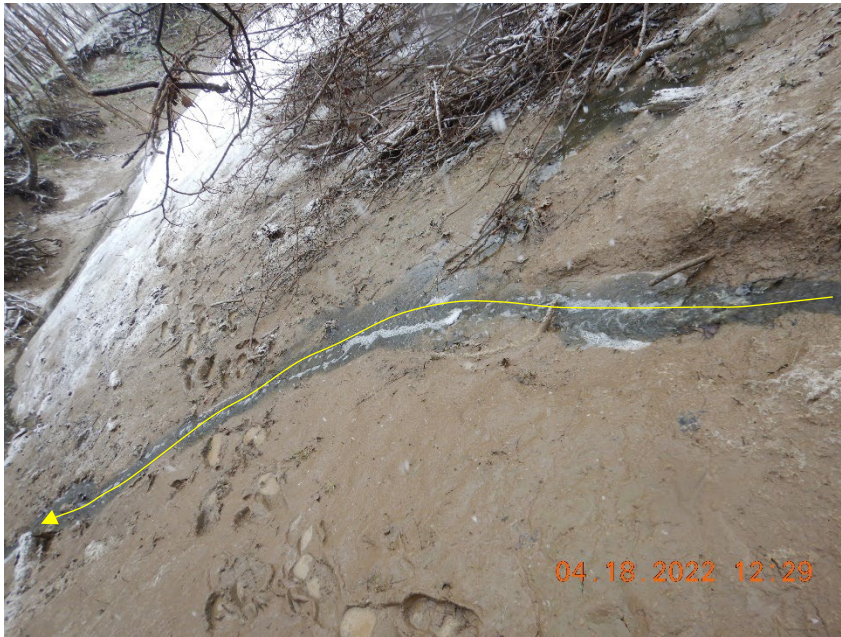
67: DSCN3741

**Description:** Flow pathway of the process wastewater discharge along the east edge of the woods adjacent to the bank of the East Branch Black River, next section of flow in sequence after Photograph DSCN3740. An arrow shows the general direction of flow.
