**CWA COMPLIANCE EVALUATION INSPECTION REPORT  
U.S. ENVIRONMENTAL PROTECTION AGENCY, REGION 5**

Compliance Sampling Inspection

Conrad Farms LLC  
19900 Indian Hollow Road  
Grafton, Ohio  
Lorain County, Ohio  
41.192011, -82.101401

**Date of Inspection:** 4/18/2022

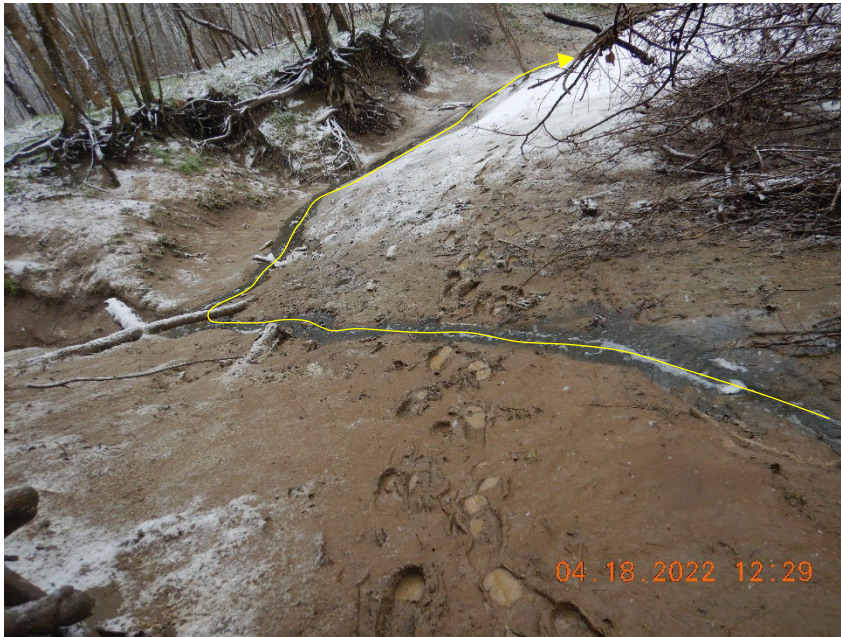
68: DSCN3742

**Description:** Flow pathway of the process wastewater discharge along the east edge of the woods adjacent to the bank of the East Branch Black River, next section of flow in sequence after Photograph DSCN3741. An arrow shows the general direction of flow.

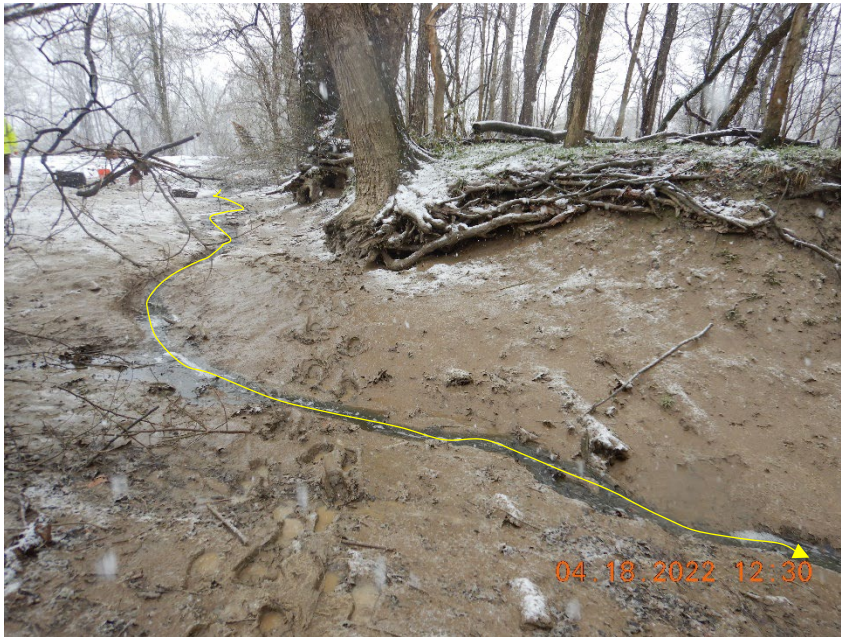
69: DSCN3743

**Description:** View looking upstream at the flow path documented in Photographs DSCN3738 through DSCN3741. An arrow shows the general direction of flow.

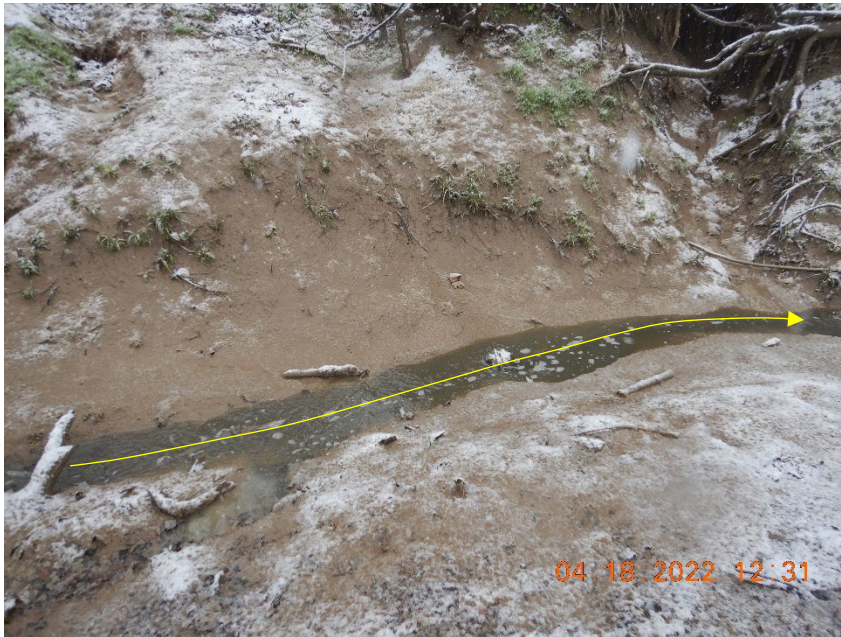
71: DSCN3745

**Description:** Flow pathway of the process wastewater discharge along the east edge of the woods adjacent to the bank of the East Branch Black River, next section of flow in sequence after Photograph DSCN3744. An arrow shows the general direction of flow.

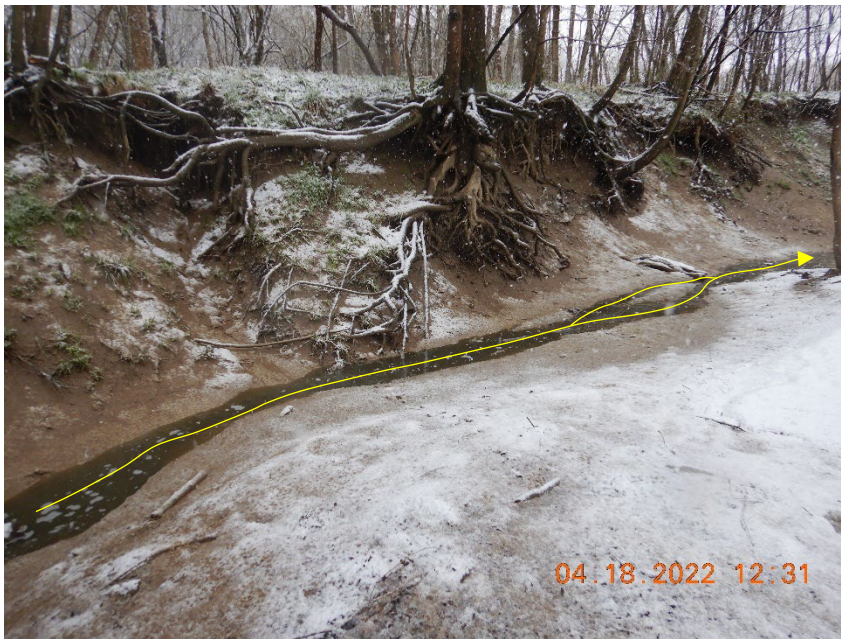
72: DSCN3746

**Description:** Flow pathway of the process wastewater discharge along the east edge of the woods adjacent to the bank of the East Branch Black River, next section of flow in sequence after Photograph DSCN3745. An arrow shows the general direction of flow.

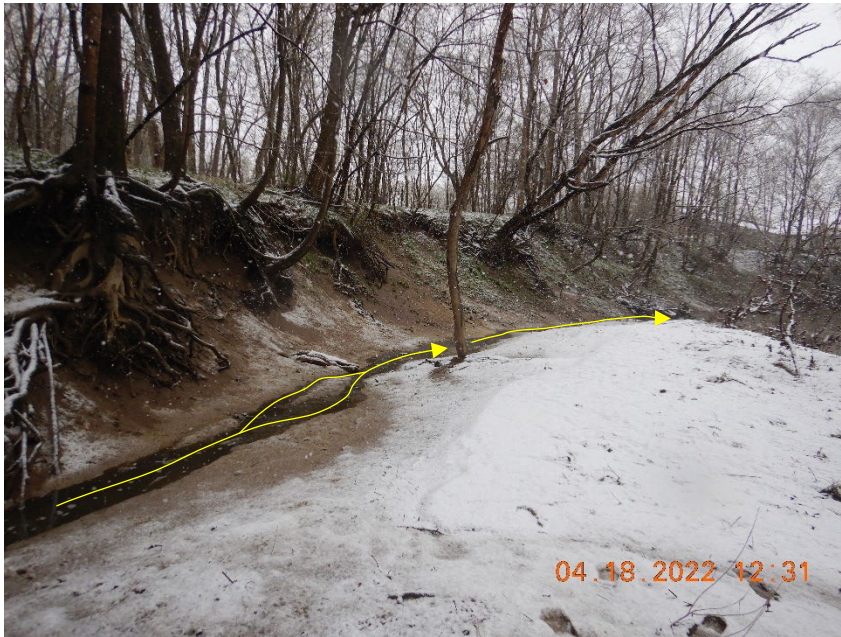
73: DSCN3747

**Description:** Flow pathway of the process wastewater discharge along the east edge of the woods adjacent to the bank of the East Branch Black River, next section of flow in sequence after Photograph DSCN3746. An arrow shows the general direction of flow.

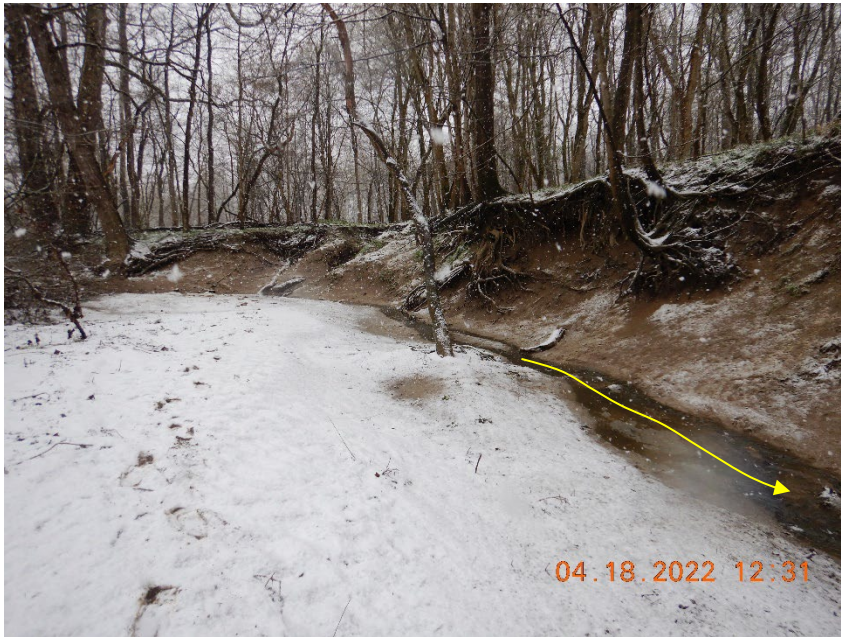
74: DSCN3748

**Description:** View looking upstream at the flow path documented in Photographs DSCN3746 through DSCN3747. An arrow shows the general direction of flow.

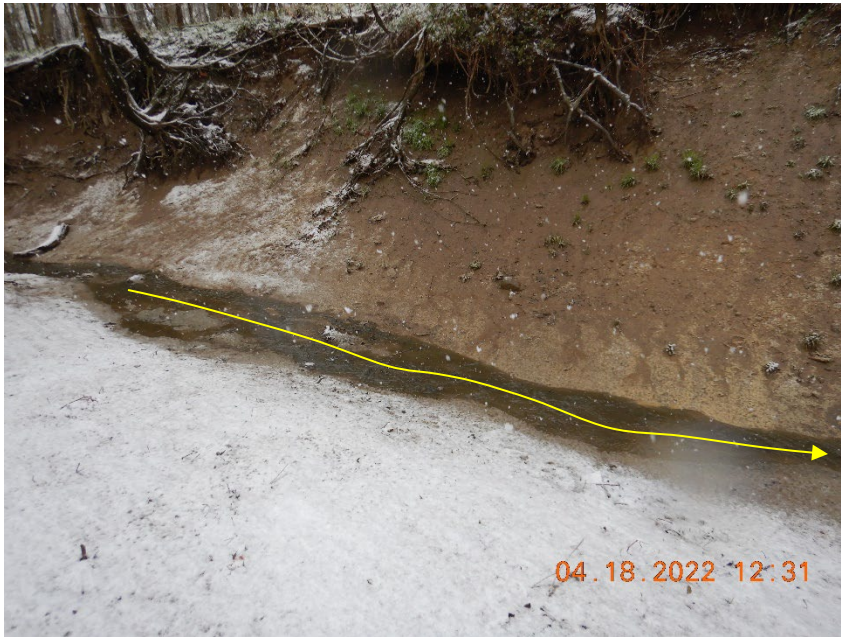
75: DSCN3749

**Description:** Flow pathway of the process wastewater discharge along the east edge of the woods adjacent to the bank of the East Branch Black River, next section of flow in sequence after Photograph DSCN3747. An arrow shows the general direction of flow.

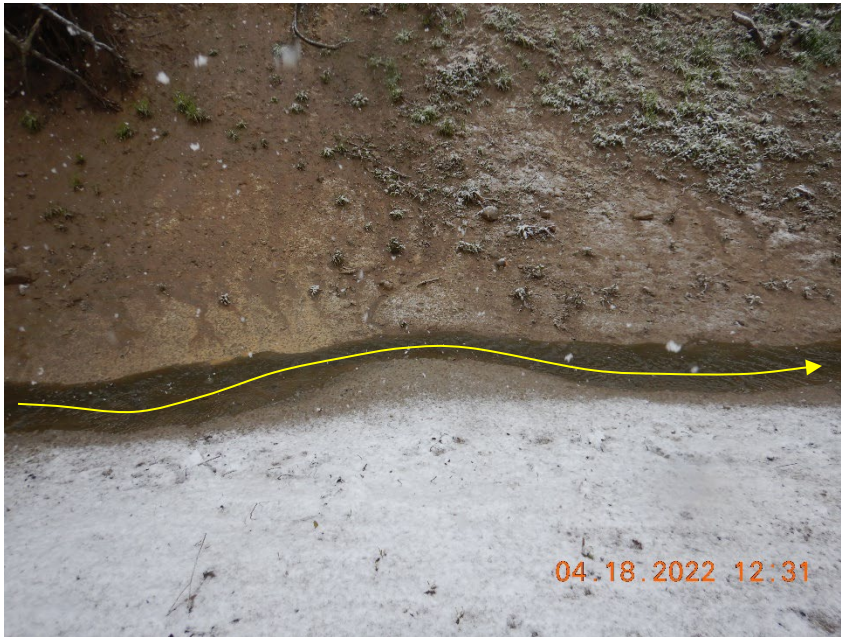
76: DSCN3750

**Description:** Flow pathway of the process wastewater discharge along the east edge of the woods adjacent to the bank of the East Branch Black River, next section of flow in sequence after Photograph DSCN3749. An arrow shows the general direction of flow.

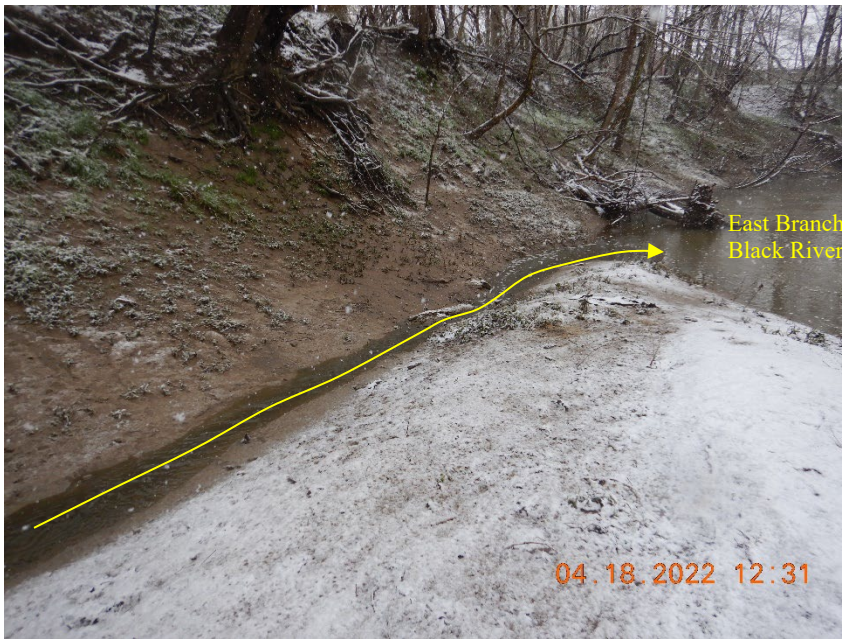
77: DSCN3751

**Description:** Flow pathway of the process wastewater discharge along the east edge of the woods adjacent to the bank of the East Branch Black River, next section of flow in sequence after Photograph DSCN3750. An arrow shows the general direction of flow. The flow pathway of the process wastewater discharge discharges here into the East Branch Black River.

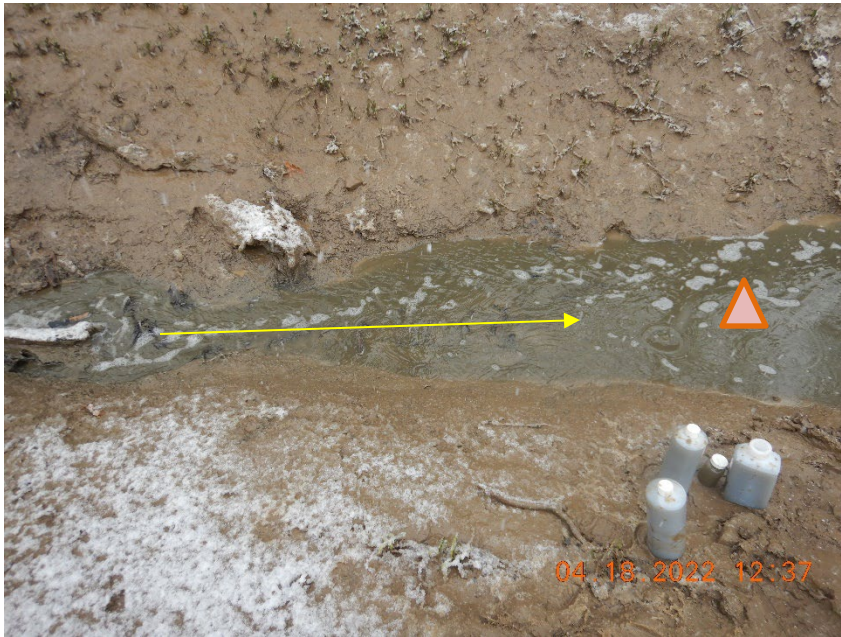
78: DSCN3752

**Description:** Location in the flow pathway of the process wastewater discharge where sample S03 was collected (identified with an orange triangle) . An arrow shows the general direction of flow.

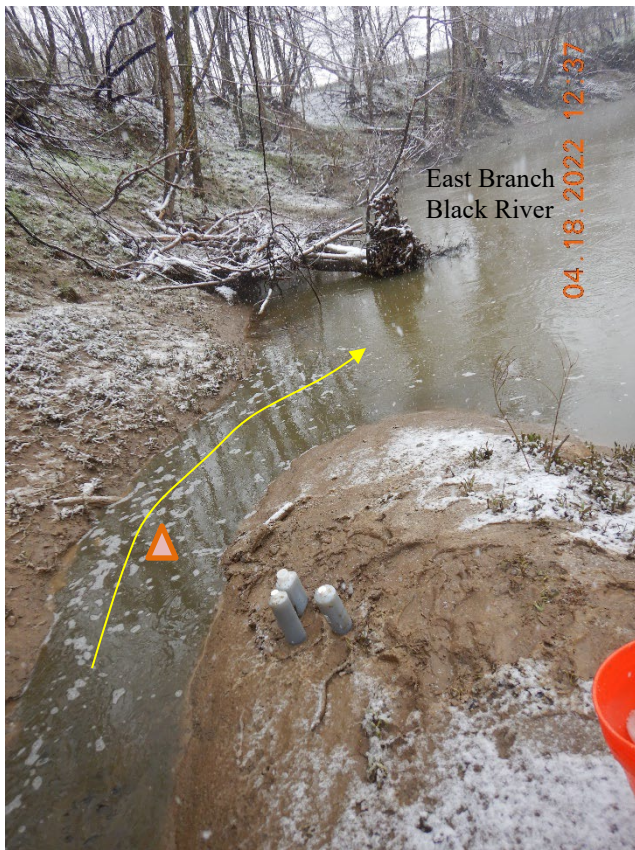
79: DSCN3753

**Description:** View of the approximate S03 sample location in the flow pathway of the process wastewater discharge (orange triangle) in relation to the discharge pathway's confluence with the East Branch Black River. An arrow shows the general direction of flow into the river.

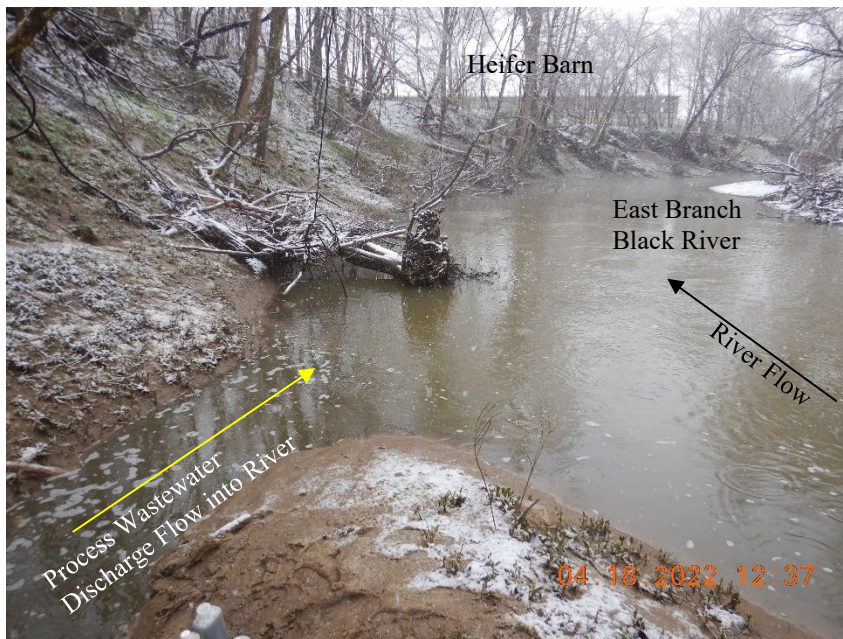
80: DSCN3754

**Description:** The flow pathway of the process wastewater discharge from the south retention pond travels through the woods and discharges into the East Branch Black River. The Conrad Farms heifer barn is visible to the north.

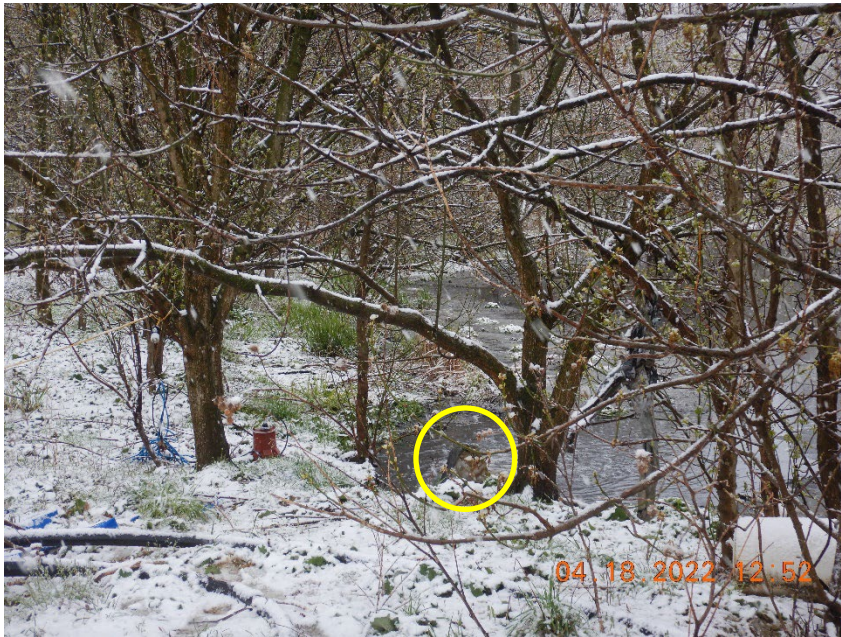
83: DSCN3758

During the walk back to the EPA vehicles, EPA observed the black pipe at the northeast edge of the south retention pond discharging sediment pond liquid into the south retention pond. EPA photographed the flow from the pipe (Photographs DSCN3757 and DSCN3758). EPA also documented the stormwater flow in the drainage swale along the exterior of the west side of the west freestall barn located on the east side of the driveway. The flow in the swale enters into a catch basin located in the grassed area on the west side of the west freestall barn (Photograph DSCN3759) between the commodity barn on the south end and the section of the west freestall barn for recently calved cows. This catch basin receives storm water from downspouts on the west freestall barn as well as runoff from the grass swale (Photographs DSCN3760 and DSCN3761). Richard Conrad stated earlier in the inspection walk-through that this catch basin drains to a surface outlet in the woods on the south end of the farm property and does not outlet to the river.

**Description:** Additional photograph of liquid discharging into the south retention pond from the black plastic piping rising out of the bank of the pond. The fan pattern of the liquid coming out of the black plastic pipe is visible to the right of the red submersible pump and below the center point of the photograph (circled in yellow).

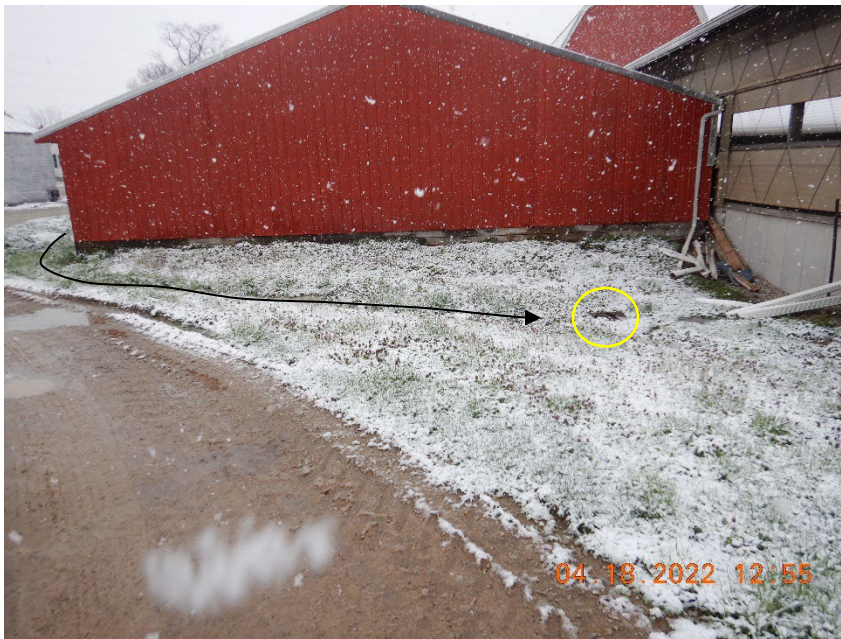
84: DSCN3759

**Description:** The precipitation run-off in the grassed swale flows around the west and south sides of the fresh pen area for recently calved cows (part of the west freestall barn) and enters into a catch basin located in the grassed area at the end of the swale on the south side of the fresh pen area. This catch basin (dark black grate visible in grass, circled in yellow in the photograph) receives storm water from downspouts on the west freestall barn as well as run-off accumulated in the grassed swale (Photographs DSCN3760 and DSCN3761). Richard Conrad stated earlier in the inspection walk-through that this catch basin drains to a surface outlet in the woods on the south end of the farm property and does not outlet to the river. An arrow shows the general direction of flow in the swale.
