# NPDES Stormwater Industrial and Construction Inspection Report

| National Database Information | |
|---|---|
| NPDES ID Number: <b>COR05I301</b> | Inspection ID: <b>202503_COR05I301</b> |
| Facility Type: <b>Gas Processing Plant</b> | Inspection Type: <b>Stormwater Industrial</b> |

| Facility Location Information | |
|---|---|
| Site/Facility and Location:<br><br><b>Ignacio Gas Plant<br/>3746 Country Road 307<br/>Durango, Colorado 81303<br/>La Plata County</b> | Mailing address:<br><br><b>Harvest Four Corners, LLC<br/>1755 Arroyo Dr,<br/>Bloomfield, New Mexico 87413</b> |

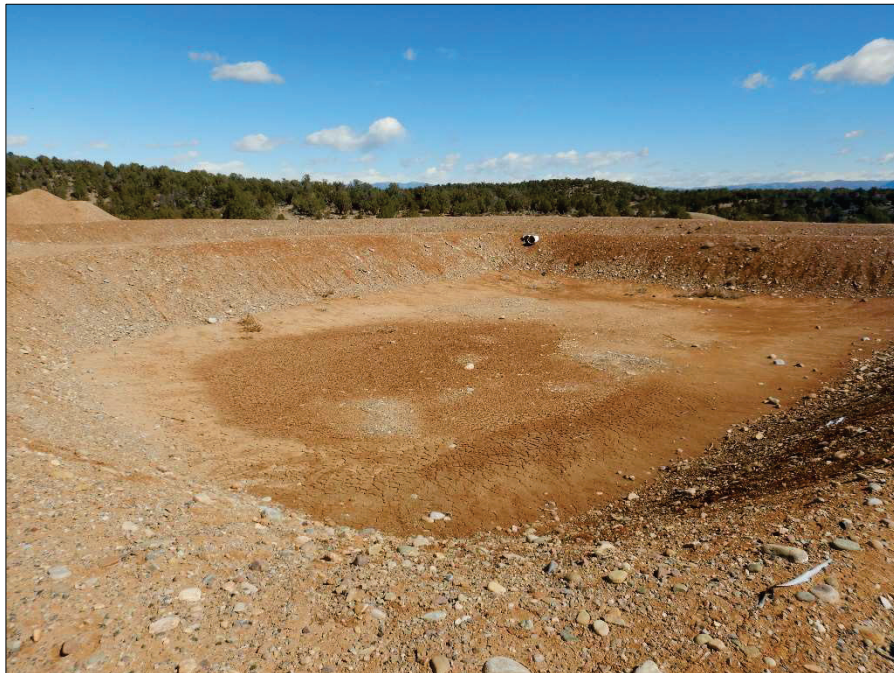
Photograph 2. View, facing Northeast, of an unlined basin in the Soil Drying Containment Area in the Northeast area of the Facility.

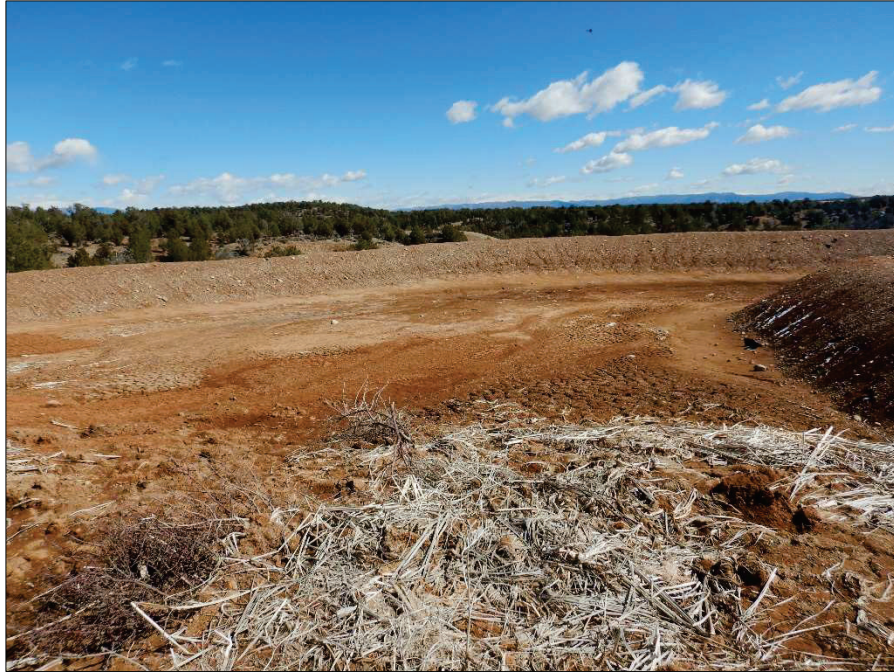
Photograph 3. Additional view, facing East, of the unlined basin in the Soil Drying Containment Area, as referenced in Photograph 2.

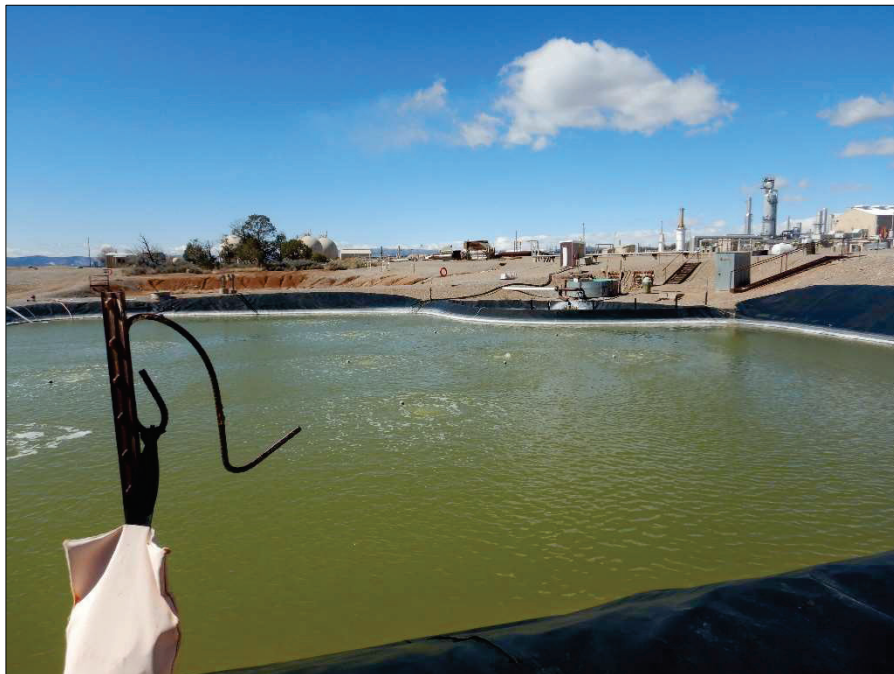
Photograph 4. View, facing West, of East Excess Pond.

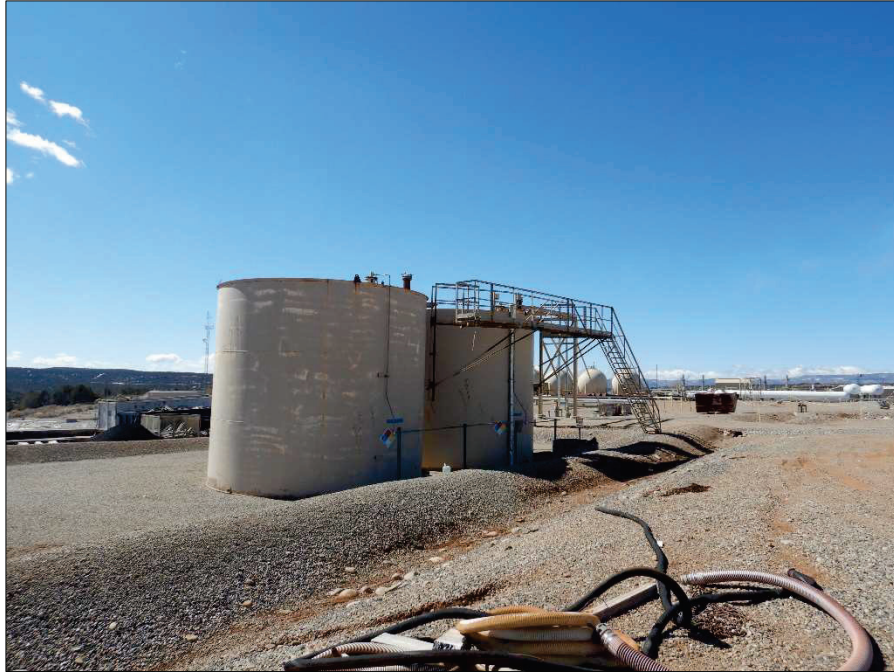
Photograph 5. View, facing Southwest, of above ground storage tanks containing industrial wastewater.

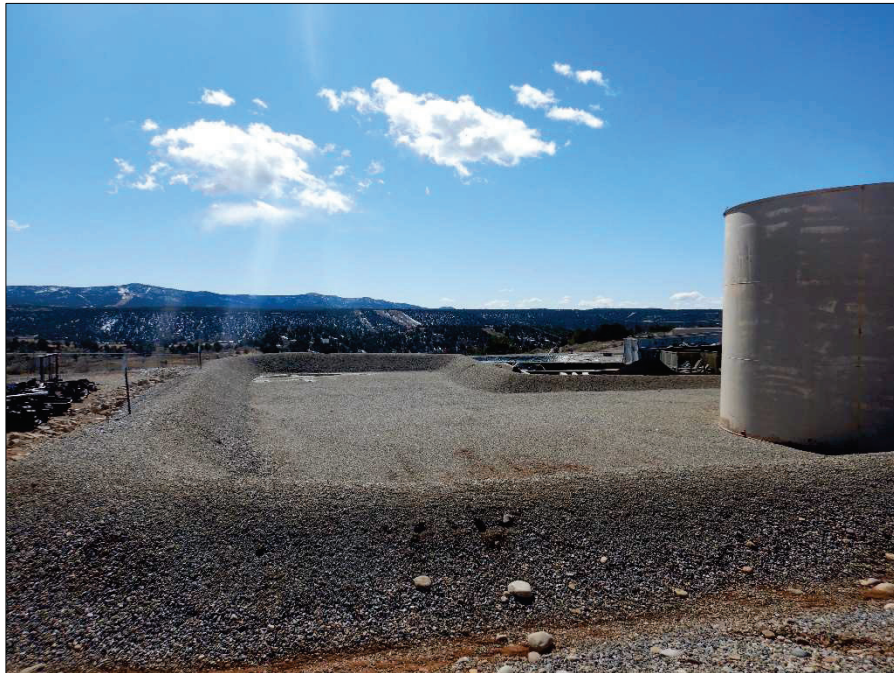
Photograph 6. View, facing South, of the secondary containment area for the above ground storage tanks, as referenced in Photograph 5.

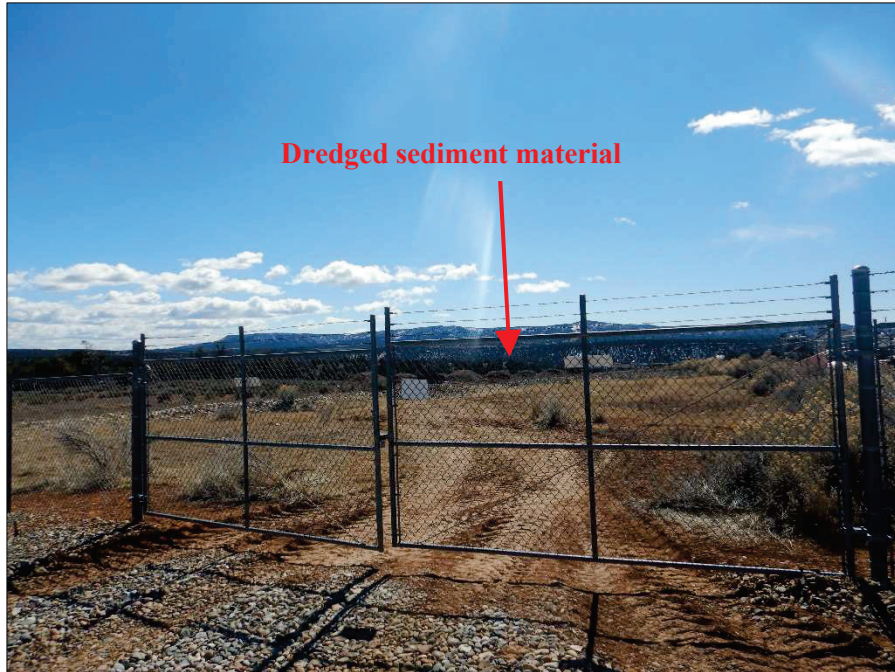
- a. Uncovered and uncontained piles of dredged sediment located outside of the fence line in the north area of the Facility (refer to Appendix A, Photographs 9 and 10).

Photograph 9. View, facing Southeast, of fence line in Drainage Area 15. Note uncovered and uncontained dredged material outside of the fence line.

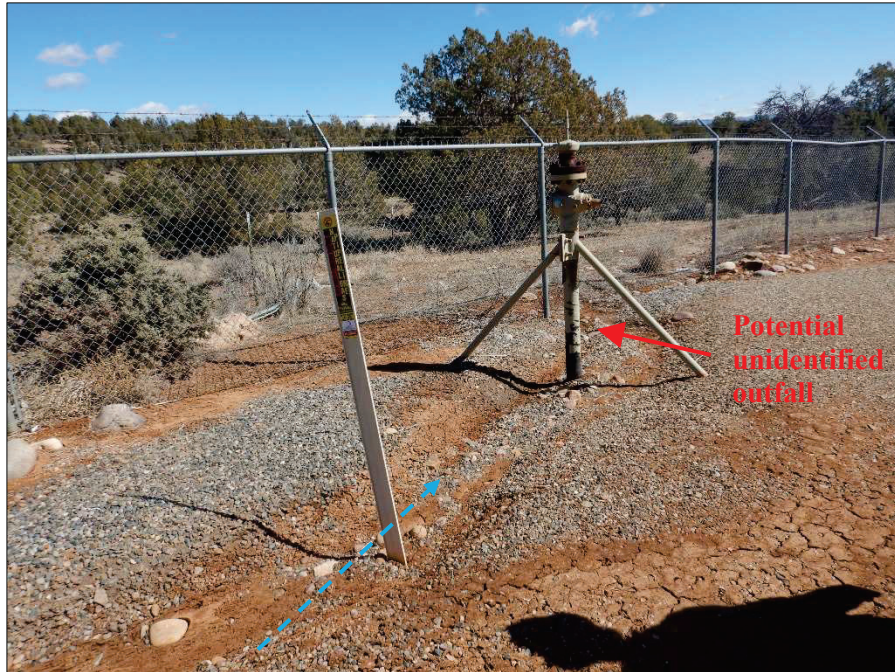
- Drainage Area 15 contains three outfalls on the site map; however the Inspection Team observed an additional three potential outfalls (refer to Appendix A, Photographs 12 through 14, 17, 18 and 25).

Photograph 13. Additional view, facing Southeast, of potential unidentified outfall in Drainage Area 15, as referenced in Photograph 12.

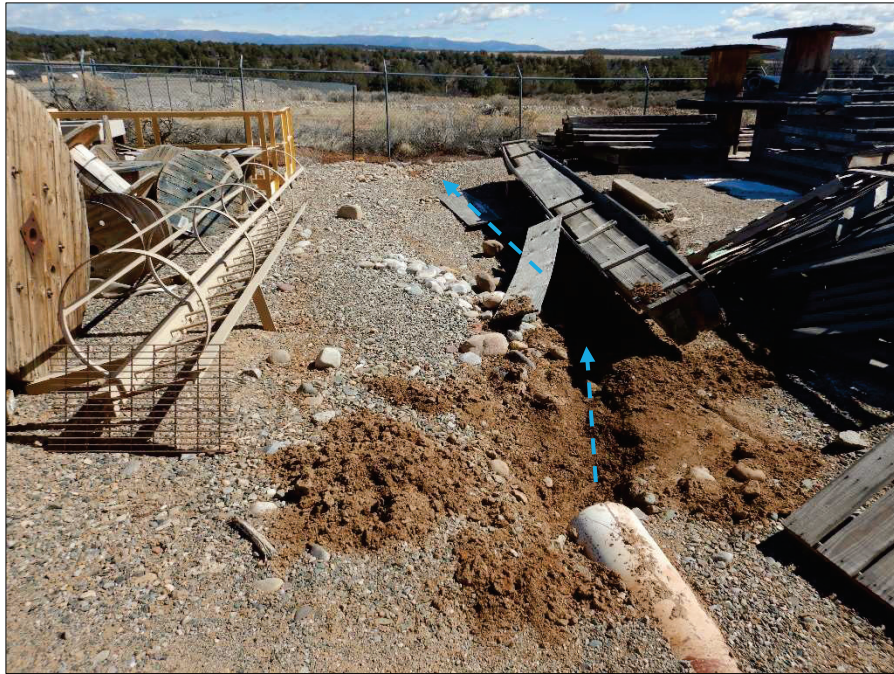
Photograph 15. View, facing East, of a stormwater drainage pathway leading from the Facility's boneyard toward the potential unidentified outfall shown in Photograph 25.

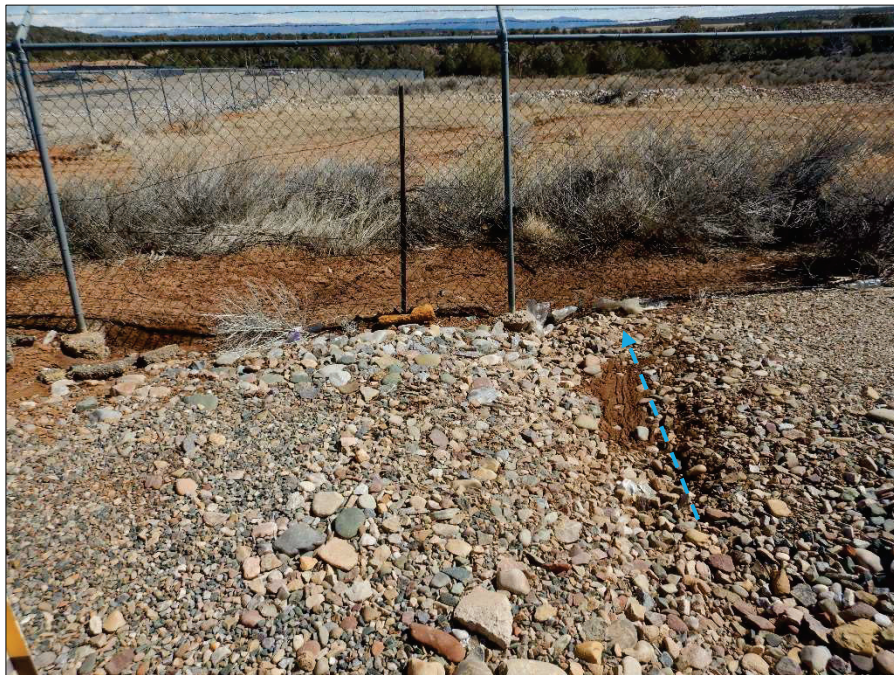
Photograph 16. Additional view, facing East, of the stormwater drainage pathway leading from the Facility's boneyard toward the potential unidentified outfall shown in Photograph 25, as referenced in Photograph 15.

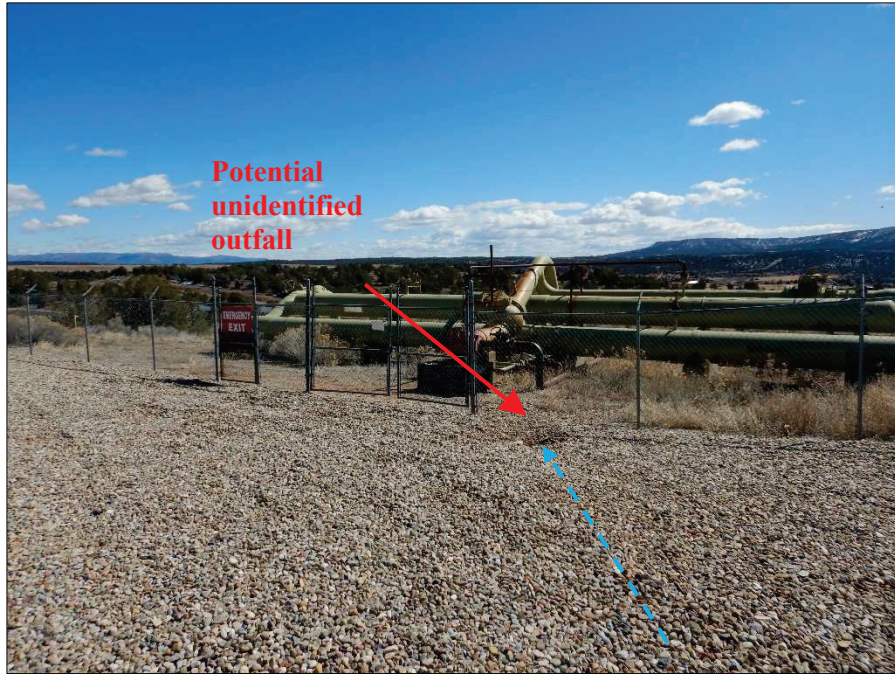
- Drainage Area 11 contains one outfall on the site map; however, the Inspection Team identified an additional potential outfall (refer to Appendix A, Photographs 19 and 20).

Photograph 19. View, facing South, of a potential unidentified outfall point in Drainage Area 11.

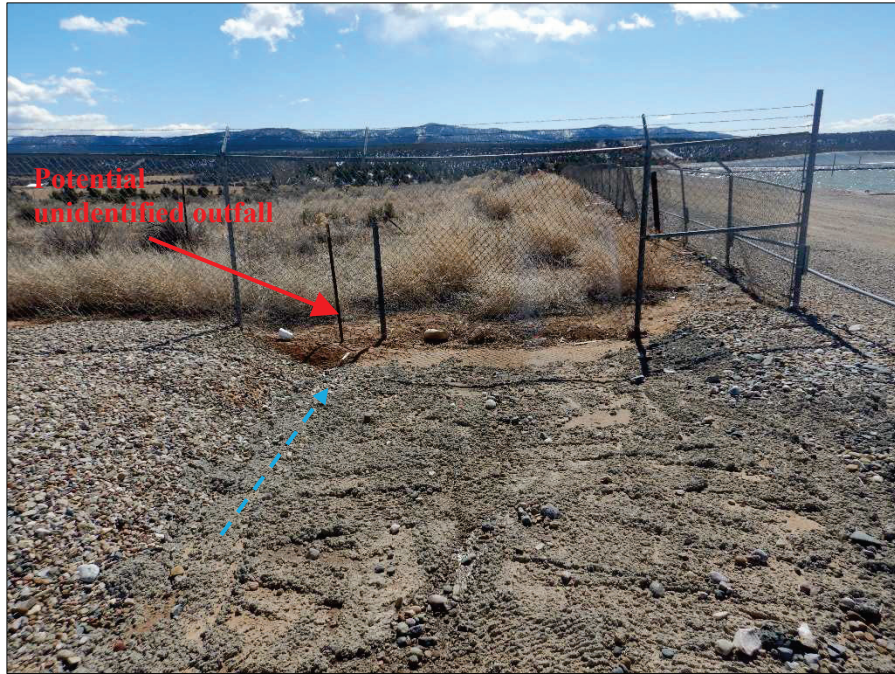
- Drainage Area 14 contains one outfall on the site map; however, the Inspection Team identified four additional potential outfalls (refer to Appendix A, Photographs 21 through 24).

Photograph 21. View, facing South, of a potential unidentified outfall in Drainage Area 14.

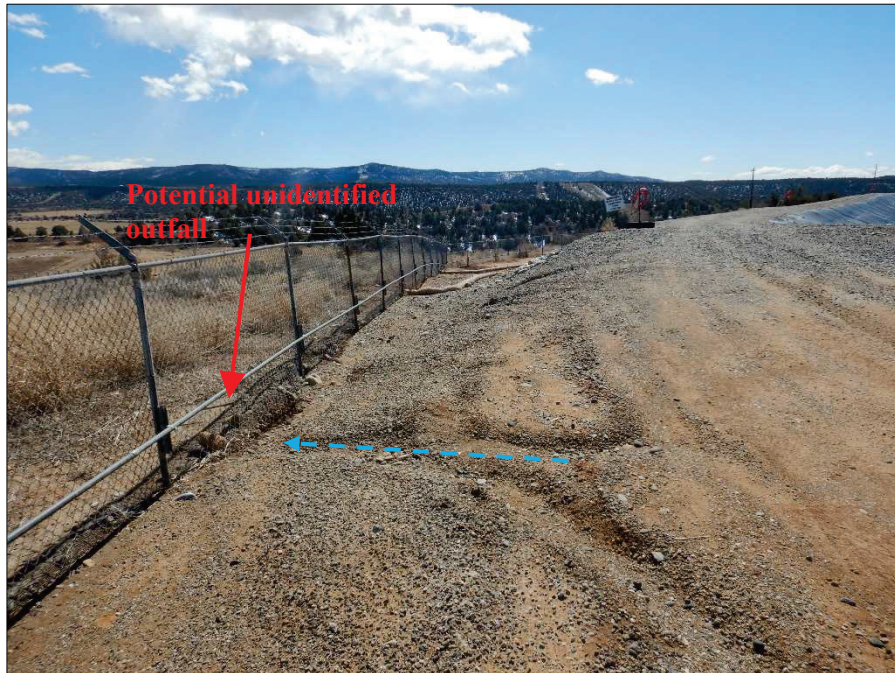
Photograph 22. View, facing South, of another potential unidentified outfall point in Drainage Area 14.

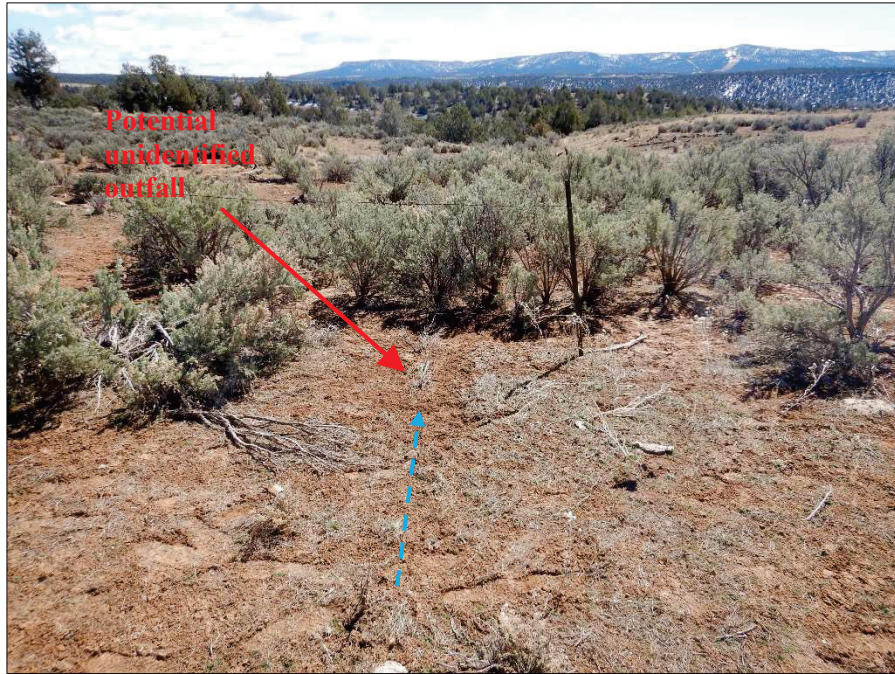
Photograph 25. View, facing Southeast, of potential unidentified outfall point near dredged sediment piles outside of fence line in Drainage Area 15.

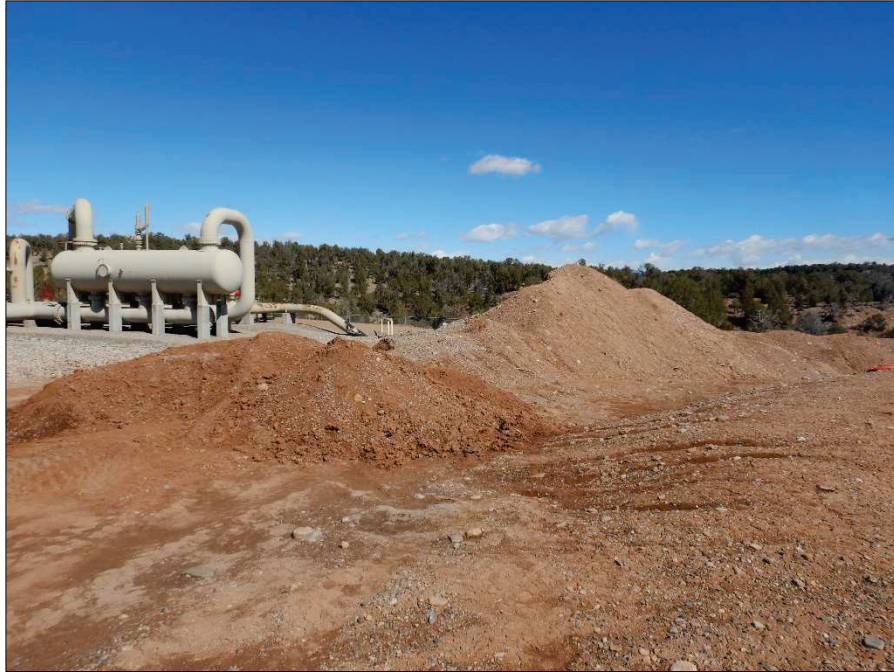
- b. Uncovered and uncontained piles of dredged sediment located outside the Soil Drying Containment area in Drainage Area 15 (refer to Appendix A, Photographs 26 and 27).

Photograph 27. Additional view, facing Northeast, of dredged material stored in Drainage Area 15, as referenced in Photograph 26. Note piles are uncovered and uncontained.

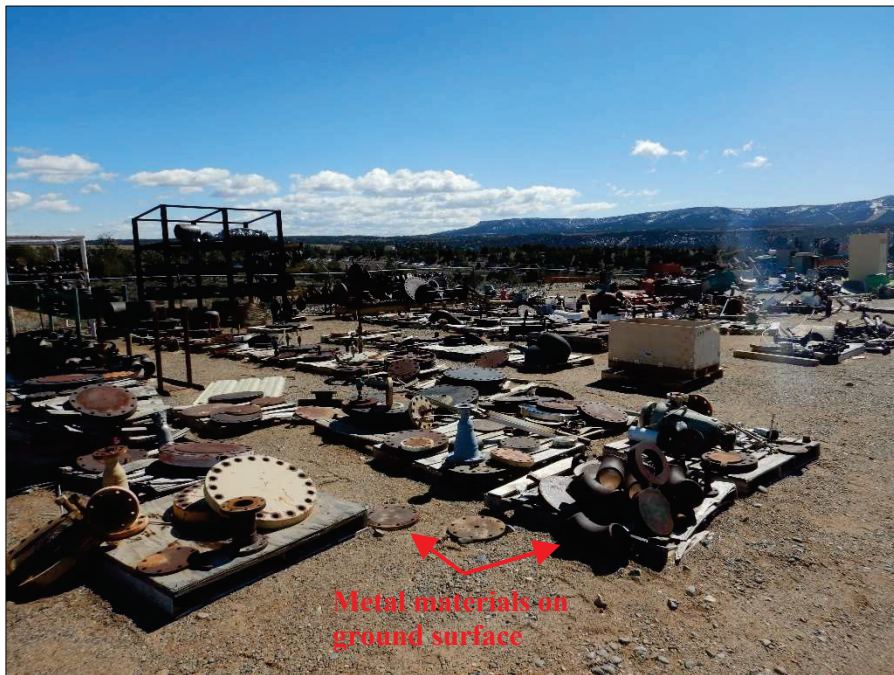
- c. Scrap and reclaimed metal parts stored directly on the ground and without containment or overhead cover in the boneyard in the east area of the Facility, as well as upgradient from Gosney Pond in the northwest area of the Facility (refer to Appendix A, Photographs 28 through 34). Some of the metal materials in the boneyard were stored on pallets or racks to prevent direct contact with stormwater flow, but many of the materials were sitting directly on the ground.

Photograph 28. View, facing Southeast, of boneyard. Note materials are uncovered and sitting on ground.

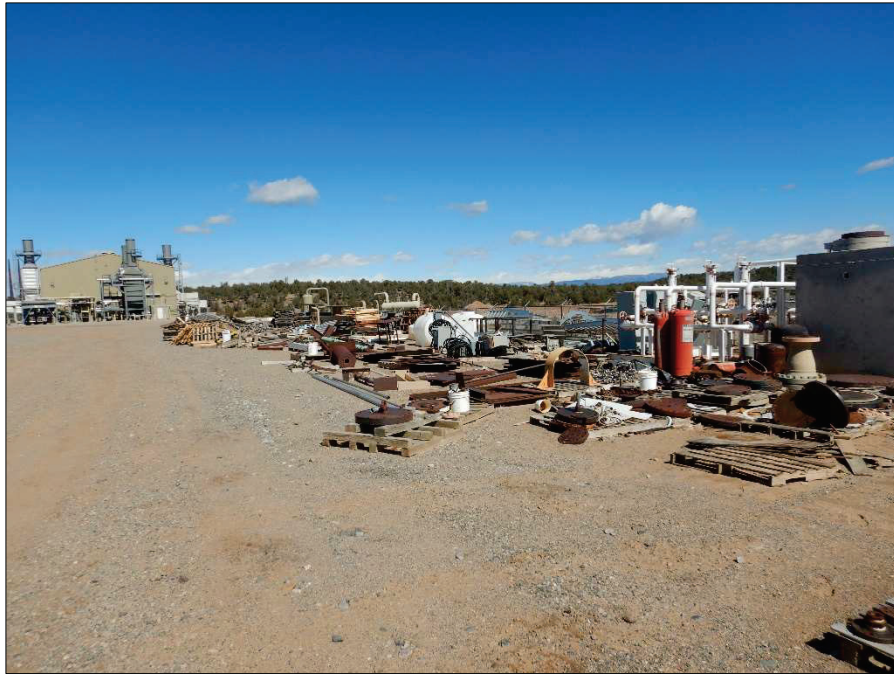
Photograph 29. Additional view, facing Northeast, of boneyard, as referenced in Photograph 28. Note materials are uncovered and sitting on the ground.

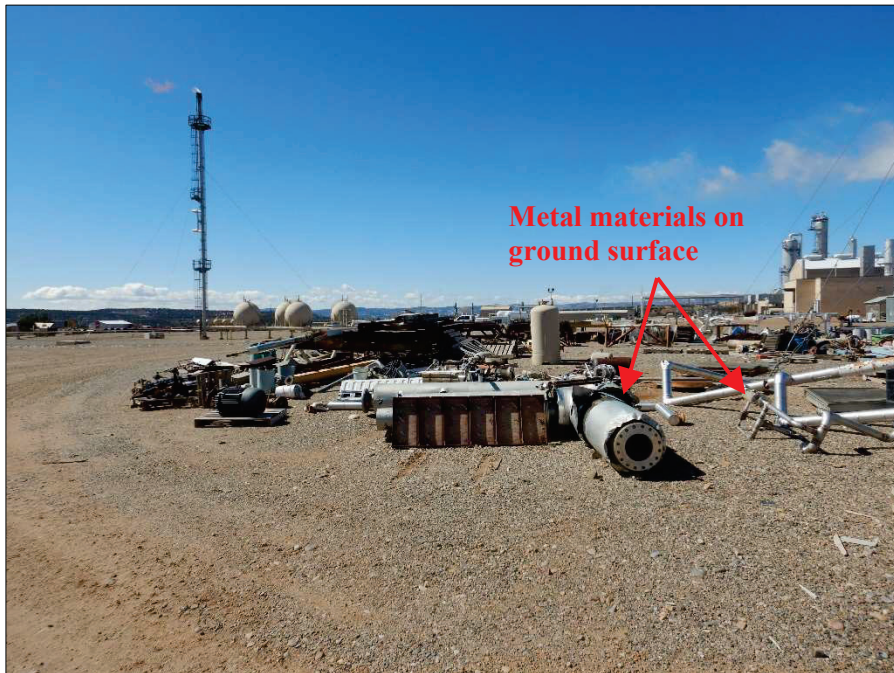
Photograph 30. Additional view, facing Southwest, of boneyard, as referenced in Photographs 28 and 29. Note materials are uncovered and sitting on the ground.

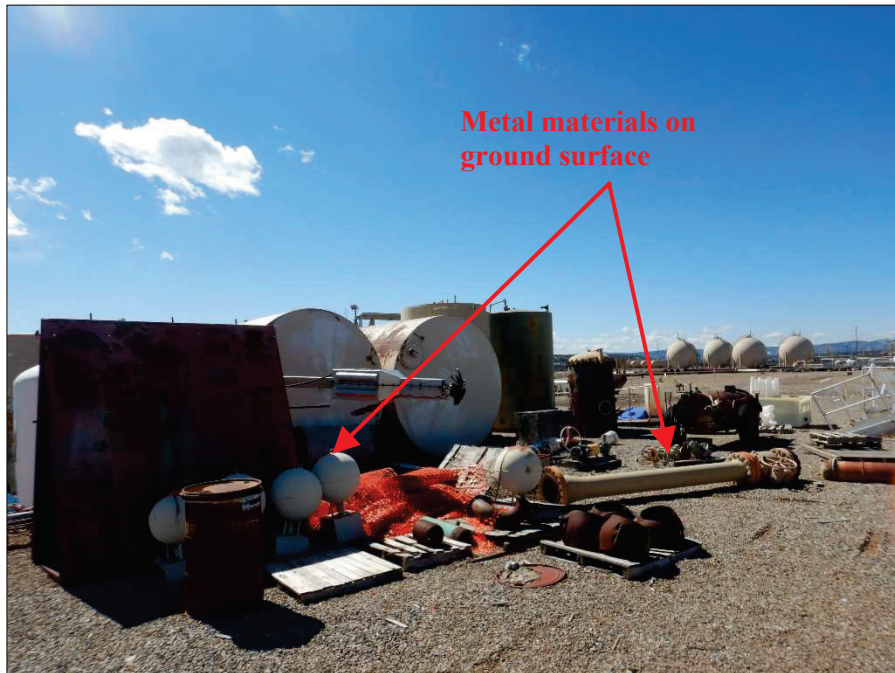
Photograph 32. Additional view, facing Southwest, of the Facility boneyard, as referenced in Photographs 28 through 31. Note materials are uncovered and sitting on the ground. The 55-gallon drum on the left side of the photo was empty at the time of the inspection.

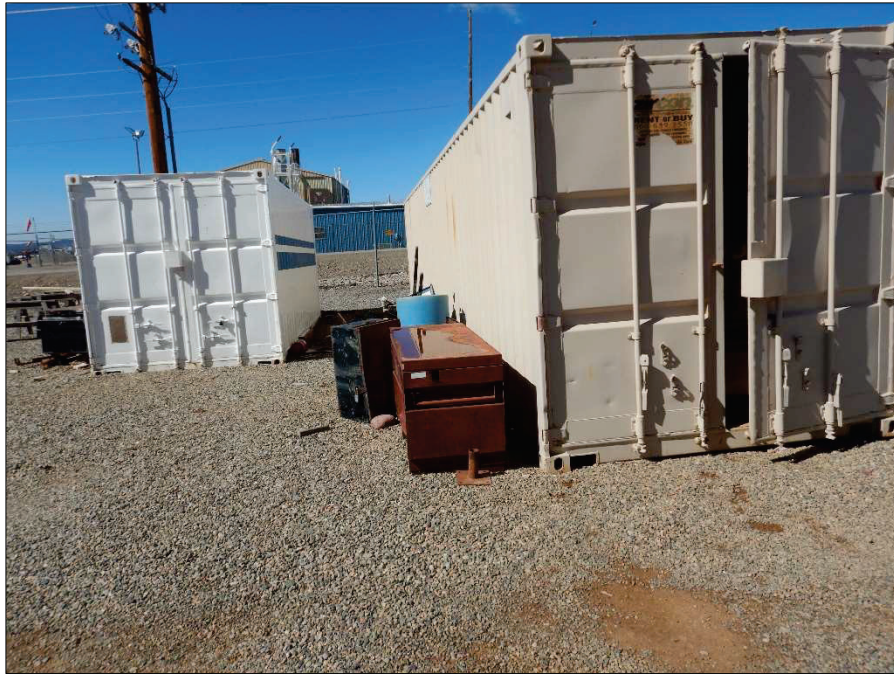
Photograph 33. View, facing West, of metal parts stored directly on the ground and without containment or overhead cover in Drainage Area 1.

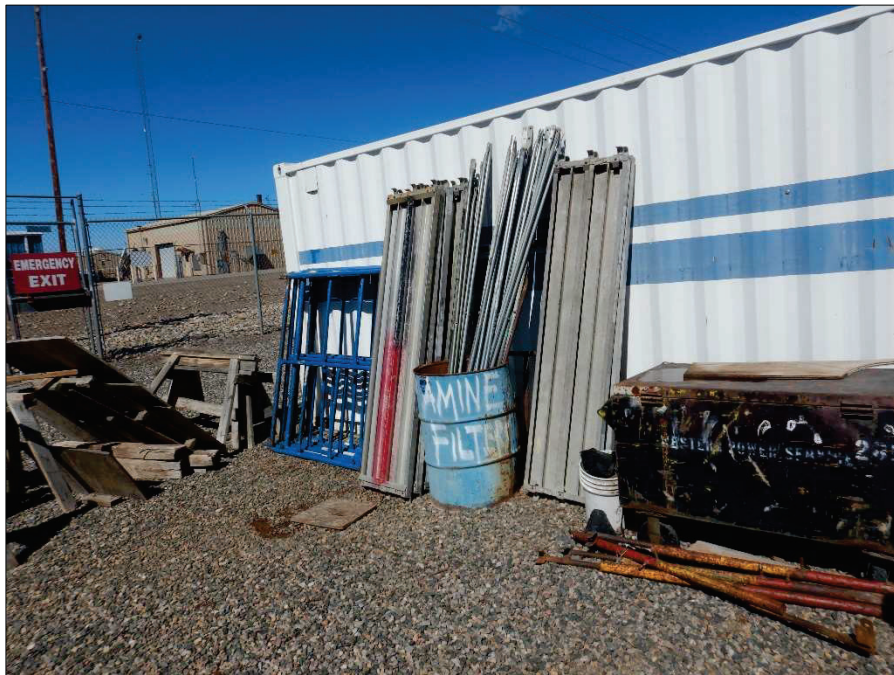
Photograph 34. Additional view, facing West, of metal parts stored directly on the ground and without containment or overhead cover, as referenced in Photograph 33.

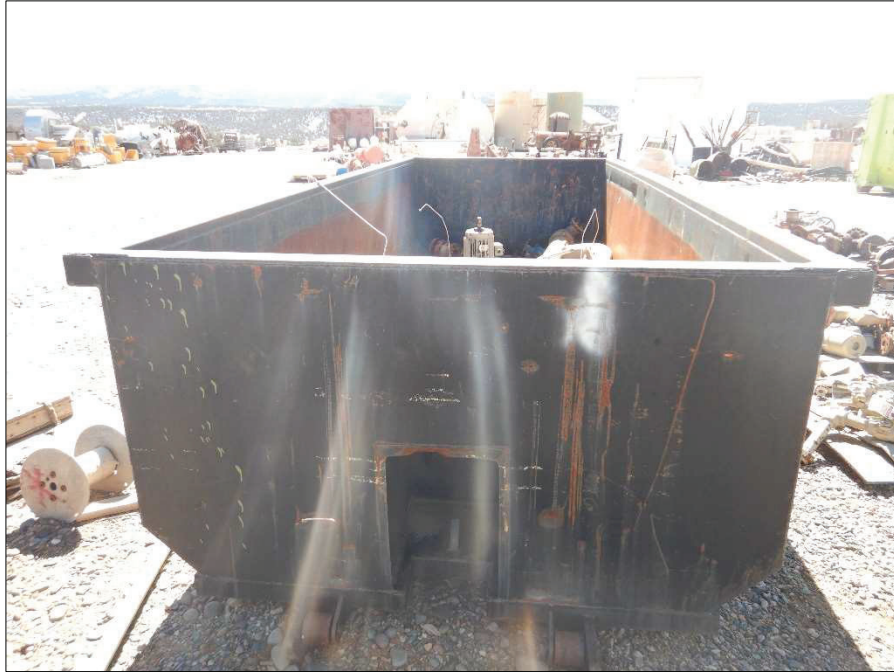
- d. An uncovered scrap metal dumpster in the boneyard (refer to Appendix A, Photographs 35 and 36). The Inspection Team observed liquid leaking from the dumpster (refer to Appendix A, Photograph 37).

Photograph 35. View, facing South, of an uncovered scrap metal dumpster in the Facility boneyard.

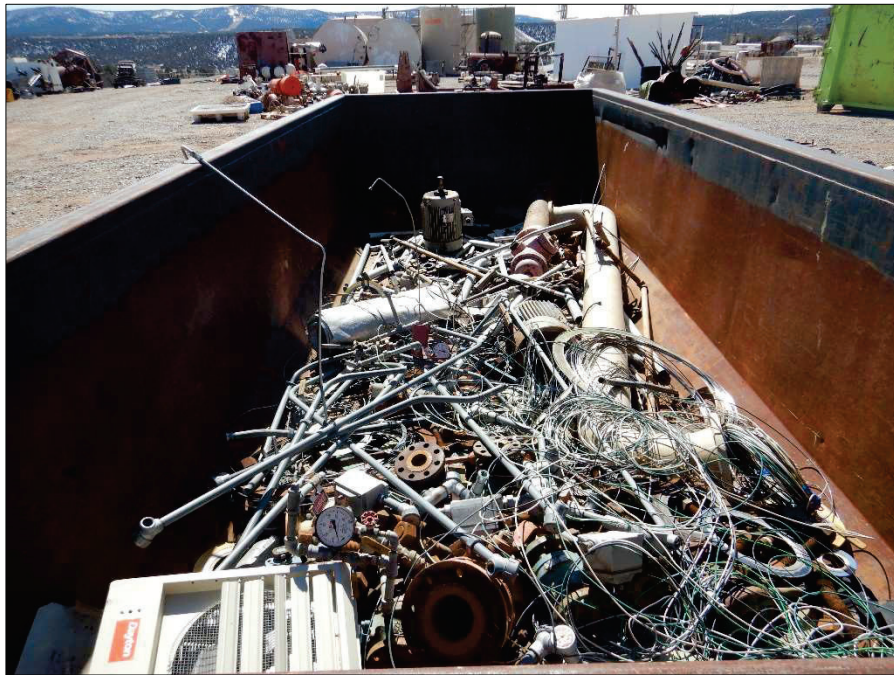
Photograph 36. View inside the uncovered scrap metal dumpster, as referenced in Photograph 35. Note dumpster is uncovered.

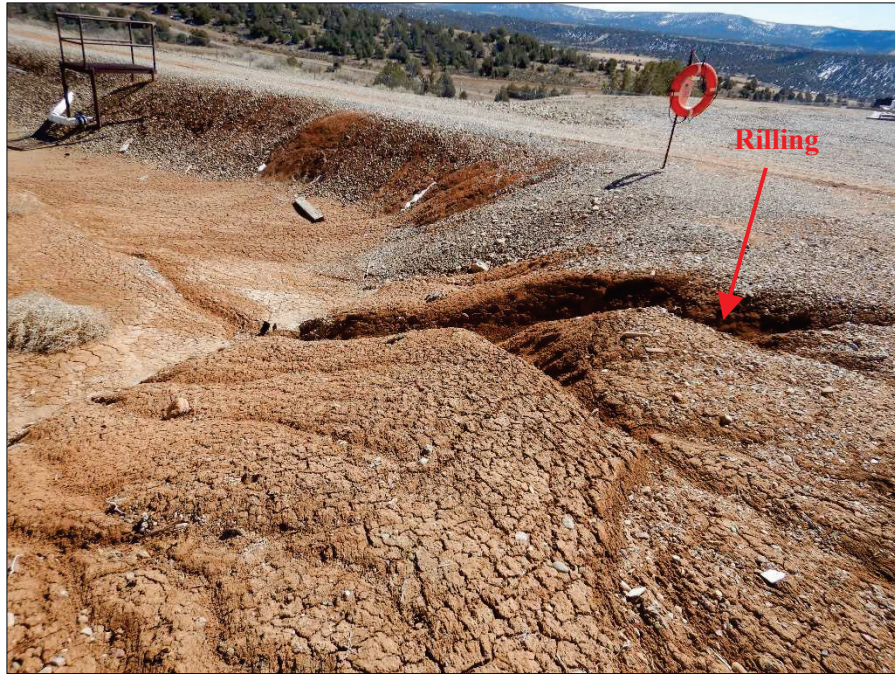
- c. The western bank of the decommissioned West Excess Pond (refer to Appendix A, Photographs 40, 41, and 42).
- d. The western bank of the ditch leading to Outfall IGP-011 from the culvert at the western end of the North Evaporation Stormwater Holding Pond (refer to Appendix A, Photograph 43).

Photograph 41. Additional view, facing Southeast, of West Excess Pond, as referenced in Photograph 40. Note rilling on the pond bank.

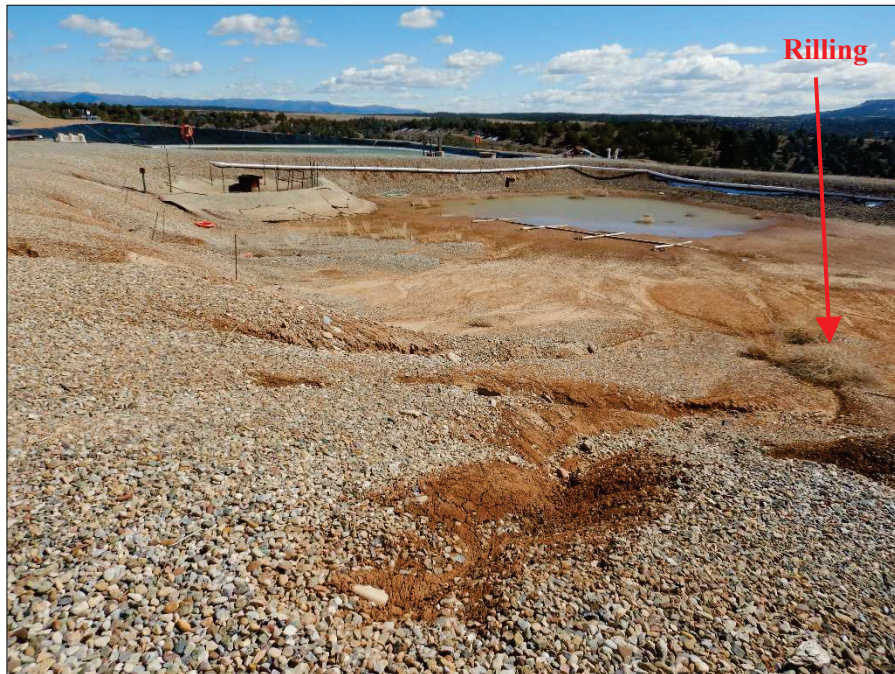
Photograph 42. Additional view, facing Southeast, of West Excess Pond, as referenced in Photographs 40 and 41. Note rilling on the pond bank.

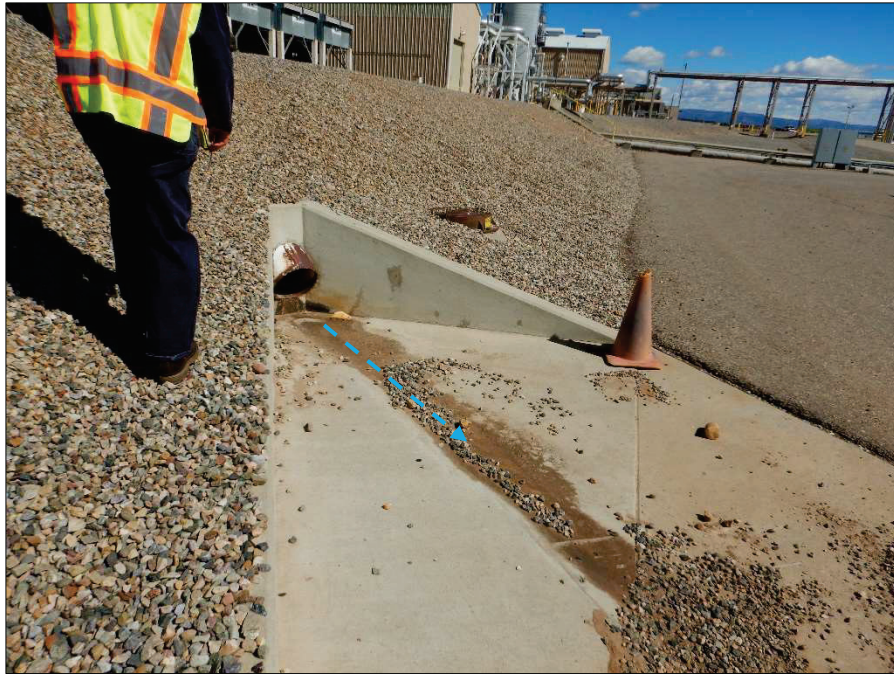
- i. In the North Evaporation Stormwater Holding Pond, as well as in the inlets, ditches, culverts and drainage channel that drain to and from of the pond (refer to Appendix A, Photographs 48 through 57).

Photograph 49. View, facing Northeast, of the outlet pipe from the inlet shown in Photograph 48. From here, flow continues across the facility parking lot toward the North Evaporation Stormwater Holding Pond. Note sediment and gravel accumulation.

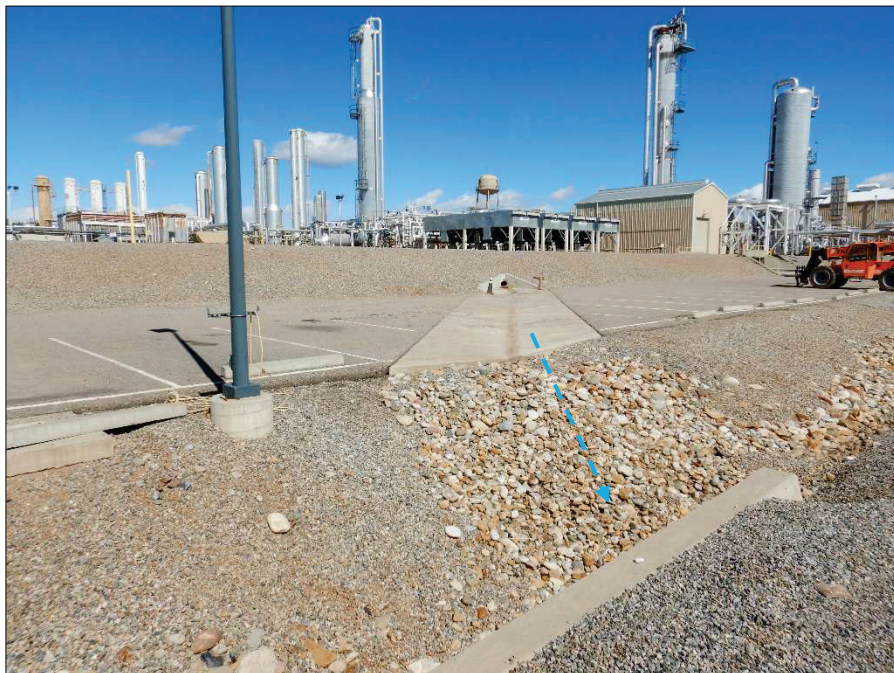
Photograph 50. View, facing Northeast, of ditch and inlet of culvert near parking lot connecting to the ditch leading to North Evaporation Stormwater Holding Pond.

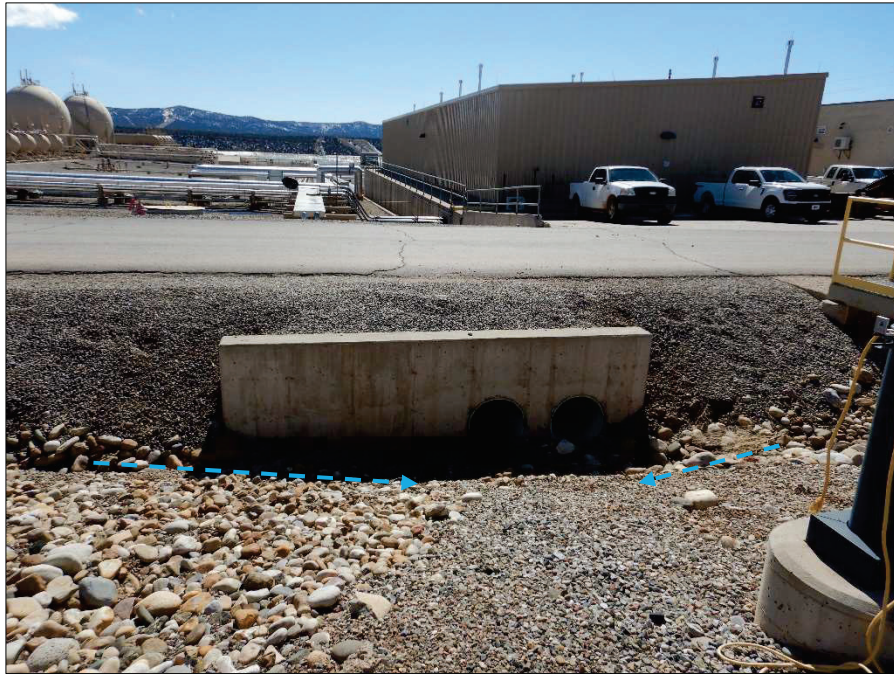
Photograph 51. Additional view, facing South, inlet of culvert and ditch near parking lot connecting to the ditch leading to North Evaporation Stormwater Holding Pond, as referenced in Photograph 50.

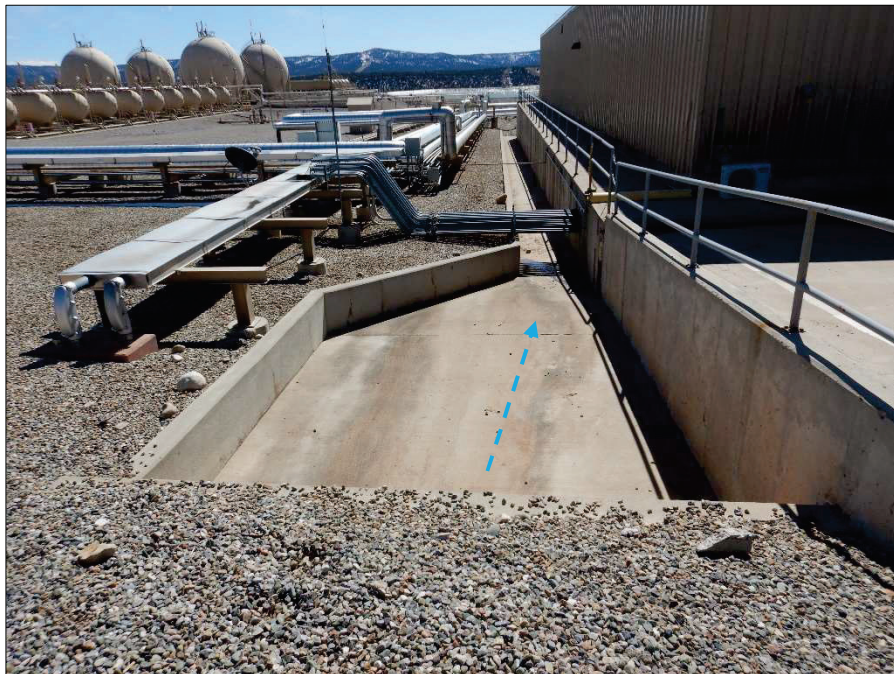
Photograph 52. Additional view, facing South, of a stormwater drainage channel connecting the locations shown in Photographs 48 through 51 to North Evaporation Stormwater Holding Pond.

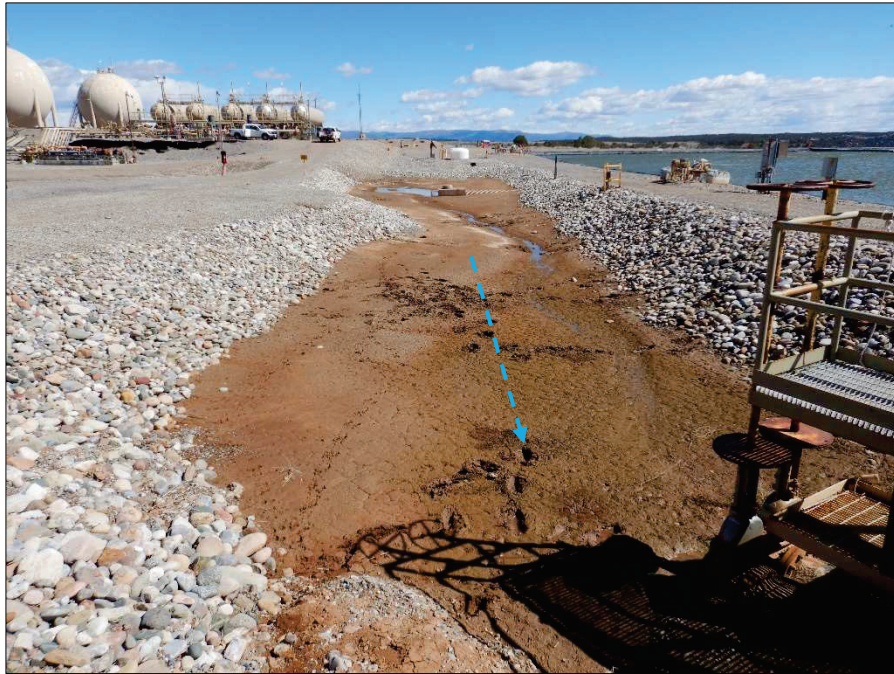
Photograph 53. View, facing East, of North Evaporation Stormwater Holding Pond. Note sediment accumulation in the pond.

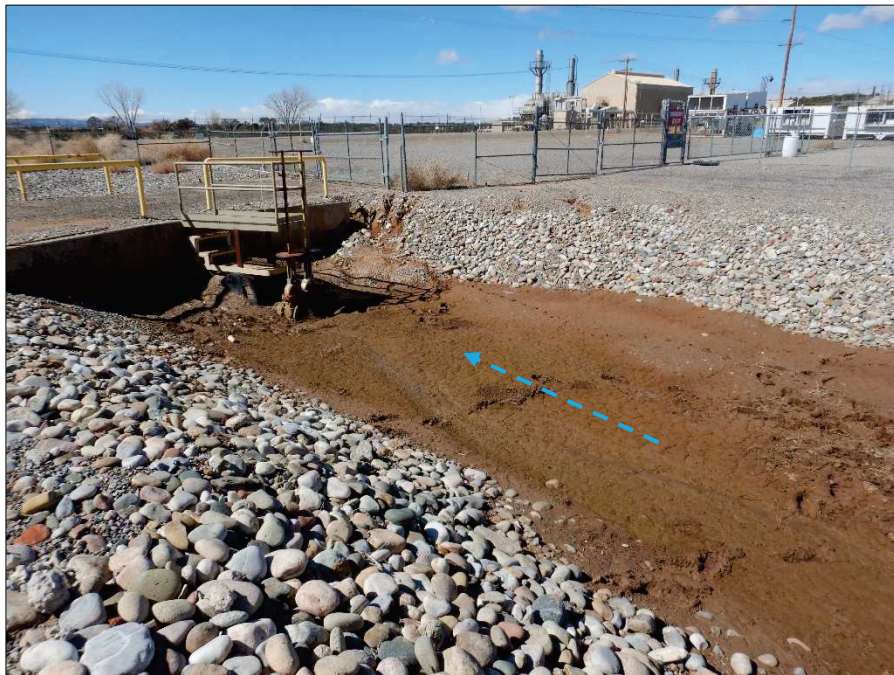
Photograph 54. Additional view, facing Northwest, of North Evaporation Stormwater Holding Pond, as referenced in Photograph 54. Note sediment accumulation in the pond.

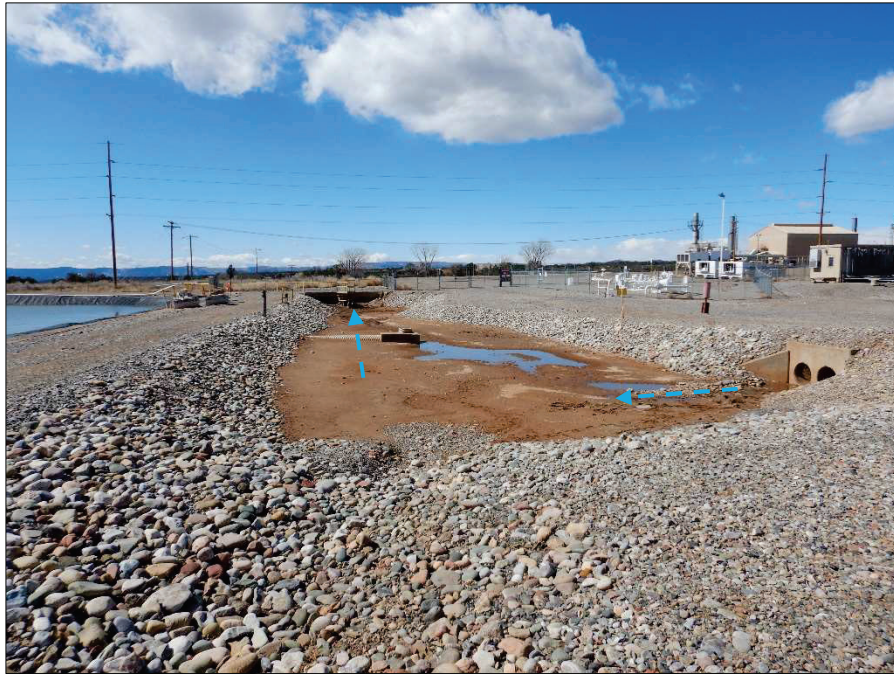
Photograph 55. Additional view, facing West, of North Evaporation Stormwater Holding Pond, as referenced in Photographs 53 and 54. Note sediment accumulation in the pond.

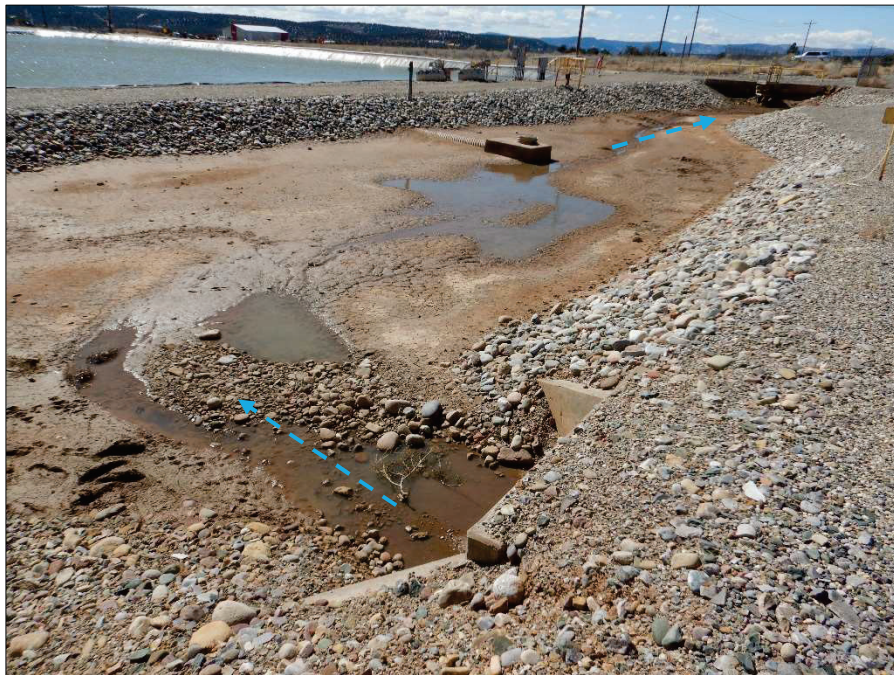
Photograph 56. Additional view, facing Southwest, of North Evaporation Stormwater Holding Pond, as referenced in Photographs 53 through 55. Note sediment accumulation in the pond.

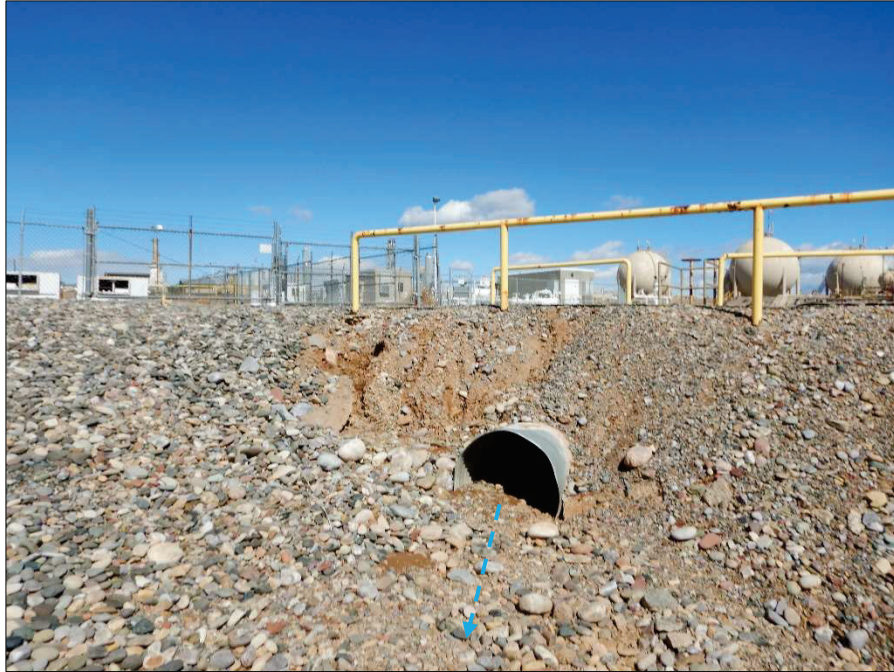
Photograph 57. View, facing Northeast, of the North Evaporation Stormwater Holding Pond discharge pipe. Note sediment and gravel accumulation in the pipe.

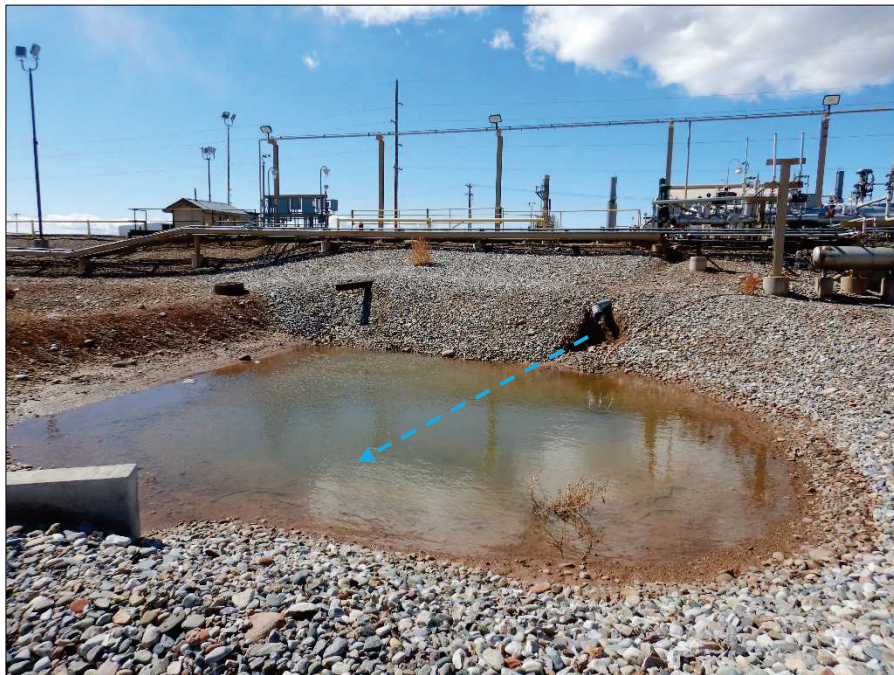
- j. In a stormwater holding pond that receives drainage from Drainage Area 7 and drains to North Evaporation Holding Pond (refer to Appendix A, Photographs 58 and 59).

Photograph 58. View, facing West, of a stormwater holding pond that receives drainage from Drainage Area 7 and drains to North Evaporation Holding Pond. Note sediment accumulation in the pond.
