# NPDES Stormwater Industrial and Construction Inspection Report

| National Database Information | |
|---|---|
| NPDES ID Number: <b>COR05I301</b> | Inspection ID: <b>202503_COR05I301</b> |
| Facility Type: <b>Gas Processing Plant</b> | Inspection Type: <b>Stormwater Industrial</b> |

| Facility Location Information | |
|---|---|
| Site/Facility and Location:<br><br><b>Ignacio Gas Plant<br/>3746 Country Road 307<br/>Durango, Colorado 81303<br/>La Plata County</b> | Mailing address:<br><br><b>Harvest Four Corners, LLC<br/>1755 Arroyo Dr,<br/>Bloomfield, New Mexico 87413</b> |

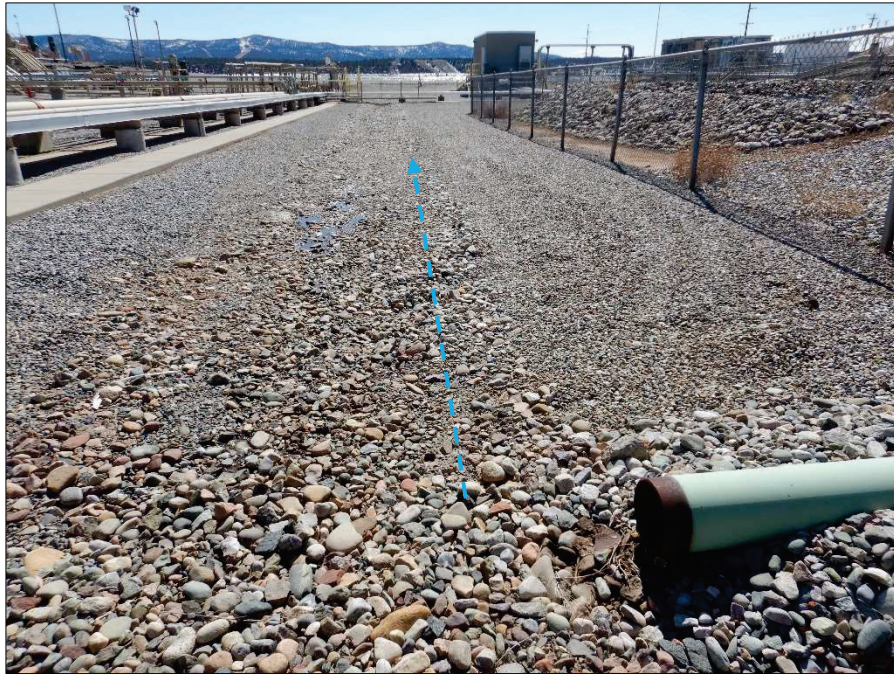
- j. In a stormwater holding pond that receives drainage from Drainage Area 7 and drains to North Evaporation Holding Pond (refer to Appendix A, Photographs 58 and 59).

Photograph 59. View, facing South, of culvert and ditch leading from the stormwater holding pond shown in Photograph 58 towards North Evaporation Stormwater Holding Pond.

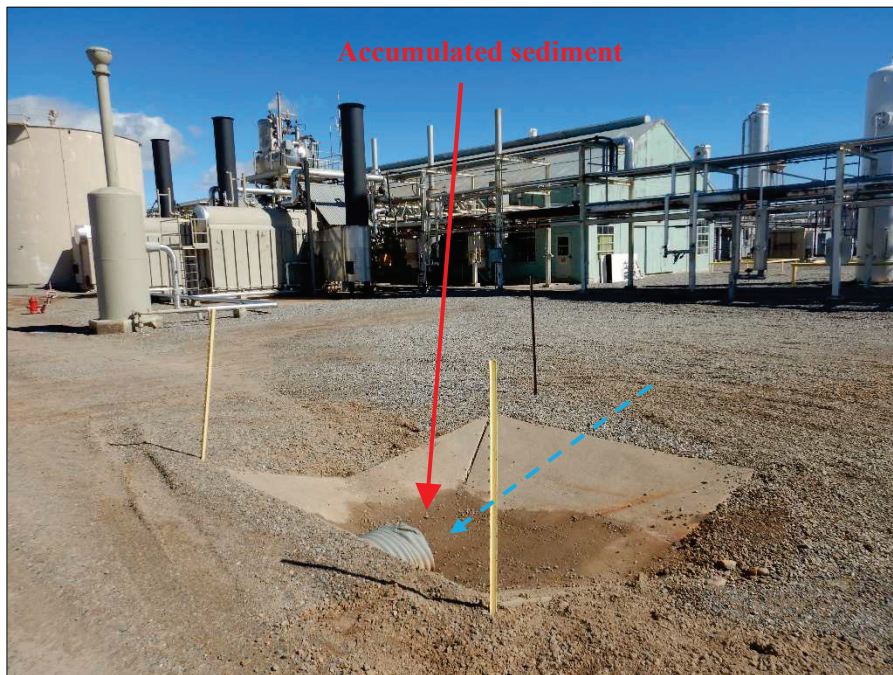
- k. In Gosney Pond, as well as in the culverts and ditches that convey stormwater both into and from Gosney Pond (refer to Appendix A, Photographs 60 through 69).

Photograph 60. View, facing Northeast, of inlet of a culvert connecting Drainage Area 1 to Gosney Pond. Note sediment accumulation.

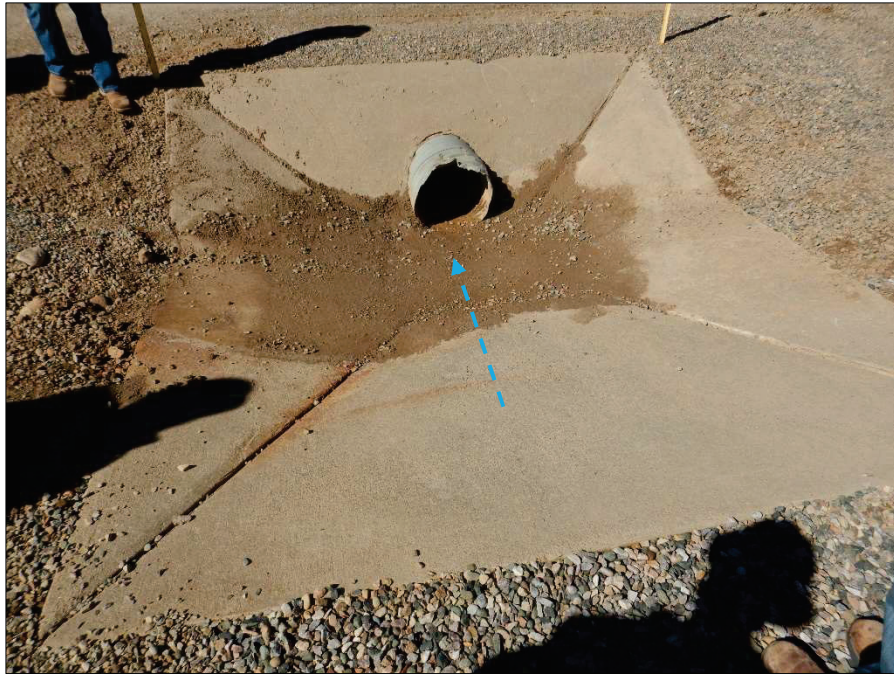
Photograph 61. Close-up view, facing West, of inlet of culvert connecting Drainage Area 1 to Gosney Pond, as referenced in Photograph 60. Note sediment accumulation.

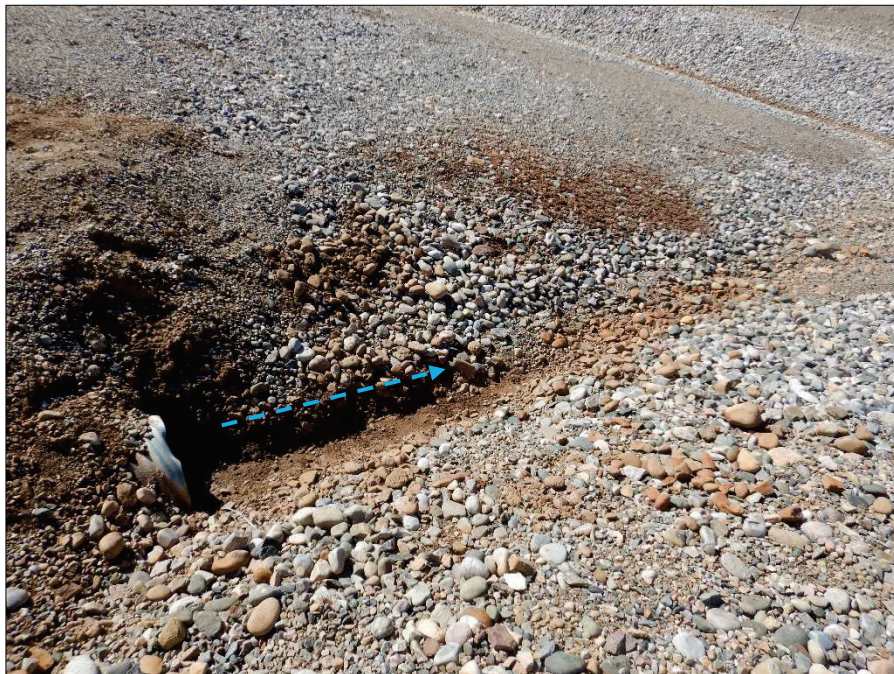
Photograph 62. View, facing Southwest, of the outlet of the culvert connecting Drainage Area 1 to Gosney Pond, as referenced in Photographs 60 and 61.

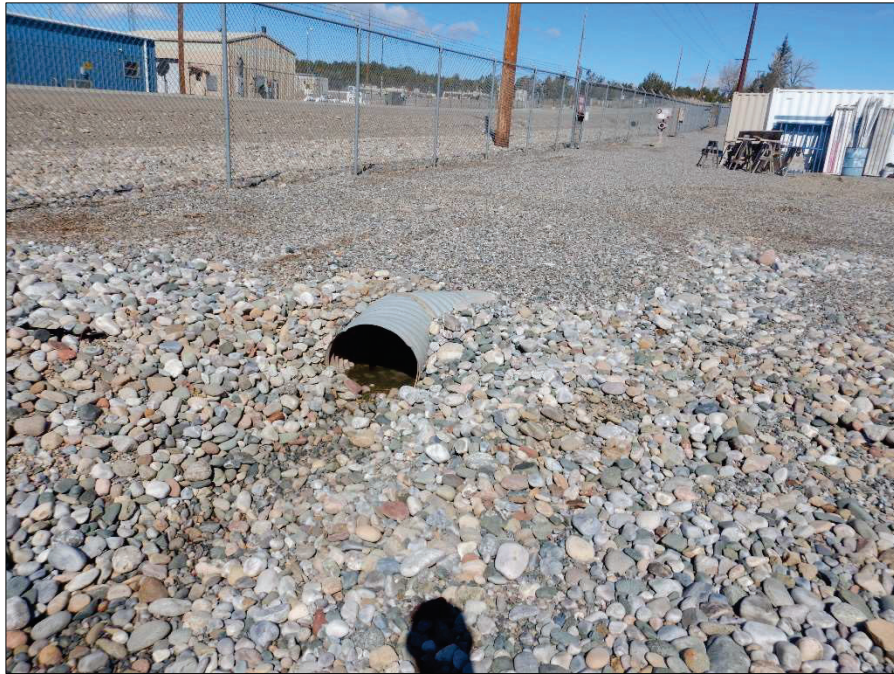
Photograph 63. View, facing North, of the outlet of a culvert connecting to Gosney Pond.

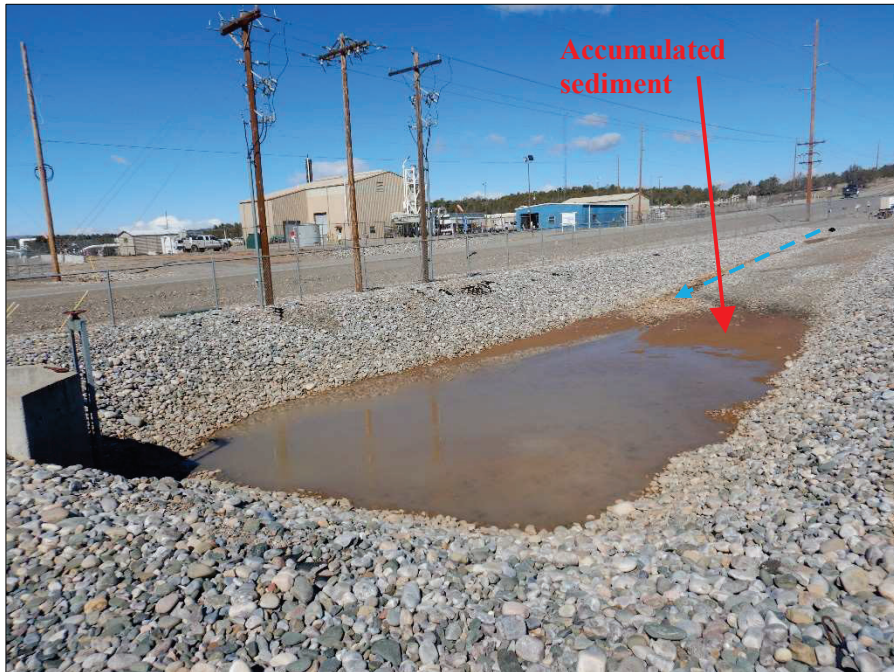
Photograph 64. View, facing Northwest, of Gosney Pond. Note accumulated sediment in the pond.

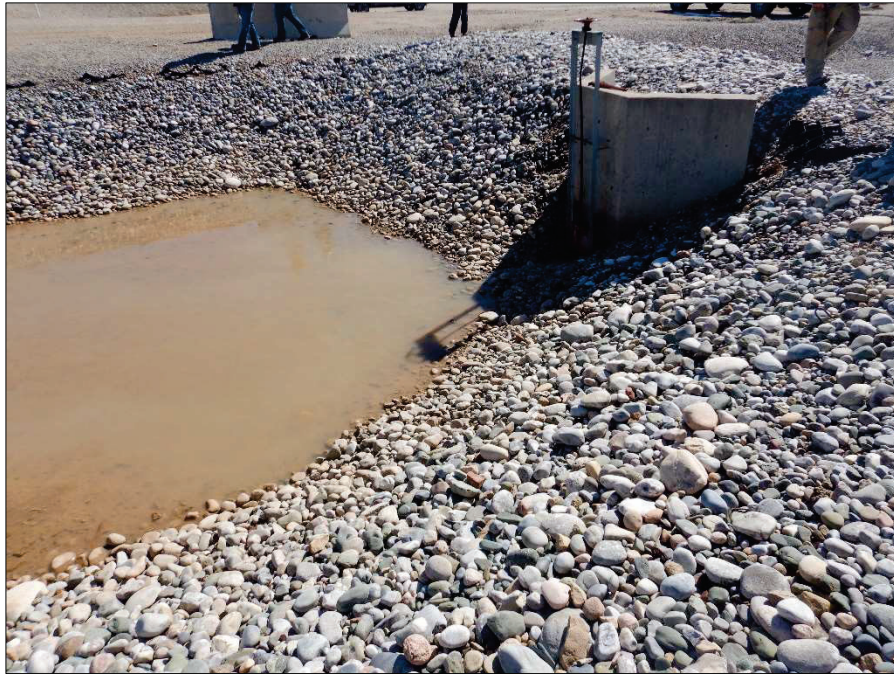
Photograph 65. Close-up view, facing Southeast, of Gosney Pond including outlet structure, as referenced in Photograph 64.

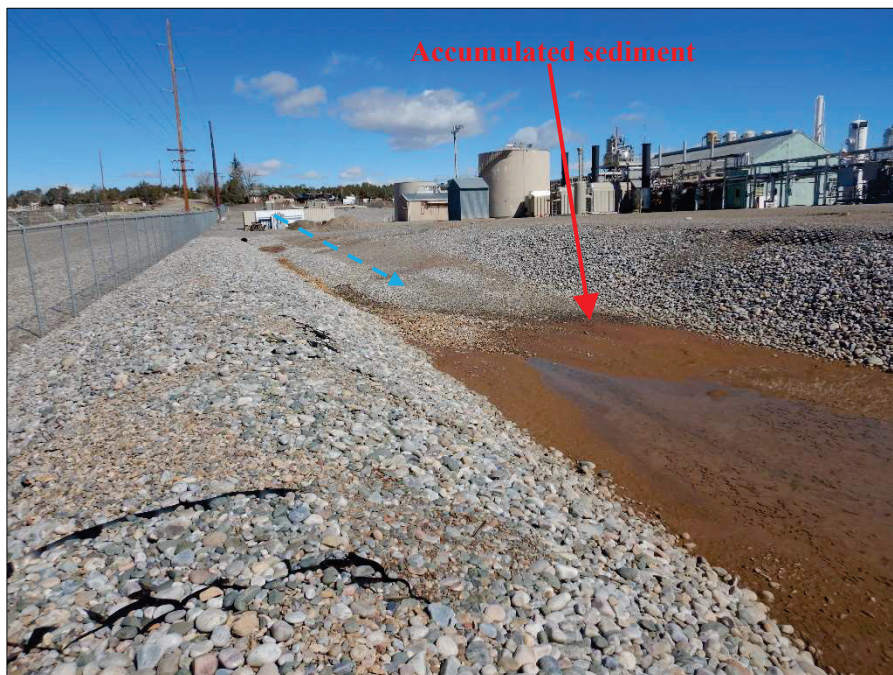
Photograph 66. Additional view, facing North, of inlet to Gosney Pond, as referenced in Photographs 64 and 65. Note accumulated sediment in the pond.

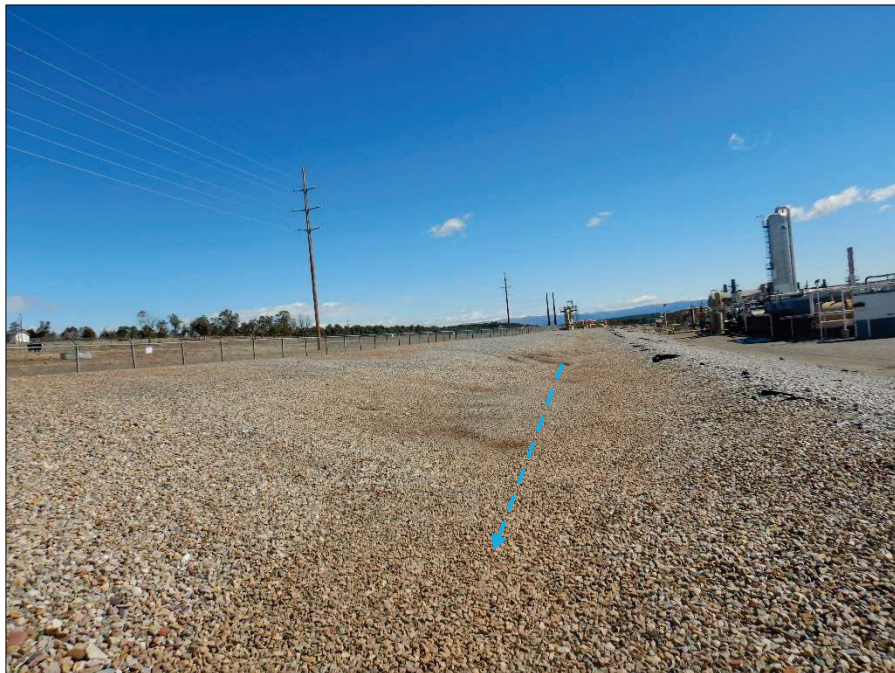
Photograph 70. View, facing East, of ditch along northern fence line of Facility that drains to Outfall IGP-001.

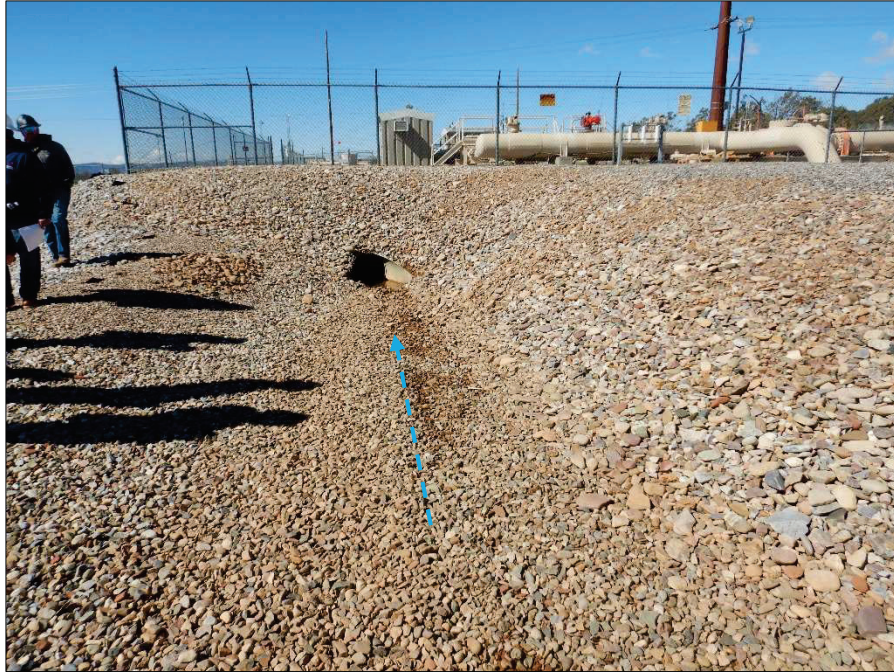
Photograph 71. View, facing West, of inlet of culvert in Drainage Area 1 leading to Outfall IGP-001.

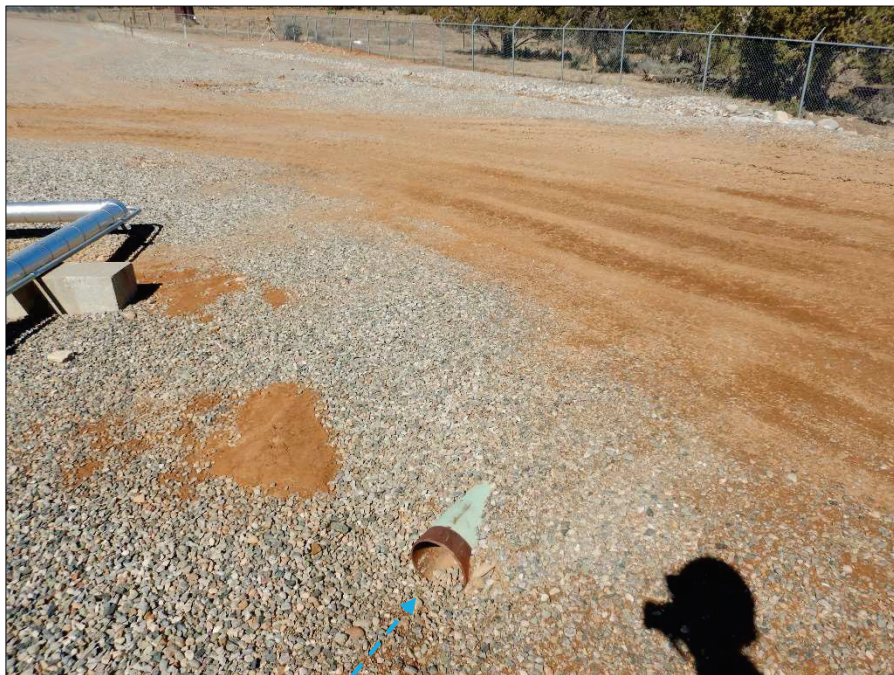
- p. In two culverts in Drainage Area 15 that ultimately drain to Outfall IGP-003 (refer to Appendix A, Photographs 83 through 87).
- q. Immediately upgradient from Outfall IGP-004 (refer to Appendix A, Photographs 88, 89, and 90).

Photograph 84. View, facing Northwest, of the inlet to culvert in Drainage Area 15, which ultimately drains to Outfall IGP-003. Note accumulated sediment and gravel at the mouth of the pipe.

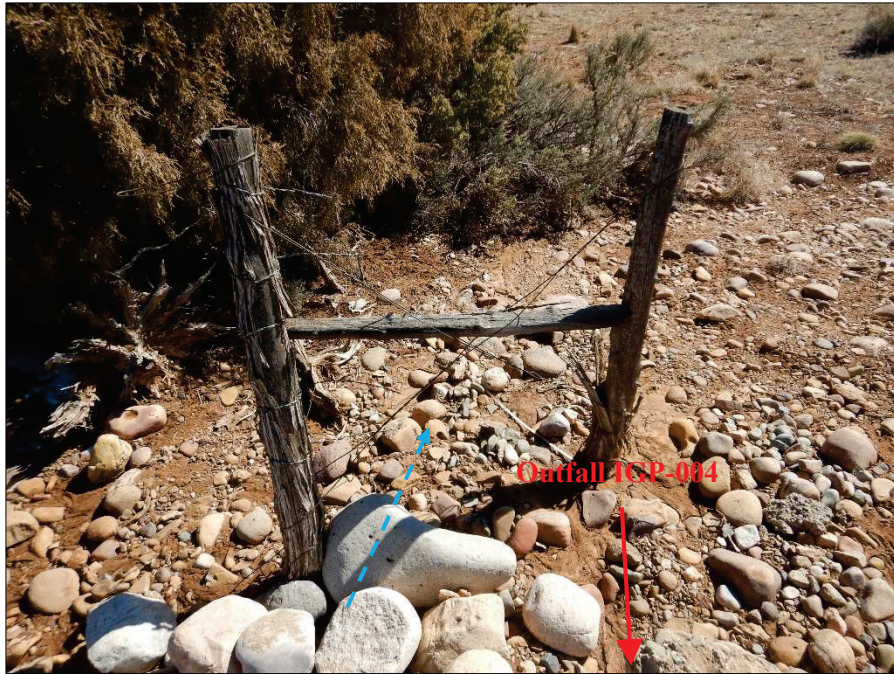
Photograph 89. Additional view, facing East, outside the fence line of Outfall IGP-004, as referenced in Photograph 88.

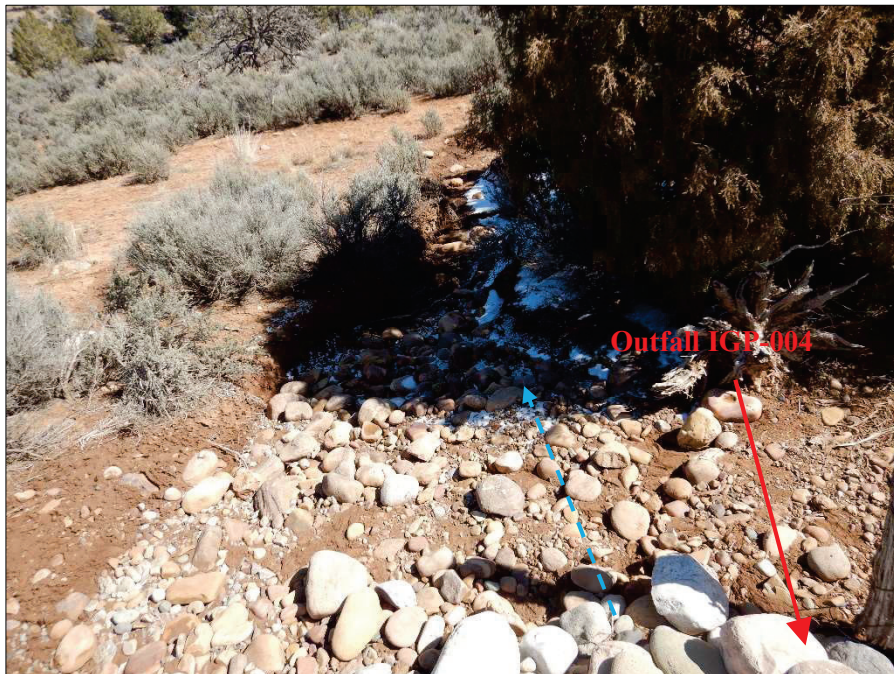
Photograph 90. Additional view, facing East, outside of the fence line of Outfall IGP-004, as referenced in Photograph 88 and 89.

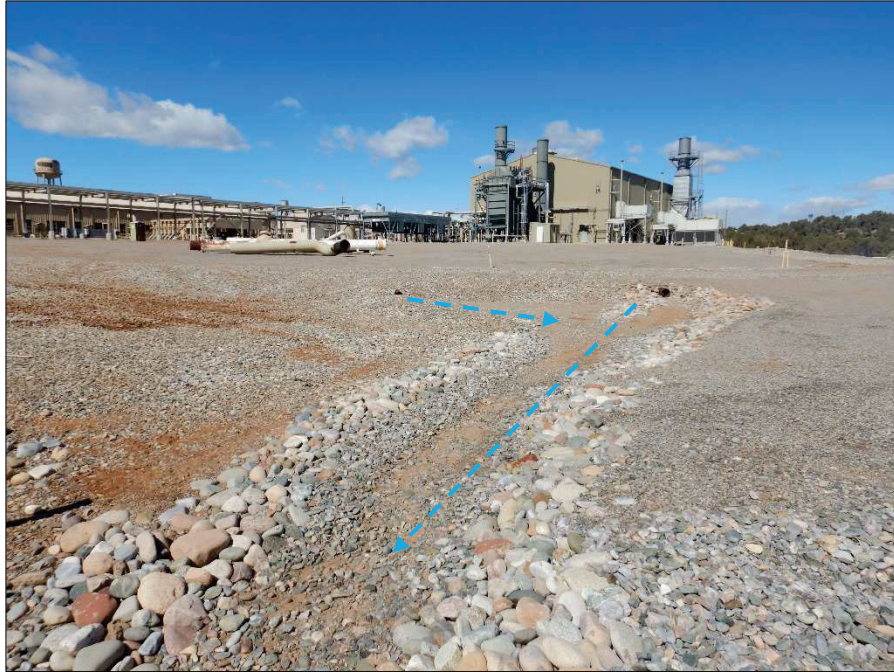
Photograph 91. View, facing Northwest, of a drainage ditch leading to Outfall IGP-006.

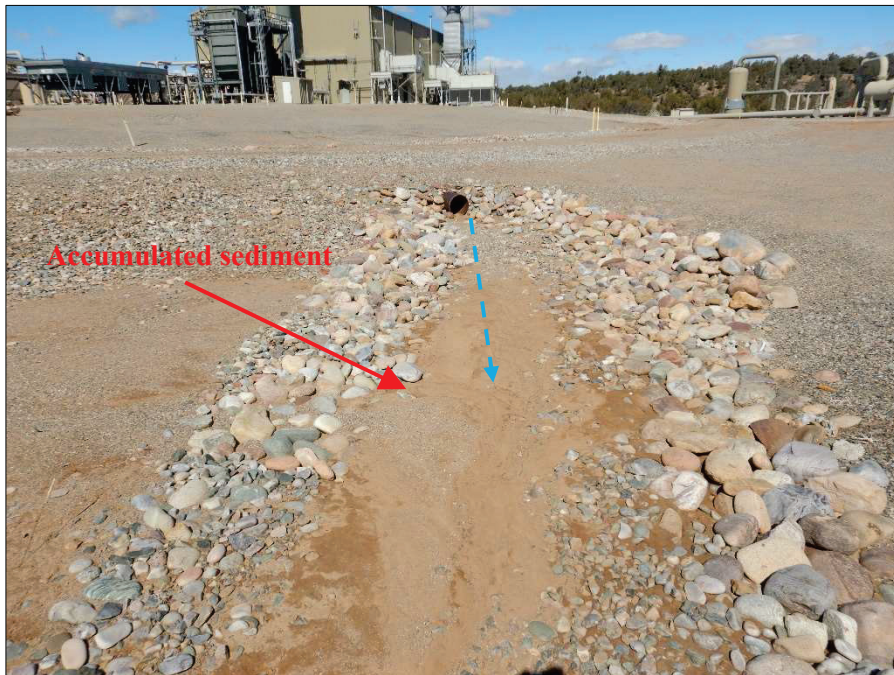
Photograph 92. Close-up view, facing northwest, of the drainage ditch leading to Outfall IGP-006, as referenced in Photograph 91.

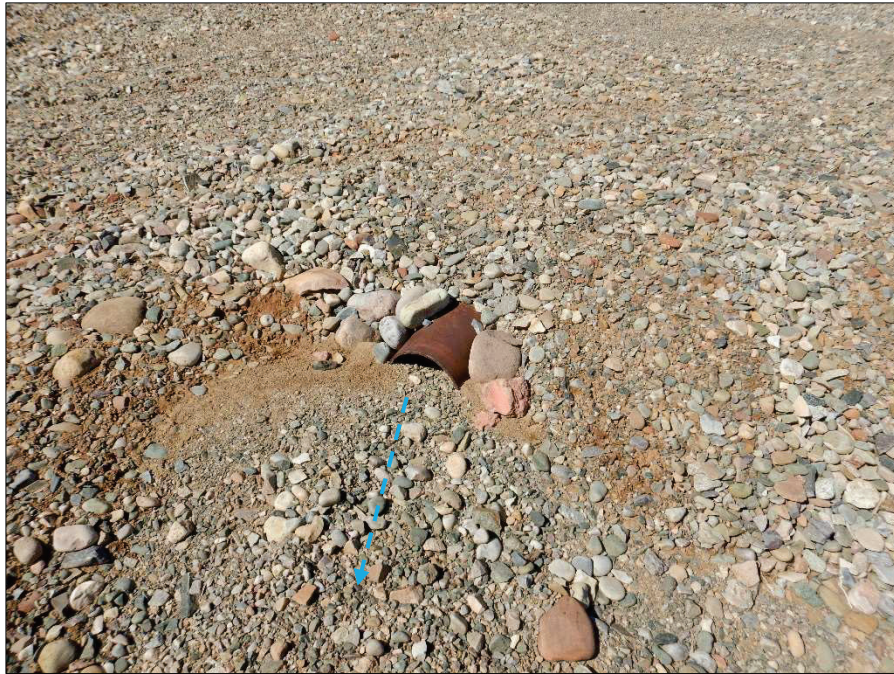
Photograph 93. Close-up view, facing Southeast, of the outlet of a culvert that discharges into the ditch leading to Outfall IGP-006, as referenced in Photographs 91 and 92. Note accumulated sediment and gravel obstructing the culvert outlet pipe.

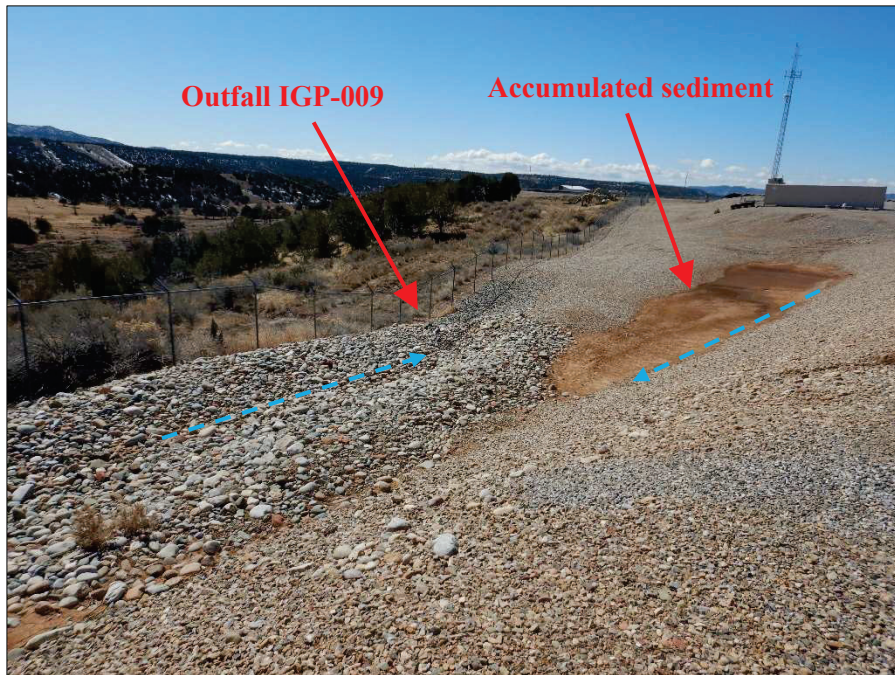
Photograph 97. View, facing Southwest, of Outfall IGP-009. Note accumulated sediment.

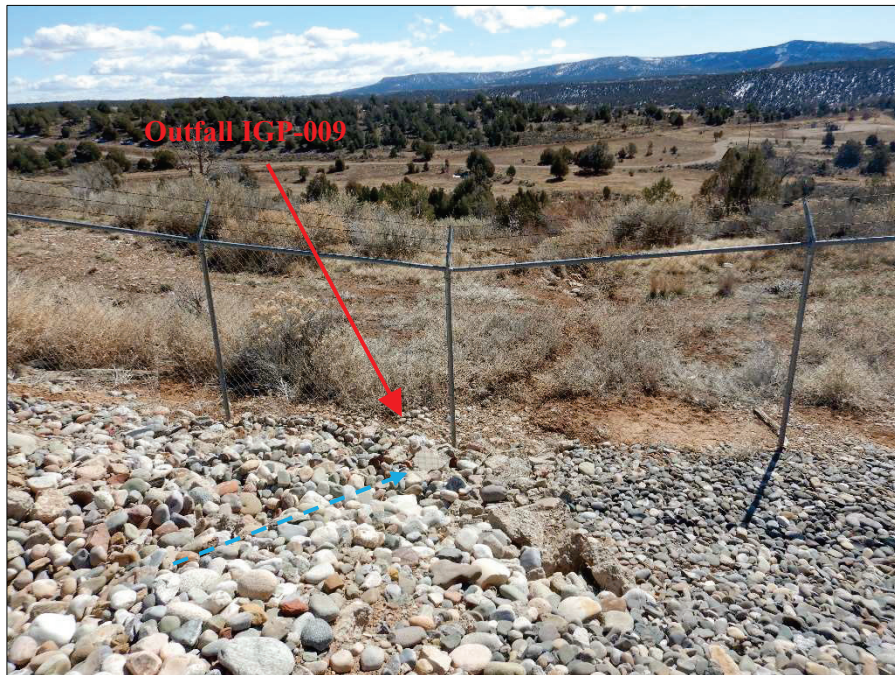
Photograph 98. Additional view, facing South, of Outfall IGP-009, as referenced in Photograph 97.

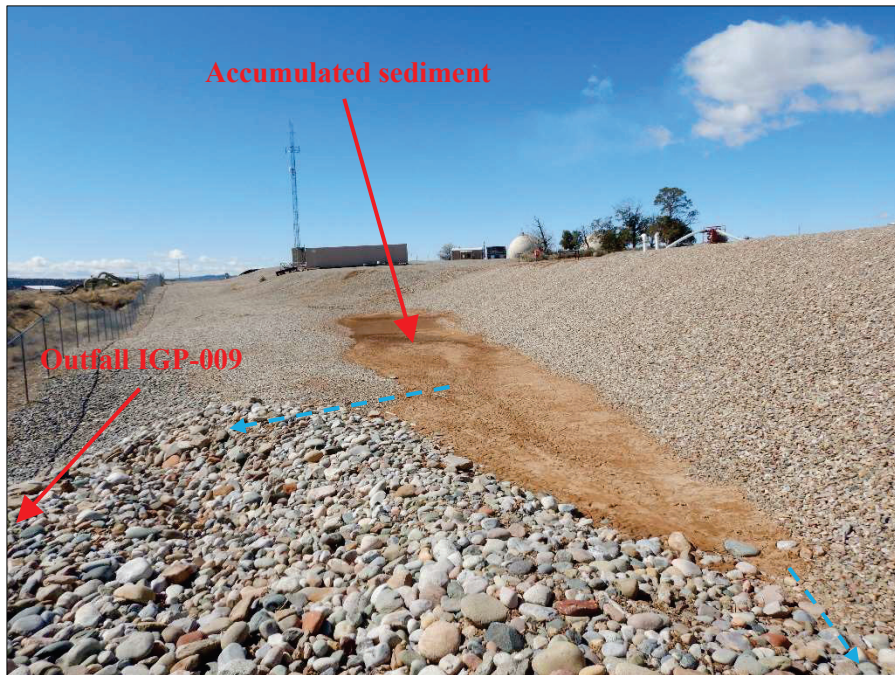
Photograph 99. Additional view, facing Southwest, of sediment accumulation near Outfall IGP-009, as referenced in Photographs 97 and 98.

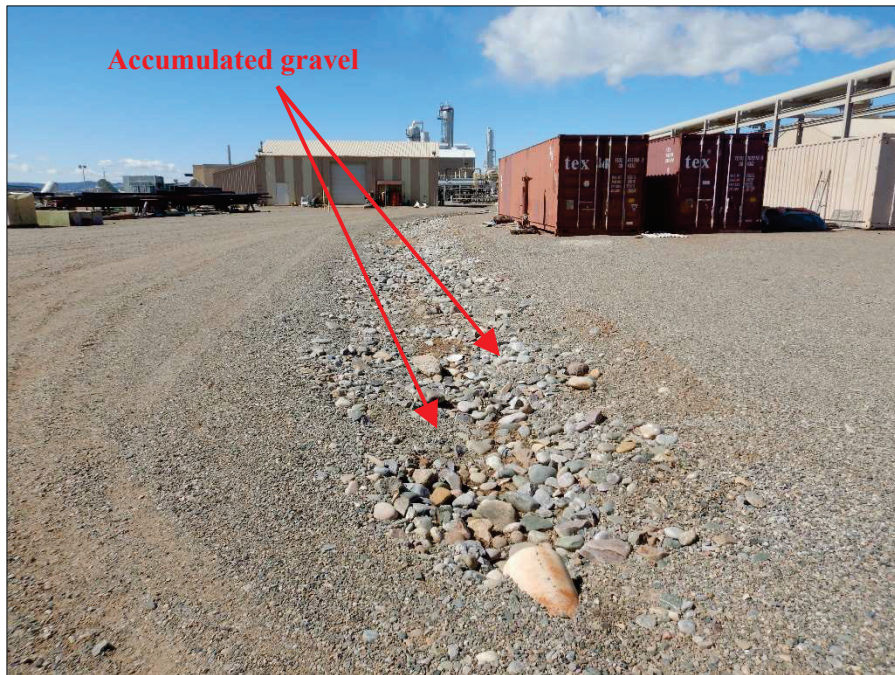
Photograph 101. View, facing West, of inlet of culvert into the Facility boneyard. Note accumulated gravel in the ditch upgradient from the culvert.

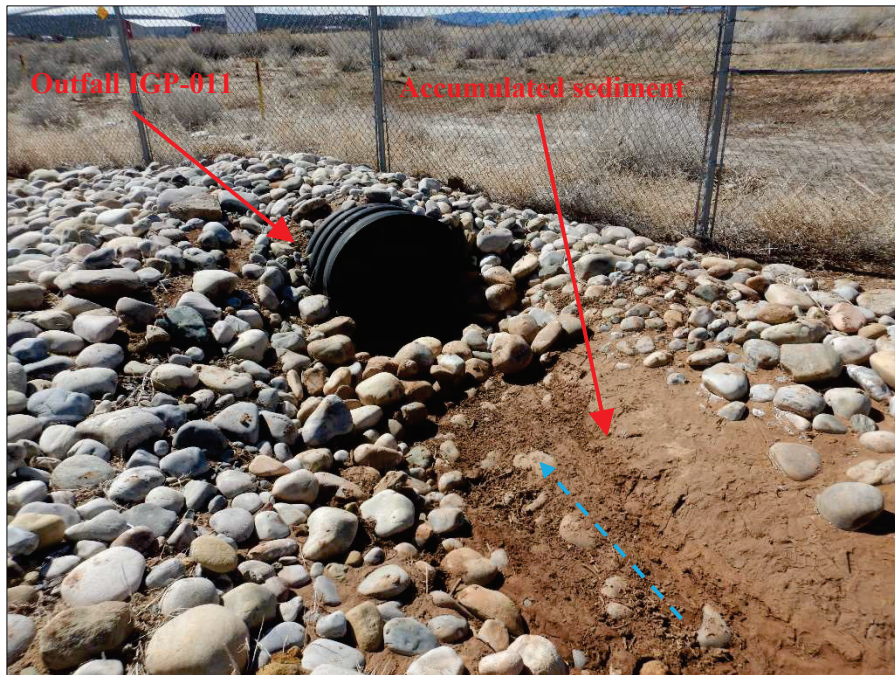
Photograph 103. Close-up view, facing Southwest, of Outfall IGP-011, as referenced in Photograph 102. Note sediment accumulation.

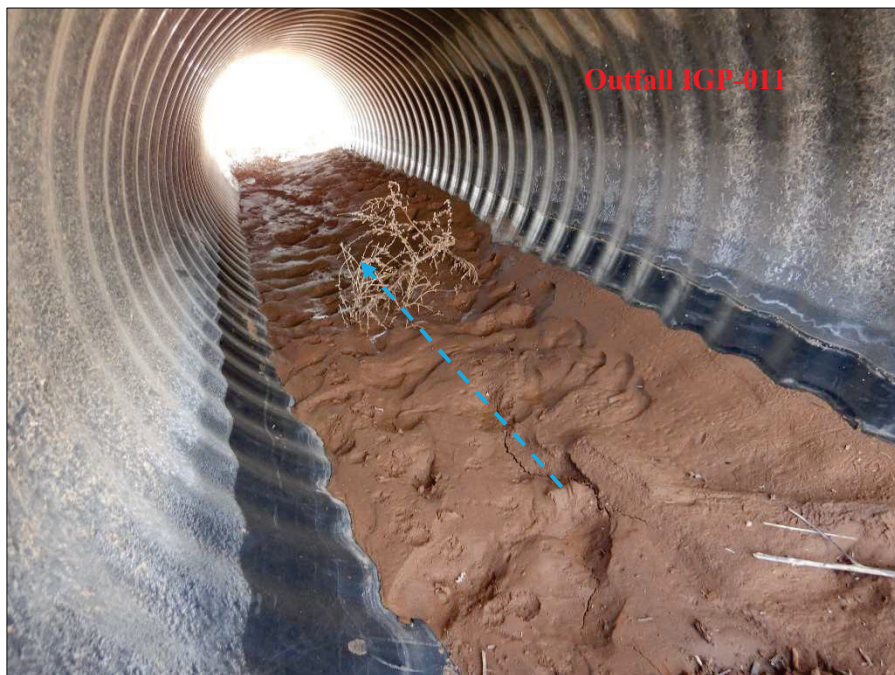
Photograph 104. Additional view, facing Southwest, of the inside of Outfall IGP-011, as referenced in Photographs 101 and 102. Note sediment accumulation.

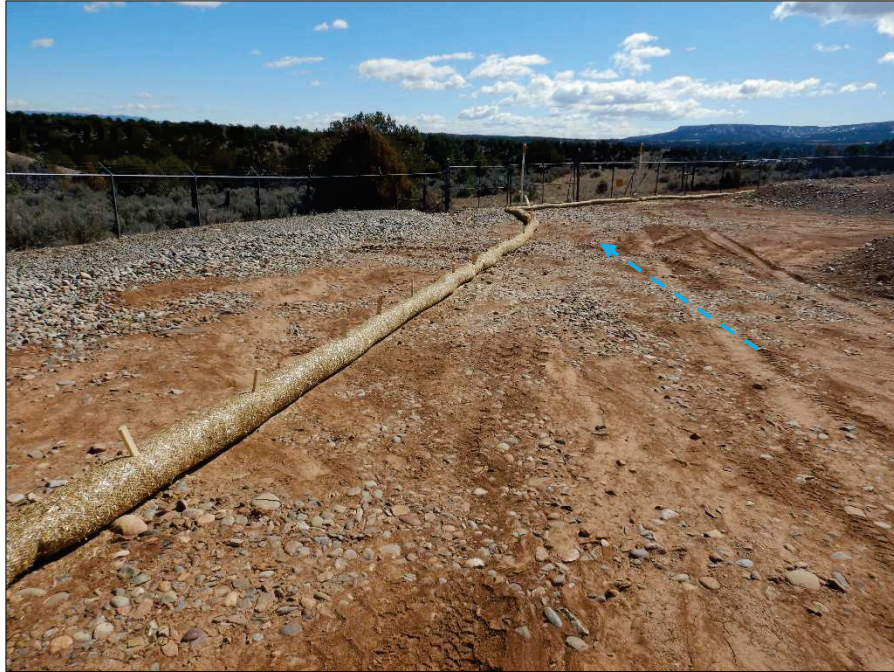
Photograph 107. View, facing Southeast, of new straw wattles near Outfall IGP-004.

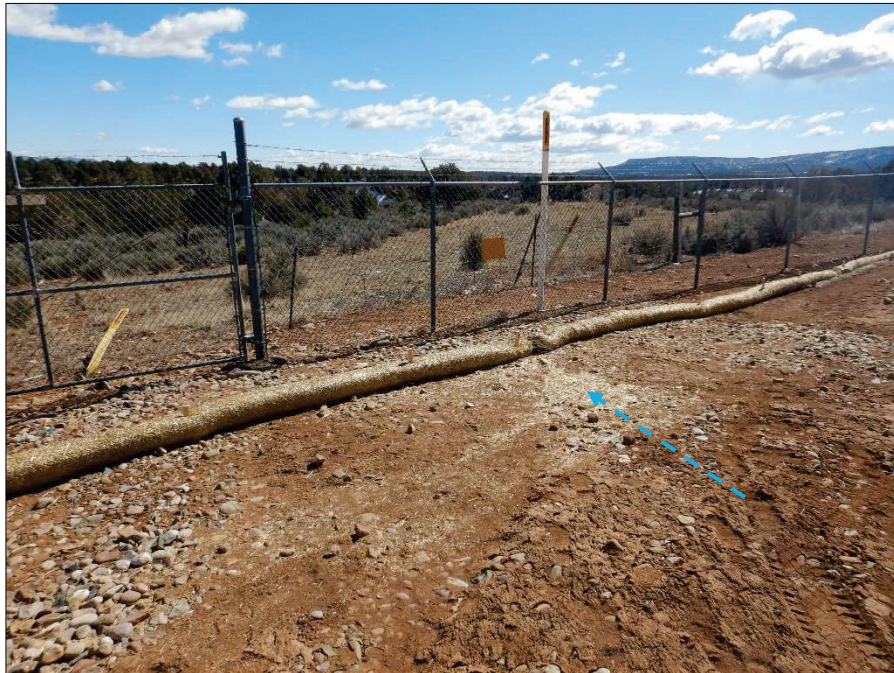
Photograph 108. Additional view, facing Southeast, of new straw wattles near Outfall IGP-004, as referenced in Photograph 107.

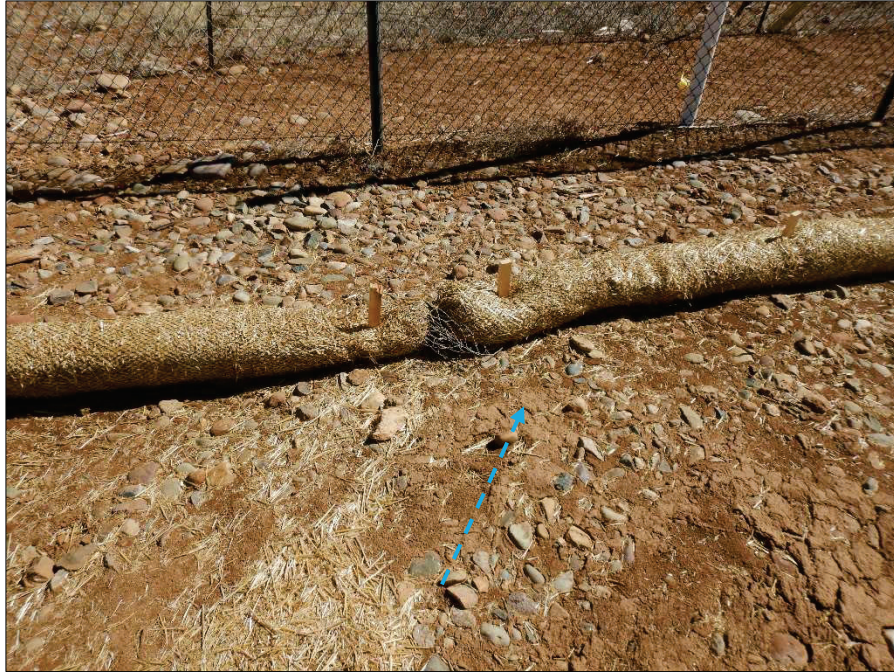
Photograph 109. Additional view, facing East, of new straw wattles near Outfall IGP-004, as referenced in Photograph 108. Note straw wattle segments are not overlapping, creating gaps.

In accordance with Part 2.1.2.3.a of the permit, ensure that all stormwater control measure maintenance needs are identified through inspections and maintenance is conducted as needed to keep control measures in effective operating condition. Provide the EPA with a written narrative description and photographs of the corrective actions to address this finding.

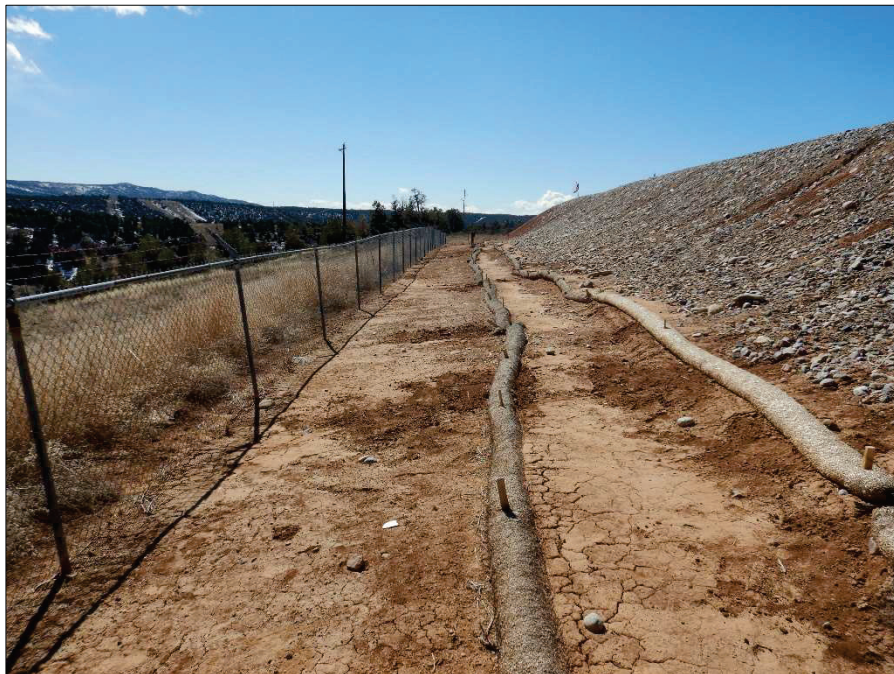
- a. Catch basins containing sediment and rocks above outlet pipes (refer to Appendix A, Photographs 75 through 82). No control measures were implemented to minimize material entering the catch basin inlets.
- b. Straw wattles that were deteriorated and/or had sediment accumulated against them (refer to Appendix A, Photographs 105 and 106). Additionally, wattles installed around the Soil Drying Containment area in the northwest area of the Facility appeared to have been recently installed, but there were gaps between some consecutive segments creating potential for sediment to leave the site (refer to Appendix A, Photographs 107, 108, and 109).
- c. Sediment accumulated against a straw wattle that had been installed along the southeastern fence line of Drainage Area 14, next to the South Evaporation Pond (refer to Appendix A, Photographs 110 and 111).

Photograph 110. View, facing Southwest, of straw wattles along the southeastern side of South Evaporation Pond. Note sediment accumulation against the wattles.

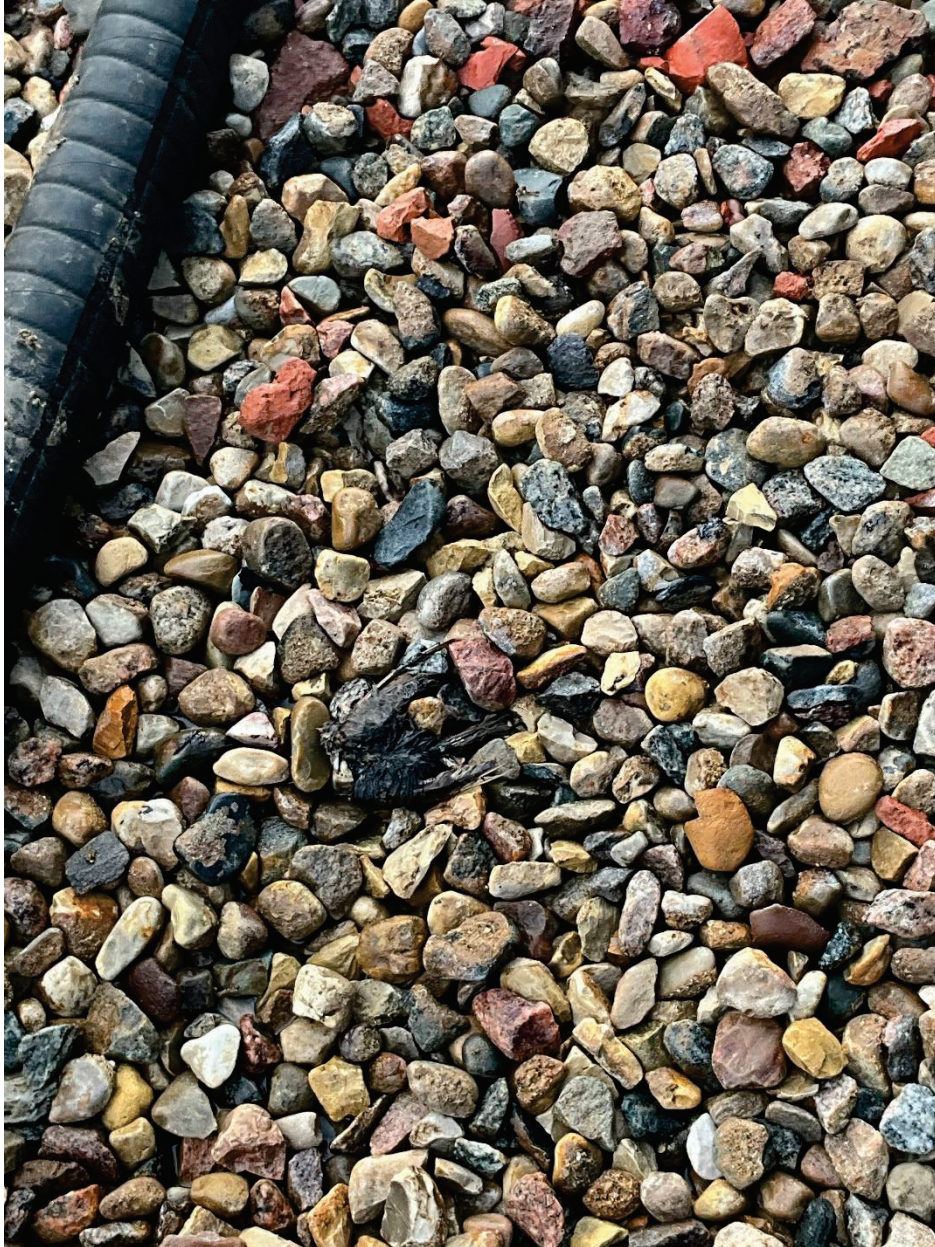
A few feet north side of the shaker bin, I observed a deceased bird that appeared to be covered in oil. See Attachment 2, photo 10. It was unclear whether oil in the nearby shaker bin (see Attachment 2, photo 14) had caused the mortality. Mr. Rykhus said that facility SOPs say to remove any liquids in the bins by transferring them to the tanks, and that the bins should not store any liquids.

A deceased bird at the site at the time of the inspection with an oily appearance on its feathers indicates that oily waste management practices at the facility presents a potential for harm to wildlife. A source of liquid, oily waste that was not physically restricted from wildlife access was the shaker bin, which held oily liquid in its northern section near where the bird was found.

Photo 10: IMG\_0284.jpg, 9/18/2024, 8:36 a.m. – photo of deceased bird that appeared to be covered in oil. Photo location is a few feet north of the solids settling bay.

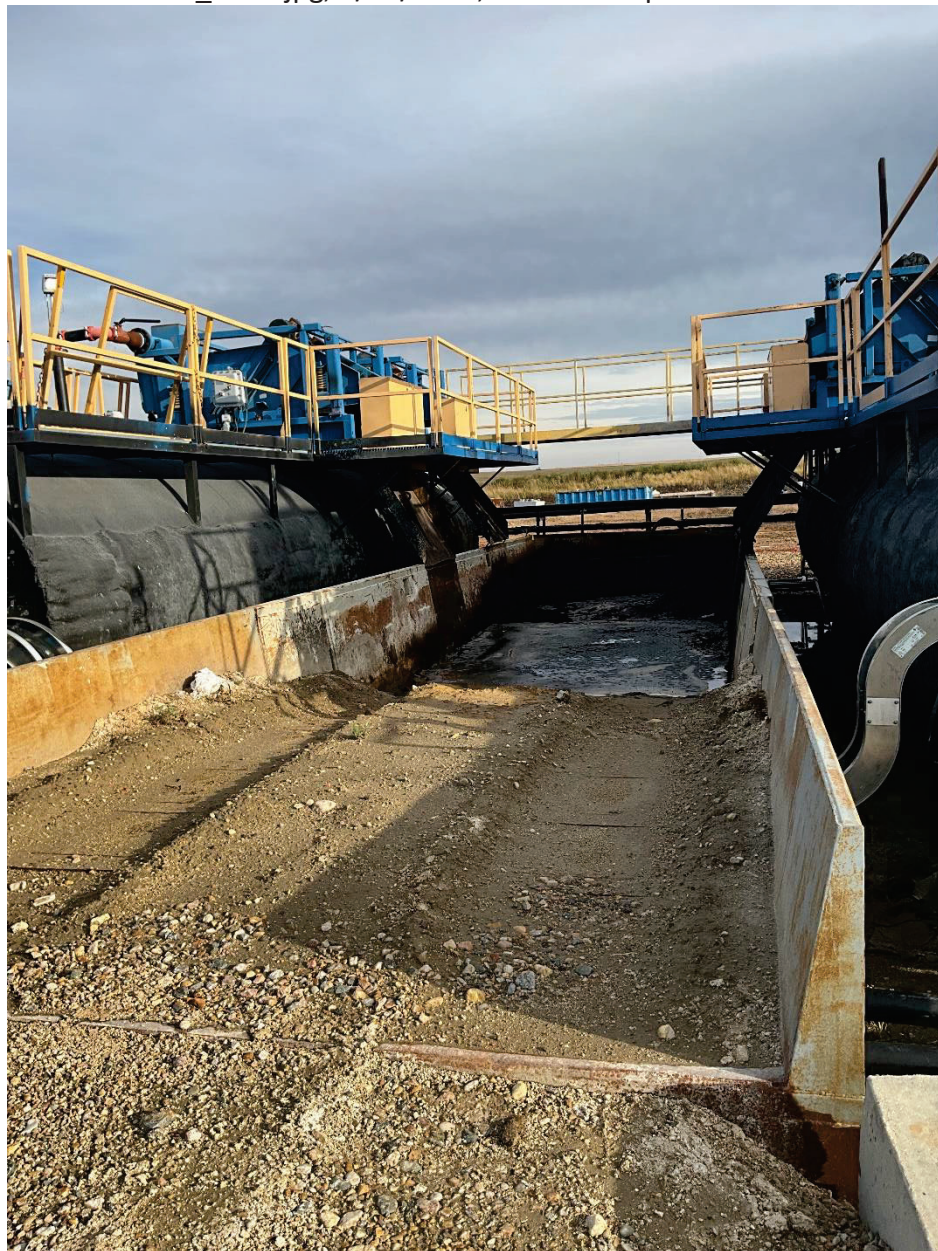
Photo 14: IMG\_0288.jpg, 9/18/2024, 9:24 a.m. – photo of the shaker bin.
