**UNITED STATES ENVIRONMENTAL PROTECTION AGENCY  
REGION 5  
77 WEST JACKSON BOULEVARD  
CHICAGO, ILLINOIS 60604**

**SUBJECT:** CLEAN AIR ACT INSPECTION REPORT  
Fairborn Cement Company, Xenia, Ohio

**Dates of Inspection:** August 23 and 24, 2022

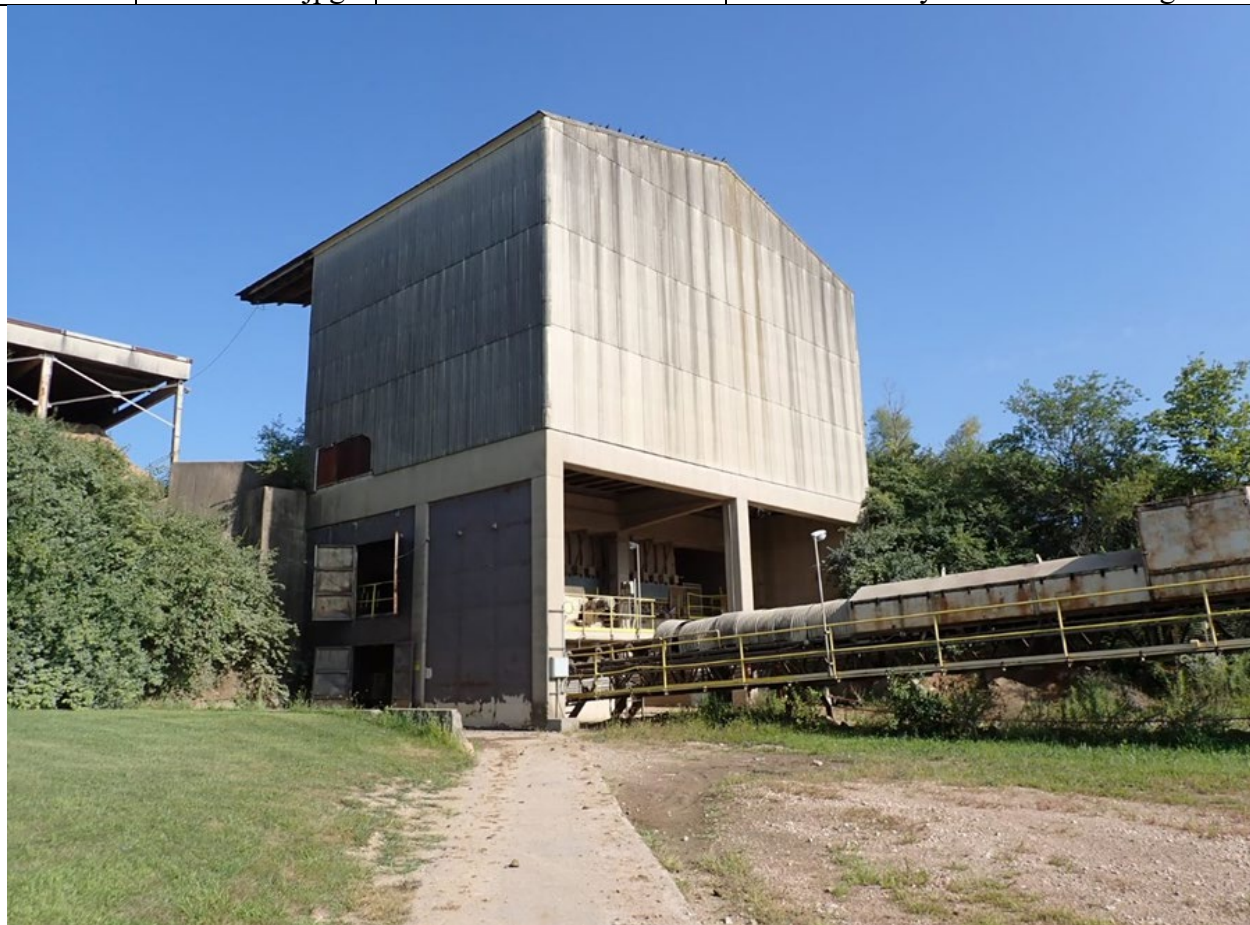
| <b>Image Number</b> | <b>File Name</b> | <b>Date and Time (incl. Time zone and DST)</b> | <b>Description of Image</b> |
|---|---|---|---|
| 2 | P8230006.jpg | 2022:08:23 08:01:55 | Clay Additive Building |

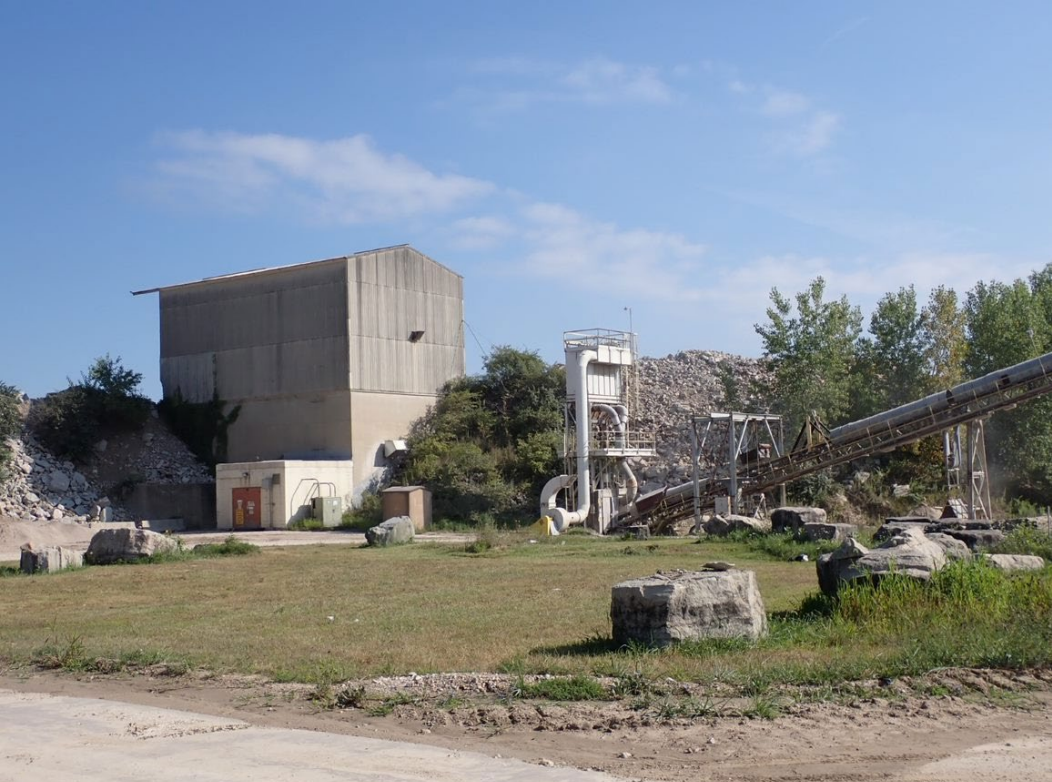
| Image Number | File Name | Date and Time (incl. Time zone and DST) | Description of Image |
|---|---|---|---|
| 4 | P8230008.jpg | 2022:08:23 08:05:59 | Limestone Crusher Adjacent to Beginning of Lime Conveyor System |

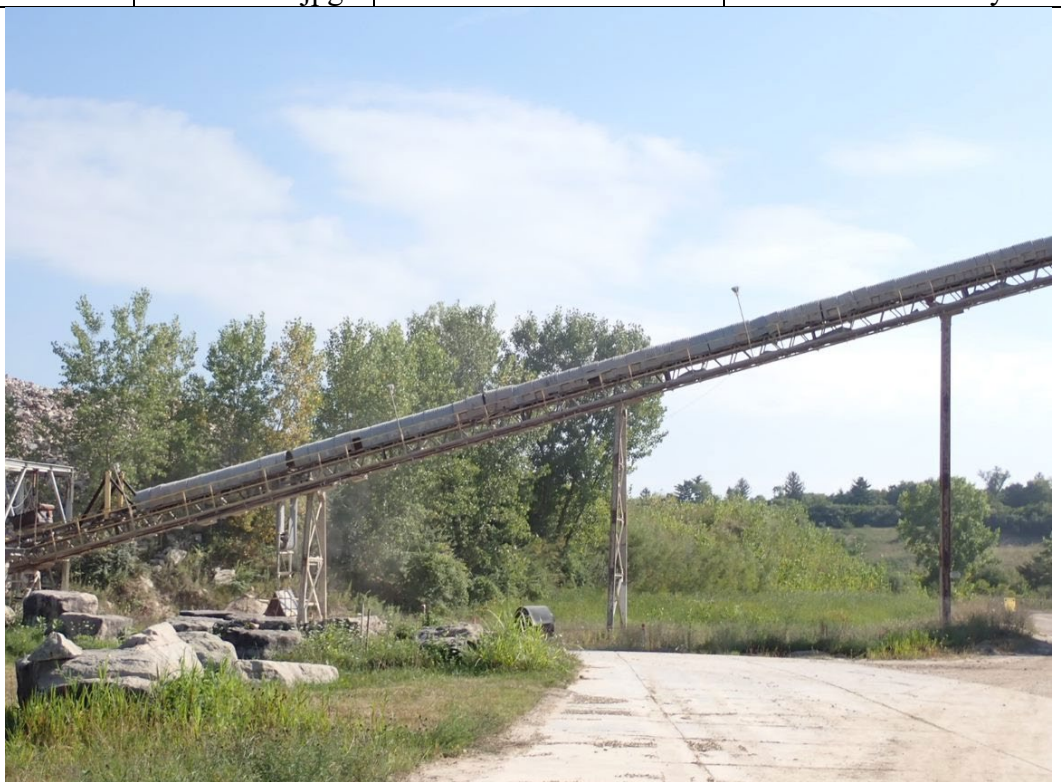
| Image Number | File Name | Date and Time (incl. Time zone and DST) | Description of Image |
|---|---|---|---|
| 6 | P8230010.jpg | 2022:08:23 08:10:56 | Lime Conveyor Transfer Line |

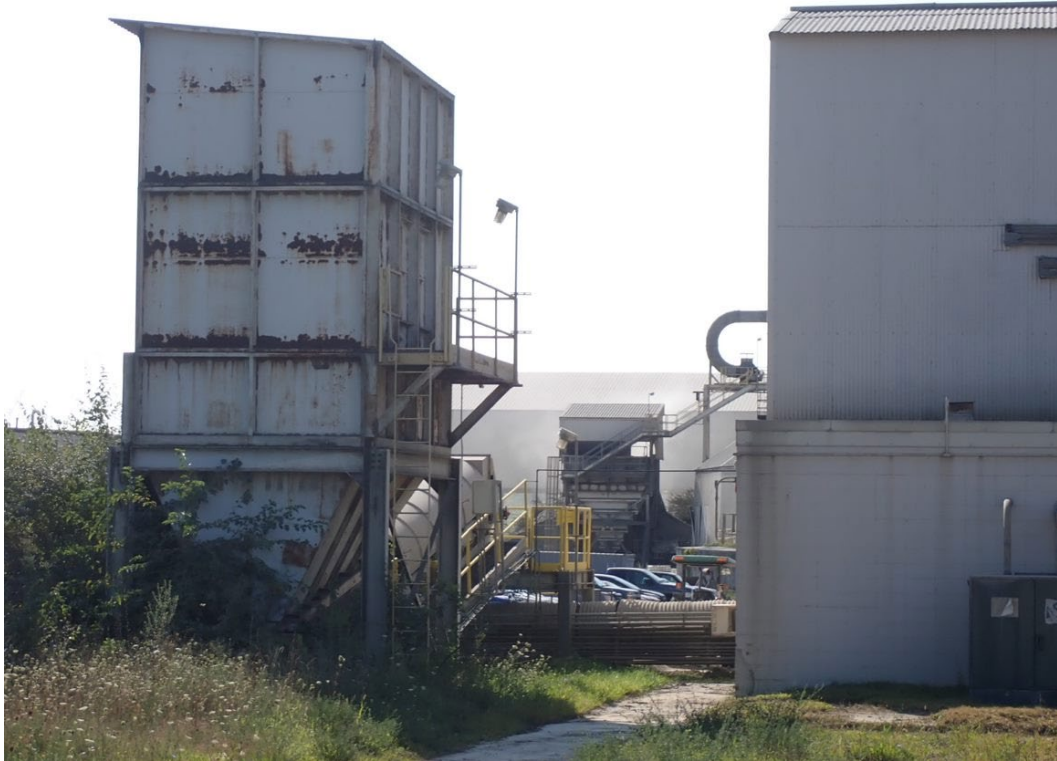
| Image Number | File Name | Date and Time (incl. Time zone and DST) | Description of Image |
|---|---|---|---|
| 8 | P8230012.jpg | 2022:08:23 08:14:47 | Clay Transfer Point |

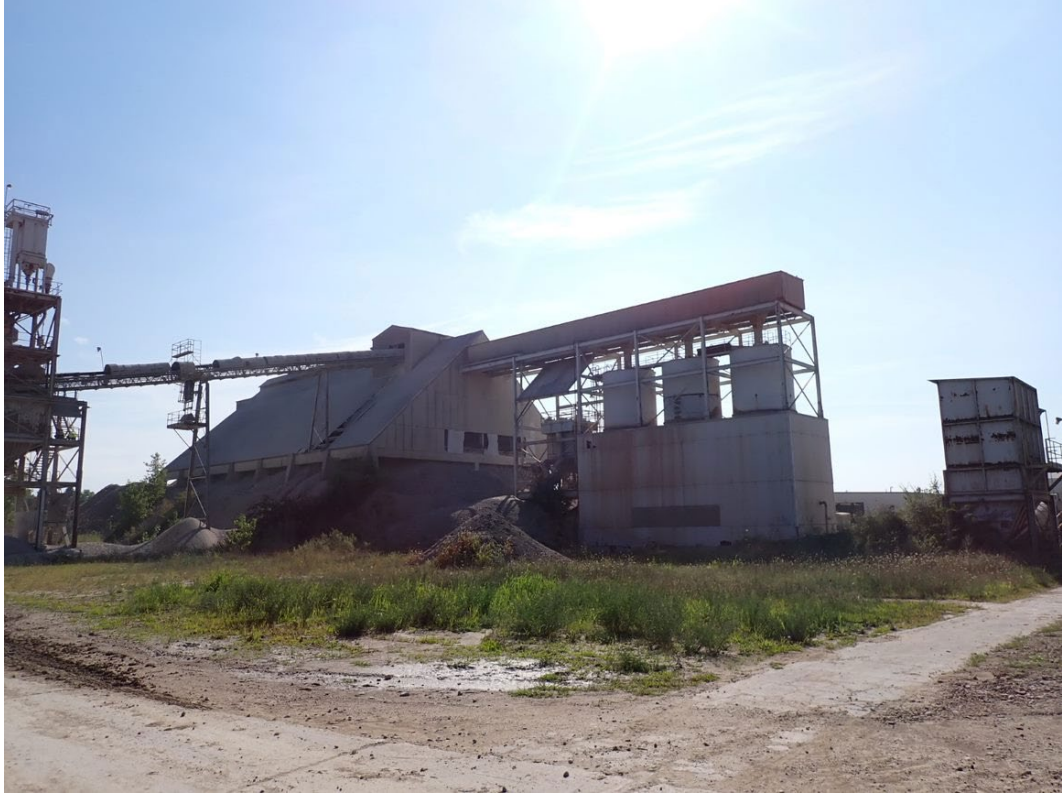
| Image Number | File Name | Date and Time (incl. Time zone and DST) | Description of Image |
|---|---|---|---|
| 9 | P8230013.jpg | 2022:08:23 08:22:52 | Limestone Tower with Additive Towers |

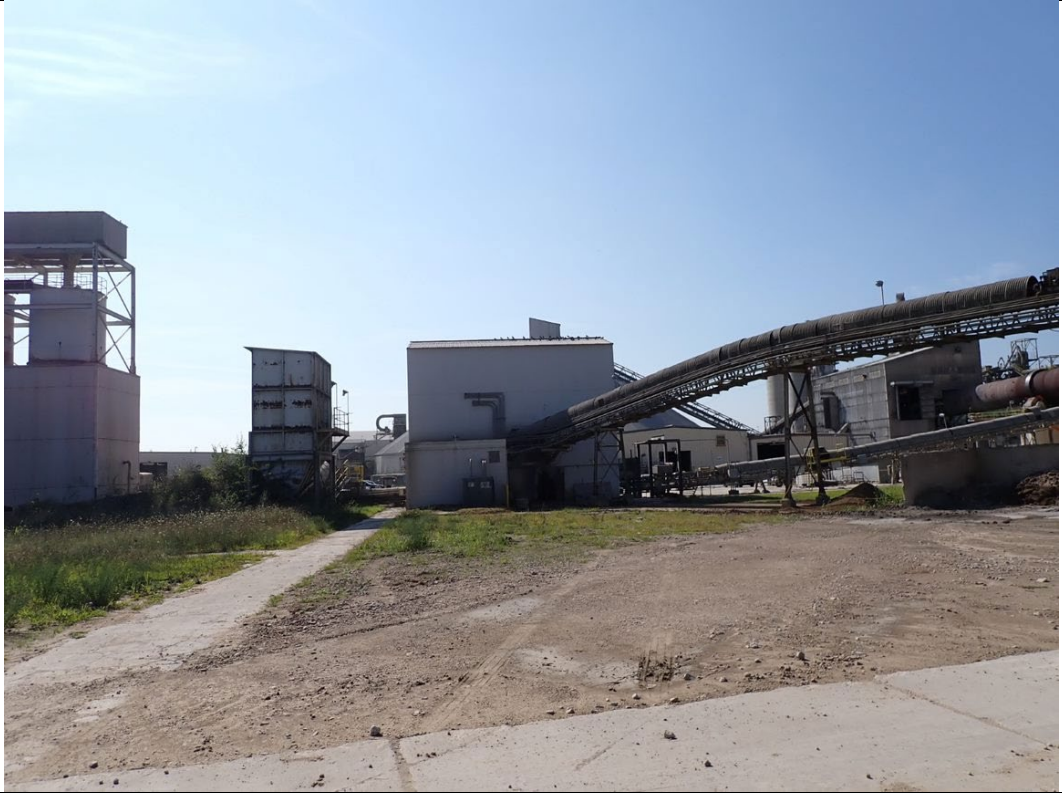
| Image Number | File Name | Date and Time (incl. Time zone and DST) | Description of Image |
|---|---|---|---|
| 10 | P8230014.jpg | 2022:08:23 08:23:45 | Collection Point of Additives, Clay, and Lime to be Sent to Raw Mill |

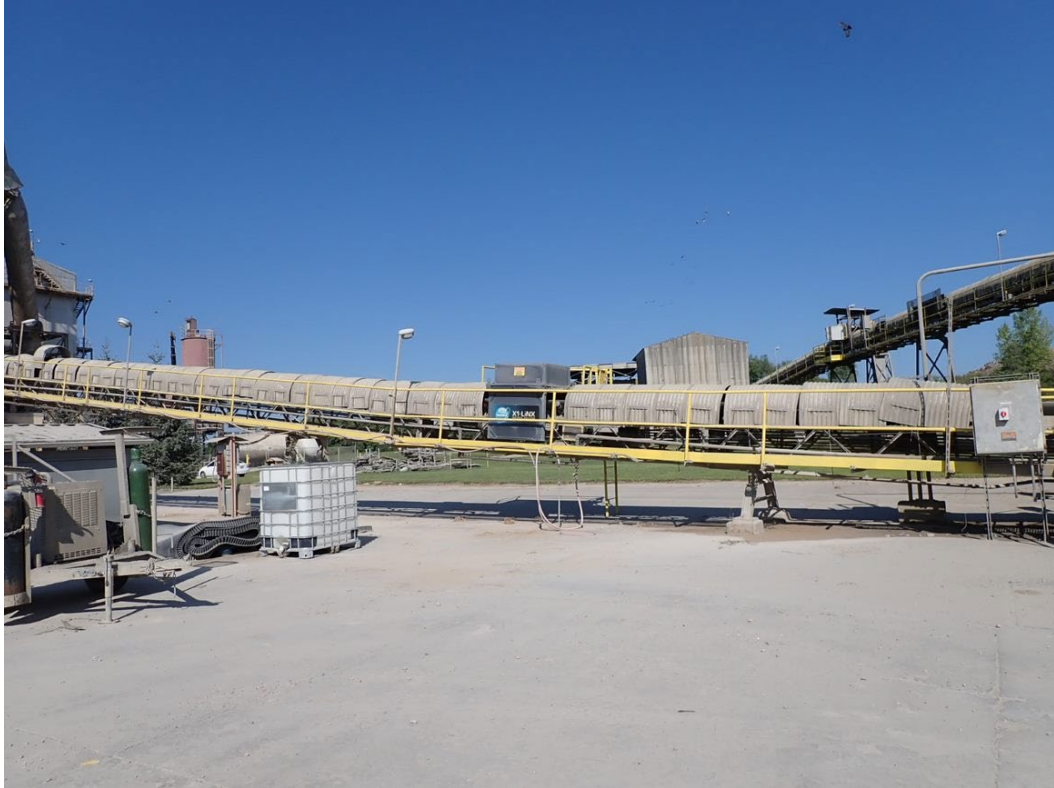
| Image Number | File Name | Date and Time (incl. Time zone and DST) | Description of Image |
|---|---|---|---|
| 11 | P8230015.jpg | 2022:08:23 08:29:29 | Conveyor X-Ray Fluorescence Monitor |

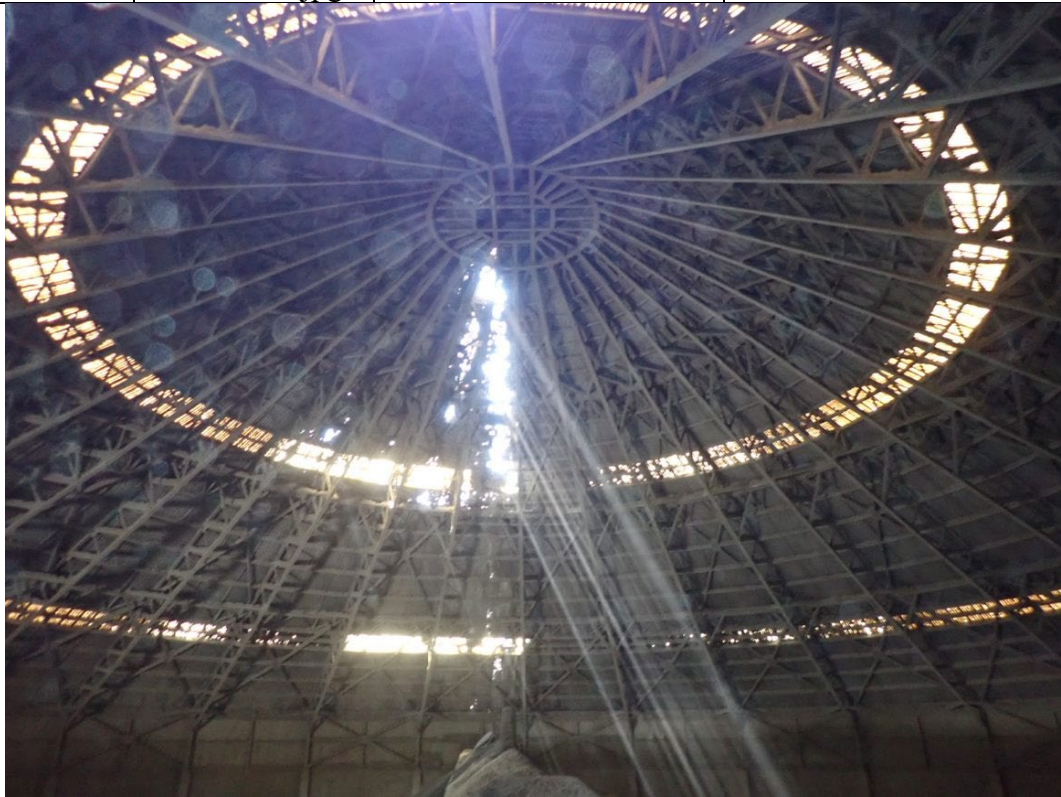
| Image Number | File Name | Date and Time (incl. Time zone and DST) | Description of Image |
|---|---|---|---|
| 15 | P8230019.jpg | 2022:08:23 11:51:46 | Inside of Clinker Storage |

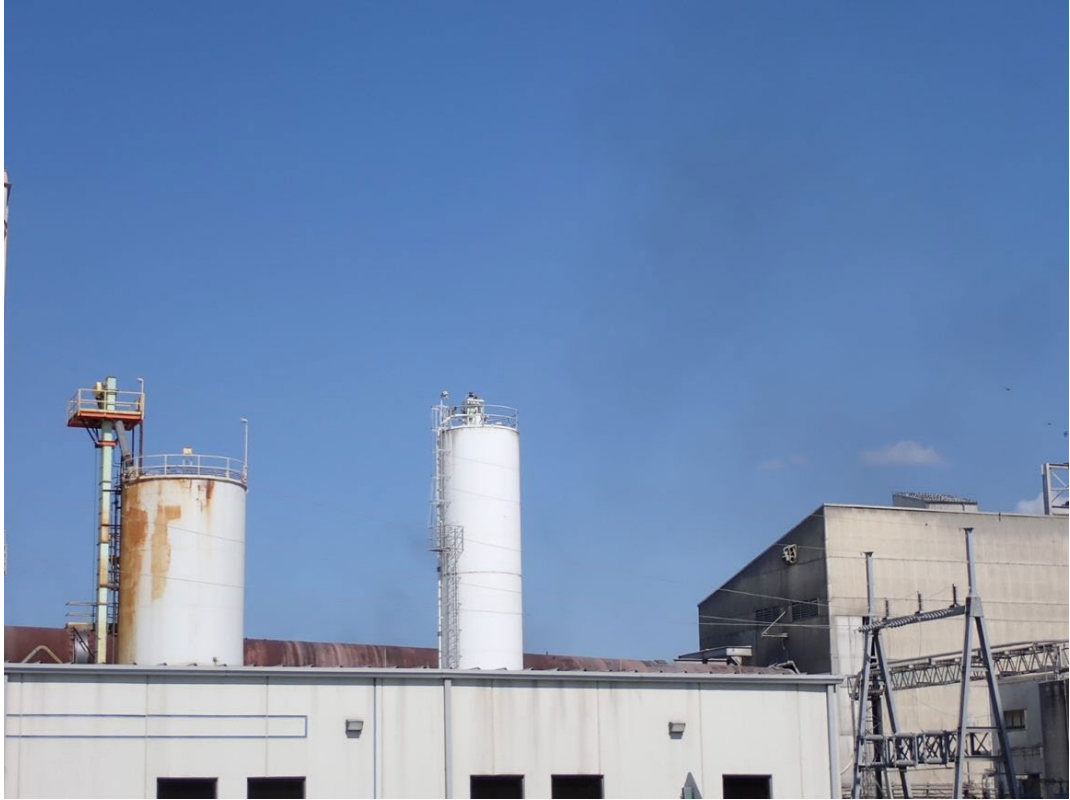
As the inspectors were getting into the car to leave at the end of the first day of the inspection, they observed a plume of black dust above the kiln and followed it back to the carbon injection system where a crew of workers was performing maintenance work. See pictures 16 through 19.

| Image Number | File Name | Date and Time (incl. Time zone and DST) | Description of Image |
|---|---|---|---|
| 16 | P8230020.jpg | 2022:08:23 13:37:11 | Back of Finish Mill |
