**Region 6 - Enforcement & Compliance Assurance Division**  
**INSPECTION REPORT**

| Regulatory Program(s) | Clean Water Act – National Pollution Discharge Elimination System (NPDES) – Brine Program | |
| Company Name: | <b>Citation Oil &amp; Gas Corp.</b> | |
| Facility Name: | <b>Healdton IV Unit</b> | |

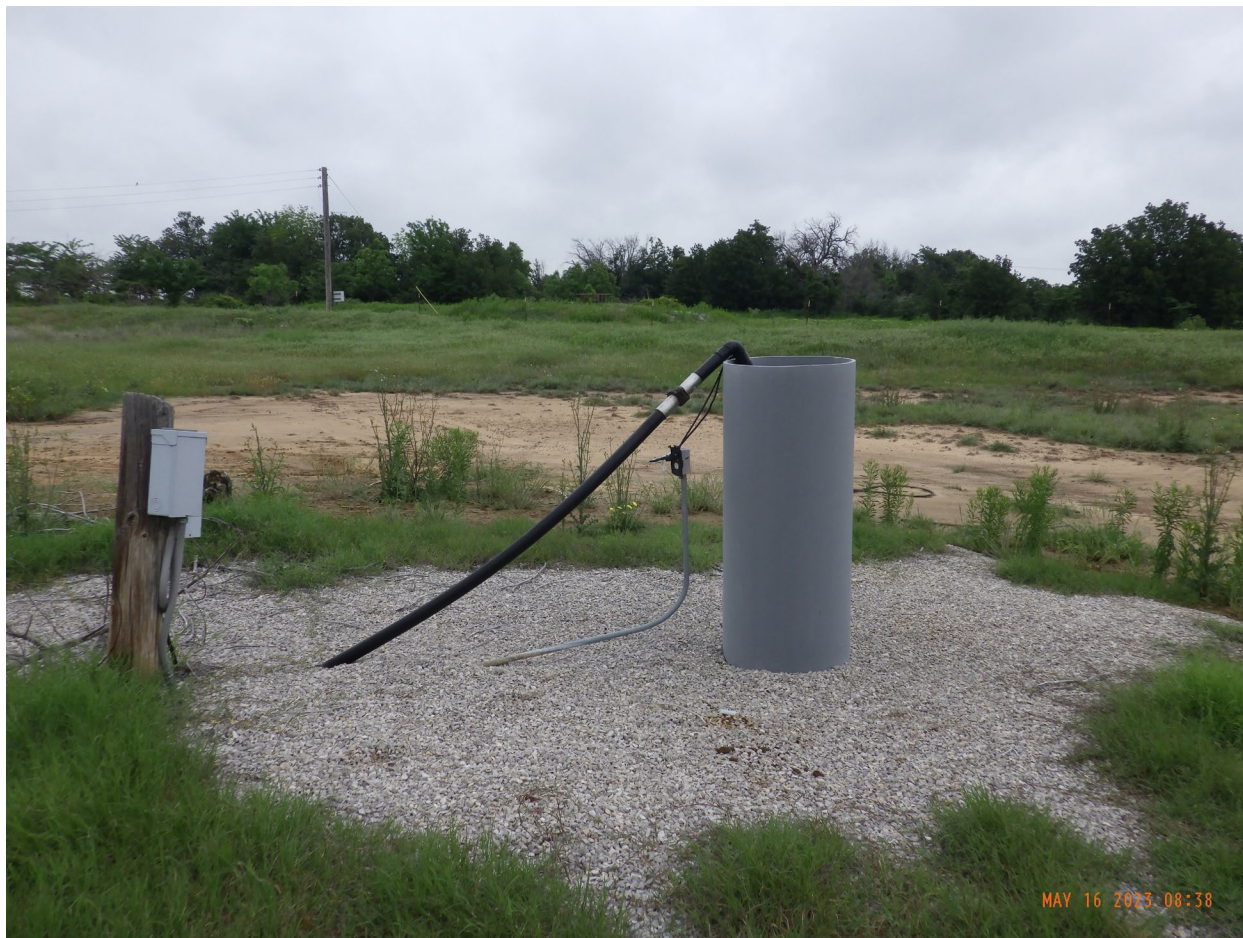
**Photo File Name:** R0010004.JPG

A recovery well or pump system was observed in **Appendix A**, Photo No. 1.
