**Region 6 - Enforcement & Compliance Assurance Division**  
**INSPECTION REPORT**

| Inspection Date(s): | 08/27/2025 | | |
| Regulatory Program(s) | NPDES Stormwater/CWA 402 | | |
| Facility Name: | <b>Tierra Hermosa Subdivison Phase I &amp; II</b> | | |

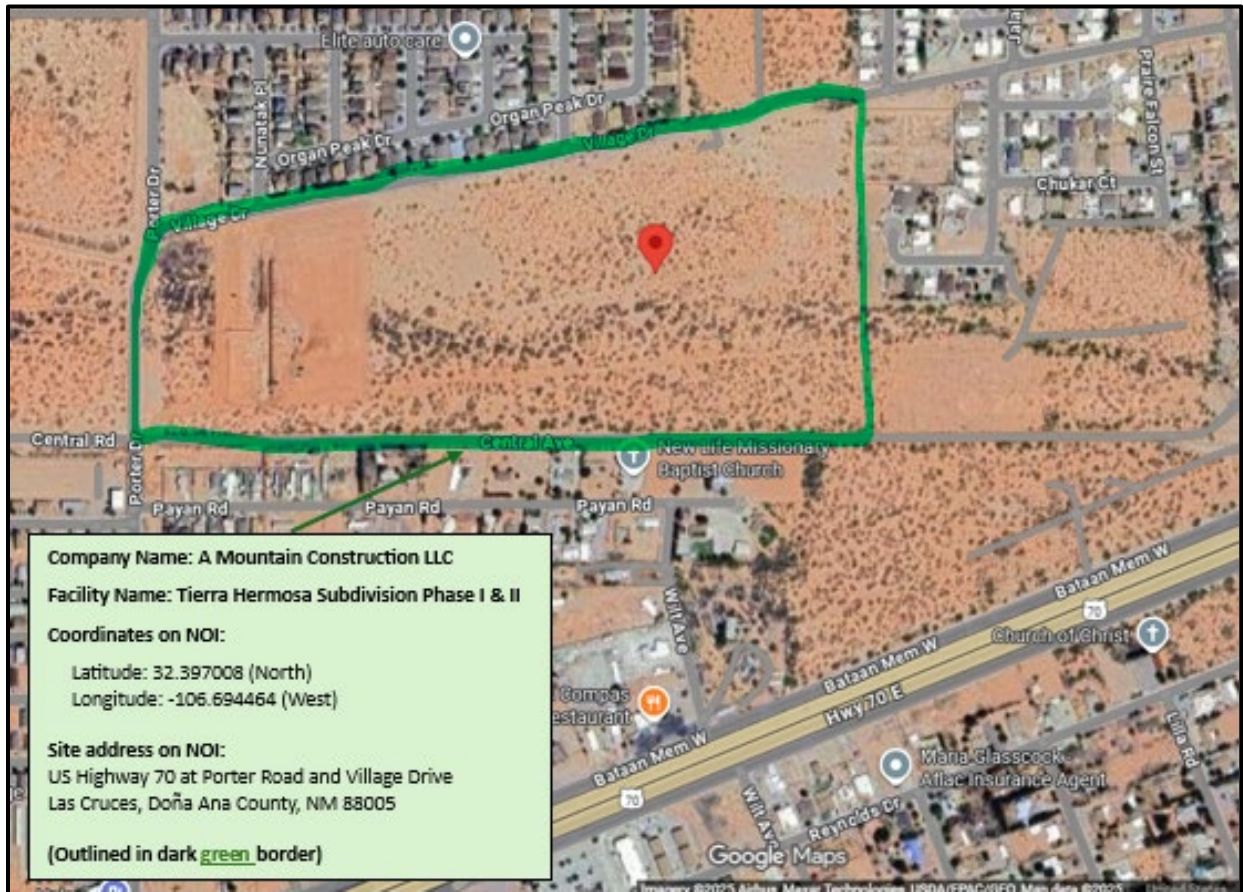
**Aerial Image #1:** Overall view of the Tierra Hermosa Subdivision Phase I & II construction site. **Note:** Aerial from Google Maps Imagery, 2025.
