## **RCRA Inspection Report**

Safety-Kleen Systems, Inc.  
3700 La Grange Rd.  
Smithfield, Kentucky 40068

EPA ID#: KYD053348108  
NAICS #: 562211 – Hazardous Waste  
Treatment and Disposal

June 05, 2024, at 9:00 AM – 6:15 PM

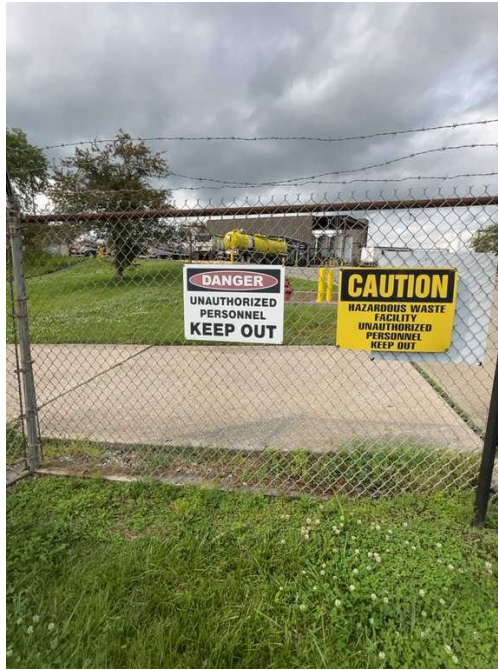
| Photo 1 | IMG-2024060517353035302345435.jpg |

SKS began operations in 1969 and occupy 104 acres, with 14 acres consisting of active operations. The facility employs 49 workers and operates four 12-hour shifts 24 hours a day, seven days a week. The facility is equipped with 24-hour security and a perimeter fence with signage throughout states “Danger Unauthorized Personnel Keep Out” (Photo 1).

| Security fence and signage. | 38.43268481, -85.23227276 |

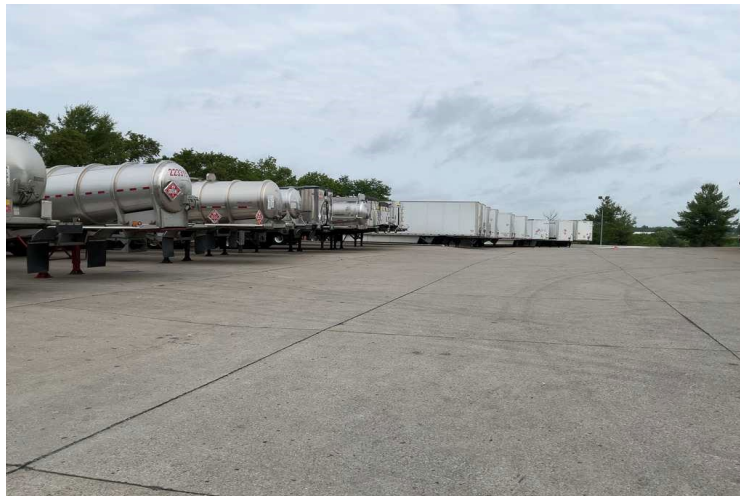
| Photo 2 | IMG-2024060509493149313275749.jpg |

This area is used to store tankers and box trucks carrying waste that are either waiting to unload waste or waiting to load waste to ship offsite (Photo 2). This area is covered under the RCRA permit as a solid waste management unit (SWMU). It was noted that a few tankers did

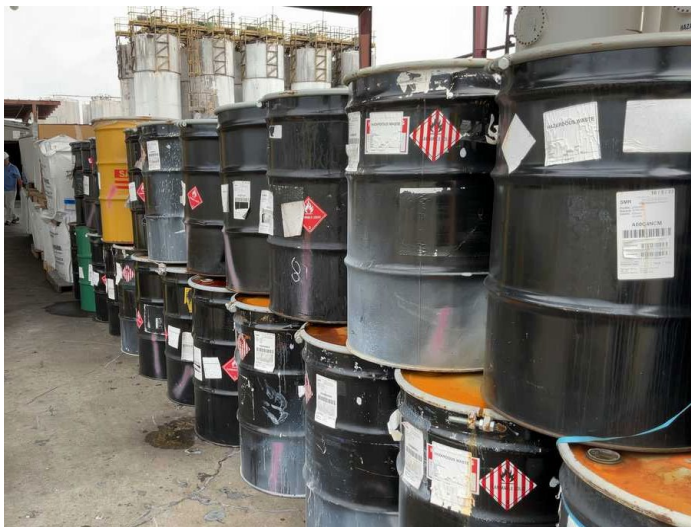
| Photo 06 | IMG-2024060510111511153092642.jpg |

| Lower Dock | 38.43348311, -85.23151407 |

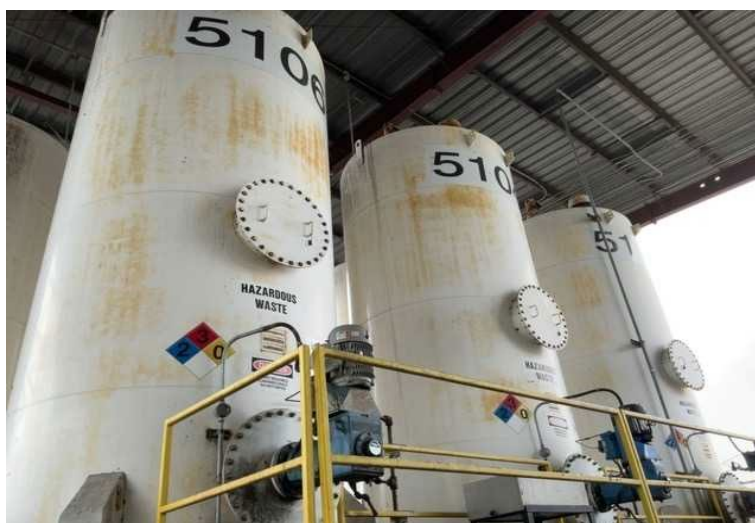
| Photo 09 | IMG-20240605102741274191032.jpg |

| D-Tank Farm | 38.43348311, -85.23151396 |

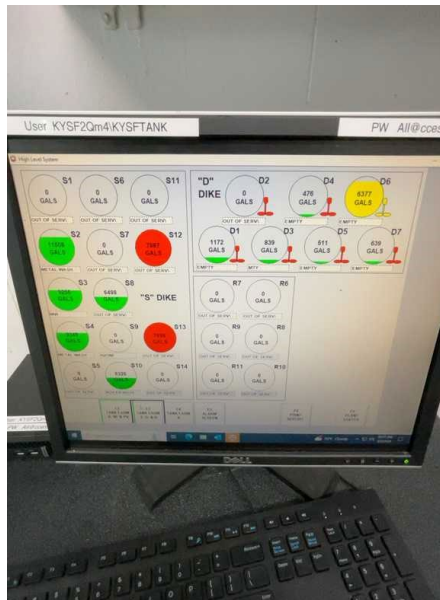
| Photo 14 | IMG-202406051037073771341342.jpg |

| Production Laboratory | 38.43348434, -85.23151361 |

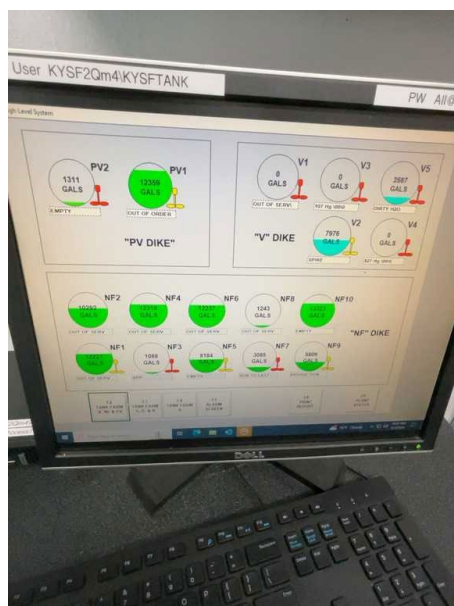
| Photo 15 | IMG-2024060510374837481315643.jpg |

| Production Laboratory | 38.43348399, -85.23151371 |

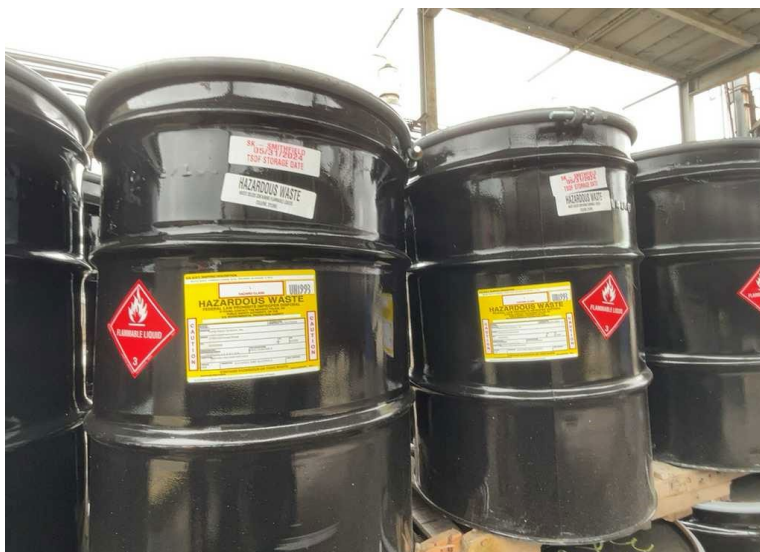
| Photo 16 | IMG-2024060510404940491367087.jpg |

| L4 Bay | 38.43375494, -85.23110525 |

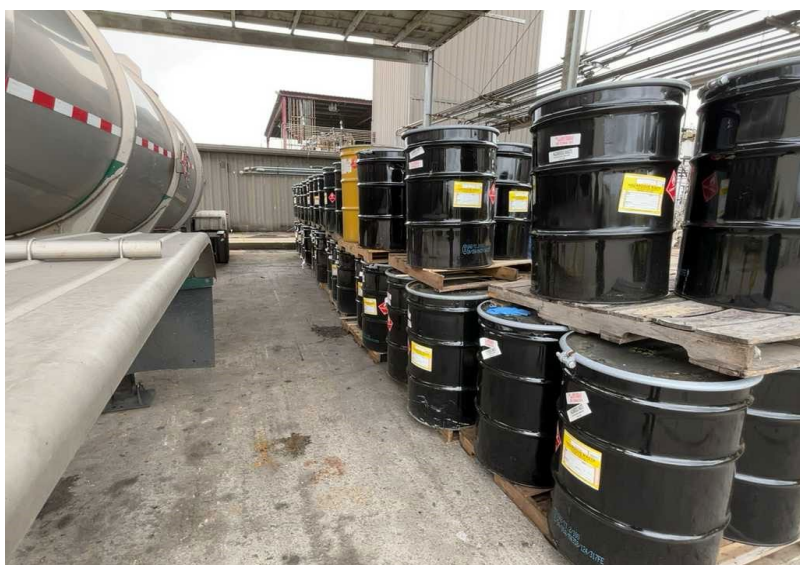
| Photo 17 | IMG-202406051042004201678348.jpg |

| L4 Bay | 38.43375547, -85.23110543 |

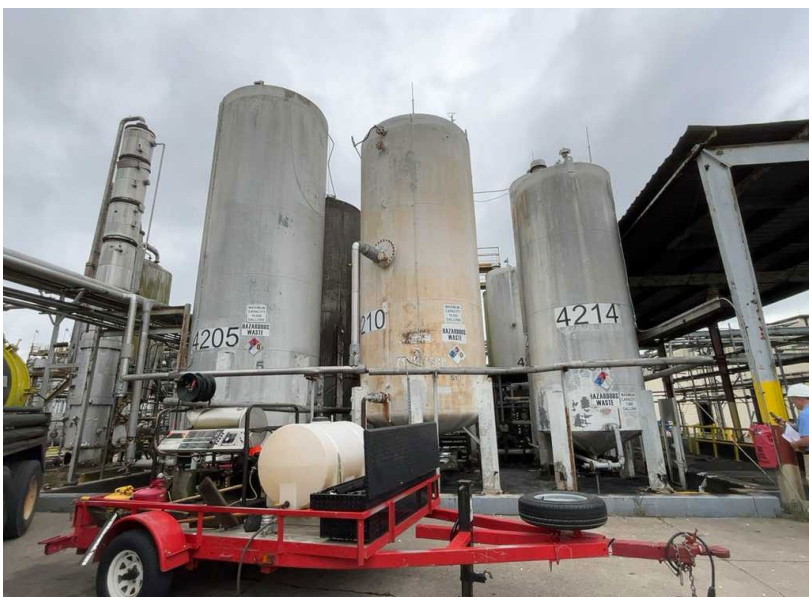
| Photo 18 | IMG-2024060510434843481409564.jpg |

The S-Dike tank farm is covered under the RCRA permit and consists of fourteen aboveground storage tanks which vary in size from 8,000 gallons to 15,000 gallons (Photo 18). The tanks are situated inside of concrete secondary containment. All the tanks were labeled “Hazardous Waste” and marked with an indication of the hazard of the contents. At the time of the inspection the tank farm was undergoing maintenance which included pressure washing and re-coating of the secondary containment.

| S Dike Tank Farm | 38.43376011, -85.23109848 |

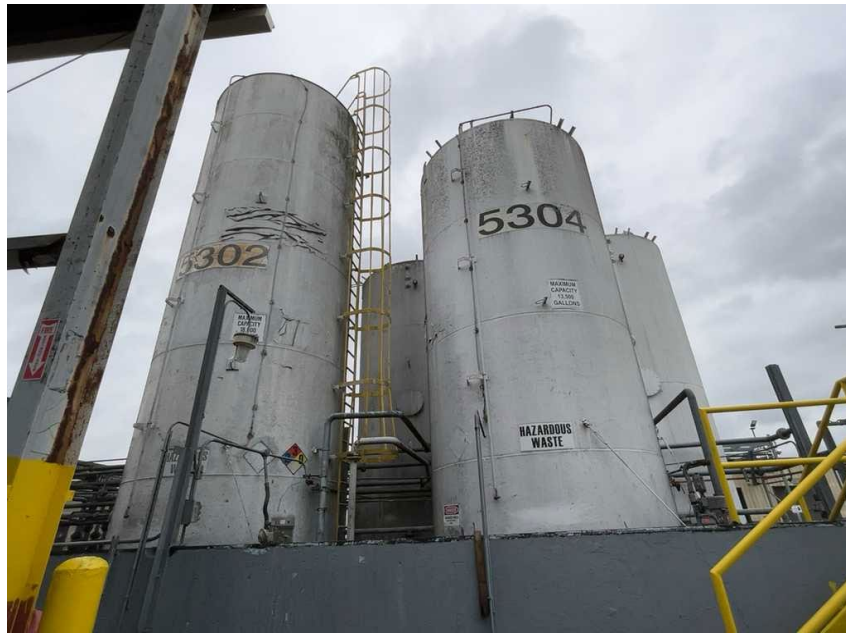
| Photo 19 | IMG-202406051051085181265293.jpg |

| V-Dike Tank Farm | 38.43348421, -85.23151404 |

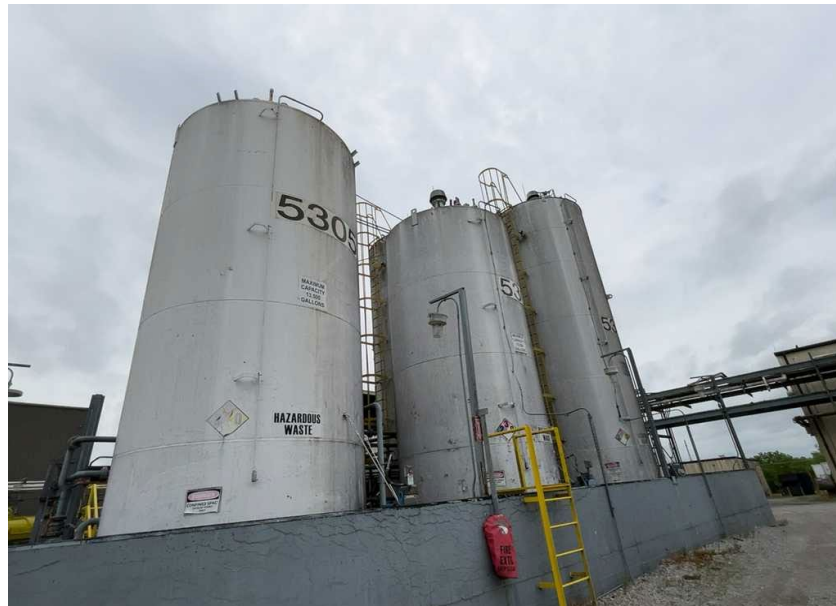
| Photo 20 | IMG-2024060510531953191112960.jpg |

| V Dike Tank Farm | 38.4337526, -85.23110974 |

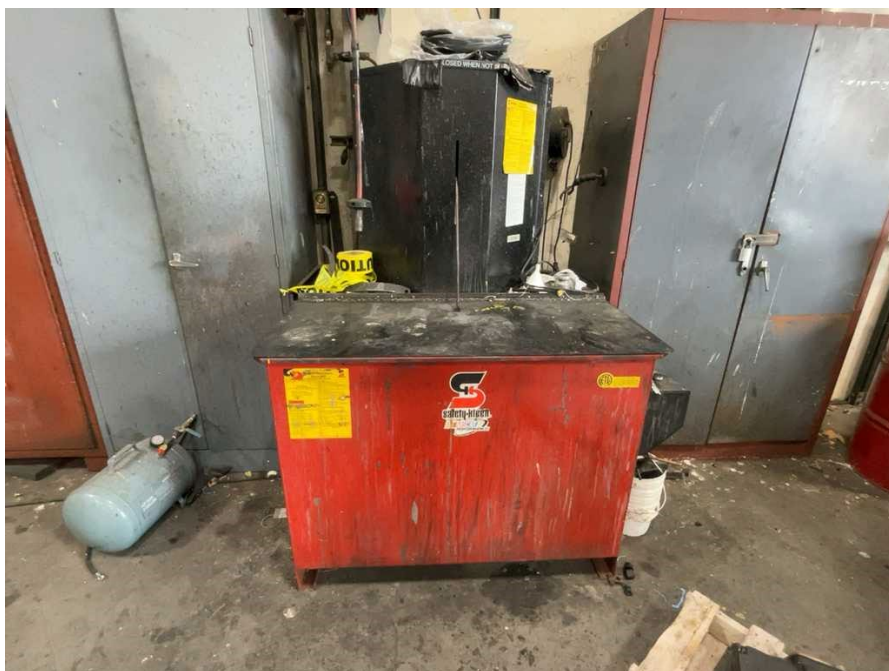
| Photo 21 | IMG-2024060510554455441336352.jpg |

The facility maintenance building stores non-hazardous shredded material and debris. Facilities also use this building for aerosol can crushing. The inspectors observed a closed parts washer (Photo 21) and one 55-gallon SAA container for the collection of residual liquid from spent aerosol cans after being punctured. The container had an aerosol can puncture device attached to it (Photo 22). The container was closed, labeled “Hazardous Waste”, and marked with an indication of the hazard of the contents.

| Maintenance Building—Parts washer. | 38.43400193, -85.23073571 |

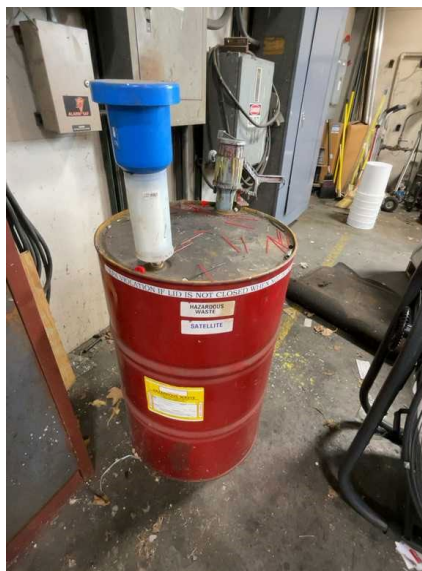
| Photo 22 | IMG-202406051056025621441291.jpg |

| Maintenance Building—55-gallon hazardous waste container for used aerosol cans. | 38.43400194, -85.23073567 |

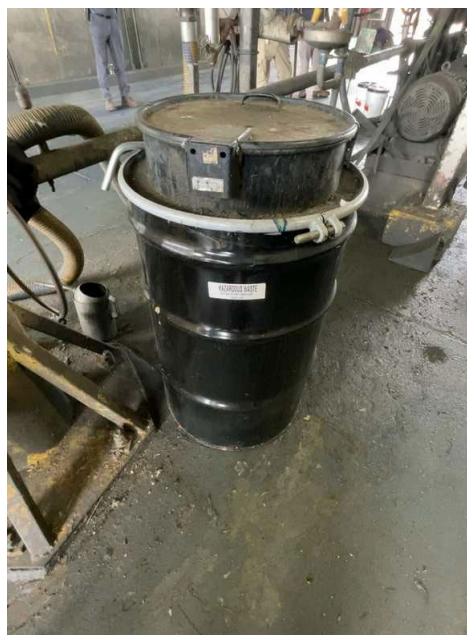
| Photo 26 | IMG-2024060511102810281538566.jpg |

| Tanker Tunnel—55-gallon container of hazardous waste used for spills from the transfer of fuel during loading and unloading. | 38.43400028, -85.23073534 |

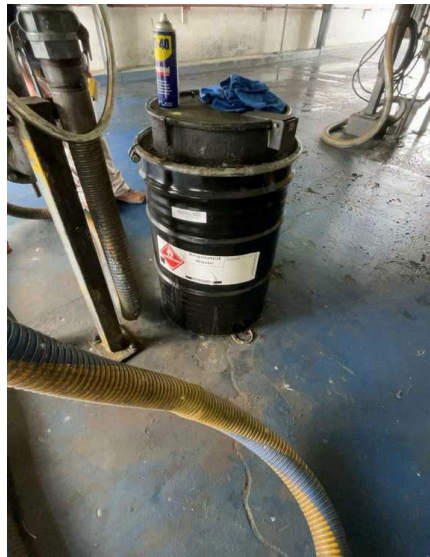
| Photo 27 | IMG-202406051106196191535081.jpg |

| Tanker Tunnel—55-gallon container of hazardous waste used for spills from the transfer of fuel during loading and unloading. | 38.43378773, -85.23105704 |

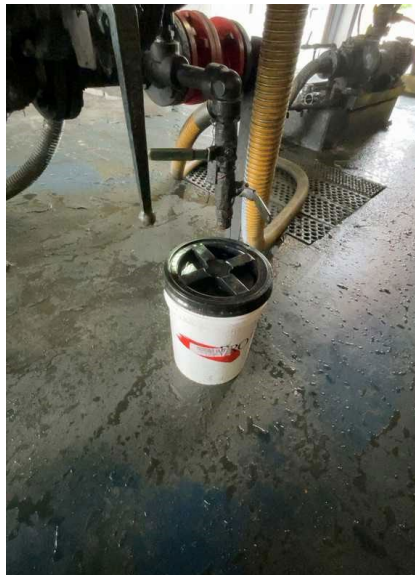
| Photo 28 | IMG-202406051107447441572061.jpg |

| Tanker Tunnel—5 gallon container for hose leaks. | 38.43400167, -85.23073613 |

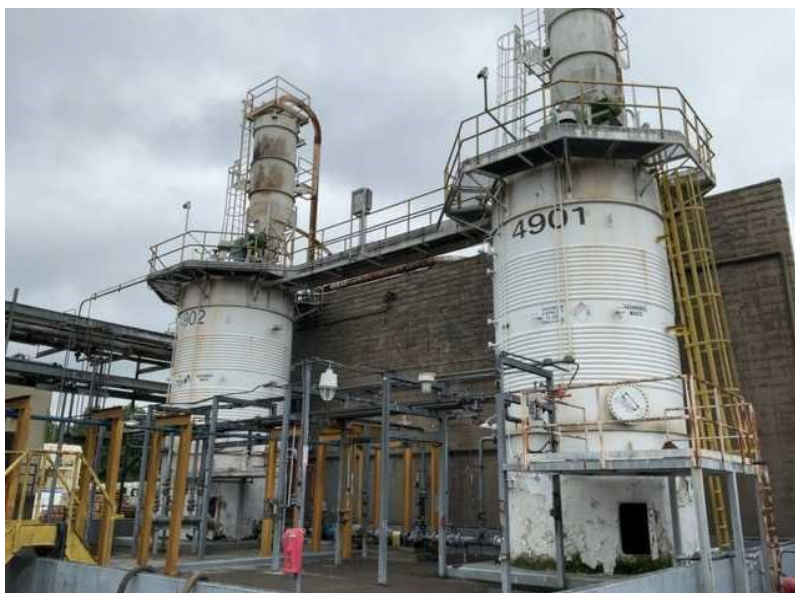
| Photo 29 | IMG-202406051119181918104378.jpg |

The PV-dike tank farm is covered under the RCRA permit and consists of two 15,000-gallon aboveground storage tanks (Photo 29) situated in concrete secondary containment, which was free of visible cracks or signs of damage. All the tanks were labeled “Hazardous Waste” and marked with an indication of the hazard of the contents. Tank system equipment such as pumps, valves, and flanges appeared to be tagged to identify each piece of equipment pursuant to Subpart BB Air Emission Standards for Equipment Leaks.

| PV Dike tank farm | 38.43459865, -85.23091998 |

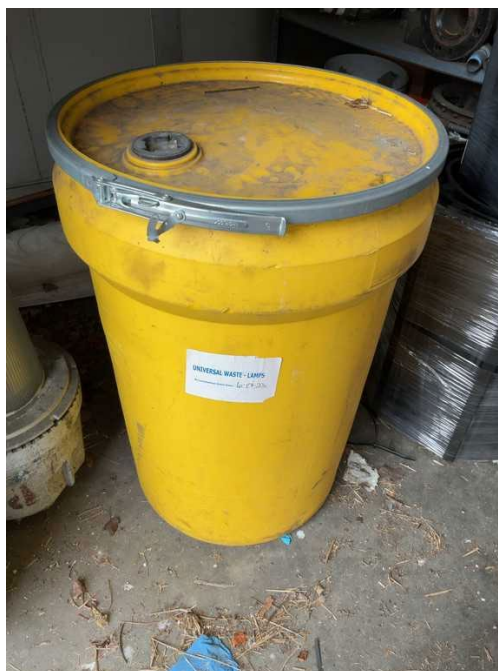
| Photo 30 | IMG-2024060511285228522778863.jpg |

This building is used for facility maintenance and stores building equipment. The inspectors observed one 30-gallon container of used lamps. The container was closed, labeled “Universal Waste”, and dated 06/17/2023 (Photo 30).

| Todd Building--30-gallon container of universal waste used lamps. | 38.43400052, -85.23073552 |

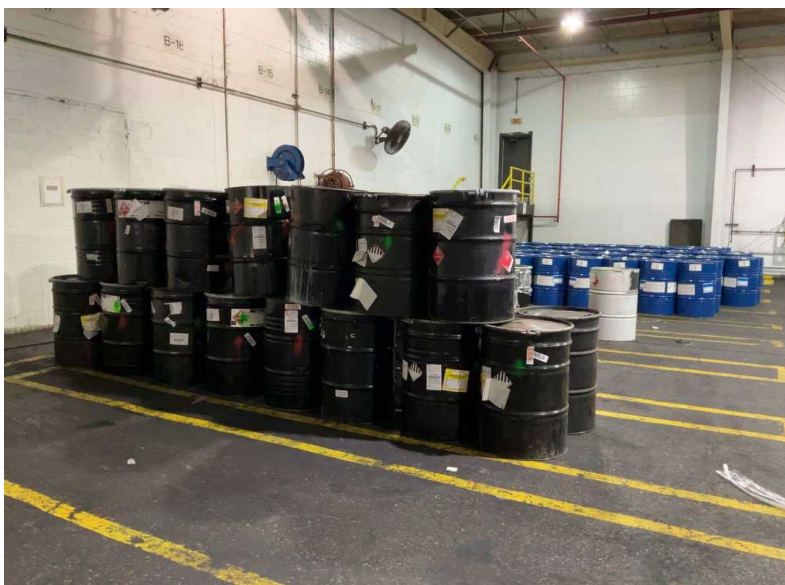
| Photo 31 | IMG-2024060511512351232165461.jpg |

| Main Warehouse—Container Storage Area B | 38.43489875, -85.23099972 |

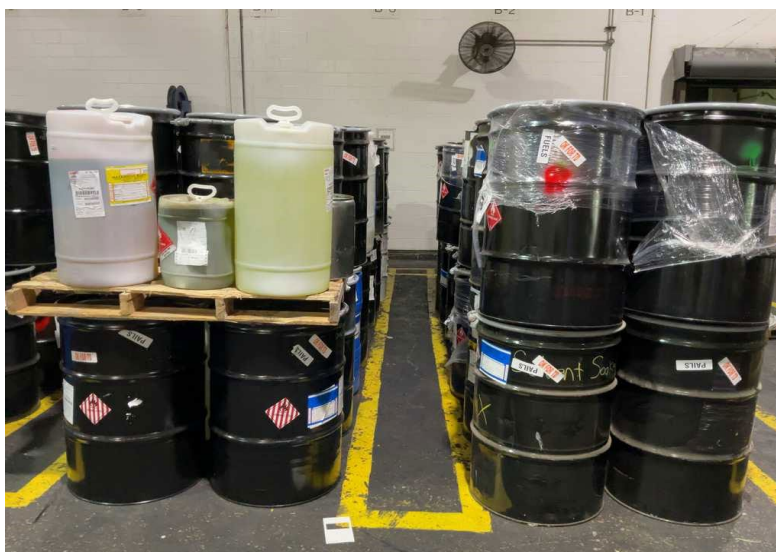
| Photo 32 | IMG-2024060511515651562326019.jpg |

| Main Warehouse—Container Storage Area B | 38.43497471, -85.2309645 |

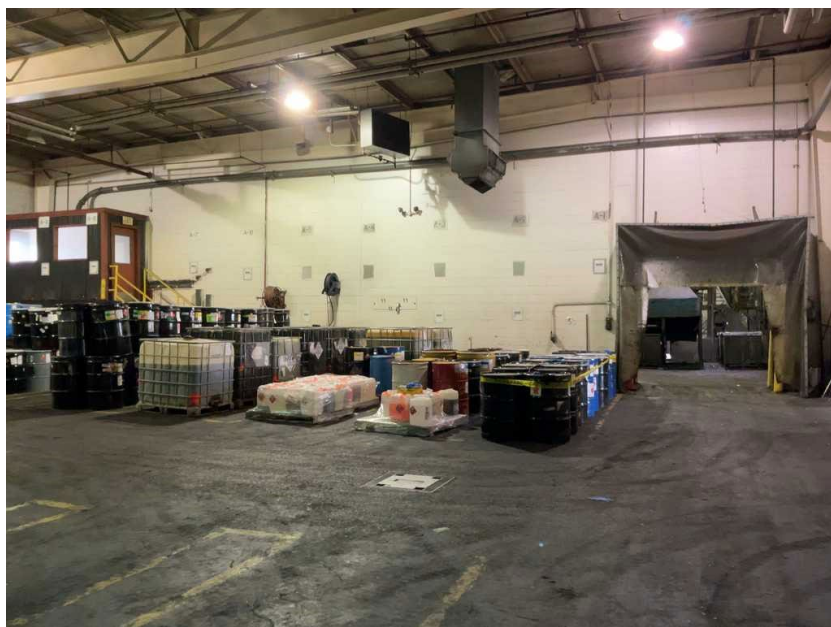
| Photo 33 | IMG-202406051201251252236169.jpg |

| Main Warehouse—Container Storage Area A | 38.43485961, -85.23102031 |

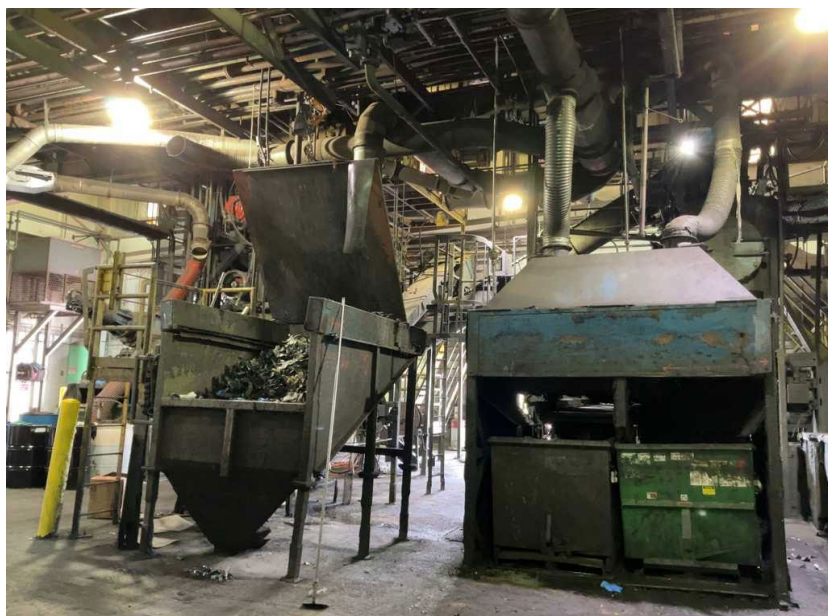
| Photo 40 | IMG-2024060512213921392550241.jpg |

| Main Warehouse—Shredder Unit and Shaker | 38.43488558, -85.2310153 |

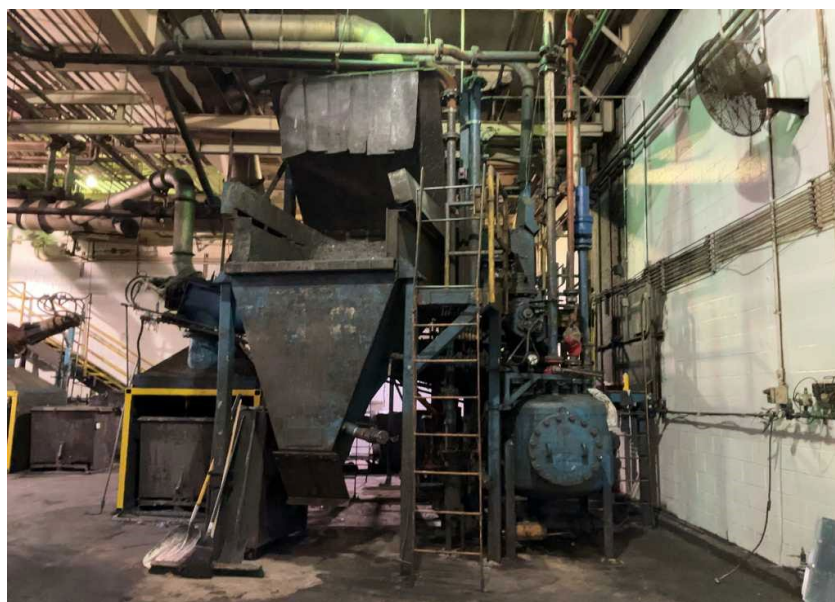
| Photo 41 | IMG-2024060512291229122355733.jpg |

| Main Warehouse—Hydro-pulper | 38.43486216, -85.23101646 |

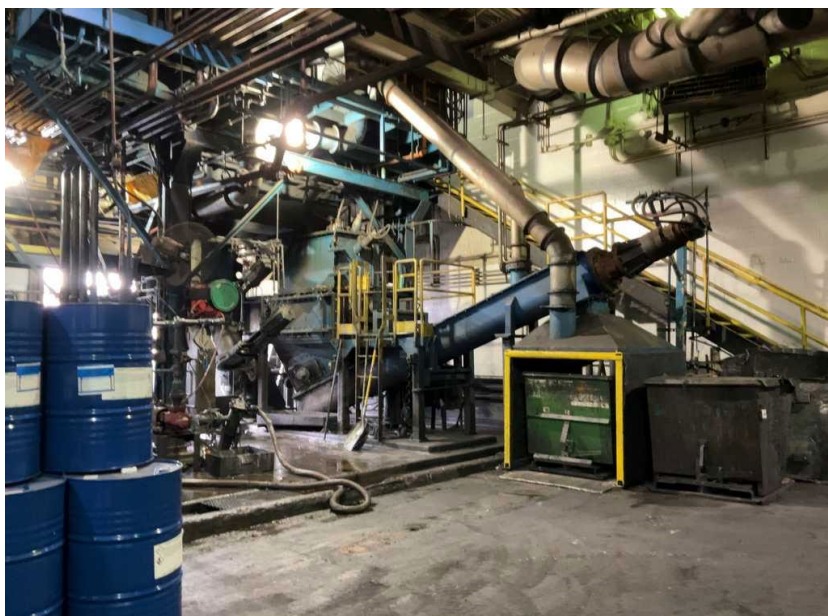
| Photo 42 | IMG-2024060512293829382425169.jpg |

Waste containers that are categorized as 1-3 waste (more liquid than solid) are transported into the ADDS (Photo 42), which is purged with nitrogen. The bottom of the container is sheared off

| Main Warehouse—ADDS | 38.43489346, -85.2310108 |

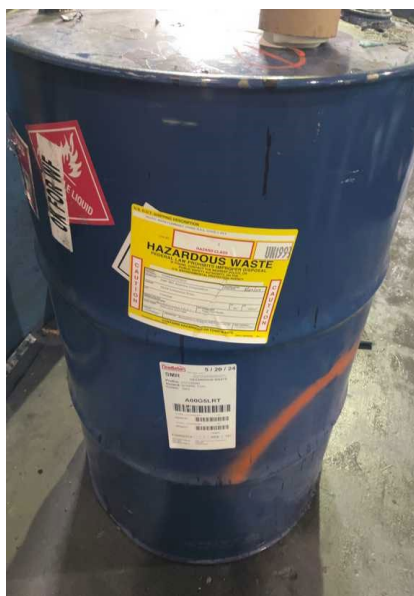
| Photo 43 | IMG-2024060512304630462102901.jpg |

Near the ADDS and hydro-pulper, the inspectors observed one 55-gallon container of alcohols, water, MEK, and toluene (Photo 43). The container was closed, labeled "Hazardous Waste", marked with an indication of the hazard of the contents, and dated 05/20/2024.

| Main Warehouse—ADDS. 55-gallon hazardous waste container for alcohol, water, MEK, and toluene. | 38.43477546, -85.2310796 |

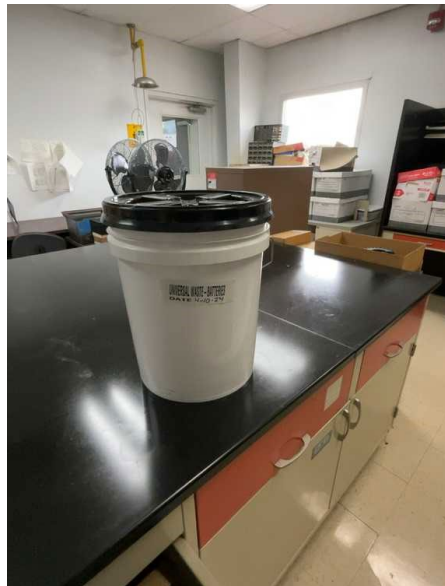
| Photo 47 | IMG-2024060512454845481119385.jpg |

- One (1) 5-gallon container of universal waste batteries. The container was closed, labeled "Universal Waste – Batteries", and dated 04/10/2024 (Photo 47).
- One (1) quart-size glass container of hazardous waste KF bath reagent (Photo 48) in an SAA. The container was closed, labeled "Hazardous Waste", and marked with an indication of the hazard of the contents.

| QC Laboratory—universal waste batteries. | 38.43449259, -85.23152322 |

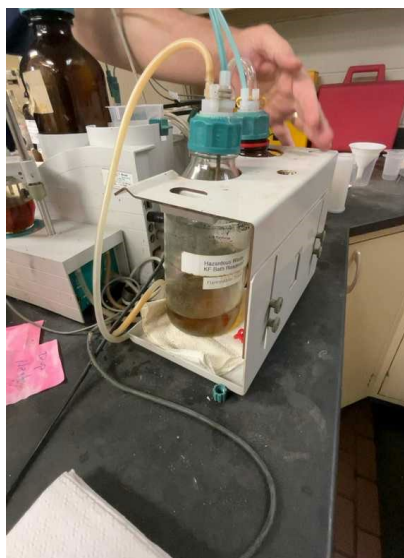
| Photo 48 | IMG-202406051250025021280572.jpg |

| QC Laboratory— Quart-size glass container of hazardous waste KF bath reagent | 38.43440583, -85.23146801 |

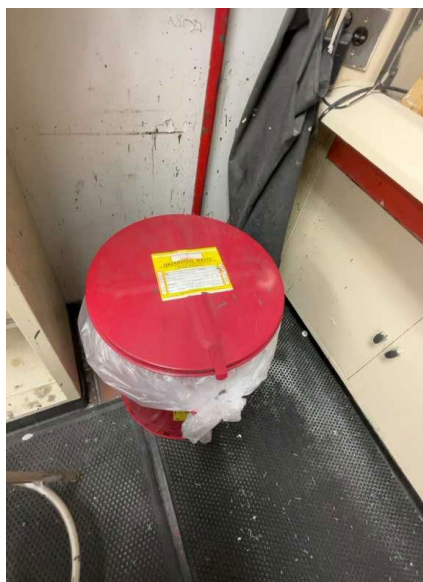
| Photo 49 | IMG-2024060512512151211325964.jpg |

- One (1) 5-gallon container of hazardous waste PPE (Photo 49) in an SAA. The container was closed, labeled “Hazardous Waste”, and marked with an indication of the hazard of the contents.
- One (1) 1-gallon glass container of hazardous waste flammables (Photo 50). The container was closed, labeled “Hazardous Waste”, marked with an indication of the hazard of the contents, and dated 06/04/2024.
- One (1) 5-gallon container of hazardous waste paper and plastic (Photo 51) in an SAA. The container was closed, labeled “Hazardous Waste”, and marked with an indication of the hazard of the contents.
- One (1) 5-gallon container of hazardous ICAP waste (Photo 52) in an SAA. The container was closed, labeled “Hazardous Waste”, and marked with an indication of the hazard of the contents.

| QC Laboratory—5-gallon container of hazardous waste PPE. | 38.43440461, -85.23146944 |

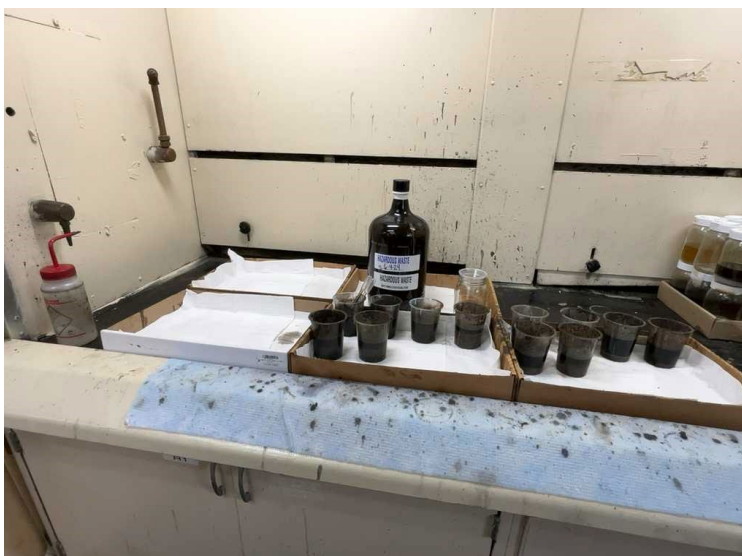
| Photo 50 | IMG-2024060512561856181249001.jpg |

| QC Laboratory—1-gallon glass container of hazardous waste flammables. | 38.43442469, -85.23147566 |

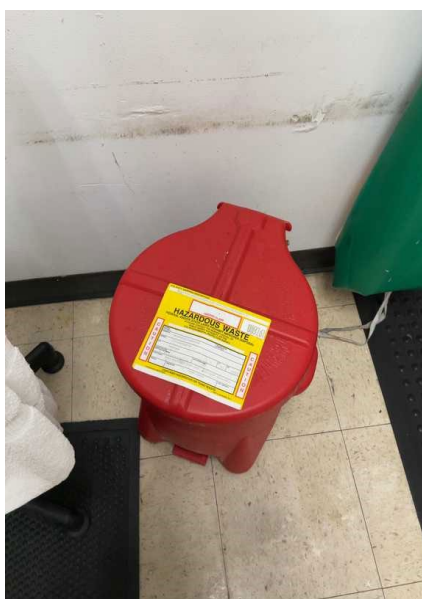
| Photo 51 | IMG-2024060512581158112117765.jpg |

| QC Laboratory—5-gallon container of hazardous waste paper and plastic. | 38.43441945, -85.23147531 |

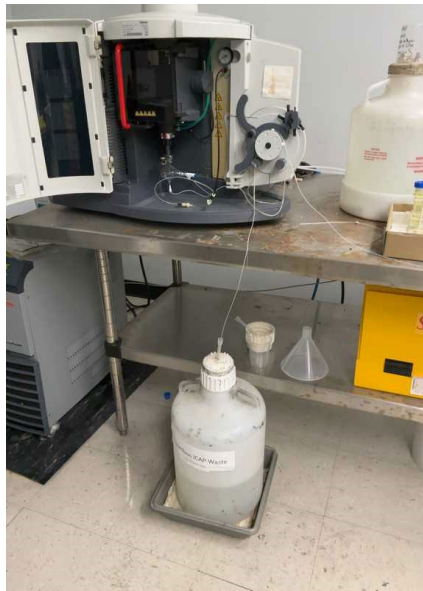
| Photo 52 | IMG-202406051302502501929332.jpg |

| QC Laboratory—5-gallon container of ICAP waste. | 38.43444765, -85.23148139 |

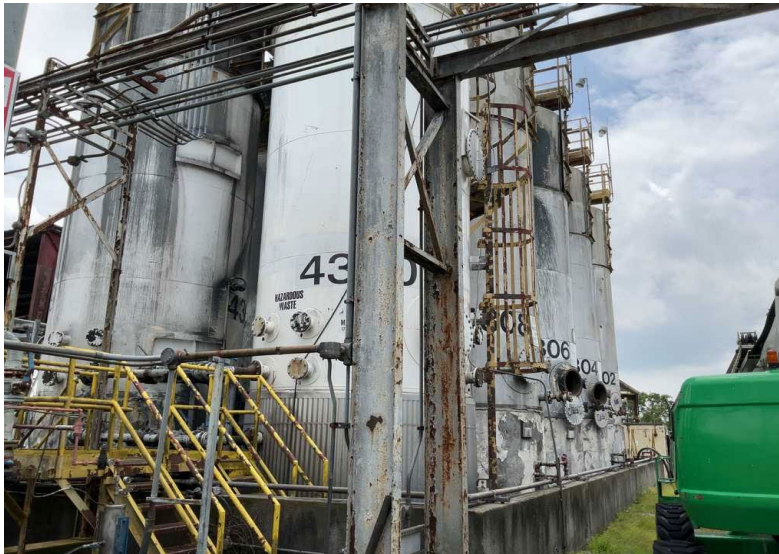
| Photo 53 | IMG-2024060513264826483662991.jpg |

The NF tank farm consists of 14 aboveground storage tanks, all with a design capacity of 18,500 gallons. The tanks are situated inside of concrete secondary containment, which appeared to have an impervious coating. All the tanks were labeled “Hazardous Waste” and marked with an indication of the hazard of the contents. Tank system equipment such as pumps, valves, and flanges appeared to be tagged to identify each piece of equipment pursuant to Subpart BB Air Emission Standards for Equipment Leaks. At the time of the inspection, this tank farm was out of service and undergoing routine maintenance (Photo 53).
