**UNITED STATES ENVIRONMENTAL PROTECTION AGENCY**  
**REGION 5**  
**77 WEST JACKSON BOULEVARD**  
**CHICAGO, ILLINOIS 60604**

**SUBJECT:** CLEAN WATER ACT INSPECTION REPORT  
*Miba Bearings US LLC*

**Facility Name:** Miba Bearings US LLC

**Date(s) of Inspection:** May 6 and 7, 2025

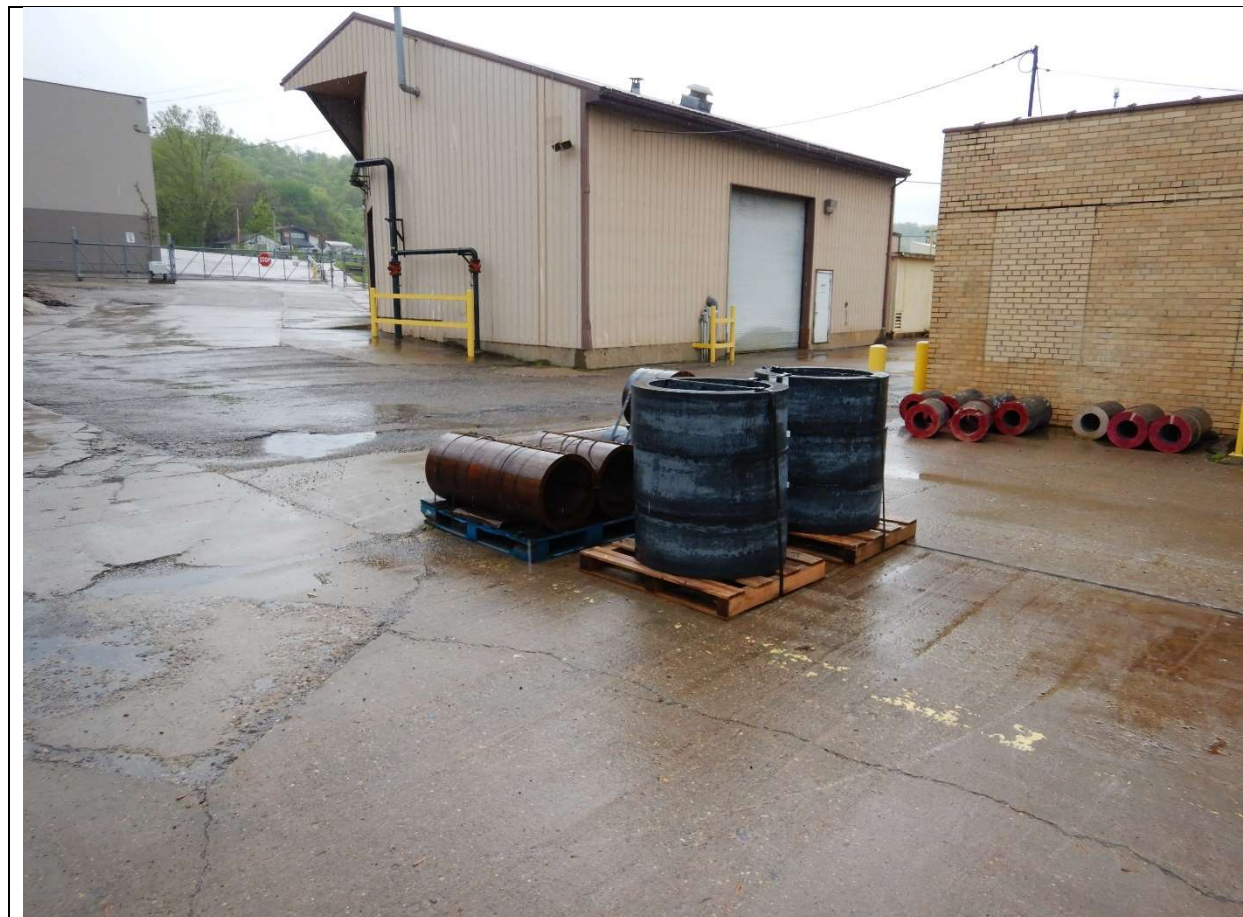
[49: DSCN2706.JPG](#)

- During the inspection, EPA inspectors observed raw materials stored outside; these materials are unfinished metal tube sections (various photos 49-81).

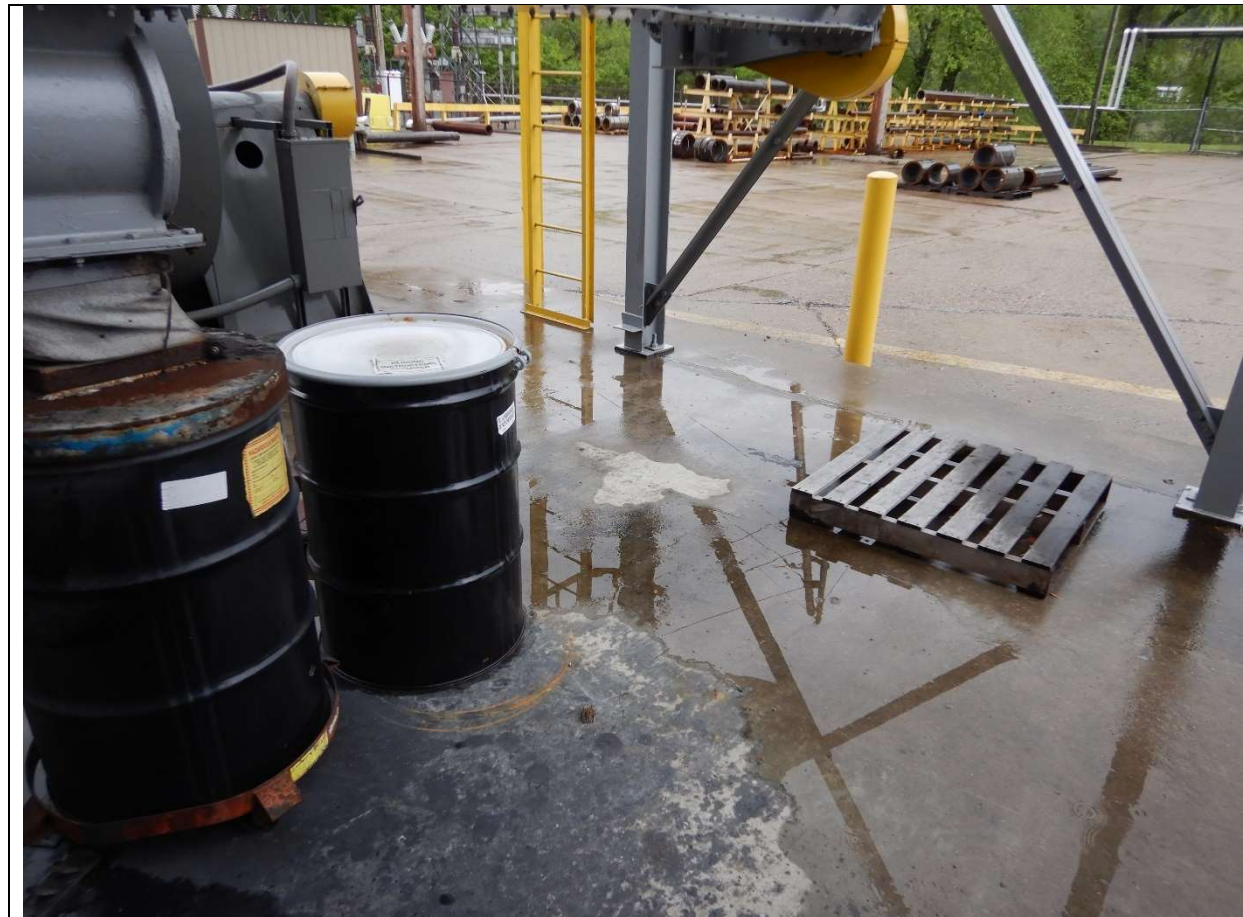
56: DSCN2713.JPG

Description: Raw metal materials stored onsite, outdoors, exposed to rainfall. In the foreground are hazardous waste containers for a dust collection system.

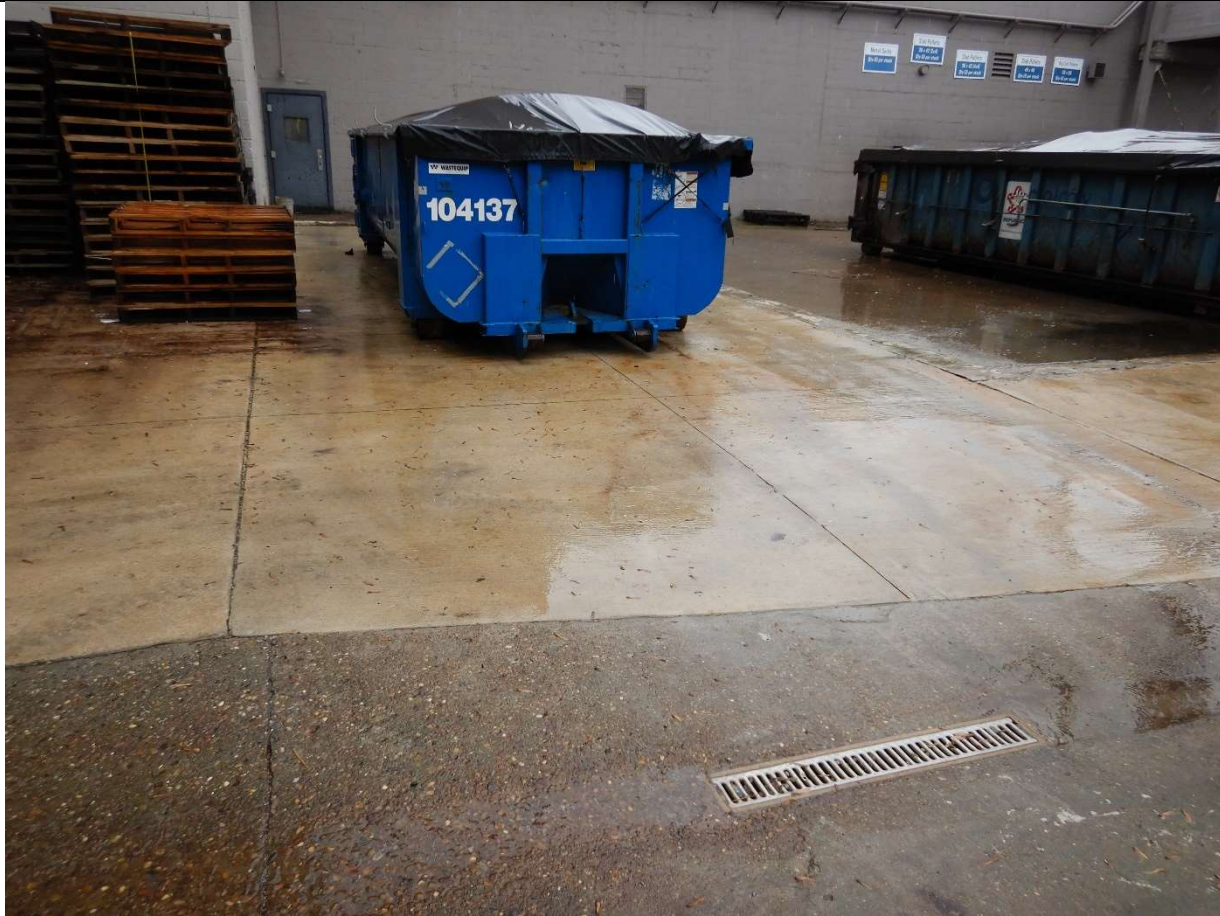
67: DSCN2724.JPG

- Hazardous waste roll-off boxes stored outside (potential material handling activity) (photos 62 through 67).
- Uncovered roll off boxes with non-hazardous waste (photos 68-70, 93, 99)

Description: Roll-off boxes storing hazardous waste at the facility. There was a stormwater grate near these boxes. The facility representatives said Gould's Electronics was responsible for this storm sewer.

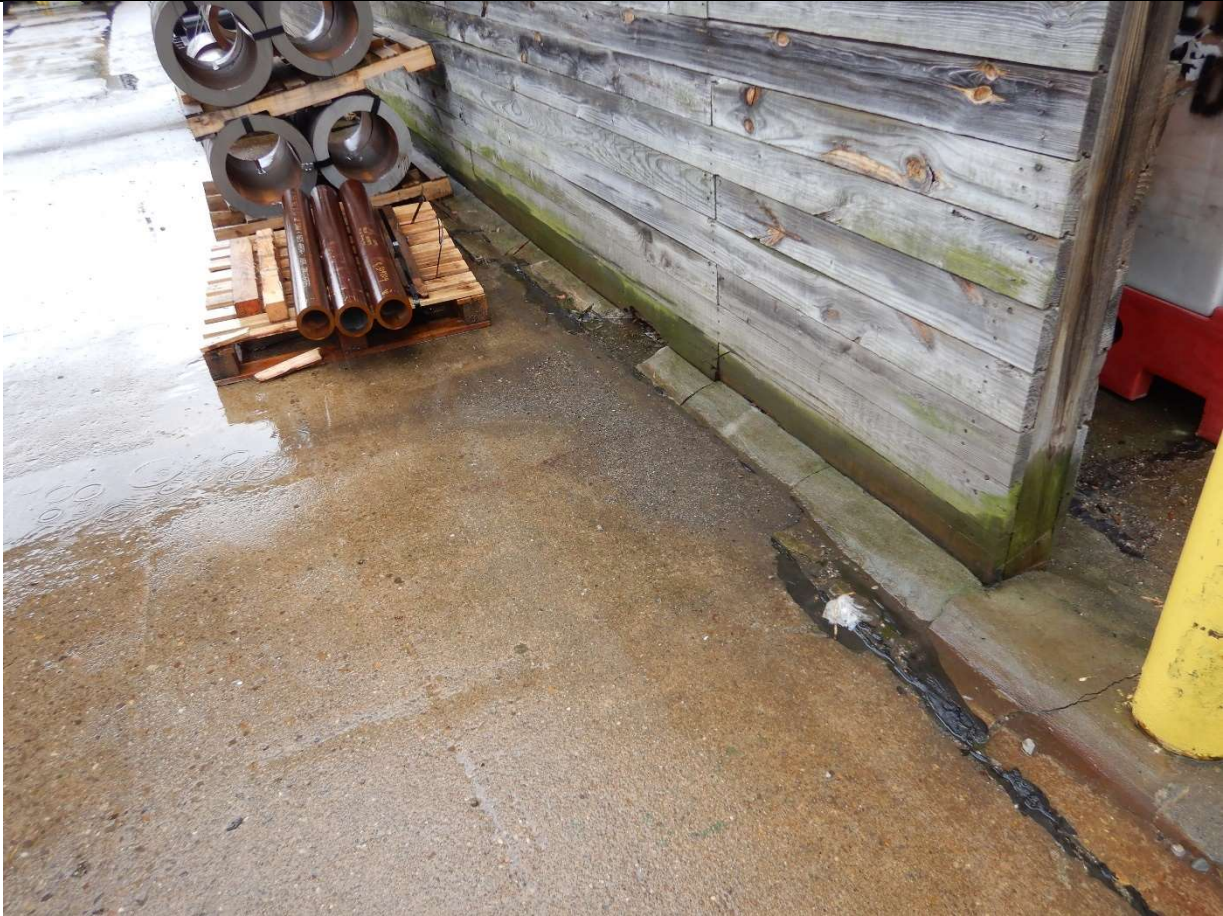
[71: DSCN2728.JPG](#)

Description: At the north end of a three-sided storage area attached to the wastewater treatment building. Storm water runoff was observed flowing through a gap in the curb surrounding the north side of storage area. The storm water continued to flow through the building and that condition is documented in photos 72 through 80.

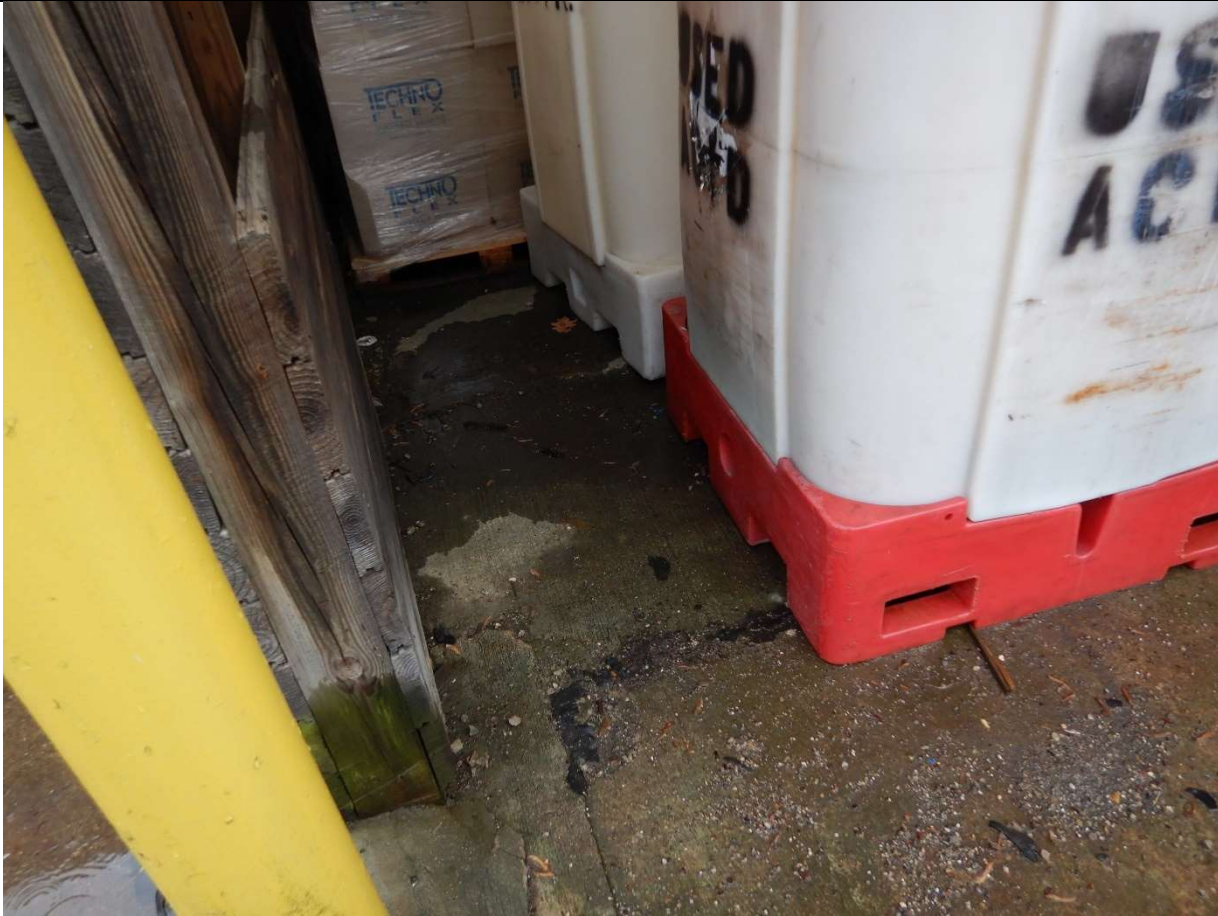
[72: DSCN2729.JPG](#)

Description: Inside the three-sided storage area attached to the wastewater treatment building, stormwater runoff flows through the space. The condition in the storage space is shown in Photos 72 through 80.

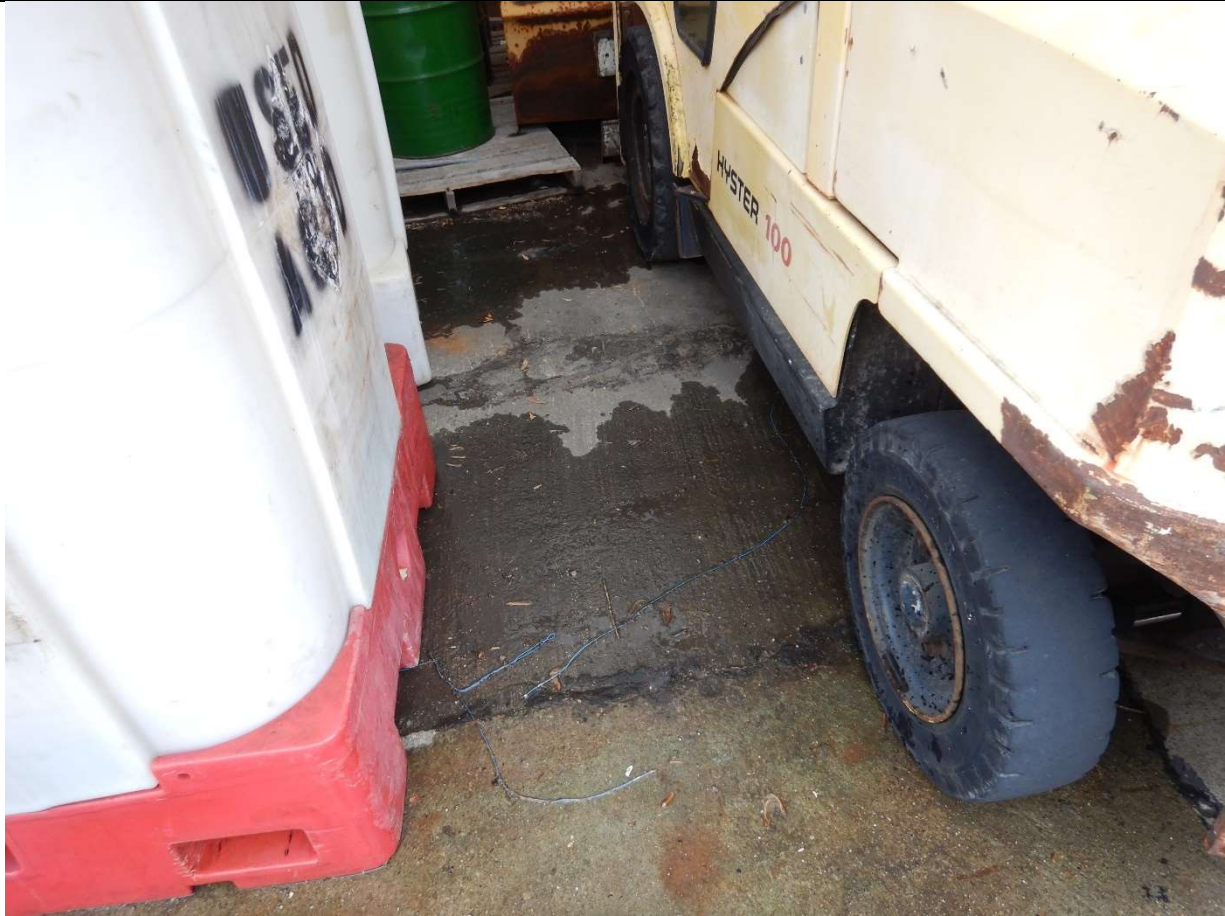
[73: DSCN2730.JPG](#)

Description: Inside the three-sided storage area attached to the wastewater treatment building, stormwater runoff flows through the space. The condition in the storage space is shown in Photos 72 through 80.

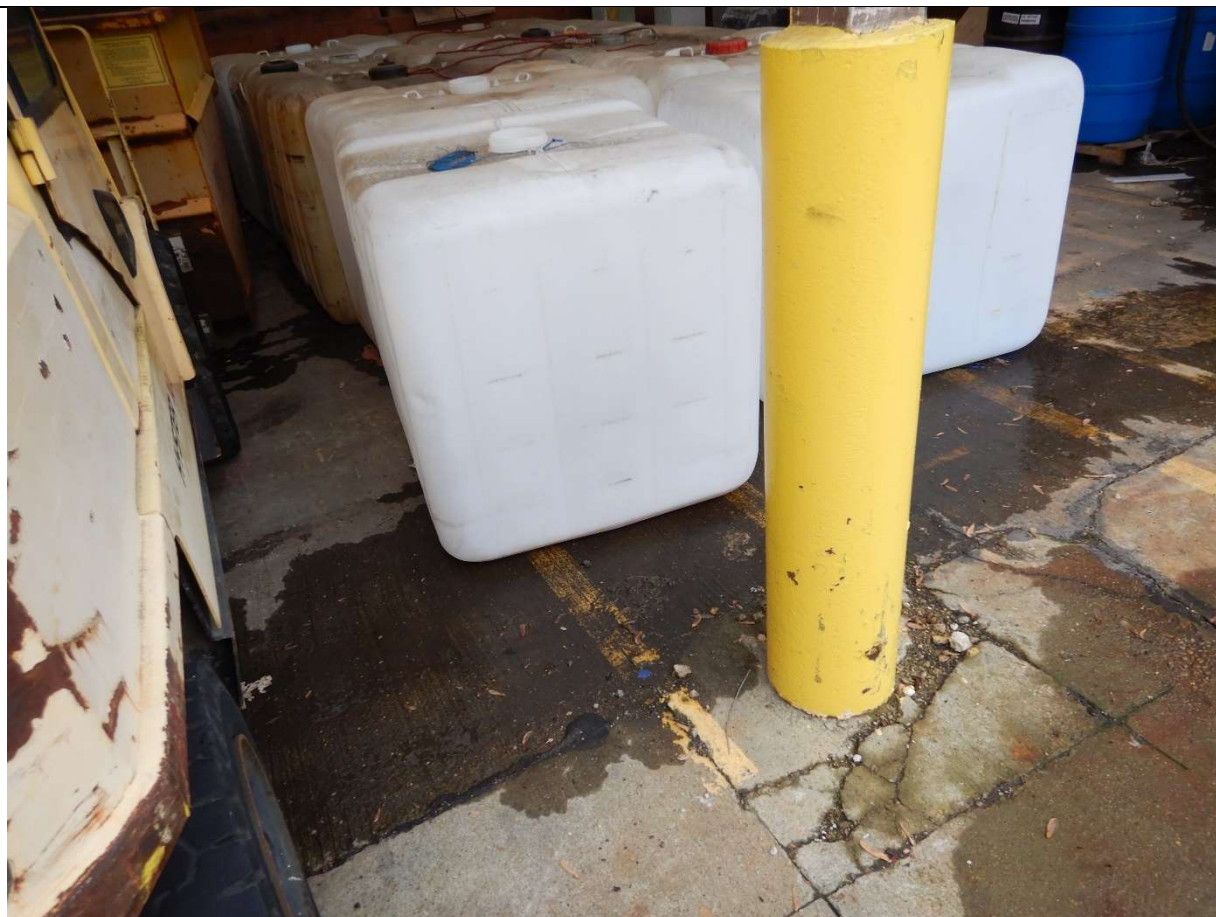
[74: DSCN2731.JPG](#)

Description: Inside the three-sided storage area attached to the wastewater treatment building, stormwater runoff flows through the space. The condition in the storage space is shown in Photos 72 through 80.

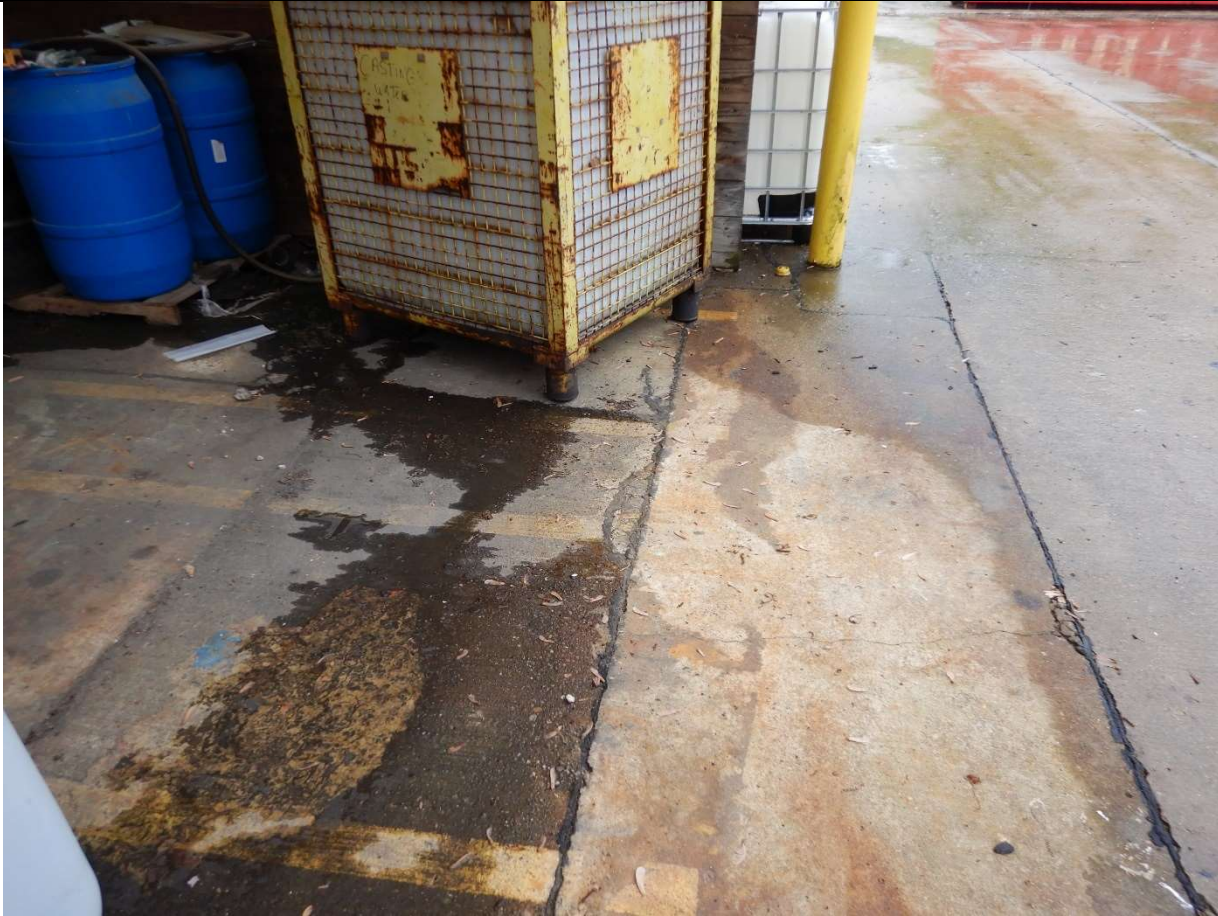
75: DSCN2732.JPG

Description: Inside the three-sided storage area attached to the wastewater treatment building, stormwater runoff flows through the space. The condition in the storage space is shown in Photos 72 through 80.

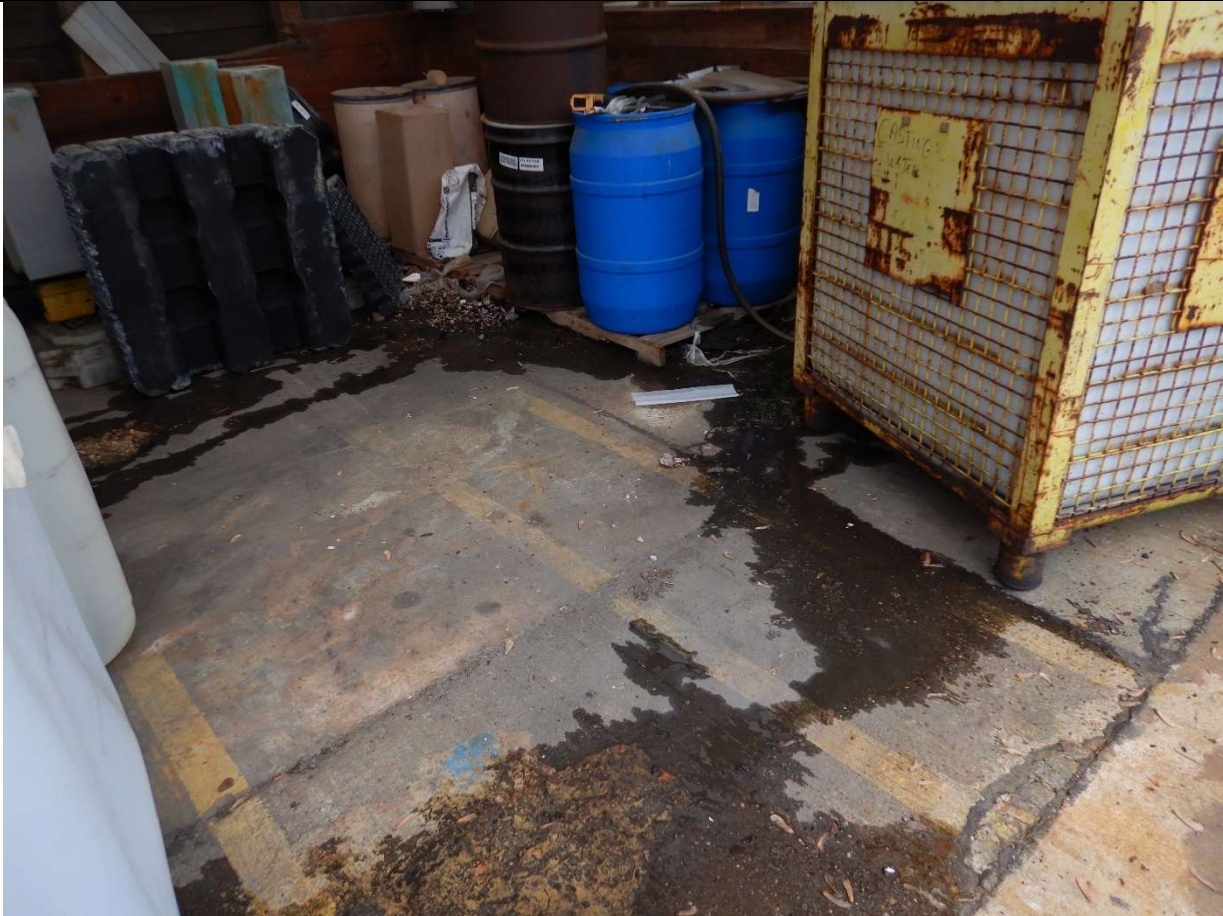
76: DSCN2733.JPG

Description: Inside the three-sided storage area attached to the wastewater treatment building, stormwater runoff flows through the space. The condition in the storage space is shown in Photos 72 through 80.

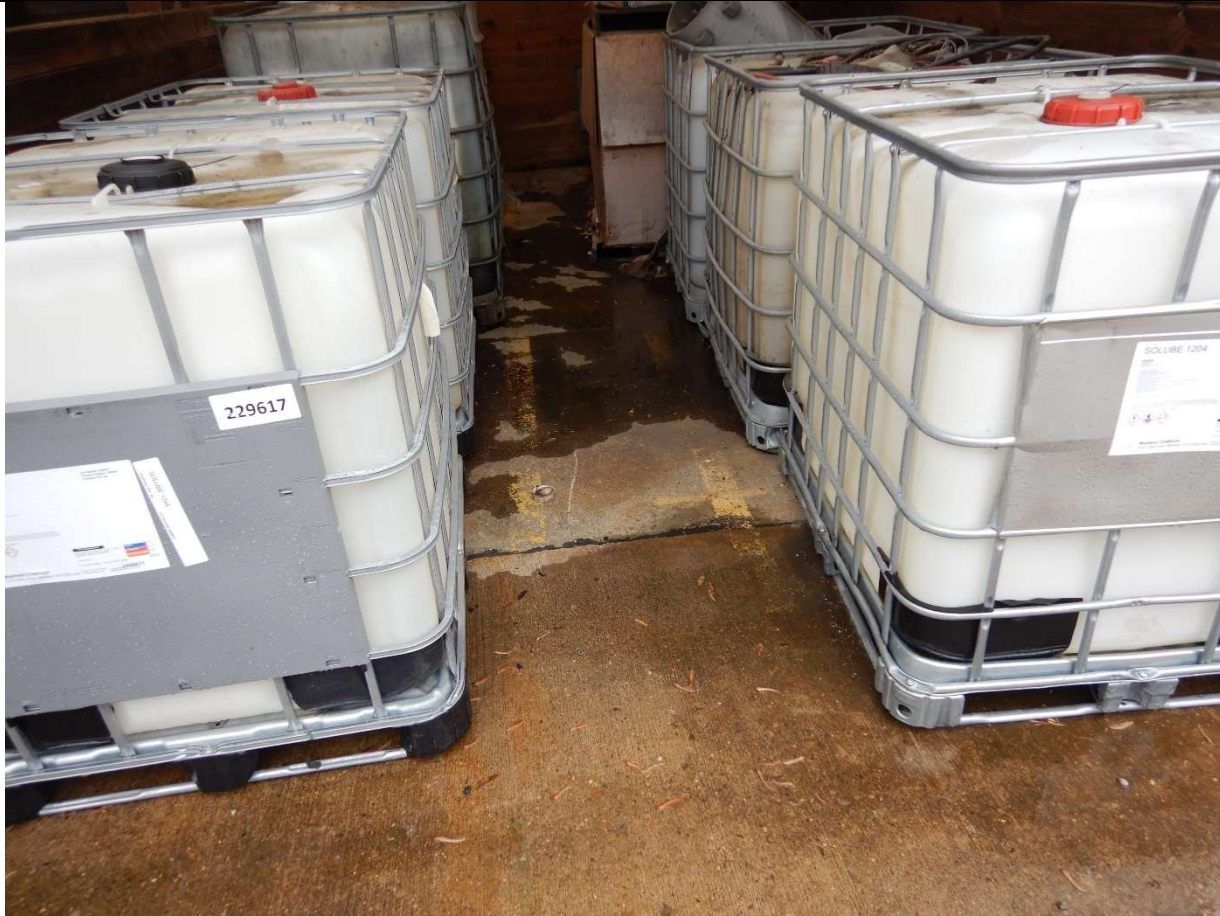
77: DSCN2734.JPG

Description: Inside the three-sided storage area attached to the wastewater treatment building, stormwater runoff flows through the space. The condition in the storage space is shown in Photos 72 through 80.

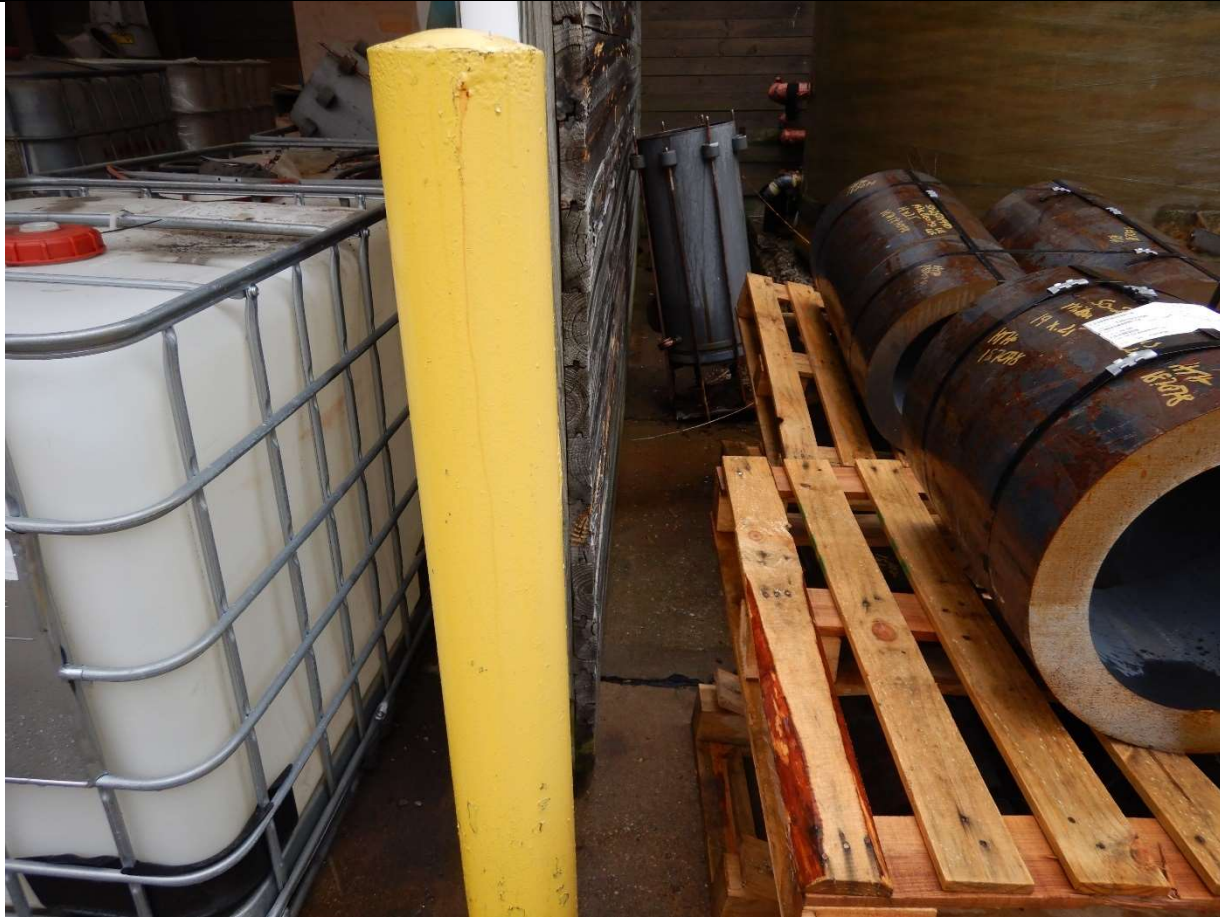
[78: DSCN2735.JPG](#)

Description: Inside the three-sided storage area attached to the wastewater treatment building, stormwater runoff flows through the space. The condition in the storage space is shown in Photos 72 through 80.

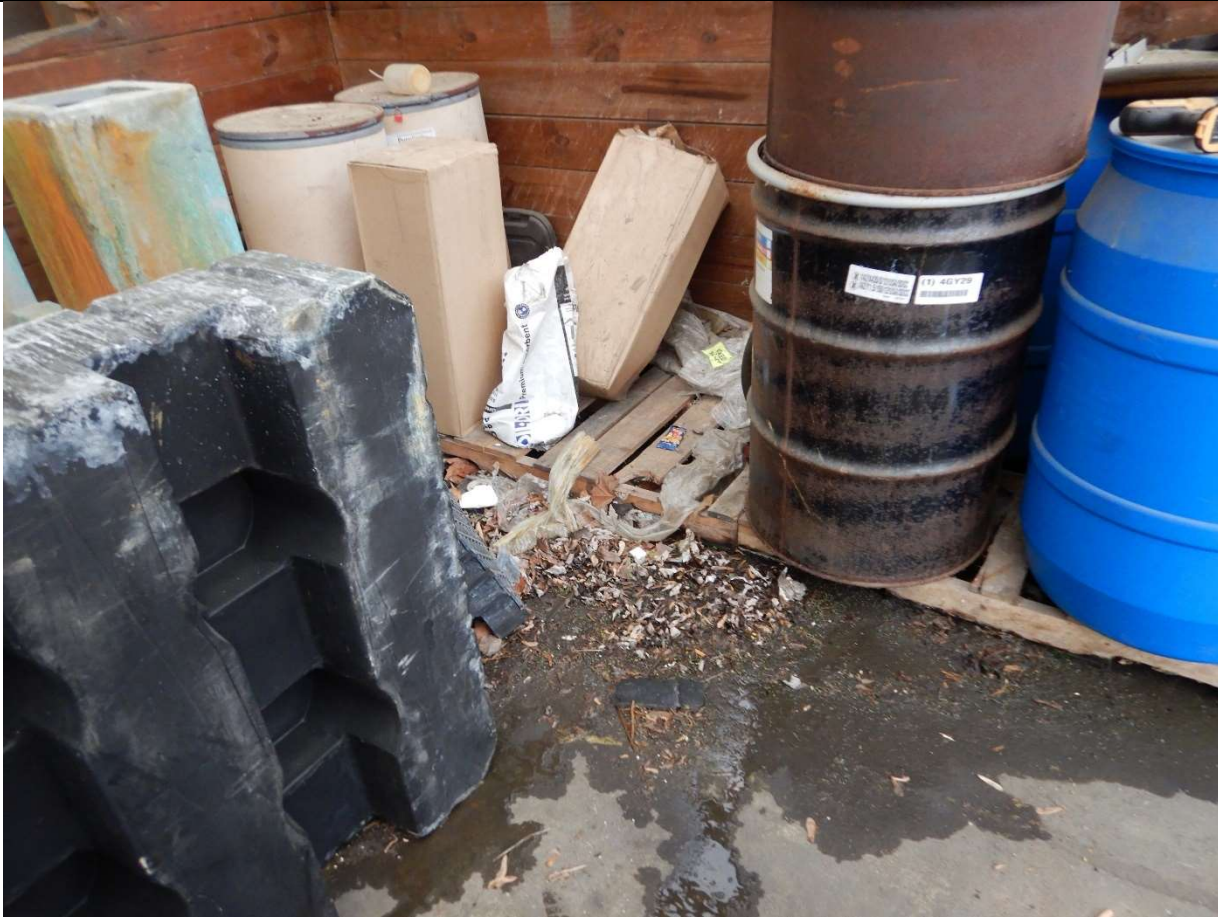
79: DSCN2736.JPG

Description: Inside the three-sided storage area attached to the wastewater treatment building, stormwater runoff flows through the space. The condition in the storage space is shown in Photos 72 through 80.

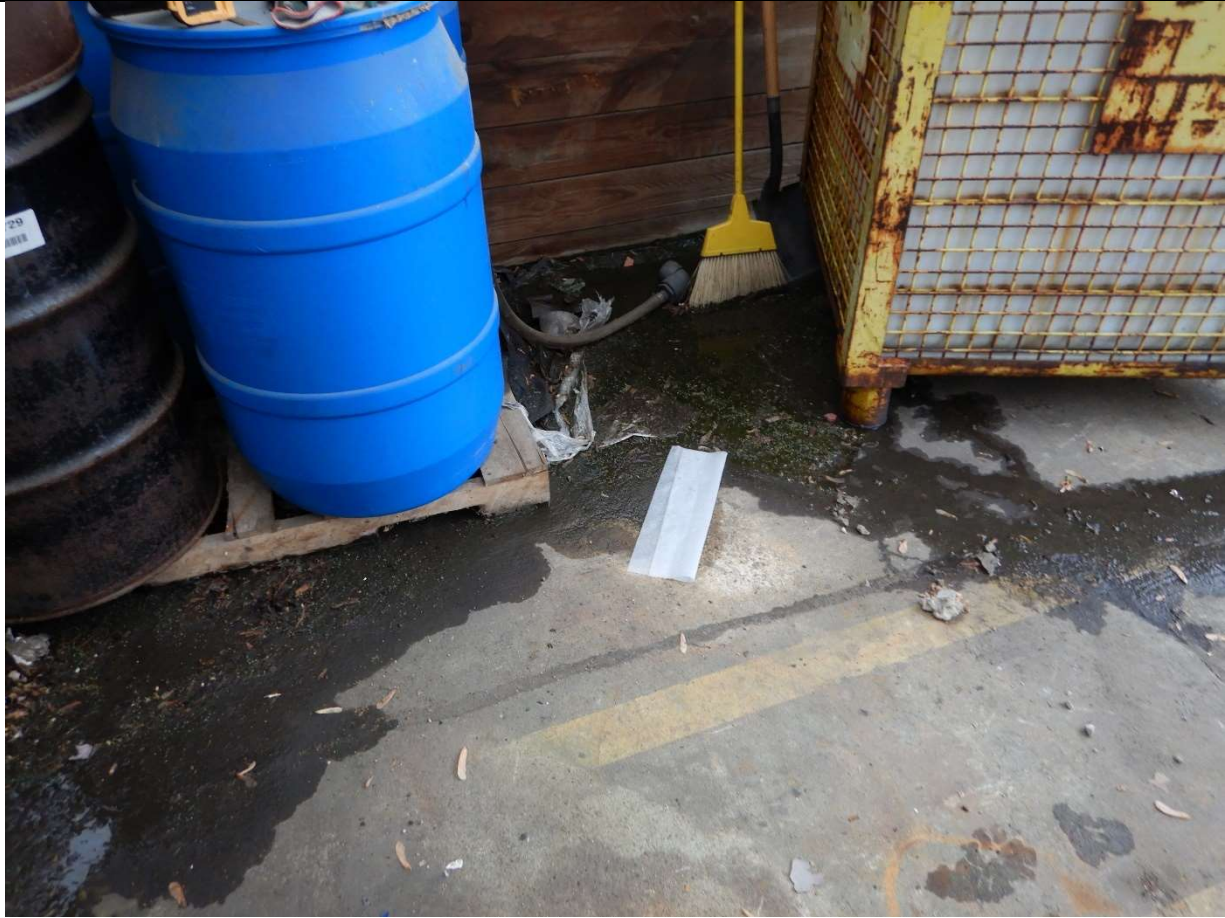
[80: DSCN2737.JPG](#)

Description: Inside the three-sided storage area attached to the wastewater treatment building, stormwater runoff flows through the space. The condition in the storage space is shown in Photos 72 through 80.

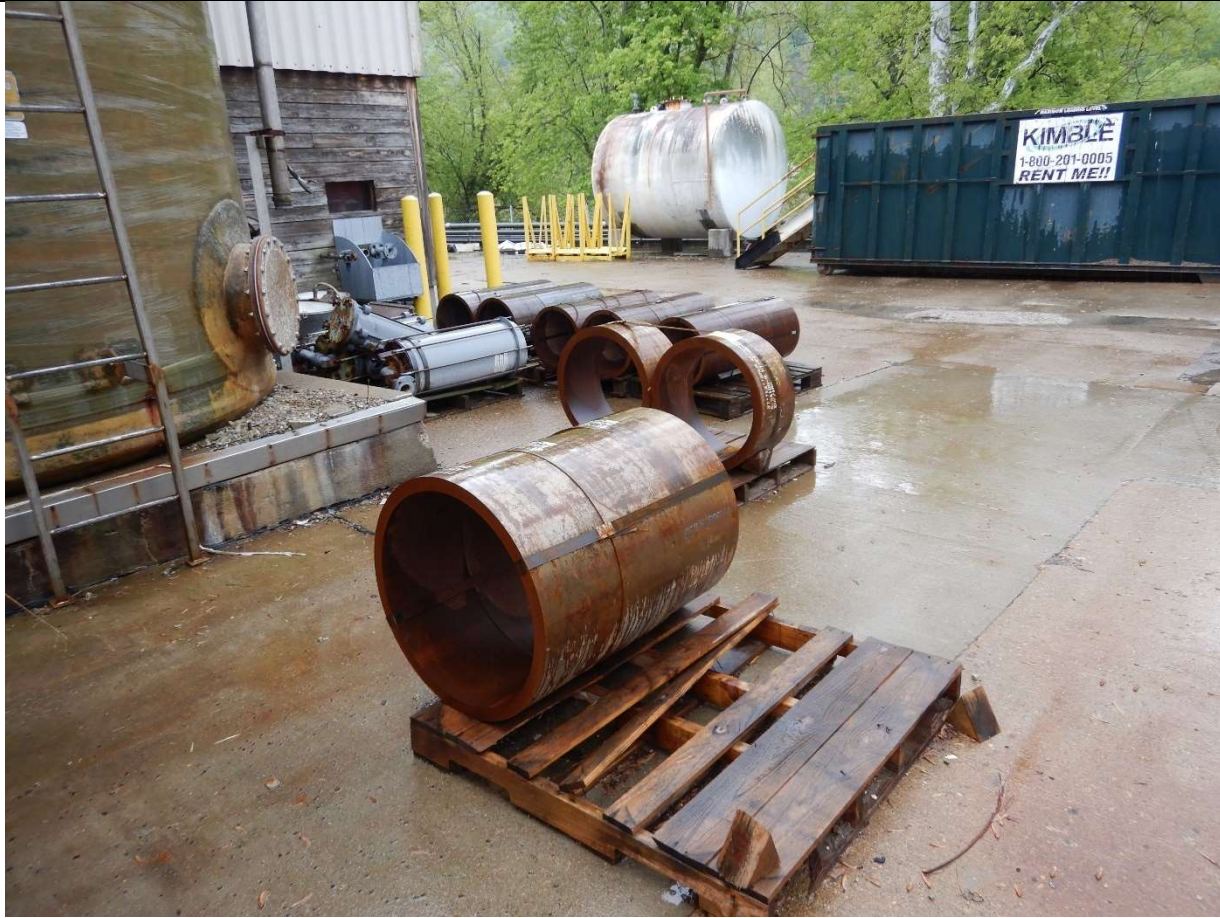
[81: DSCN2738.JPG](#)

Description: Material storage and west and south of the wastewater treatment building, and a roll off container with non-hazardous storage.

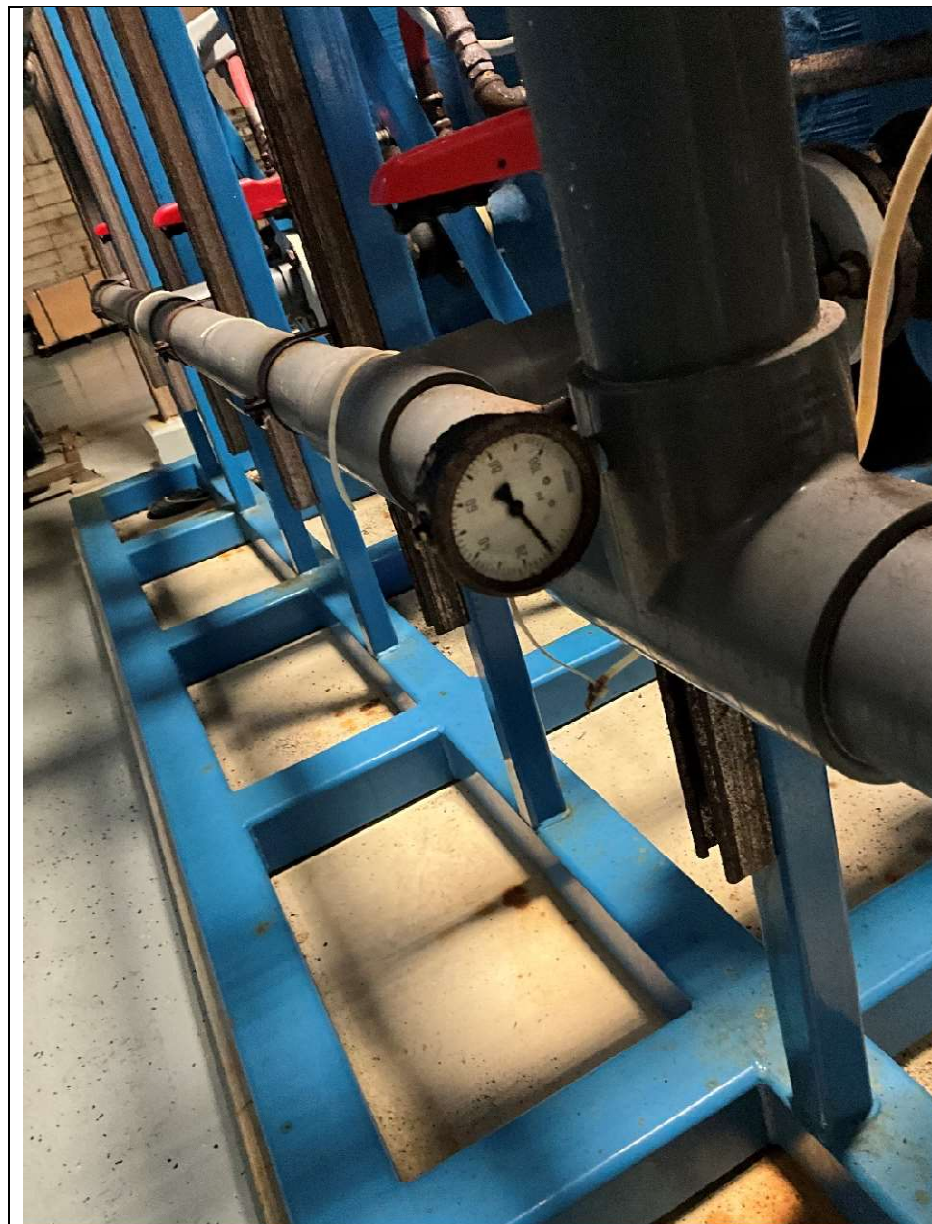
114: IMG\_0090.jpeg

Description: Downstream pressure gage at the filters. EPA observed this gage for a pump cycle, and the needle did not move when the pumps feeding the filters cycled.

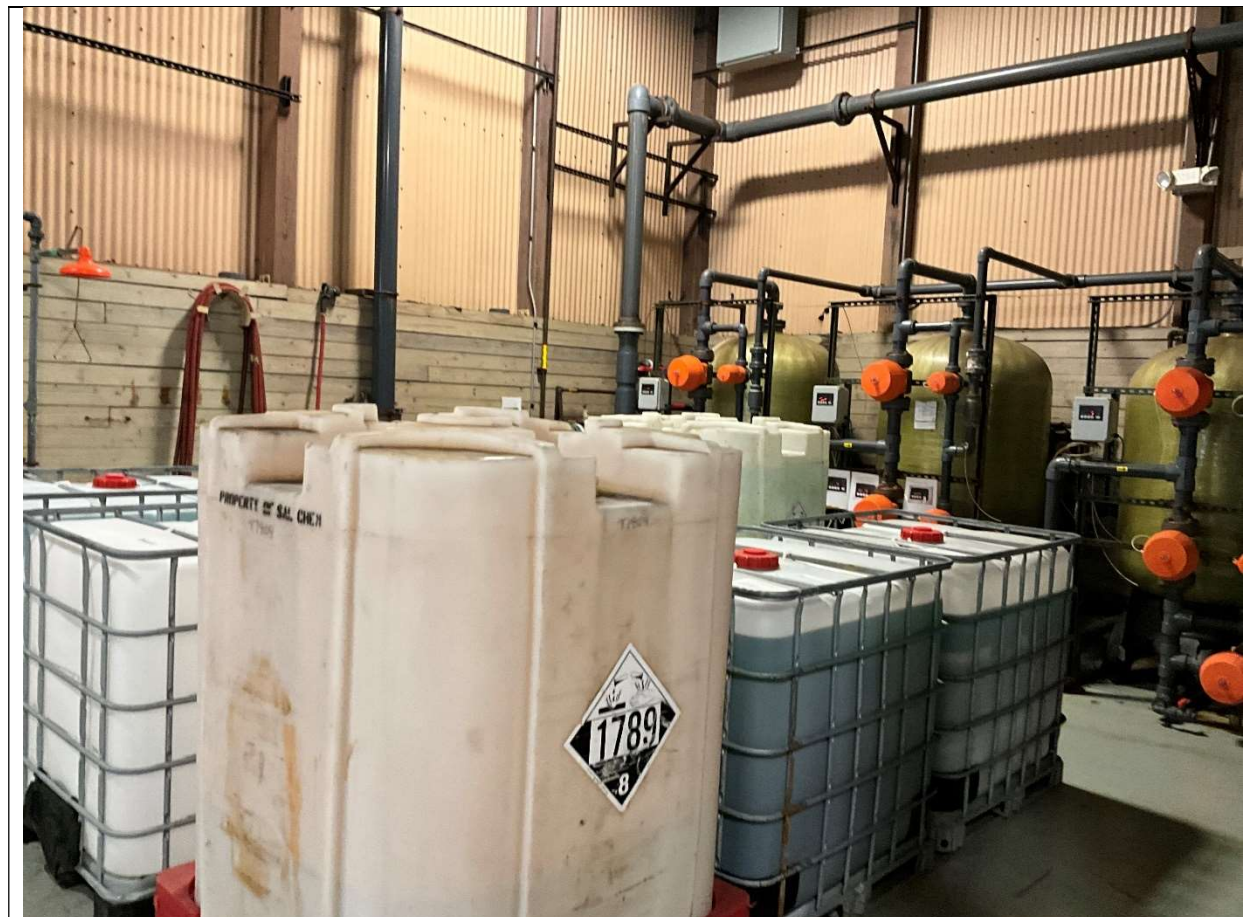
[123: IMG\\_0099.jpeg](#)

Description: In the wastewater treatment building, at the location of chemical storage and hazardous waste storage in the wastewater building. Behind the storage totes was a water softener system for water used in the plant.

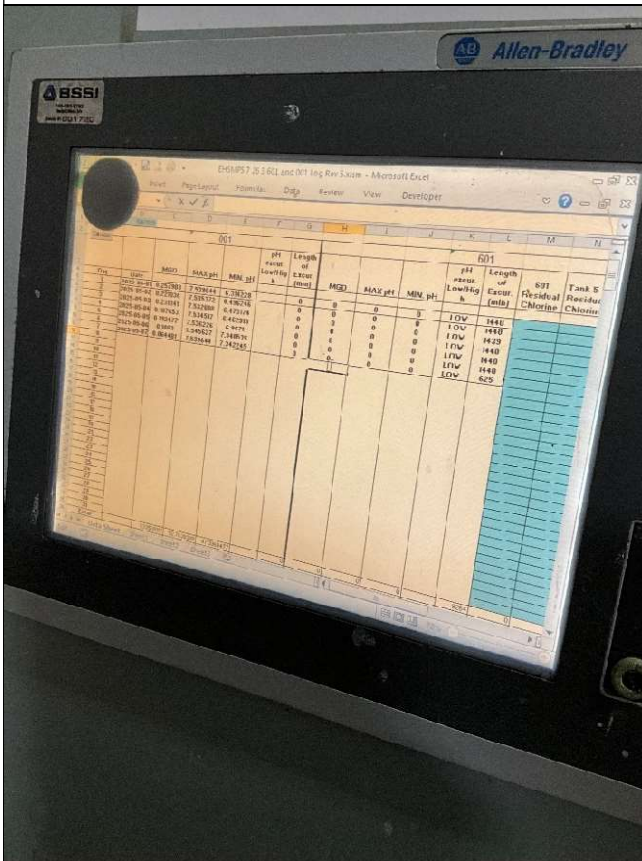
**126: IMG\_0102.jpeg**

**Description:** At the location of flow measurement for Outfall 001.
