**Region 6 Compliance Assurance and Enforcement Division  
INSPECTION REPORT**

| Inspection Date(s): | 08/21-22/2024 | | |
| Company Name: | International Paper Co | | |
| Facility Name: | Mansfield Mill | | |

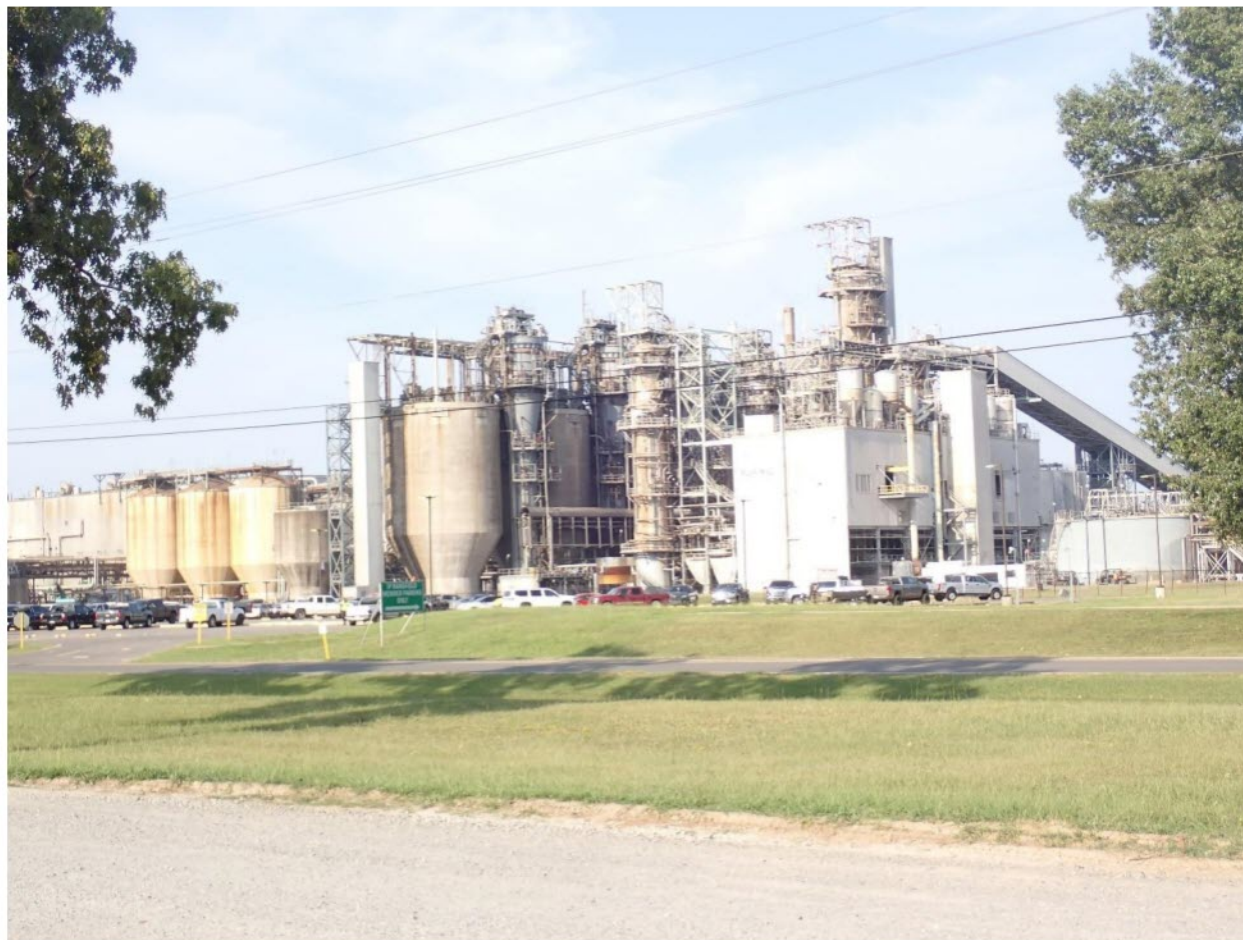
Photo No. 1

Photograph File Name: P8220160.JPG  
Date of Photograph: 08/22/2024  
Latitude and Longitud: 32.1567100 -93.5599159  
Orientation: N  
Map Datum: WGS-84  
Time of Photo: 04:34 PM  
Photographer: Jack Arias  
Description: This image shows the entrance and the facility.

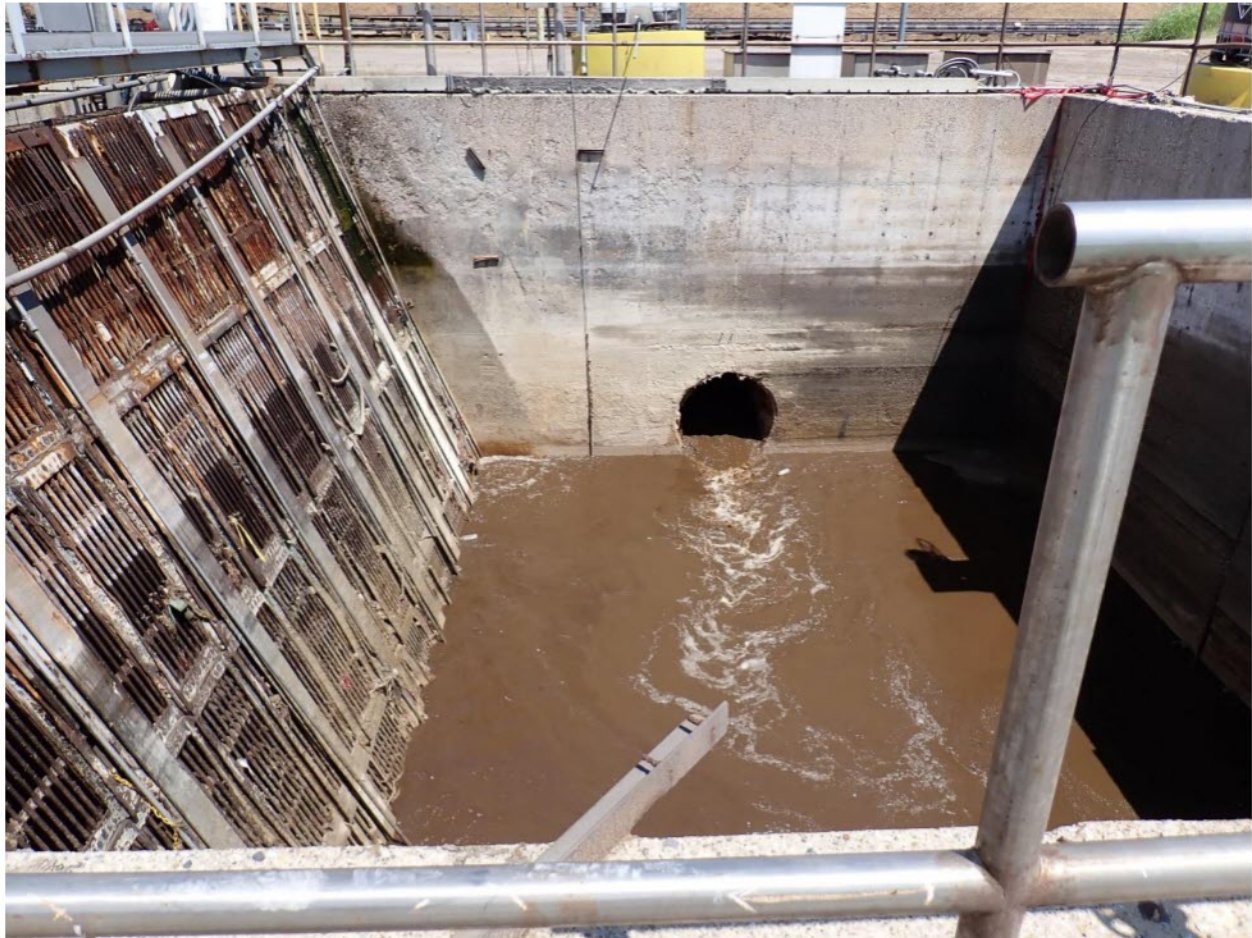
Photograph File Name: P8210055.JPG  
Date of Photograph: 08/21/2024  
Latitude and Longitude: 32.156380 -93.554439  
Orientation: SE  
Map Datum: WGS-84  
Time of Photo: 11:05 AM  
Photographer: Jack Arias  
Description:

This image shows the lift pit system which is part of the wastewater treatment system. This system received and collected wastewater from trenches, sewers, and hard piping wastewater.

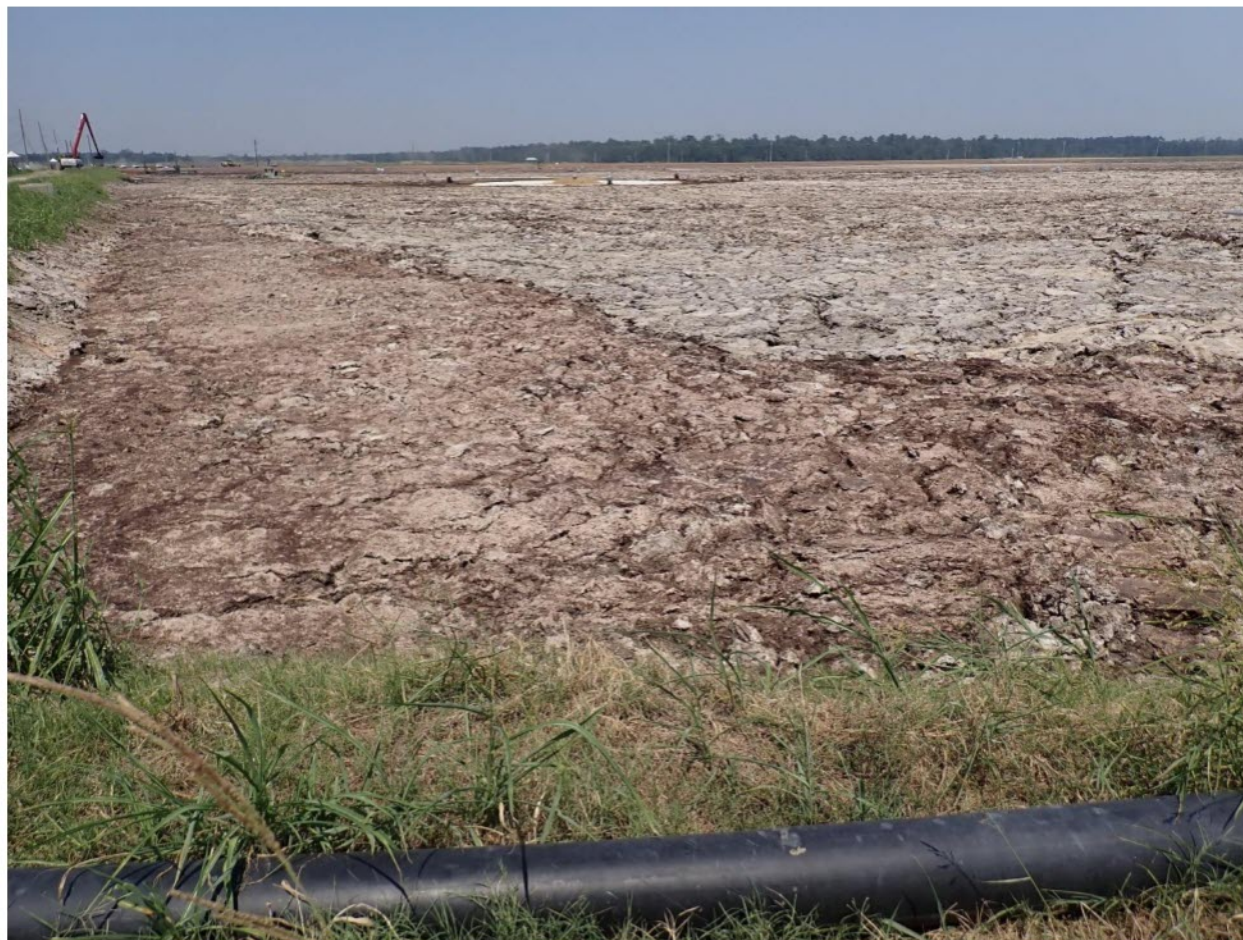
Photograph File Name: P8210103.JPG  
Date of Photograph: 08/21/2024  
Latitude and Longitude: 32.160163 -93.551060  
Orientation: SE  
Map Datum: WGS-84  
Time of Photo: 12:55 PM  
Photographer: Jack Arias  
Description:

This image shows the surge basin system. This system is the greatest part of the wastewater treatment system. This system received and treated various process wastewater streams from the mill procedures.

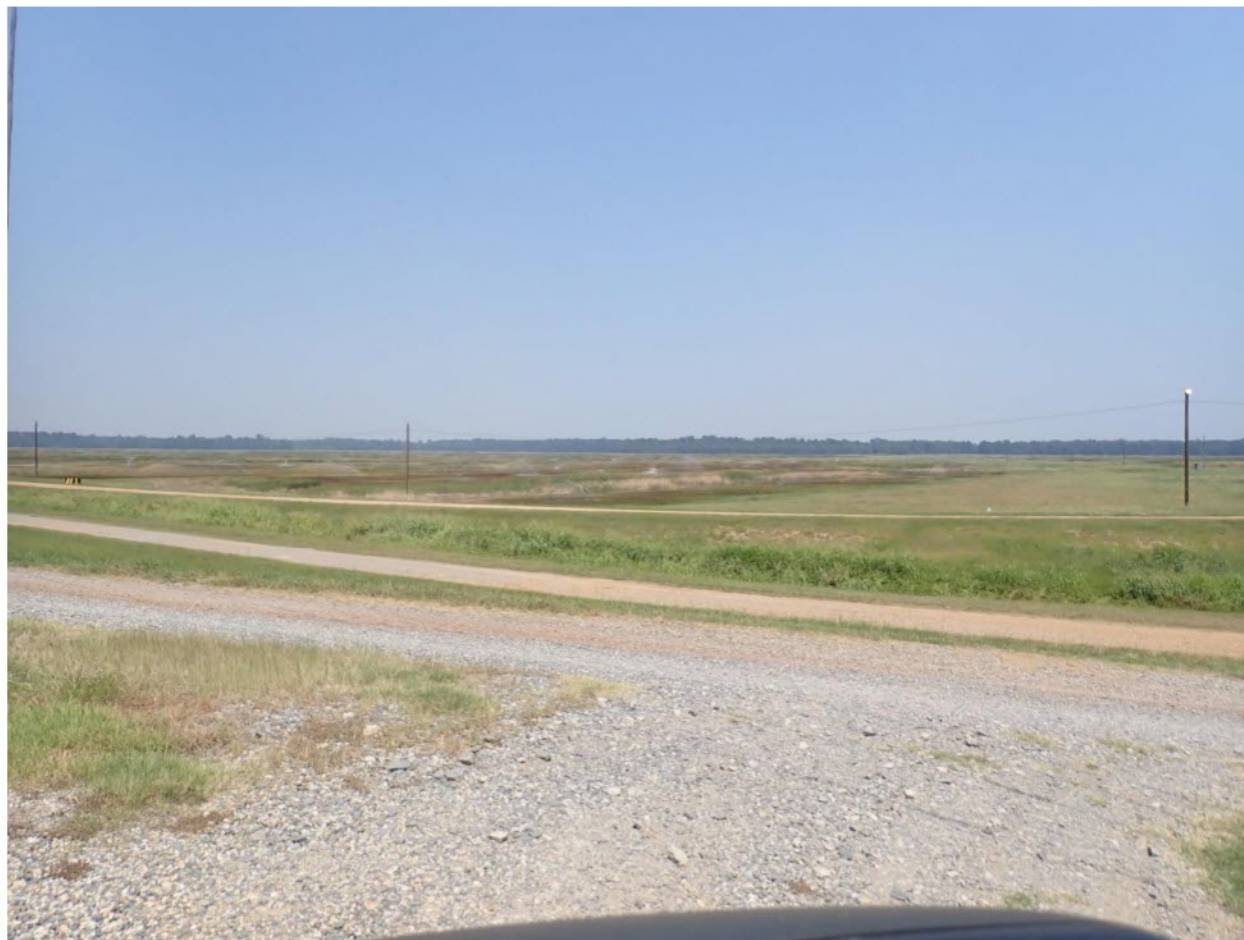
Photograph File Name: P8210113.JPG  
Date of Photograph: 08/21/2024  
Latitude and Longitud: 32.156593 -93.543281  
Orientation: SE  
Map Datum: WGS-84  
Time of Photo: 1:24 PM  
Photographer: Jack Arias  
Description:

This image shows the overland flow treatment system. Here the wastewater is sprayed onto terraced fields where biodegradation takes place in the soil.

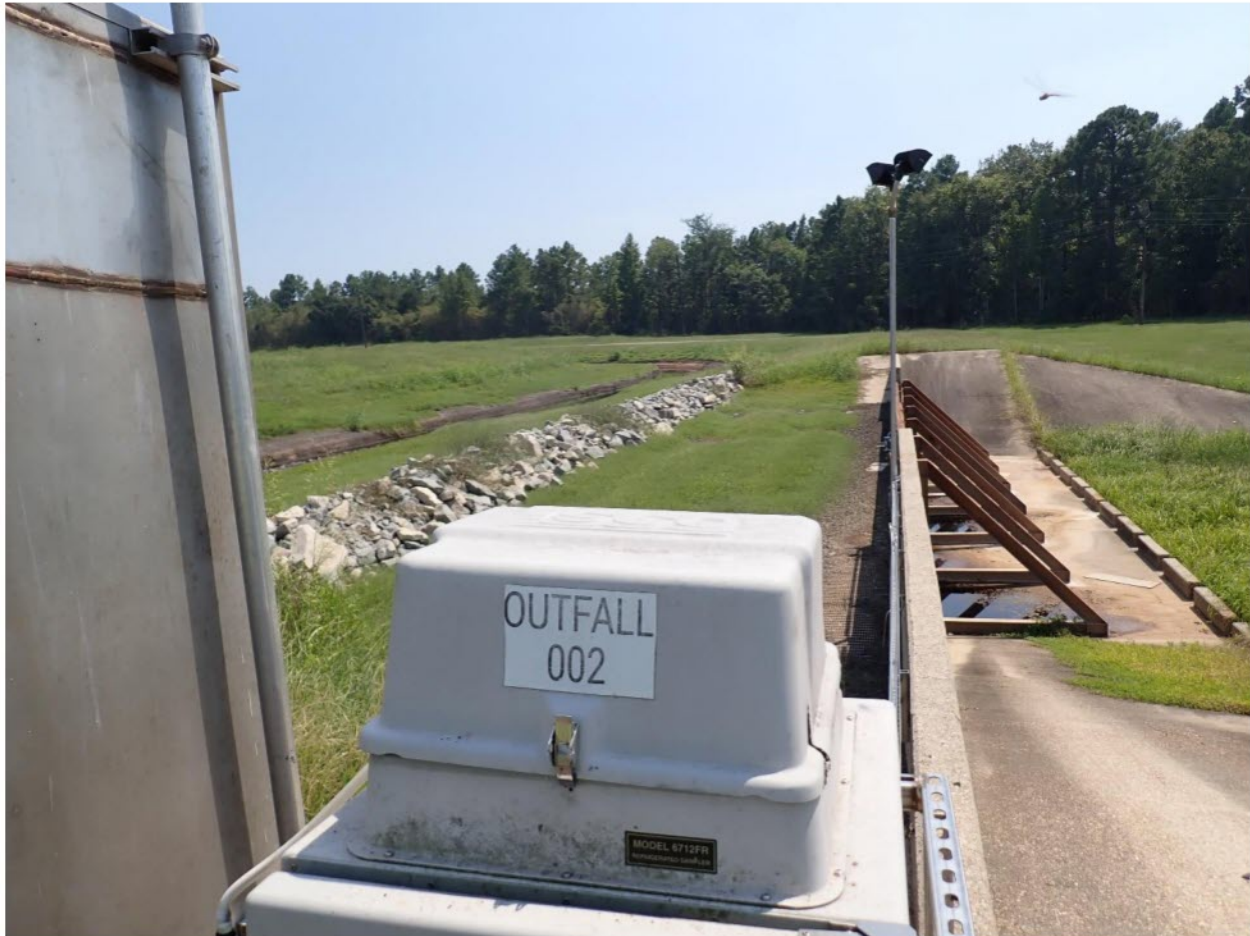
Photograph File Name: P8210115.JPG  
Date of Photograph: 08/21/2024  
Latitude and Longitude: 32.160163 -93.551060  
Orientation: SE  
Map Datum: WGS-84  
Time of Photo: 1:24 PM  
Photographer: Jack Arias  
Description:

This image shows outfall 002 that receives and includes an intermittent overflow of treated combined process wastewater, process area storm water runoff, landfill leachate, utility wastewater, miscellaneous wastewater, non-process area stormwater runoff, and monitored treated sanitary wastewater from internal outfalls 101 and 201.
