**Region 6 - Enforcement & Compliance Assurance Division**  
**INSPECTION REPORT**

| <b>Inspection Date(s):</b> | 02/24/2025 – 02/25/2025 | |
| <b>System Name:</b> | <b>Deming Municipal Water System</b> | |
| <b>PWS ID:</b> | NM3528616 | |

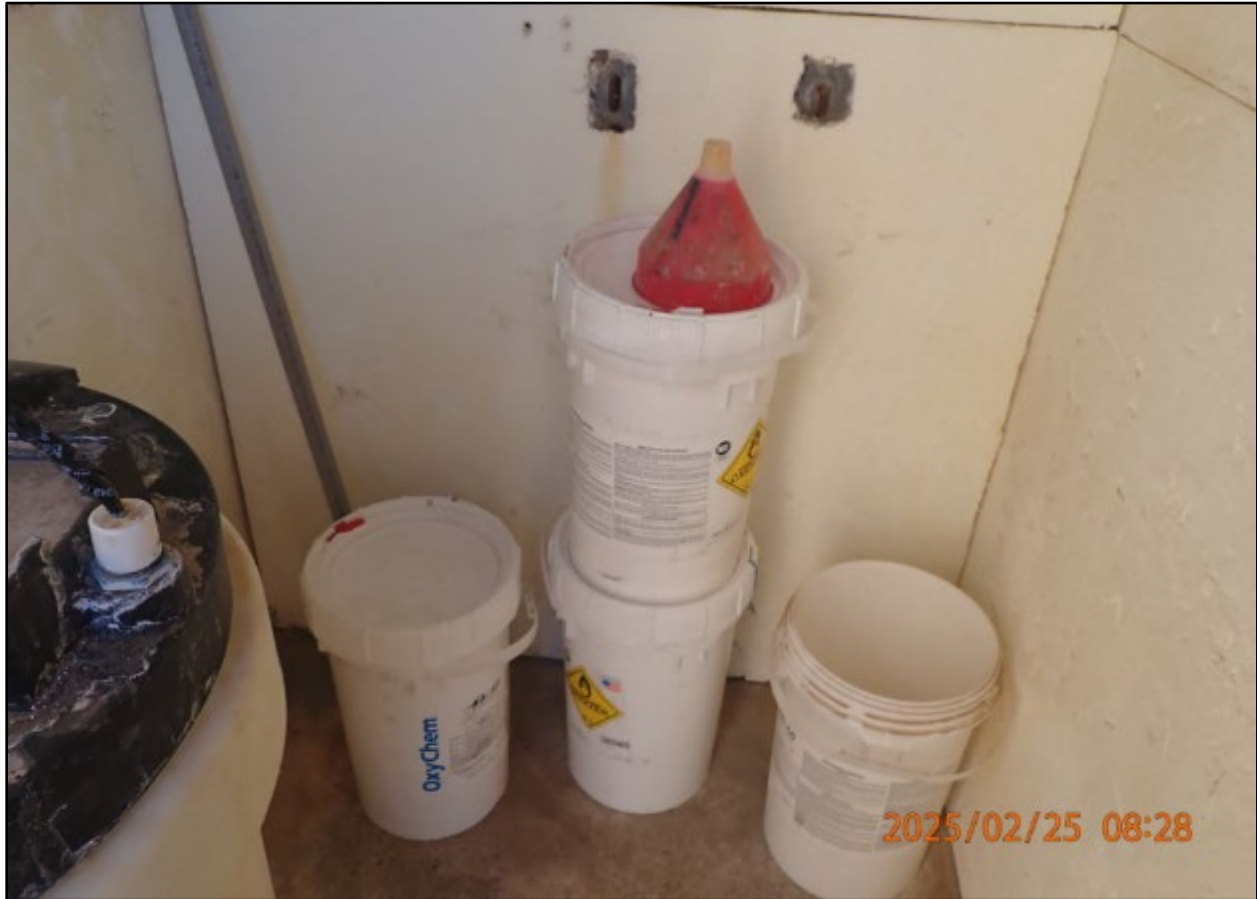
**Photograph 10. 02/25/2025 08:27 P2250280.JPG**

The EPA inspection team observed that the calcium hypochlorite feed room had an open electrical box with exposed wiring, no ventilation (automatic or manual), a chemical container open to atmosphere, and no secondary containment for the chemical tank (Refer to [Appendix 1, Photographs 8, 9, 10, and 11](#)). The eyewash station was inoperable, according to System representatives.

**Observation 11.** The EPA Inspection Team observed that there was no secondary containment for the chemical storage or feed systems in the calcium hypochlorite feed rooms at all inspected well stations (Refer to Appendix 1, Photographs 10, 13, 14, 17, 23, and 24).

**Observation 12.** The EPA Inspection Team observed chemical storage containers with openings and not vented outside of the building in the calcium hypochlorite feed rooms at all inspected well stations (Refer to Appendix 1, Photographs 10, 13, 14, 17, 23, and 24).

Description: Chlorine feed for Well #1 without secondary containment and open to the room atmosphere.
