## **Appendix B**

# **Photograph Log**

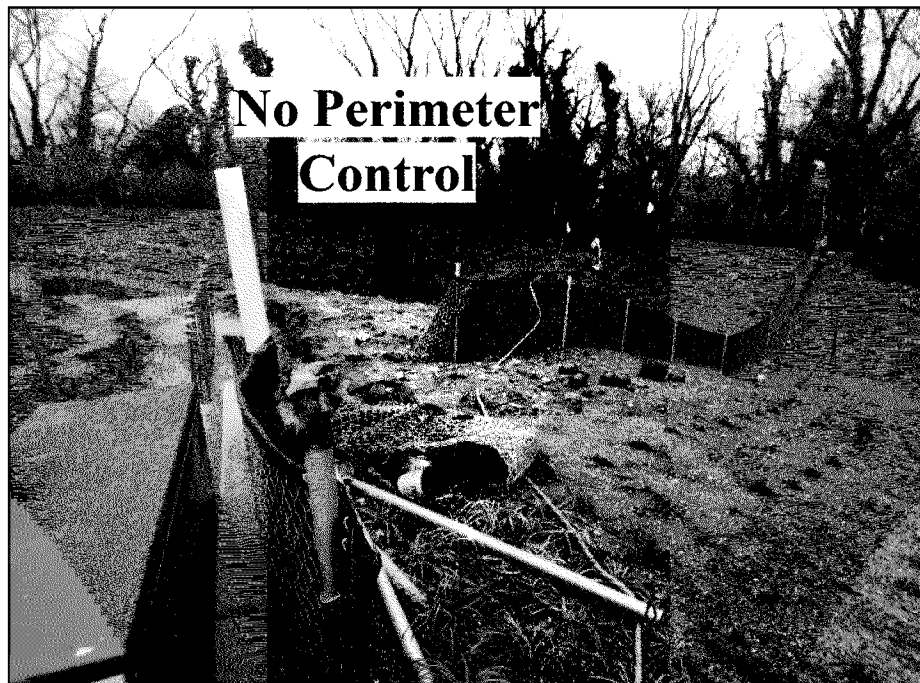
**Photograph 22.** (DSCN3926.JPG) View, facing northeast, of a silt fence along the east perimeter. The EPA Inspection team did not observe perimeter controls at one location along the southeast perimeter.

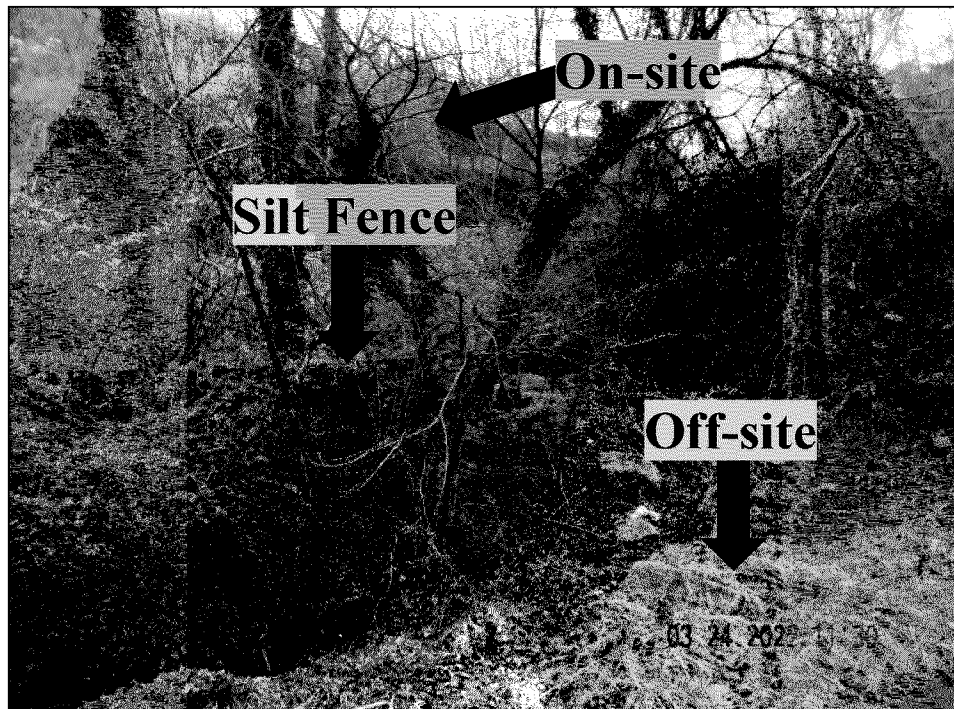
**Photograph 23.** (DSCN4069.JPG) View, facing south, of a silt fence along the north perimeter. Photograph was taken off-site.

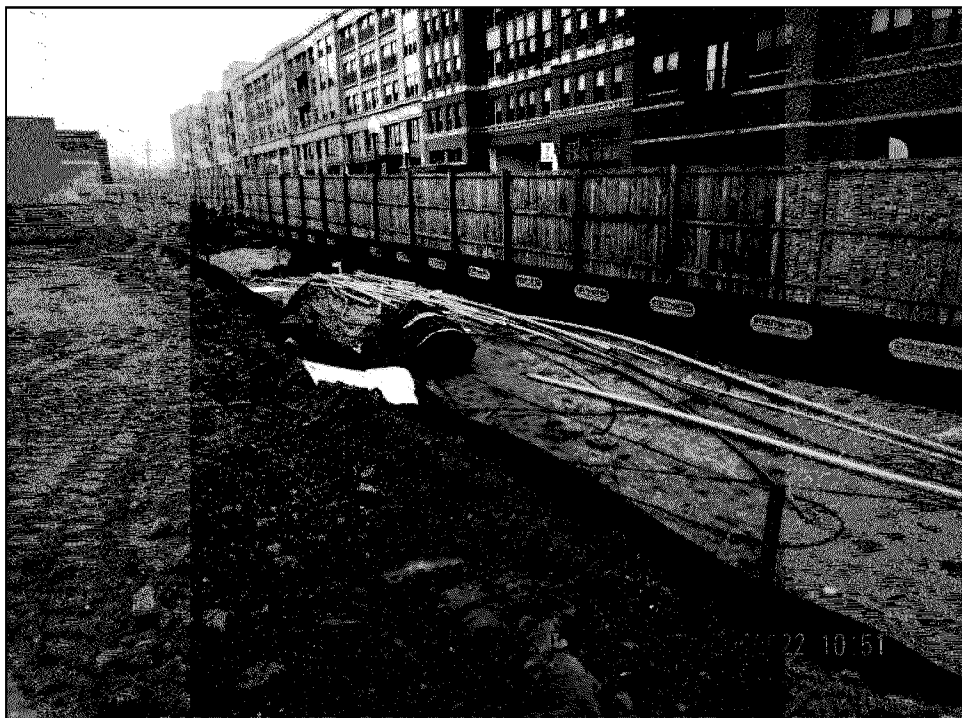
**Photograph 24.** (DSCN4053.JPG) View, facing south, of a silt fence along the west perimeter.

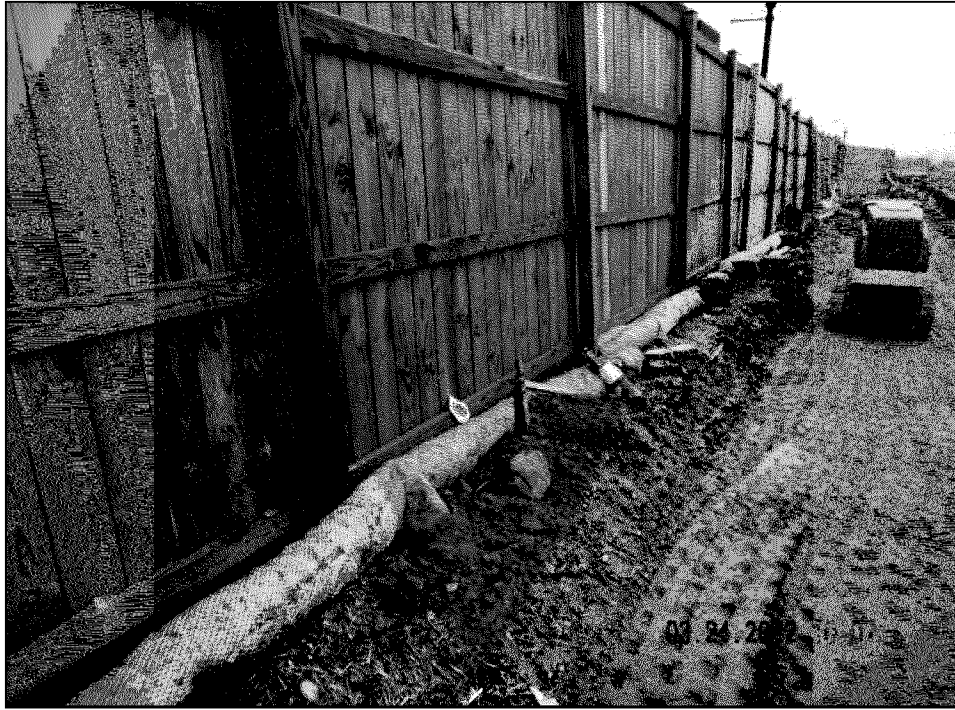
**Photograph 25.** (DSCN3948.JPG) View, facing northwest, of a filter sock along the west perimeter.

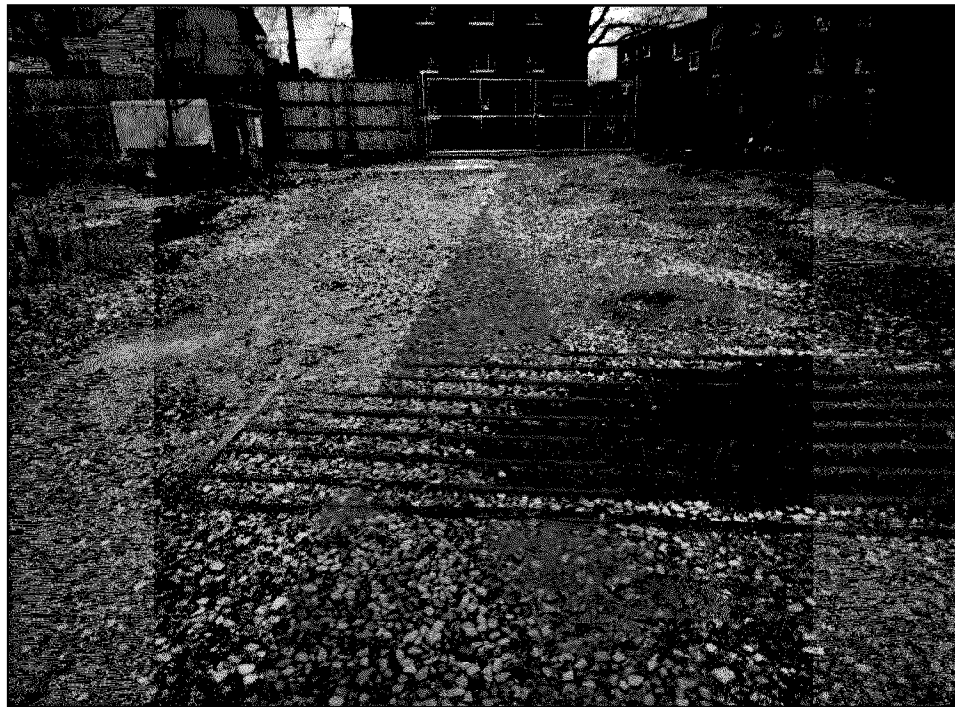
**Photograph 26.** (DSCN4004.JPG) View, facing west, of a wash rack at the stabilized construction entrance at the northwest corner.

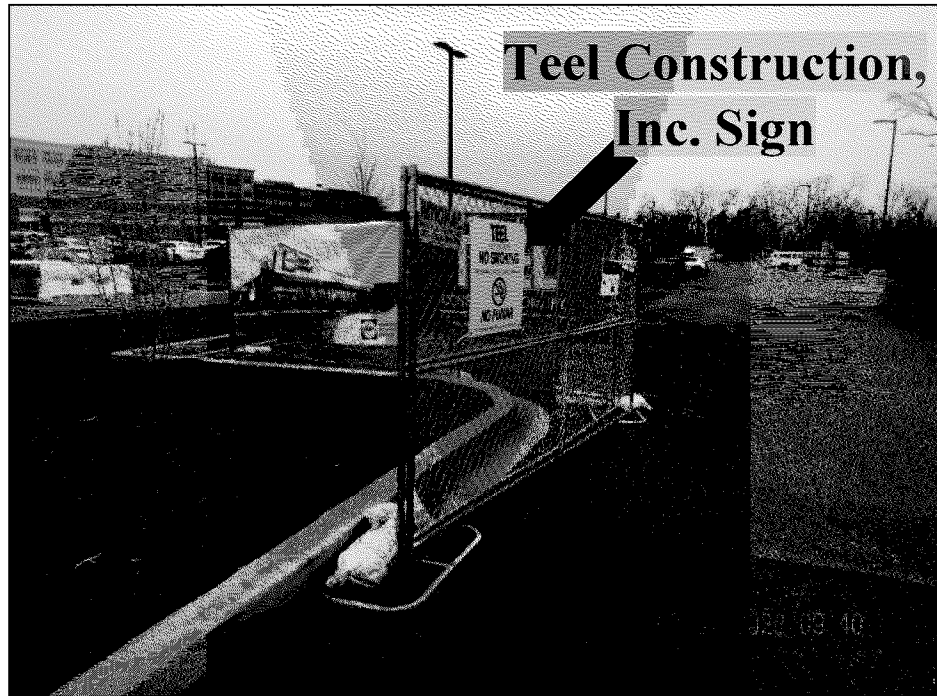
**Photograph 27.** (DSCN3919.JPG) View, facing north, of the paved entrance that led to the disturbed area of the site. A Teel Construction, Inc. sign was posted at this location.

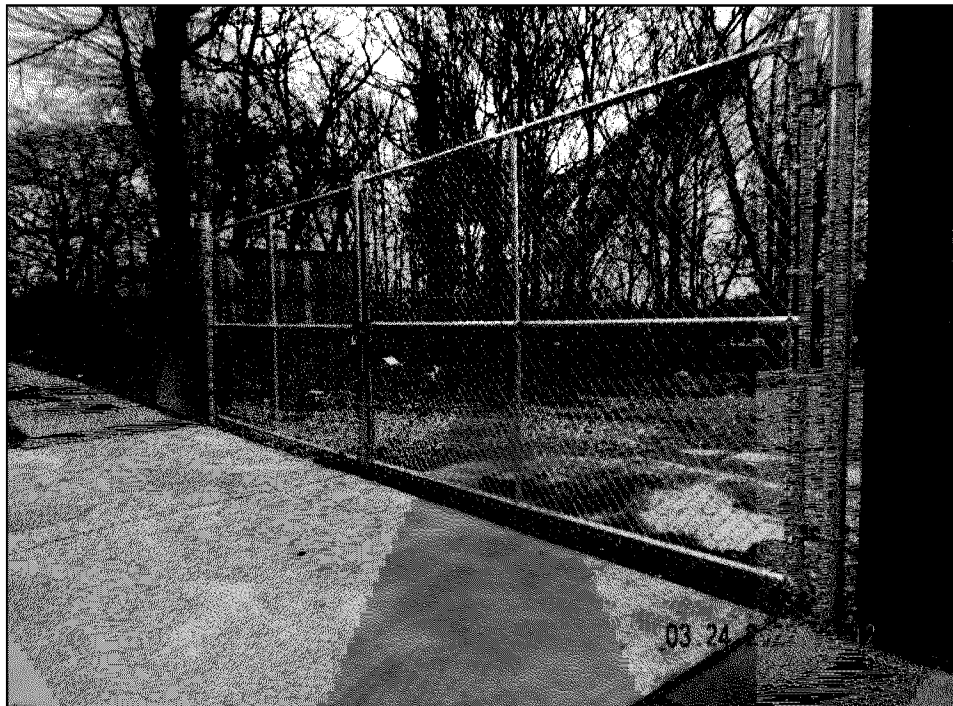
**Photograph 28.** (DSCN4068.JPG) View, facing northeast, of the stabilized construction entrance at the northwest corner of the site. Permit-required elements were not posted on a sign at this location.

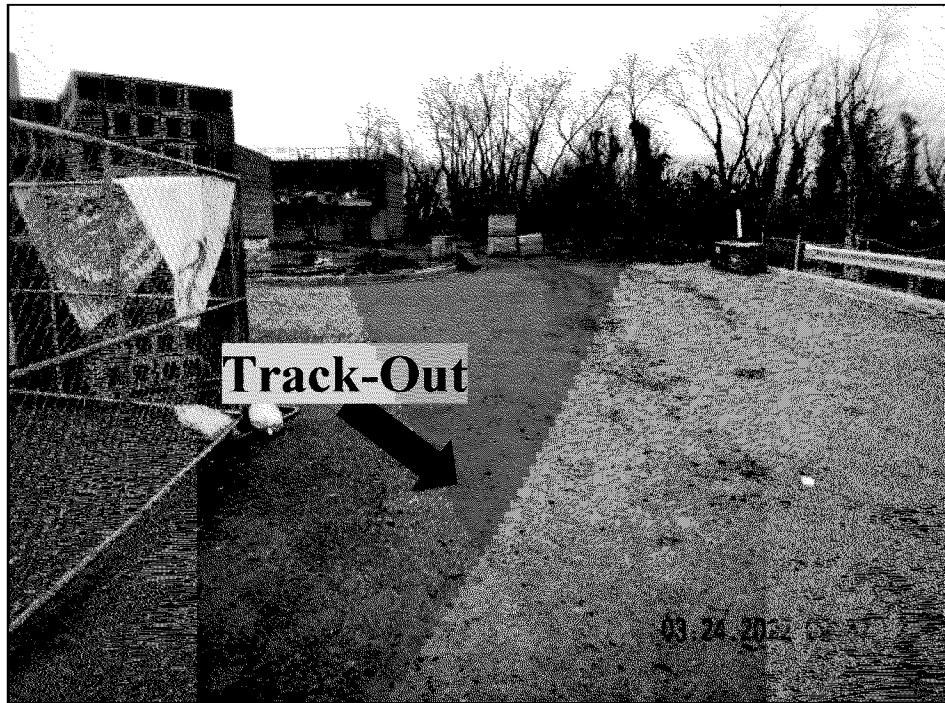
**Photograph 29.** (DSCN3924.JPG) View, facing north, of the paved entrance that led to the disturbed area of the site. Note the sediment track-out along the entrance.

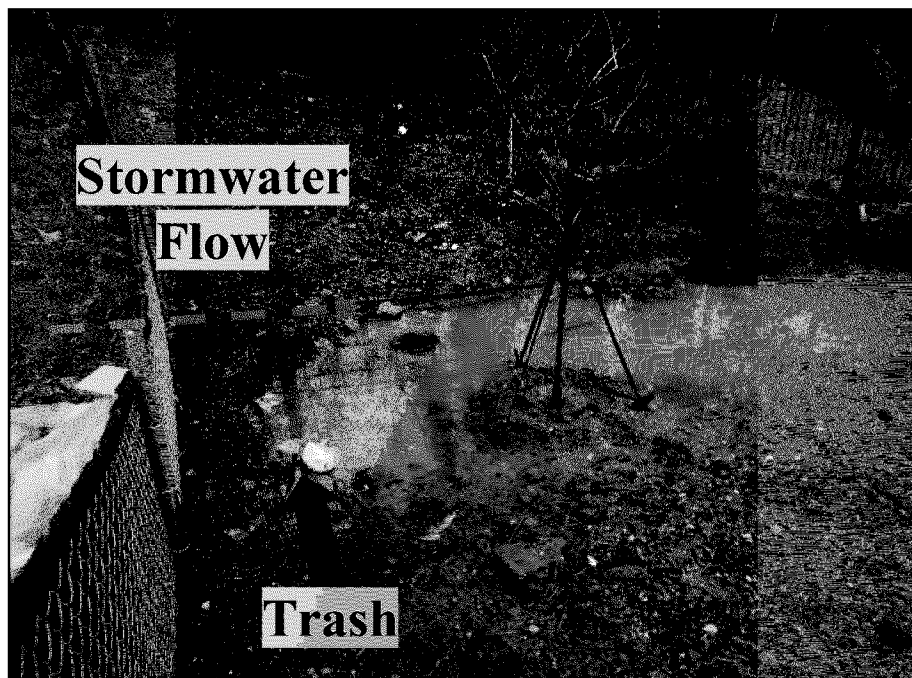
**Photograph 34.** (DSCN3929.JPG) View, facing southeast, of the sediment-laden stormwater pooled at the southeast corner of the site. The pool contained trash and was downgradient of the locations shown in Photographs 31 through 33.

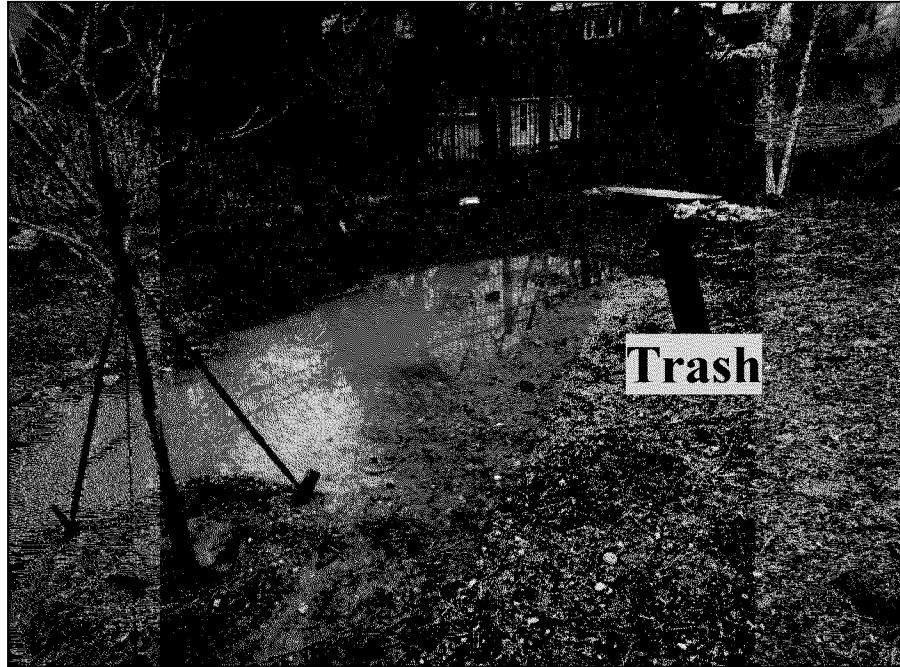
**Photograph 35.** (DSCN3930.JPG) View, facing south, of the sediment-laden stormwater pooled at the southeast corner of the site. Trash was located downgradient of the pool.

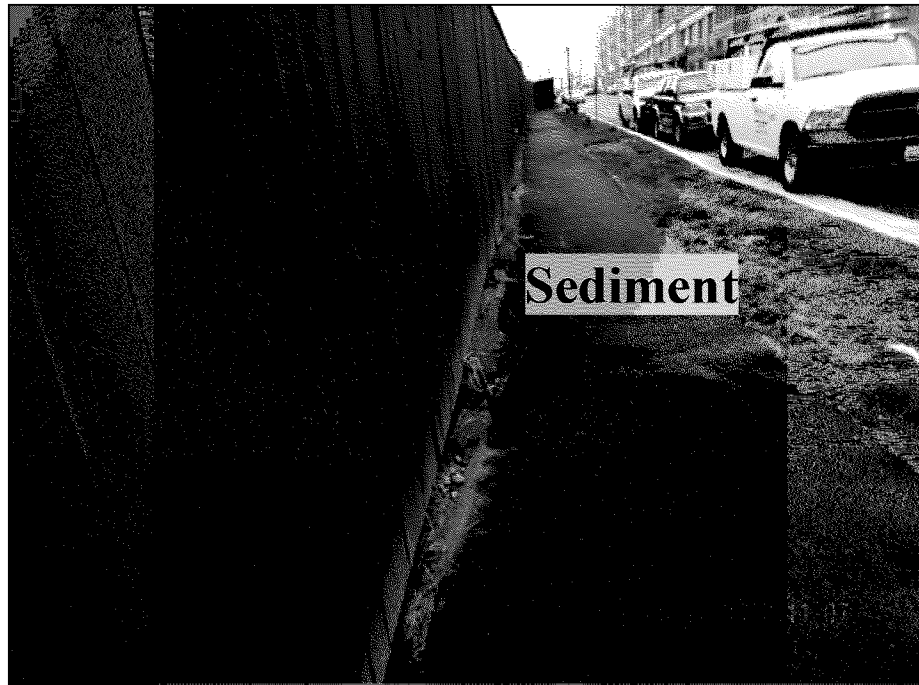
**Photograph 45.** (DSCN4063.JPG) View, facing south, of sediment located off-site adjacent to the west perimeter. Photograph was taken off-site.

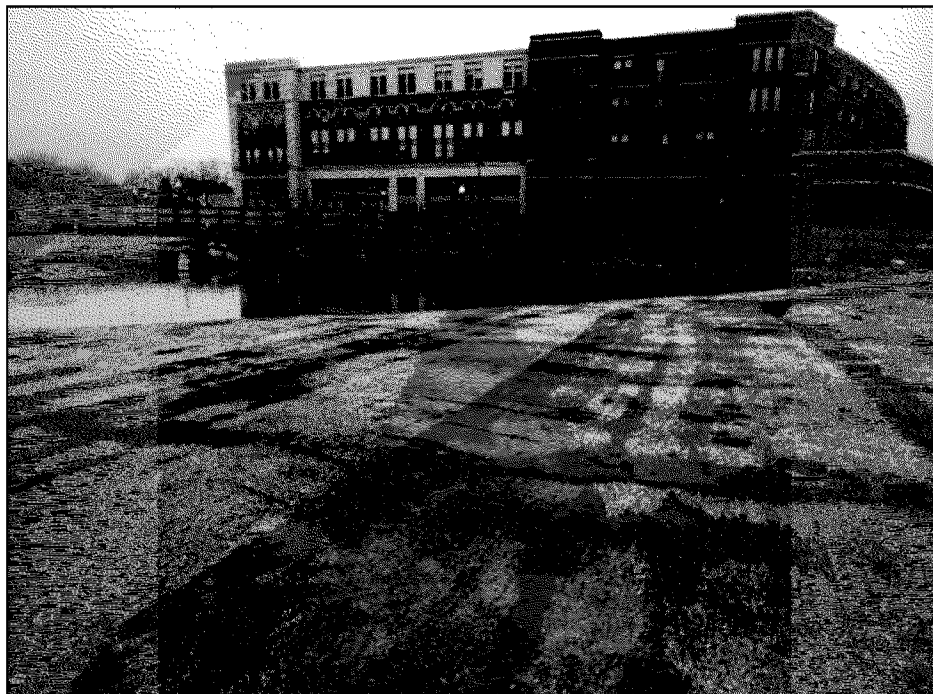
**Photograph 46.** (DSCN4014.JPG) View, facing south, of stormwater pooled adjacent to the mid-west perimeter in the north area of the site.

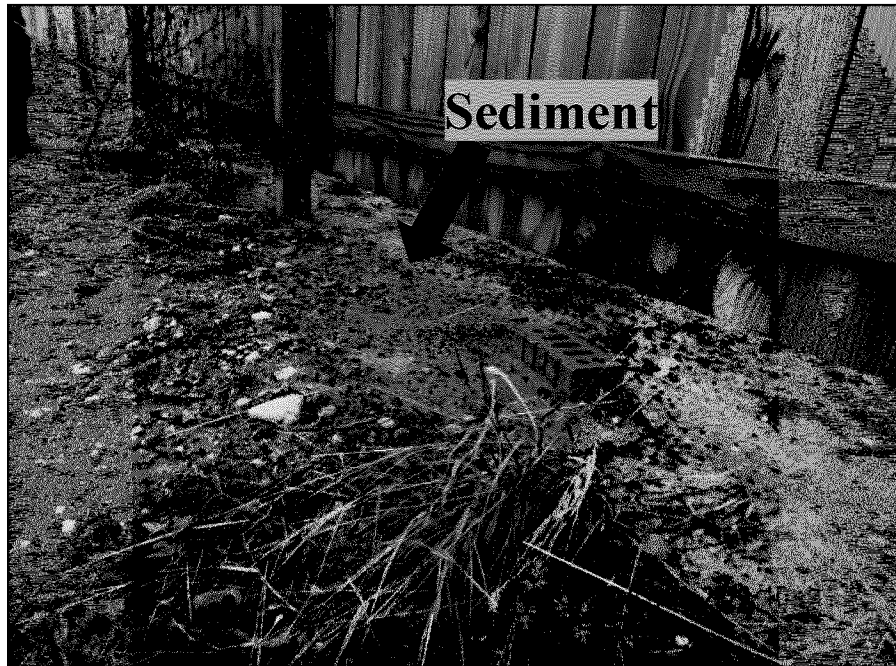
**Photograph 49.** (DSCN4022.JPG) View, facing south, of the mid-west perimeter downgradient of the pooled stormwater in the north area of the site shown in Photographs 46 through 48. Note the sediment. The EPA Inspection Team did not observe perimeter controls at this location.

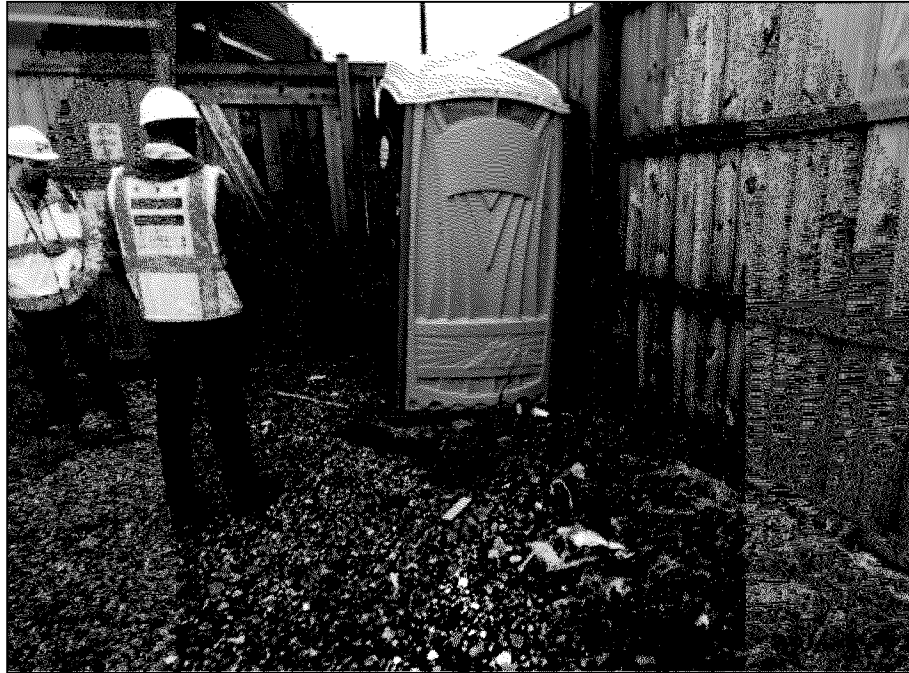
**Photograph 51.** (DSCN4019.JPG) View, facing south, of a portable toilet located adjacent to the mid-west perimeter in the north area of the site. The portable toilet did not have a containment pan or have any other observable secondary containment.

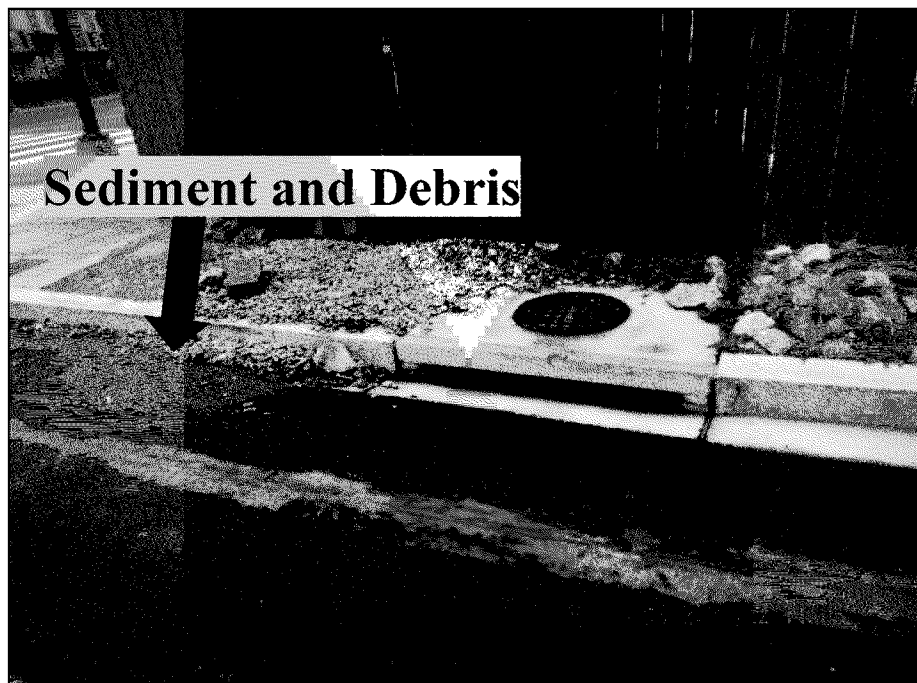
**Photograph 52.** (DSCN4065.JPG) View, facing north, of the mid-west perimeter downgradient of the portable toilet. The location was on the other side of the wooden fence of the location shown in Photograph 51. Note the sediment. Photograph was taken offsite.

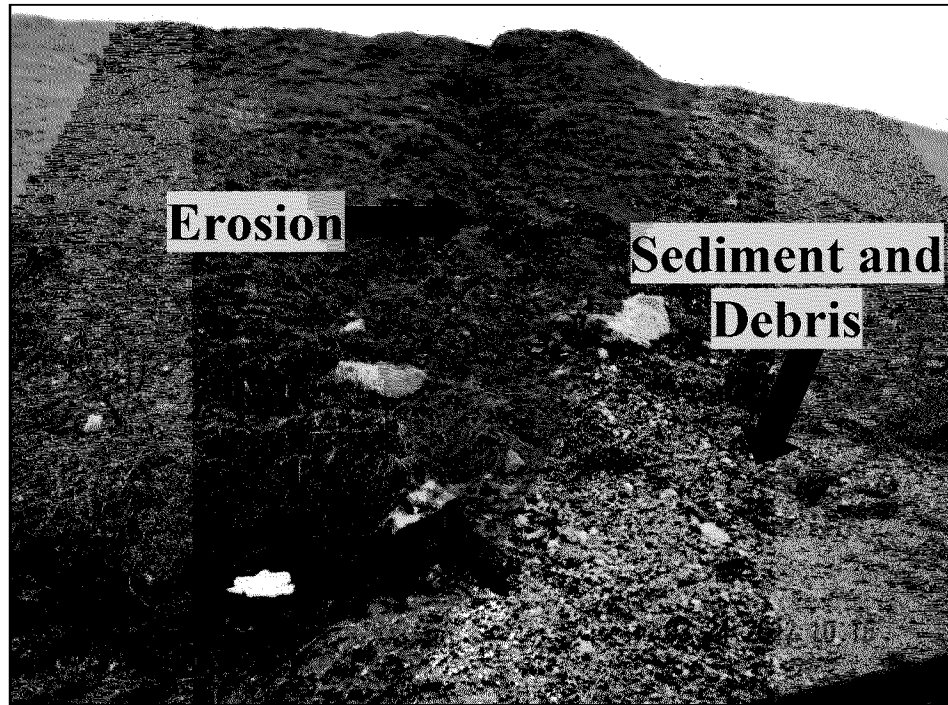
**Photograph 57.** (DSCN3967.JPG) View, facing west, of erosion, sediment, and debris downgradient of a stabilized stockpile.

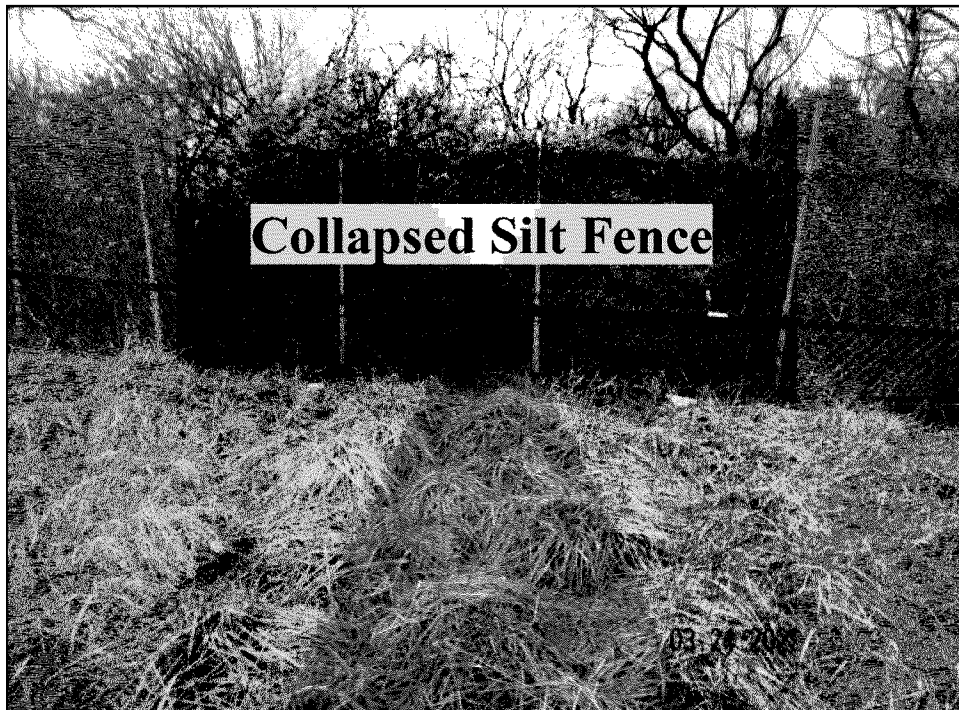
**Photograph 62.** (DSCN3977.JPG) View, facing east, of collapsed silt fencing along the east perimeter.

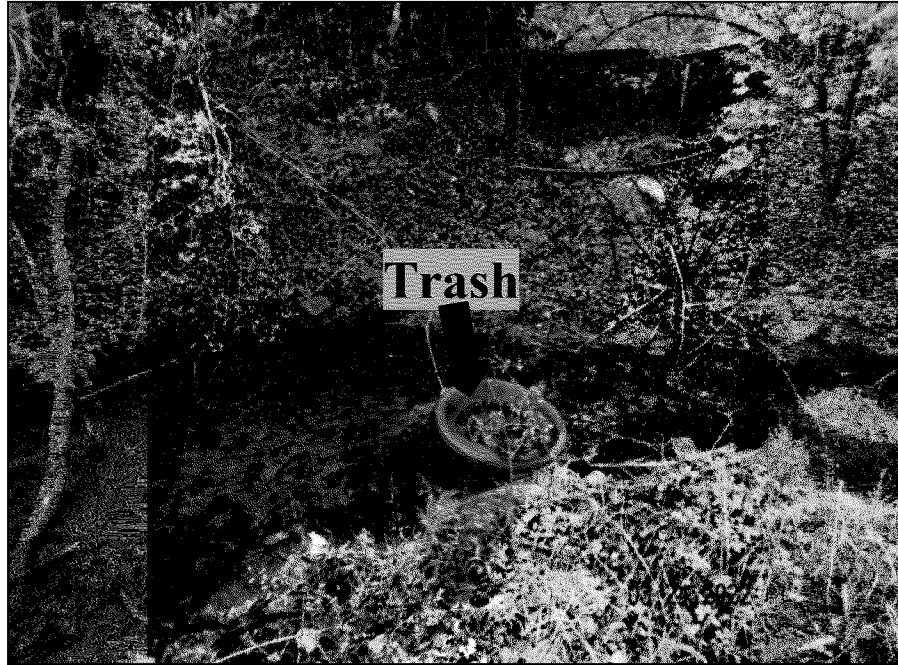
**Photograph 69.** (DSCN4072.JPG) View, facing south, of stormwater pooled north of the site's north perimeter downgradient of the steep slope. Stormwater flows downgradient from this location. Note the trash. Photograph was taken offsite.

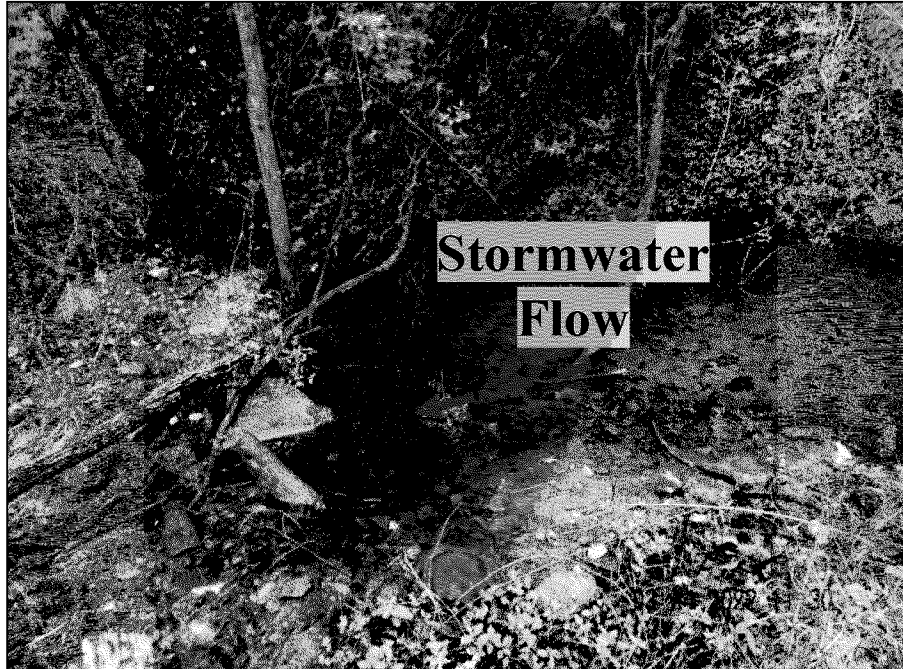
**Photograph 71.** (DSCN4073.JPG) View, facing east, of stormwater pooled north of the site's north perimeter downgradient of the steep slope. The EPA Inspection Team observed stormwater flow from the pool shown in Photographs 69 and 70 downgradient to this location during the inspection. Photograph was taken offsite.

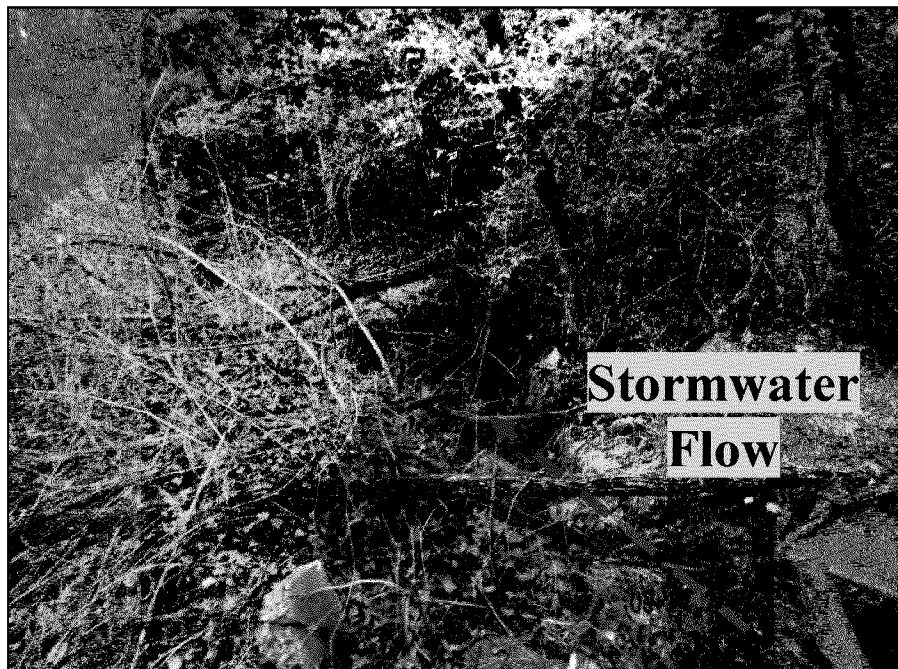
**Photograph 72.** (DSCN4074.JPG) View, facing north, of debris downgradient of the pool shown in Photographs 69 through 71. Stormwater flowed through the debris before reaching the stormwater inlet in Photograph 10. Photograph was taken offsite.

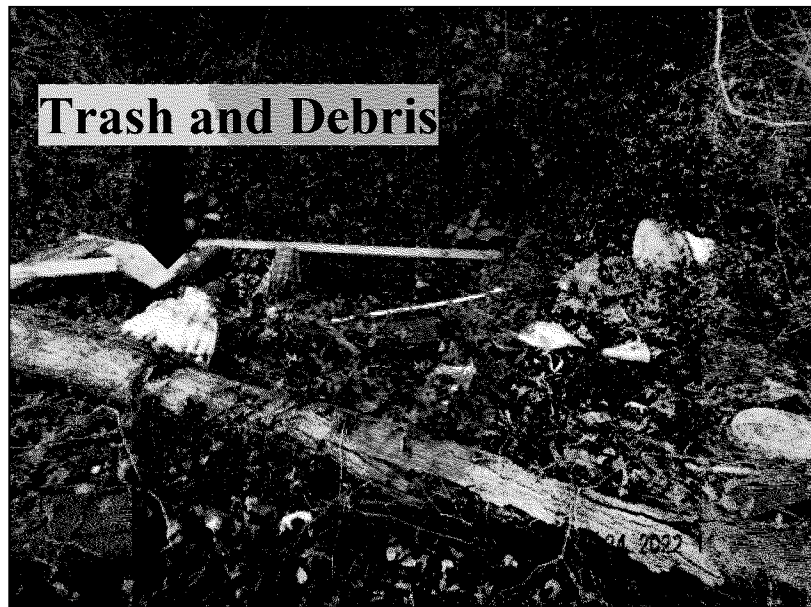
**Photograph 73.** (DSCN4079.JPG) View, facing east, of trash and debris collected north of the site. Stormwater flowed from the pooled stormwater shown in Photograph 69 through 71 downgradient through the trash and debris. This location is downgradient of the location shown in Photograph 72. Photograph was taken offsite.

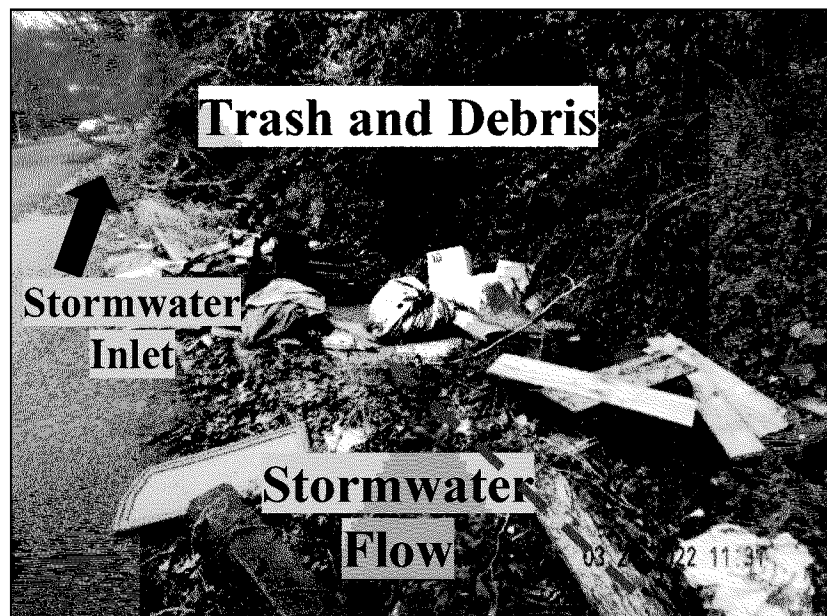
**Photograph 74.** (DSCN4080.JPG) View, facing east, of trash and debris collected north of the site. Stormwater flowed from the pooled stormwater shown in Photograph 69 through 71 downgradient through the trash and debris to the stormwater inlet shown in Photograph 10. This location is downgradient of the location shown in Photographs 72 and 73. Photograph was taken offsite.

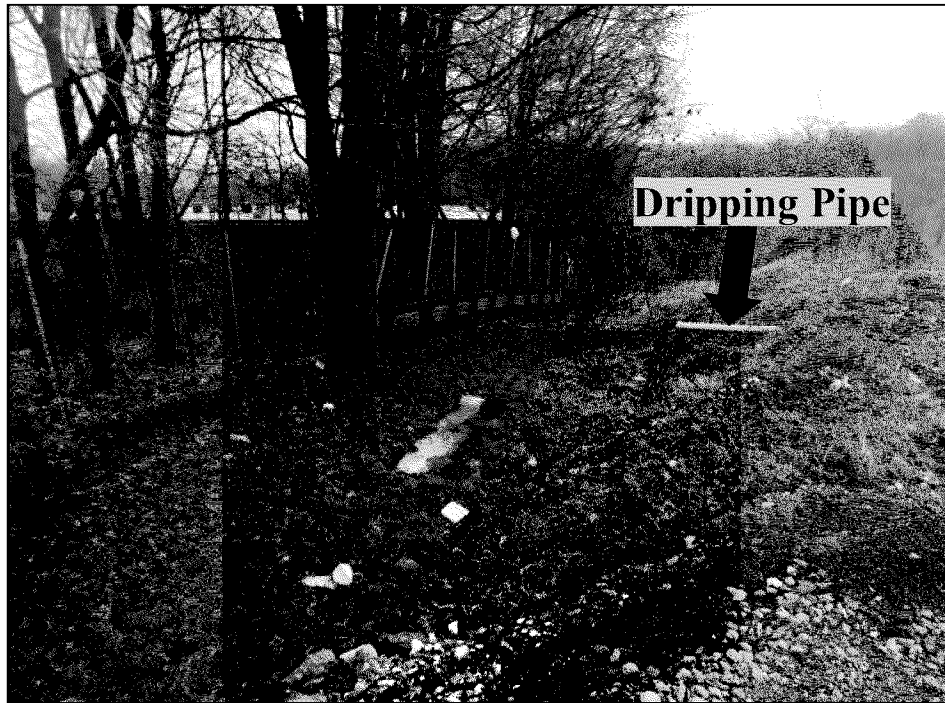
**Photograph 75.** (DSCN4006.JPG) View, facing east, of an unlabeled dripping pipe that ran underneath the stabilized construction entrance at the northeast corner of the site.

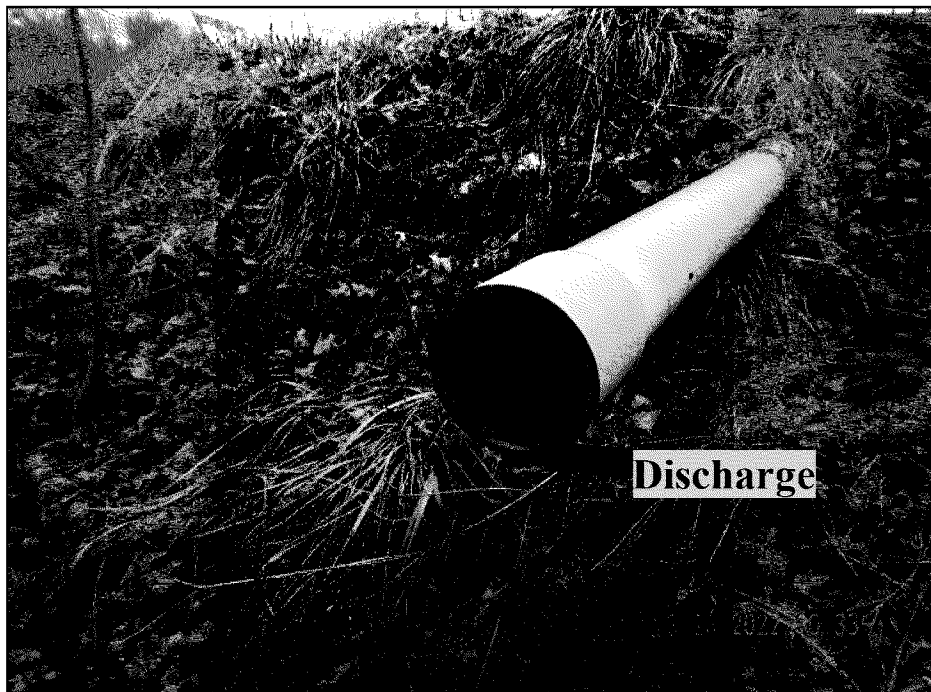
**Photograph 76.** (DSCN4009.JPG) View of the unlabeled dripping pipe shown in Photograph 75. The EPA Inspection Team did not observe signs of pollutants originating from the discharge, such as sediment, foam, or discoloring.
