## REGION 10 Enforcement Division

### INSPECTION REPORT

| <b>Company Name:</b> | Hilcorp North Slope, LLC | | |
| <b>Facility or Site Name:</b> | HILCORP NORTH SLOPE PRUDHOE BAY UNIT | | |

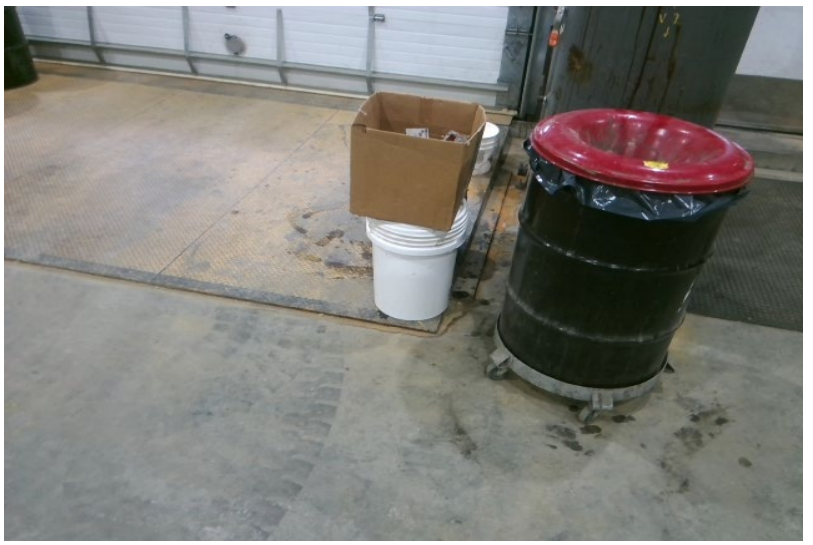
| <p>[Title]</p> <p>06/16/2021 09:51 AM (AKT)</p> <p>Jon Jones</p> <p>Hazardous Waste Process Facility (HWPF)</p> <p>No CBI</p> <p>No PII</p> <p>View of the floor inside the HWPF.</p> | |

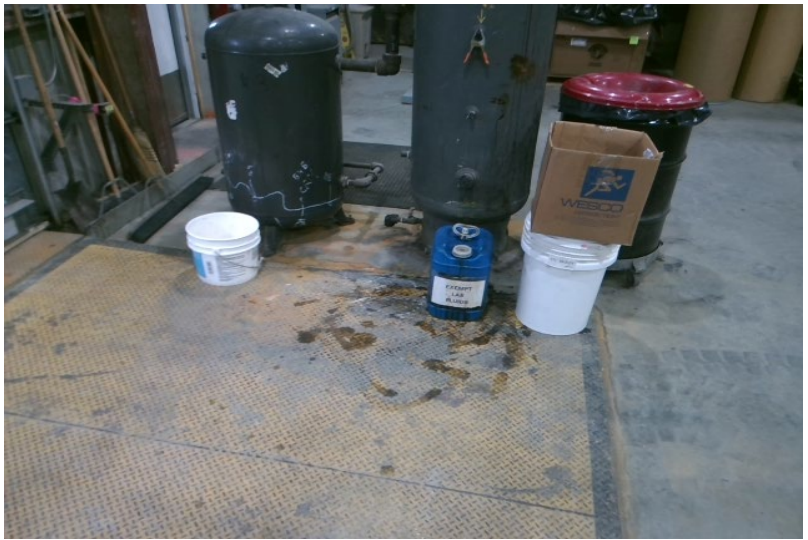
| <div>[Title]</div> <div>06/16/2021 09:51 AM (AKT)</div> <div>Jon Jones</div> <div>Hazardous Waste Process Facility (HWPF)</div> <div>No CBI</div> <div>No PII</div> <div>Another view of the floor inside the HWPF.</div> | |

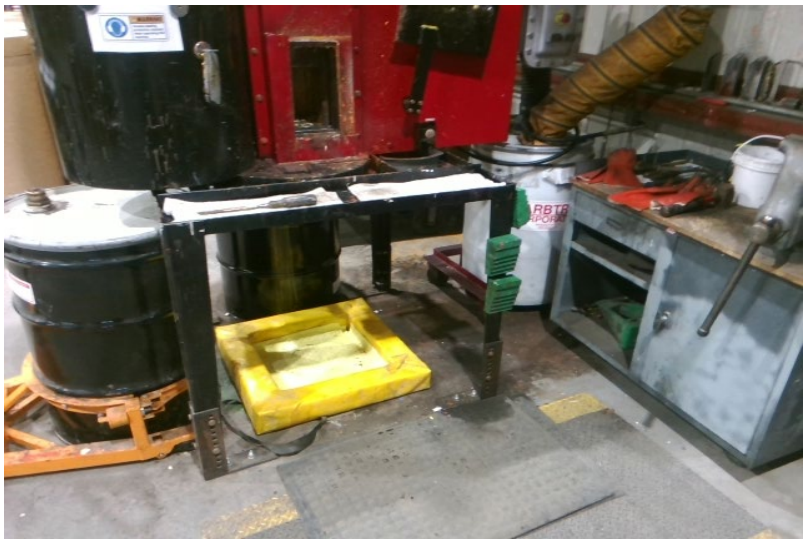
| <div>[Title]</div> <div>06/16/2021 09:51 AM (AKT)</div> <div>Jon Jones</div> <div>Hazardous Waste Process Facility (HWPF)</div> <div>No CBI</div> <div>No PII</div> <div>Another view of the floor inside the HWPF.</div> | |

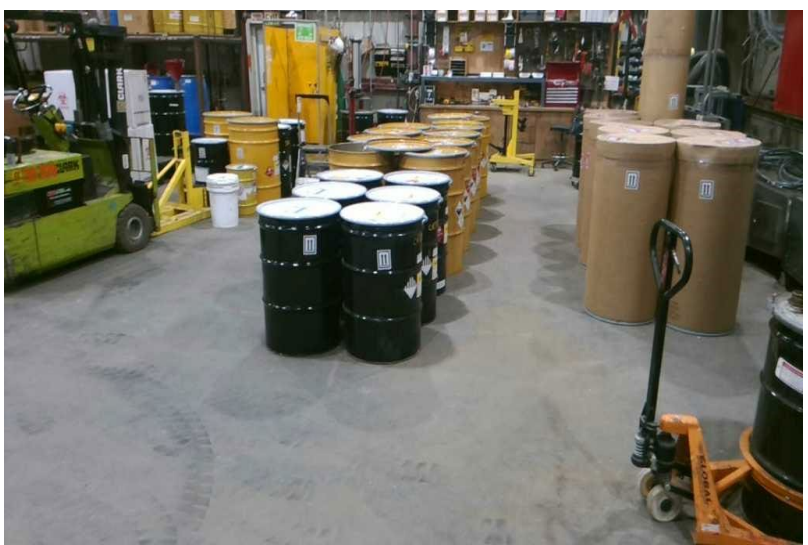
| <div>[Title]</div> <div>06/16/2021 09:54 AM (AKT)</div> <div>Jon Jones</div> <div>Hazardous Waste Process Facility (HWPF)</div> <div>No CBI</div> <div>No PII</div> <div>Additional views of the floor inside the HWPF.</div> | |

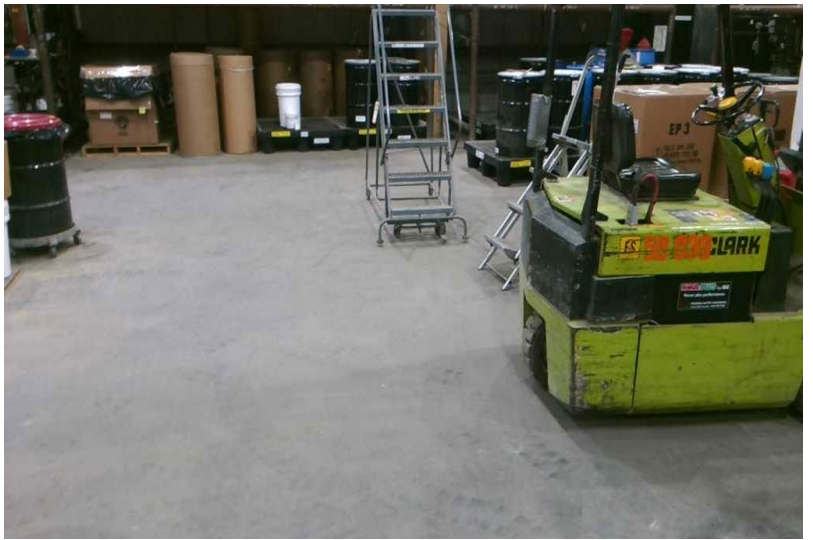
| <div data-bbox="65 168 715 219" data-label="Text">[Title]</div> <div data-bbox="65 219 715 277" data-label="Text">06/16/2021 09:54 AM (AKT)</div> <div data-bbox="65 277 715 336" data-label="Text">Jon Jones</div> <div data-bbox="65 336 715 394" data-label="Text">Hazardous Waste Process Facility (HWPF)</div> <div data-bbox="65 394 715 452" data-label="Text">No CBI</div> <div data-bbox="65 452 715 510" data-label="Text">No PII</div> <div data-bbox="65 510 715 741" data-label="Text">Additional views of the floor inside the HWPF.</div> | |

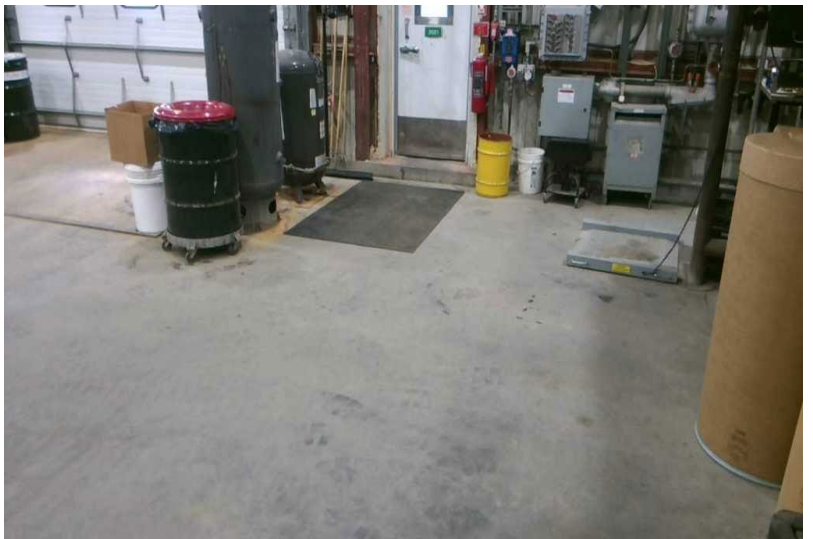
| <div data-bbox="65 741 715 792" data-label="Text">[Title]</div> <div data-bbox="65 792 715 851" data-label="Text">06/16/2021 09:55 AM (AKT)</div> <div data-bbox="65 851 715 909" data-label="Text">Jon Jones</div> <div data-bbox="65 909 715 967" data-label="Text">Hazardous Waste Process Facility (HWPF)</div> <div data-bbox="65 967 715 1025" data-label="Text">No CBI</div> <div data-bbox="65 1025 715 1084" data-label="Text">No PII</div> <div data-bbox="65 1084 715 1314" data-label="Text">Additional views of the floor inside the HWPF.</div> | |

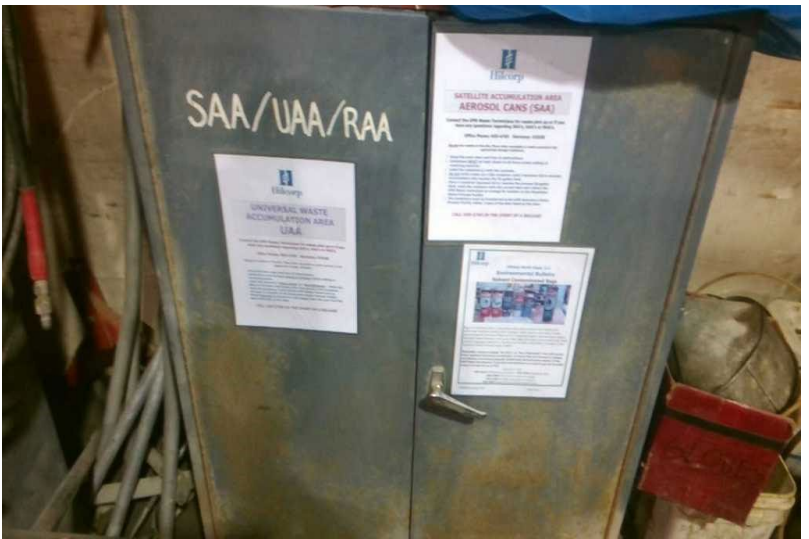
| <div>[Title]</div> <div>06/17/2021 08:56 AM (AKT)</div> <div>Jon Jones</div> <div>Hover craft hangar</div> <div>No CBI</div> <div>No PII</div> <div>Close-up view of the gray SAA/UAA/RAA cabinet.</div> | |

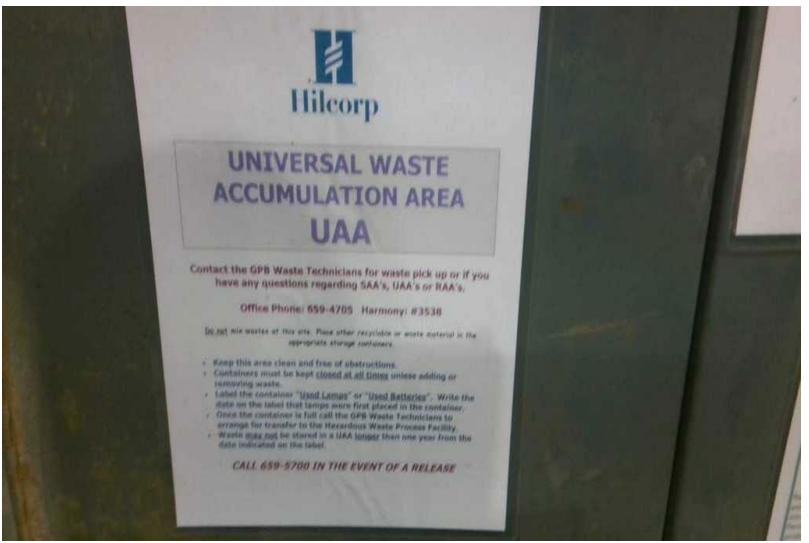
| <div>[Title]</div> <div>06/17/2021 08:56 AM (AKT)</div> <div>Jon Jones</div> <div>Hover craft hangar</div> <div>No CBI</div> <div>No PII</div> <div>Close-up view of the labeling on the outside of the gray cabinet.</div> | |

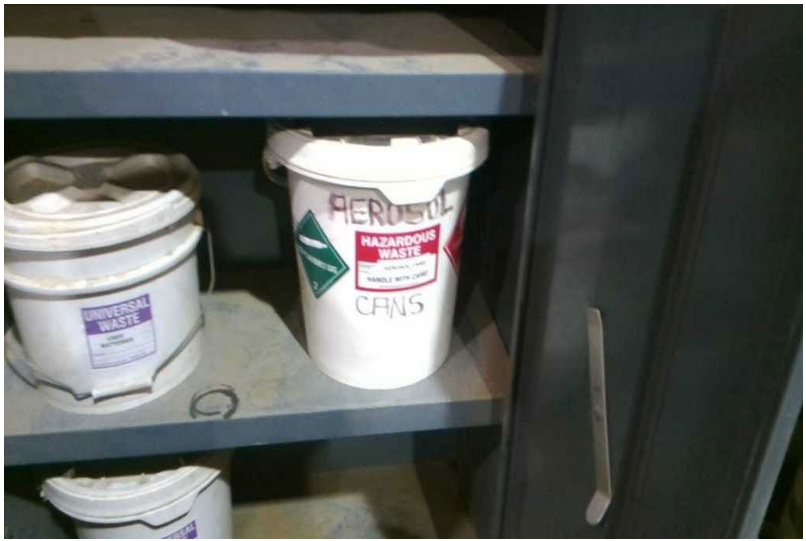
| <p>[Title]</p> <p>06/17/2021 09:06 AM (AKT)</p> <p>Jon Jones</p> <p>Hover craft hangar</p> <p>No CBI</p> <p>No PII</p> <p>View of the labeling on the waste aerosol SAA container and UAA battery container inside the gray cabinet.</p> | |

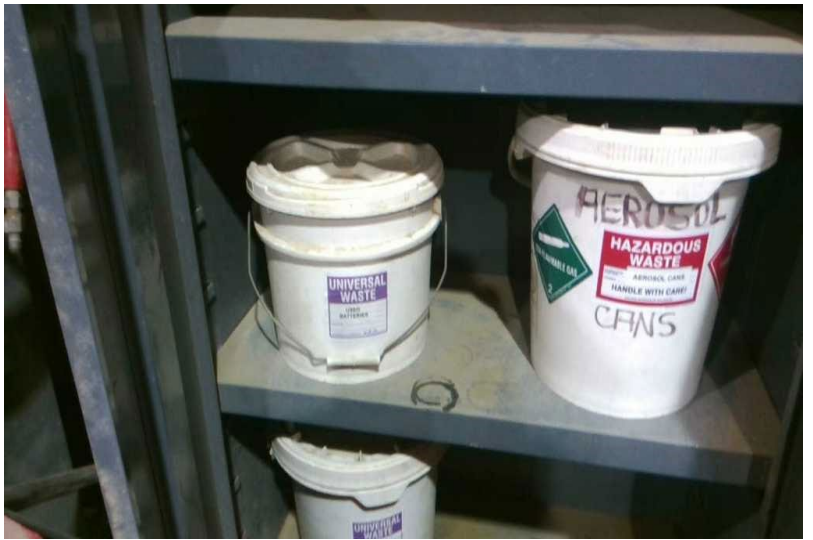
| <div>[Title]</div> <div>06/17/2021 09:08 AM (AKT)</div> <div>Jon Jones</div> <div>Hover craft hangar</div> <div>No CBI</div> <div>No PII</div> <div>Another view of the labeling on the waste aerosol SAA container and UAA battery container inside the gray cabinet.</div> | |
