**Region 6 - Enforcement & Compliance Assurance Division**  
**INSPECTION REPORT**

| Inspection Date(s): | 5/14/2025 - 5/15/2025 | |
| Company Name: | <b>Nemaha Environmental Services, LLC</b> | |
| Facility Name: | <b>Gray Commercial Mud Disposal, SWD, and Reclamation Facility</b> | |

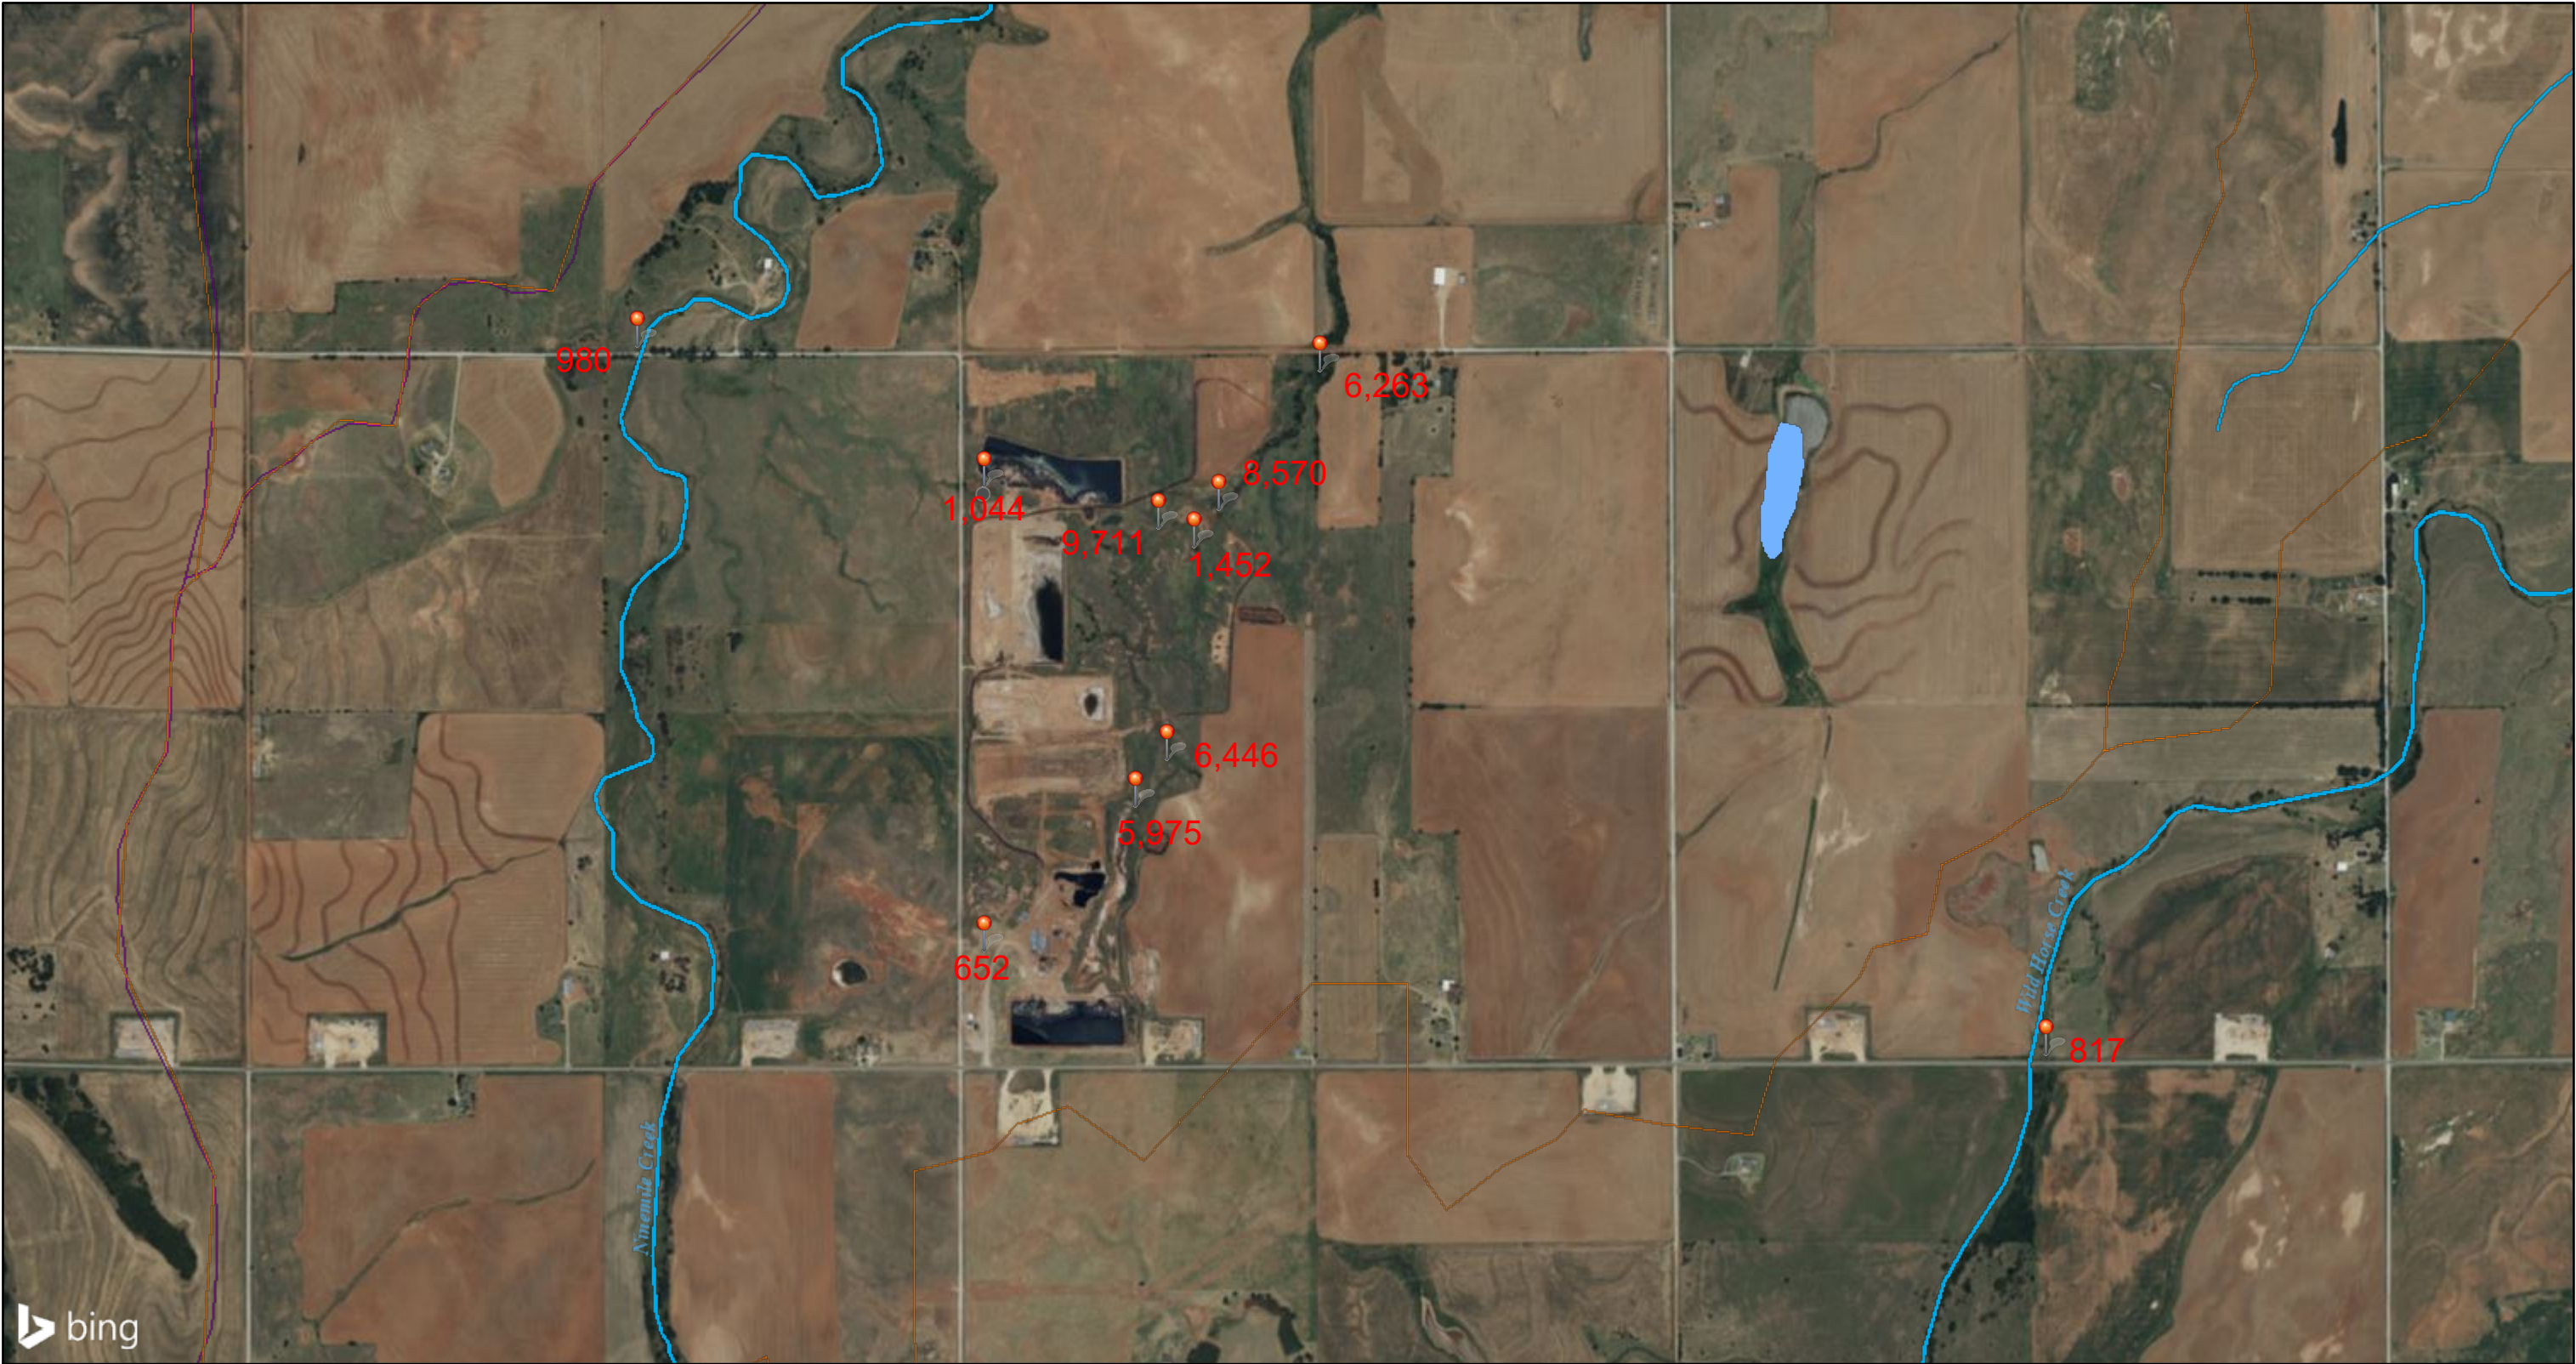
Map 2: TDS Readings at the Facility

At the facility, I observed a TDS reading of 652 mg/L in the runoff catchment area near the field office as well as upstream and downstream observations, see photo No. 60 through photo No. 62.

At the facility, near North Garland Road, I observed a pond and a TDS reading of 1,044 mg/L in the pond, see photo No. 63 and photo No. 64.

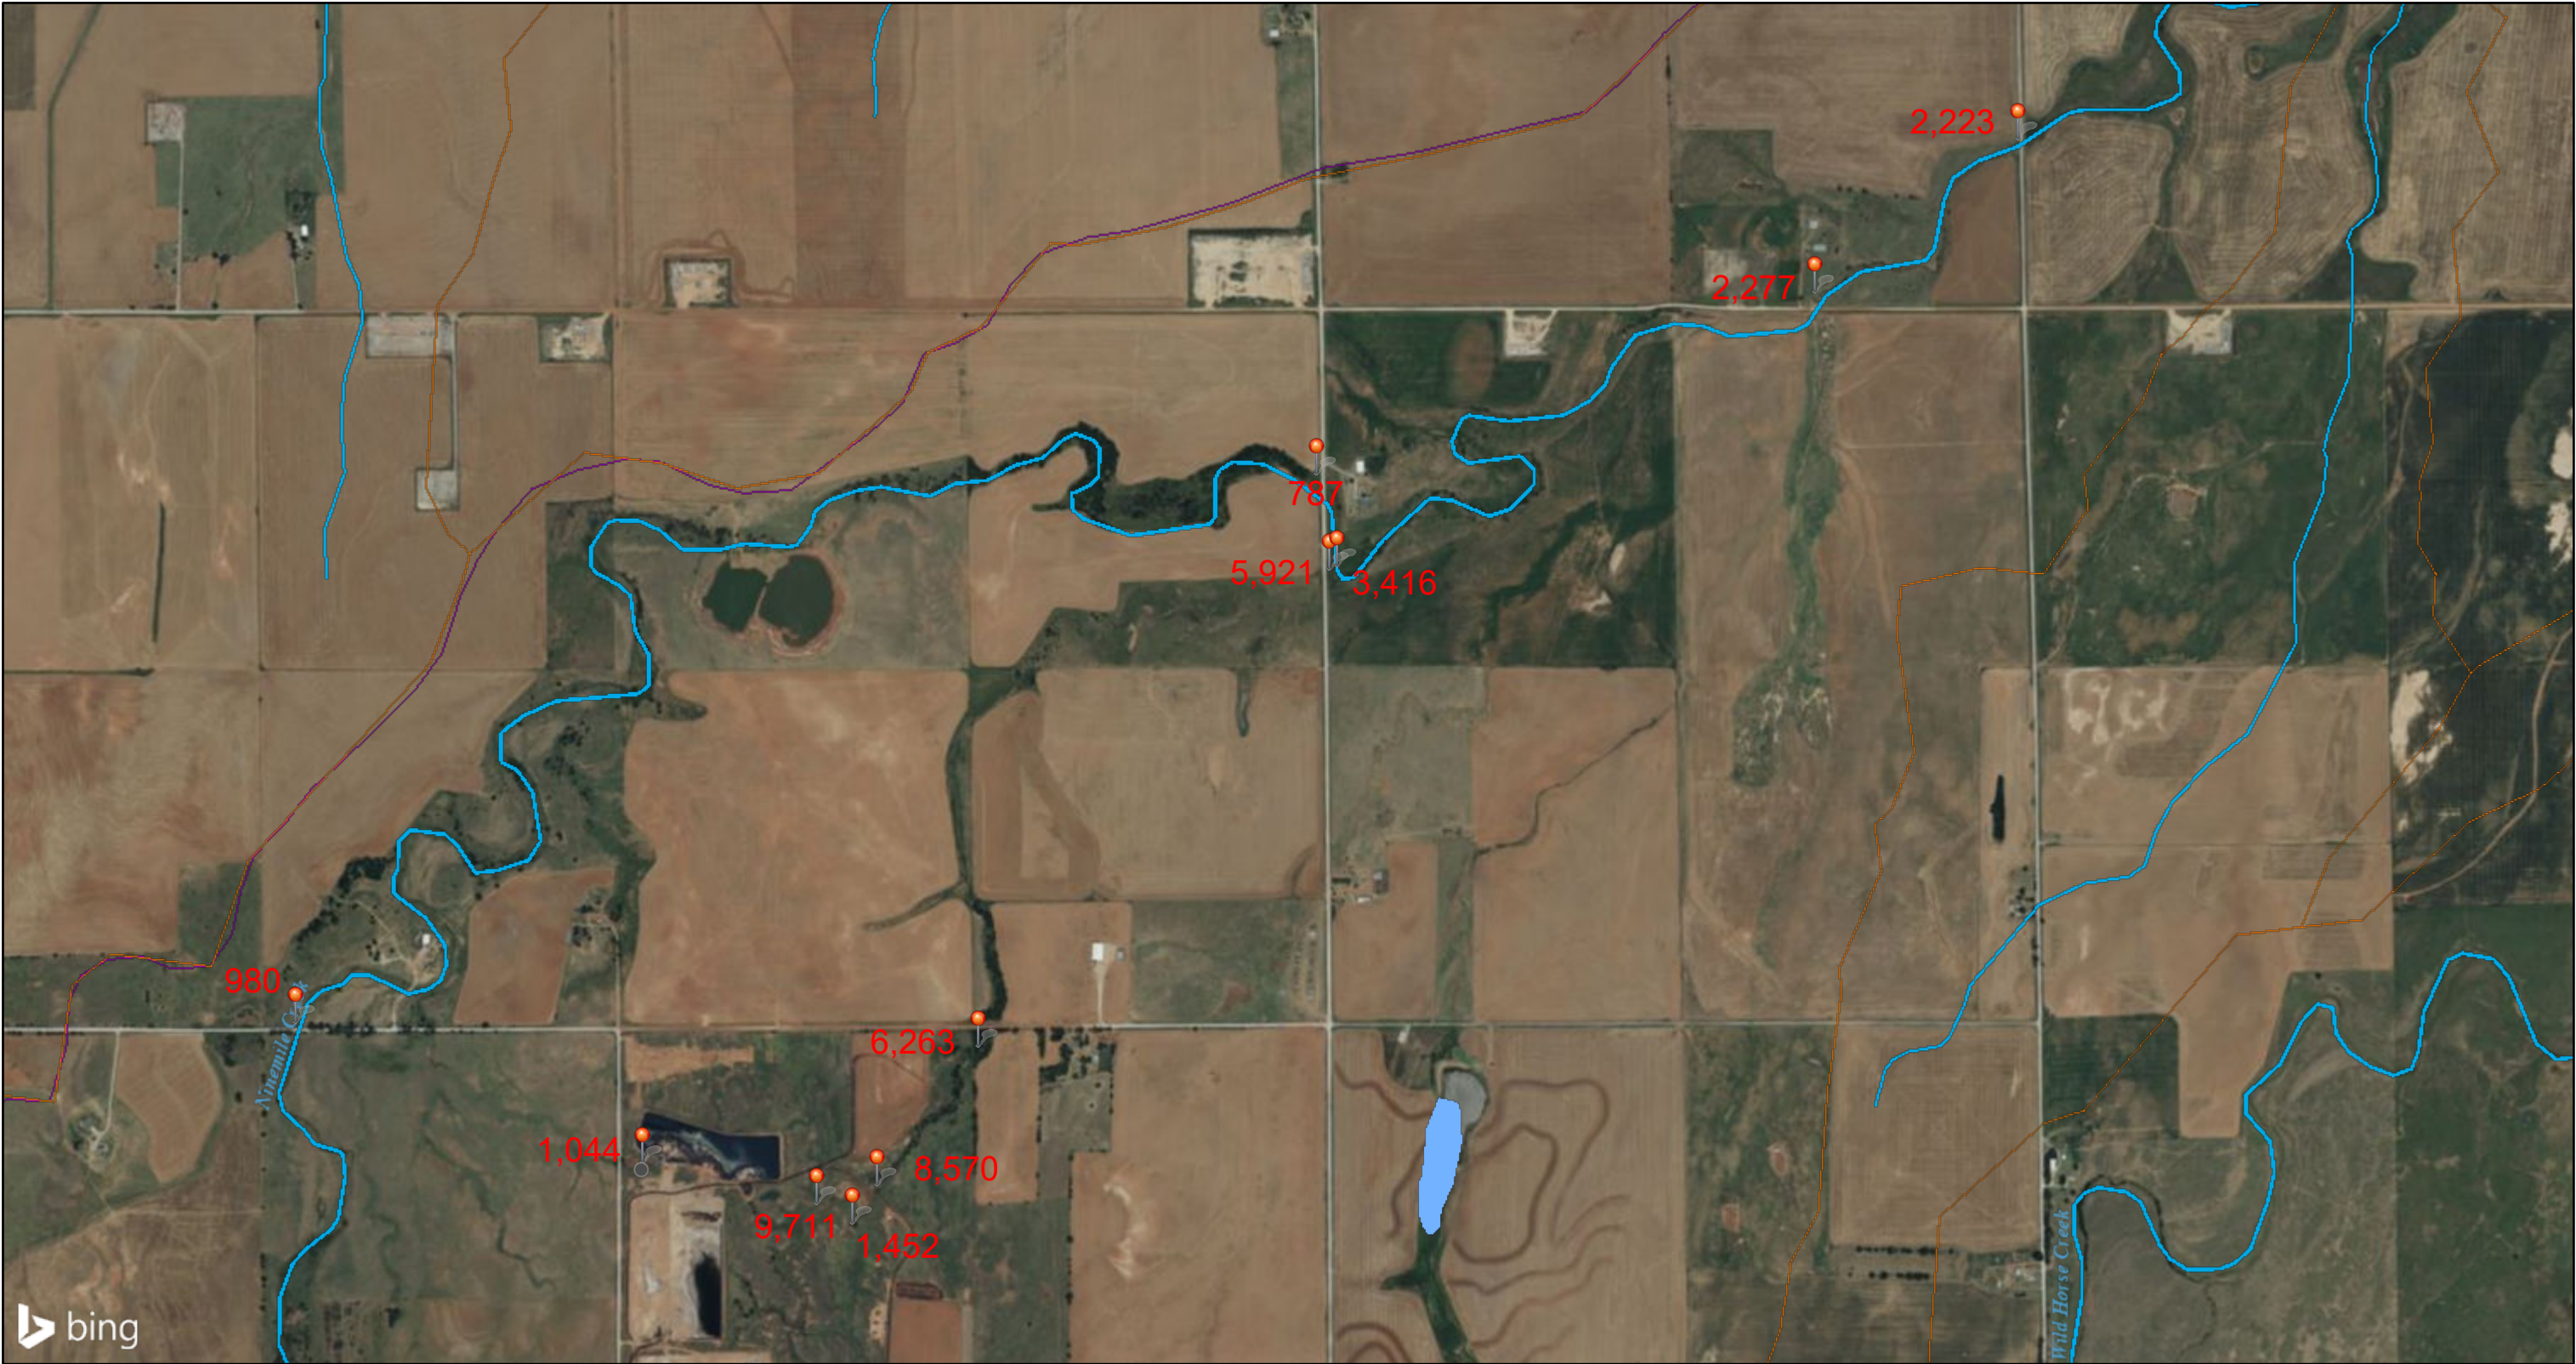
Map 3: TDS Readings along 9-Mile Creek

I observed a TDS reading of 3,416 mg/L in 9-Mile Creek where the unnamed tributary flows into 9-Mile Creek. I also observed the flow path, bed and banks, and vegetation of the unnamed tributary upstream and downstream of the TDS reading, see photo No. 29 through photo No. 31.

I observed a TDS reading of 2,277 mg/L in 9-Mile Creek. I also observed the flow path, bed and banks and vegetation of the unnamed tributary upstream and downstream of the TDS reading, see photo No. 32 through photo No. 34.

Working downstream, I observed a TDS reading of 2,223 mg/L in 9-Mile Creek. I also observed the flow path, bed and banks, and vegetation of the unnamed tributary upstream and downstream of the TDS reading, see photo No. 35 through photo No. 37.

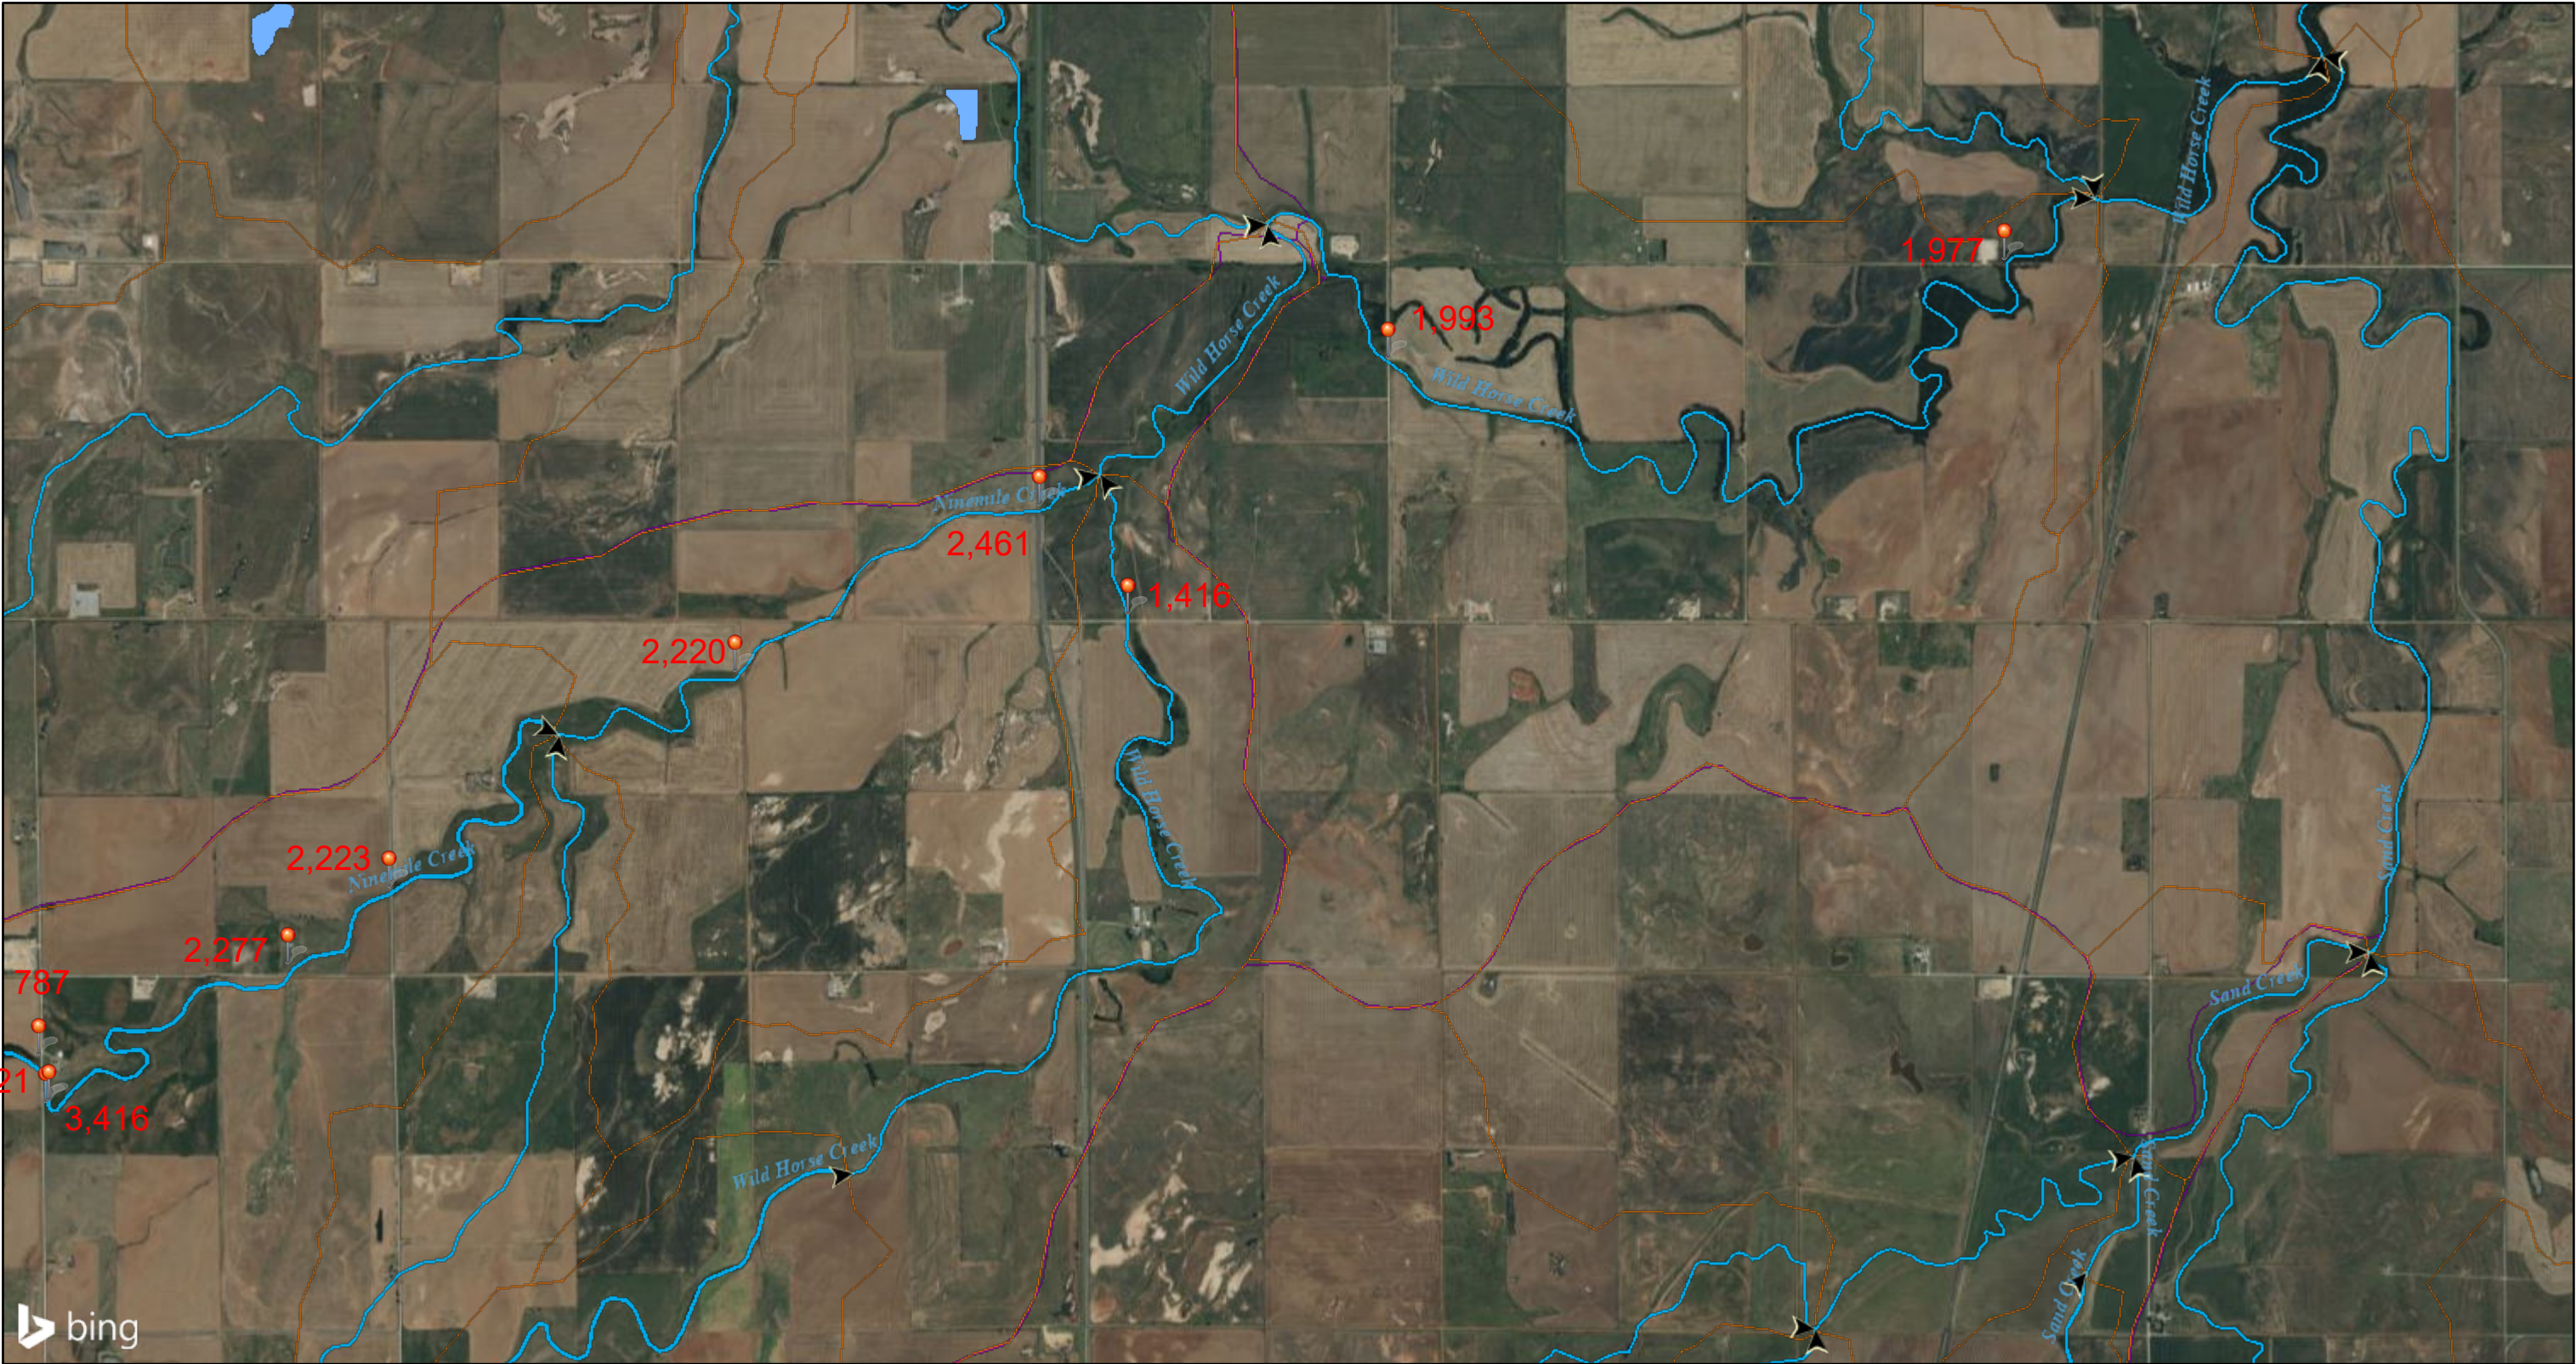
Map 4: TDS Readings along 9-Mile Creek and Wild Horse Creek

Continuing downstream in 9-Mile Creek I observed a TDS reading of 2,461 mg/L in 9-Mile Creek. I also observed the flow path, bed and banks and vegetation of the unnamed tributary upstream and downstream of the TDS reading, see photo No. 41 through photo No. 43.

Continuing downstream, I observed a TDS reading of 1,993 mg/L in Wild Horse Creek, approximately 1.23 miles after 9-Mile Creek enters Wild Horse Creek. I also observed the flow path, bed and banks, and vegetation of the unnamed tributary upstream and downstream of the TDS reading, see photo No. 44 through photo No. 46.

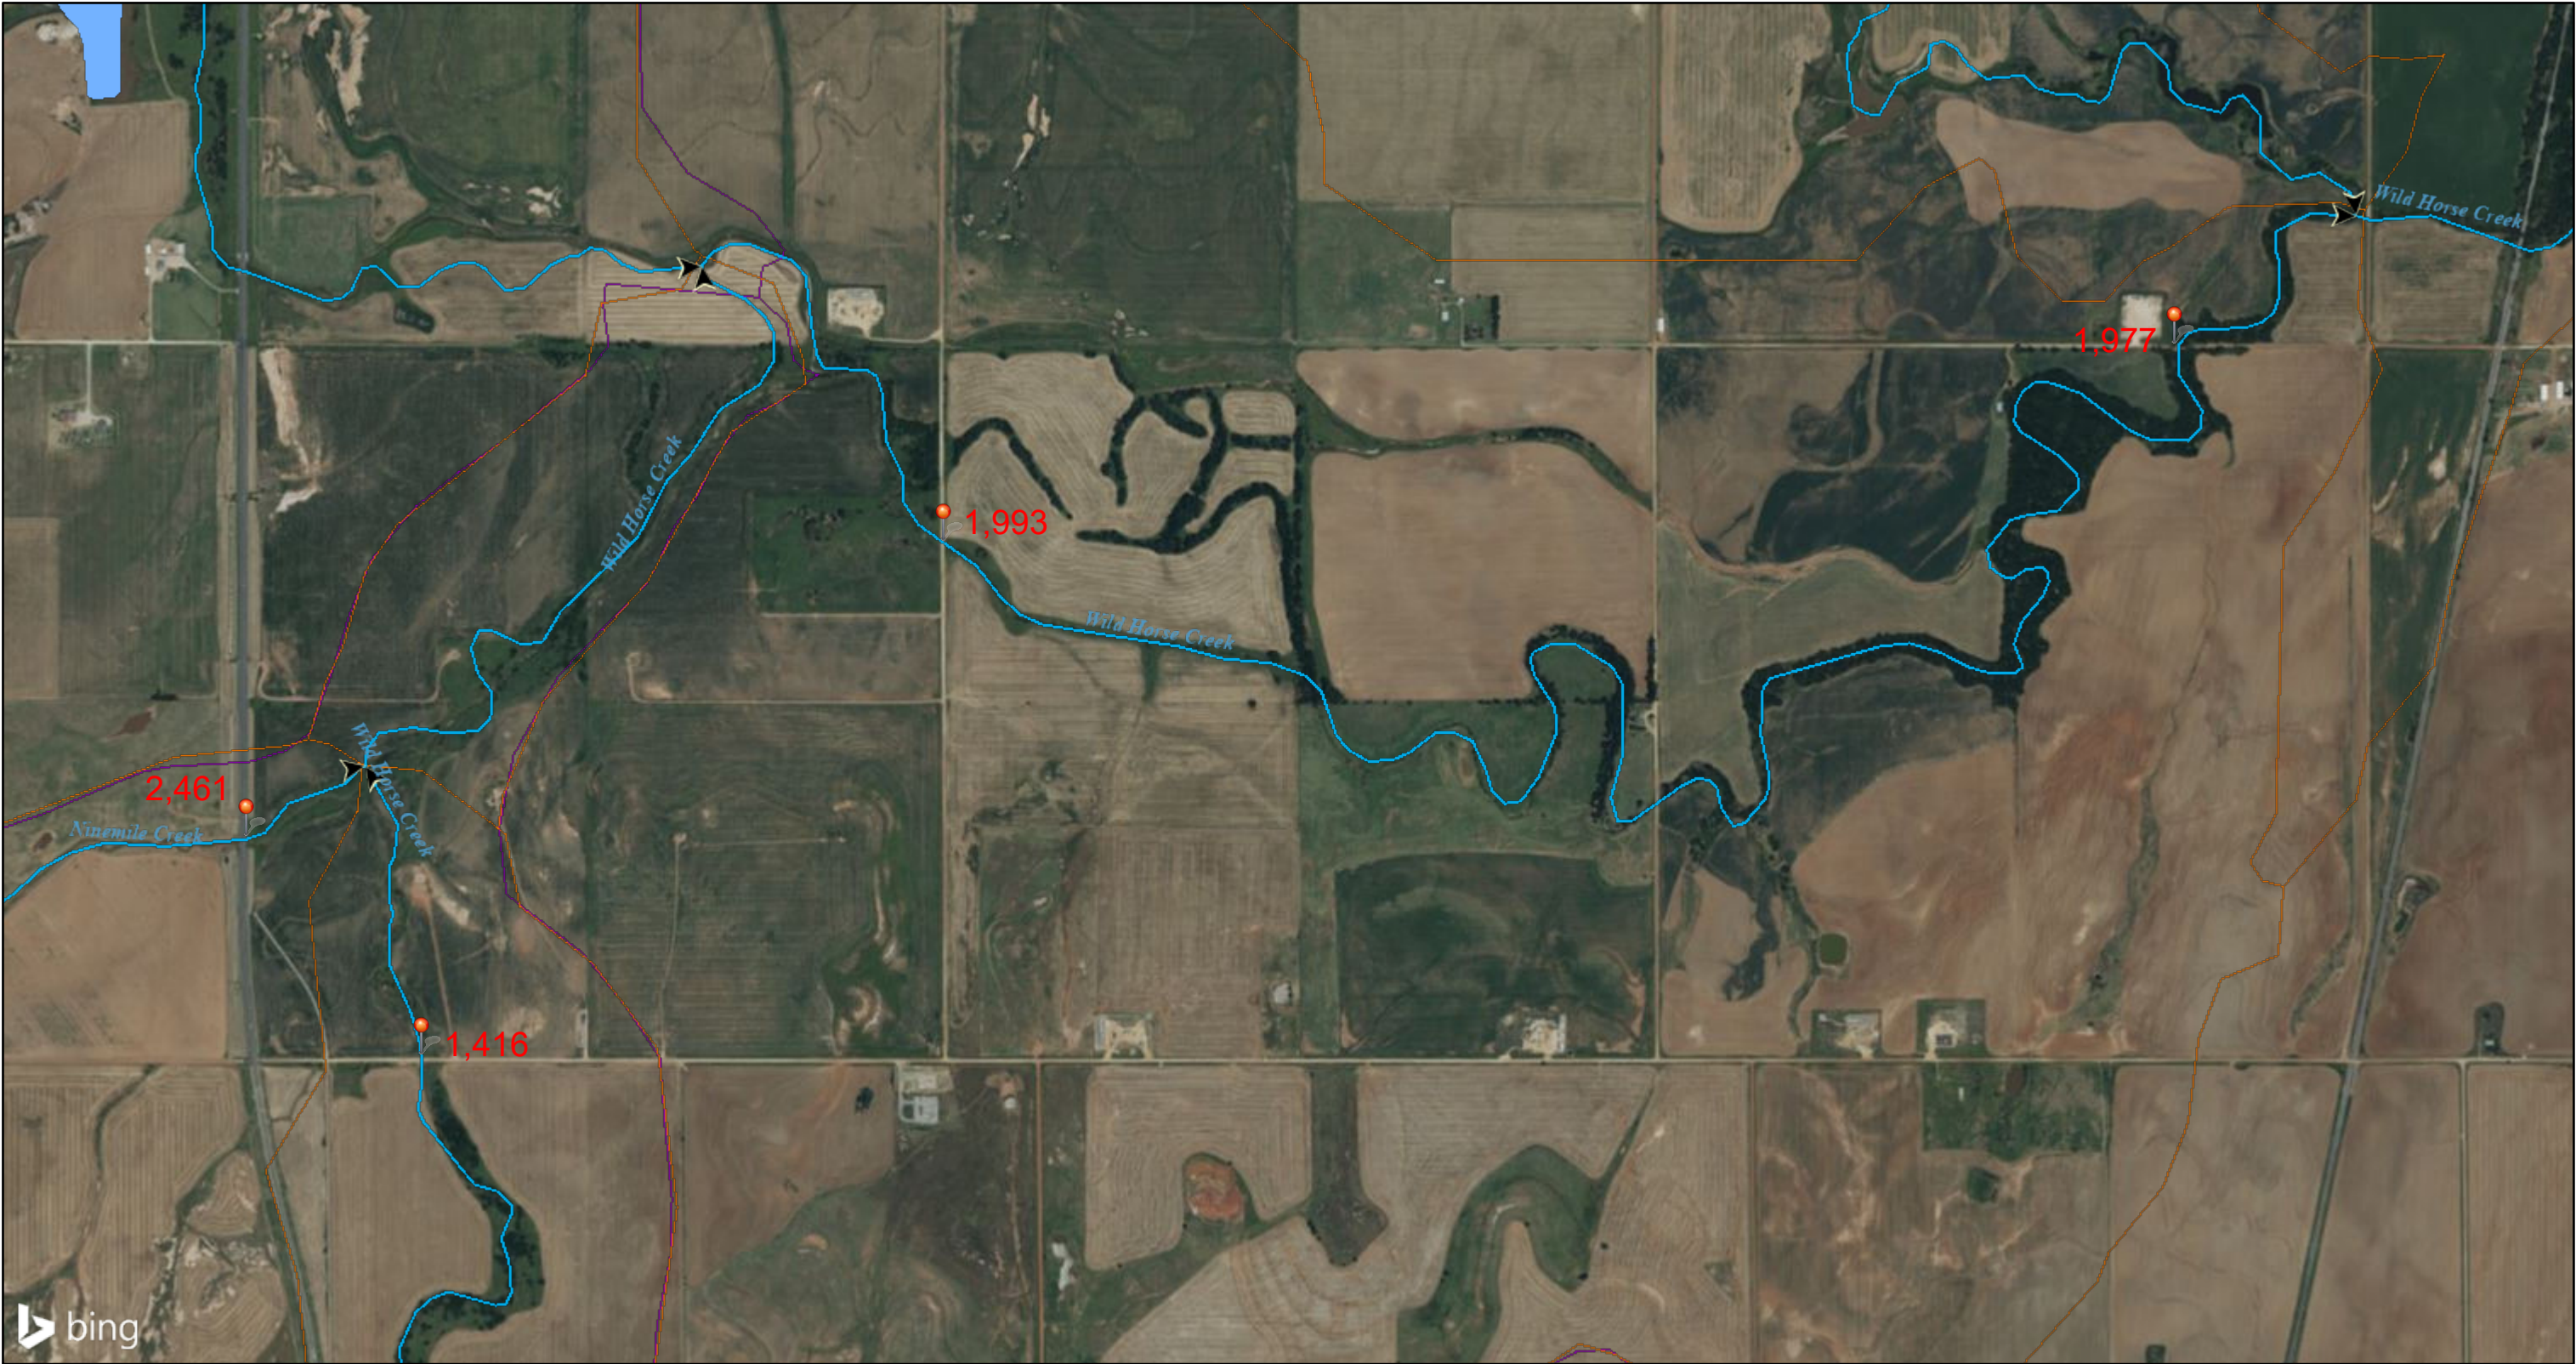
Map 5: TDS Readings along Wild Horse Creek and 9-Mile Creek

Upstream of the confluence between Wild Horse Creek and 9-Mile Creek, I observed a background TDS reading of 1,416 mg/L in Wild Horse Creek. I also observed the flow path, bed and banks and vegetation of the unnamed tributary upstream and downstream of the TDS reading, see photo No. 47 through photo No. 49.

Working downstream, I observed a TDS reading of 1,977 mg/L in the Wild Horse Creek. I also observed the flow path, bed and banks, and vegetation of the unnamed tributary upstream and downstream of the TDS reading, see photo No. 50 through photo No. 52.
