# **DTE ELECTRIC COMPANY MONROE POWER PLANT CLEAN WATER ACT (CWA) INSPECTION**

**Monroe, Michigan**

**Permit #: MI0001848**

**Inspection Date: August 29 and 30, 2023**

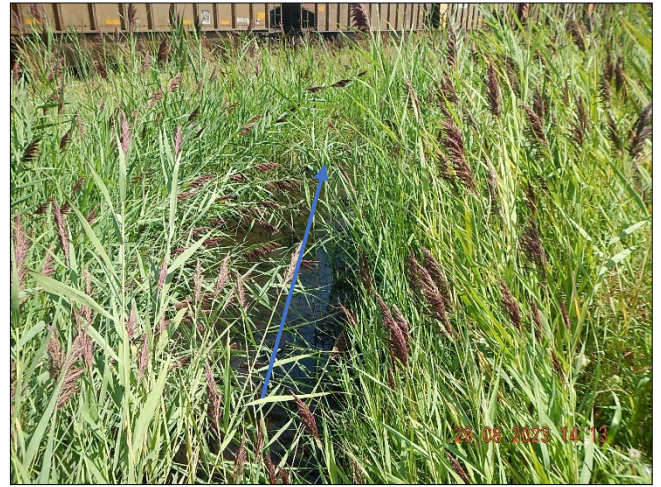
The Inspection Team observed that vegetation growing in and around PS1 prevented a good visual observation of flow in PS1 (Photographs 11 and 12). Additionally, the Inspection Team observed accumulated solids and fines in PS2 (Photographs 25 and 26).

Photograph 11. DTE - Monroe Plant DSCN0097.JPG  
Description: Close up view of ditch that receives discharge from SS#6.

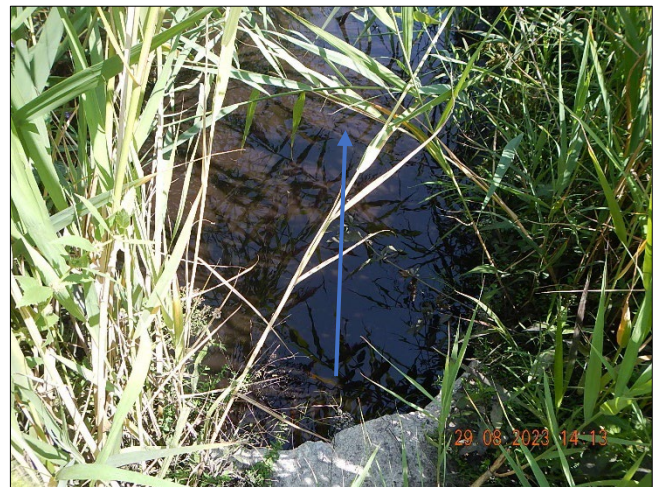
Photograph 12. DTE - Monroe Plant DSCN0098.JPG  
Description: Additional close view of ditch that receives discharge from SS#6 as seen in Photograph 11.

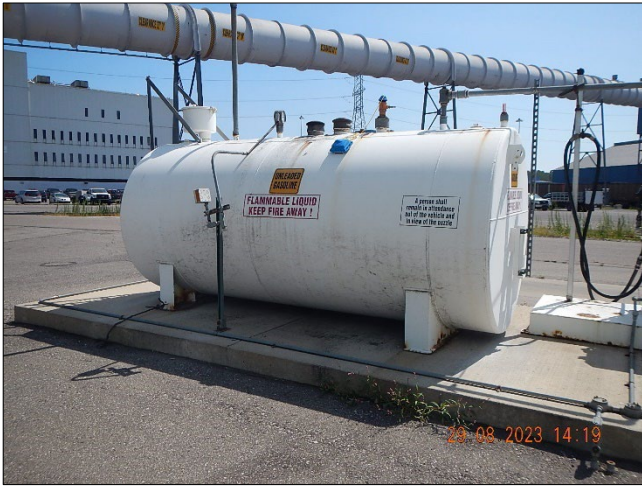
The Inspection Team observed the fueling station and maintenance station located on the south side of the Generating Building in the drainage area for SS#2. Diesel and gasoline were stored in double walled tanks (Photographs 13 and 14).

Photograph 13. DTE - Monroe Plant DSCN0099.JPG  
Description: View, facing east, of the double-walled gasoline tank at the fueling station seen in Photograph 14.

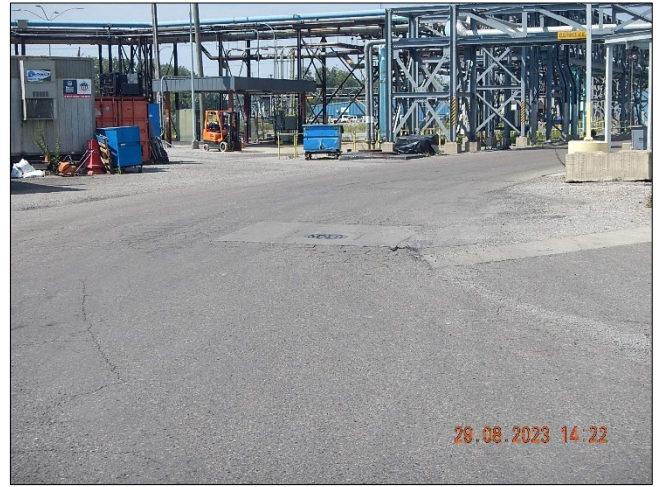
Photograph 15. DTE - Monroe Plant DSCN0101.JPG  
Description: View of a drop inlet located downgradient from the fueling area and the motor pool. This inlet connects to Storm Station (SS#2).

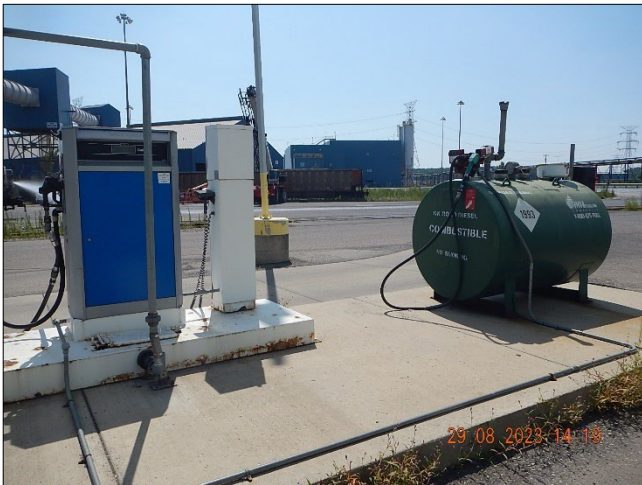
Photograph 14. DTE - Monroe Plant DSCN0100.JPG  
Description: View, facing east, of a fueling station across from the Motor Pool Building. The 500 gallon, double-walled diesel storage tank is visible on the right side of the photo.

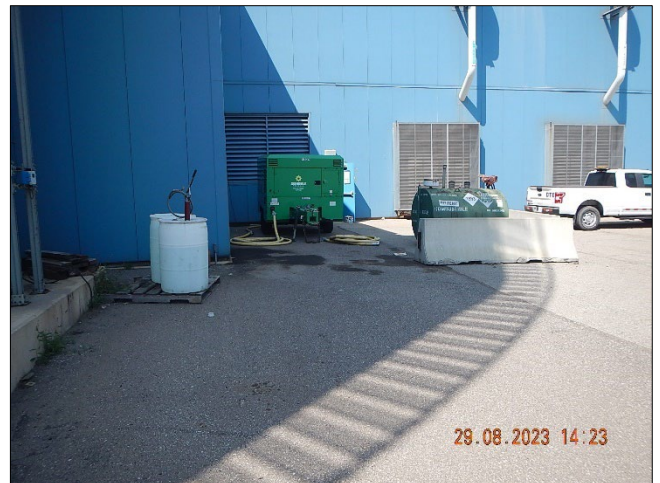
The Inspection Team observed two uncontained 55-gallon drums of diesel exhaust fluid (DEF) on a pallet and a double-walled, empty diesel tank next to the Generating Building within the SS#2 drainage area (Photograph 16), north of the fueling station. The DEF and diesel were temporarily stored at this location to service a portable generator while a permanent generator was down for service.

Photograph 16. DTE - Monroe Plant DSCN0102.JPG  
Description: View, facing north, of two 50-gallon barrels with diesel exhaust fluid (DEF) stored outside not undercover and without secondary containment. Also pictured are a portable generator and double-walled diesel tank.

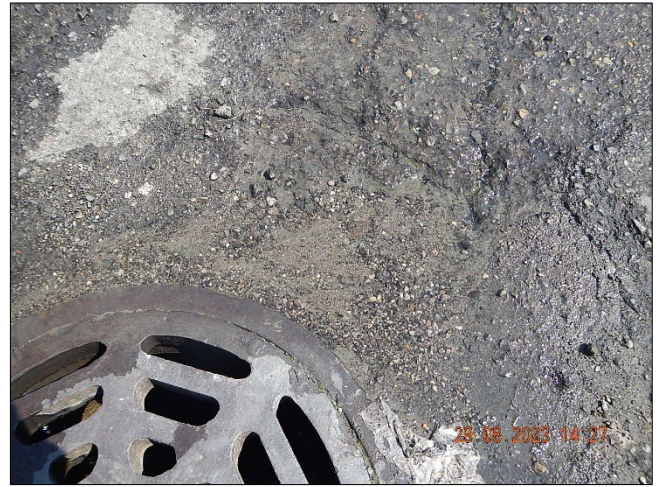
The maintenance station in SS#2 drainage area across the road south of the fueling station, consisted of an enclosed garage with trench drains at each garage door (Photograph 20) and an outdoor wash rack (Photograph 18). Light vehicle maintenance occurs at the maintenance station. The maintenance station trench drains connect to an OWS which discharges to SS#2. Runoff from a wash rack located adjacent to the maintenance station flows overland to a drop inlet that connects to SS#2 (Photographs 18 and 19).

Photograph 19. DTE - Monroe Plant DSCN0105.JPG  
Description: Additional photo of the inlet seen in Photograph 18.

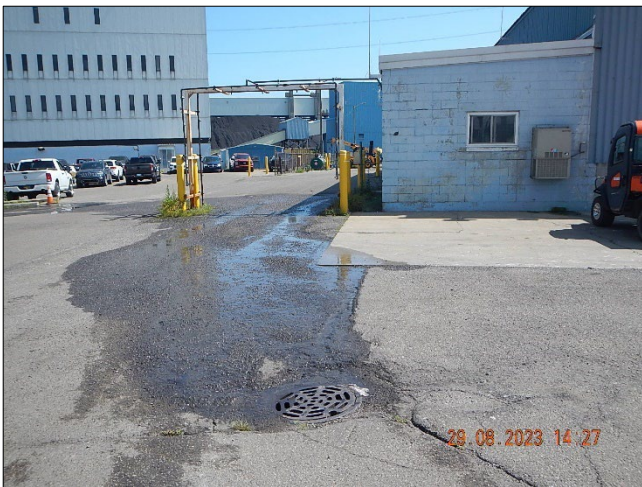
Photograph 18. DTE - Monroe Plant DSCN0104.JPG  
Description: View, facing north, of inlet below a vehicle wash station at the Motor Pool. The inlet connects to SS#2.

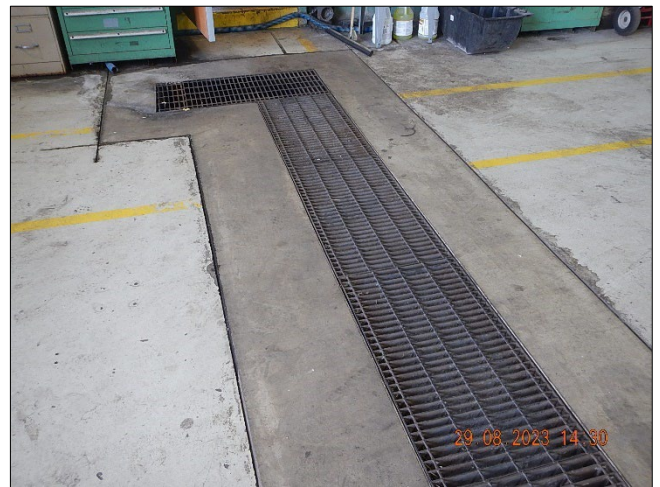
Photograph 20. DTE - Monroe Plant DSCN0106.JPG  
Description: General view of a trench drain inside the Motor Pool. The trench drain connects to SS#2 via an oil water separator (OWS).

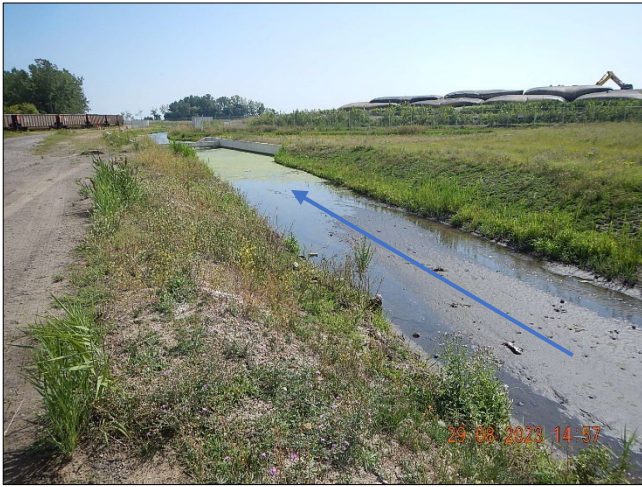
The Inspection Team observed sediment and debris accumulation in PS1 and PS2 (Photographs 25, 26, and 99).

Photograph 25. DTE - Monroe Plant DSCN0111.JPG  
Description: View, facing southeast, of process swale channel.

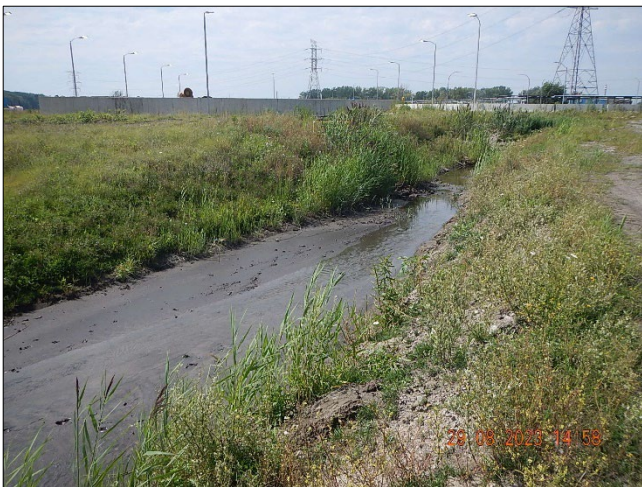
Photograph 26. DTE - Monroe Plant DSCN0112.JPG  
Description: View, facing northwest, of process swale channel.

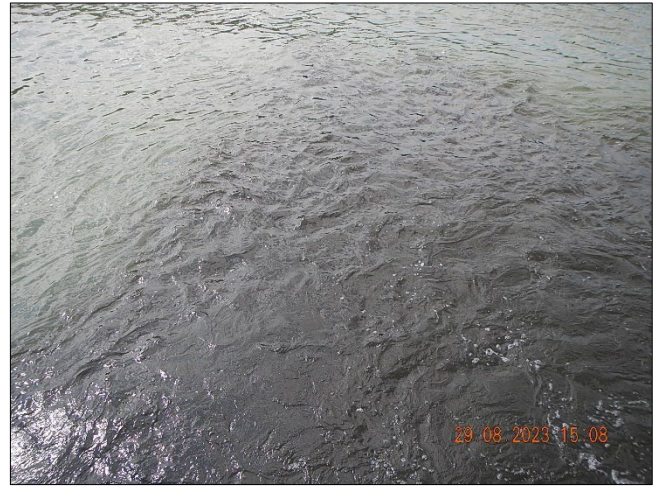
The Inspection Team observed a dark plume in the Discharge Channel immediately downstream of MP 001H on August 29 (Photographs 31 and 32) and 30 (Photograph 125). On August 30, 2023, a Facility representative used a plastic water bottle to collect a sample from the plume as well as by Outfall 001. Facility representatives suggested that the plume resulted from recent storm events that stirred up sediment in the Discharge Channel at MP 001H (Photographs 123, 124, and 126).

Photograph 31. DTE - Monroe Plant DSCN0117.JPG  
Description: View, facing west, of the discharge canal side of 001H. Discoloration was visible in the area where the South Process Pond water entered the canal.

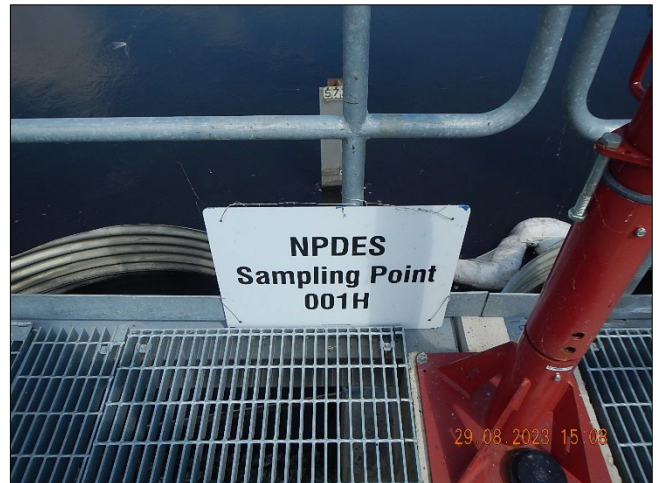
Photograph 32. DTE - Monroe Plant DSCN0118.JPG  
Description: View of 001H facing east towards the south process pond.

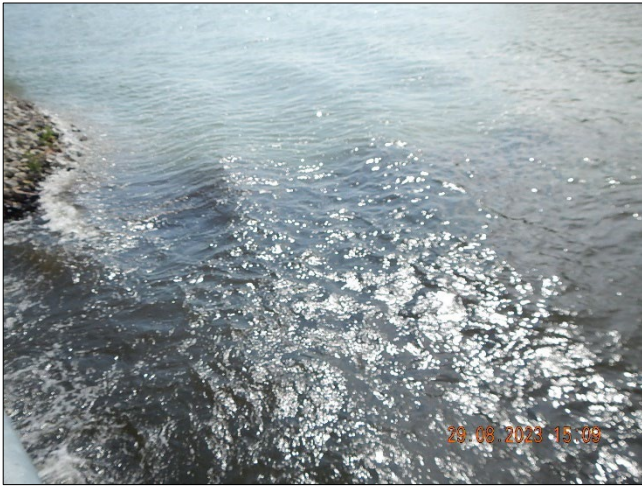
Photograph 33. DTE - Monroe Plant DSCN0119.JPG  
Description: Additional view of the same location seen in Photograph 31.

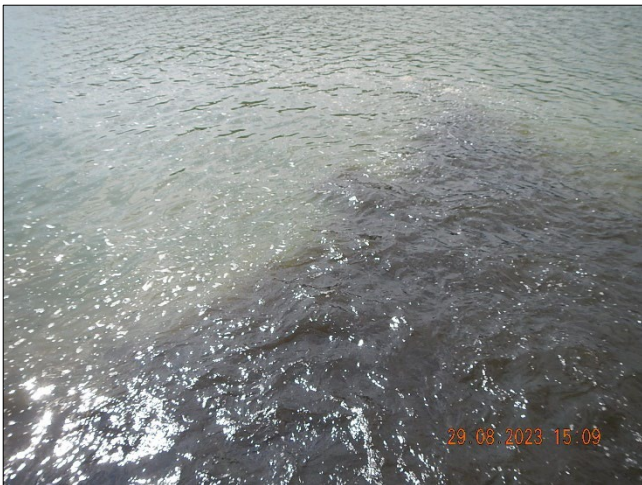
Photograph 34. DTE - Monroe Plant DSCN0120.JPG  
Description: Additional view of the same location seen in Photograph 31 and 33.

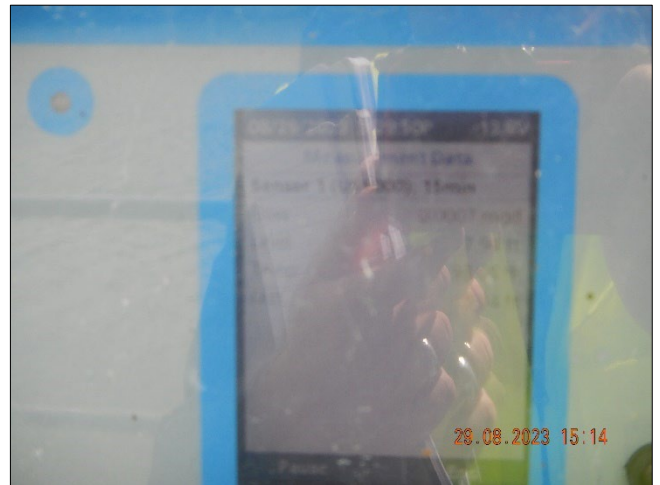
The South Process Pond discharges to the Discharge Channel through MP 001H (Photographs 30, 32, and 34). Flow rate through MP 001H is measured with an optical flow meter backed up with a staff gage (Photographs 35 and 36).

Photograph 36. DTE - Monroe Plant DSCN0122.JPG  
Description: View of flow meter at 001H.

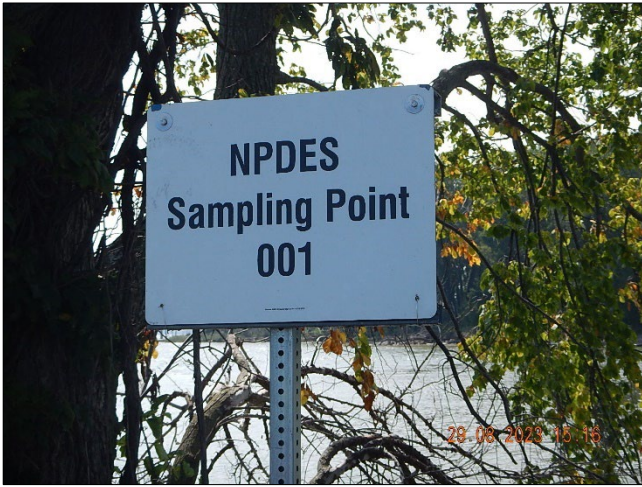
The Inspection Team observed the Outfall 001 sign where the Facility representatives stated they sampled (Photographs 37 and 38). Outfall 001 is identified in the permit as 41.87500, -83.35000, in the approximate center of the Discharge Canal just before entry into Lake Erie discharge Channel south of MP 001H and north of Lake Erie. Stormwater and process wastewater from all MPs flows into the Discharge Channel upstream of Outfall 001.

The Facility representative explained that monitoring samples at Outfall 001 are collected from the Discharge Channel from the shoreline at the “NPDES Sampling Point 001” sign (Photograph 37). The Inspection Team observed that this location is not at the coordinates identified in the Permit and, moreover, a peninsula extends from the Discharge Channel’s eastern shore in a northwesterly direction, downstream from where Outfall 001 samples are collected. The main Discharge Channel flow goes to the west of the peninsula while samples are collected from backwater flow.

Photograph 37. DTE - Monroe Plant DSCN0123.JPG  
Description: View, facing west, of the NPDES Sampling Point 001 (001). The drainage canal is located just beyond the sign.

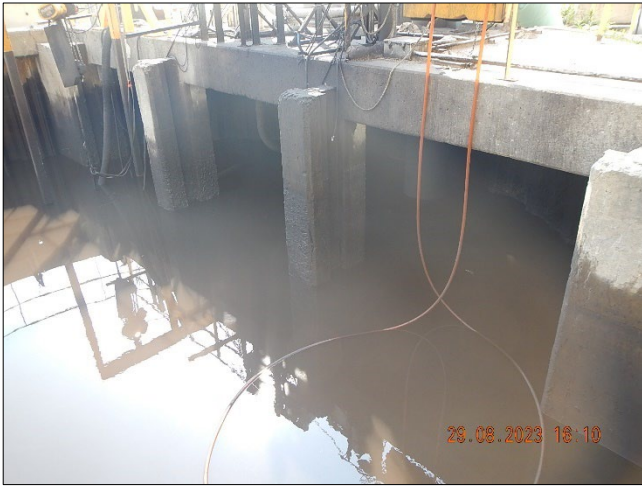
SS#2 is equipped with an oil skimmer (Photograph 45) and AST for used oil (Photograph 46) and discharges effluent by pump or gravity feed northwest to SS#1. Facility representatives stated the SS#2 skimmer was down for maintenance during the inspection.

Photograph 45. DTE - Monroe Plant DSCN0131.JPG  
Description: General view of the SS#2 skimmer.

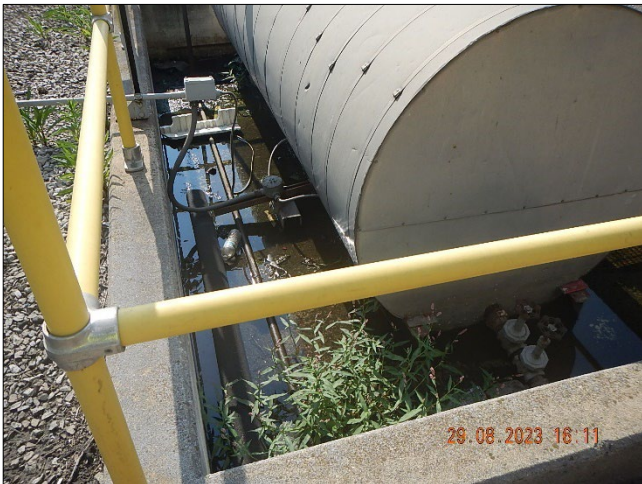
Photograph 46. DTE - Monroe Plant DSCN0132.JPG  
Description: View of the concrete containment area around the SS#2 single-wall used oil tank.

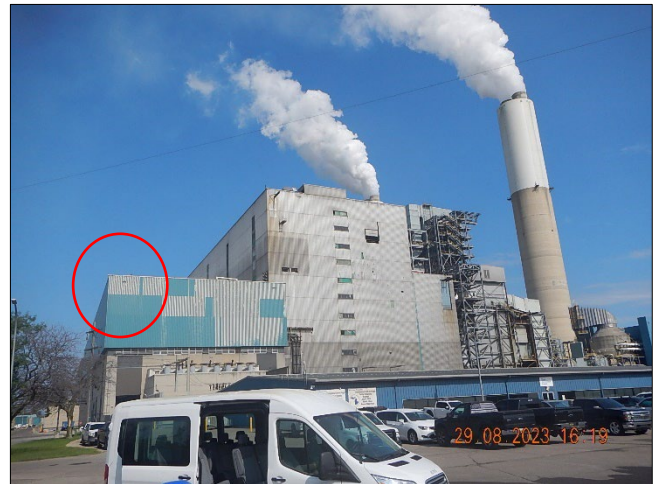
The Inspection Team observed SS#1, (Photographs 47, 49, 50, and 52) which collects wastewater from the floor drains in the south side of the Generating Building (Photograph 48), Unit 3 oil room sump, and SS#2 (Photograph 53). The Inspection Team walked through the Generation Building and observed the ASTs and floor drains which flow to the OWS which discharges to SS#1.

Photograph 48. DTE - Monroe Plant DSCN0134.JPG  
Description: View, looking northeast, at the Main Plant and PAC building in front of it. Roof drains on the northwestern side of the turbine house roof (circled) are piped to SS#1.

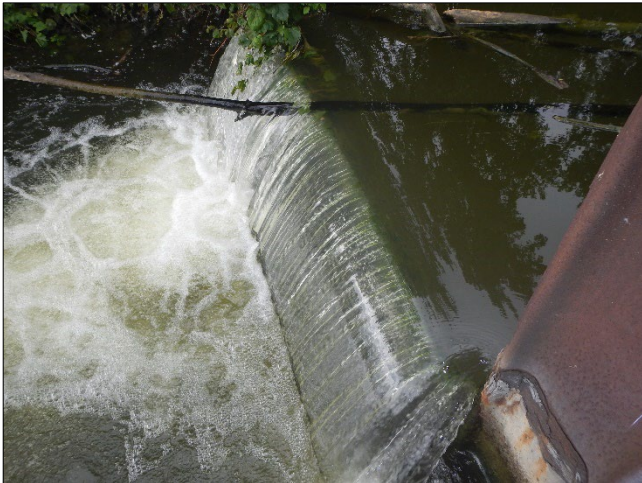
MP 001F is located where the discharge channel flows over a weir (Photographs 61, 62, 63, 64, 65, 66). Facility representatives collect monitoring samples from the weir curtain (Photograph 66). Flow rate through MP 001F is measured from the staff gage. The Inspection Team observed a boom across the MP 001F discharge channel, upstream of MP 001F, to capture floatable materials.

Photograph 66. DTE - Monroe Plant DSCN0152.JPG  
Description: Close view of the Outfall 001F effluent weir. The permittee referred to the weir as "v notch" but looked to be a rectangular weir.

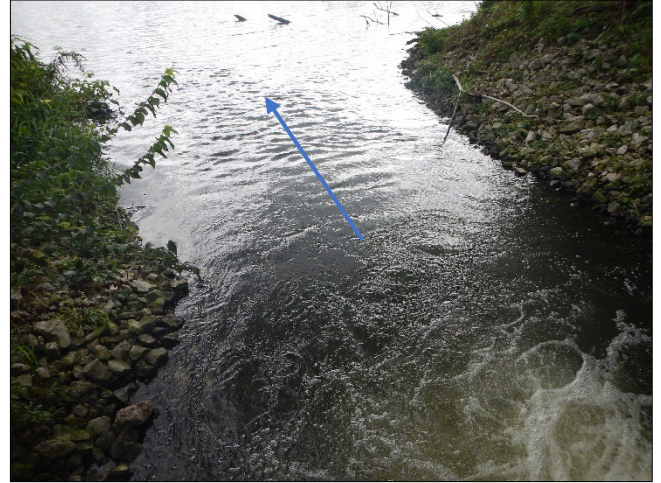
The Fly Ash Basin is located on the eastern side of the On Site area. MP 001F is located at the northeast corner of On Site (Photograph 68) and receives wastewater from the Fly Ash Basin via a discharge point along the eastern side of the basin that passes through three box weirs. Fly ash slurry is piped from the main plant and deposited into the Fly Ash Basin. At the time of

Photograph 68. DTE - Monroe Plant DSCN0154.JPG  
Description: View looking southeast at water flowing into the Discharge Canal from Outfall 001F.

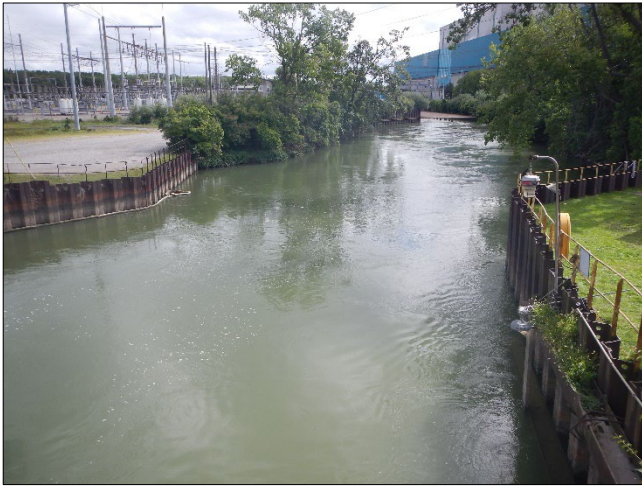
The Inspection Team observed MP 001A, located on the east side of the Main Plant entrance (Photograph 79). MP 001A is just upstream from the City of Monroe's municipal wastewater treatment plant (WWTP) outfall (Photograph 80). The Inspection Team observed where discharge from Outfall 001 combines with water in the Facility's Discharge Canal west of the City of Monroe WWTP outfall (Photograph 82).

Photograph 80. DTE - Monroe Plant DSCN0166.JPG  
Description: View, facing west, of the wastewater treatment plant outfalls into the discharge canal.

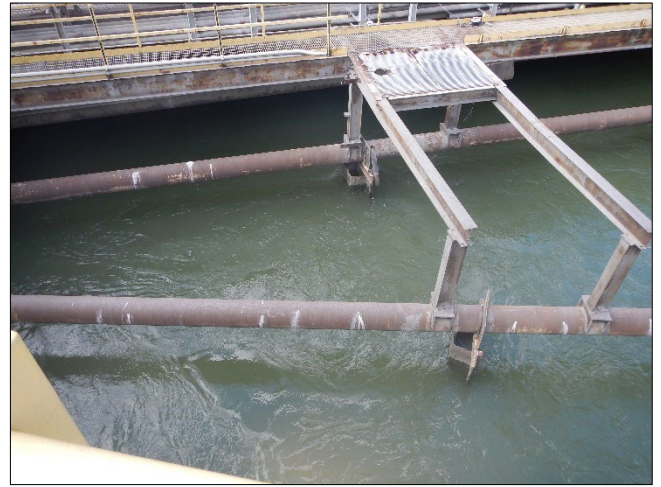
The Inspection Team observed that booms placed in the cooling water channel, upstream from Outfall 001A, were parallel to the flow instead of perpendicular to flow which could allow floatable material to reach Outfall 001A.

The Inspection Team observed that booms placed in the cooling water channel, upstream from Outfall 001A, were parallel to the flow instead of perpendicular to flow which could allow floatable material to reach Outfall 001A (Photographs 81 and 84).

Photograph 81. DTE - Monroe Plant DSCN0167.JPG  
Description: View, facing east, at the cooling water discharge canal.

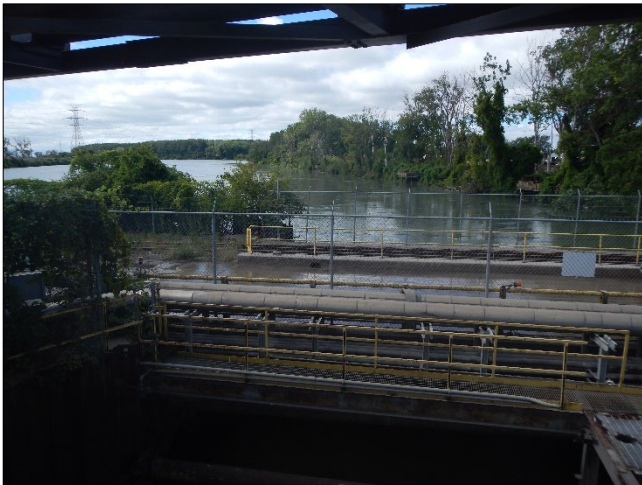
Photograph 82. DTE - Monroe Plant DSCN0168.JPG  
Description: General view, facing west, of where the discharge canal and cooling water discharge meet beyond 001A.

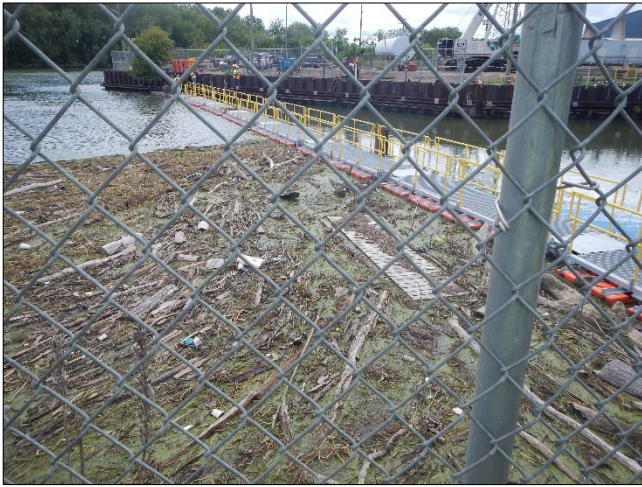
Facility representatives stated that 90 percent of the flow through MP 001A is cooling water. The Inspection team observed the process where the cooling water is diverted from River Raisin (Photograph 85) into the cooling water channel (Photographs 86 and 87), routed through the greenhouse building (Photograph 88), and returned to the cooling water channel upstream from Outfall 001A (Photograph 84). Effluent monitoring samples are collected from the middle of the cooling water channel at Outfall 001A (Photograph 83). Flow through Outfall 001A is based on maximum pump capacity, Outfall 001A is equipped with 12 pumps, which may result in the Facility overreporting flow through Outfall 001A.

Photograph 85. DTE - Monroe Plant DSCN0171.JPG  
Description: View, facing north, of cooling water intake location where water is taken from the River Raisin.

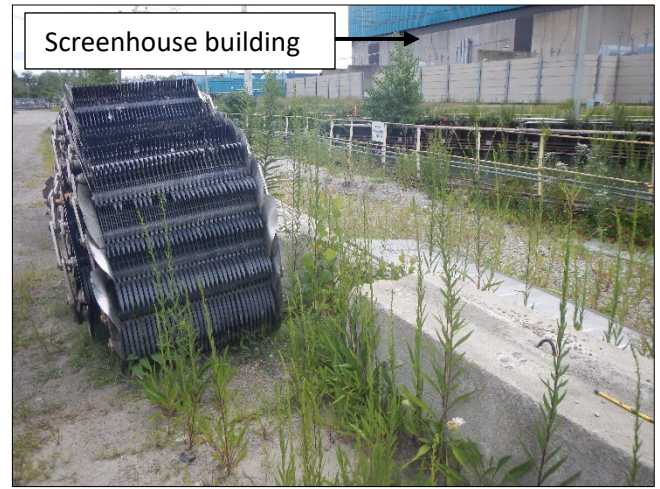
Photograph 87. DTE - Monroe Plant DSCN0173.JPG  
Description: Traveling screen next to the channel on the north side of the screen house building.

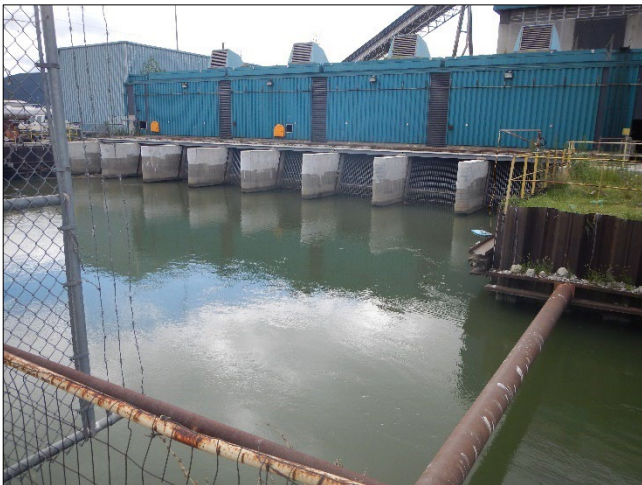
Photograph 86. DTE - Monroe Plant DSCN0172.JPG  
Description: View, facing south, of the cooling water intakes.

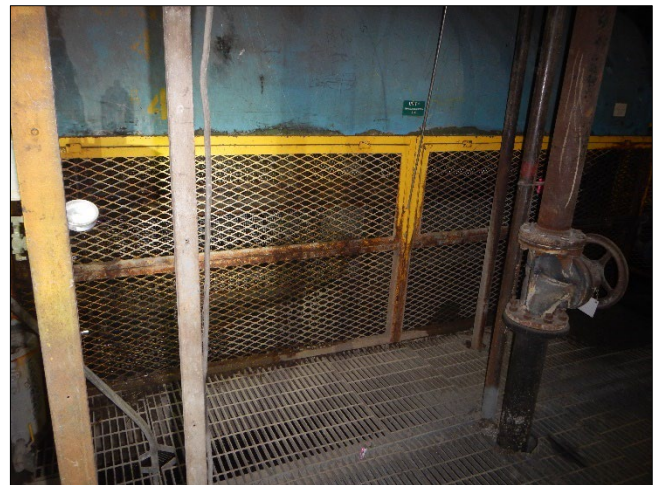
Photograph 88. DTE - Monroe Plant DSCN0174.JPG  
Description: General view inside the Number 3 and 4 screenhouse building.

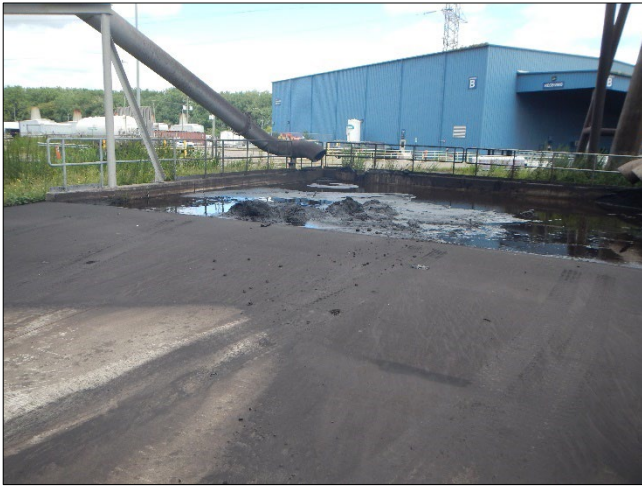
The Inspection Team observed coal fines on the ground outside the U2A Building (Photograph 90), south of Warehouse B (Photograph 92), and immediately east of the Coal Fines Washdown Pond (Photograph 89).

Photograph 89. DTE - Monroe Plant DSCN0175.JPG  
Description: View, facing north, of the Coal Fines Washdown Pond.

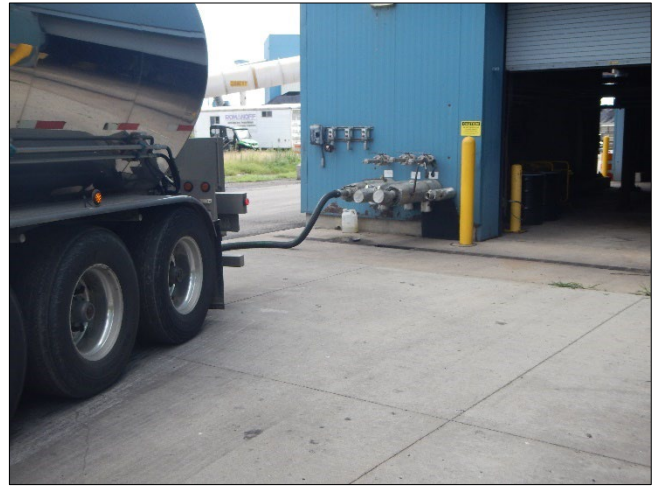
The Inspection Team observed a tanker unloading urea to the U2A building (Photograph 91) and coal fines on the ground adjacent to an outdoor work area, next to the U2A Building (Photograph 90). Facility representatives told the Inspection Team that urea offloading area drains to SS#4.

Photograph 91. DTE - Monroe Plant DSCN0177.JPG  
Description: View, facing south, of urea being offloaded into the U2A Building.

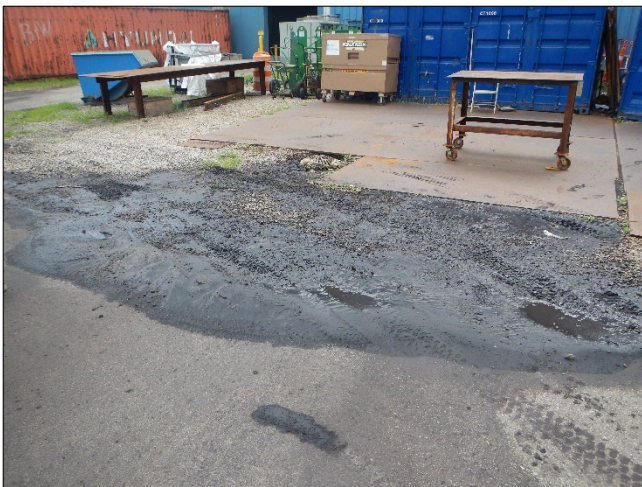
The April 2023 SWPPP, Section 5.2 states “drips, leaks, and spills are immediately cleaned up.”

Photograph 90. DTE - Monroe Plant DSCN0176.JPG  
Description: Coal fines on the ground adjacent to the U2A Building. Runoff from this area goes to SS#4.

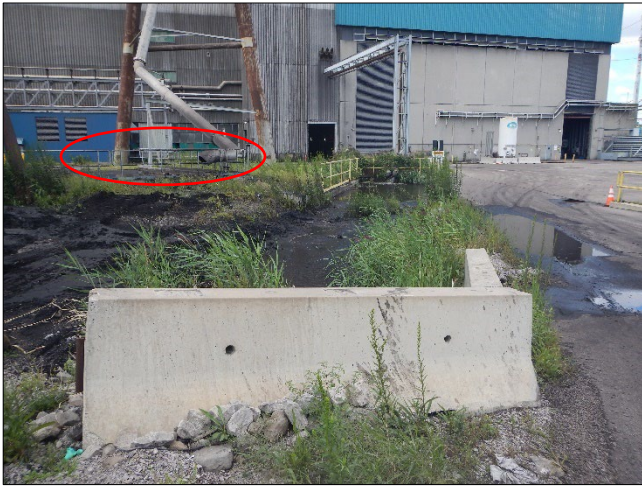
The Inspection Team observed coal fines on the ground immediately east of the Coal Fines Washdown Pad (Photograph 93), upstream of SS#4.

Photograph 93. DTE - Monroe Plant DSCN0179.JPG  
Description: Coal fines on the ground, immediately east of the Coal Fines Washdown Pond (circled, see also Photograph 89).

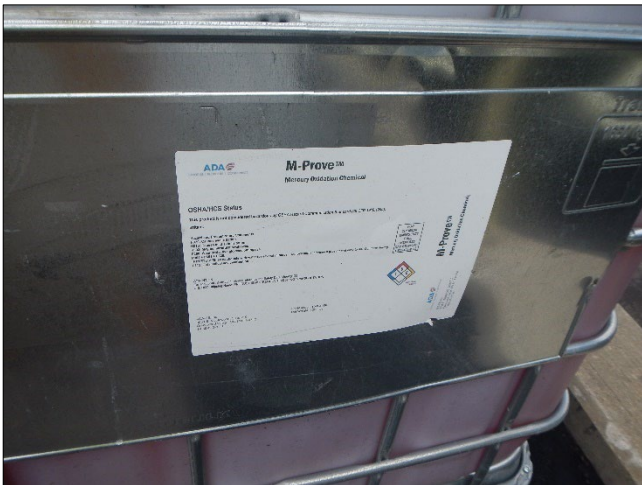
The Inspection Team observed chemical totes and hoppers stored outside without cover or containment on the east side of Warehouse B (Photographs 92, 94, and 95). The Inspection Team observed accumulated stormwater in the hoppers (Photograph 96).

Chemical totes and hoppers were observed to be stored outside without cover or containment (Photographs 92, 94, 95, and 96).

Photograph 94. DTE - Monroe Plant DSCN0180.JPG  
Description: Up-close view of totes seen in Photograph 92.

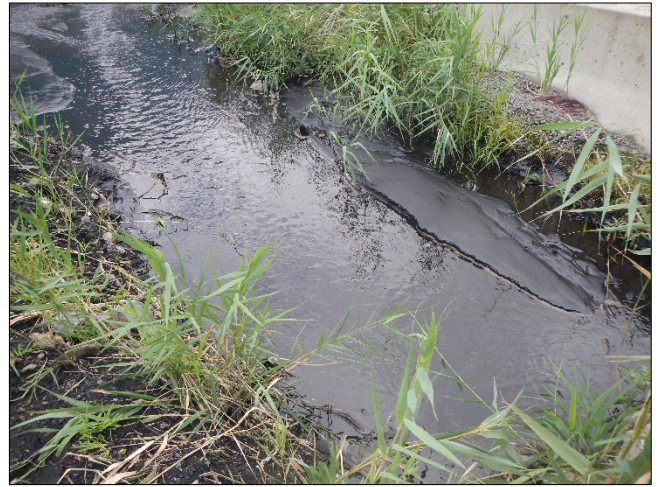
Photograph 99. DTE - Monroe Plant DSCN0185.JPG  
Description: The Process Swale starts east of SS#4.

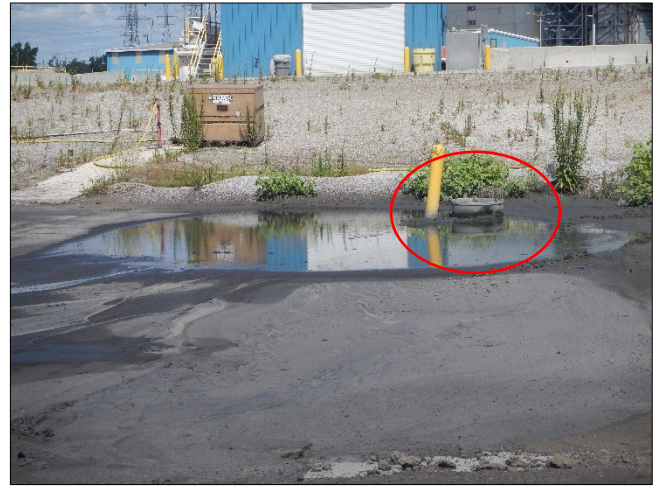
When cleaned the material from the primary basins is placed on the transfer pad to be sold, and the secondary basin material receives additional drying before it is taken to a dry landfill offsite (Photographs 106 and 111). The Inspection Team observed that the transfer pad was equipped with a sump at each corner, each sump pumps back to the sedimentation basins (Photograph 107).

Photograph 107. DTE - Monroe Plant DSCN0193.JPG  
Description: The Bottom Ash Transfer Pad is equipped with a sump in each corner (circled). The sumps pump stormwater back to the sedimentation basins.

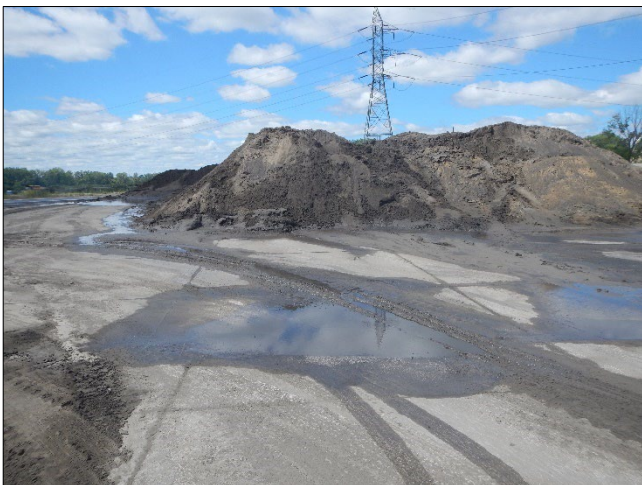
Photograph 106. DTE - Monroe Plant DSCN0192.JPG  
Description: View, facing south, of the Bottom Ash transfer Pad.

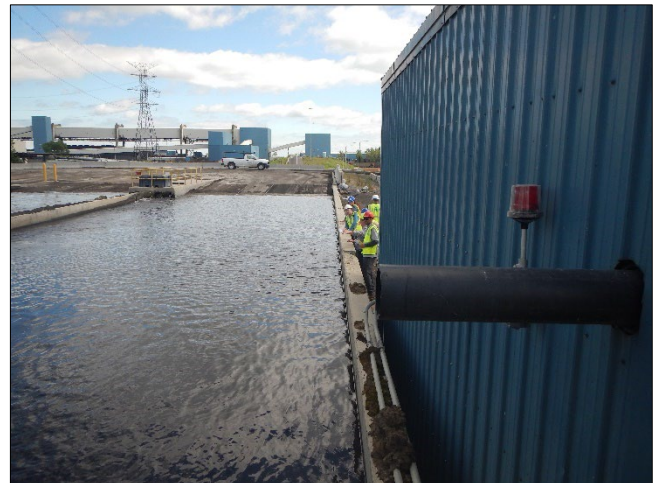
The bottom ash transfer (BAT) is the Facility location for dewatering bottom ash. The dewatering process includes primary and secondary basins for each of the four power generating units. The water passes through the primary settling basin (Photographs 108 and 109) to the secondary settling basin by gravity (Photographs 110, 112, and 113). Water that leaves the basin enters the process swale. Facility representatives stated that maintenance is performed by stopping the flow to the basins and that the primary settling basins are cleaned every other day and the secondary approximately every two weeks.

Photograph 108. DTE - Monroe Plant DSCN0194.JPG  
Description: View, facing east, of the Bottom Ash Transfer Area sedimentation basins.

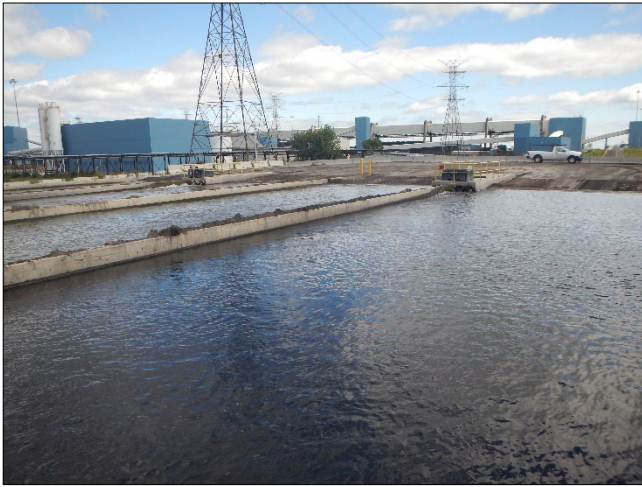
Photograph 109. DTE - Monroe Plant DSCN0195.JPG  
Description: Additional view, facing east, of the Bottom Ash Transfer area sedimentation basins see in Photograph 108.

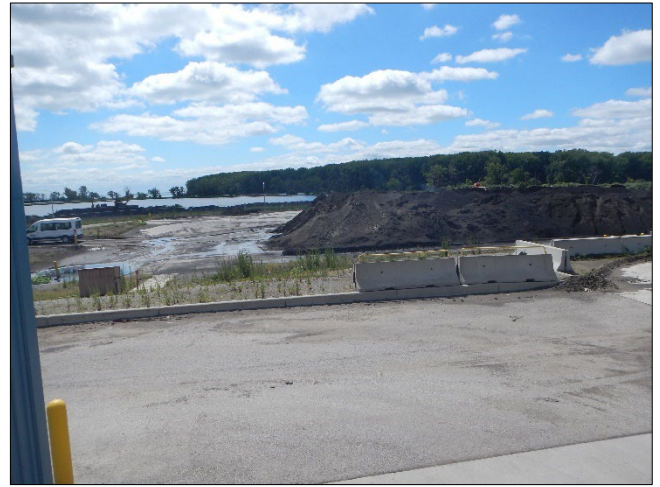
Photograph 111. DTE - Monroe Plant DSCN0197.JPG  
Description: View, facing south, of the CCR Transfer Pad and Bottom Ash Transfer Pad.

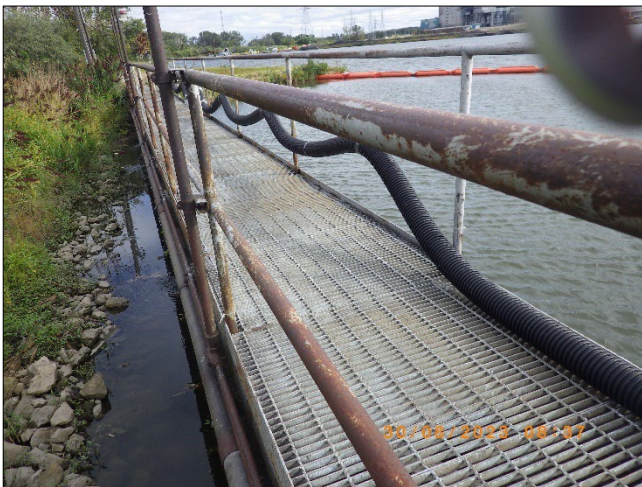
The Inspection Team reviewed DMRs for April, May, and June 2023. Monitoring results from MP 001B were not provided on these three DMRs. The Inspection Team observed leaks in the containment wall between the Inactive Bottom Ash Basin and the Discharge Channel on August 29, 2023. Several members of the Inspection Team returned to MP 001B on August 30, 2023 and photo documented that the Inactive Bottom Ash Basin was leaking through the containment wall to the Discharge Channel at several locations north and south of the MP 001B (Photographs 116, 117, 118, 119, 120, 121, and 122).

Photograph 120. DTE - Monroe Plant RIMG3197.JPG  
Description: General view of walkway on the western side of the inactive bottom ash basin.

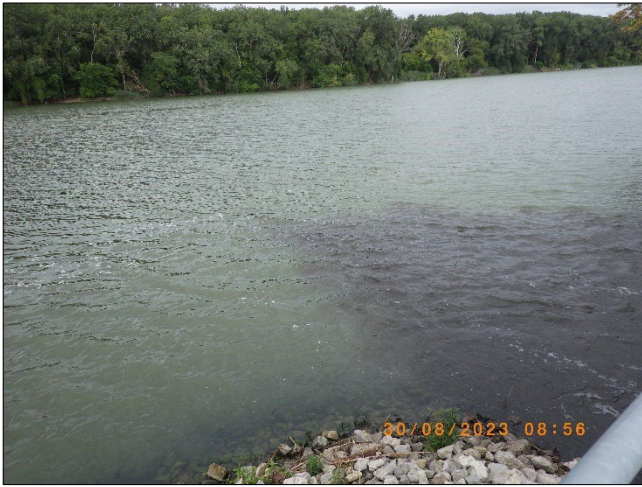
The Inspection Team observed a plume of discoloration at MP 001H. Water was collected for observation purposes on August 20, 2023. The source of the plume was unknown, Facility representatives suggested that the plume resulted from recent storm events that stirred up sediment in the South Process Pond (Photographs 123, 124, and 126).

Photograph 125. DTE - Monroe Plant RIMG3202.JPG  
Description: View of the water discoloration by 001H when the plastic water bottle samples were taken on August 30, 2023.
