## EPA Region 10 Enforcement Division

### INSPECTION REPORT

| Company Name | King County DOT Department of Local Services - Road Services Division | |

**APPENDIX 1: PHOTO LOG**

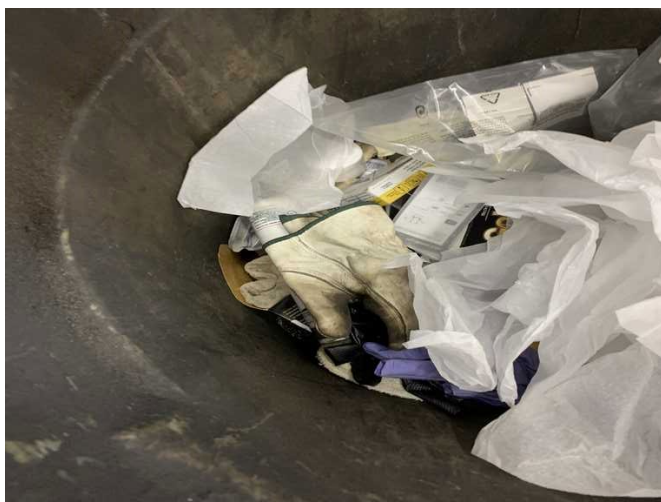
| [Title] | IMG_0026.jpg | |

| Close-up view of the same waste aerosol can in the trash receptacle. | | |

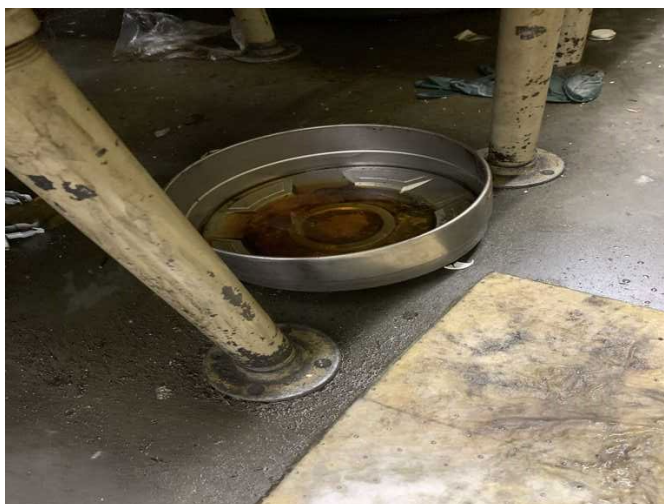
| [Title] | IMG_0030.jpg | |

| View of another used oil drain pan that is not labeled with the words "Used Oil." | | |

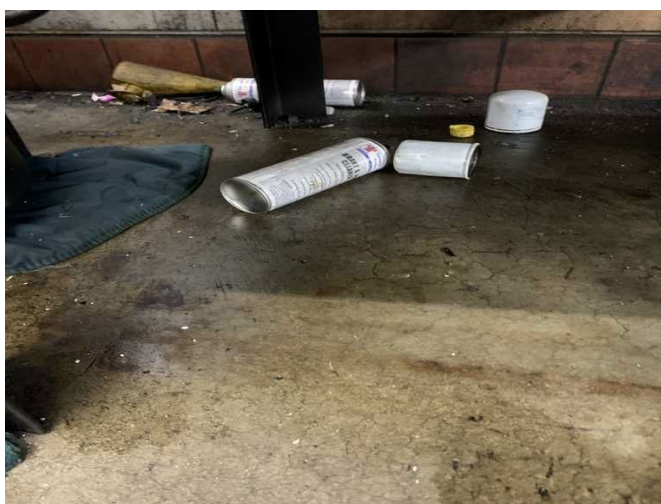
| [Title] | IMG_0033.jpg | |

| crusher. At the time of the inspection, the facility was not managing their waste aerosol cans as hazardous waste. | | |

| View of waste aerosol cans seen here on the floor behind the facility's oil filter crusher. | | |

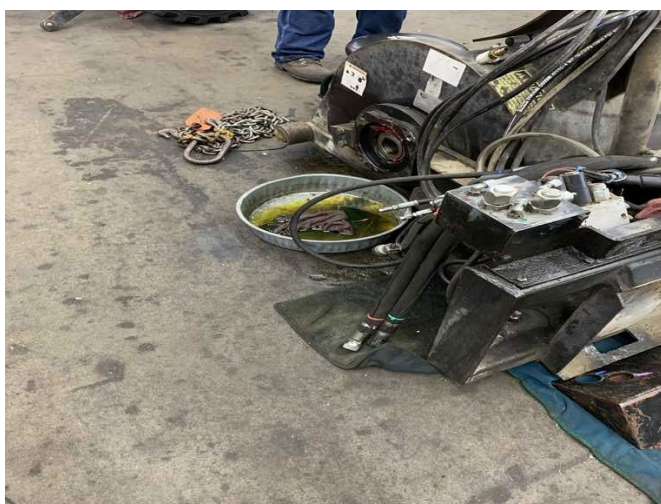
| [Title] | IMG_0007.jpg | |

| View of an oil drain pan that contains used oil and is not labeled with the words "Used Oil." | | |

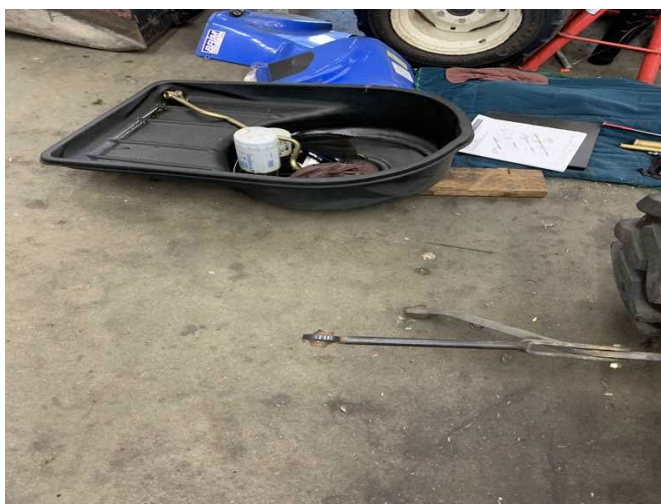
| [Title] | | IMG_0009.jpg | |

| Another view of the same unlabeled used oil drain pan seen in IMG_0006.jpg and IMG_0007.jpg | | | |

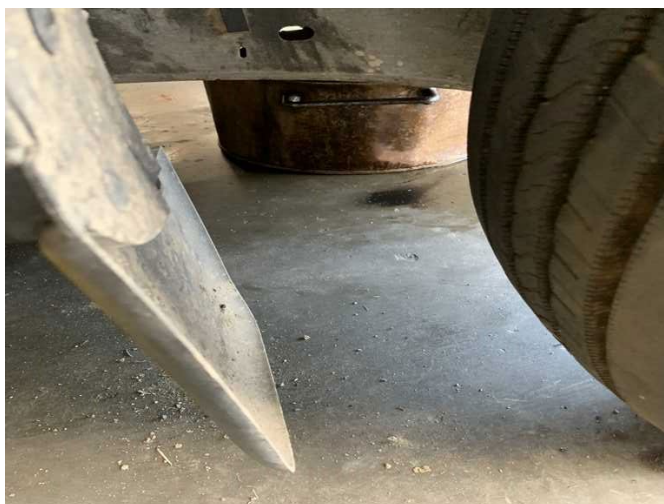
| [Title] | IMG_0012.jpg | |

| Another view of the same used oil drain pan seen in IMG_0009.jpg | | |

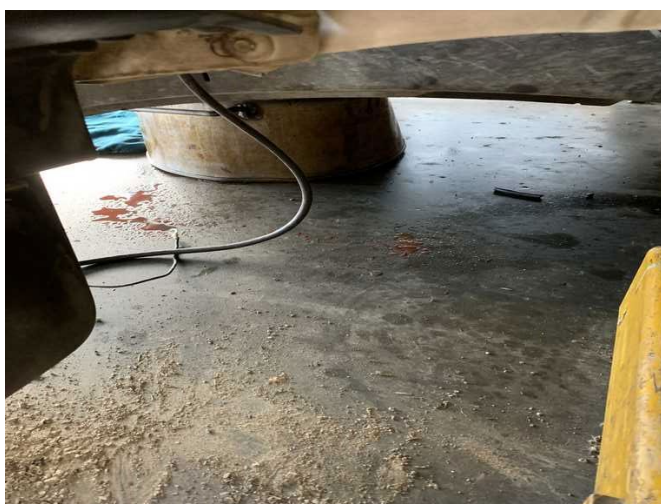
| [Title] | IMG_0013.jpg | |

| Another view of an unlabeled used oil drain pan. | | |

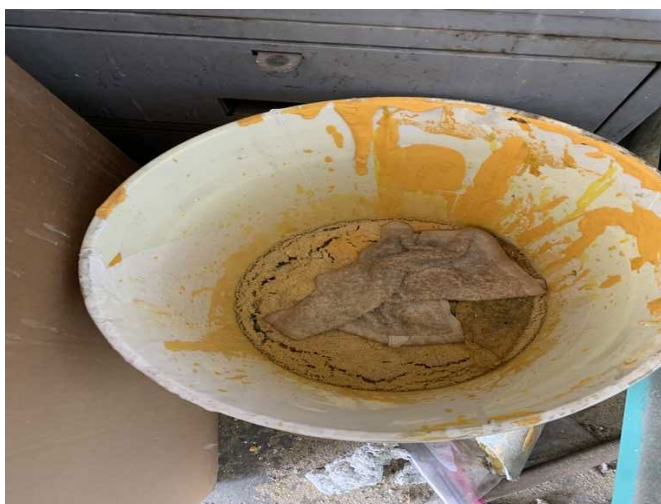
| [Title] | IMG_0062.jpg | |

| View of a bucket of mop water that is a dark color and was described as oily water, leading to questions of whether a dangerous waste designation needs to be made. | | |

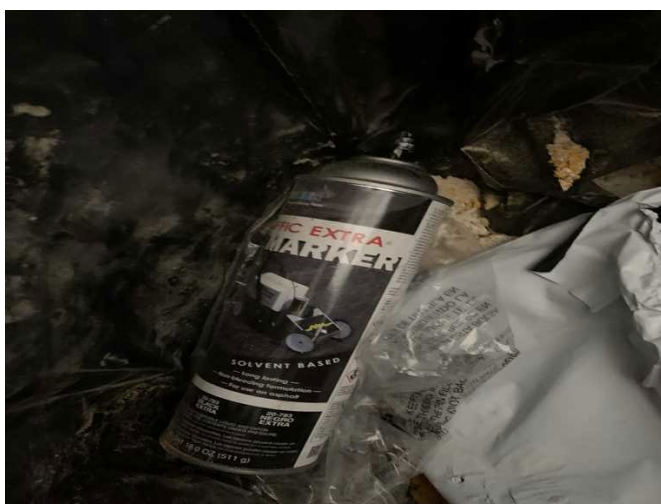
| [Title] | IMG_0061.jpg | |

| View of a waste aerosol can in a trash receptacle. | | |

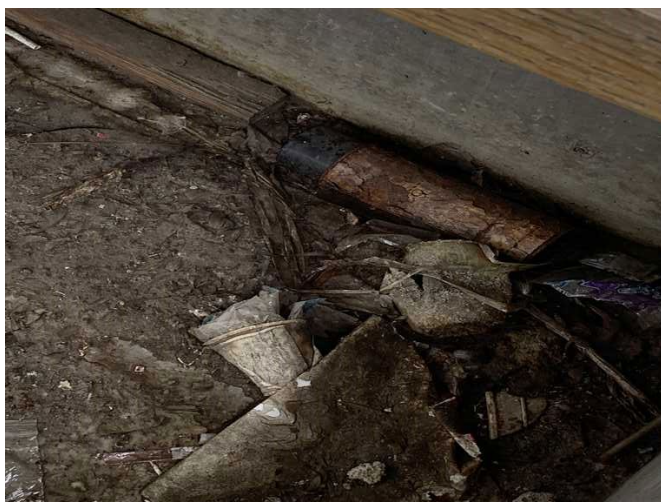
| [Title] | | IMG_0046.jpg | |

| View of damaged container of traffic paint that appears to need a waste determination. | | | |

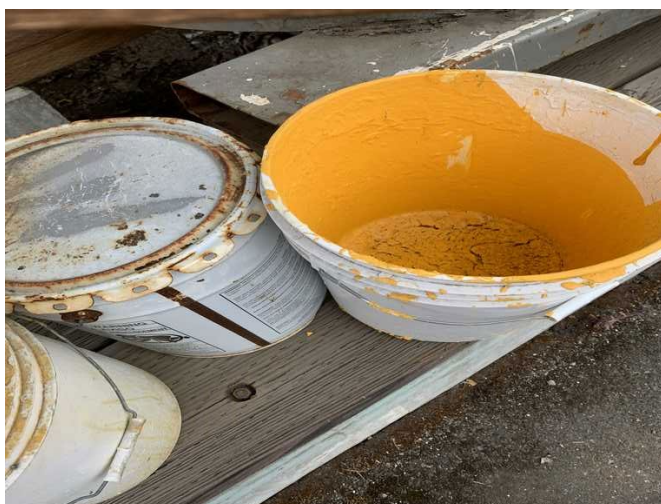
| [Title] | | IMG_0037.jpg | |

| View of another 5-gallon container that holds waste traffic paint that was allowed to dry out in the container. | | | |

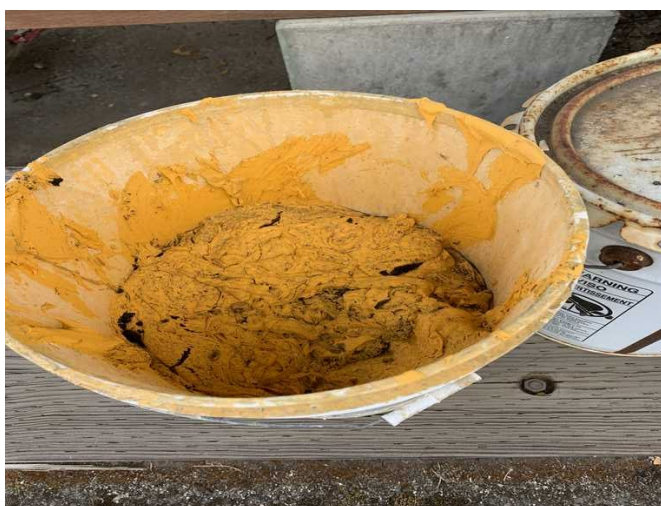
| [Title] | | IMG_0036.jpg | |

| View of three 5-gallon traffic paint containers that require a waste determination. Two of the three containers hold waste yellow traffic paint that had been allowed to dry out in the containers. | | | |

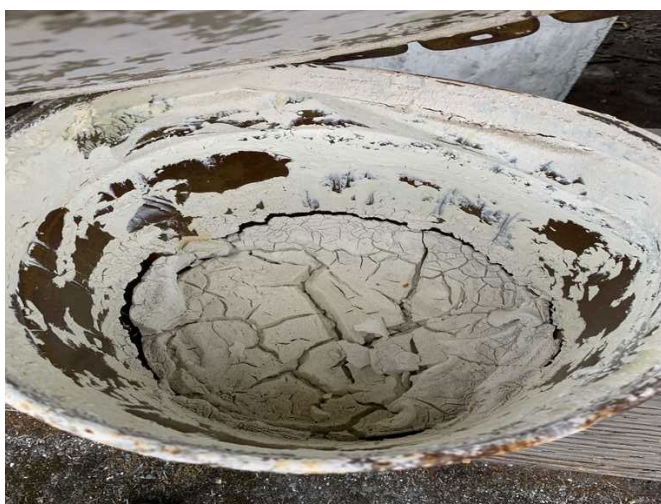
| [Title] | IMG_0039.jpg | |

| View of the closed container of traffic paint that requires a waste determination. | | |

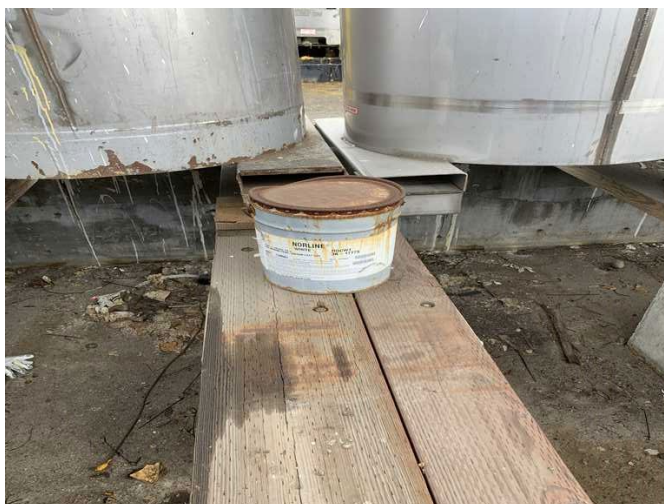
| [Title] | IMG_0043.jpg | |

| View of waste yellow traffic paint that had been allowed to dry out in the container. | | |

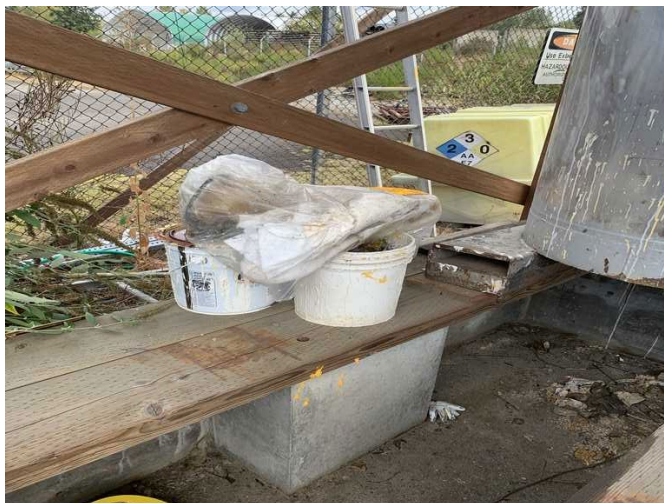
| [Title] | | IMG_0050.jpg | |

| View of another 5-gallon container of waste yellow traffic paint that had been allowed to dry out in the container. | | | |

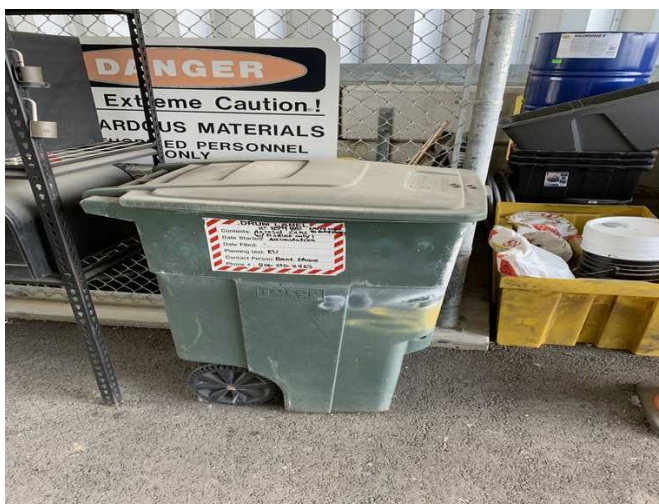
| [Title] | IMG_0063.jpg | |

| A trash receptacle outside the fenced CAA had a capacity of 96 gallons and contained approximately 25 waste aerosol cans. Facility personnel stated that the container was being utilized as a satellite accumulation area (SAA) container. The SAA container was not labeled with the words "Hazardous Waste" and was not marked with a hazard indicator.. Mr. Dhoore labeled the container with the words "Hazardous Waste" and a hazard indicator during the inspection. | <b>Citations:</b> | <b>Sections:</b> |

| View of a trash receptacle that is being used as a SAA container for the accumulation of waste aerosol cans. | | |

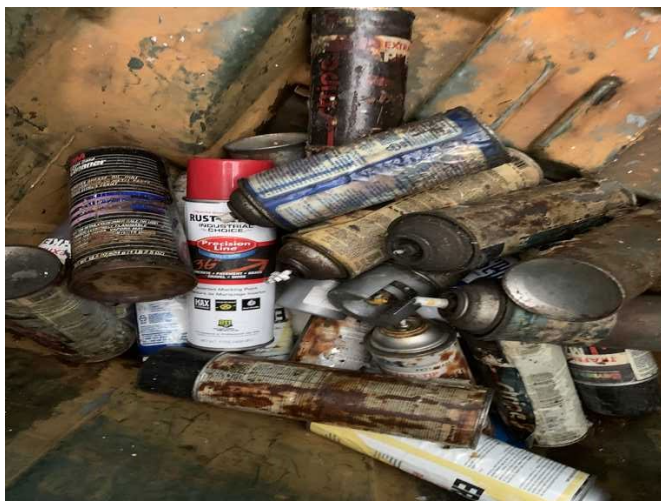
| [Title] | IMG_0066.jpg | |

| View of the waste aerosol cans inside the waste aerosol SAA container. | | |

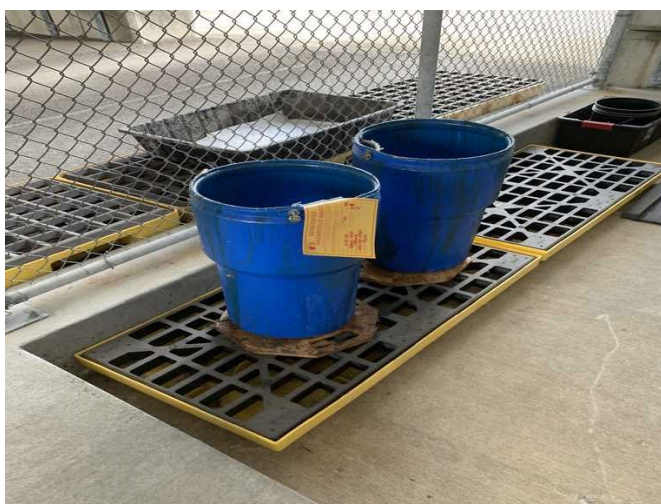
| [Title] | | IMG_0071.jpg | |

| Two, blue, 15-gallon containers held waste epoxy resin and had been brought into the CAA on 8/10/22. At the time of the inspection, both containers were not closed. One of the two was labeled with the words "Hazardous Waste" and marked with an ASD of 8/10/22, but had no hazard indicator. The second of the two was not labeled with the words "Hazardous Waste" or marked with a hazard indicator and ASD. | <b>Citations:</b> | <b>Sections:</b> |

| View of the two open containers of waste epoxy. | | | |

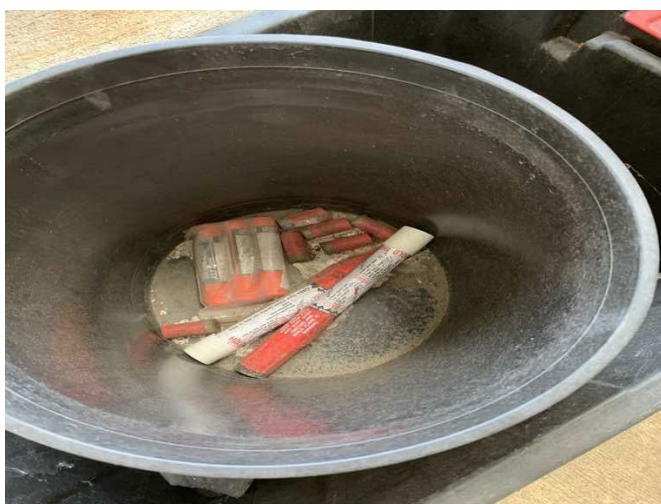
| [Title] | IMG_0078.jpg | |

| A 5-gallon container held hazardous waste flares but at the time of the inspection, the container was not labeled with the words "Hazardous Waste" and not marked with an ASD. The container was also not closed. | <b>Citations:</b> | <b>Sections:</b> |

| View of the open container of waste flares seen in the CAA. | | |

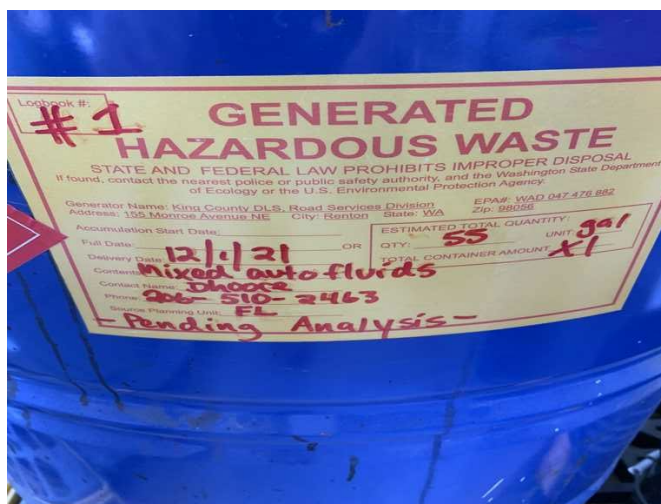
| [Title] | IMG_0080.jpg | |

| View of the label on a container of mixed auto fluids that is also marked as "Pending Analysis." The date on the container indicates that the waste has been in accumulation for greater than 90 days. | | |

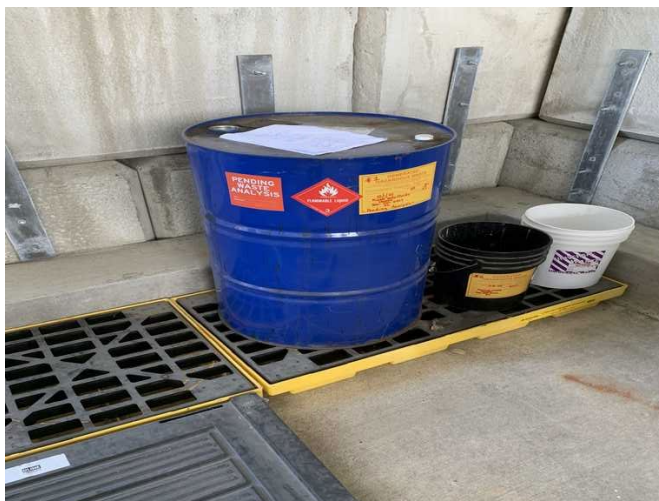
| [Title] | IMG_0079.jpg | |

| View of the container holding waste auto fluids that has been in accumulation at the CAA for greater than 90 days. | | |

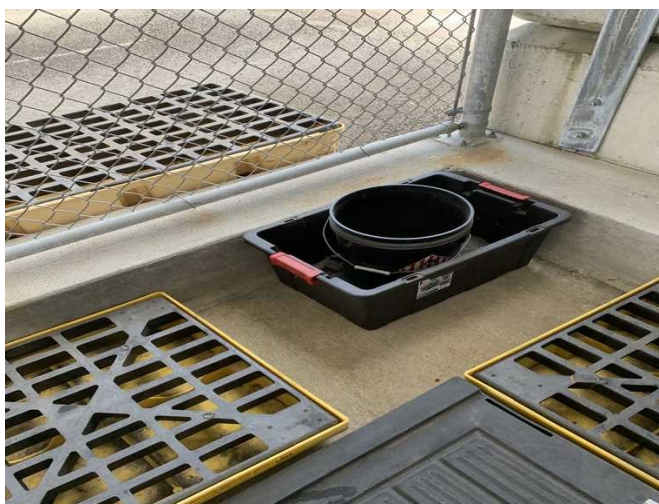
| [Title] | IMG_0076.jpg | |

| View of an open container of waste Chlor-d-tect kits. | | |

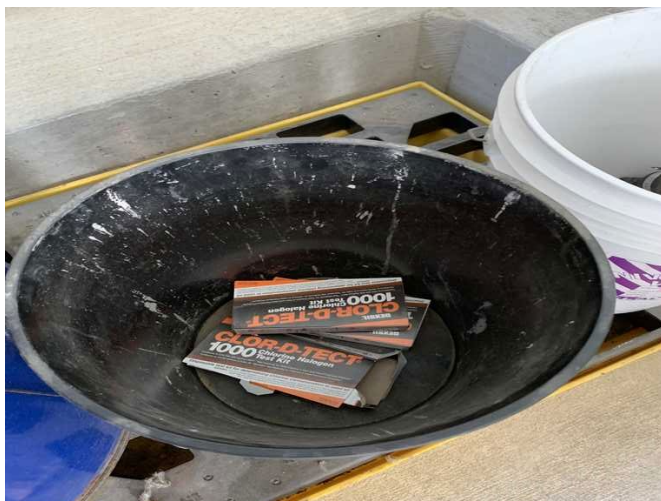
| [Title] | IMG_0082.jpg | |

| View of the waste Chlor-d-TECT kits inside the open container. | | |

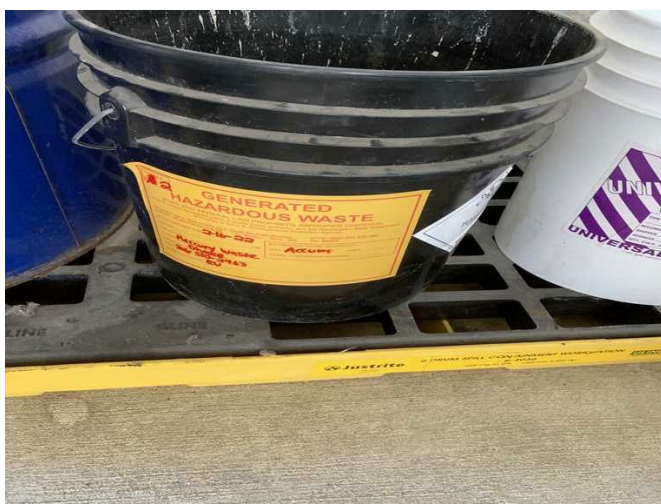
| [Title] | IMG_0081.jpg | |

| Close-up view of the label on the container of waste chlor-d-TECT kits. | | |

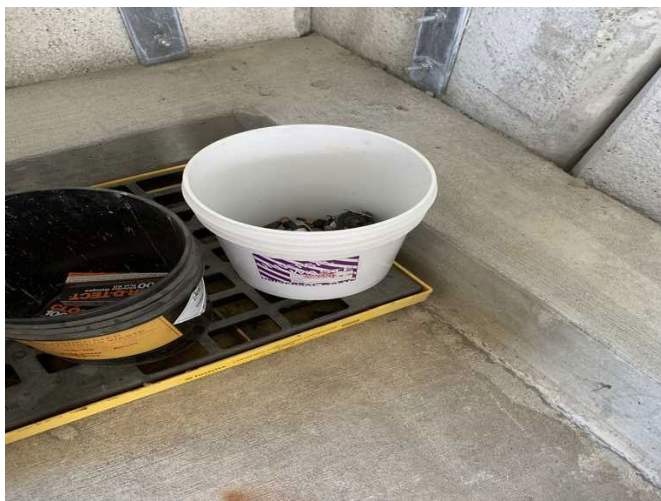
| [Title] | | IMG_0083.jpg | |

| Another view of the container of universal waste mercury switches. | | | |

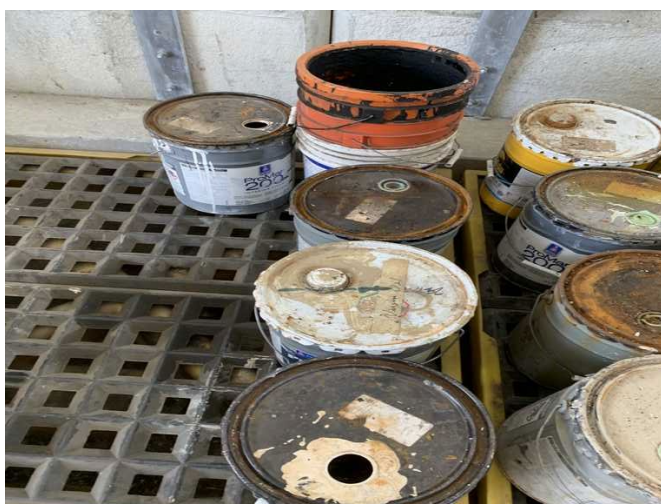
| [Title] | | IMG_0087.jpg | |

| The facility takes in orphaned waste that is left on the roadside in King County and during my inspection of the CAA I saw a pallet that contained twenty 5-gallon containers of various wastes. Seventeen of the containers were not labeled with the words "Hazardous Waste" or marked with hazard indicators. Two 5-gallon waste containers that were also not labeled with the words "Hazardous Waste" or marked with hazard indicators, and they were also not closed. There was also one 5-gallon container that was labeled with the words "Hazardous Waste" but wasn't marked with a hazard indicator. | <b>Citations:</b> | <b>Sections:</b> |

| View of two containers of orphaned waste in the CAA, each with an open bung hole. | | | |

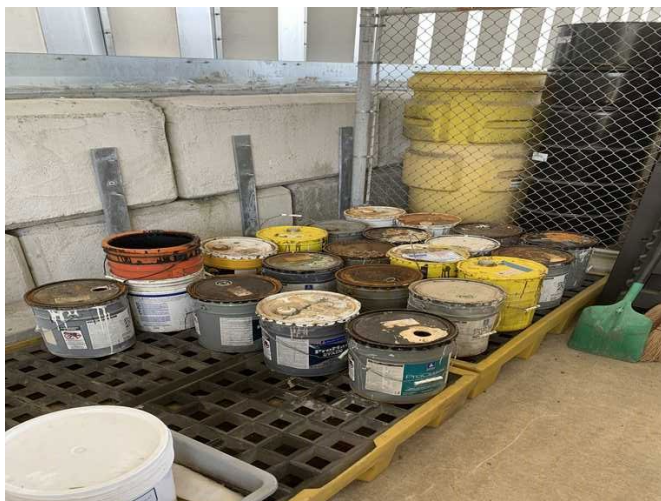
| [Title] | | IMG_0086.jpg | |

| View of the orphaned waste containers inside the CAA. | | | |

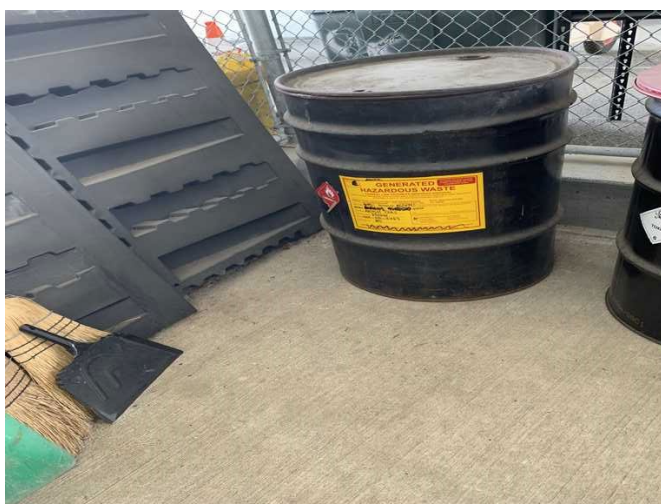
| [Title] | | IMG_0090.jpg | |

| View of the waste aerosol accumulation container inside the CAA that was not closed and had been in accumulation for greater than 90 days. | | | |

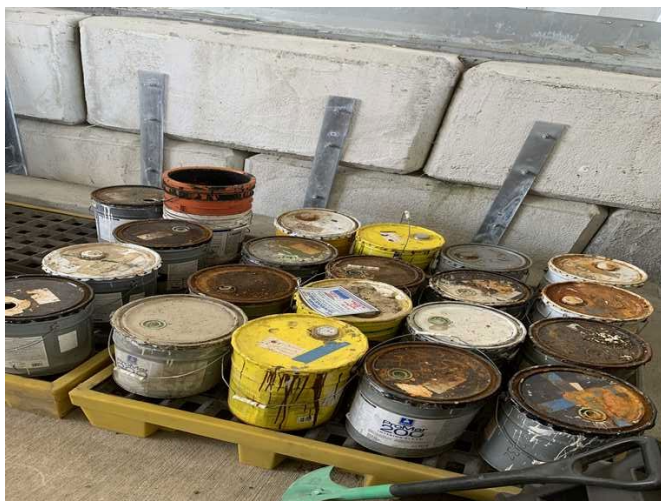
| [Title] | | IMG_0089.jpg | |

| Another view of the orphaned waste containers in the CAA. | | | |

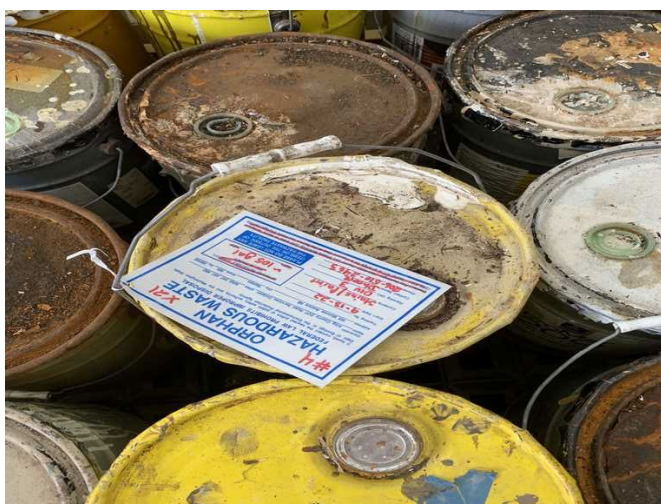
| [Title] | | IMG_0088.jpg | |

| View of the only orphaned waste container upon which a label with the words "Hazardous Waste" and an ASD had been placed. | | | |
